**Phase 1 Investigation  
For A Proposed Development  
On Land Adjacent To  
9 Taylors Lane,  
Bolton  
BL2 6QS**

**On Behalf of Ms Haslam**

**Date: February 2013**

**Report QA No. 13016**

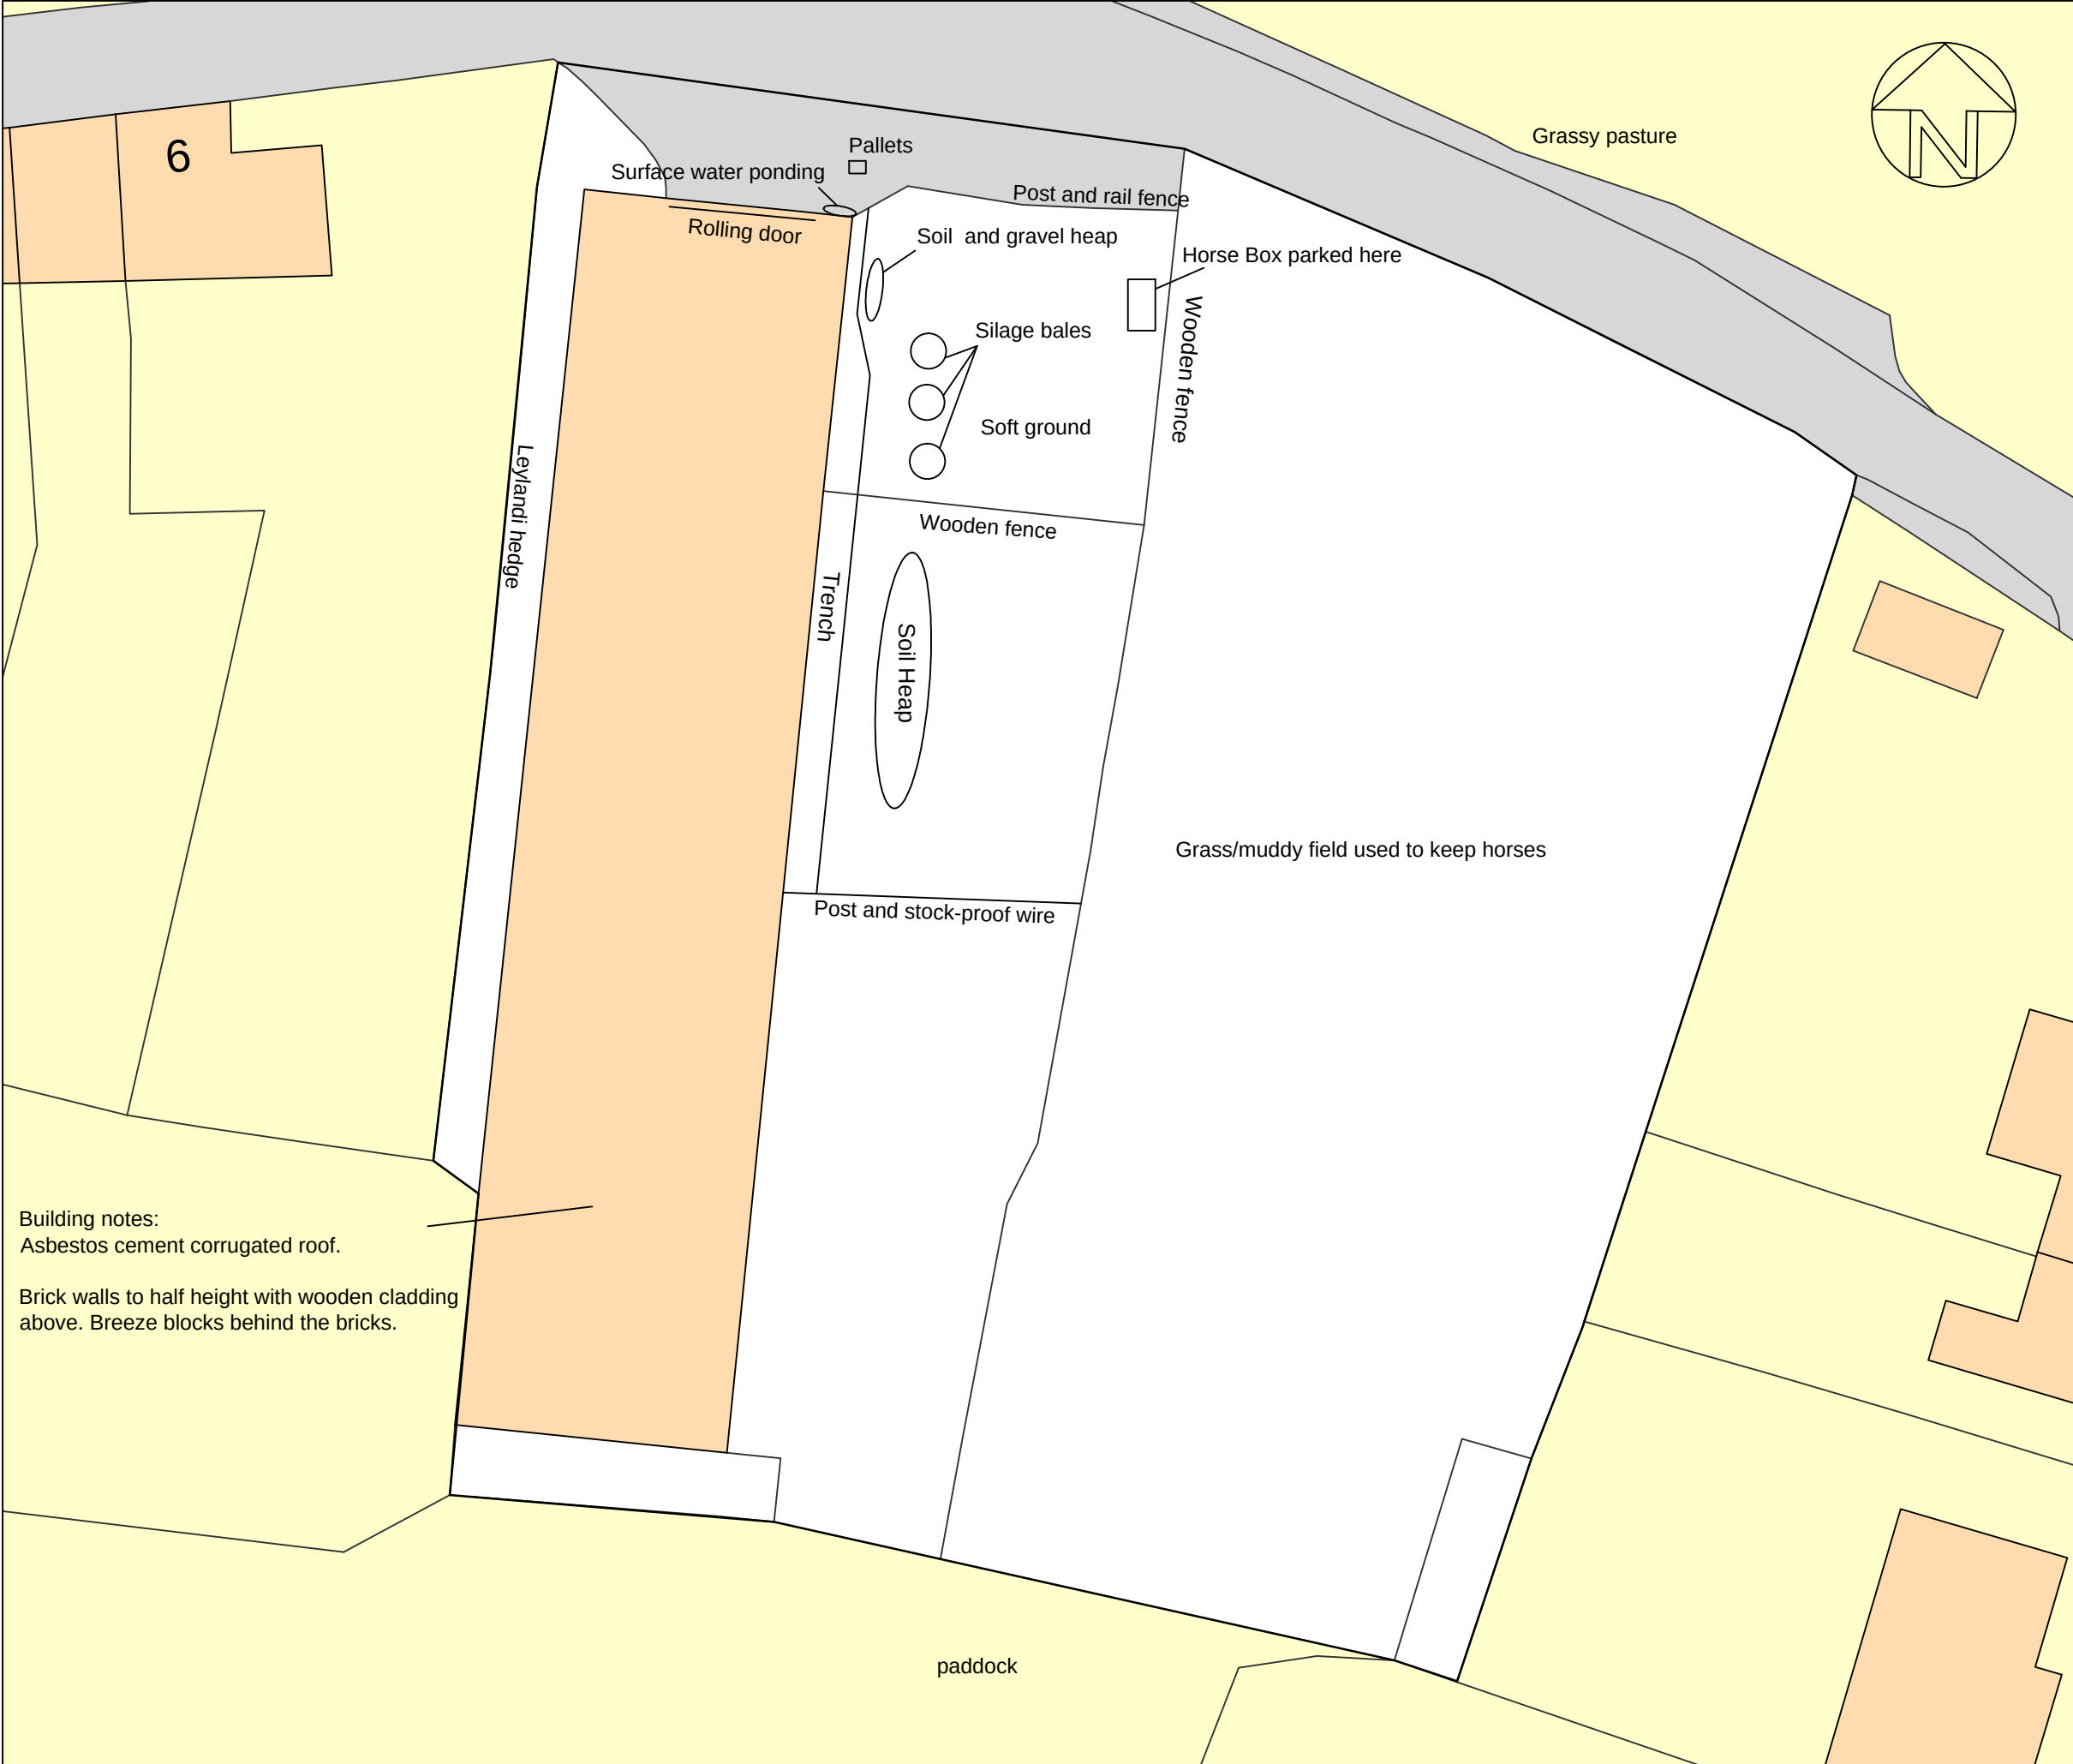
PLAN TITLE  
Key Site Features

Building notes:  
Asbestos cement corrugated roof.

Brick walls to half height with wooden cladding above. Breeze blocks behind the bricks.

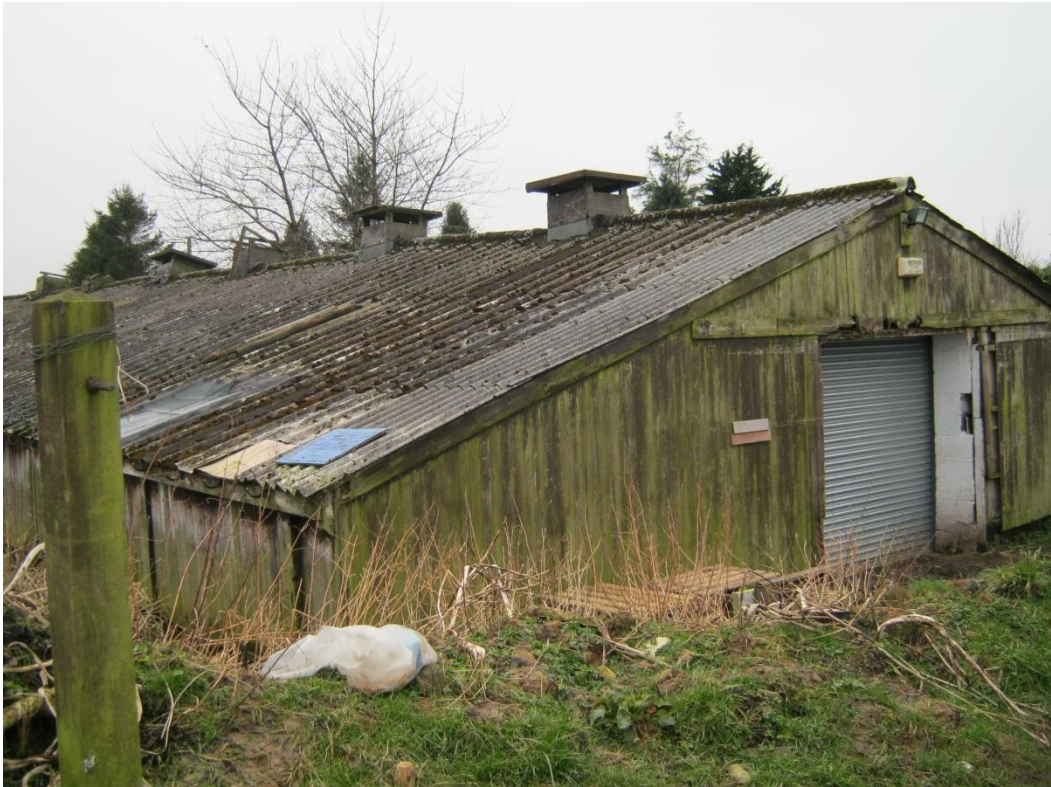
The site comprises a large single storey building (22m x 5m, photo 1) adjacent to the western site boundary and four paddocks used for keeping horses. The building is used for stabling horses (southern half) and restoring old cars (northern half) and has reportedly been used in the past to keep poultry. The building is constructed from breeze blocks with bricks cladding the exterior to half height (approximately 1m) and wooden cladding above. The roof is constructed from corrugated asbestos cement sheets, cracked and patched in places. The floor comprises a concrete slab, which appeared to be in reasonable condition. No staining was observed associated with the storage of cars. Access to the building is via a rolling aluminium door.

Photo 1: The Northern end of the barn, with the pallets and standing water in the foreground.

The roof of the building is very likely to be constructed from corrugated asbestos cement sheets. Prior to demolition, an asbestos survey should be undertaken by a qualified professional and any Asbestos Containing Materials (ACM) identified removed by a licensed contractor prior to demolition.

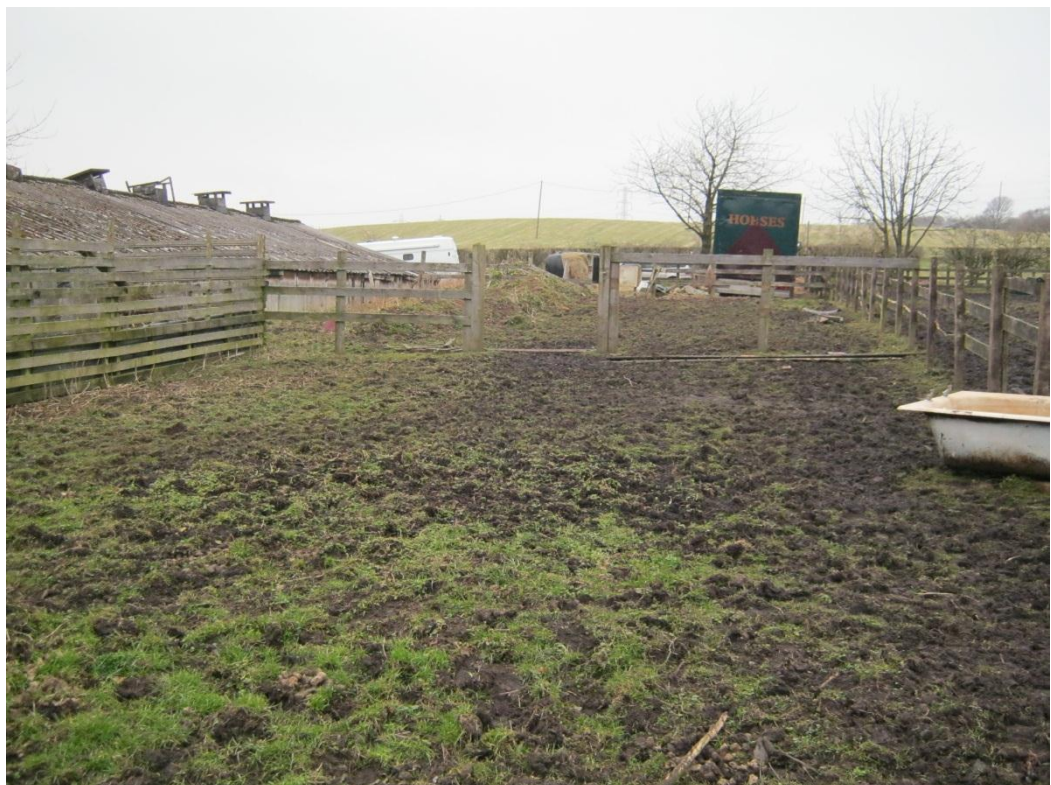
With the exception of the building, the site is surfaced with soft ground. The ground was observed to be wet and very muddy, where horses have torn it up (photo 2). The ground immediately adjacent to the building has been lowered by approximately 1m to prevent surface water from running into the building (photo 3), and the removed soil is stockpiled in long mounds in the paddocks adjacent to the building. The mounded soil appeared clean and clay-rich (photo 4).

Photo 2: View from the southern boundary up towards the horse box.

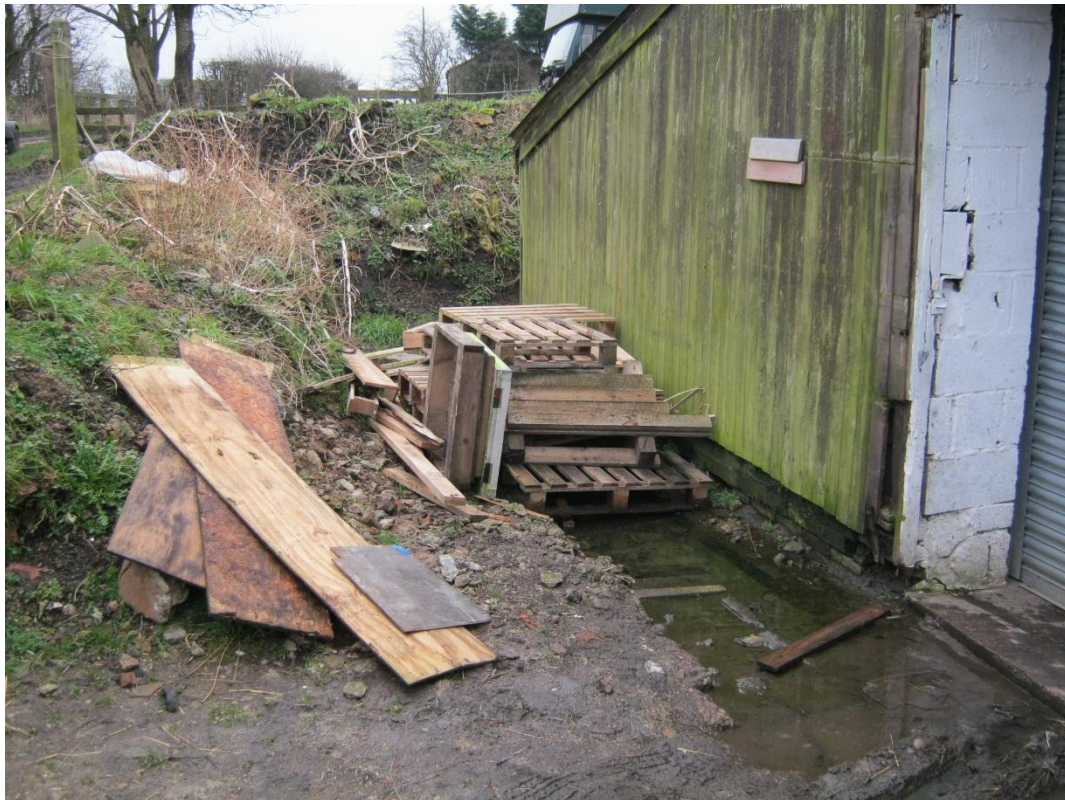
Photo 3: Wooden pallets and standing surface water in front of the entrance to the barn.

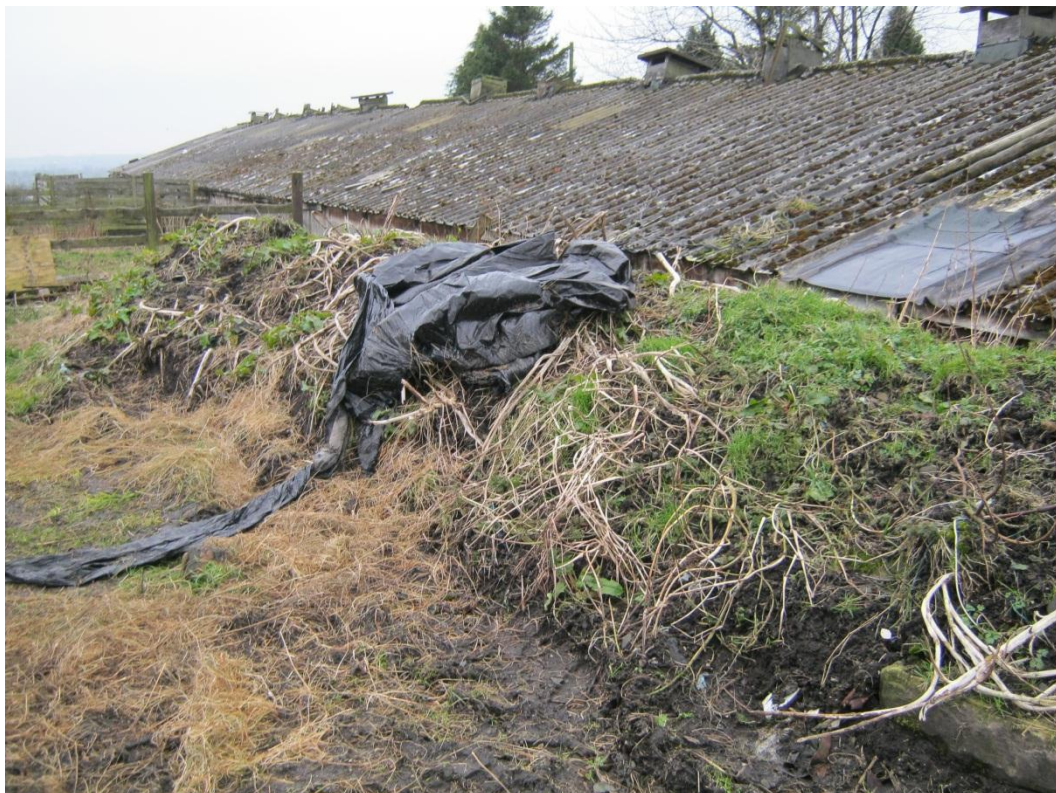
Photo 4: Stockpile of soil at the eastern edge of the barn.

A check on quality of topsoil and sub-soil intended for retention or re-use in proposed garden and other soft landscaped open spaces to confirm suitability.

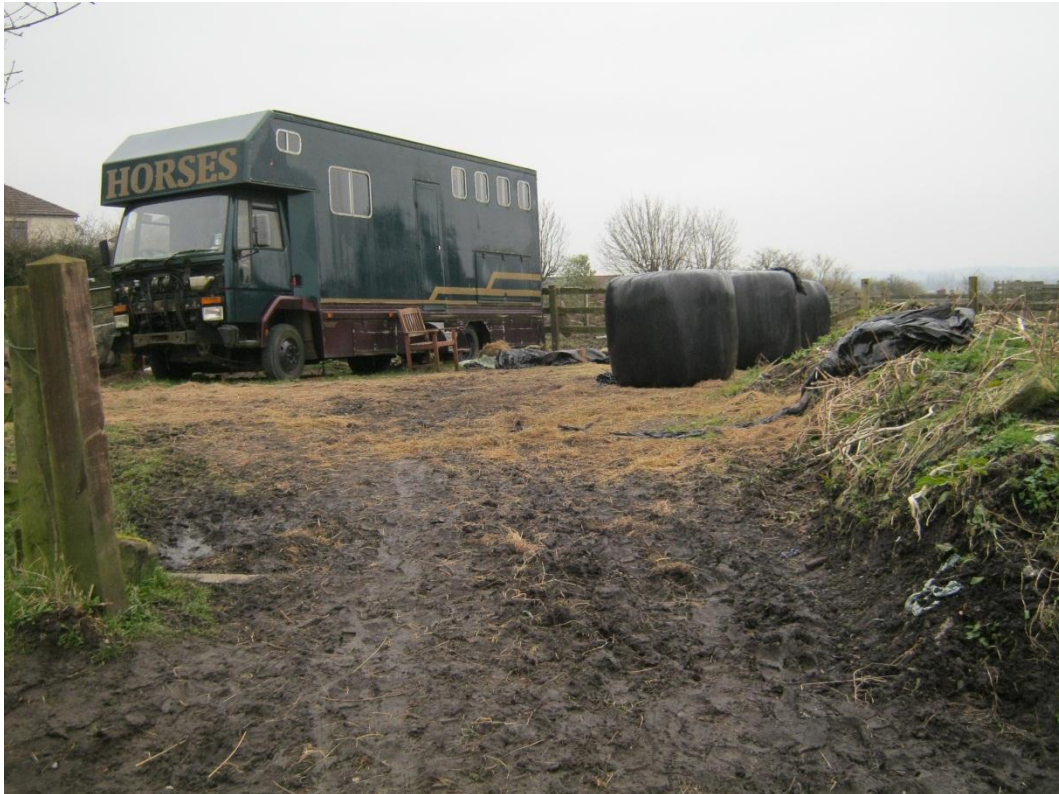
A horse box is parked on site, near the site entrance (photo 5). No oil staining was observed associated with it. Various piles of debris were observed during the walkover, which will require removal prior to development works in accordance with the waste regulations.

Photo 5: View looking east from the site entrance.

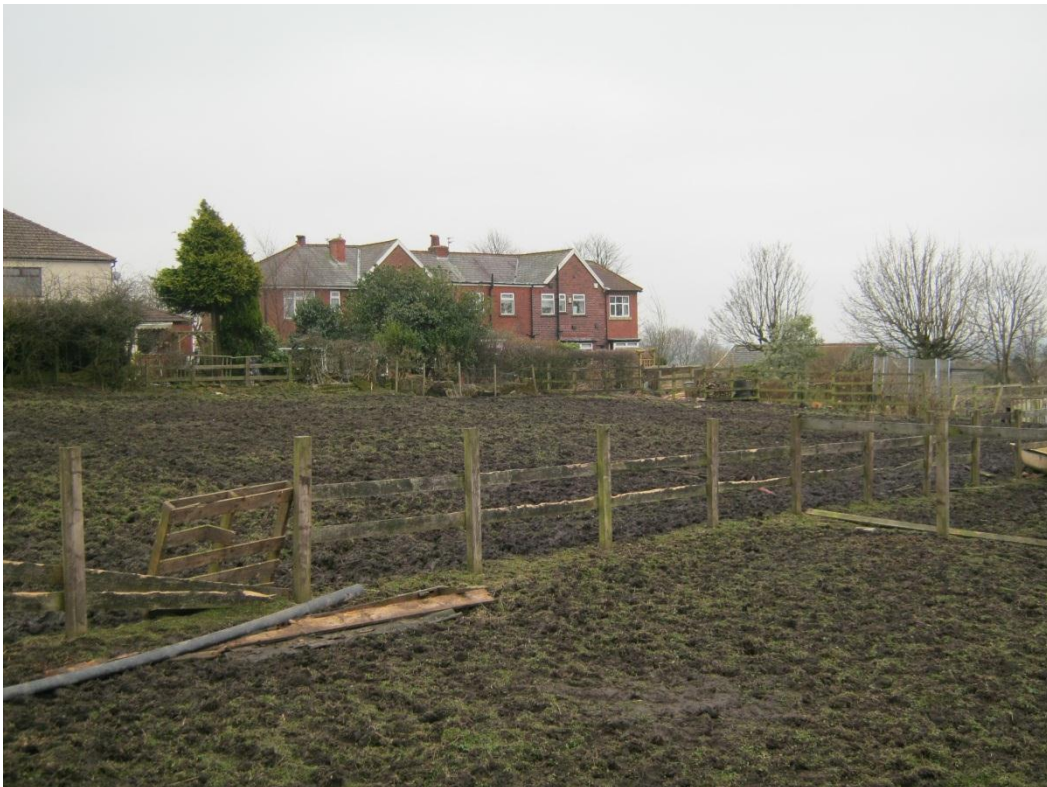
The site is bounded to the east and west by residential properties (photo 6) and to the north and south by grassy pasture.

Photo 6: View towards neighbouring residences across the paddock.
