**RE: NX418 PLOTS 1, 2, 3, 4, 5, 6 & 7 GAS & COVER SYSTEM VALIDATION REPORT –  
LAND AT RECTORY LANE, EAST LANCASHIRE PAPER MILL ISLAND SITE, RADCLIFFE**

NX418 Land at Rectory Lane, ELPM Radcliffe

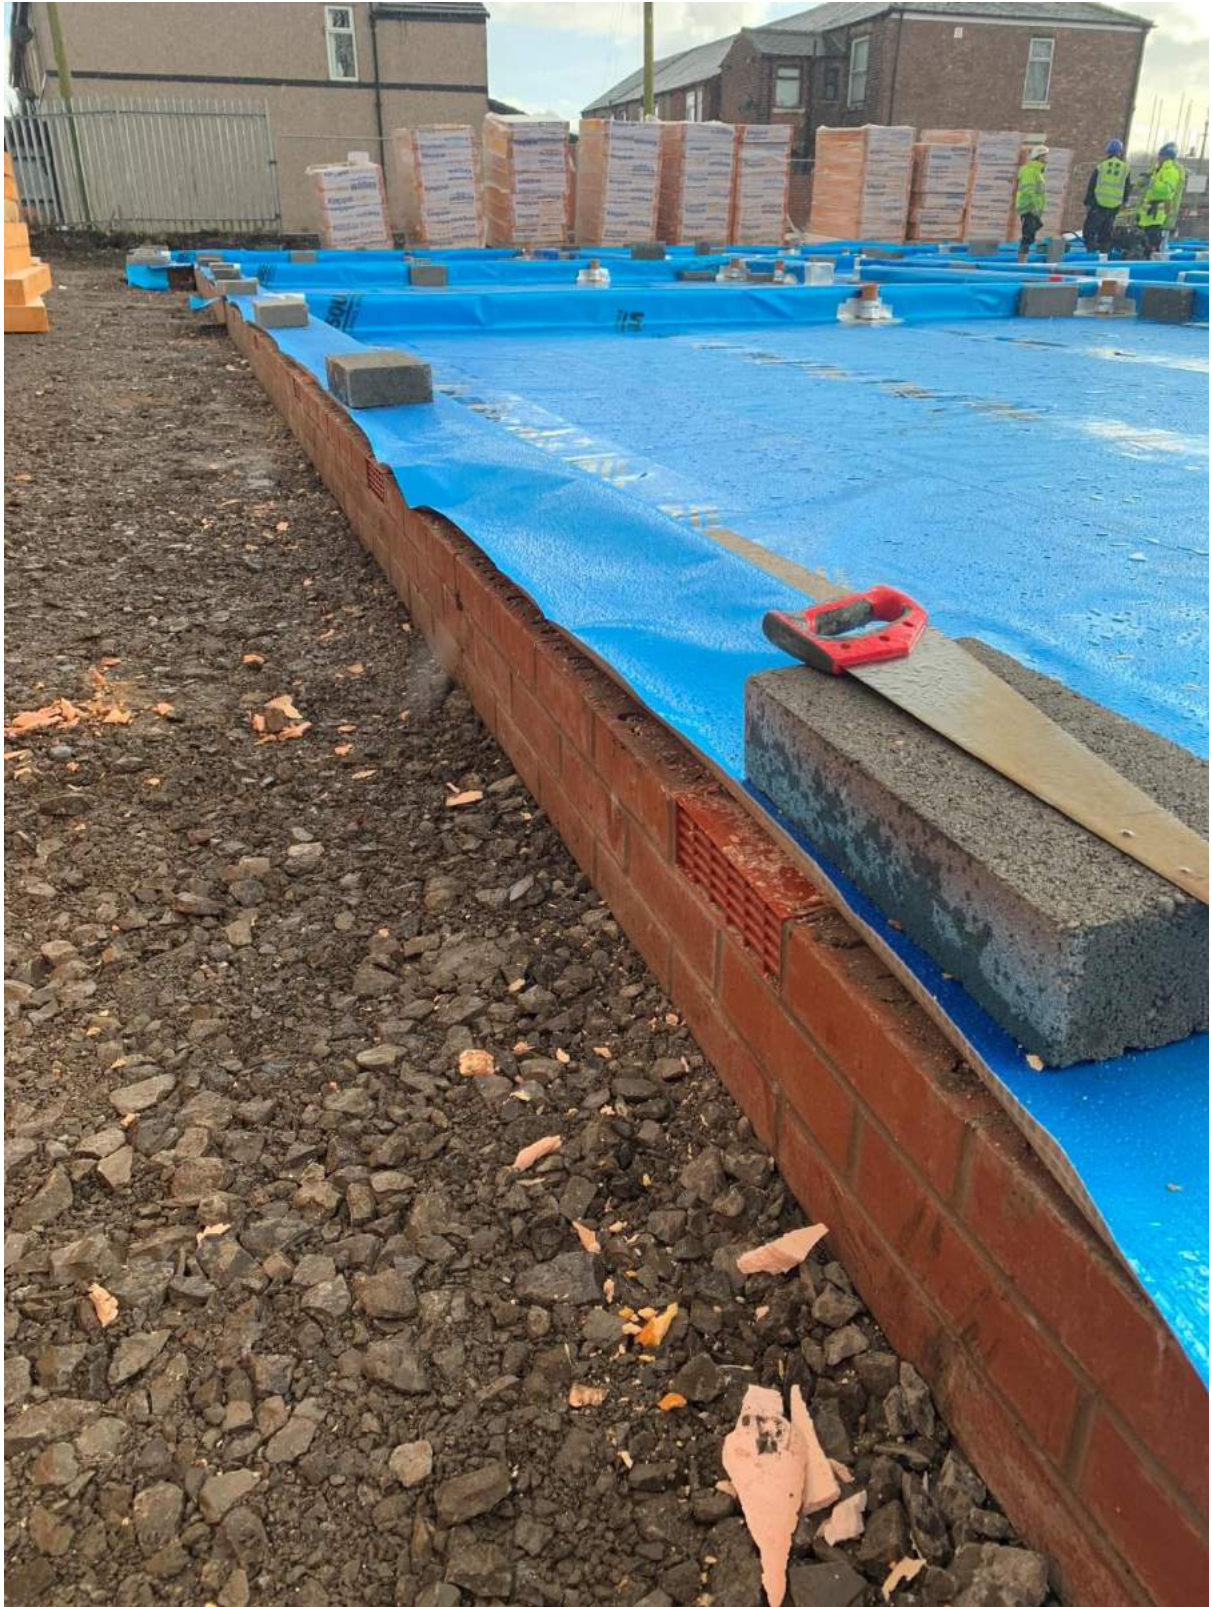
**PLATE 8: Subfloor Venting on 2m to 3m centres**

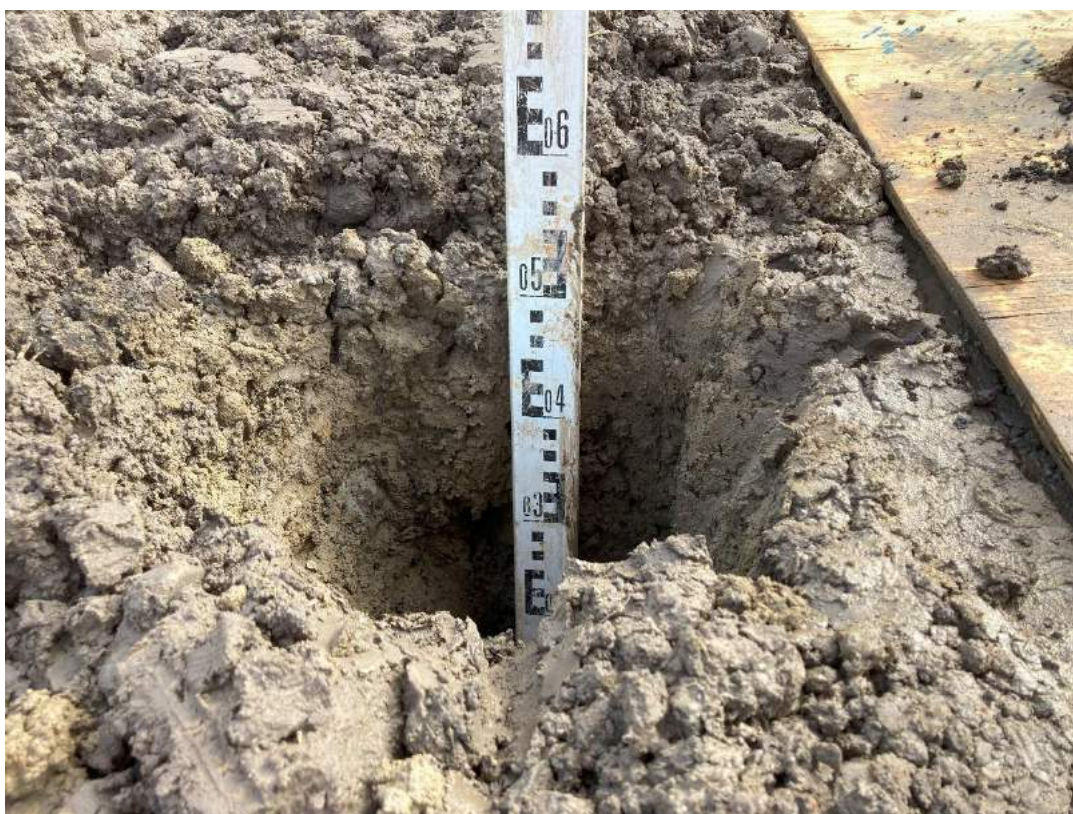
**Plate 5 – Plot 1 rear garden cover system GL to 0.60mbgl with 0.15m of topsoil.**

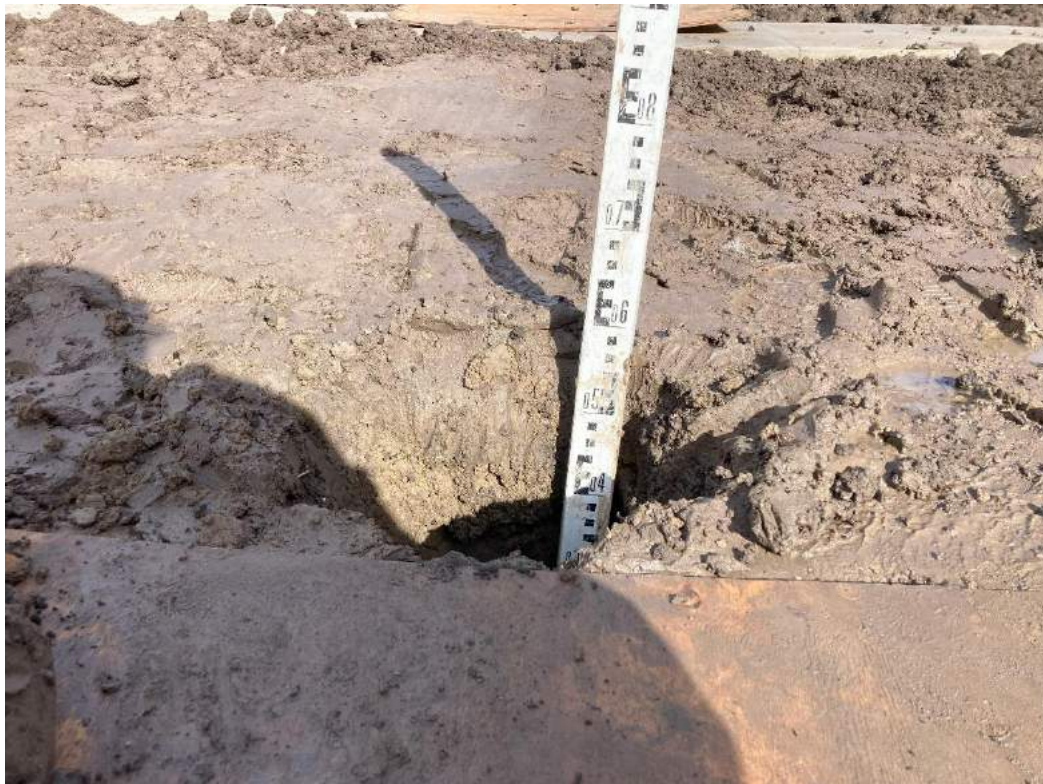
**Plate 10 – Plot 2 rear garden cover system GL to 0.60mbgl with 0.15m of topsoil.**

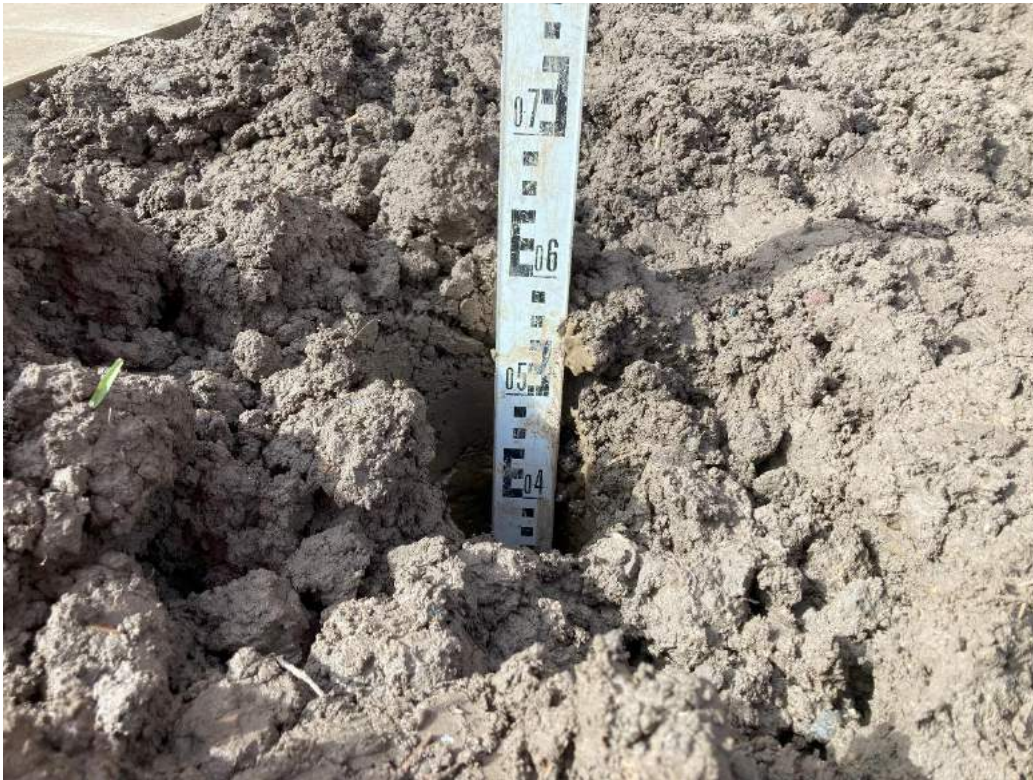
**Plate 13 – Plot 3 front garden cover system GL to 0.60mbgl with 0.15m of topsoil.**

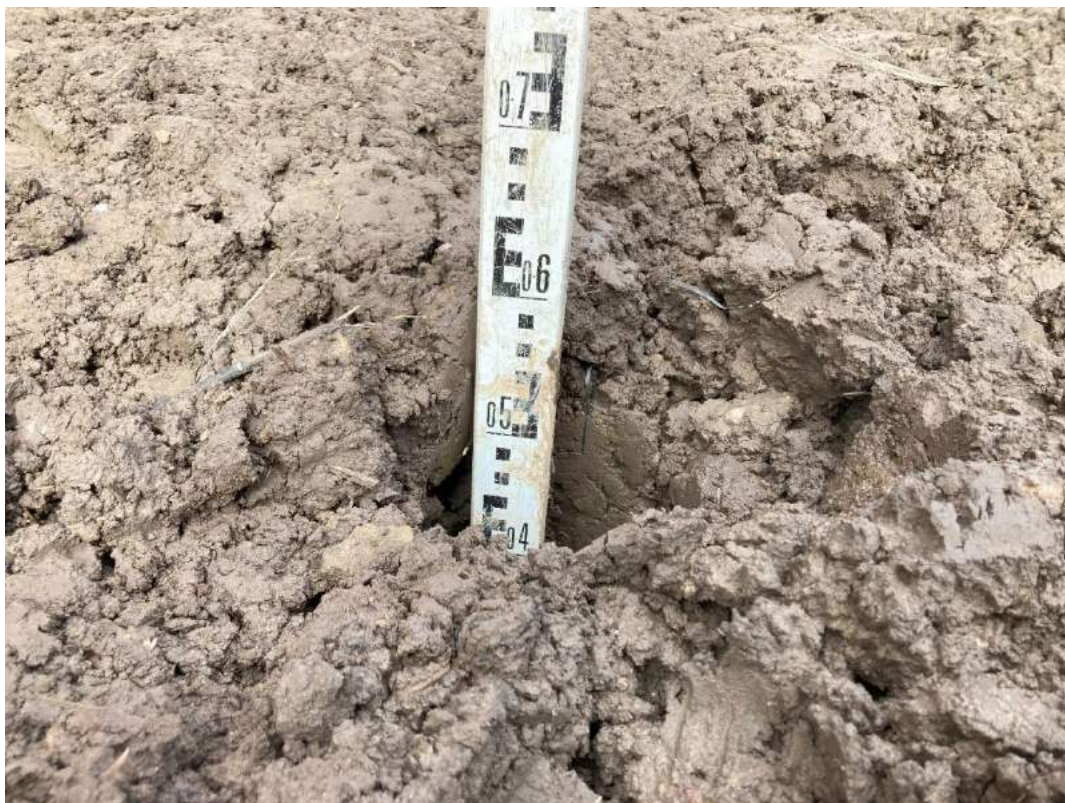
**Plate 18 – Plot 4 front garden cover system GL to 0.60mbgl with 0.15m of topsoil.**

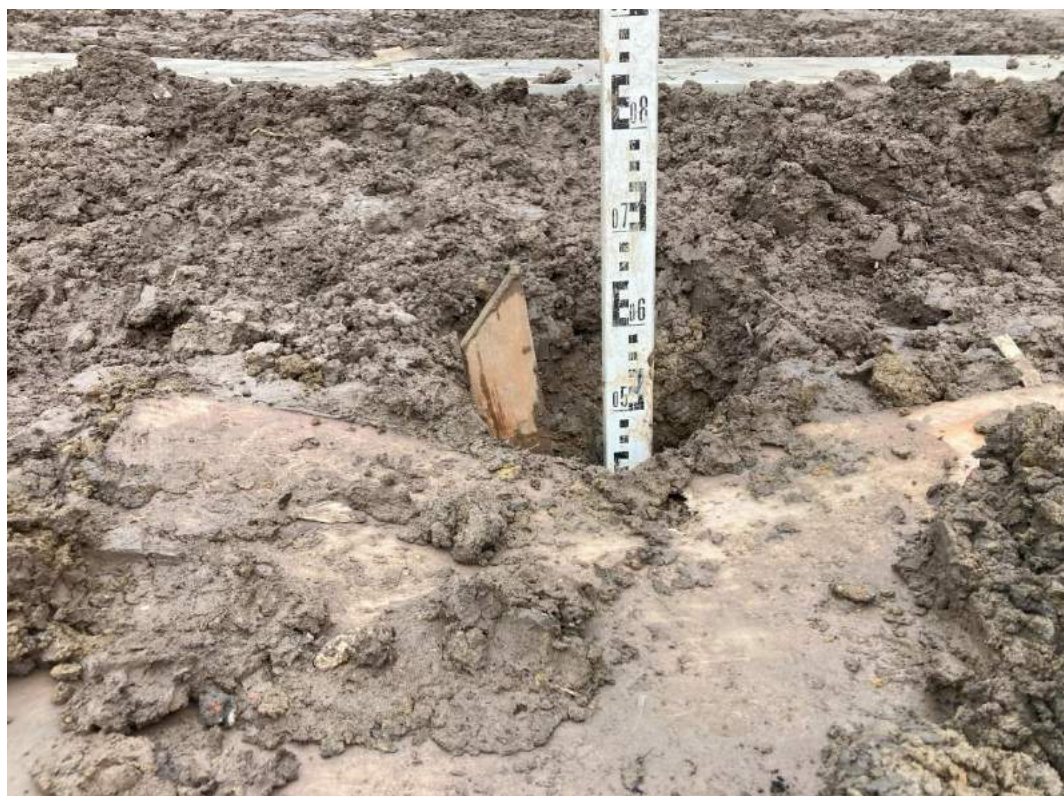
**Plate 20 – Plot 4 rear garden cover system GL to 0.60mbgl with 0.15m of topsoil.**

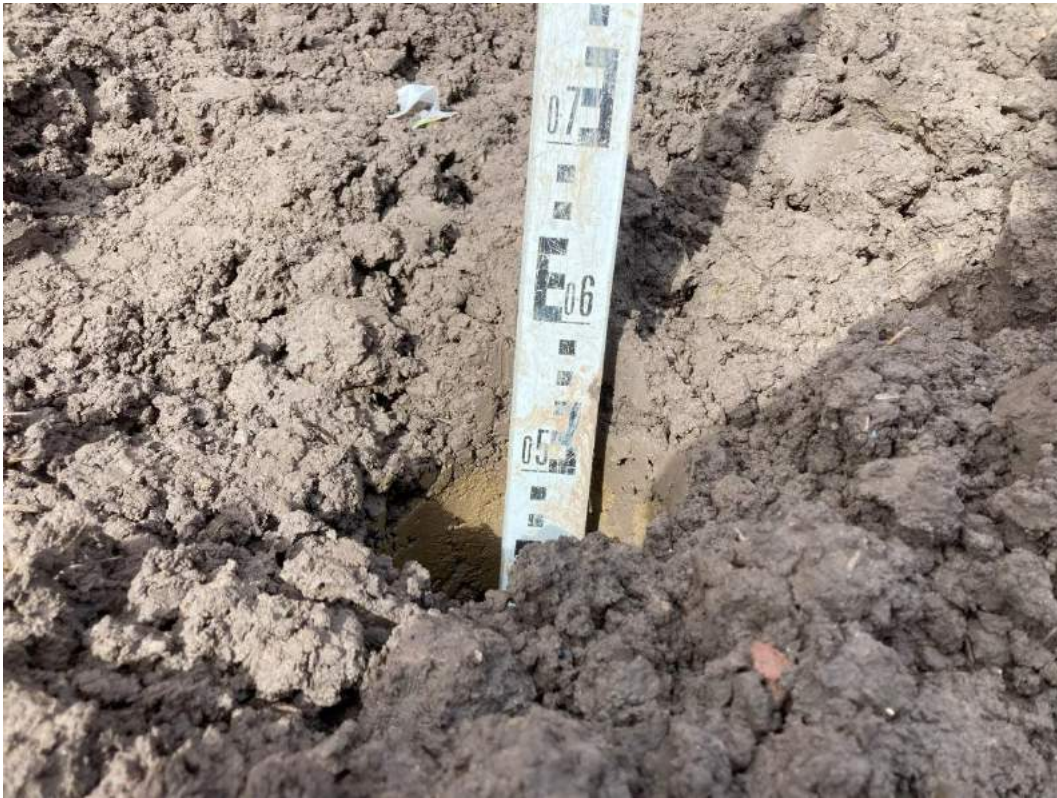
**Plate 23 – Plot 5 front garden cover system GL to 0.60mbgl with 0.15m of topsoil.**

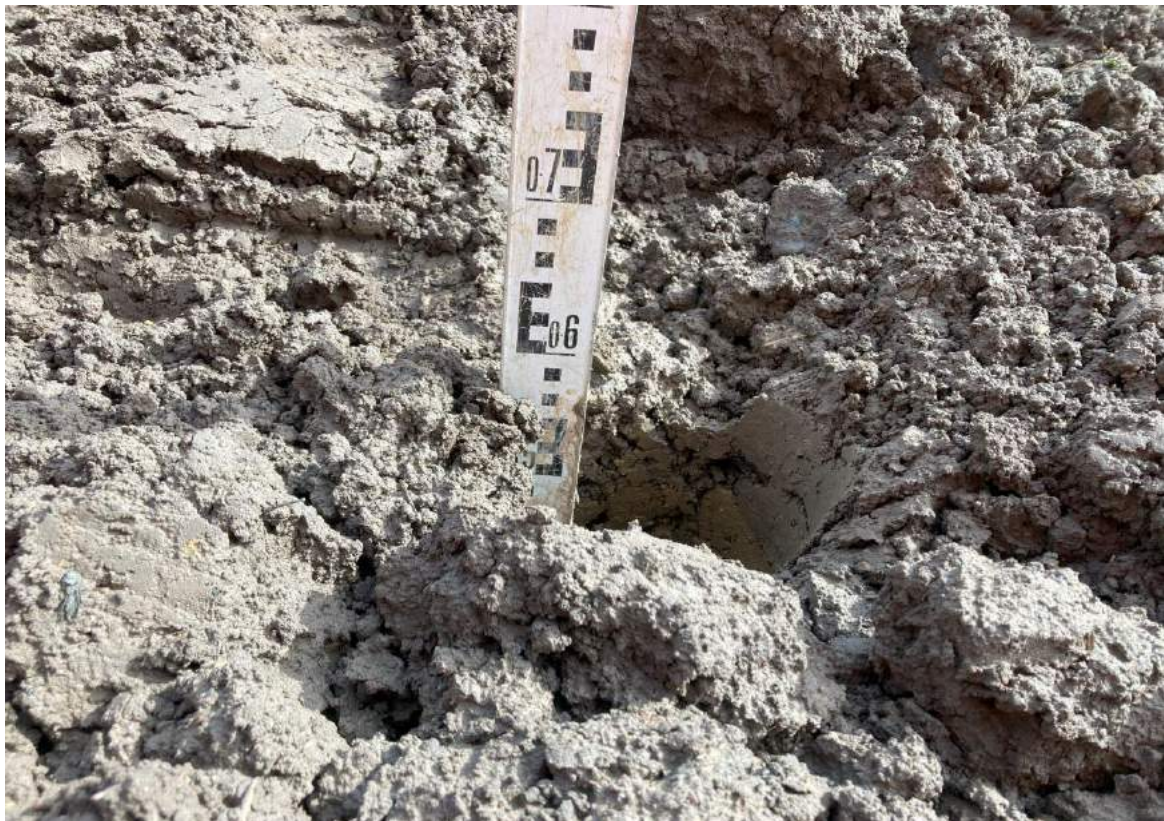
**Plate 28 – Plot 5 front garden cover system GL to 0.60mbgl with 0.15m of topsoil.**
