# **HIGHWAY DILAPIDATION SURVEY**

## **BEALEYS INDUSTRIAL ESTATE**

**Wild St, Radcliffe, Manchester M26 2PE**

**PHOTOS TAKEN 25<sup>TH</sup> MARCH 2026  
KATIE STEWART – ASSISTANT ENGINEER**

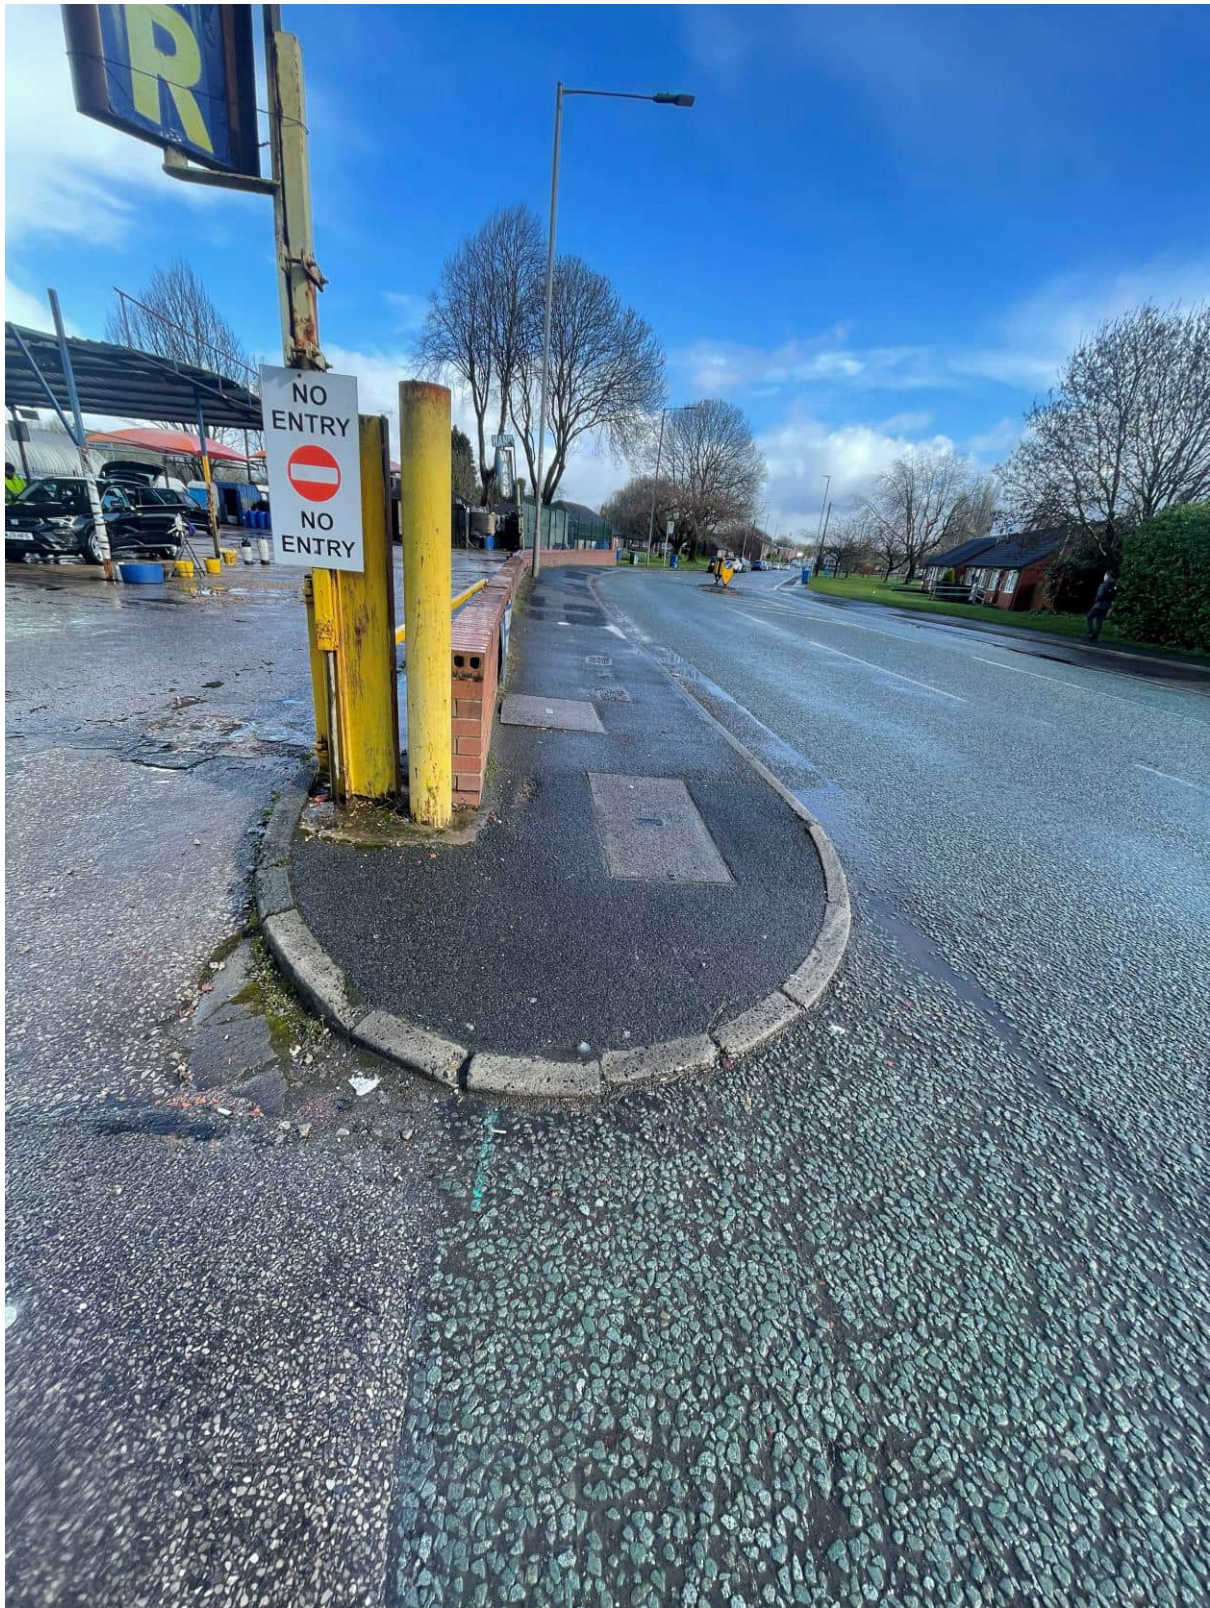
FRAME 1

| <b>FRAME</b> | <b>KERB<br/>CONDITION</b> | <b>FOOTPATH<br/>CONDITION</b> | <b>CARRIAGEWAY<br/>CONDITION</b> | <b>GENERAL<br/>CONDITION</b> |
|---|---|---|---|---|
| <b>1</b> | Radius kerbs damaged, poor condition and level inconsistent. | Medium condition tarmac footpath, well-worn with BT box positioned in footpath. | Evidence of holding water on channel line. | Signs of aging, wear and tear. |

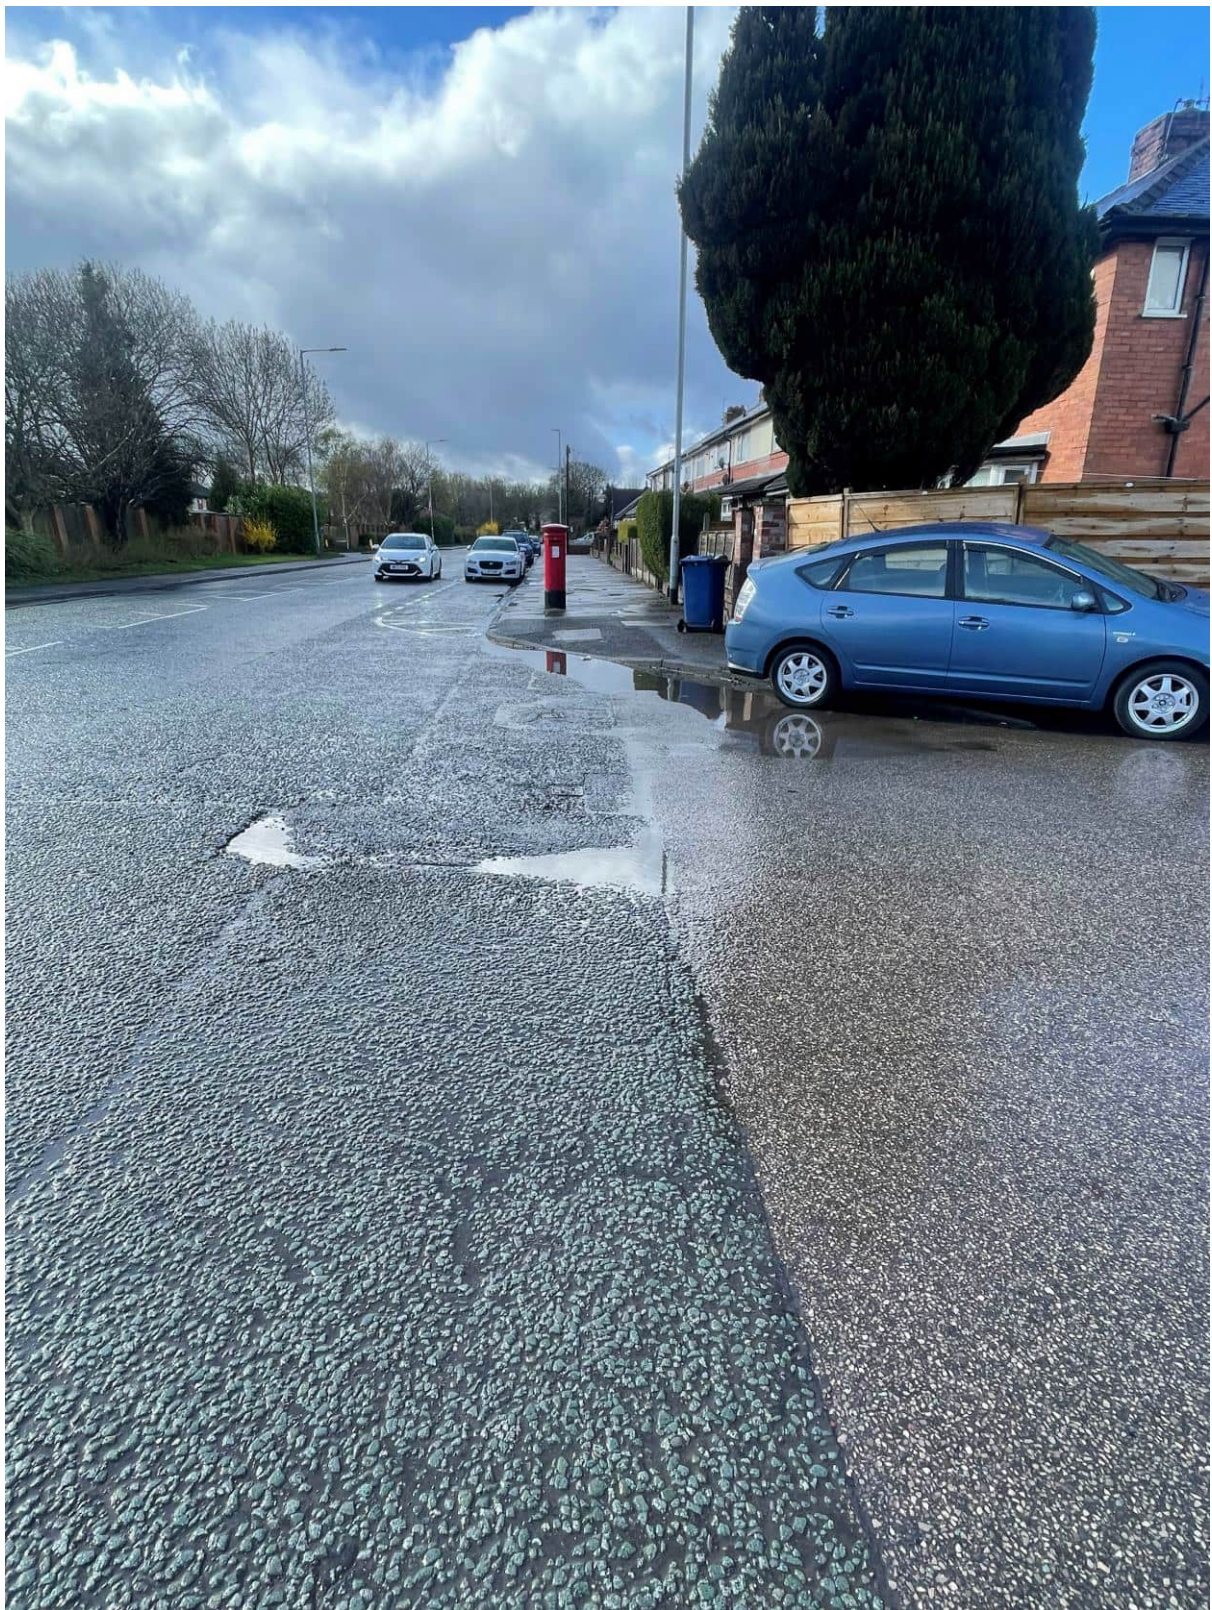
FRAME 2

| <b>FRAME</b> | <b>KERB<br/>CONDITION</b> | <b>FOOTPATH<br/>CONDITION</b> | <b>CARRIAGEWAY<br/>CONDITION</b> | <b>GENERAL<br/>CONDITION</b> |
|---|---|---|---|---|
| <b>2</b> | N/a | N/a | Surface in poor condition with potholes, patches, stress fractures with ponding in the middle of junction. | Carriageway showing signs of wear and deterioration. |

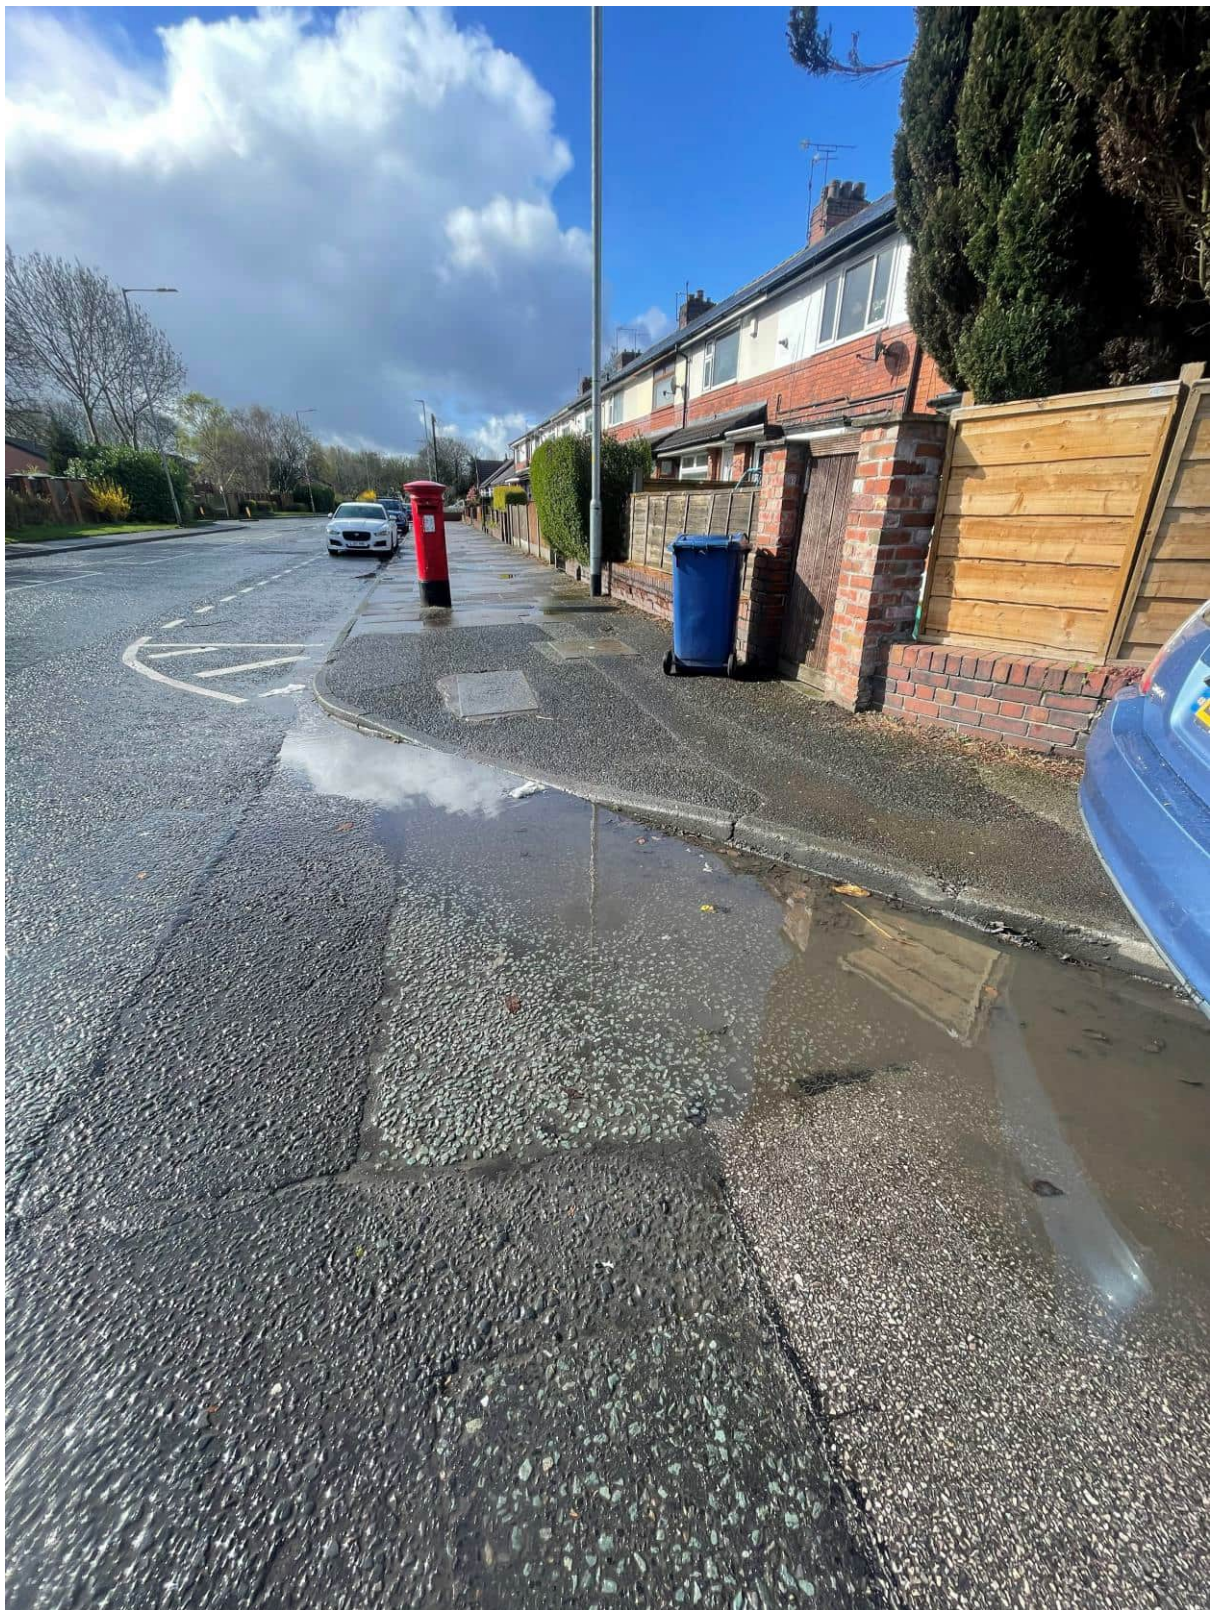
FRAME 3

| <b>FRAME</b> | <b>KERB<br/>CONDITION</b> | <b>FOOTPATH<br/>CONDITION</b> | <b>CARRIAGEWAY<br/>CONDITION</b> | <b>GENERAL<br/>CONDITION</b> |
|---|---|---|---|---|
| <b>3</b> | Kerbs damaged and poor condition. | Tarmac Poor condition. Various scars associated with patch utilities repairs. | Large amount of ponding on junction around kerbs and leading into site. | Footpath in poor condition. Carriageway showing signs of wear and deterioration. |

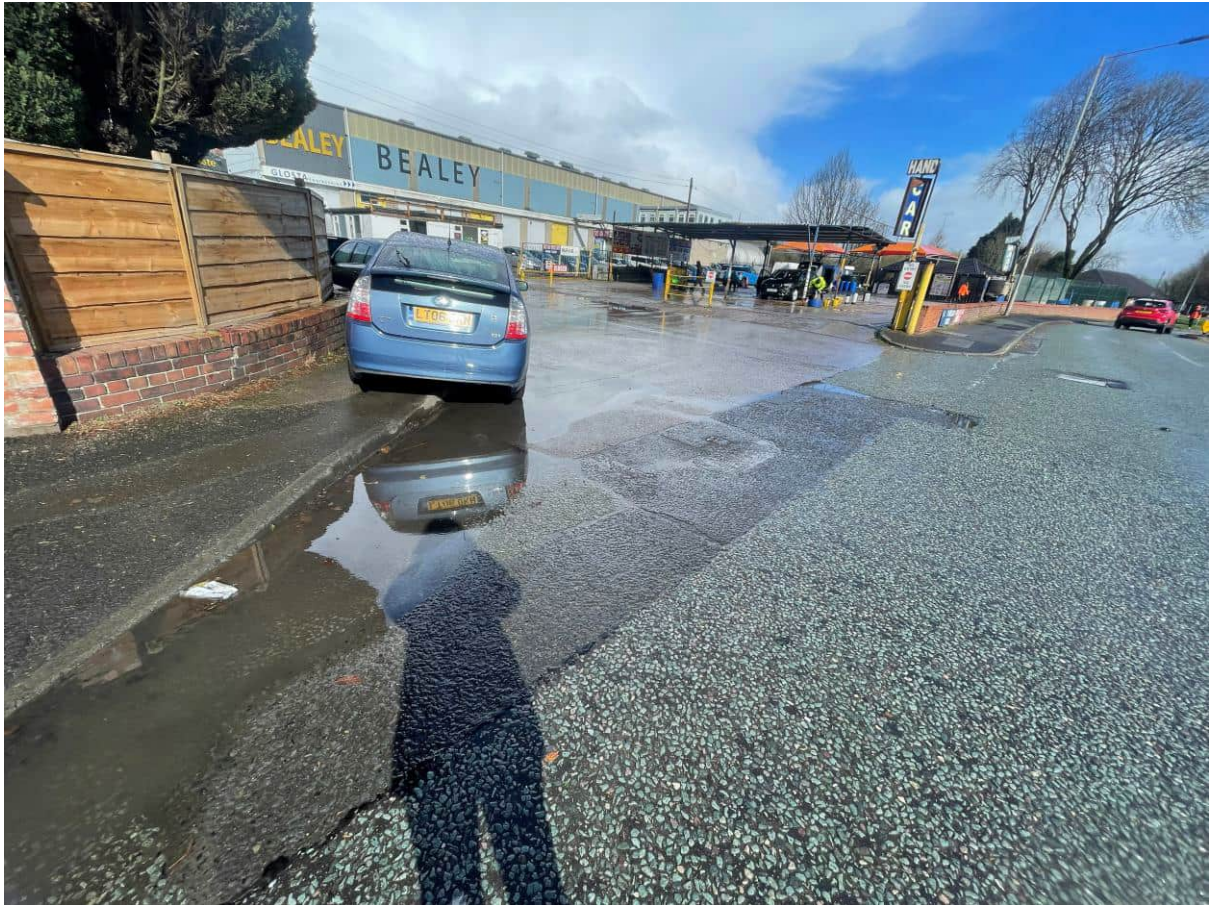
FRAME 4

| <b>FRAME</b> | <b>KERB<br/>CONDITION</b> | <b>FOOTPATH<br/>CONDITION</b> | <b>CARRIAGEWAY<br/>CONDITION</b> | <b>GENERAL<br/>CONDITION</b> |
|---|---|---|---|---|
| <b>4</b> | Kerbs damaged and poor condition. | Tarmac Poor condition. Various scars associated with patch utilities repairs. | Large amount of ponding on junction around kerbs and leading into site. | Footpath in poor condition. Carriageway showing signs of wear and deterioration. |

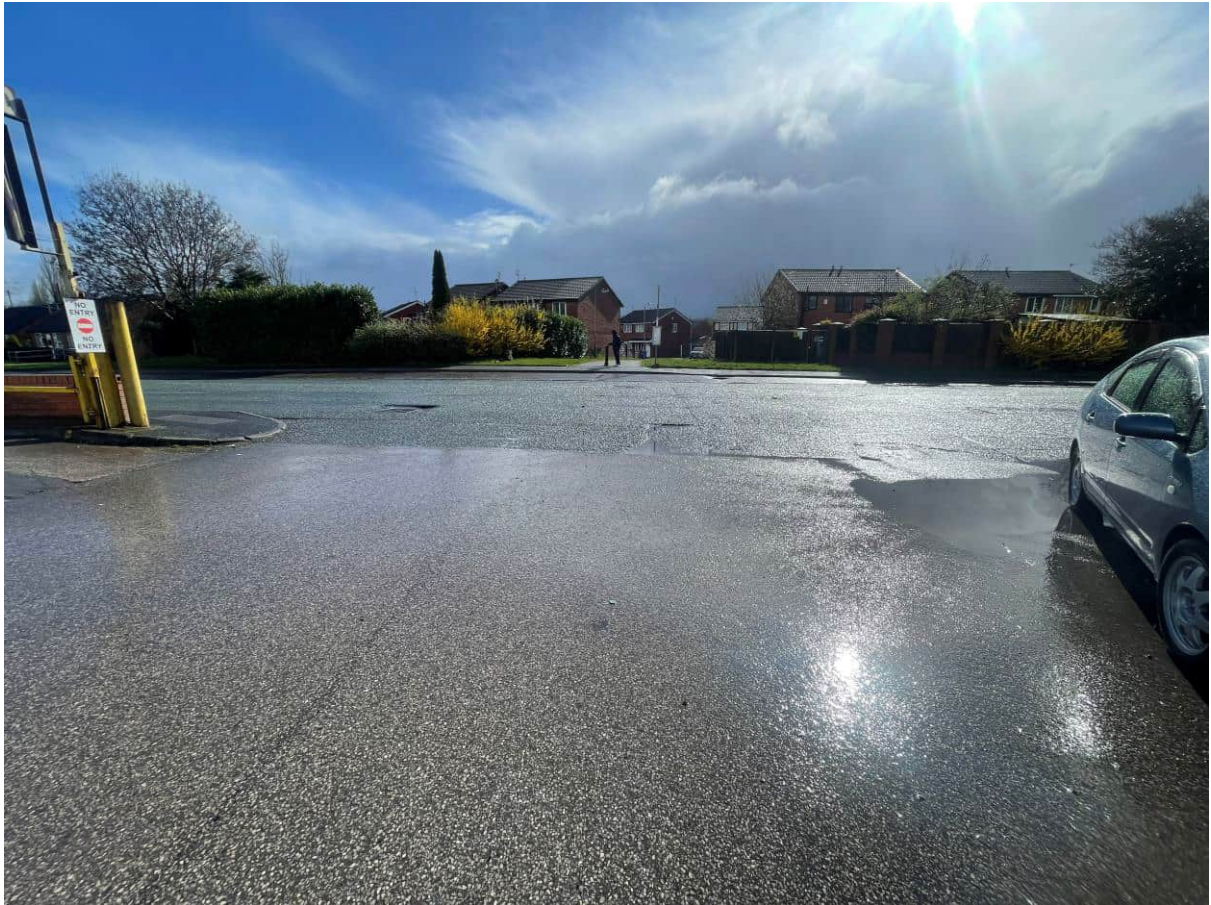
FRAME 5

| <b>FRAME</b> | <b>KERB<br/>CONDITION</b> | <b>FOOTPATH<br/>CONDITION</b> | <b>CARRIAGEWAY<br/>CONDITION</b> | <b>GENERAL<br/>CONDITION</b> |
|---|---|---|---|---|
| <b>5</b> | N/a | N/a | Section of carriageway surface in reasonable condition. | Reasonable condition. |

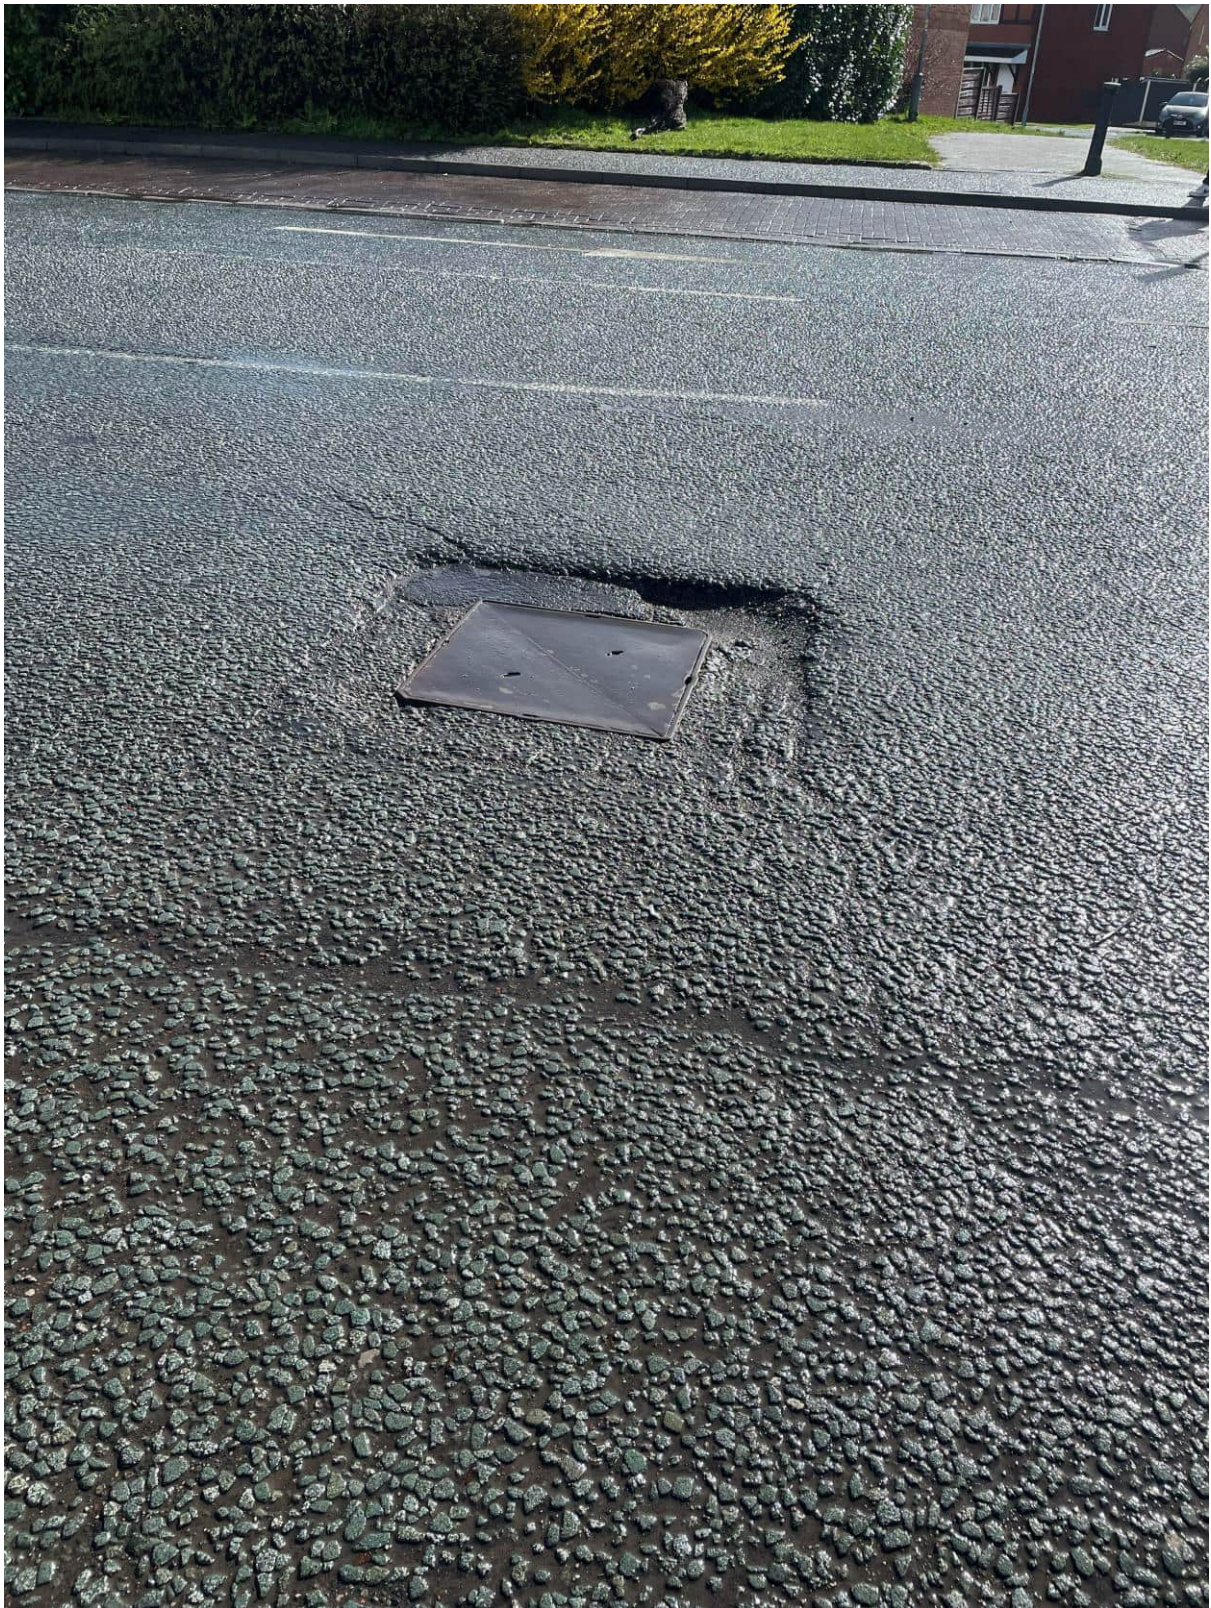
FRAME 6

| <b>FRAME</b> | <b>KERB<br/>CONDITION</b> | <b>FOOTPATH<br/>CONDITION</b> | <b>CARRIAGEWAY<br/>CONDITION</b> | <b>GENERAL<br/>CONDITION</b> |
|---|---|---|---|---|
| <b>6</b> | N/a | N/a | Manhole positioned on existing road (Dumers Lane) settled and tarmac deterioration | Poor condition. |

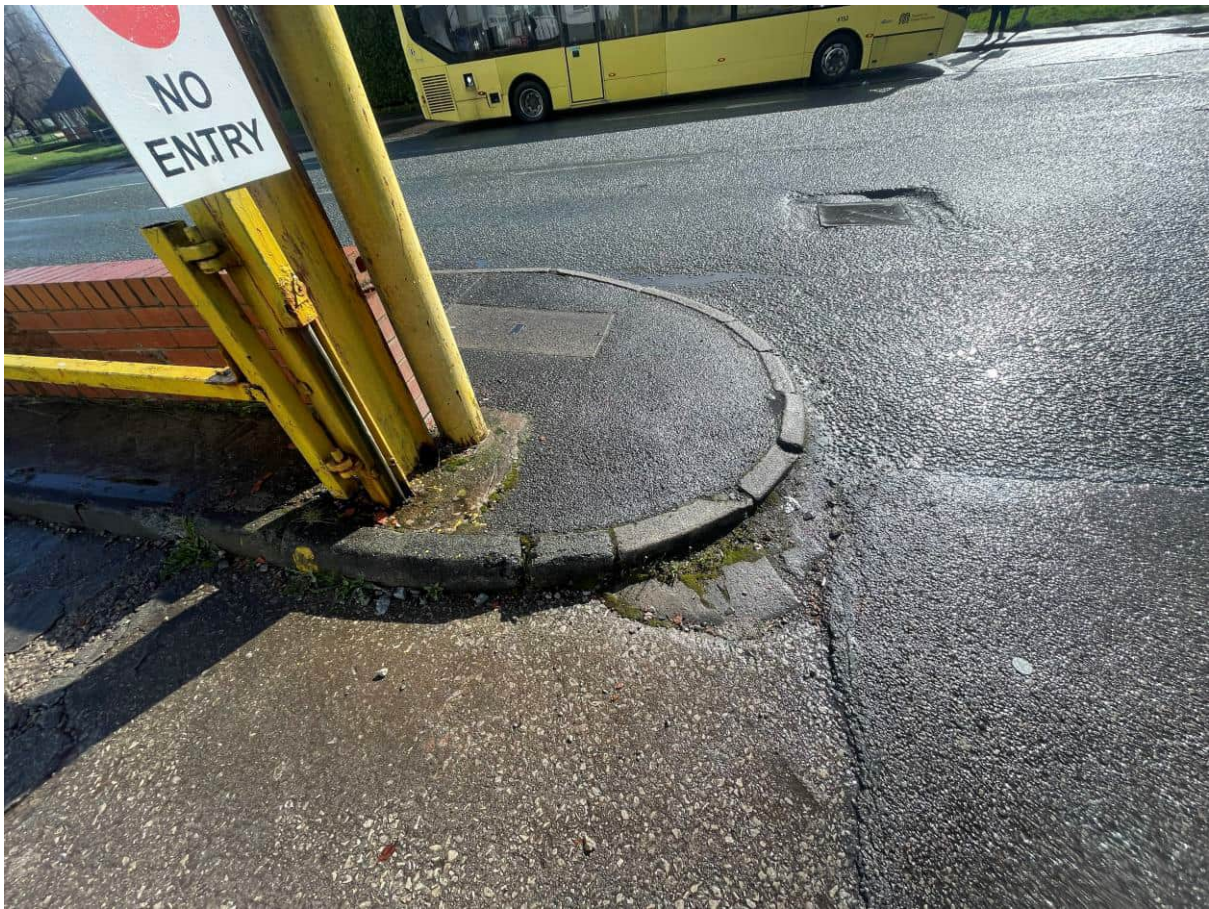
FRAME 7

| <b>FRAME</b> | <b>KERB<br/>CONDITION</b> | <b>FOOTPATH<br/>CONDITION</b> | <b>CARRIAGEWAY<br/>CONDITION</b> | <b>GENERAL<br/>CONDITION</b> |
|---|---|---|---|---|
| <b>7</b> | Radius kerbs damaged, poor condition and level inconsistent. | Medium condition tarmac footpath, well-worn with BT box positioned in footpath. | Weeds around kerb line. Change of surfacing, poor condition. | Carriageway entering car wash – poor condition. |

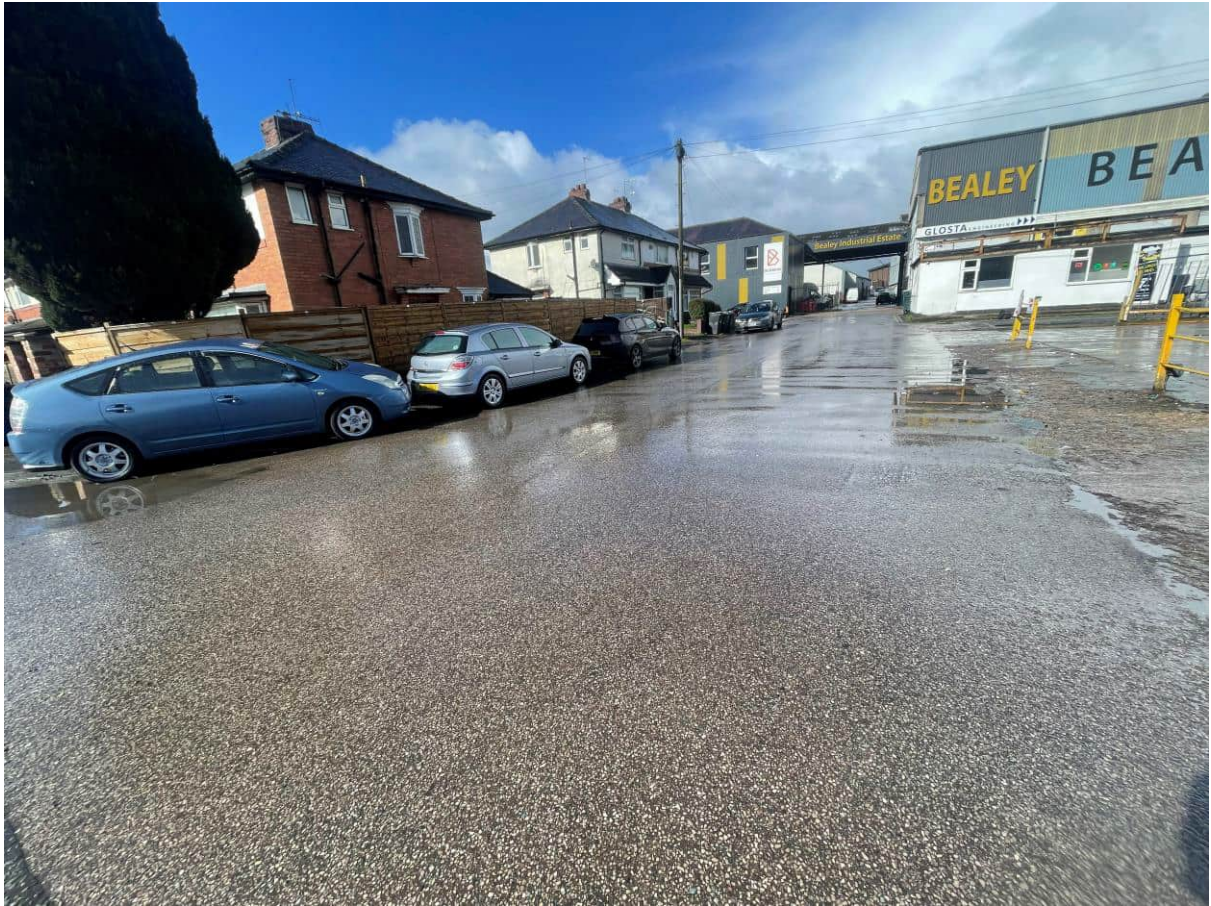
FRAME 8

| <b>FRAME</b> | <b>KERB<br/>CONDITION</b> | <b>FOOTPATH<br/>CONDITION</b> | <b>CARRIAGEWAY<br/>CONDITION</b> | <b>GENERAL<br/>CONDITION</b> |
|---|---|---|---|---|
| <b>8</b> | N/a | N/a | Section of carriageway surface in | Reasonable condition. |

| | | | reasonable condition. | |

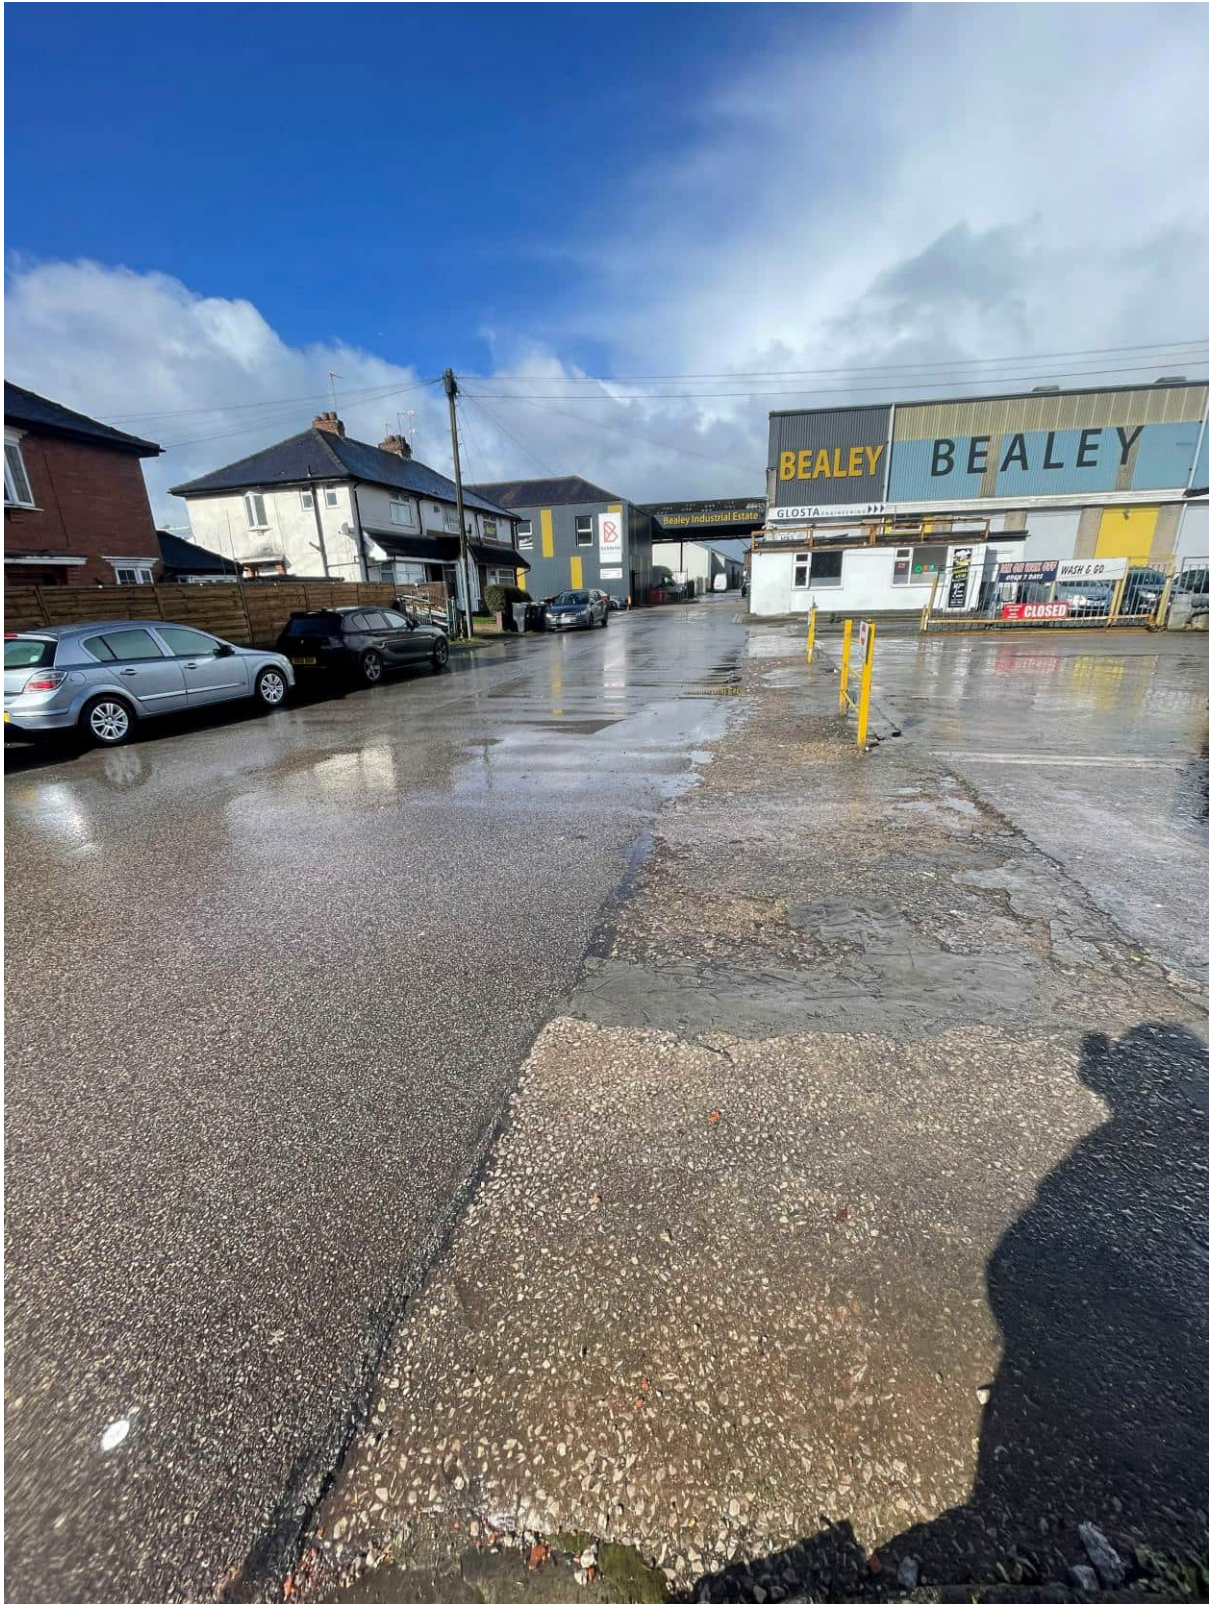
FRAME 9

| 9 | N/a | N/a | Entrance into carpark surfacing deteriorated, uneven surface. | Surfacing in poor condition. |

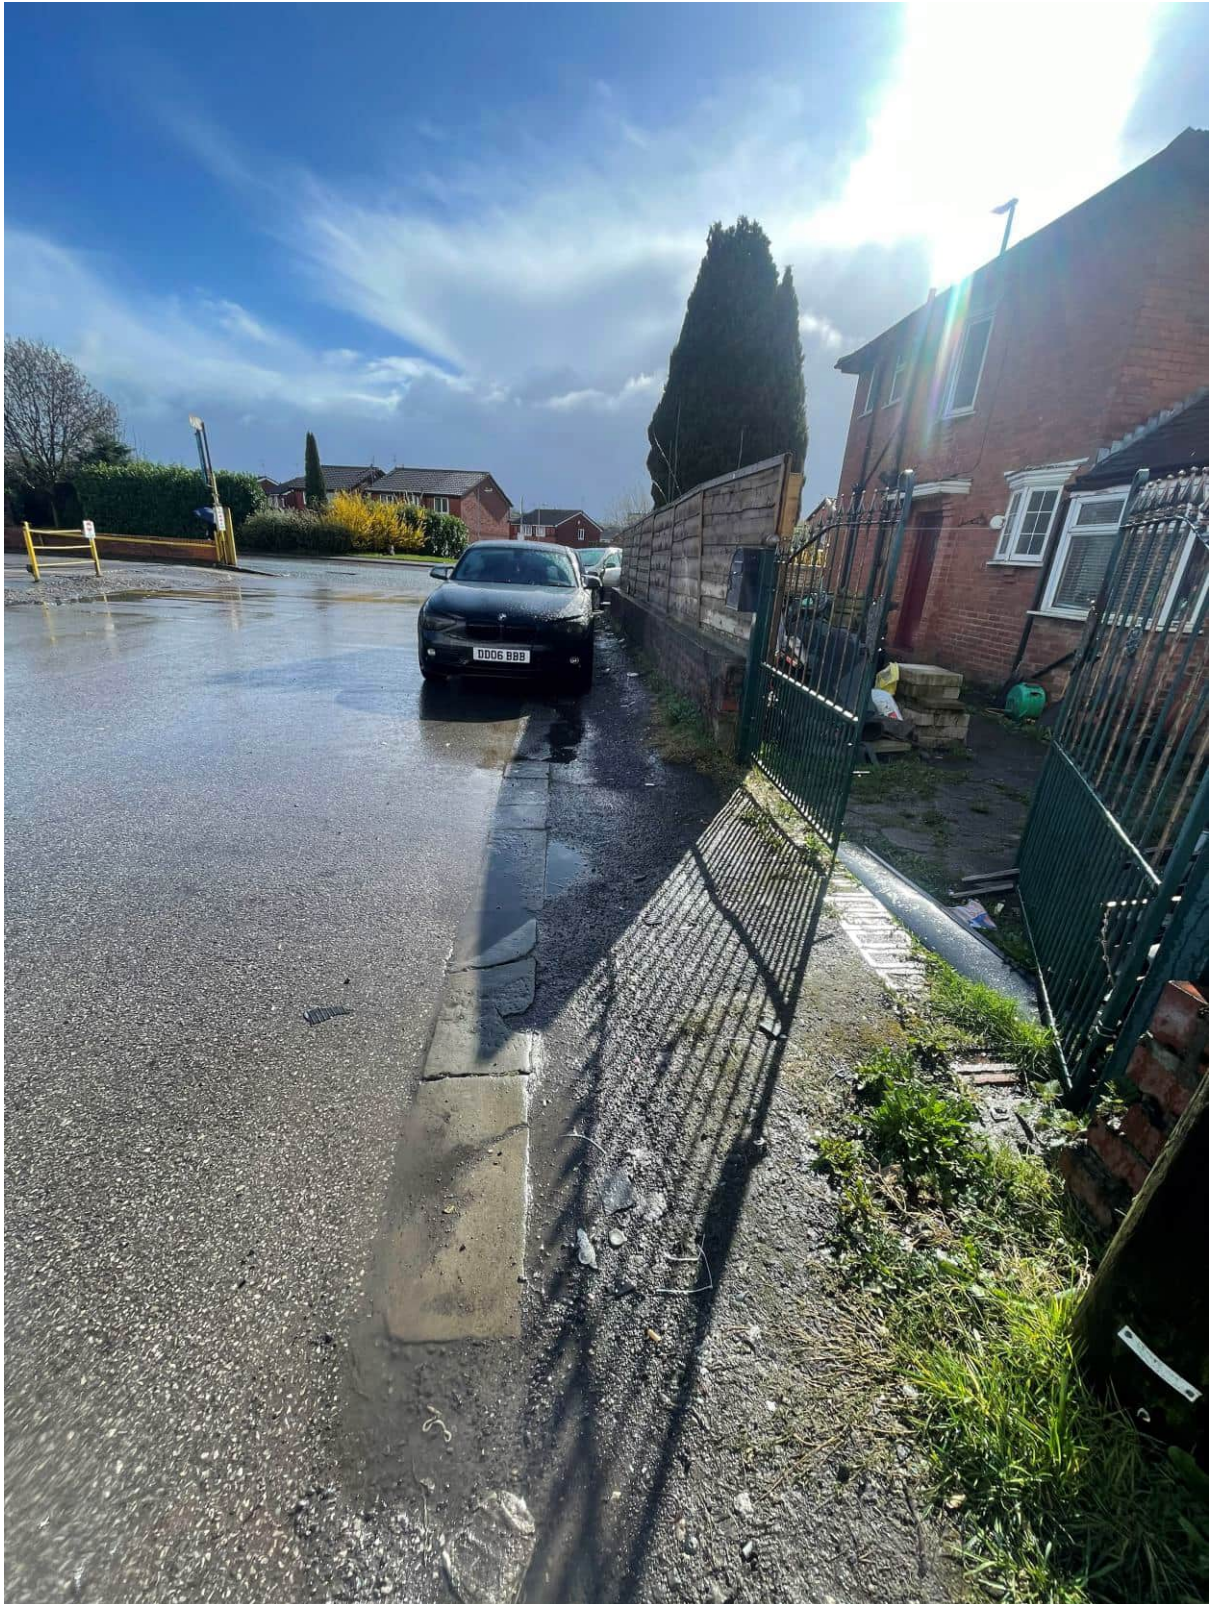
FRAME 10

| 10 | Parked vehicles restricting kerbs. Kerb line damaged and in poor condition. | Parked vehicles restricting footpath. Weeds located down the boundary line, poor conditioned uneven footpath with minor ponding. | Section of carriageway surface in reasonable condition. | Footpath & Kerbs In poor condition. |

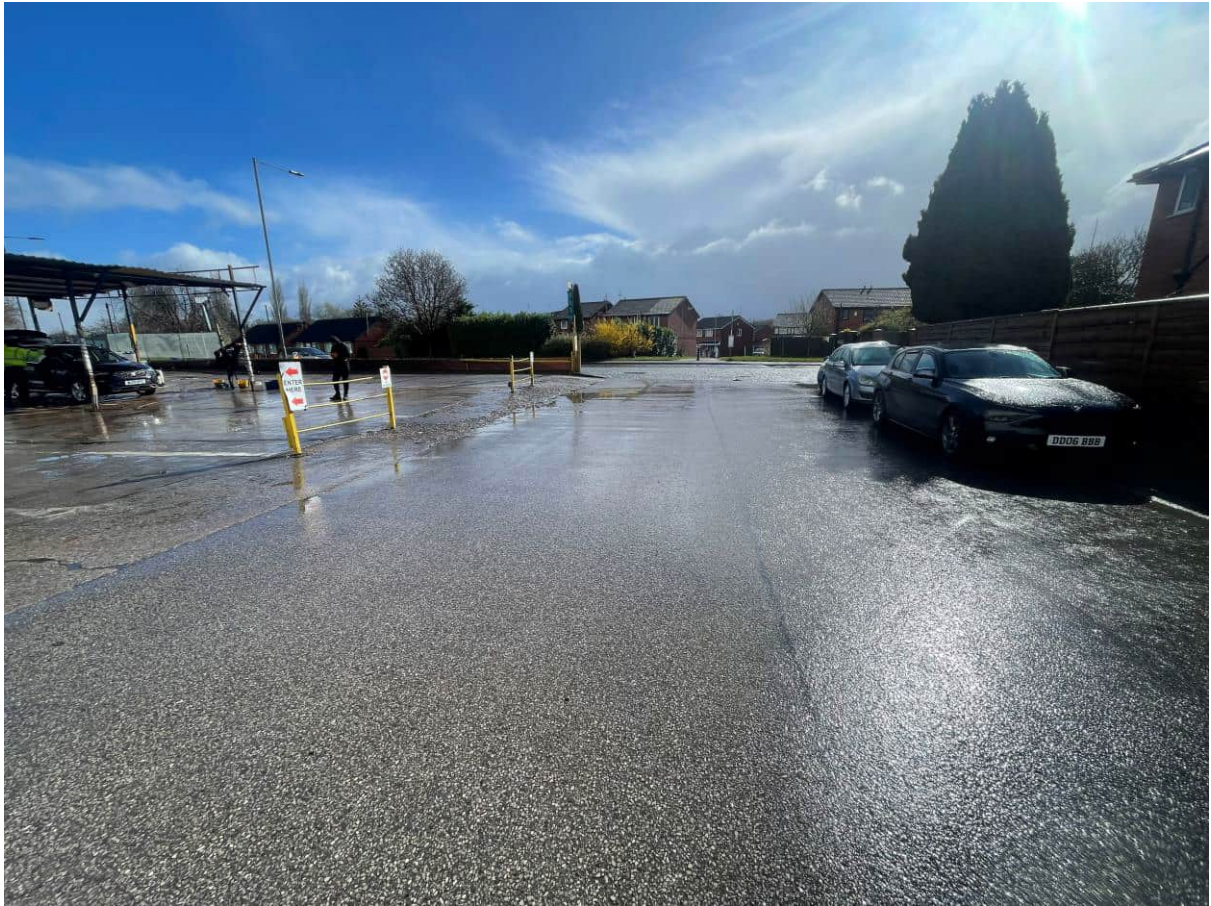
FRAME 11

| 11 | N/a | N/a | Section of carriageway surface in reasonable condition. | Reasonable condition. |

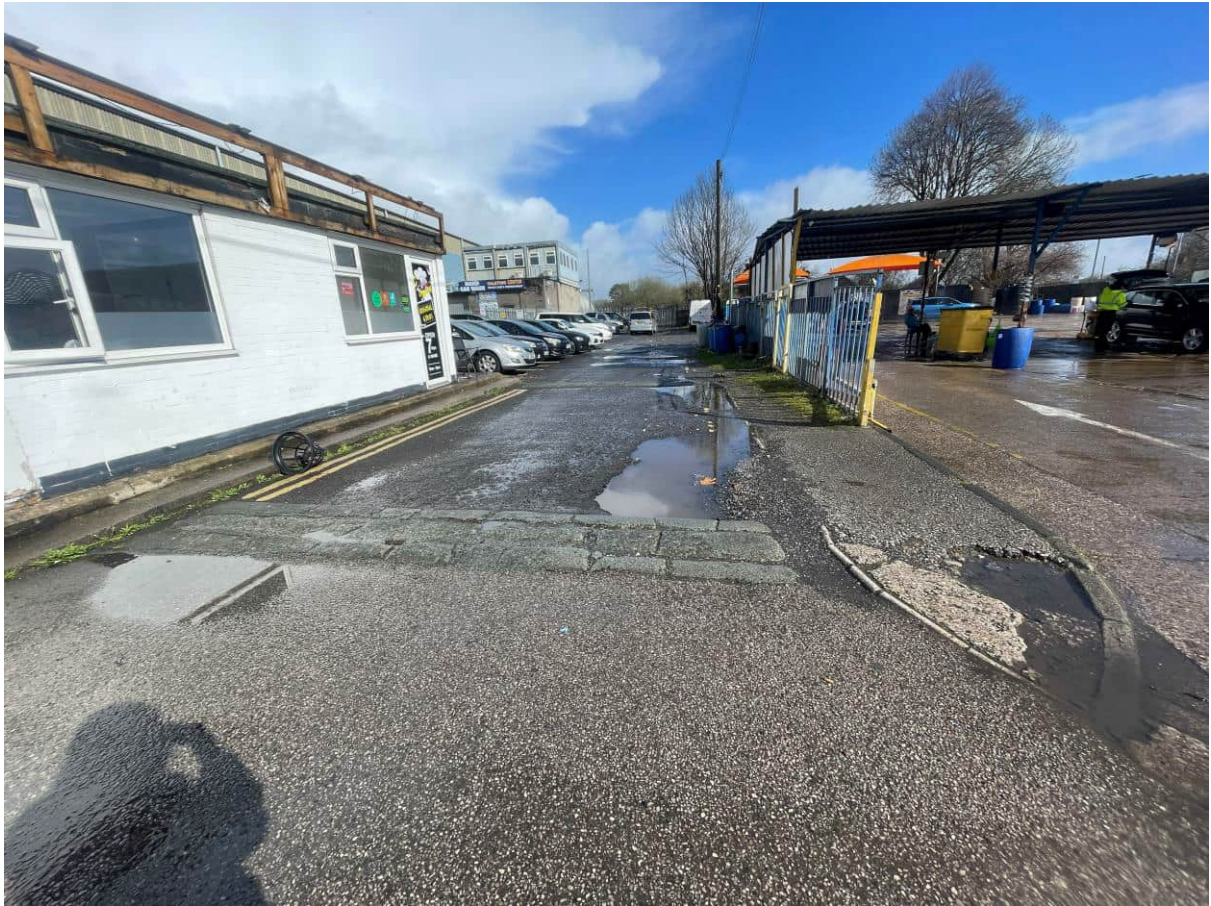
FRAME 12

| 12 | N/a | N/a | Site entrance poor condition, stoned ramp, ponding. | Poor condition |

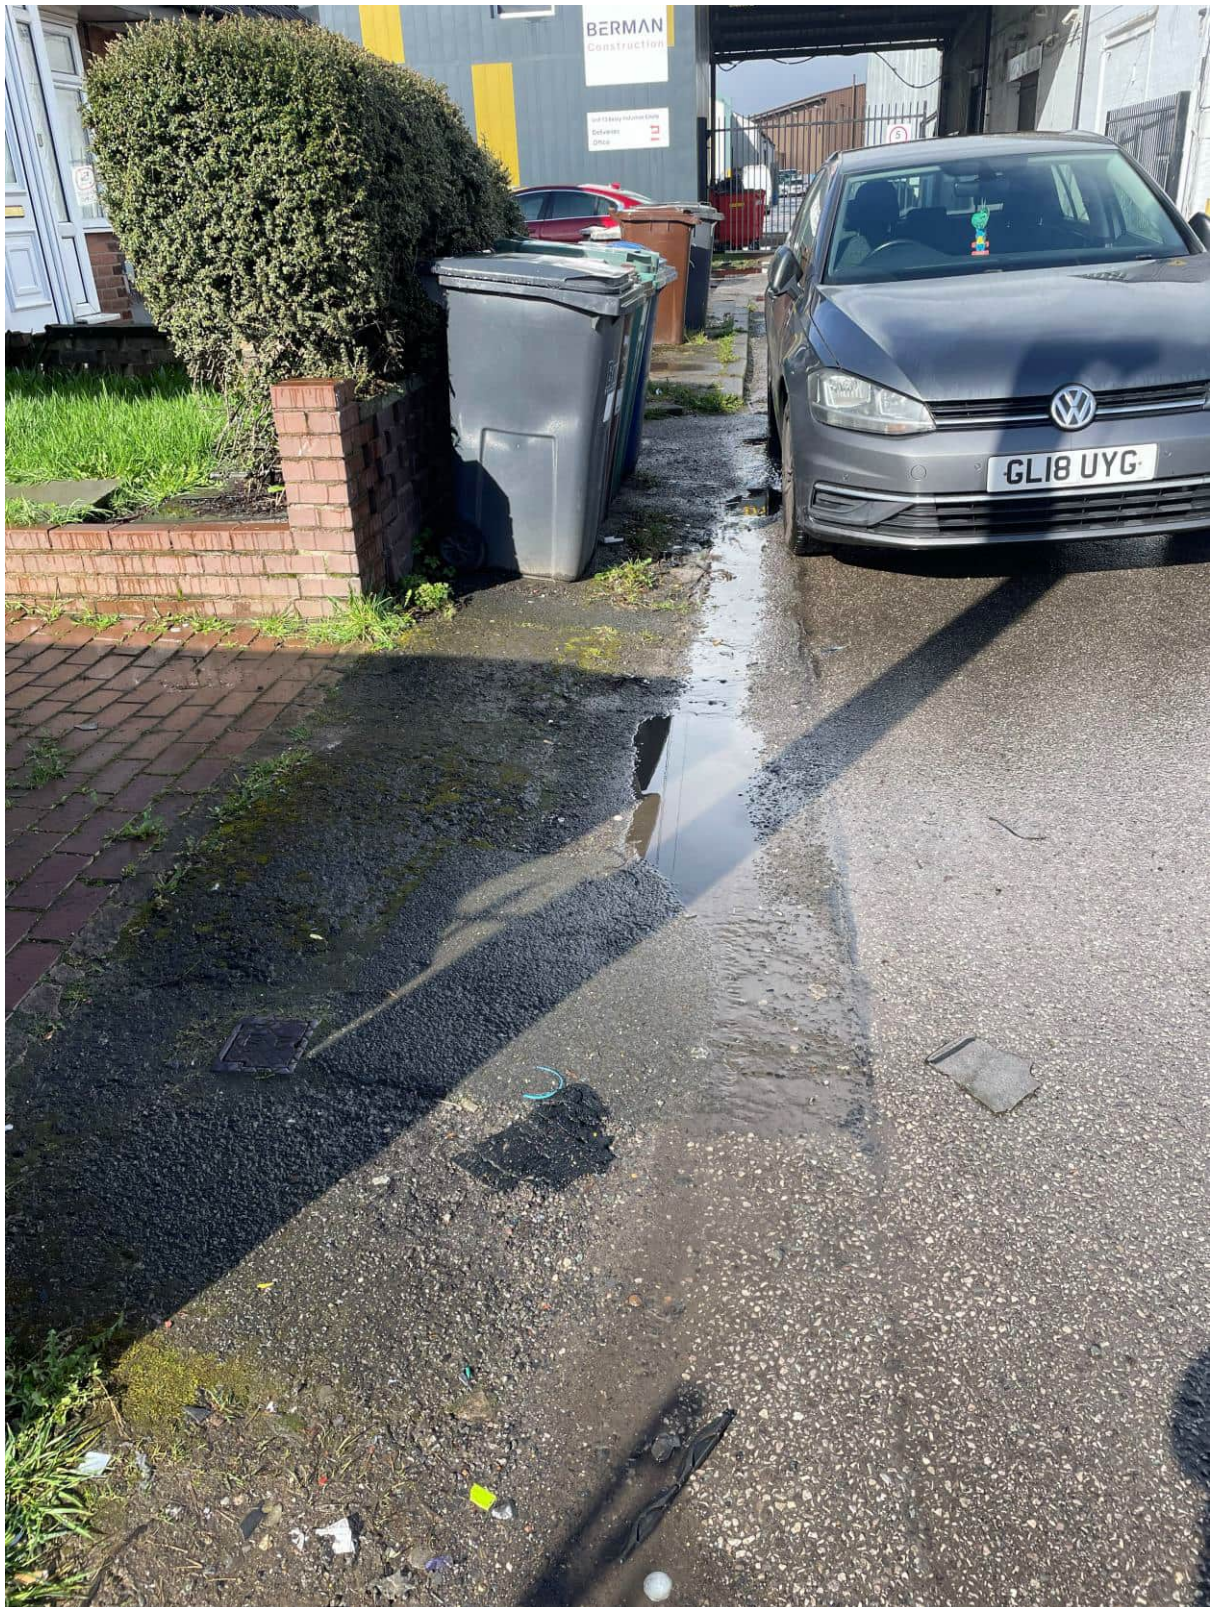
FRAME 13

| 13 | N/a | Weeds located down the boundary line, poor conditioned uneven footpath with minor ponding. | N/a | Poor condition |

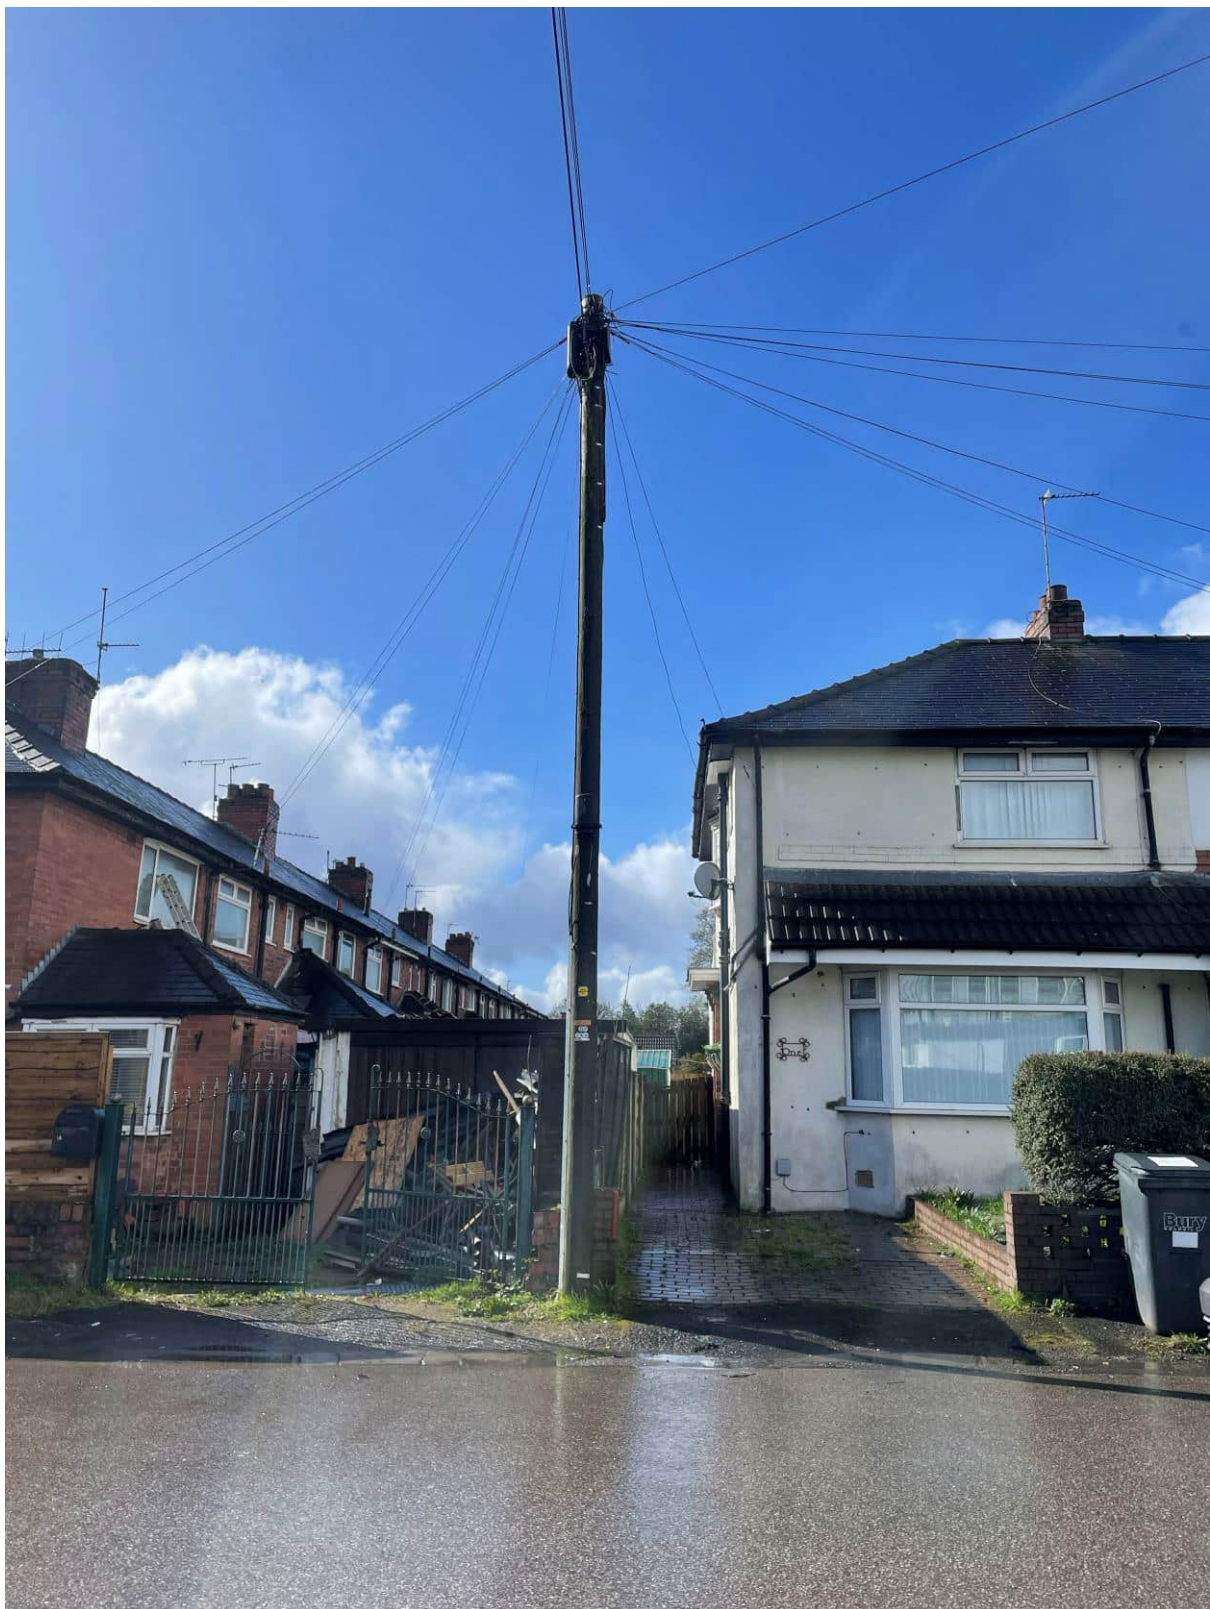
FRAME 14

| 14 | Kerbs damaged, poor condition and level inconsistent. | Overheads BT pole positioned in footpath. Weeds located down the boundary line, poor conditioned uneven footpath with minor ponding. | N/a | Poor condition |
