# **HIGHWAY DILAPIDATION SURVEY**

## **BEALEYS INDUSTRIAL ESTATE**

**Wild St, Radcliffe, Manchester M26 2PE**

**PHOTOS TAKEN 25<sup>TH</sup> MARCH 2026  
KATIE STEWART – ASSISTANT ENGINEER**

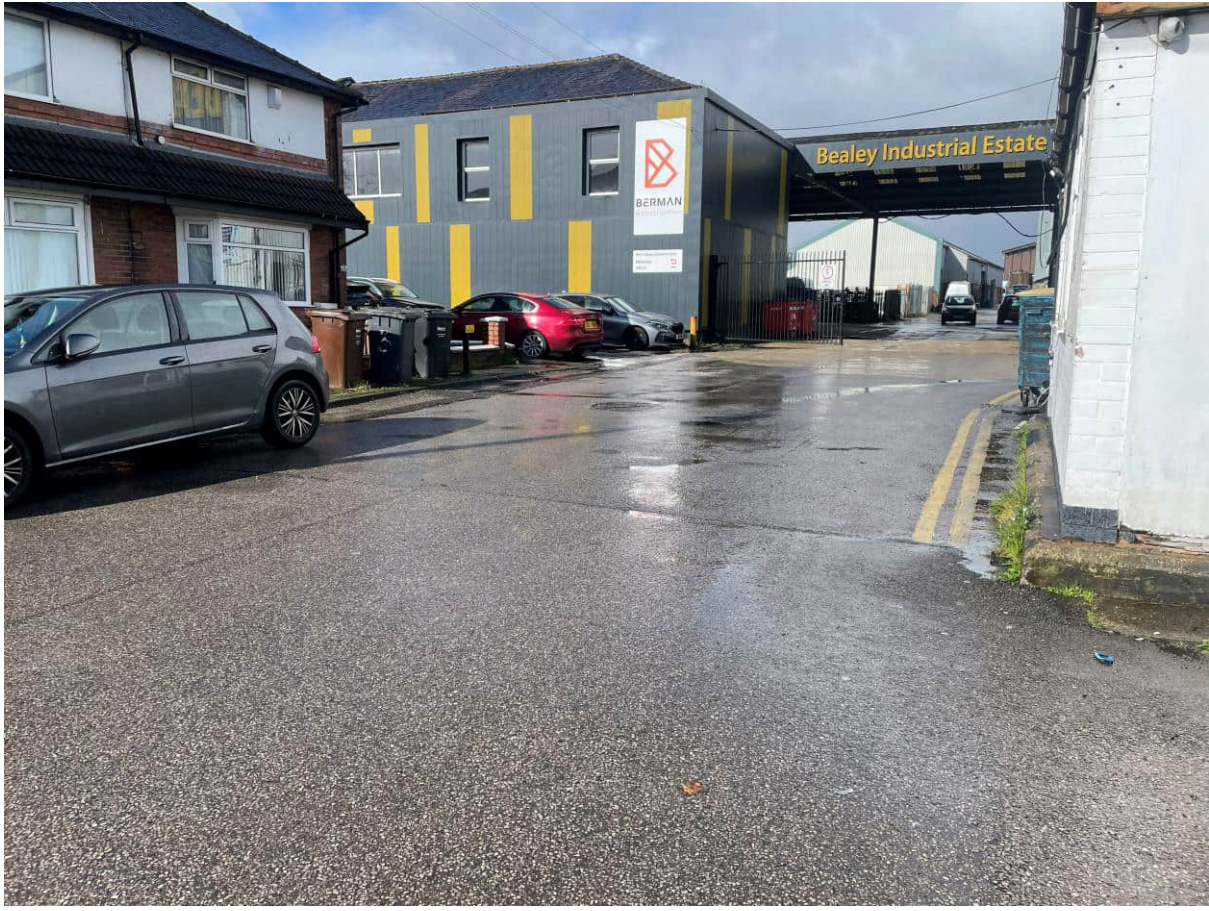
FRAME 15

| 15 | N/a | N/a | Section of carriageway in reasonable condition, worn yellow lining, weeds located down existing building. | Carriageway in reasonable condition. |

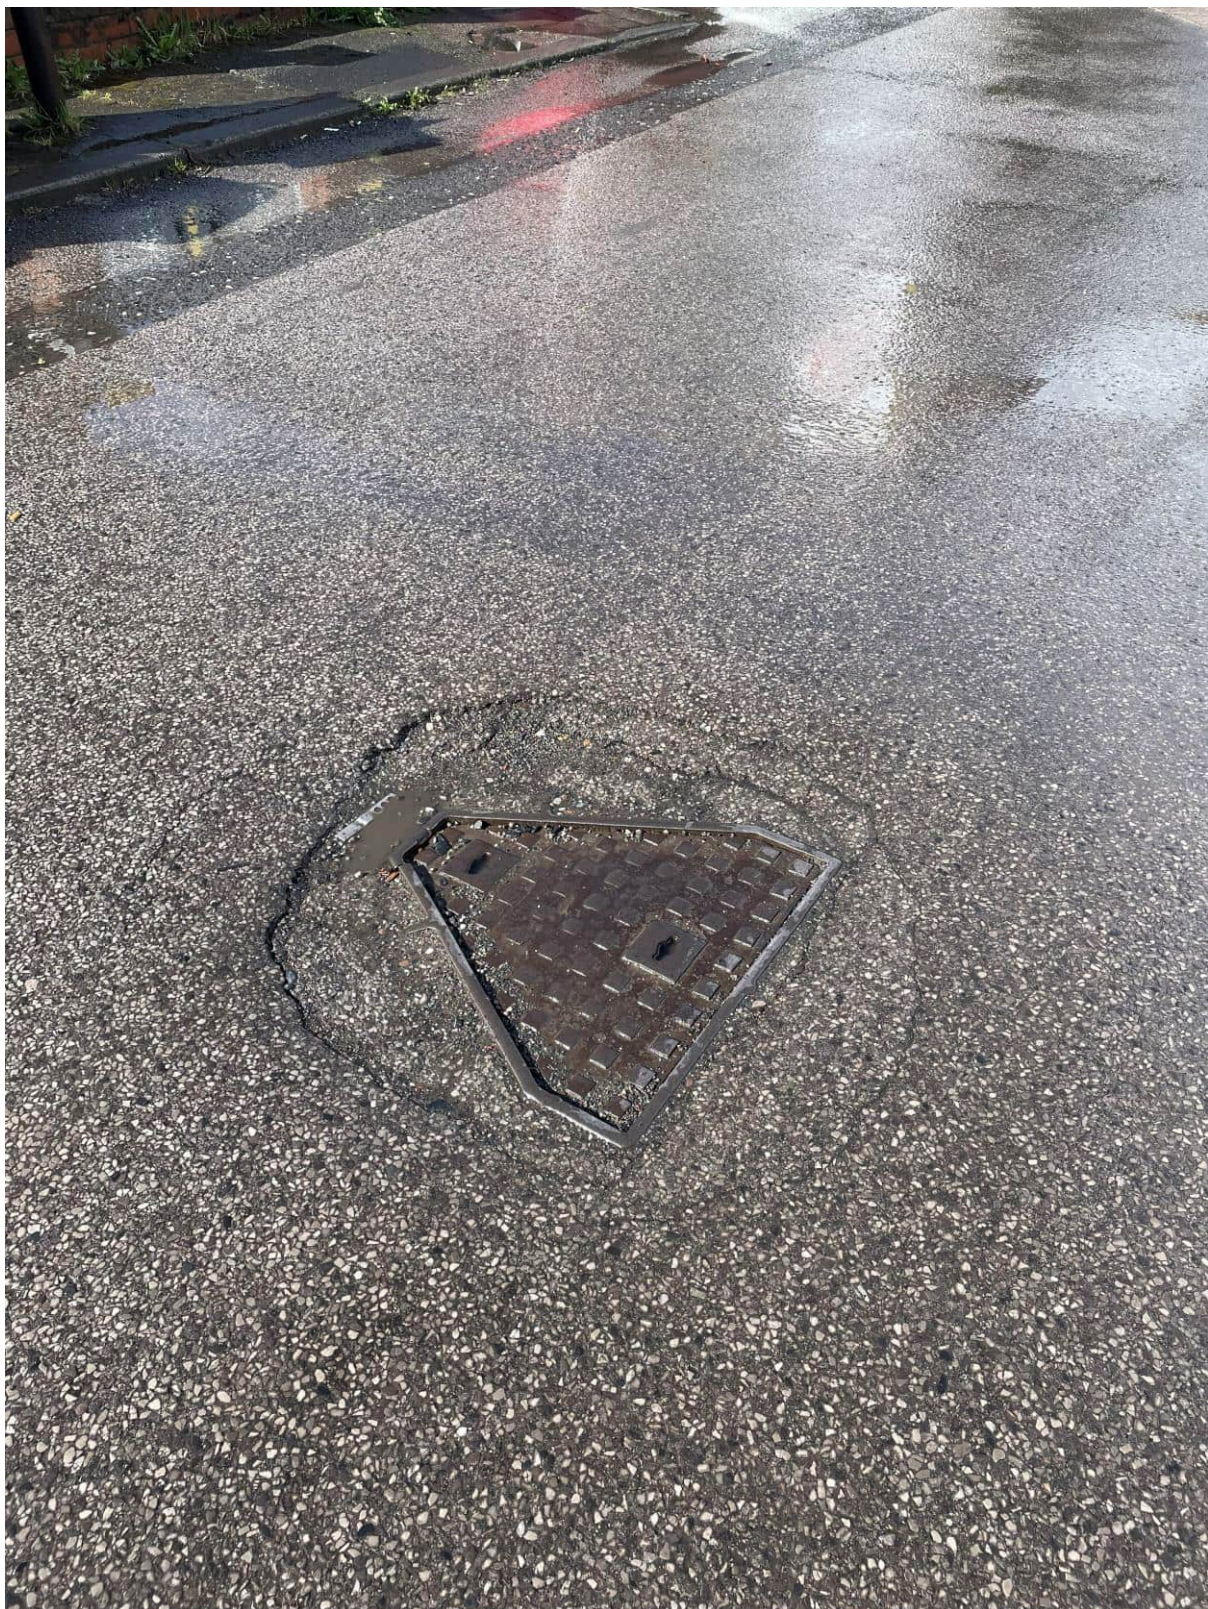
FRAME 16

| 16 | N/a | N/a | Carriageway settled around Manhole. | Manhole lid is reasonable condition. |

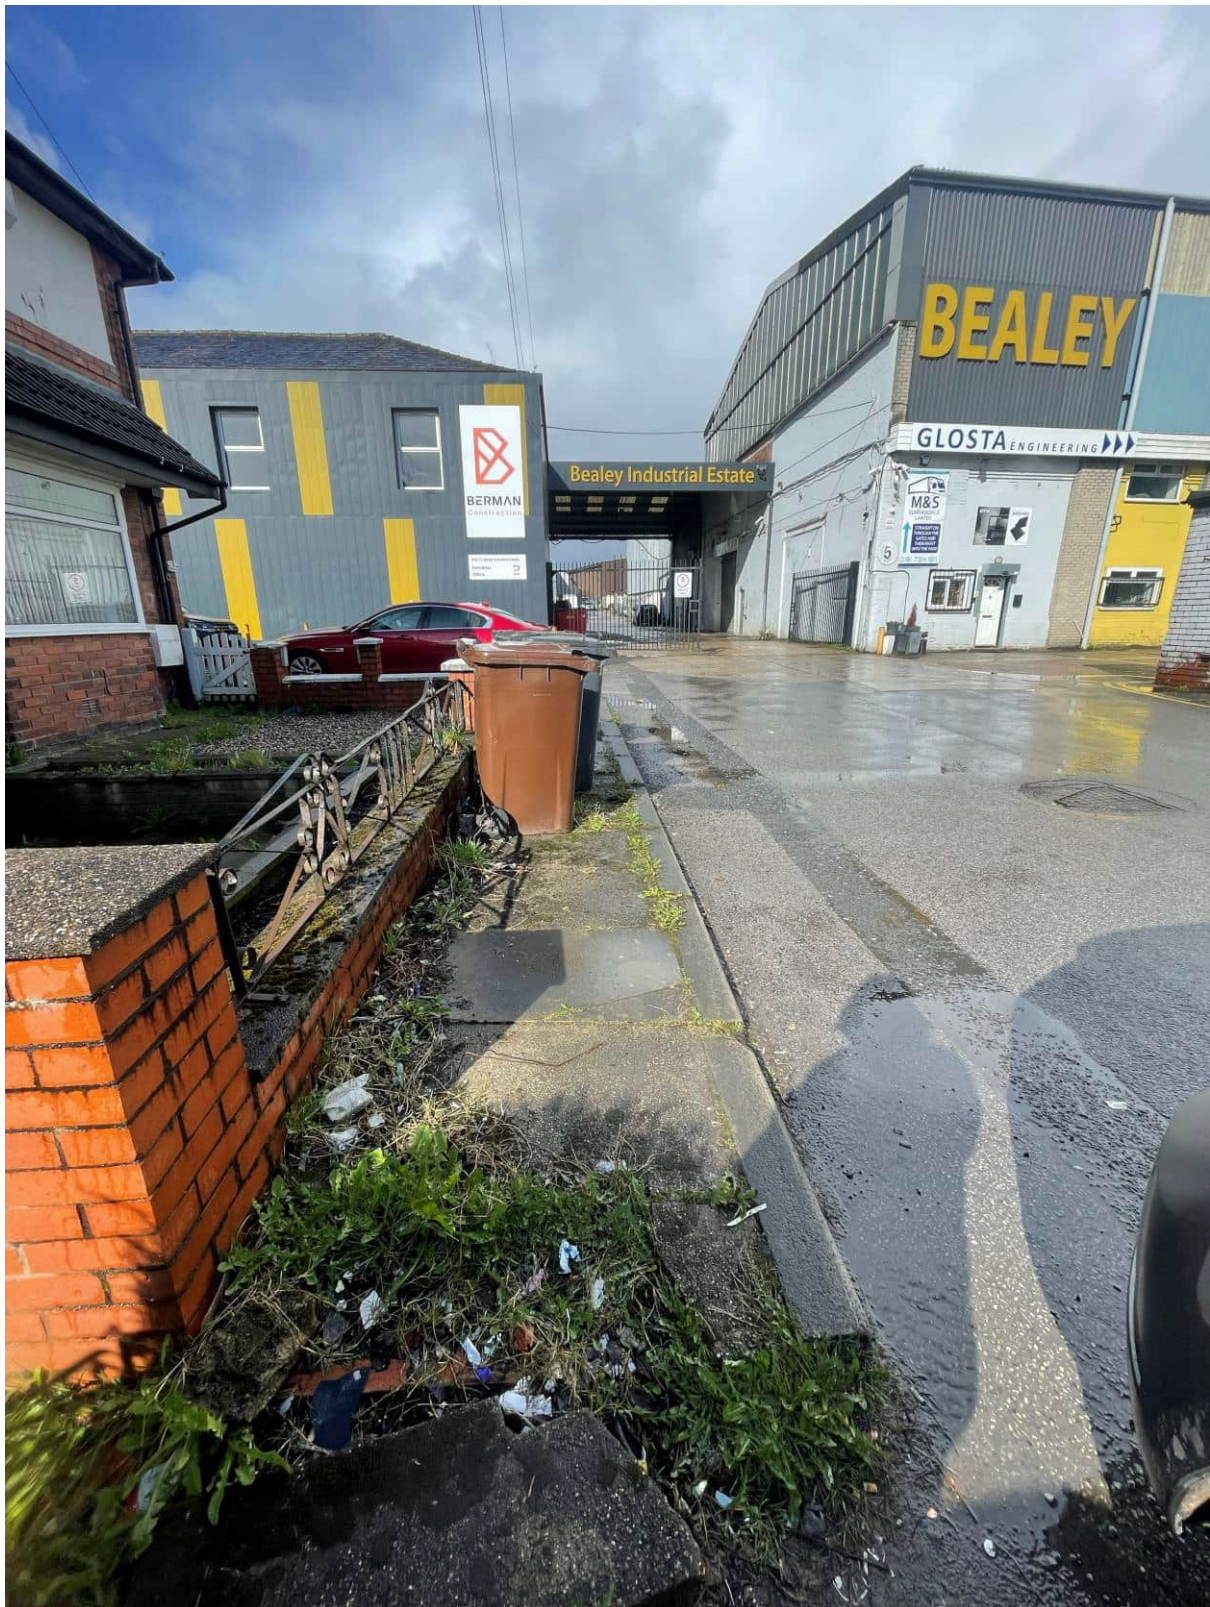
FRAME 17

| <b>17</b> | Kerb line consistent, kerbs well-worn and damaged. Weeds at the back of kerb line. | Footpath damaged, uneven with poor condition. Footpath covered in weeds and rubbish. | Utilities patch running though carriageway. | Carriageway in reasonable condition. Kerbs and footpaths poor. |

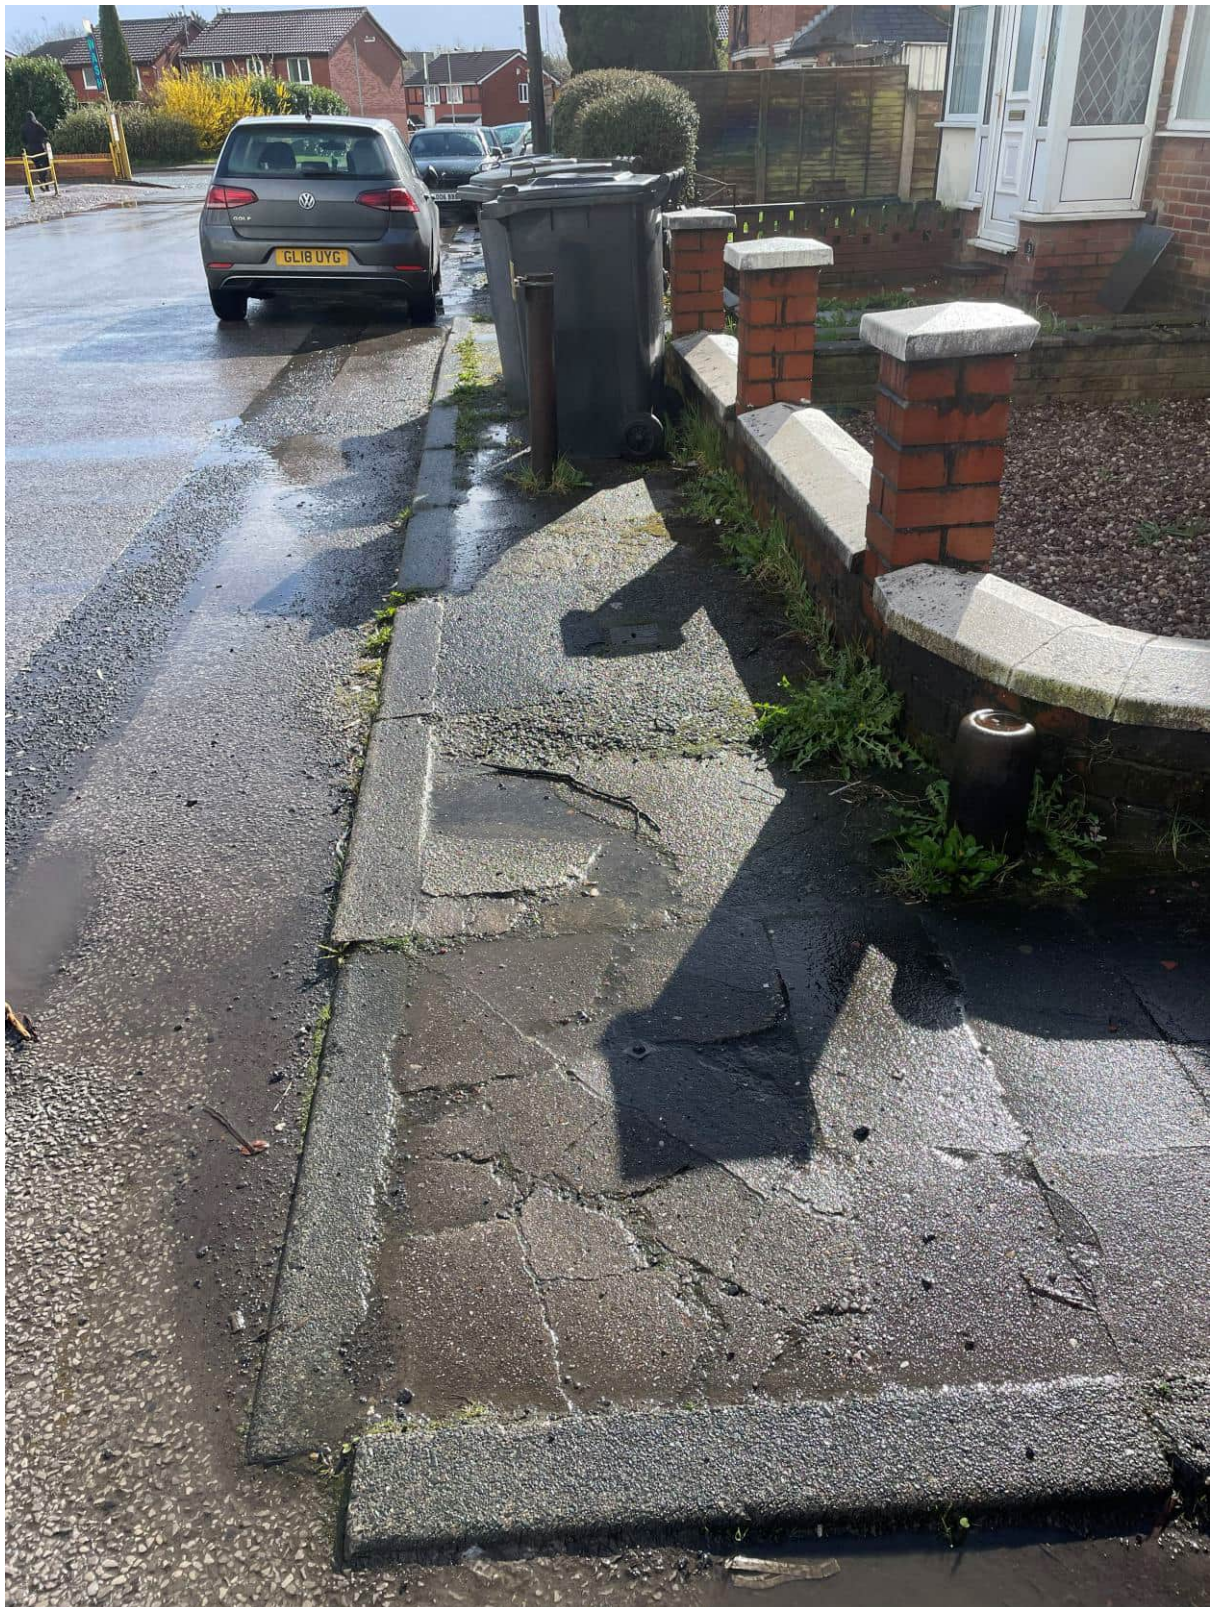
FRAME 18

| <b>18</b> | Kerbs well worn, running flush with carriageway. Weeds running along kerb line. | Footpath damaged with cracked flags, weeds running along back of footpath. | Reasonable condition. Utilities patch running though carriageway. | Reasonable Condition |

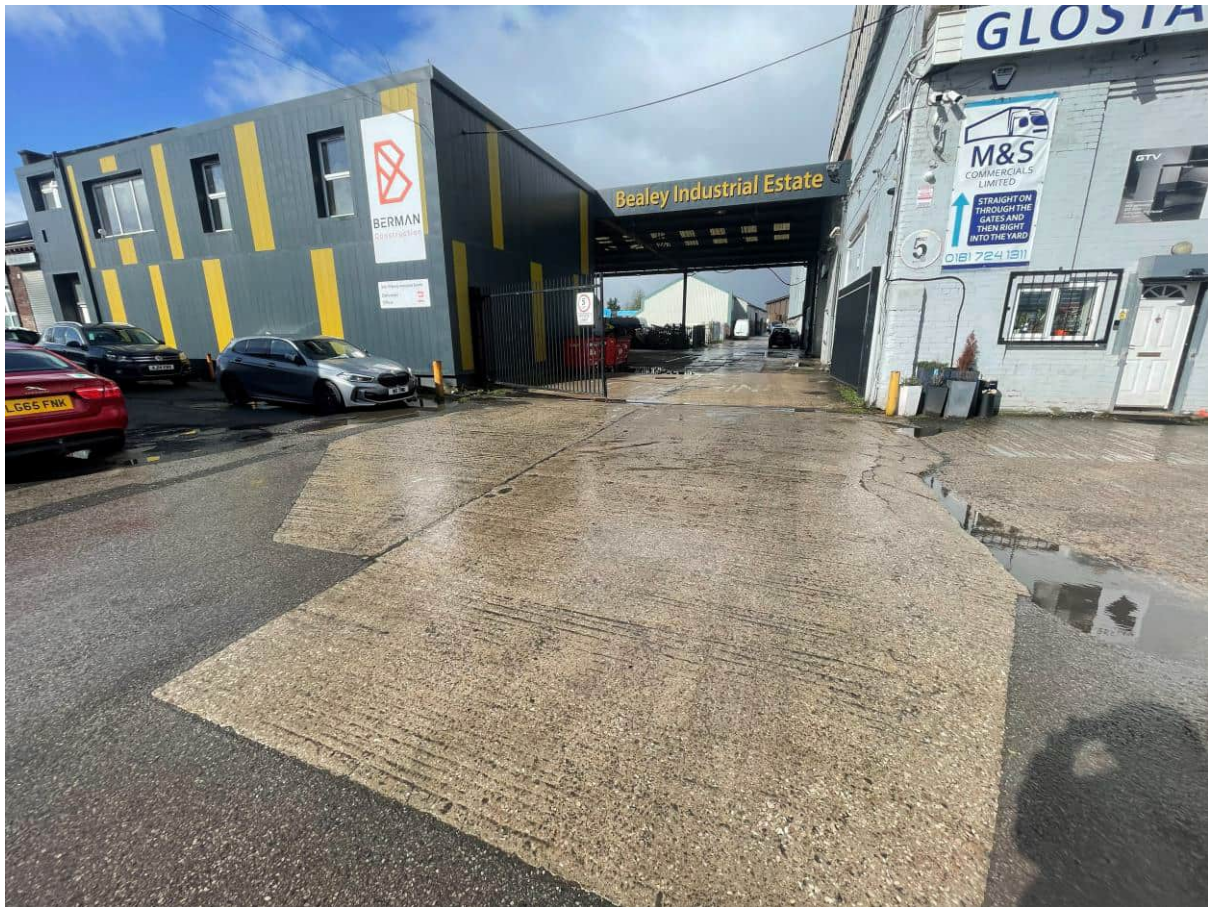
FRAME 19

| <b>19</b> | N/a | N/a | Carriageway surfacing material changed, cracking and ponding due to level change. | Poor condition |

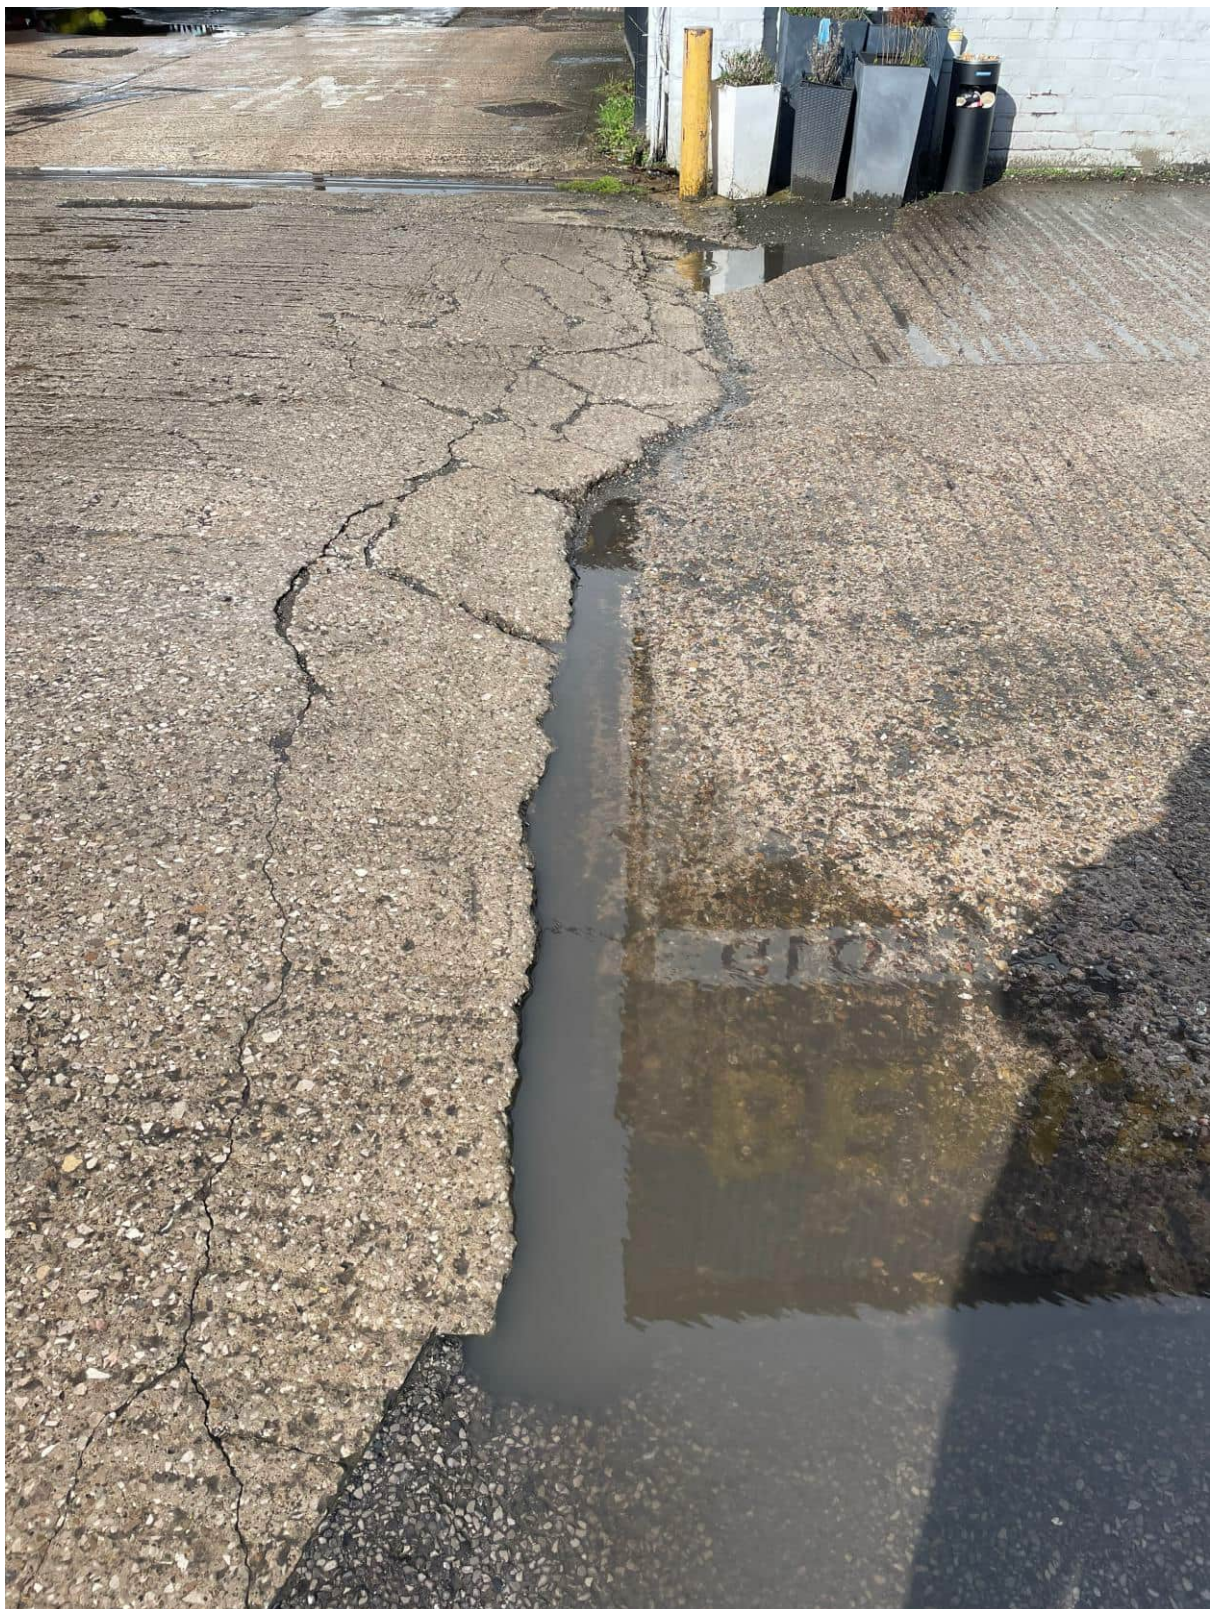
FRAME 20

| <b>20</b> | N/a | N/a | Carriageway surfacing material changed, cracking and ponding due to level change. | Poor condition |

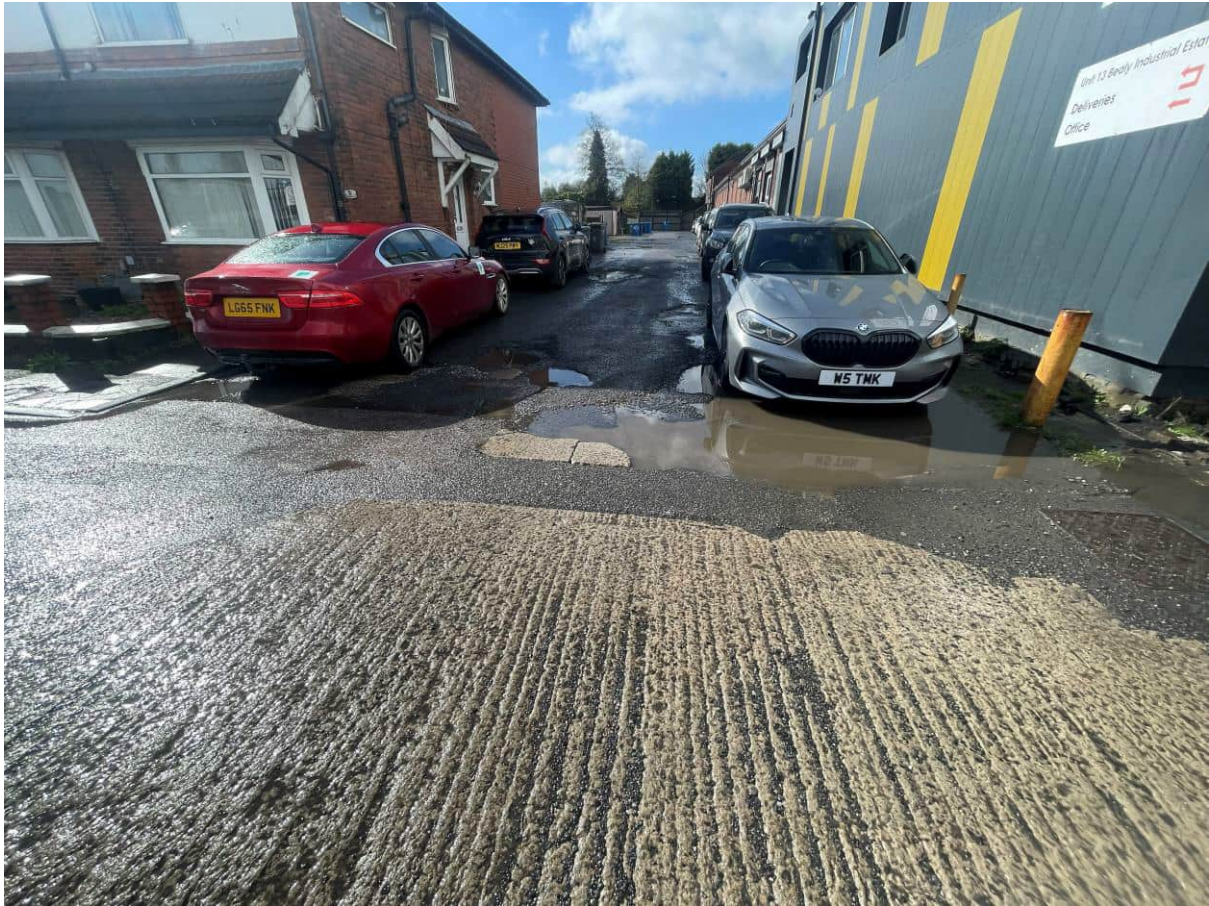
FRAME 21

| <b>21</b> | N/a | N/a | Carriageway surfacing material changed, cracking and ponding. Ironworks in reasonable condition. | Poor condition |

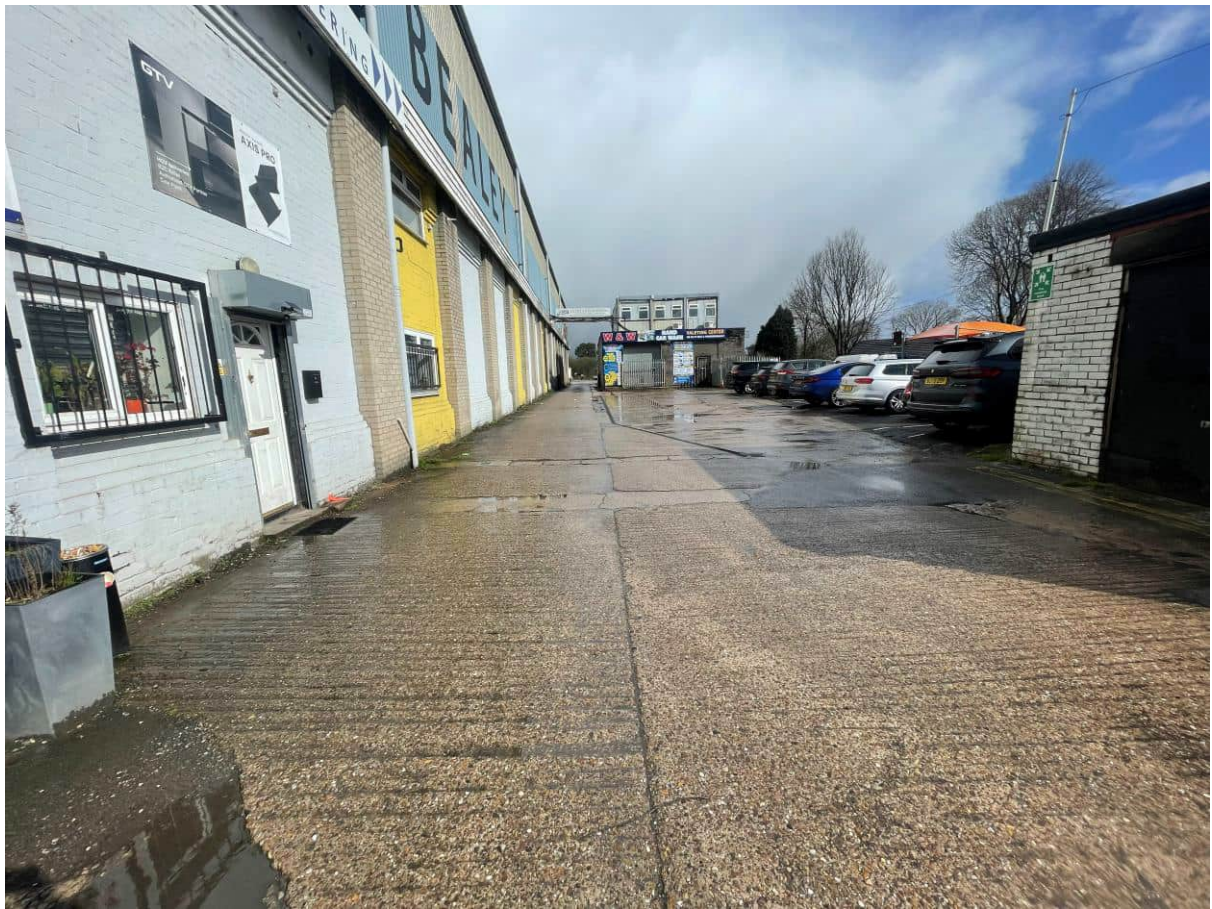
FRAME 22

| <b>22</b> | N/a | N/a | Surfacing in poor condition, uneven surfacing, cracking in material with utilities works patches. | Poor condition |

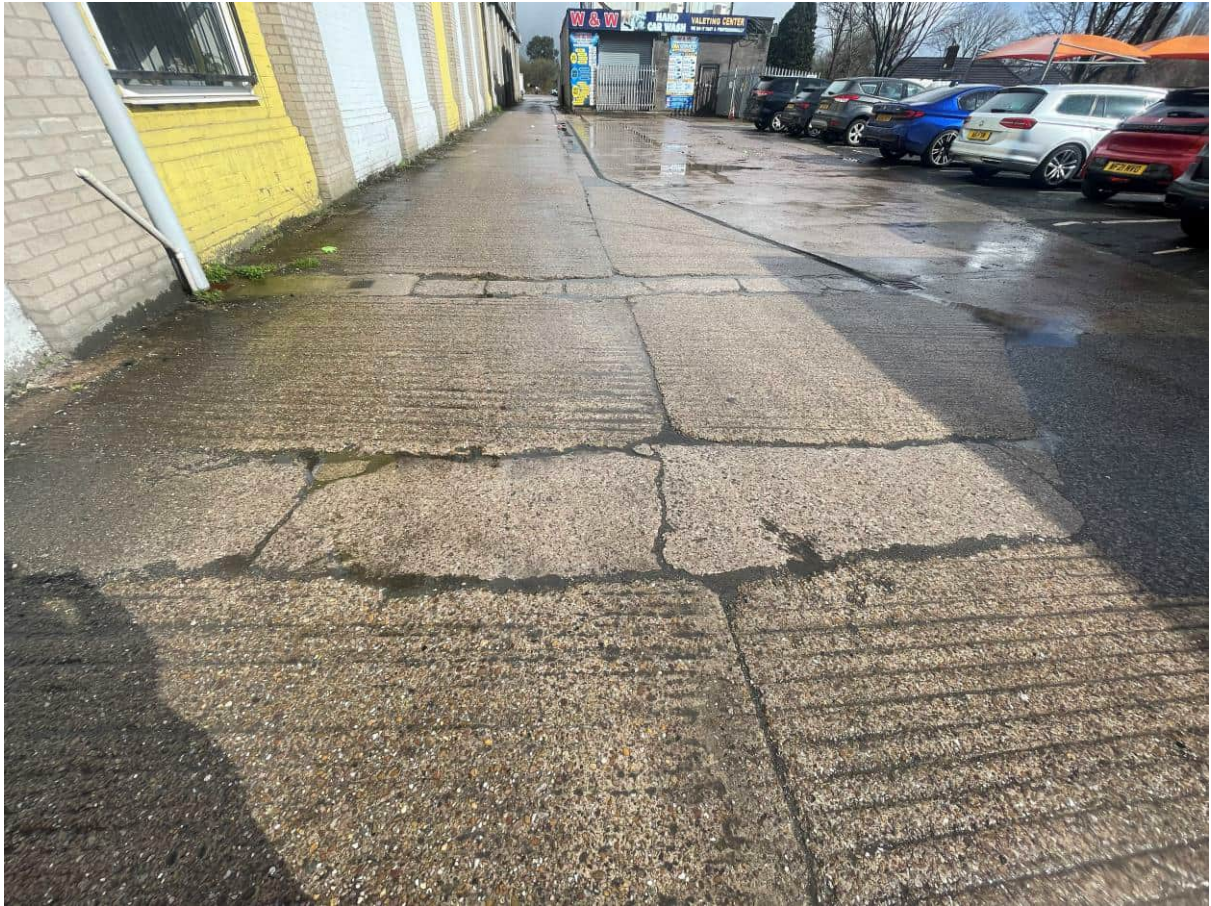
FRAME 23

| <b>23</b> | N/a | N/a | Surfacing in poor condition, uneven surfacing, cracking in material with utilities works patches. | Poor condition |

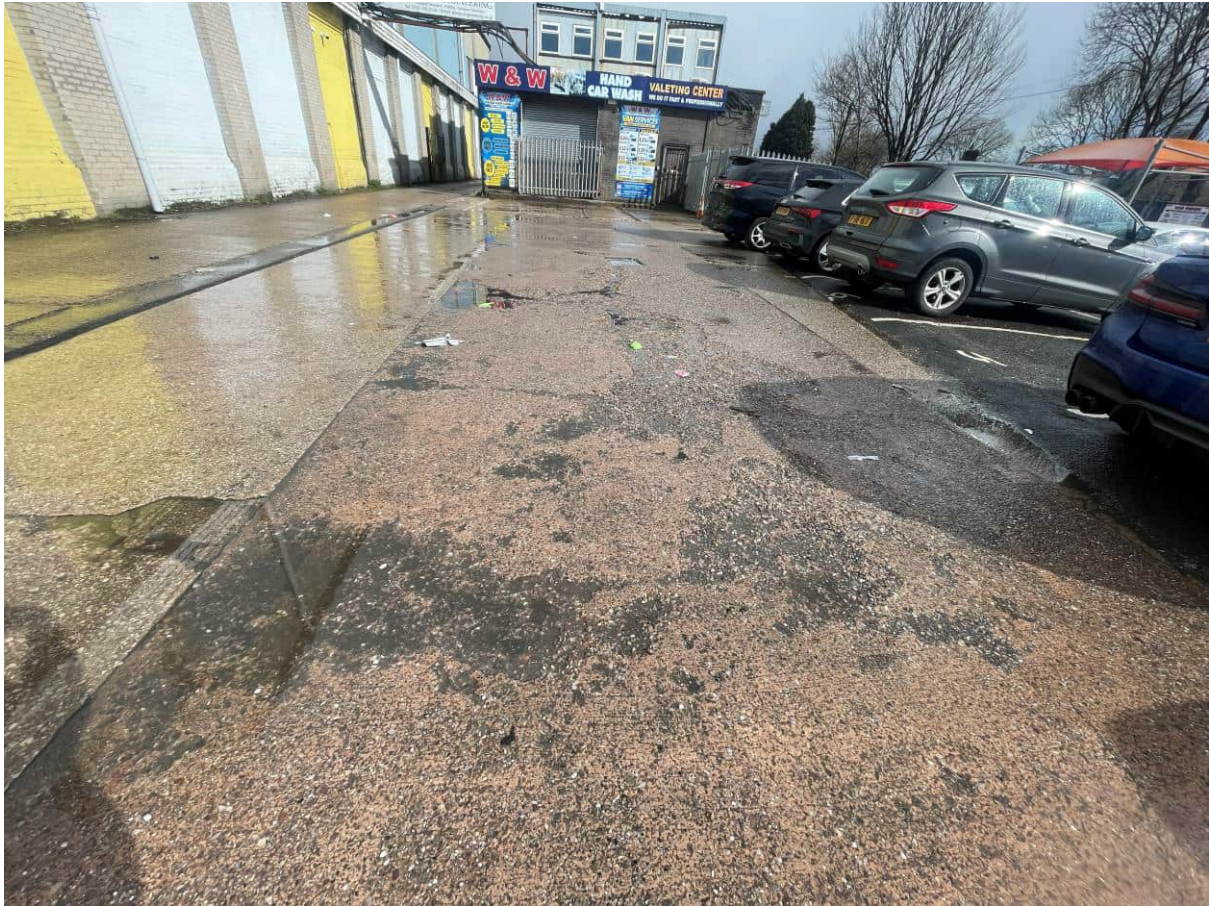
FRAME 24

| <b>24</b> | N/a | N/a | Tarmacked Car park to the right-hand side. Potholes and ponding with patched surfacing. | Poor condition |

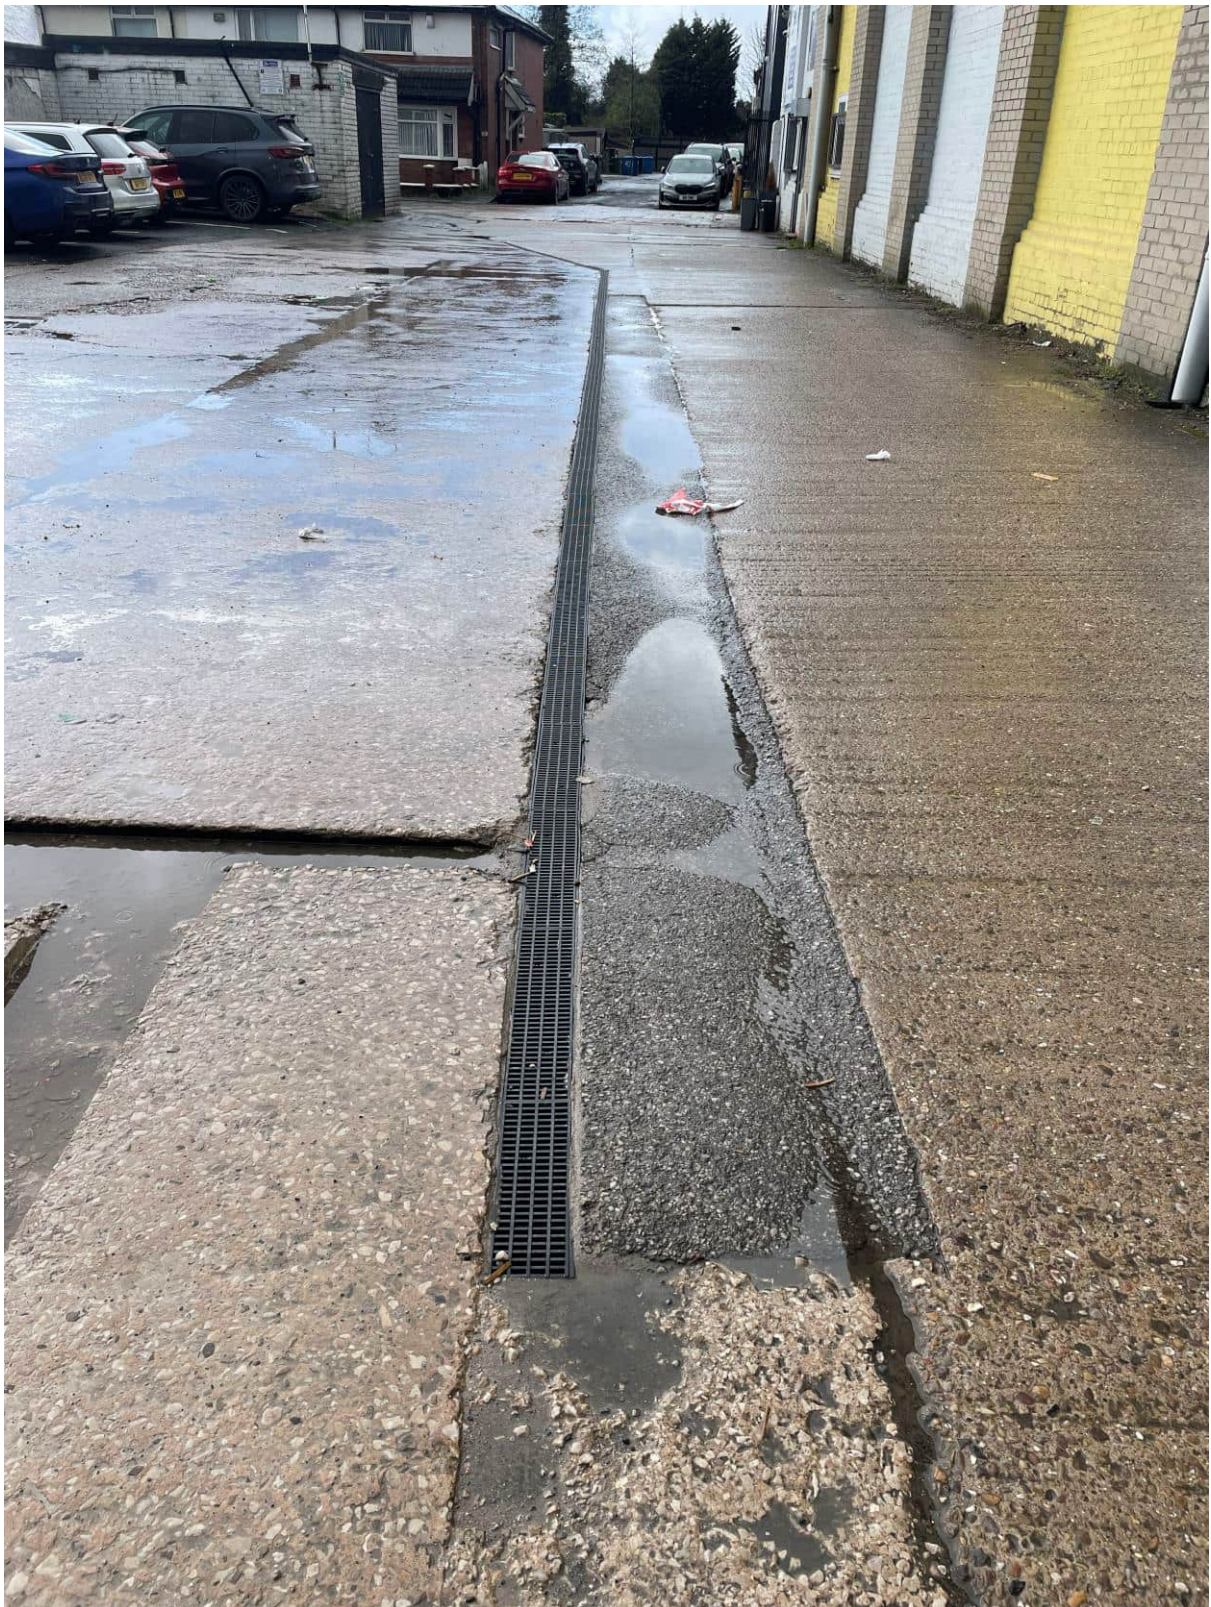
FRAME 25

| <b>25</b> | N/a | N/a | Utilities trench patches. | Poor condition |

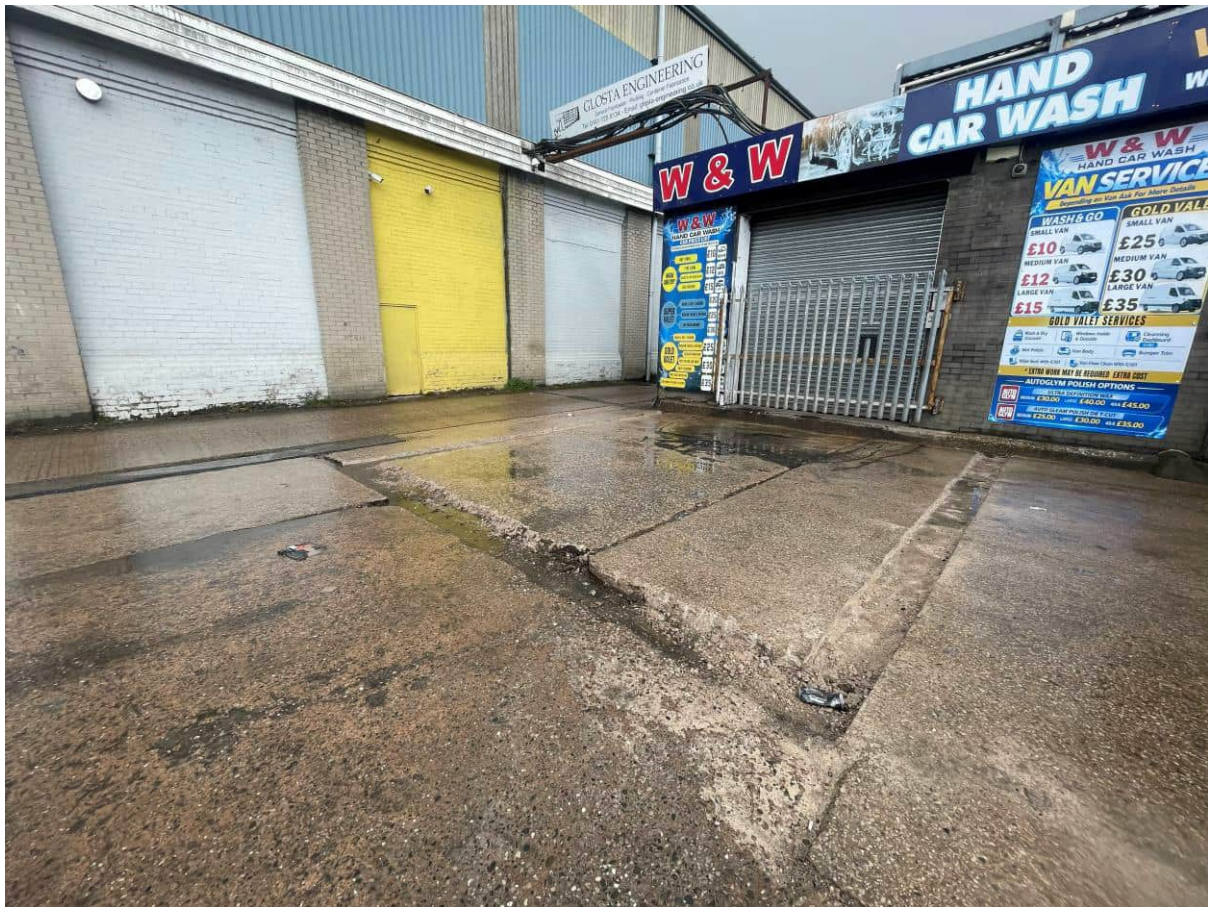
FRAME 26

| <b>26</b> | N/a | N/a | Surfacing in poor condition, uneven surfacing, cracking in material with ponding. | Poor condition |

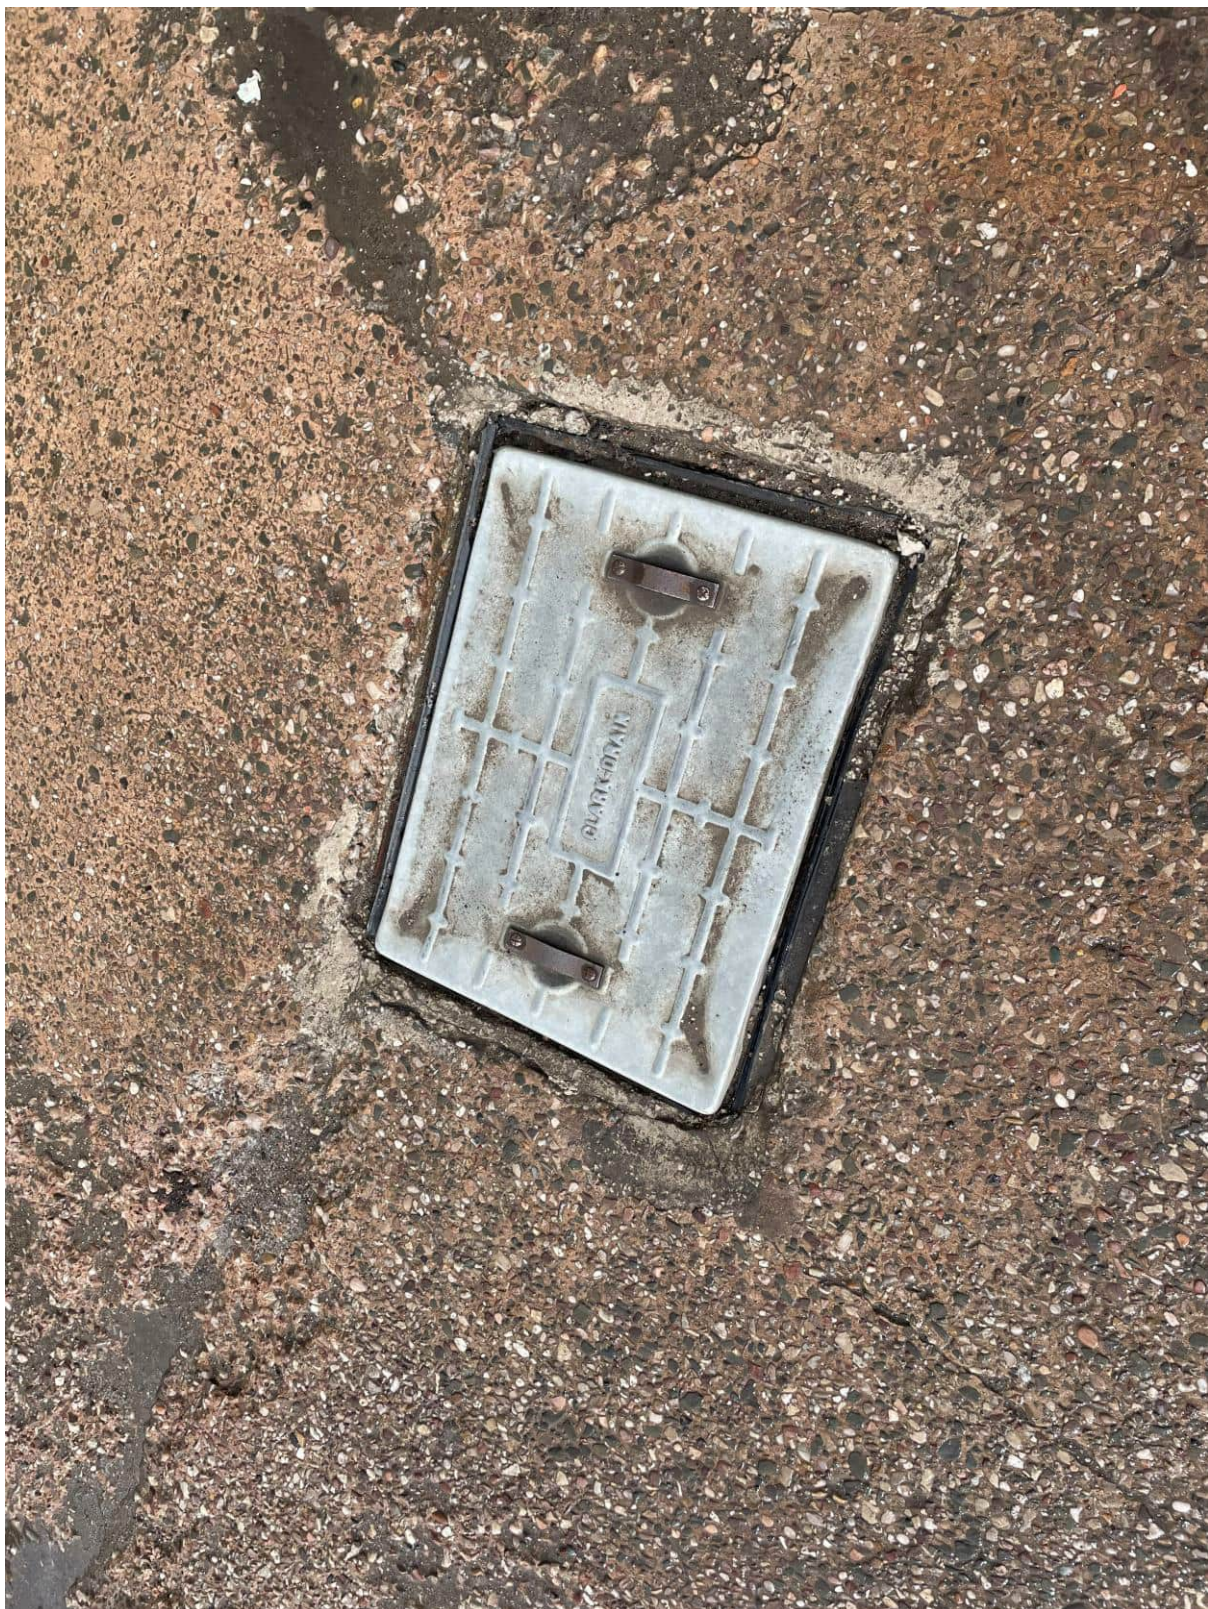
FRAME 27

| <b>27</b> | N/a | N/a | Clark drain positioned in carriageway, damaged worn-down lid. | Poor condition. |
