# STRUCTURAL INSPECTION

## **Silver Street Bury (Former Barclays Bank)**

Property Address: Silver Street, Bury

Inspection Details: GENERAL STRUCTURAL INSPECTION

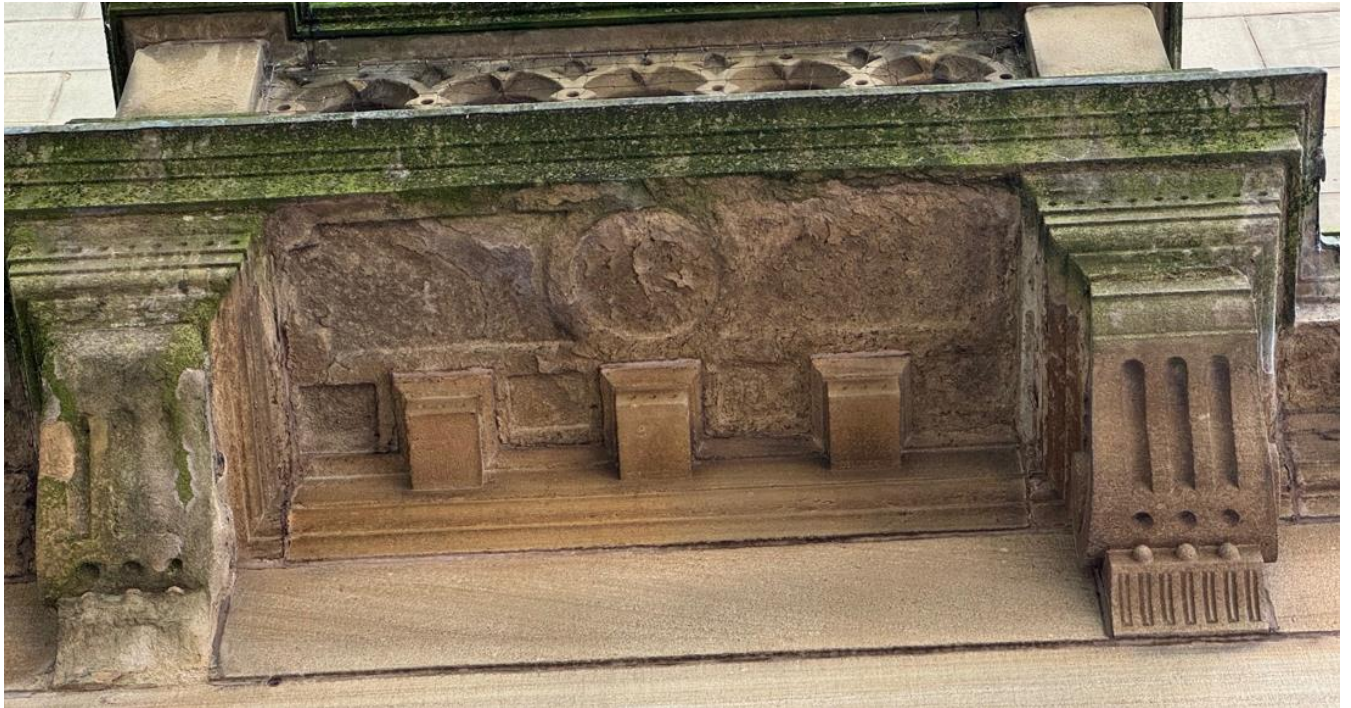
The external elevations were constructed using decorative sandstone blocks. The front and side balconies were showing signs of salt crystallization decay to the underside, which is typically common for sandstone of this age. There appeared to be signs of water ingress and moss build up around the areas near trees.

Photo 2: Decayed Balcony, Bank Street

The external elevations require some attention, although this is not of any significance. Treating and repairing the water ingress and decay will prevent any further damage which could cause structural damage. The roof wasn't accessible at the time of the survey but given the condition of the building it is highly recommended that this must be revisited once access has been installed. It is recommended that the brickwork under the front window of the stairwell at first floor and ground floor is to be repaired as the integrity of the bricks have been compromised due to years of aging and works carried out. Stone plinths should also be repaired by competent stone masons to prevent any further decay. Masonry that has been damaged during removal of the plaster must be raked out and repointed.

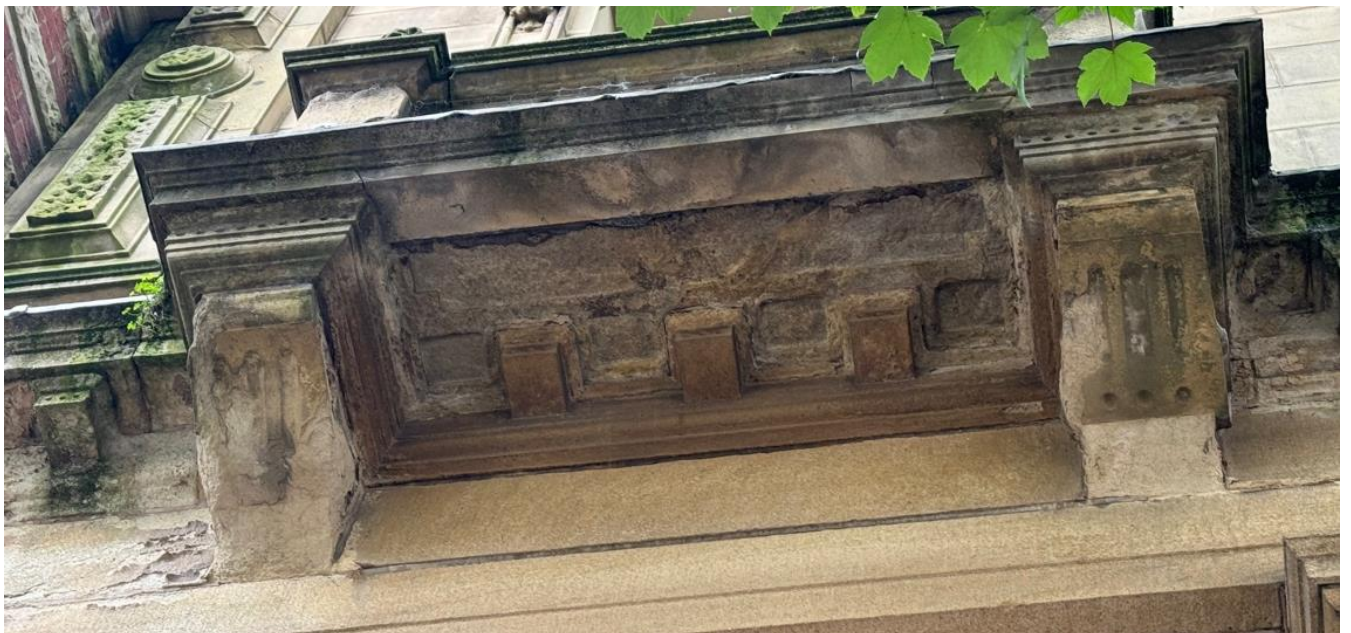
Photo 3: Decayed balcony Bank Street

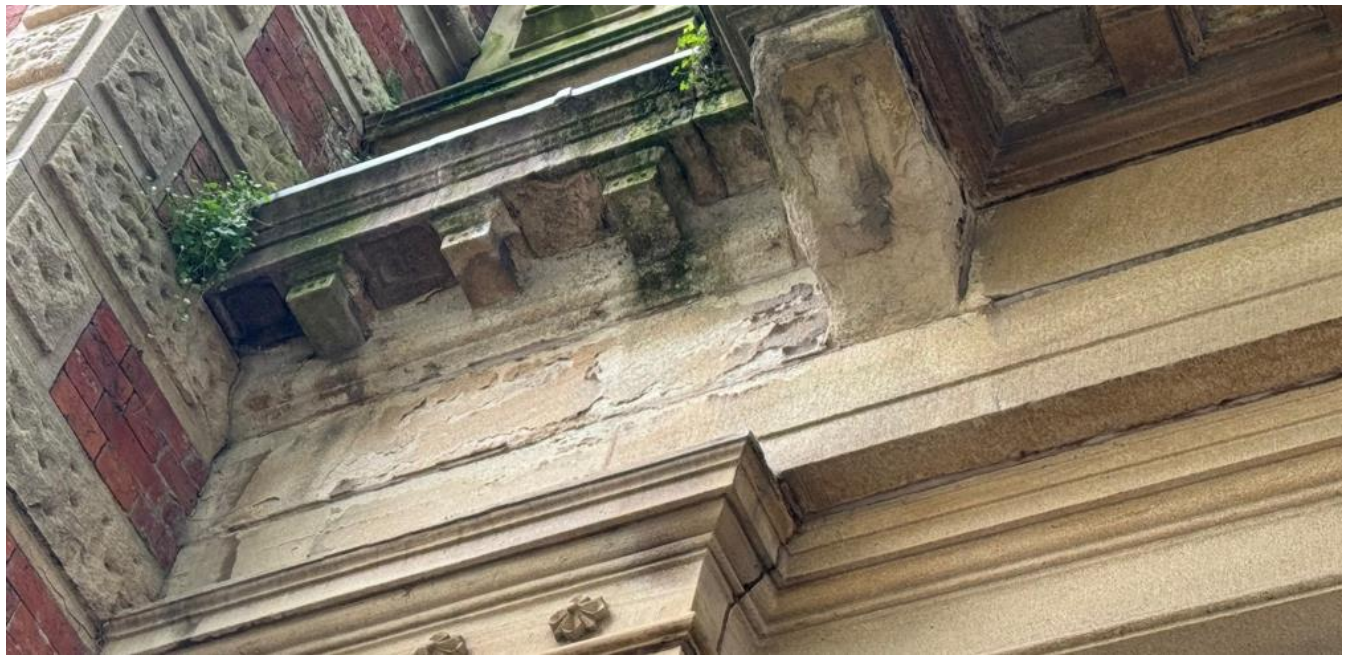
Photo 4: Decayed stonework, Bank Street

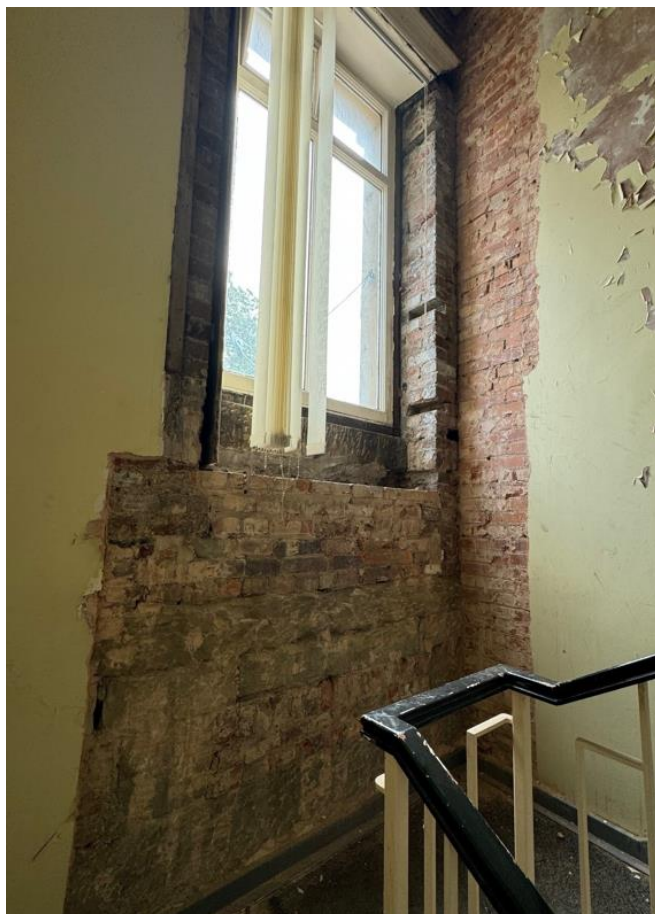
The stairwell brick work under the front window appeared to be in bad condition, large areas of mortar has spalled and deteriorated and cracked brickwork. The stone plinth under the window also has large chunks missing.

Photo 5: Masonry First floor Stairwell

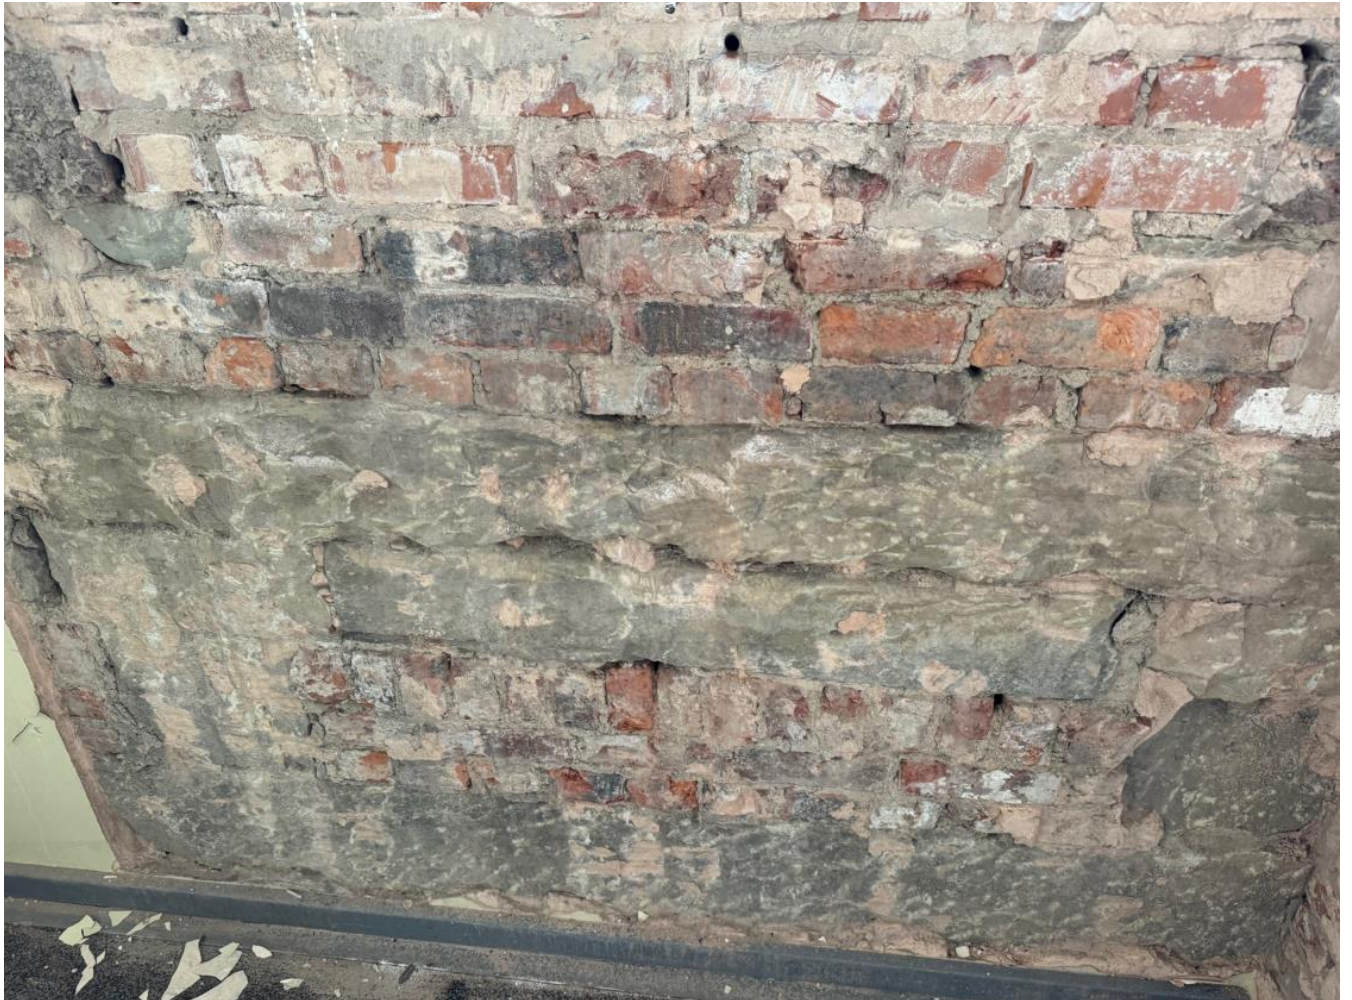
Photo 6: Damaged masonry and stone plinth First floor Stairwell

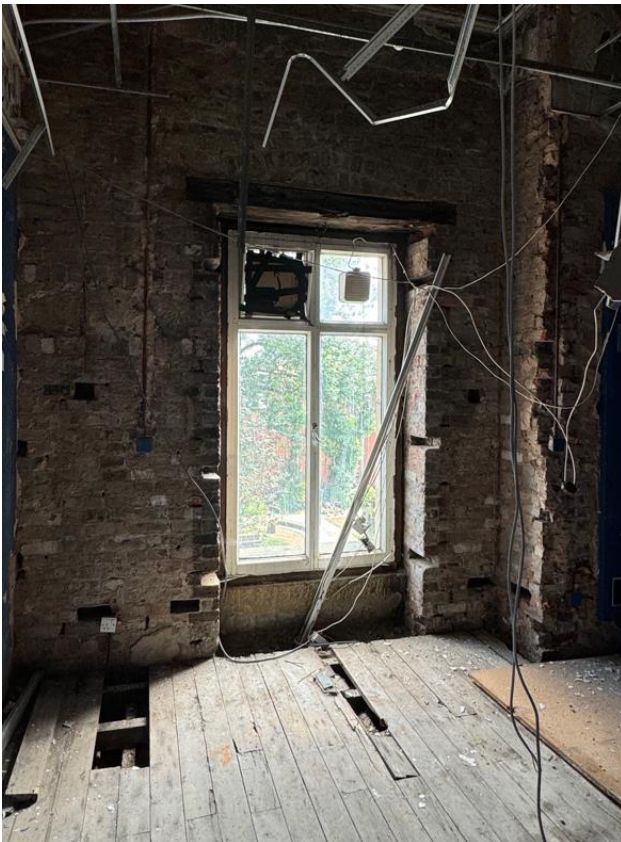
Walls and joists were both exposed in the front two rooms at the first floor just off the stairwell, floor joists appeared to be rotten in areas. Timber lintels above front elevation windows were rotten and in bad condition, brickwork was missing, a buttressing wall appeared to have been removed with snapped

Photo 8: First floor room 1 front elevation, snapped brickwork

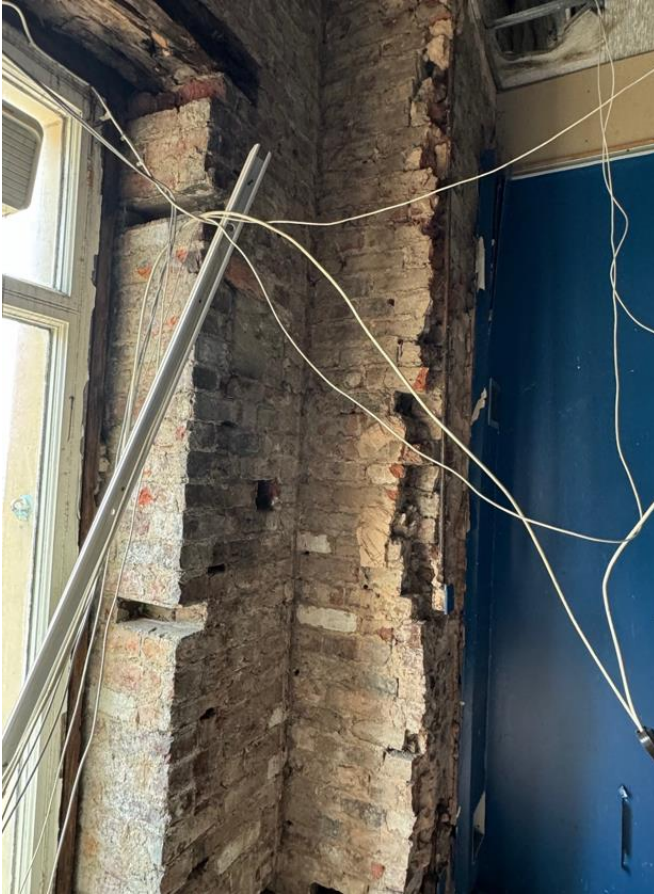
Photo 9: First floor room 1 front elevation, snapped brickwork and failed timber lintel

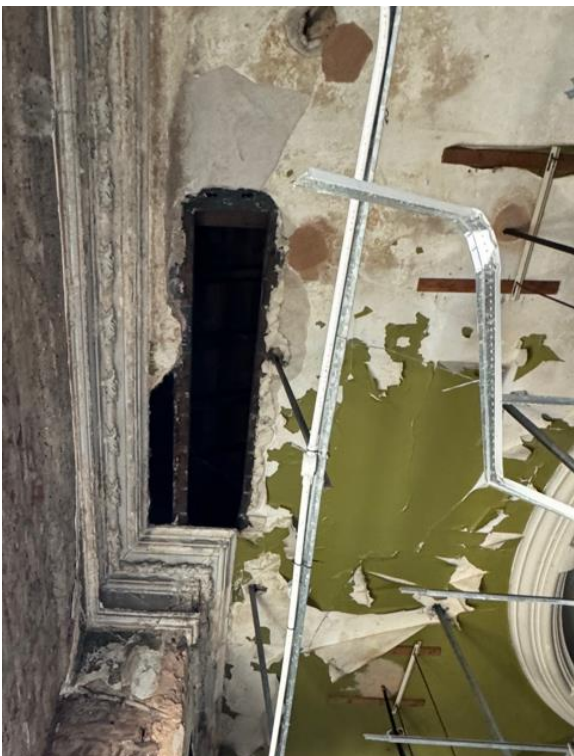
bricks visible. Existing coving in the top left corner of the front elevation room appeared to be damp and rotten. The rear rooms located on the first floor, again appeared to have exposed brickwork and floor joists. Brickwork was missing, spalling mortar. Bricks have been damaged when removing the plaster during the stripping out phase. False ceilings were damp and partially collapsed.

Photo 10: First floor room 1 damaged ceiling and coving

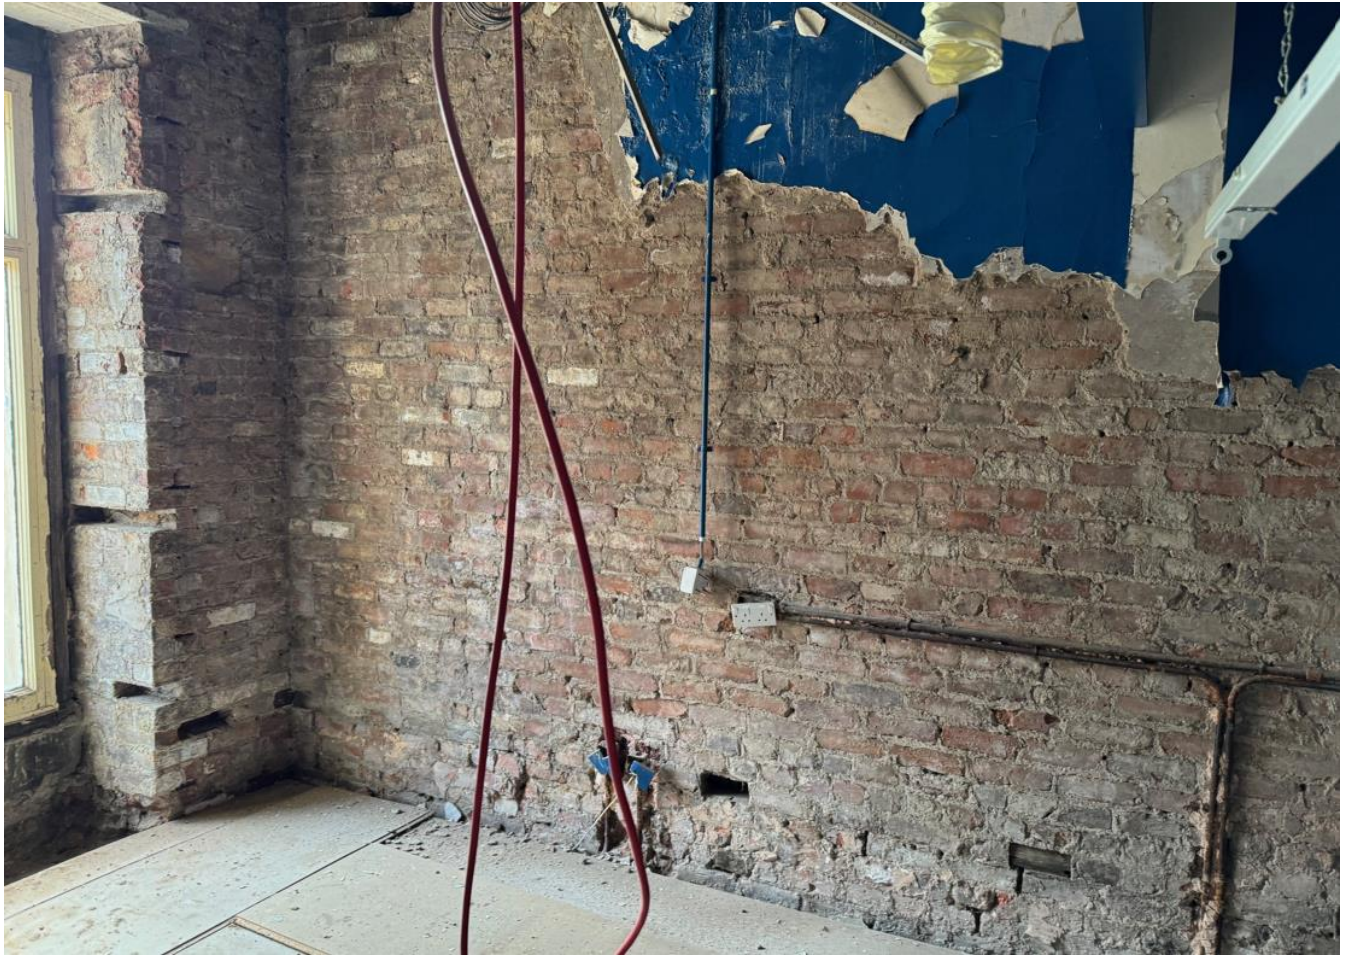
Photo 11: First floor room 1, moderate exposed brickwork

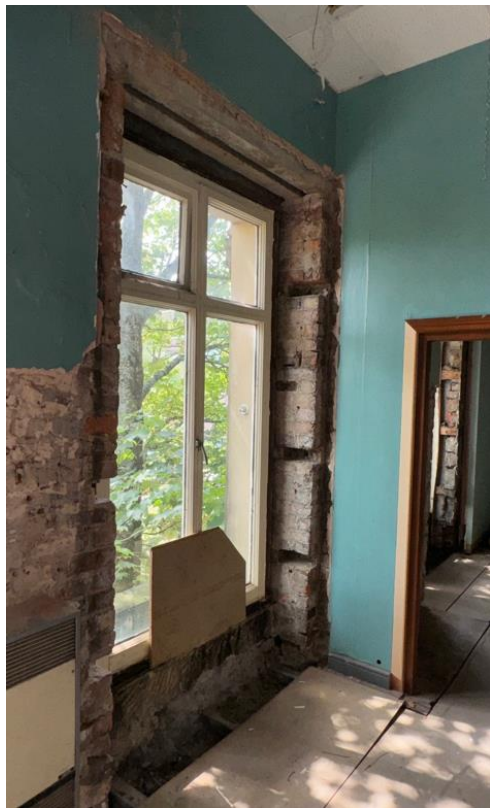
Photo 12: First floor room 2, front widow reveal with missing bricks

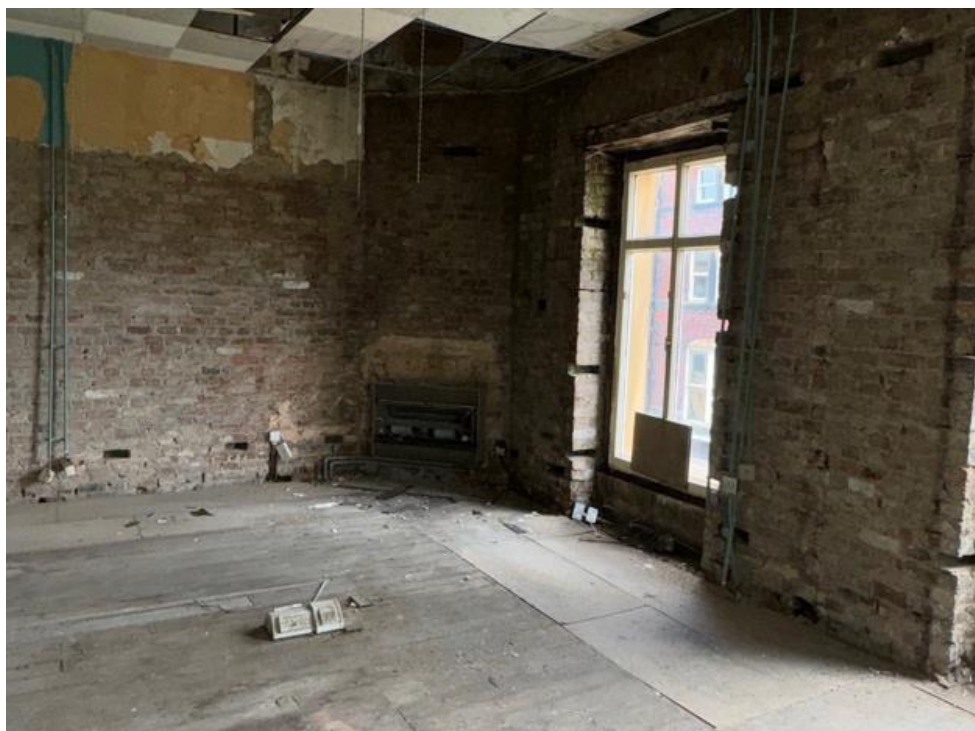
Photo 13: First floor room 2, exposed brickwork

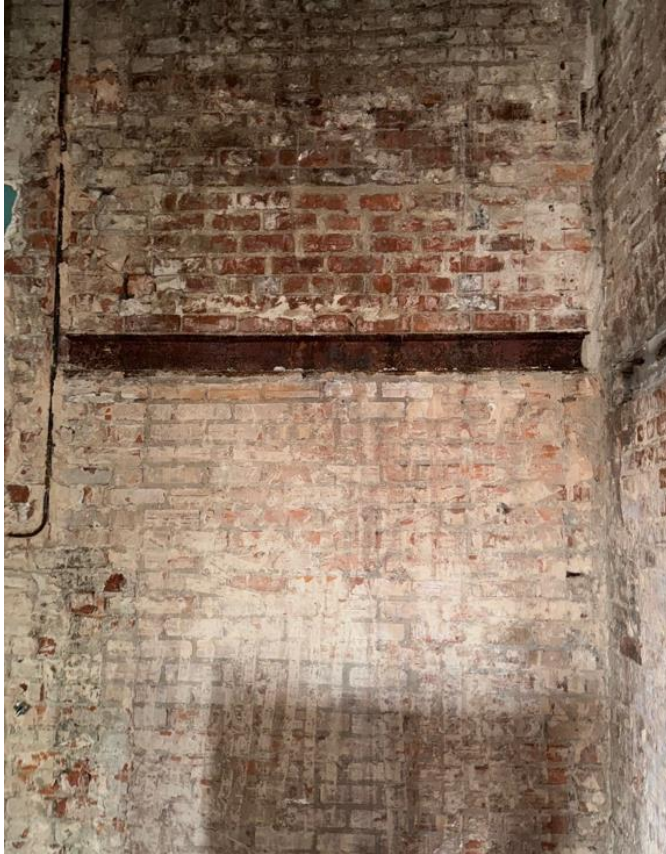
Photo 14: First floor rear of the hall, Exposed damage brickwork

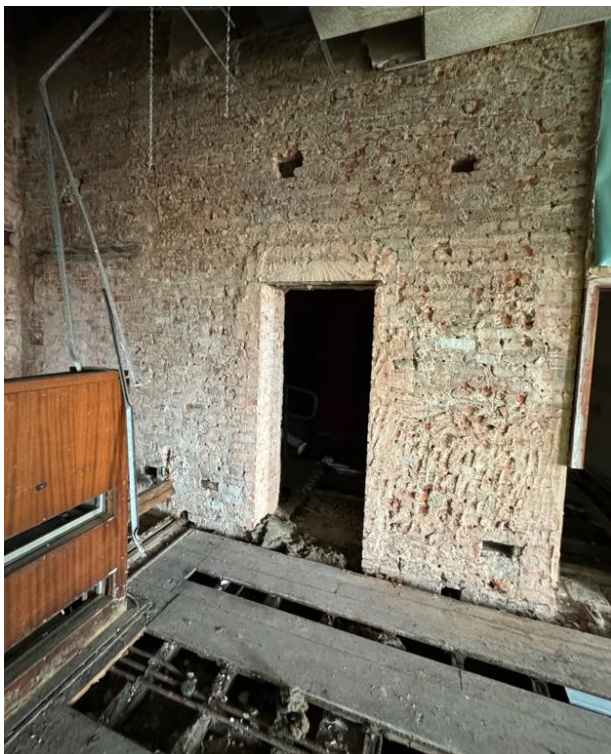
Photo 15: First floor rear of the hall, Exposed damage brickwork

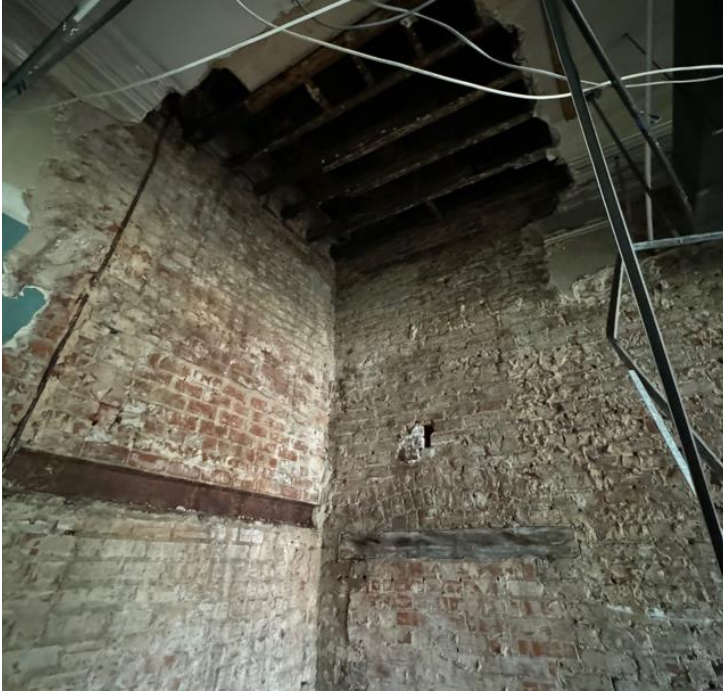
Photo 16: First floor rear of the hall, damaged ceiling

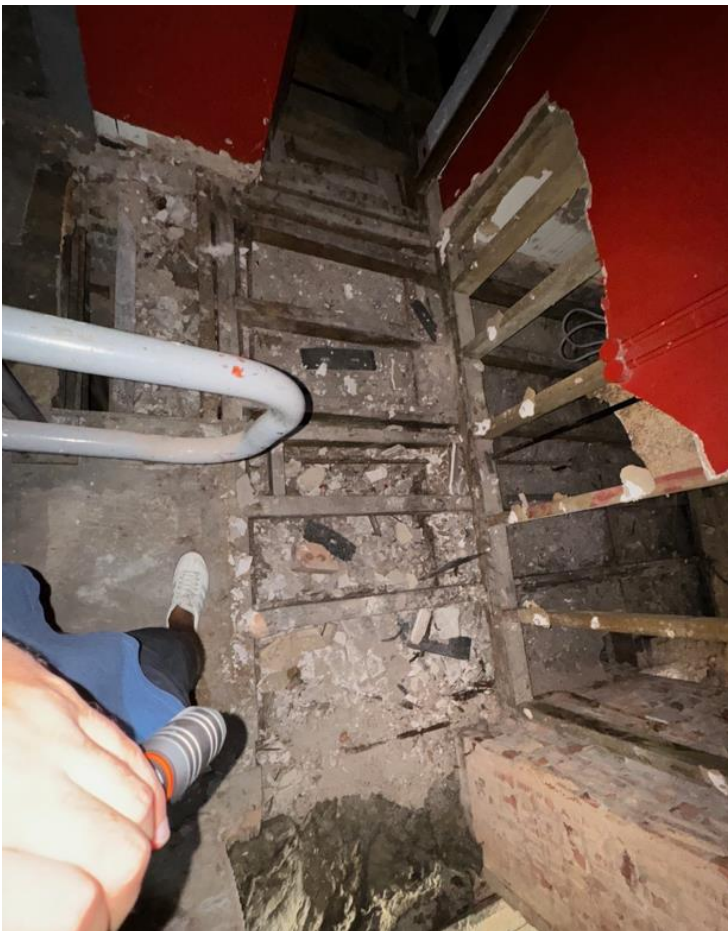
The first floor was lacking maintenance and had deteriorated over time, joists exposed in room 1 and room 2 appeared to be rotten due to damp. These joists must be replaced, although during the survey only a small area of the joists was exposed a further check would be required and any joists which appear to be rotten must be replaced. Walls in the same area were in moderate condition, slight area of damaged brick due to what looks like the removal of a wall, but this is normal for a property of this age and remedial works must be carried out. The coving in room 1 showed serious signs of decay which could have been from a leak, further action is required on this area. The timber lintel over room 2 front elevation appeared to be in bad condition and lost all its integrity, it is recommended this lintel must be replaced. The back rooms of the first floor had large areas of exposed brickwork, the walls had missing bricks which must be corrected, all walls that have been damaged when plaster was removed require repointing. Floor joists in the back right corner of the first floor show excessive rotting and all the floor is to be replaced. The first-floor mezzanine floor is proposed to be removed so no works are required in this area. Ceilings of the first floor appear to be compromised access was restricted but it appeared some areas of the ceiling were rotten, this being indicated by damp coving, it is recommended that when access is installed the ceiling joists must be inspected further and replaced if required.

Photo 17: First floor rear room, rotten floor joists

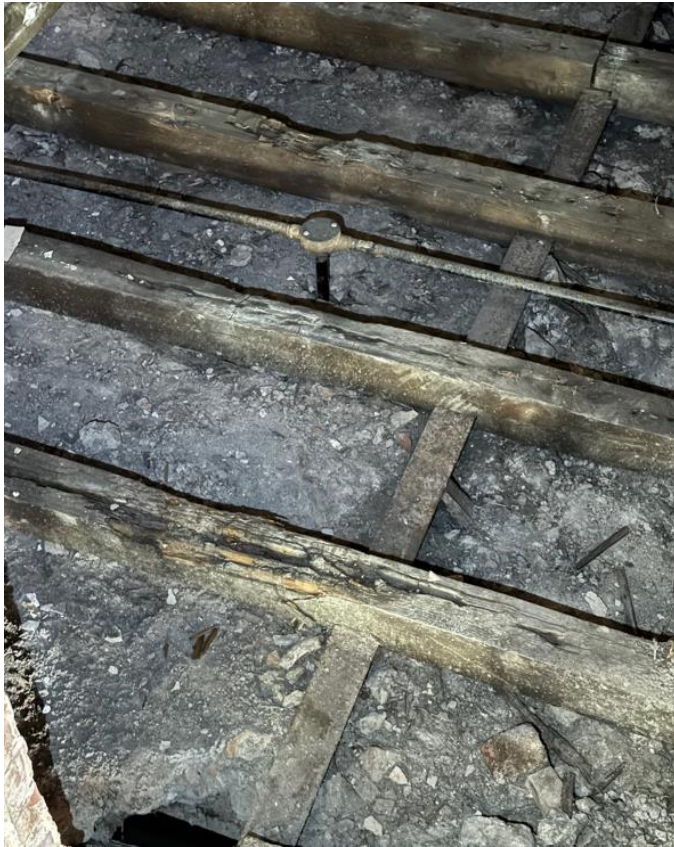
Photo 18: First floor rear room, rotten floor joists

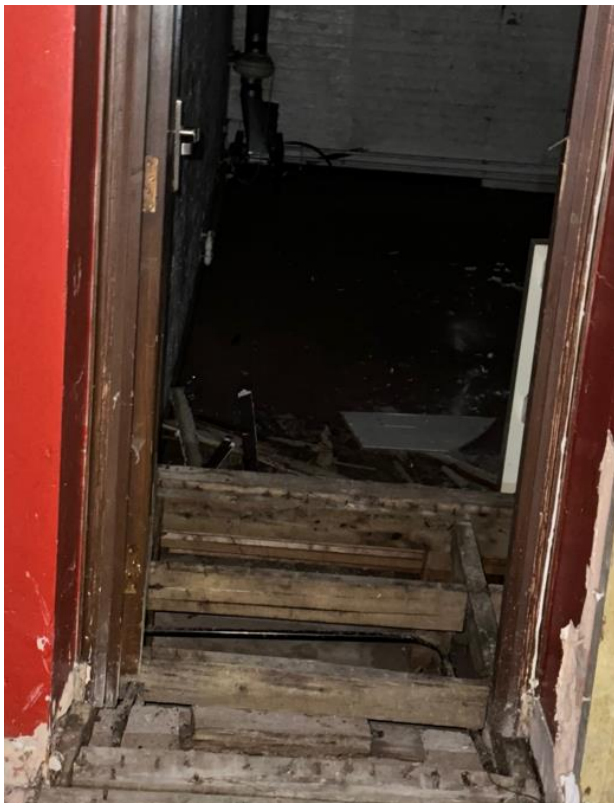
Photo 19: First floor rear room, rotten floor joists

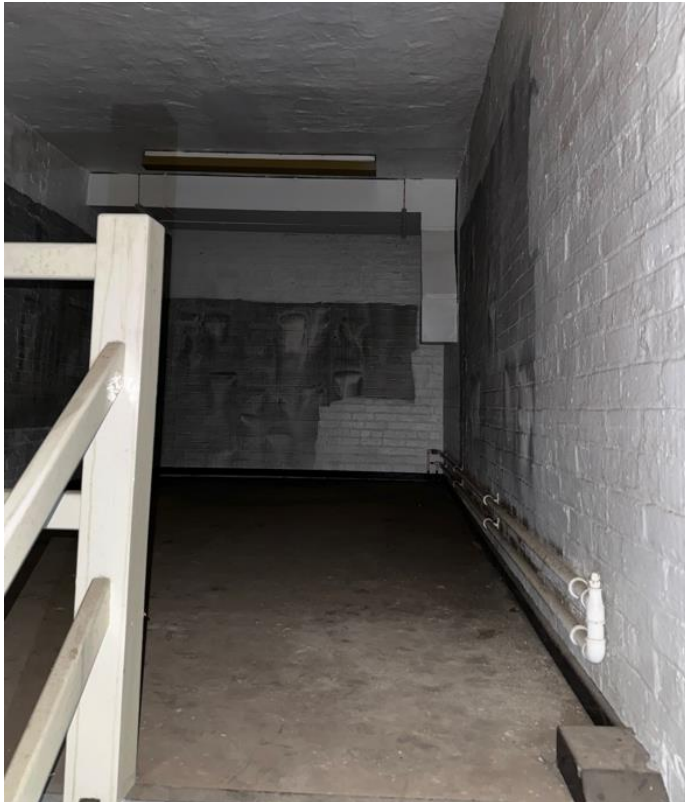
The Mezzanine was constructed using a timber deck supported off the perimeter masonry walls. Overall, the mezzanine was in reasonable condition and showed no signs of defect.

Photo 20: First floor mezzanine floor

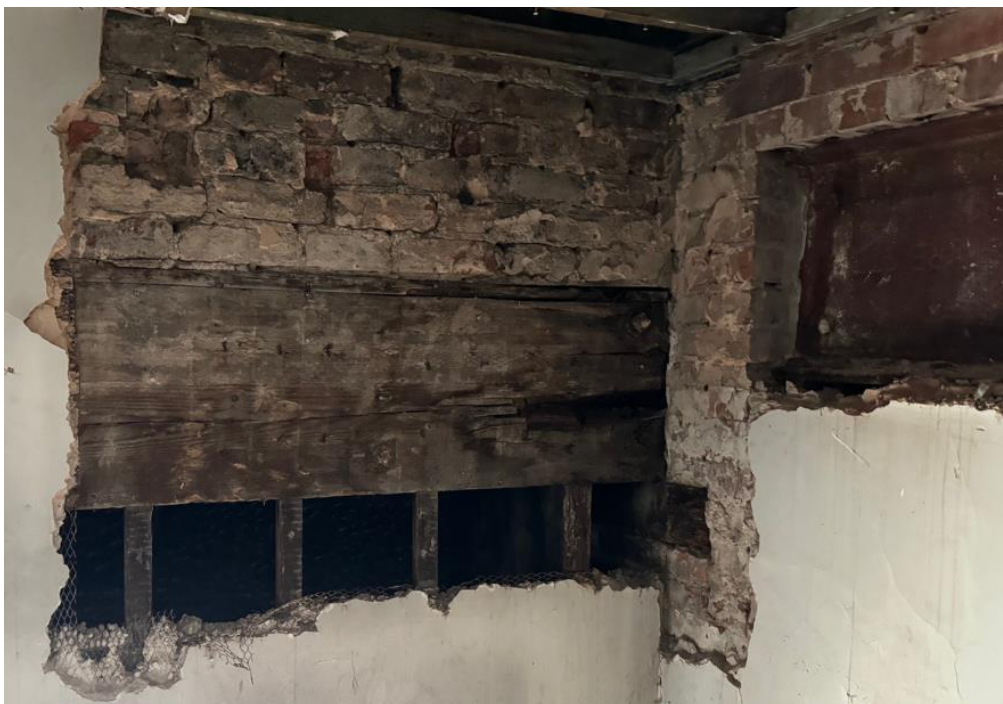
The front elevation room on the ground floor mezzanine appeared to have exposed brickwork, reviling stone plinths and timber lintels. The lintel had large cracks and chunks missing from the right-hand edge at bearing point and the stone plinth was also damaged with large chunks missing. The brick infill around the reveal wasn't acceptable for today's standards.

Photo 21: Ground floor mezzanine, room 1 rotten lintel and exposed steelwork

The ground floor mezzanine front elevation brickwork was exposed and remedial works replacing of brickwork and repointing is required, overall the brickwork appeared in moderate condition. The stone plinth also requires repair. Room 2 the timber lintel over the window has structurally failed and rotten this must be replaced. The steel beams installed in these areas do not comply with today's building regulation and heights of steel must be raised or removed and a redesign is required. The floors from above appear to have failed because of the deterioration of the concrete and corrosion of the reinforcement. This is deemed unsafe and must be removed and a new floor reinstalled. The mezzanine bathrooms require further investigation, plaster was still present during the survey. The hallway wall requires attention with brick to be partially removed and replaced brickwork cleaning and repointing. The failed floor above is also in this area with a hole present through the slab. It is of the same opinion that this floor must be replaced as it is beyond repair.

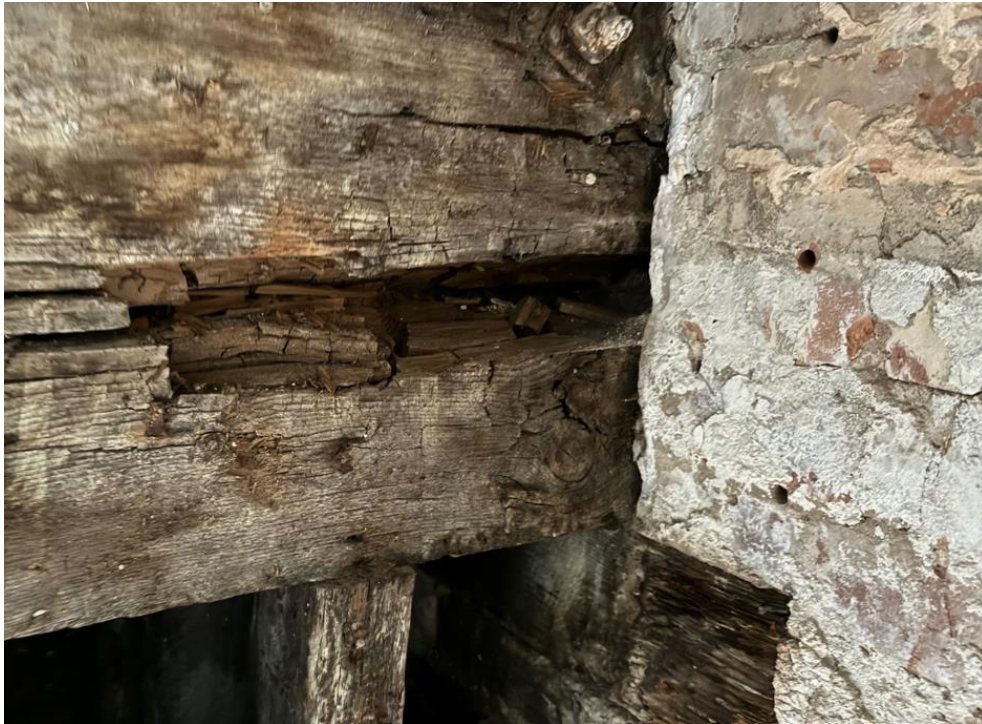
Photo 22: Ground floor mezzanine, room 1 rotten lintel

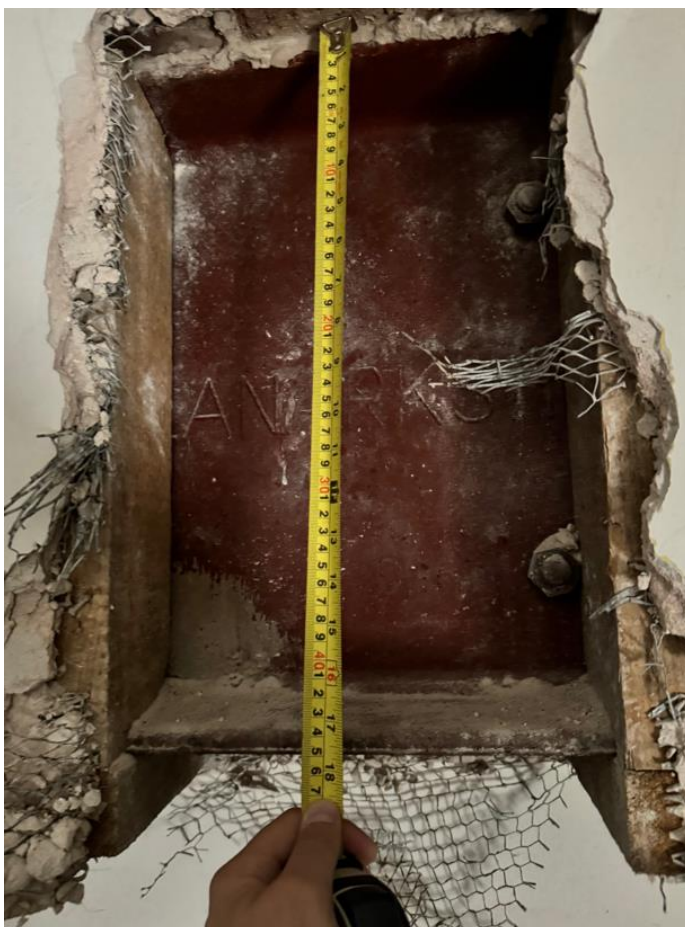
Photo 23: Ground floor mezzanine, room 1 exposed steelwork

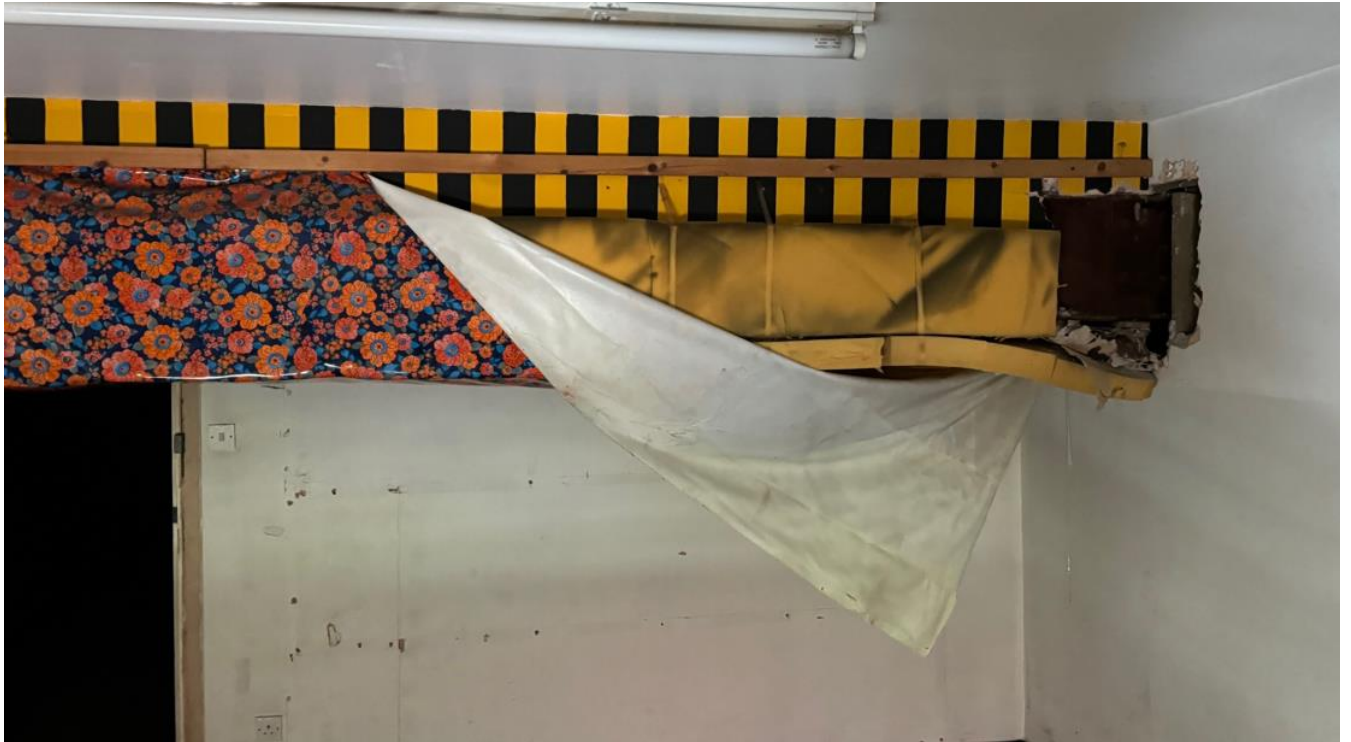
Photo 23: Ground floor mezzanine, room 1 exposed steelwork

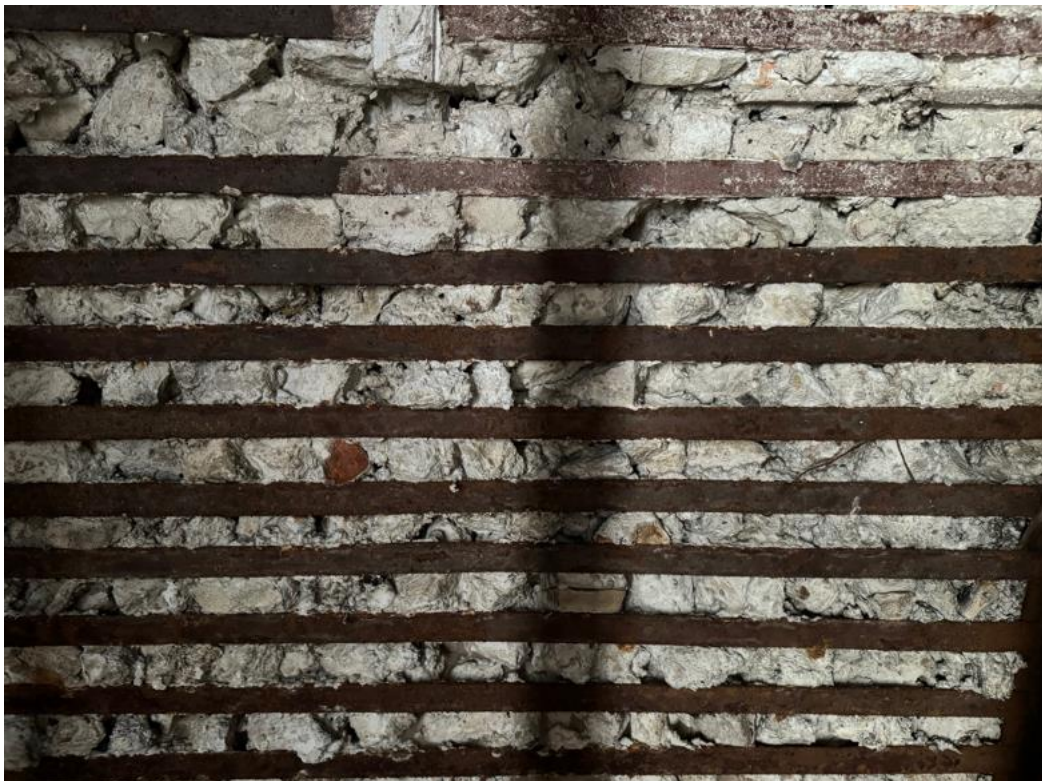
The Rear hallway of the ground floor mezzanine floor had exposed brickwork which requires attention. The bricks had failed and large areas of mortar which spalled. The concrete floor above also had a hole in it.

Photo 23: Ground floor mezzanine, hallway corrugated reinforcement and failed slab (from above)

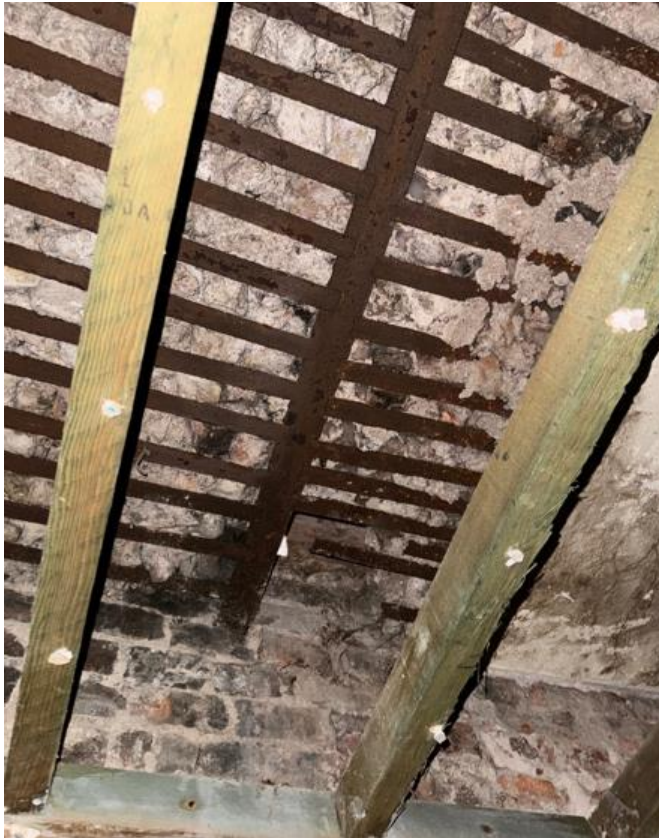
Photo 24: Ground floor mezzanine, hallway corroded reinforcement and failed slab (from above)

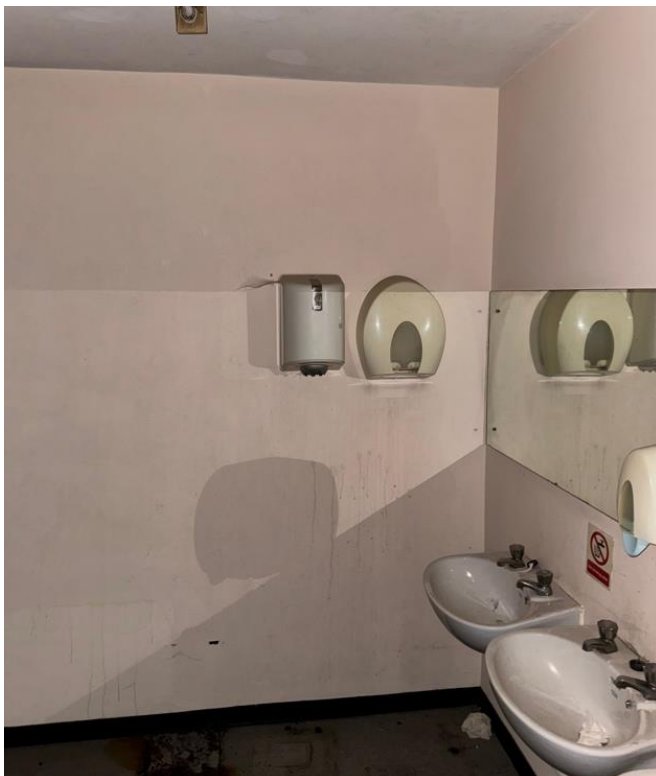
The ground floor mezzanine toilets were still fully furnished with plastered walls, there appeared to be no serious signs of deterioration and was in moderate condition. The Ground floor plant room was constructed in masonry with an RC slab and RC roof, this seemed more of a modern constructed room which could have been an extension to the original building. There were no signs of significant structural defect at the time of the survey.

Photo 26: Ground floor mezzanine, toilets

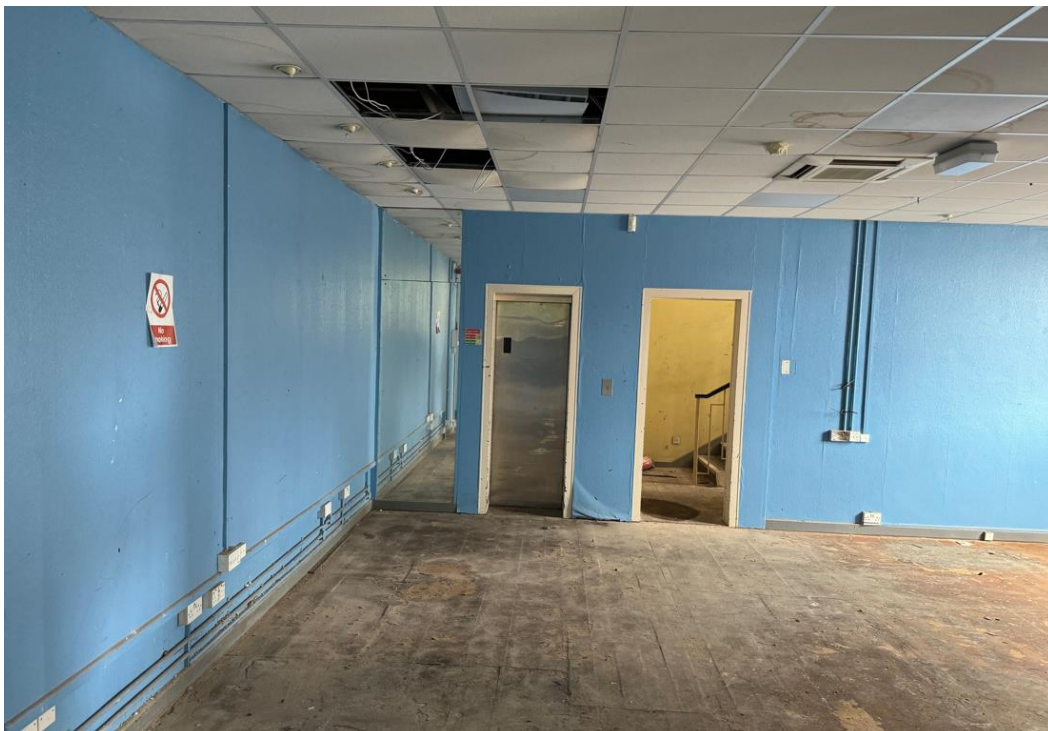
The right-side room next to the stairwell was also lacking maintenance and appears to have been left for some years, the ceiling was covered with a false ceiling and was damaged with water marks and partially removed/collapsed. Wallpaper was falling off maybe due to damp being present, the main structure was mainly covered so it was difficult to observe the permanent structure in this area at the time of the survey. Overall, it appeared to be in moderate condition but lacking maintenance and attention.

Photo 28: Ground floor right side room

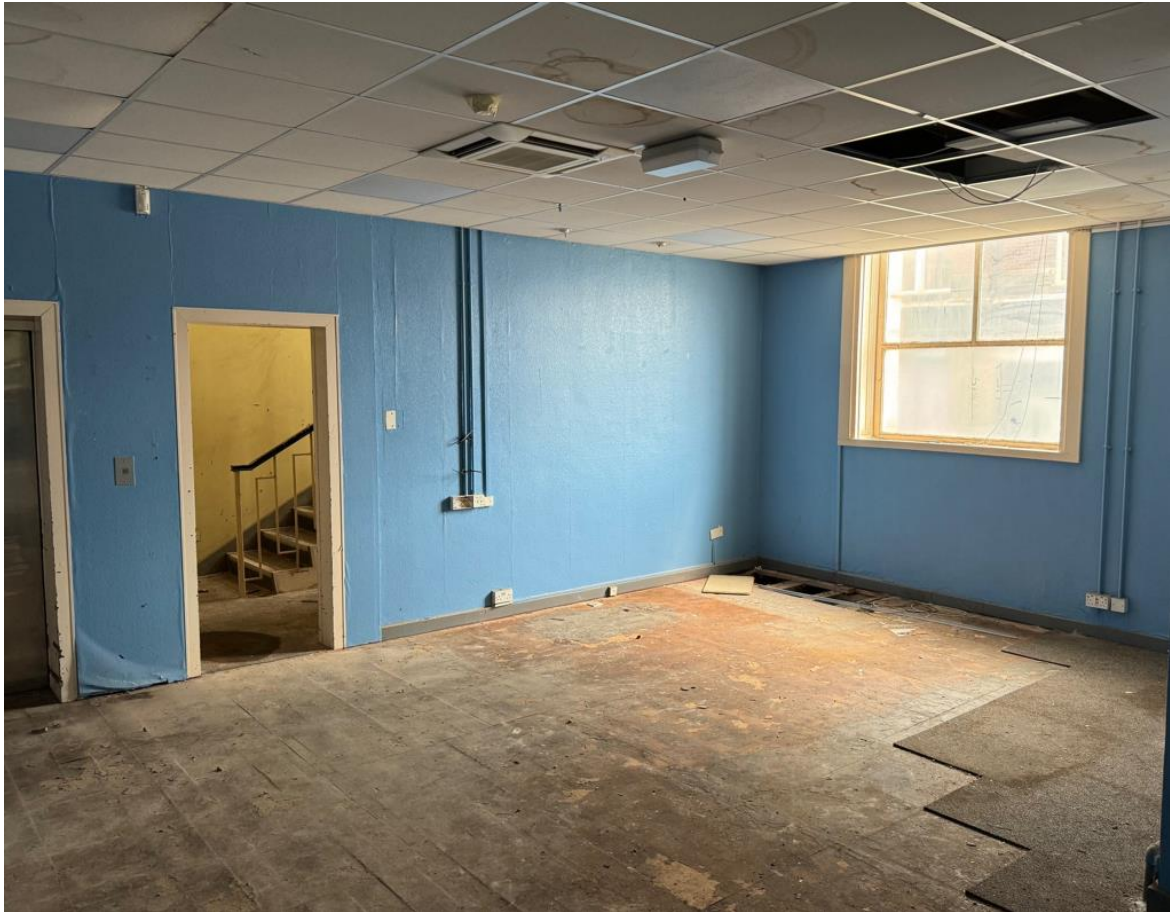
Photo 29: Ground floor right side room

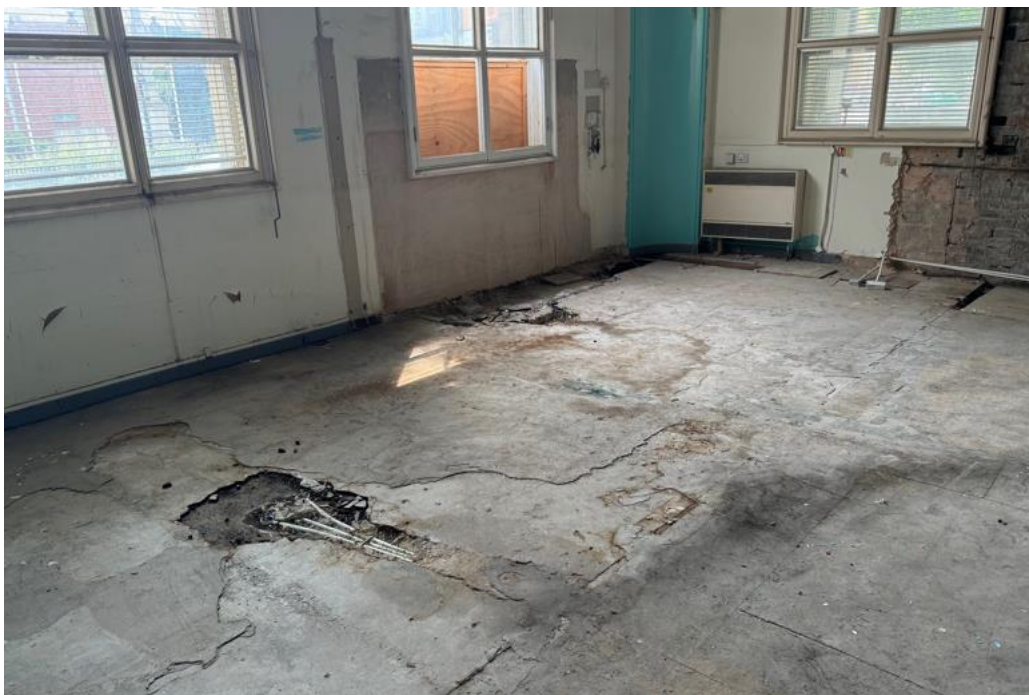
Photo 30: Ground floor main hall, Damage floor

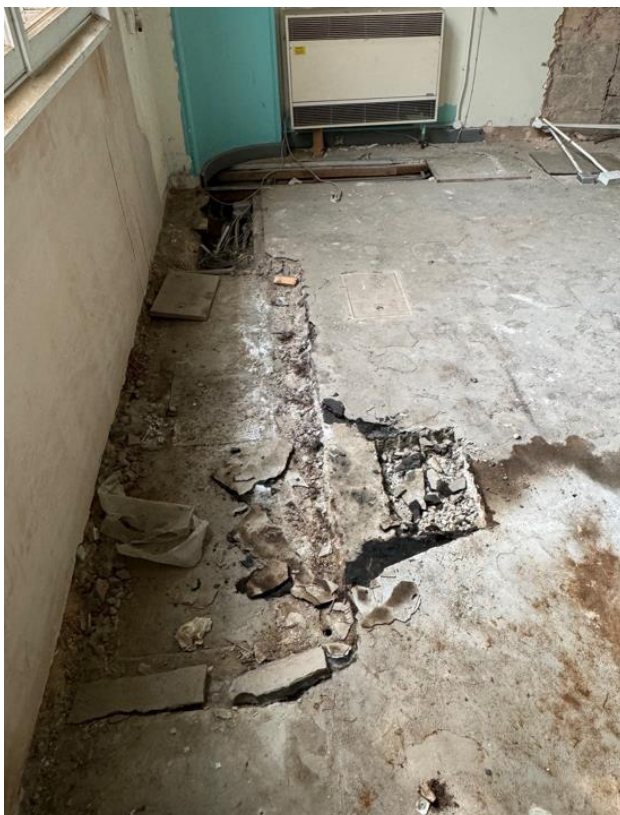
Photo 32: Ground floor main hall, Damaged floor
