# STRUCTURAL INSPECTION

## **Silver Street Bury (Former Barclays Bank)**

Property Address: Silver Street, Bury

Inspection Details: GENERAL STRUCTURAL INSPECTION

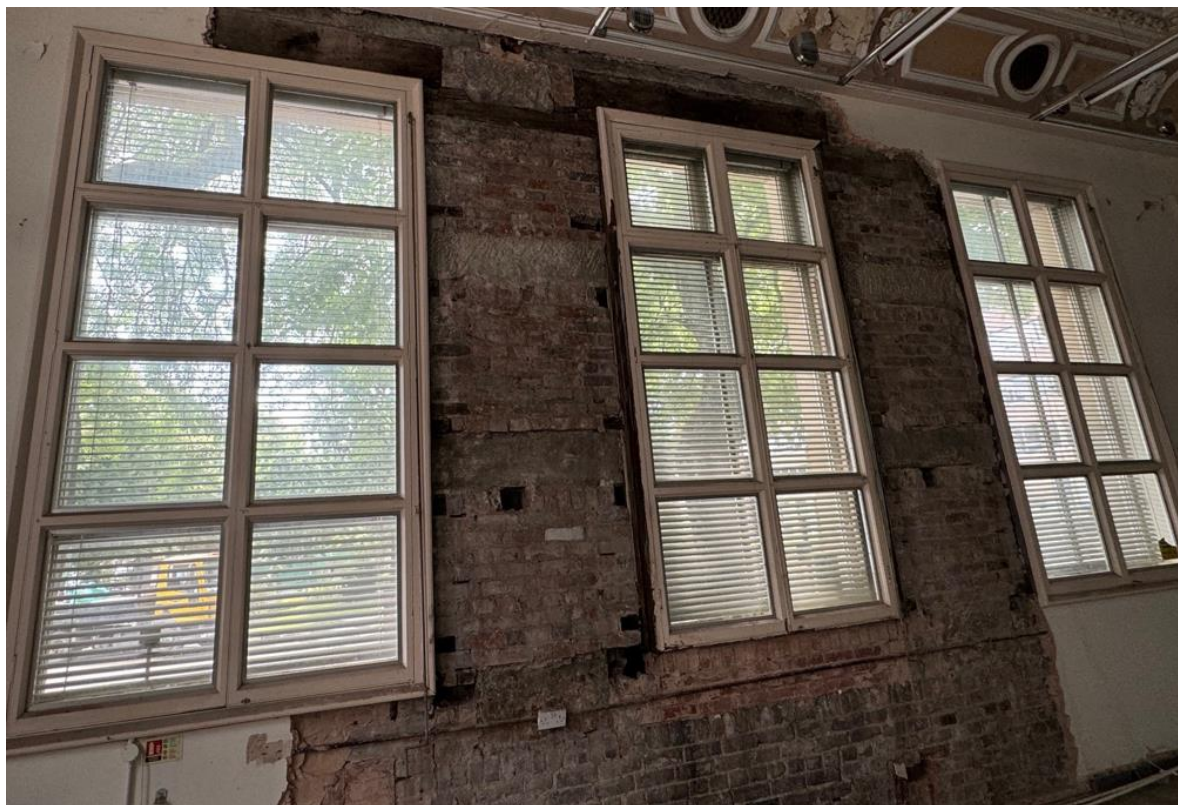
The ground floor entrance hallway was lacking maintenance, the front main hall had numerous areas with exposed brickwork. The brickworks appear to be very patchy with infills of different brick which will have occurred over a number of years, bricks looked aged and damaged with mortar spalling. Timber lintels over external windows appeared in bad condition. Some floor joists exposed appeared to be rotten with some in good condition.

Photo 33: Ground floor main hall, exposed brickwork with missing bricks

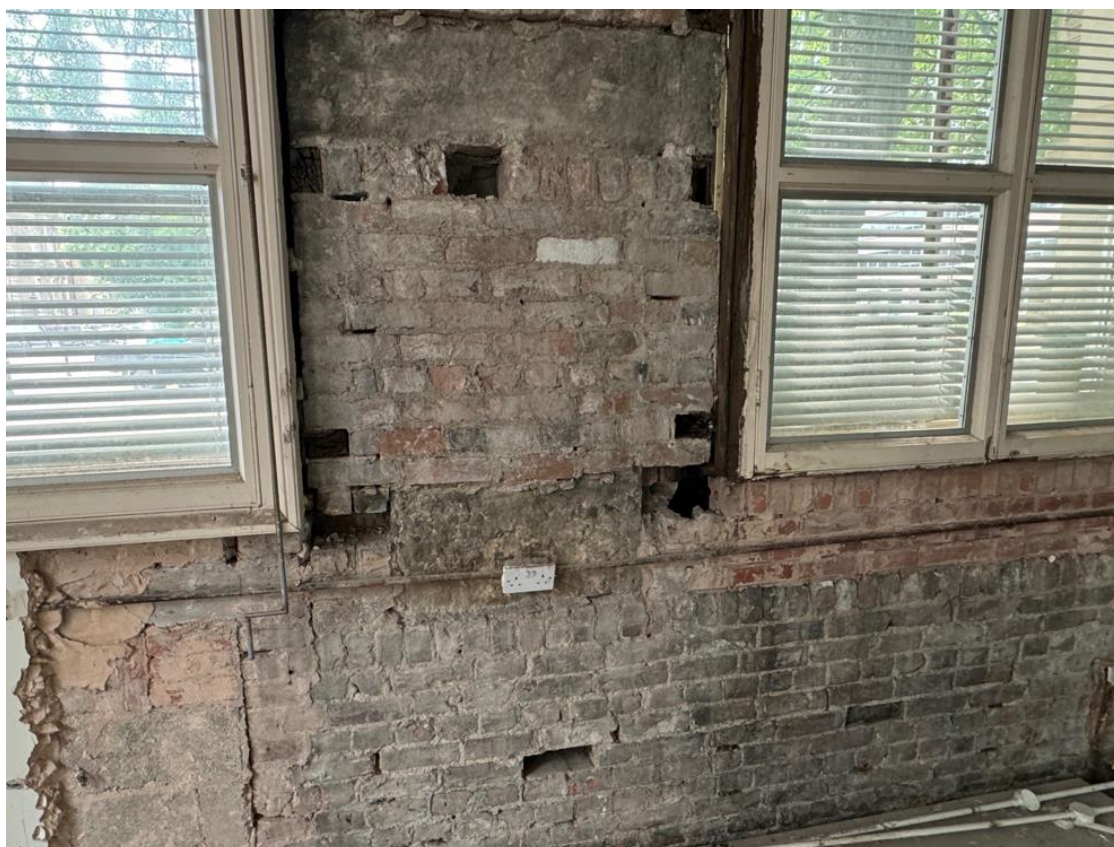
Photo 34: Ground floor main hall, exposed brickwork with missing bricks

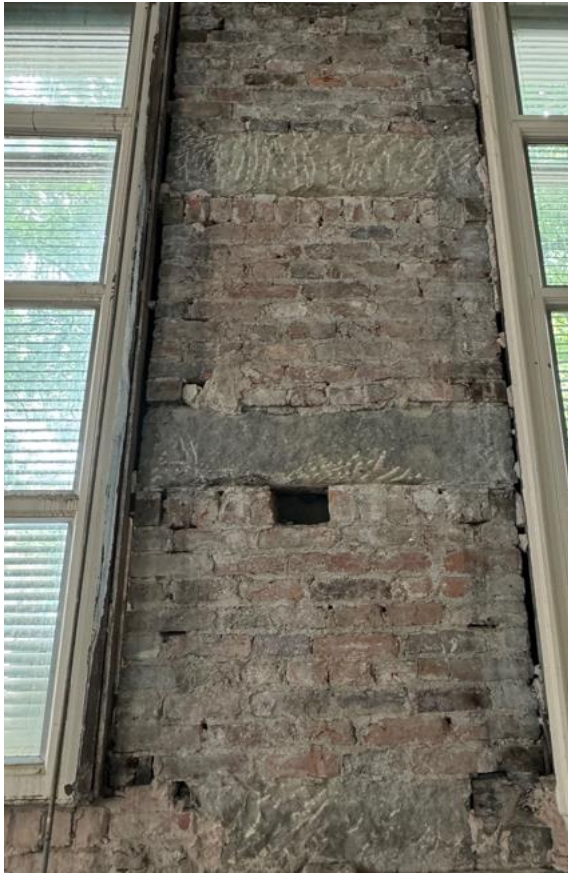
The ground floor brickwork was in moderate condition in part of the building in small areas require attention to the front elevation and side elevation off Bank Street. Stone plinths showing signs of deterioration, but no significant structural defect must require attention during construction phase. It is recommended that the lintels are replaced due to the large cracking. The right side of the ground floor

Photo 35: Ground floor main hall, damaged stone plinths

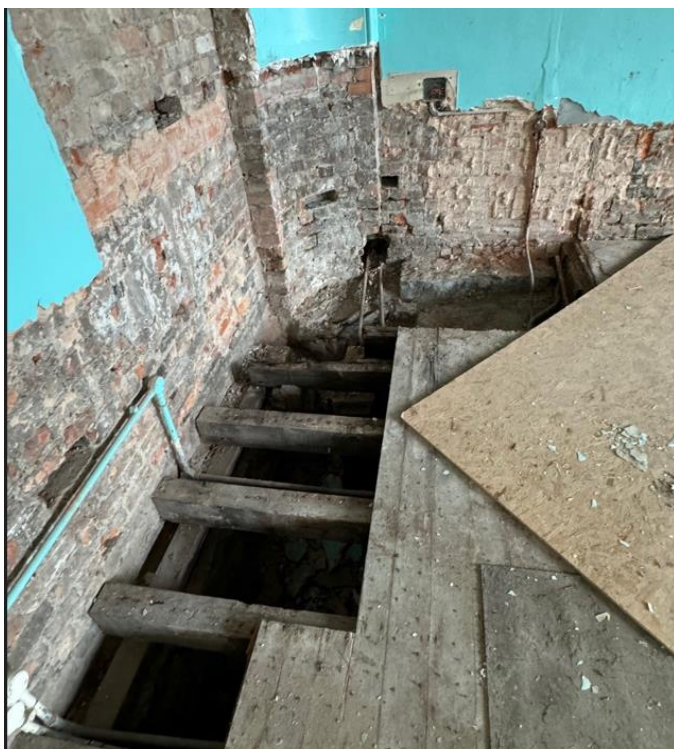
Photo 36: Ground floor main hall, exposed rotten joists

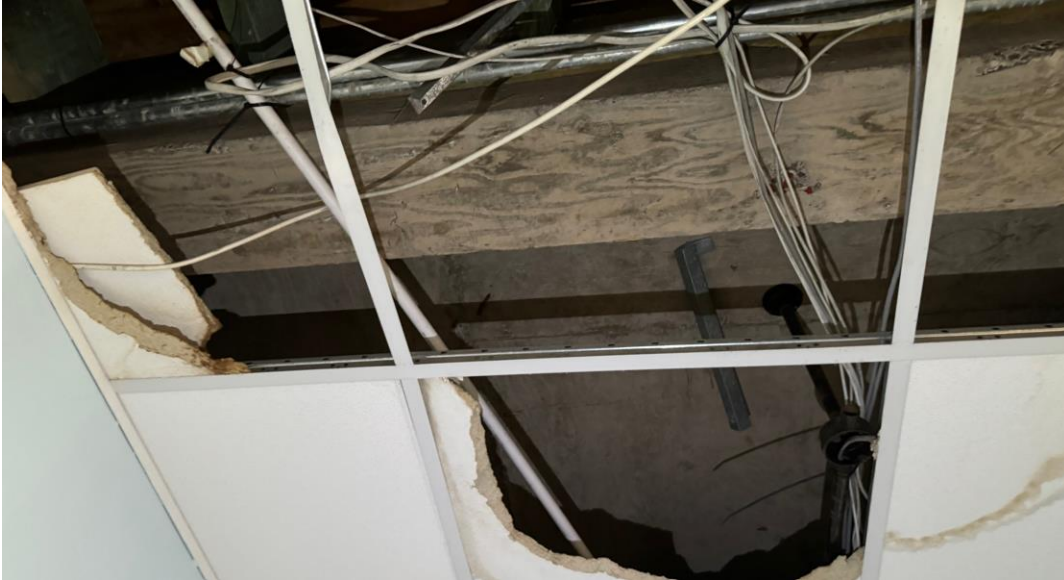
The hallway to the rear of the main hall lacked maintenance, an old service hatch was installed in this location, but access was available at the time of the survey. Above the false ceiling there appeared to be an RC beam spanning front to back of the building.

Photo 37: Ground floor rear of main hall, exposed beam

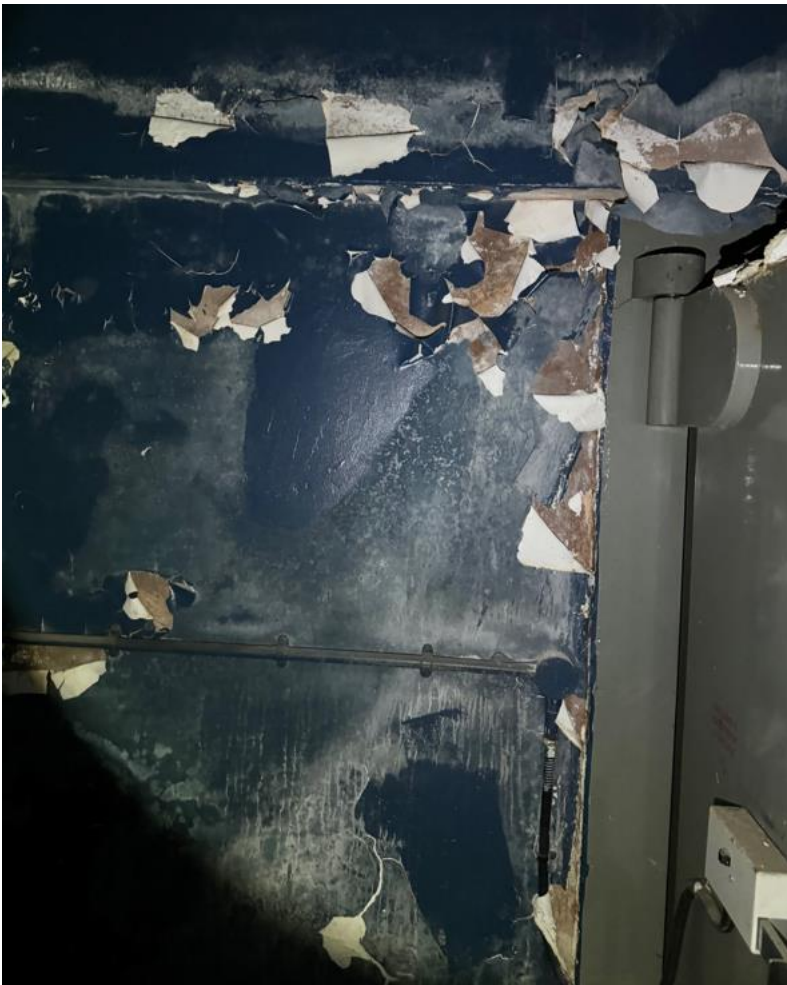
requires further inspection, large areas of the walls were covered with plaster. It is recommended that the false ceiling is removed and ceilings above are checked. The area lacks maintenance, but it is of the opinion that there are no serious signs of structural defects. The rear of the ground floor was dark during the survey making it very difficult to inspect, masonry was exposed which was at one time a chimney. It is recommended that this brickwork is made good before covering. The existing bank vaults were all lacking maintenance. The area appeared to be visually damp with paint falling off the walls as a result of this.

Photo 38: Ground floor rear, damp and peeling paint

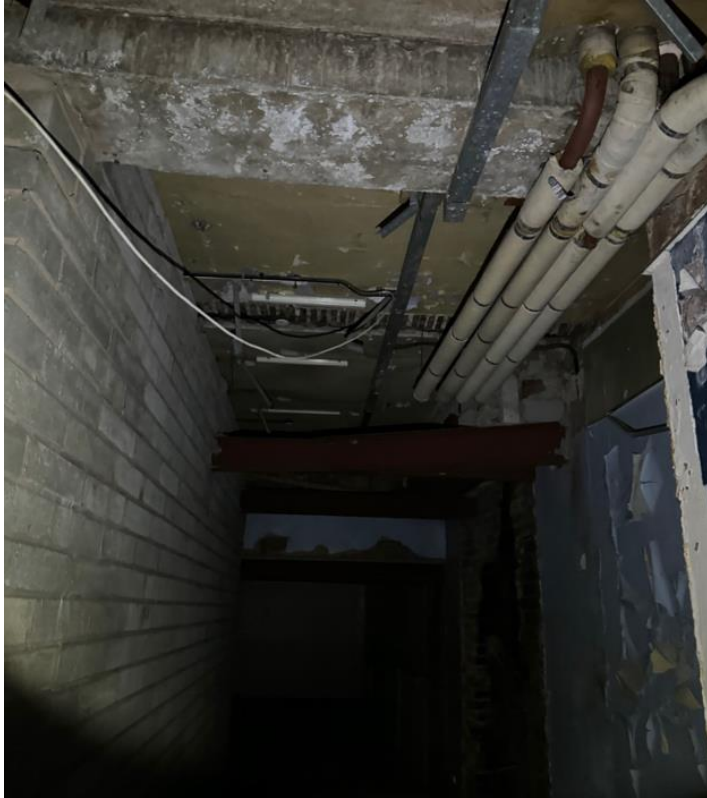
Photo 39: Ground floor rear, exposed ceiling and masonry

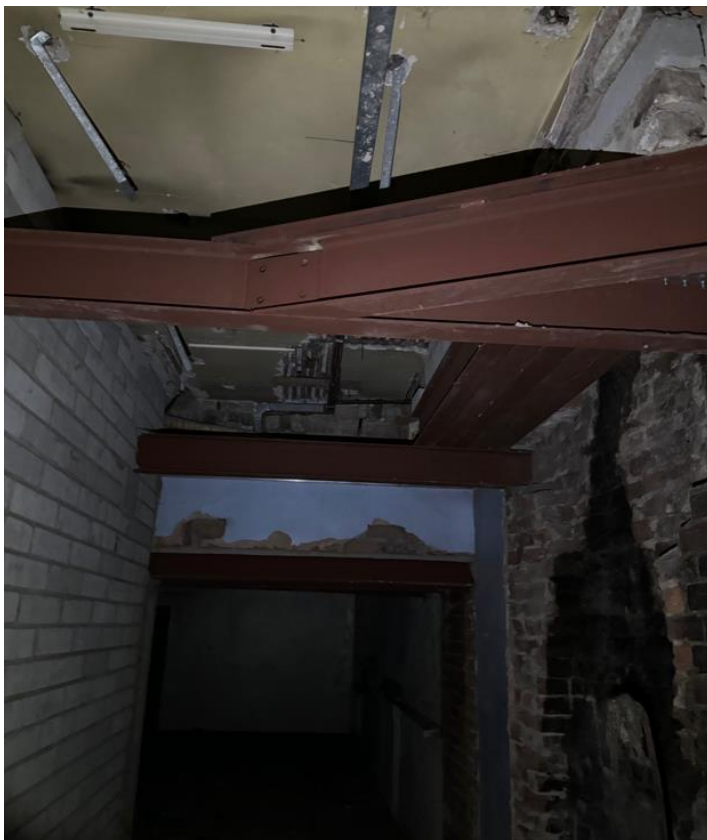
To the rear of the ground floor appeared to be an extension to the existing building in some parts. The lack of power made the survey in this location particularly hard. Numerous steel beams had been installed during assumed previous building works, brickwork was left unfinished after what appeared to be a chimney removal. What was likely at one time bank vaults consisted of heavy-duty iron doors with RC floors and roof with masonry walls. Some of these areas were in moderate condition. The main entrance at the rear was mostly unfinished wall with exposed brickwork and steel, this may be due to demolition works that have been carried out. Some rooms lacked maintenance; paint was falling off the walls which could be due to damp being present. The rooms showed the age of the building and the lack of maintenance.

Photo 40: Ground floor rear, exposed steels

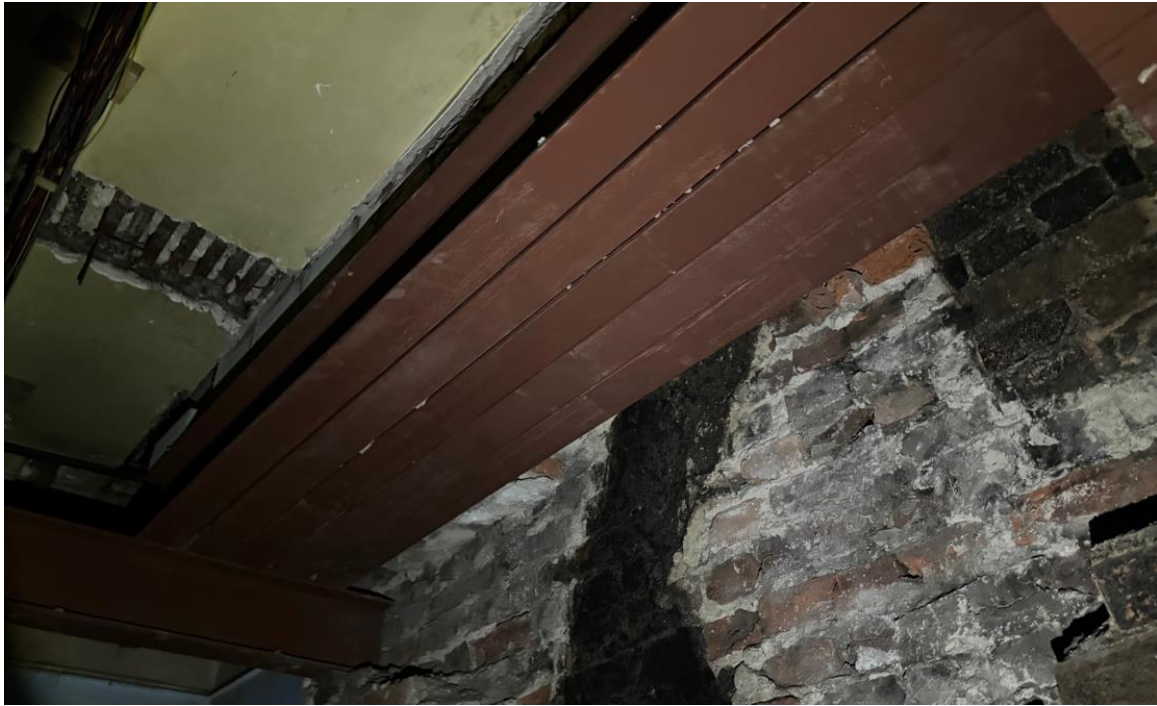
Photo 41: Ground floor rear, exposed steels

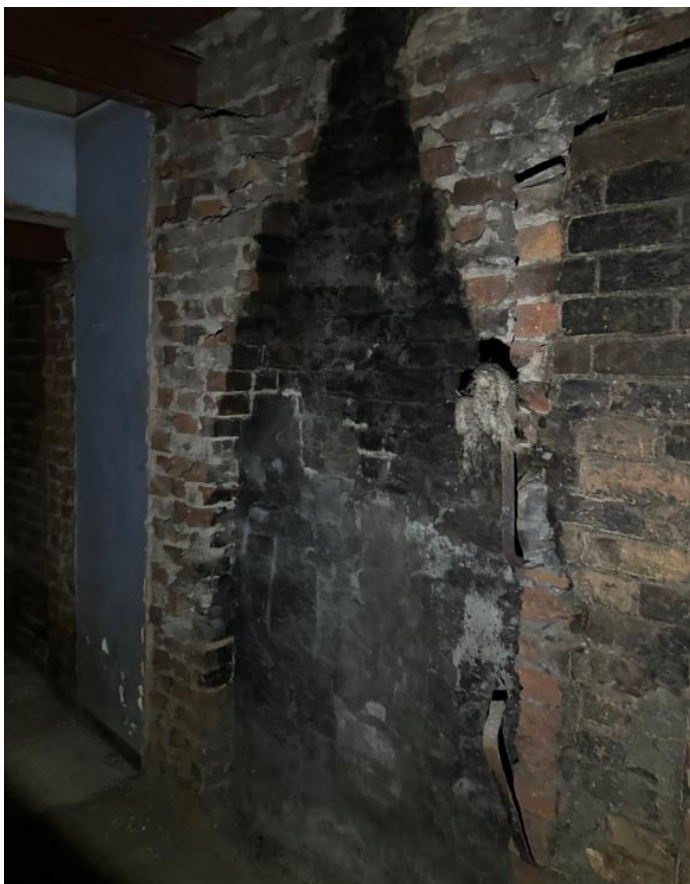
Photo 42: Ground floor rear, removed chimney

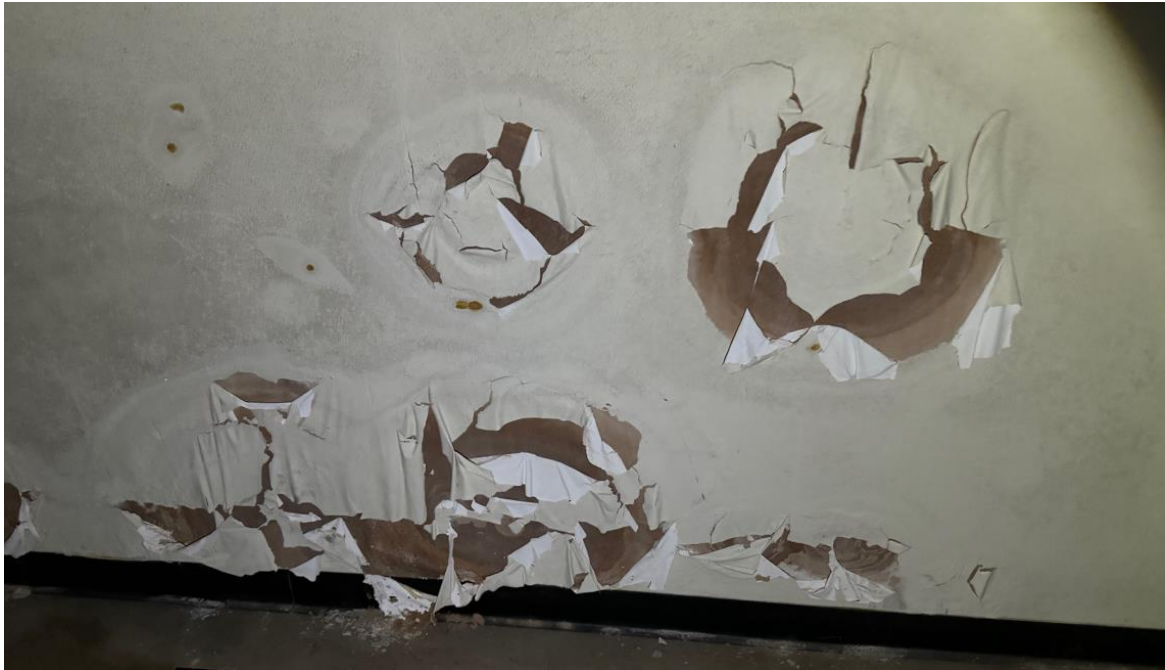
Photo 43: Ground floor rear, damp walls
