**Issue Date**  
23<sup>rd</sup> May 2023

**Reference Number**  
HCA03405

## Asbestos Demolition Survey

Whitefield Fire Station

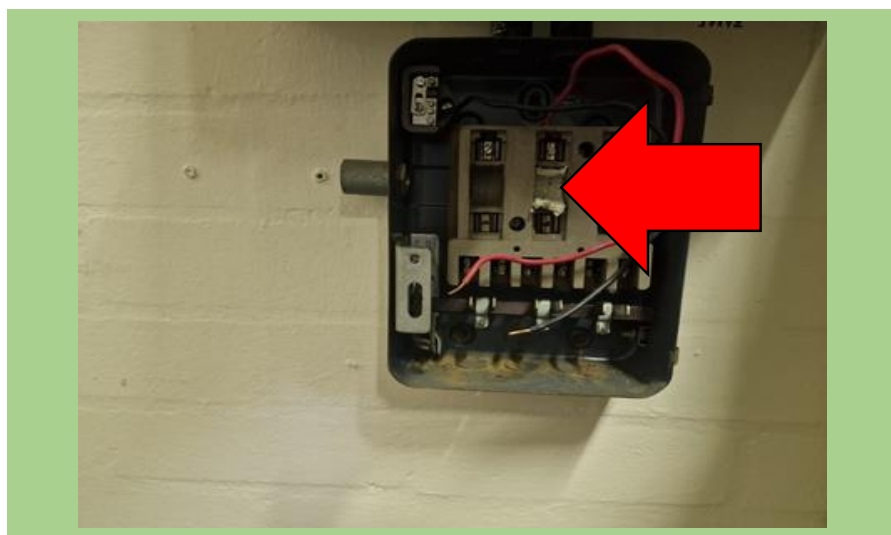
| Sample Number | 3 | Floor Plan Colour | Pink |

| Floor, Room | Ground floor, G.01 | Location | Within the wall mounted electrical box |
| Material | Textile | Quantity | 1 unit |

| Material Assessment | | Priority Assessment | |
|---|---|---|---|
| Extent of Damage (0-3) | 1 | Likelihood of Disturbance (0-3) | 0 |

| Management Recommendation | Priority |

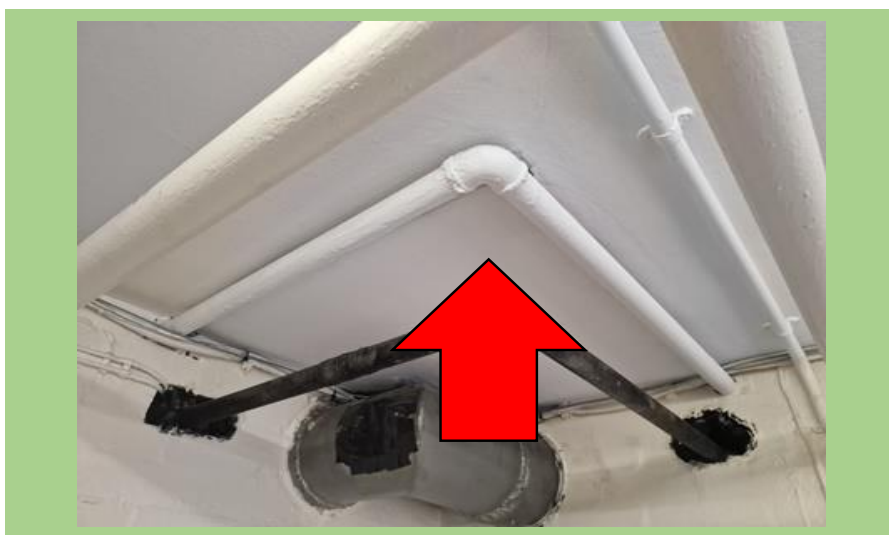
| Sample Number | 4 | Floor Plan Colour | Green |

| Floor, Room | Ground floor, G.02 | Location | Small panel to the ceiling, above the metal duct and pipework |
| Material | Insulating board | Quantity | 1 sq.m. |

| Material Assessment | | Priority Assessment | |
|---|---|---|---|
| Extent of Damage (0-3) | 1 | Likelihood of Disturbance (0-3) | 0 |

| Management Recommendation | Priority |

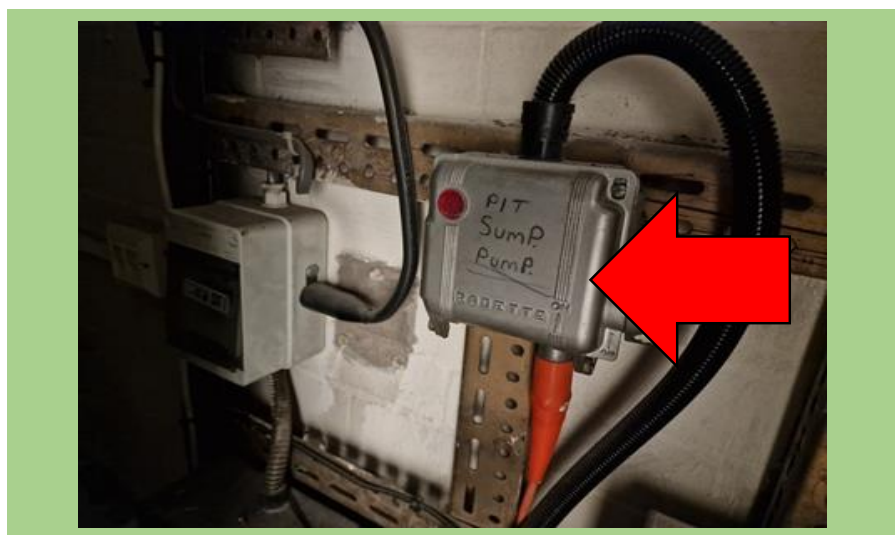
| Sample Number | 20 NS | Floor Plan Colour | Pink |

| Floor, Room | Ground floor, G.22 | Location | Within the wall mounted electrical box |
| Material | Presumed asbestos containing materials | Quantity | 1 unit |

| Material Assessment | | Priority Assessment | |
|---|---|---|---|
| Extent of Damage (0-3) | 1 | Likelihood of Disturbance (0-3) | 0 |

| Management Recommendation | Priority |

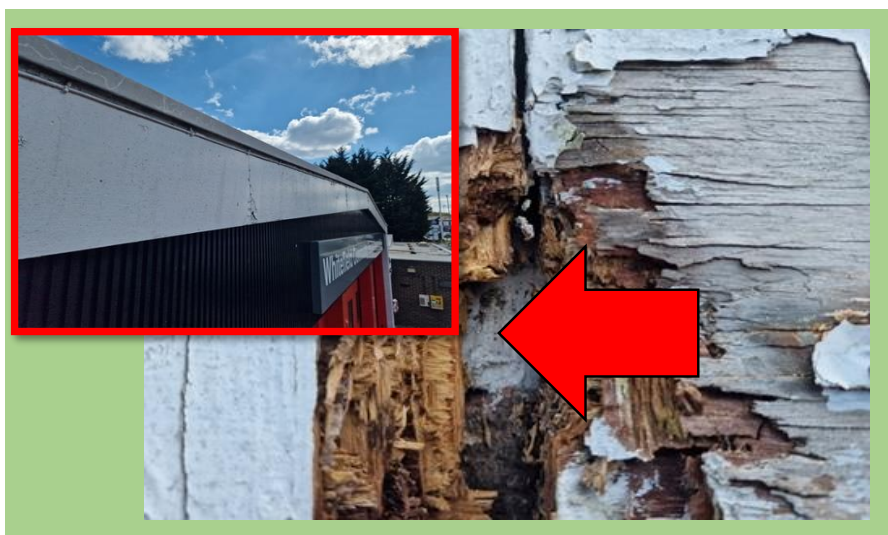
| Sample Number | 25 | Floor Plan Colour | Green |

| Sample Number | Floor, Room | Location | Material | Quantity | Risk Level Posed | Accessibility | Management Recommendation |
|---|---|---|---|---|---|---|---|
| 25 | External, RF.03 | Fascia panelling, behind the timber cladding, engine room roof | Insulating board | 50 lin.m. | LOW | DIFFICULT | Remove |

| Floor, Room | External, RF.03 | Location | Fascia panelling, behind the timber cladding, engine room roof |
| Material | Insulating board | Quantity | 50 lin.m. |

| Material Assessment | | Priority Assessment | |
|---|---|---|---|
| Extent of Damage (0-3) | 1 | Likelihood of Disturbance (0-3) | 0 |

| Management Recommendation | Priority |

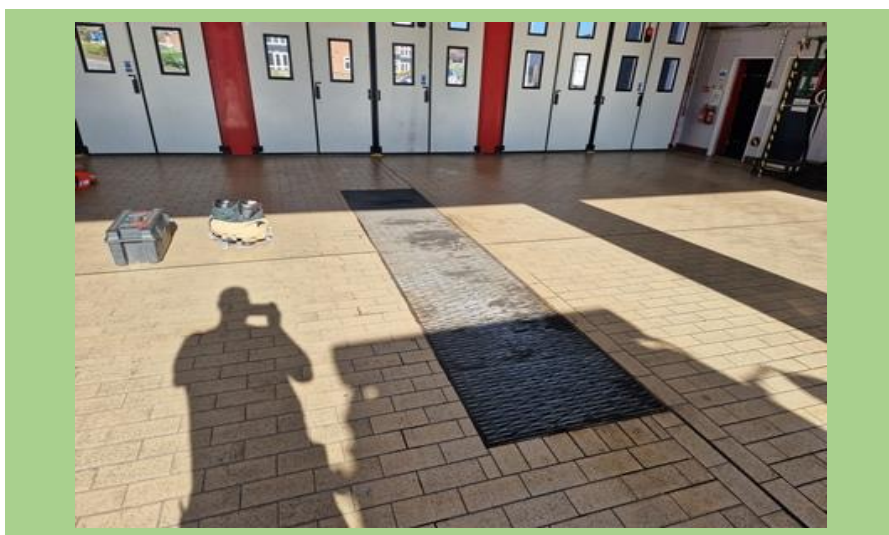
| Sample Number | 33 NA | Floor Plan Colour | Grey hatched |

| Floor, Room | Ground floor, G.07 | Location | Engine room pit |

| Unable to remove the metal grid. |

| Management Recommendation | Priority |

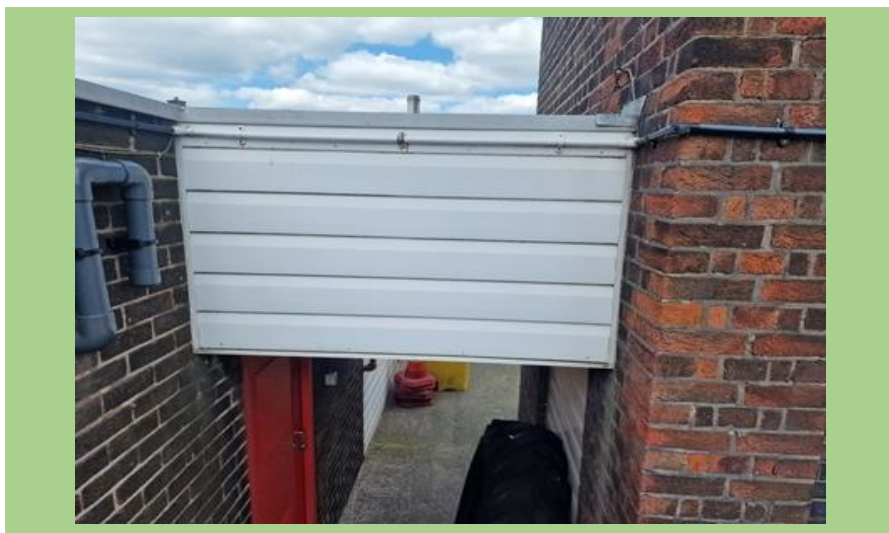
| Sample Number | 34 NA | Floor Plan Colour | Grey hatched |

| Floor, Room | External | Location | Canopy void between the hose room and the tower |

| Unable to access the void without causing irreparable damage. |

| Management Recommendation | Priority |

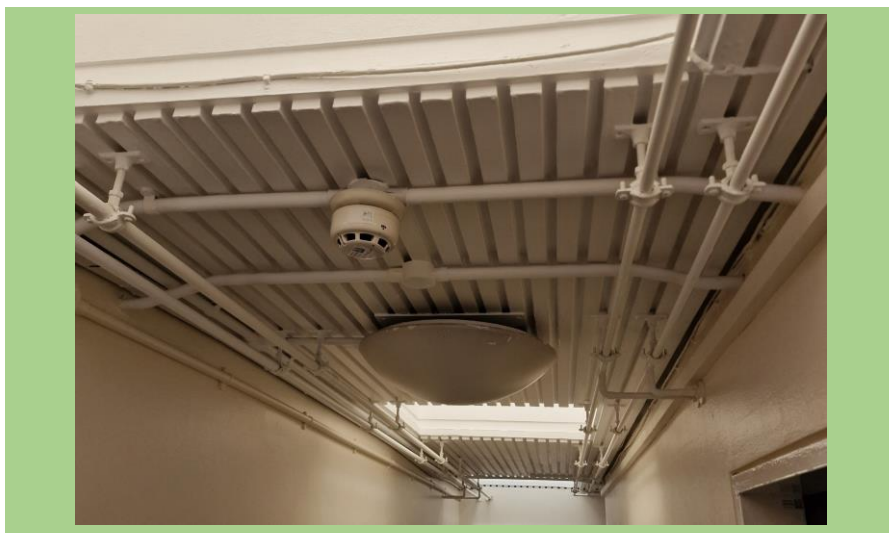
| Sample Number | 35 NA | Floor Plan Colour | Grey hatched |

| Sample Number | Floor, Room | Location | Management Recommendation |
|---|---|---|---|
| 35 NA | Grond floor, throughout | Ceiling voids, above the timber and plasterboard ceilings | Access and inspect |

| Floor, Room | Grond floor, throughout | Location | Ceiling voids, above the timber and plasterboard ceilings |

| Access would have caused unacceptable levels of damage. |

| Management Recommendation | Priority |
