## MANAGEMENT SURVEY FOR ASBESTOS-CONTAINING MATERIALS

**CLIENT:** Mott MacDonald (Manchester)

**SITE:** Spring Lane School & Radcliffe Leisure Centre, Spring Lane, Radcliffe, Manchester, M26 2SZ

**TYPE OF SURVEY:** Management Survey

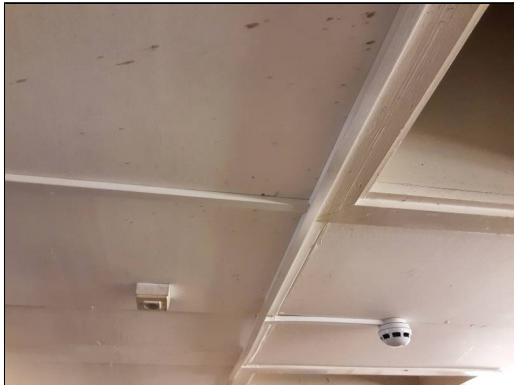
| Assessment details | | | | Comments | Photograph |
|---|---|---|---|---|---|
| Assessment no. | 0001 | Accessibility | Usually inaccessible or unlikely to be disturbed | | |

| Building | Floor/<br>Room | Assessment<br>Number | Location/<br>position | Product<br>type | Surface<br>treatment | Condition | Extent | Accessibility | Level of<br>identification | Asbestos<br>type | Material<br>risk | Priority<br>risk | Action |
|---|---|---|---|---|---|---|---|---|---|---|---|---|---|
| School & Leisure Centre | Ground Floor / G8 | 0001 | Insulating board ceiling | Board | Surface Sealed | Low Damage | 30m <sup>2</sup> | Usually inaccessible or unlikely to be disturbed | Identified | Amosite | ( 6 ) Low | - | Manage |

| Assessment details | | | | Comments | Photograph |
|---|---|---|---|---|---|
| Building | School & Leisure Centre | Floor/ room | Ground Floor / G8 | | |

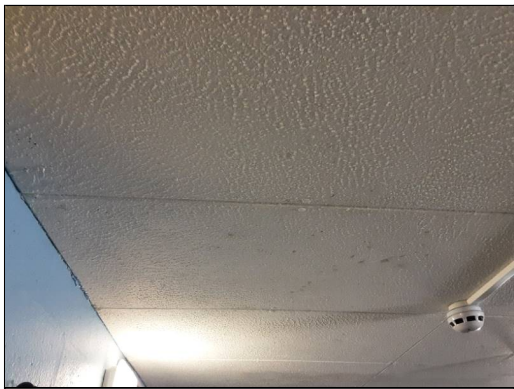
| Assessment details | | | | Comments | Photograph |
|---|---|---|---|---|---|
| Assessment no. | 0002 | Accessibility | Usually inaccessible or unlikely to be disturbed | | |

| Building | Floor/<br>Room | Assessment<br>Number | Location/<br>position | Product<br>type | Surface<br>treatment | Condition | Extent | Accessibility | Level of<br>identification | Asbestos<br>type | Material<br>risk | Priority<br>risk | Action |
|---|---|---|---|---|---|---|---|---|---|---|---|---|---|
| School & Leisure Centre | Ground Floor / G8 | 0002 | Textured coating to board ceiling | Board | Surface Sealed | Low Damage | 16m <sup>2</sup> | Usually inaccessible or unlikely to be disturbed | Identified | Amosite | ( 6 ) Low | - | Manage |

| Assessment details | | | | Comments | Photograph |
|---|---|---|---|---|---|
| Building | School & Leisure Centre | Floor/ room | Ground Floor / G8 | | |

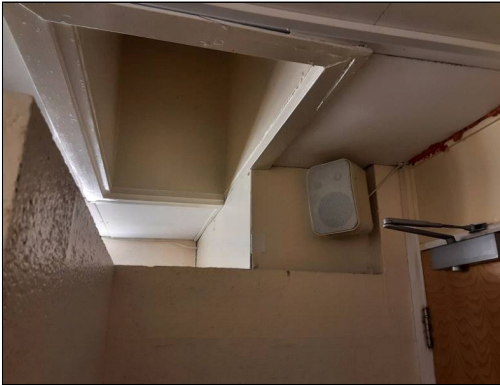
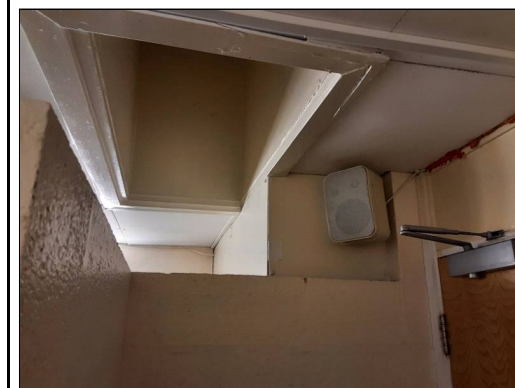
| Assessment details | | | | Comments | |
|---|---|---|---|---|---|
| Assessment no. | 0003 | Accessibility | Easily disturbed | | |

| Building | Floor/<br>Room | Assessment<br>Number | Location/<br>position | Product<br>type | Surface<br>treatment | Condition | Extent | Accessibility | Level of<br>identification | Asbestos<br>type | Material<br>risk | Priority<br>risk | Action |
|---|---|---|---|---|---|---|---|---|---|---|---|---|---|
| School & Leisure Centre | Ground Floor / G8 | 0003 | Insulating board boxing | Board | Surface Sealed | Low Damage | 4m <sup>2</sup> | Easily disturbed | Identified | Amosite | ( 6 ) Low | - | Manage |

| Assessment details | | | | Comments | |
|---|---|---|---|---|---|
| Building | School & Leisure Centre | Floor/ room | Ground Floor / G8 | | |
| Material risk | Low | Material risk score | 6 | | |

| Assessment details | | | | Comments | |
|---|---|---|---|---|---|
| Action | Manage | | | | |

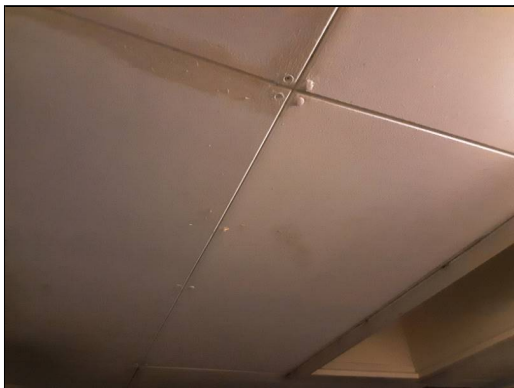
| Assessment details | | | | Comments | Photograph |
|---|---|---|---|---|---|
| Assessment no. | 0004 | Accessibility | Usually inaccessible or unlikely to be disturbed | | |

| Building | Floor/<br>Room | Assessment<br>Number | Location/<br>position | Product<br>type | Surface<br>treatment | Condition | Extent | Accessibility | Level of<br>identification | Asbestos<br>type | Material<br>risk | Priority<br>risk | Action |
|---|---|---|---|---|---|---|---|---|---|---|---|---|---|
| School & Leisure Centre | Ground Floor / G9 | 0004 | Insulating board Ceiling | Board | Surface Sealed | Low Damage | 8m <sup>2</sup> | Usually inaccessible or unlikely to be disturbed | Strongly Presumed (001) | Amosite | ( 6 ) Low | - | Manage |

| Assessment details | | | | Comments | Photograph |
|---|---|---|---|---|---|
| Building | School & Leisure Centre | Floor/ room | Ground Floor / G9 | | |

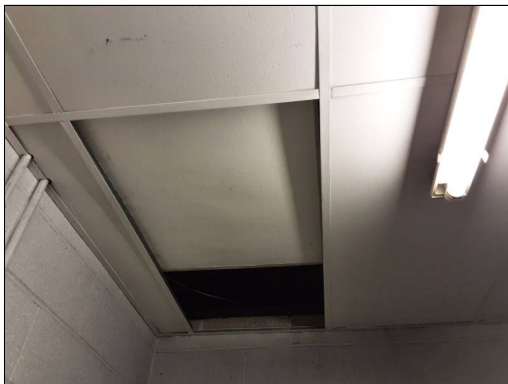
| Assessment details | | | | Comments | Photograph |
|---|---|---|---|---|---|
| Assessment no. | 0005 | Accessibility | Usually inaccessible or unlikely to be disturbed | | |

| Building | Floor/<br>Room | Assessment<br>Number | Location/<br>position | Product<br>type | Surface<br>treatment | Condition | Extent | Accessibility | Level of<br>identification | Asbestos<br>type | Material<br>risk | Priority<br>risk | Action |
|---|---|---|---|---|---|---|---|---|---|---|---|---|---|
| School & Leisure Centre | Ground Floor / G11 | 0005 | Insulating board suspended ceiling | Board | Surface Sealed | Low Damage | 12m <sup>2</sup> | Usually inaccessible or unlikely to be disturbed | Identified | Amosite | ( 6 ) Low | - | Manage |

| Assessment details | | | | Comments | Photograph |
|---|---|---|---|---|---|
| Building | School & Leisure Centre | Floor/ room | Ground Floor / G11 | | |

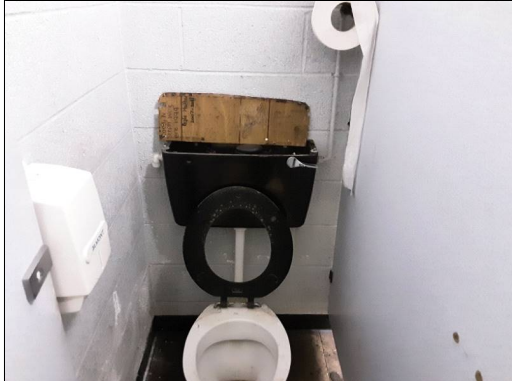
| Assessment details | | | | Comments | Photograph |
|---|---|---|---|---|---|
| Assessment no. | 0006 | Accessibility | Easily disturbed | | |

| Building | Floor/<br>Room | Assessment<br>Number | Location/<br>position | Product<br>type | Surface<br>treatment | Condition | Extent | Accessibility | Level of<br>identification | Asbestos<br>type | Material<br>risk | Priority<br>risk | Action |
|---|---|---|---|---|---|---|---|---|---|---|---|---|---|
| School & Leisure Centre | Ground Floor / G11 | 0006 | Resin toilet cistern | Bitumen | Completely Sealed | Low Damage | 1m <sup>2</sup> | Easily disturbed | Identified | Amosite | ( 4 ) Very low | - | Manage |

| Assessment details | | | | Comments | Photograph |
|---|---|---|---|---|---|
| Building | School & Leisure Centre | Floor/ room | Ground Floor / G11 | | |

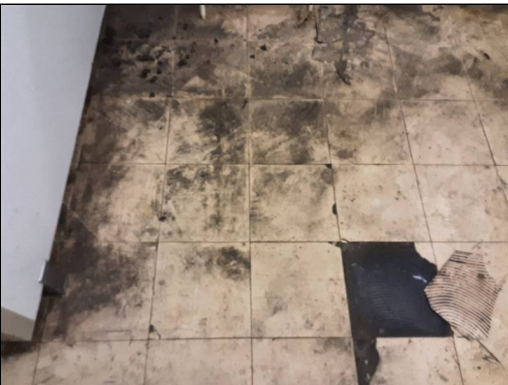
| Assessment details | | | | Comments | Photograph |
|---|---|---|---|---|---|
| Assessment no. | 0007 | Accessibility | Routinely disturbed | | |

| Building | Floor/<br>Room | Assessment<br>Number | Location/<br>position | Product<br>type | Surface<br>treatment | Condition | Extent | Accessibility | Level of<br>identification | Asbestos<br>type | Material<br>risk | Priority<br>risk | Action |
|---|---|---|---|---|---|---|---|---|---|---|---|---|---|
| School & Leisure Centre | Ground Floor / G11 | 0007 | Floor tiles with adhesive floor | Thermoplastic Tiles | Completely Sealed | Low Damage | 12m <sup>2</sup> | Routinely disturbed | Identified | Chrysotile | ( 3 ) Very low | - | Manage |

| Assessment details | | | | Comments | Photograph |
|---|---|---|---|---|---|
| Building | School & Leisure Centre | Floor/ room | Ground Floor / G11 | Beige | |

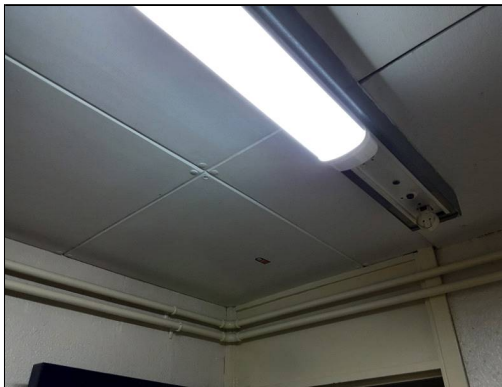
| Assessment details | | | | Comments | <div>Photograph</div> |
|---|---|---|---|---|---|
| Assessment no. | 0008 | Accessibility | Usually inaccessible or unlikely to be disturbed | | |

| Building | Floor/<br>Room | Assessment<br>Number | Location/<br>position | Product<br>type | Surface<br>treatment | Condition | Extent | Accessibility | Level of<br>identification | Asbestos<br>type | Material<br>risk | Priority<br>risk | Action |
|---|---|---|---|---|---|---|---|---|---|---|---|---|---|
| School & Leisure Centre | Ground Floor / G12 | 0008 | Insulating board Ceiling | Board | Surface Sealed | Low Damage | 6m <sup>2</sup> | Usually inaccessible or unlikely to be disturbed | Strongly Presumed (001) | Amosite | ( 6 ) Low | - | Manage |

| Assessment details | | | | Comments | <div>Photograph</div> |
|---|---|---|---|---|---|
| Building | School & Leisure Centre | Floor/ room | Ground Floor / G12 | | |

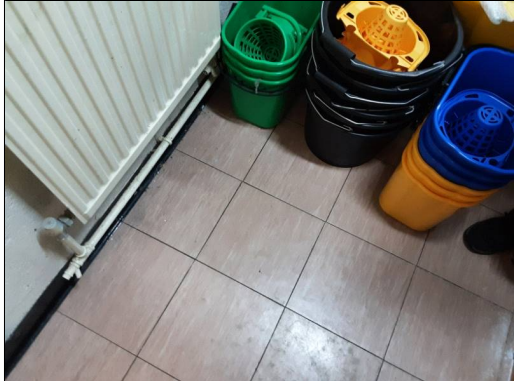
| Assessment details | | | | Comments | Photograph |
|---|---|---|---|---|---|
| Assessment no. | 0009 | Accessibility | Routinely disturbed | | |

| Building | Floor/<br>Room | Assessment<br>Number | Location/<br>position | Product<br>type | Surface<br>treatment | Condition | Extent | Accessibility | Level of<br>identification | Asbestos<br>type | Material<br>risk | Priority<br>risk | Action |
|---|---|---|---|---|---|---|---|---|---|---|---|---|---|
| School & Leisure Centre | Ground Floor / G12 | 0009 | floor tiles with adhesive floor | Vinyl Floor Tiles | Completely Sealed | Low Damage | 6m <sup>2</sup> | Routinely disturbed | Identified | Chrysotile | ( 3 ) Very low | - | Manage |

| Assessment details | | | | Comments | Photograph |
|---|---|---|---|---|---|
| Building | School & Leisure Centre | Floor/ room | Ground Floor / G12 | Beige | |

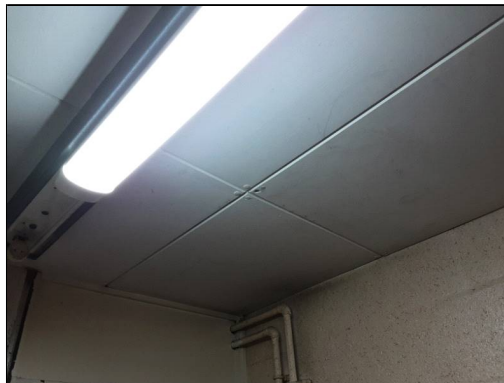
| Assessment details | | | | Comments | <div>Photograph</div> |
|---|---|---|---|---|---|
| Assessment no. | 0010 | Accessibility | Usually inaccessible or unlikely to be disturbed | | |

| Building | Floor/<br>Room | Assessment<br>Number | Location/<br>position | Product<br>type | Surface<br>treatment | Condition | Extent | Accessibility | Level of<br>identification | Asbestos<br>type | Material<br>risk | Priority<br>risk | Action |
|---|---|---|---|---|---|---|---|---|---|---|---|---|---|
| School & Leisure Centre | Ground Floor / G13 | 0010 | Insulating board Ceiling | Board | Surface Sealed | Low Damage | 6m <sup>2</sup> | Usually inaccessible or unlikely to be disturbed | Strongly Presumed (001) | Amosite | ( 6 ) Low | - | Manage |

| Assessment details | | | | Comments | <div>Photograph</div> |
|---|---|---|---|---|---|
| Building | School & Leisure Centre | Floor/ room | Ground Floor / G13 | | |

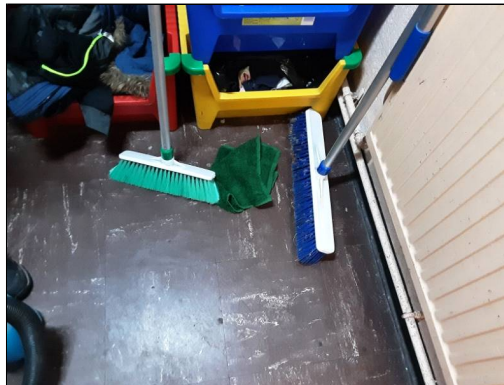
| Assessment details | | | | Comments | Photograph |
|---|---|---|---|---|---|
| Assessment no. | 0011 | Accessibility | Routinely disturbed | | |

| Building | Floor/<br>Room | Assessment<br>Number | Location/<br>position | Product<br>type | Surface<br>treatment | Condition | Extent | Accessibility | Level of<br>identification | Asbestos<br>type | Material<br>risk | Priority<br>risk | Action |
|---|---|---|---|---|---|---|---|---|---|---|---|---|---|
| School & Leisure Centre | Ground Floor / G13 | 0011 | floor tiles with adhesive floor | Vinyl Floor Tiles | Completely Sealed | Low Damage | 6m <sup>2</sup> | Routinely disturbed | Identified | Chrysotile | ( 3 )<br>Very low | - | Manage |

| Assessment details | | | | Comments | Photograph |
|---|---|---|---|---|---|
| Building | School & Leisure Centre | Floor/ room | Ground Floor / G13 | Brown | |

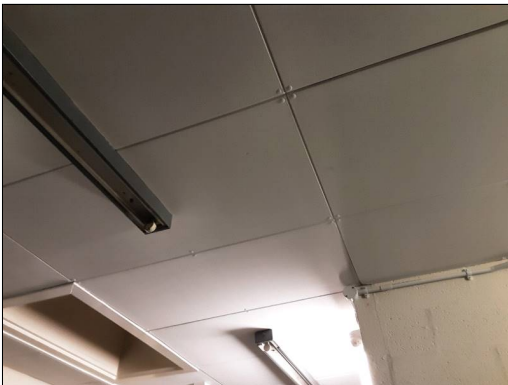
| Assessment details | | | | Comments | Photograph |
|---|---|---|---|---|---|
| Assessment no. | 0012 | Accessibility | Usually inaccessible or unlikely to be disturbed | | |

| Building | Floor/<br>Room | Assessment<br>Number | Location/<br>position | Product<br>type | Surface<br>treatment | Condition | Extent | Accessibility | Level of<br>identification | Asbestos<br>type | Material<br>risk | Priority<br>risk | Action |
|---|---|---|---|---|---|---|---|---|---|---|---|---|---|
| School & Leisure Centre | Ground Floor / G16 | 0012 | Insulating board ceiling | Board | Surface Sealed | Low Damage | 30m <sup>2</sup> | Usually inaccessible or unlikely to be disturbed | Identified | Amosite | ( 6 ) Low | - | Manage |

| Assessment details | | | | Comments | Photograph |
|---|---|---|---|---|---|
| Building | School & Leisure Centre | Floor/ room | Ground Floor / G16 | | |

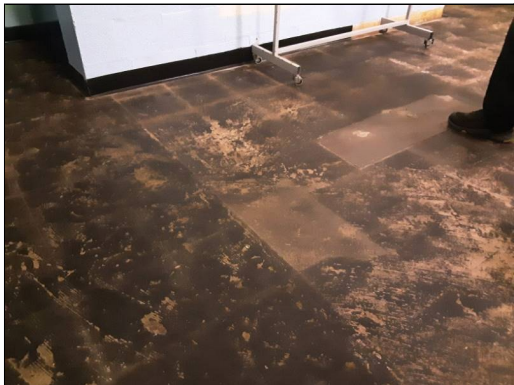
| Assessment details | | | | Comments | Photograph |
|---|---|---|---|---|---|
| Assessment no. | 0013 | Accessibility | Routinely disturbed | | |

| Building | Floor/<br>Room | Assessment<br>Number | Location/<br>position | Product<br>type | Surface<br>treatment | Condition | Extent | Accessibility | Level of<br>identification | Asbestos<br>type | Material<br>risk | Priority<br>risk | Action |
|---|---|---|---|---|---|---|---|---|---|---|---|---|---|
| School & Leisure Centre | Ground Floor / G16 | 0013 | adhesive floor | Bitumen | Completely Sealed | Low Damage | 30m <sup>2</sup> | Routinely disturbed | Identified | Chrysotile | ( 3 )<br>Very low | - | Manage |

| Assessment details | | | | Comments | Photograph |
|---|---|---|---|---|---|
| Building | School & Leisure Centre | Floor/ room | Ground Floor / G16 | | |

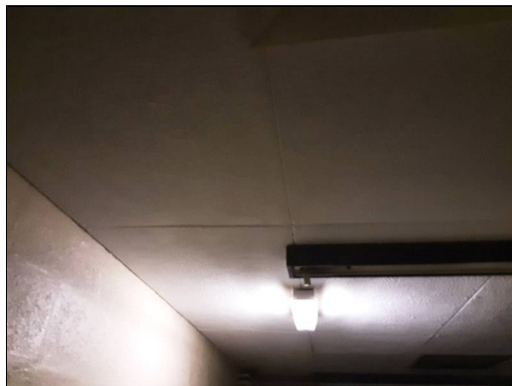
| Assessment details | | | | Comments | <div>Photograph</div> |
|---|---|---|---|---|---|
| Assessment no. | 0014 | Accessibility | Usually inaccessible or unlikely to be disturbed | | |

| Building | Floor/<br>Room | Assessment<br>Number | Location/<br>position | Product<br>type | Surface<br>treatment | Condition | Extent | Accessibility | Level of<br>identification | Asbestos<br>type | Material<br>risk | Priority<br>risk | Action |
|---|---|---|---|---|---|---|---|---|---|---|---|---|---|
| School & Leisure Centre | Ground Floor / G17 | 0014 | Insulating board Ceiling | Board | Surface Sealed | Low Damage | 12m <sup>2</sup> | Usually inaccessible or unlikely to be disturbed | Strongly Presumed (012) | Amosite | ( 6 ) Low | - | Manage |

| Assessment details | | | | Comments | <div>Photograph</div> |
|---|---|---|---|---|---|
| Building | School & Leisure Centre | Floor/ room | Ground Floor / G17 | | |

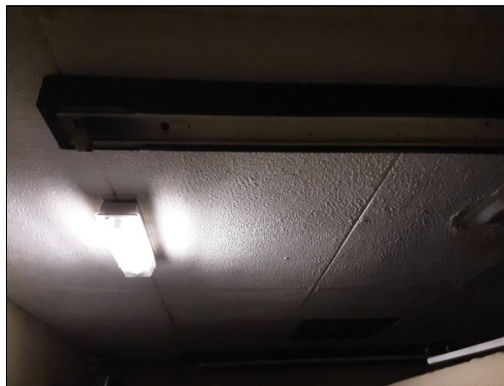
| Assessment details | | | | Comments | <div>Photograph</div> |
|---|---|---|---|---|---|
| Assessment no. | 0015 | Accessibility | Usually inaccessible or unlikely to be disturbed | | |

| Building | Floor/<br>Room | Assessment<br>Number | Location/<br>position | Product<br>type | Surface<br>treatment | Condition | Extent | Accessibility | Level of<br>identification | Asbestos<br>type | Material<br>risk | Priority<br>risk | Action |
|---|---|---|---|---|---|---|---|---|---|---|---|---|---|
| School & Leisure Centre | Ground Floor / G17 | 0015 | Textured coating to board Ceiling | Board | Surface Sealed | Low Damage | 12m <sup>2</sup> | Usually inaccessible or unlikely to be disturbed | Strongly Presumed (002) | Amosite | ( 6 ) Low | - | Manage |

| Assessment details | | | | Comments | <div>Photograph</div> |
|---|---|---|---|---|---|
| Building | School & Leisure Centre | Floor/ room | Ground Floor / G17 | | |

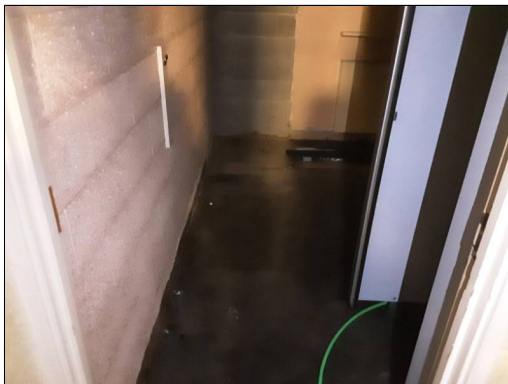
| Assessment details | | | | Comments | Photograph |
|---|---|---|---|---|---|
| Assessment no. | 0016 | Accessibility | Routinely disturbed | | |

| Building | Floor/<br>Room | Assessment<br>Number | Location/<br>position | Product<br>type | Surface<br>treatment | Condition | Extent | Accessibility | Level of<br>identification | Asbestos<br>type | Material<br>risk | Priority<br>risk | Action |
|---|---|---|---|---|---|---|---|---|---|---|---|---|---|
| School & Leisure Centre | Ground Floor / G20 | 0016 | Adhesive Floor | Bitumen | Completely Sealed | Low Damage | 10m <sup>2</sup> | Routinely disturbed | Strongly Presumed (013) | Chrysotile | ( 3 )<br>Very low | - | Manage |

| Assessment details | | | | Comments | Photograph |
|---|---|---|---|---|---|
| Building | School & Leisure Centre | Floor/ room | Ground Floor / G20 | | |

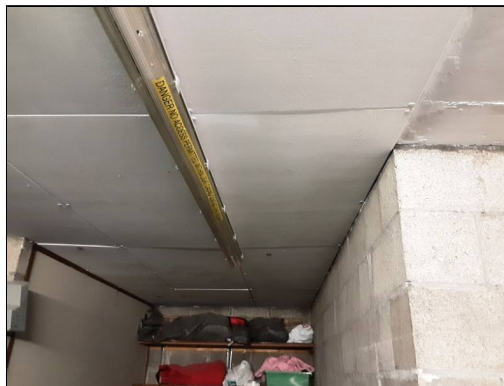
| Assessment details | | | | Comments | |
|---|---|---|---|---|---|
| Assessment no. | 0017 | Accessibility | Usually inaccessible or unlikely to be disturbed | | |

| Building | Floor/<br>Room | Assessment<br>Number | Location/<br>position | Product<br>type | Surface<br>treatment | Condition | Extent | Accessibility | Level of<br>identification | Asbestos<br>type | Material<br>risk | Priority<br>risk | Action |
|---|---|---|---|---|---|---|---|---|---|---|---|---|---|
| School & Leisure Centre | Ground Floor / G31 | 0017 | Insulating board Ceiling | Board | Surface Sealed | Low Damage | 10m <sup>2</sup> | Usually inaccessible or unlikely to be disturbed | Strongly Presumed (012) | Amosite | ( 6 ) Low | - | Manage |

| Assessment details | | | | Comments | |
|---|---|---|---|---|---|
| Building | School & Leisure Centre | Floor/ room | Ground Floor / G31 | | |

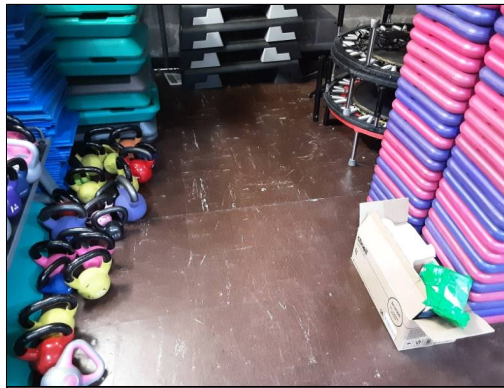
| Assessment details | | | | Comments | Photograph |
|---|---|---|---|---|---|
| Assessment no. | 0018 | Accessibility | Routinely disturbed | | |

| Building | Floor/<br>Room | Assessment<br>Number | Location/<br>position | Product<br>type | Surface<br>treatment | Condition | Extent | Accessibility | Level of<br>identification | Asbestos<br>type | Material<br>risk | Priority<br>risk | Action |
|---|---|---|---|---|---|---|---|---|---|---|---|---|---|
| School & Leisure Centre | Ground Floor / G31 | 0018 | Floor tiles and adhesive Floor | Vinyl Floor Tiles | Completely Sealed | Low Damage | 10m <sup>2</sup> | Routinely disturbed | Strongly Presumed (011) | Chrysotile | ( 3 )<br>Very low | - | Manage |

| Assessment details | | | | Comments | Photograph |
|---|---|---|---|---|---|
| Building | School & Leisure Centre | Floor/ room | Ground Floor / G31 | Brown | |

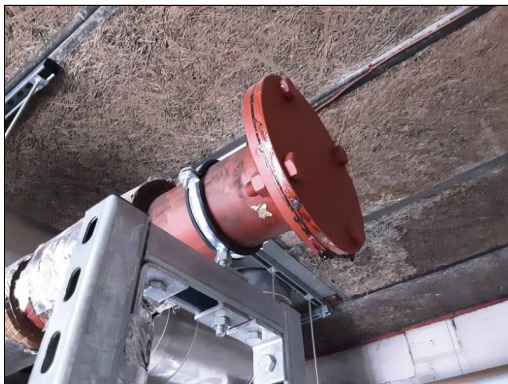
| Assessment details | | | | Comments | Photograph |
|---|---|---|---|---|---|
| Assessment no. | 0020 | Accessibility | Usually inaccessible or unlikely to be disturbed | | |

| Building | Floor/<br>Room | Assessment<br>Number | Location/<br>position | Product<br>type | Surface<br>treatment | Condition | Extent | Accessibility | Level of<br>identification | Asbestos<br>type | Material<br>risk | Priority<br>risk | Action |
|---|---|---|---|---|---|---|---|---|---|---|---|---|---|
| School & Leisure Centre | Ground Floor / G92 | 0020 | Gasket pipes | | Surface Sealed | Low Damage | 10lm | Usually inaccessible or unlikely to be disturbed | Identified | Chrysotile | ( 5 ) Low | - | Manage |

| Assessment details | | | | Comments | Photograph |
|---|---|---|---|---|---|
| Building | School & Leisure Centre | Floor/ room | Ground Floor / G92 | | |

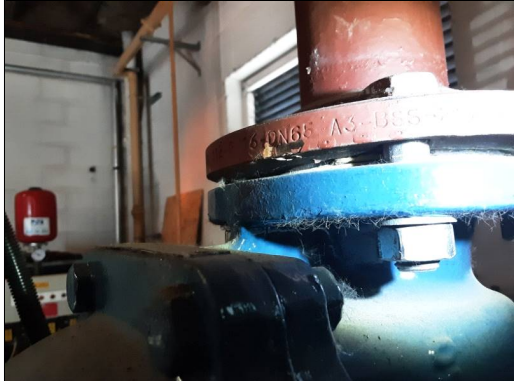
| Assessment details | | | | Comments | Photograph |
|---|---|---|---|---|---|
| Assessment no. | 0021 | Accessibility | | | |

| Assessment details | | | | Comments | Photograph |
|---|---|---|---|---|---|
| Building | School & Leisure Centre | Floor/ room | Ground Floor / G92 | | |

| Assessment details | | | | Comments | Photograph |
|---|---|---|---|---|---|
| Action | No further action required | | | | |

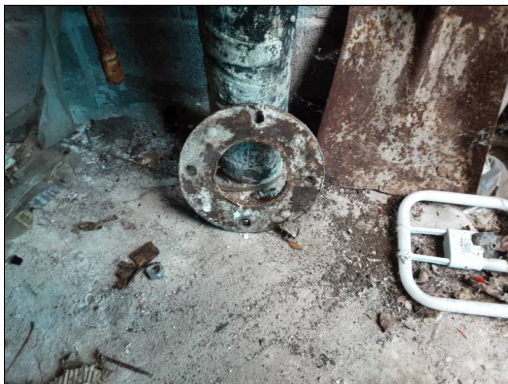
| Assessment details | | | | Comments | Photograph |
|---|---|---|---|---|---|
| Assessment no. | 0022 | Accessibility | Usually inaccessible or unlikely to be disturbed | | |

| Building | Floor/<br>Room | Assessment<br>Number | Location/<br>position | Product<br>type | Surface<br>treatment | Condition | Extent | Accessibility | Level of<br>identification | Asbestos<br>type | Material<br>risk | Priority<br>risk | Action |
|---|---|---|---|---|---|---|---|---|---|---|---|---|---|
| School & Leisure Centre | Ground Floor / G94 | 0022 | Gasket floor | | Surface Sealed | Low Damage | 1m <sup>2</sup> | Usually inaccessible or unlikely to be disturbed | Identified | Chrysotile | ( 4 )<br>Very low | - | Manage |

| Assessment details | | | | Comments | Photograph |
|---|---|---|---|---|---|
| Building | School & Leisure Centre | Floor/ room | Ground Floor / G94 | | |

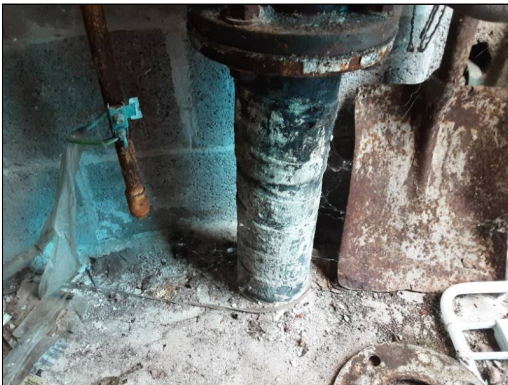
| Assessment details | | | | Comments | Photograph |
|---|---|---|---|---|---|
| Assessment no. | 0023 | Accessibility | | | |

| Assessment details | | | | Comments | Photograph |
|---|---|---|---|---|---|
| Building | School & Leisure Centre | Floor/ room | Ground Floor / G94 | | |

| Assessment details | | | | Comments | Photograph |
|---|---|---|---|---|---|
| Action | No further action required | | | | |

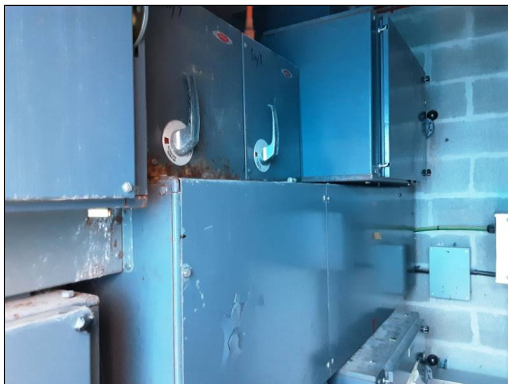
| Assessment details | | | | Comments | Photograph |
|---|---|---|---|---|---|
| Assessment no. | 0024 | Accessibility | | | |

| Assessment details | | | | Comments | Photograph |
|---|---|---|---|---|---|
| Building | School & Leisure Centre | Floor/ room | Ground Floor / G95 | No access to electrics - live services | |

| Assessment details | | | | Comments | Photograph |
|---|---|---|---|---|---|
| Action | Inspect Prior to Disturbance | | | | |

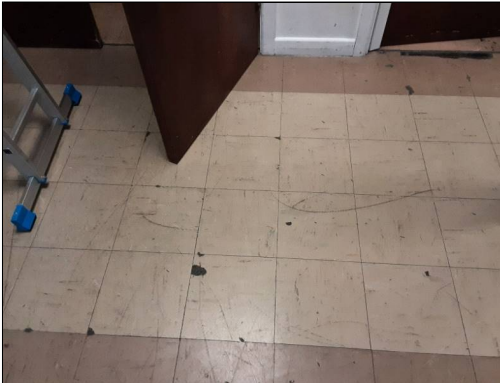
| Assessment details | | | | Comments | Photograph |
|---|---|---|---|---|---|
| Assessment no. | 0025 | Accessibility | Routinely disturbed | | |

| Building | Floor/<br>Room | Assessment<br>Number | Location/<br>position | Product<br>type | Surface<br>treatment | Condition | Extent | Accessibility | Level of<br>identification | Asbestos<br>type | Material<br>risk | Priority<br>risk | Action |
|---|---|---|---|---|---|---|---|---|---|---|---|---|---|
| School & Leisure Centre | Ground Floor / G114 | 0025 | Floor tiles with adhesive floor | Thermoplastic Tiles | Completely Sealed | Low Damage | 20m <sup>2</sup> | Routinely disturbed | Identified | Chrysotile | ( 3 )<br>Very low | - | Manage |

| Assessment details | | | | Comments | Photograph |
|---|---|---|---|---|---|
| Building | School & Leisure Centre | Floor/ room | Ground Floor / G114 | Grey and baige | |

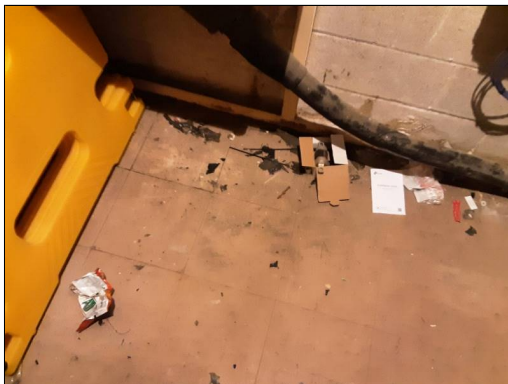
| Assessment details | | | | Comments | Photograph |
|---|---|---|---|---|---|
| Assessment no. | 0026 | Accessibility | Routinely disturbed | | |

| Building | Floor/<br>Room | Assessment<br>Number | Location/<br>position | Product<br>type | Surface<br>treatment | Condition | Extent | Accessibility | Level of<br>identification | Asbestos<br>type | Material<br>risk | Priority<br>risk | Action |
|---|---|---|---|---|---|---|---|---|---|---|---|---|---|
| School & Leisure Centre | Ground Floor / G116 | 0026 | Floor tiles with adhesive Floor | Thermoplastic Tiles | Completely Sealed | Low Damage | 4m <sup>2</sup> | Routinely disturbed | Strongly Presumed (025) | Chrysotile | ( 3 )<br>Very low | - | Manage |

| Assessment details | | | | Comments | Photograph |
|---|---|---|---|---|---|
| Building | School & Leisure Centre | Floor/ room | Ground Floor / G116 | Grey | |

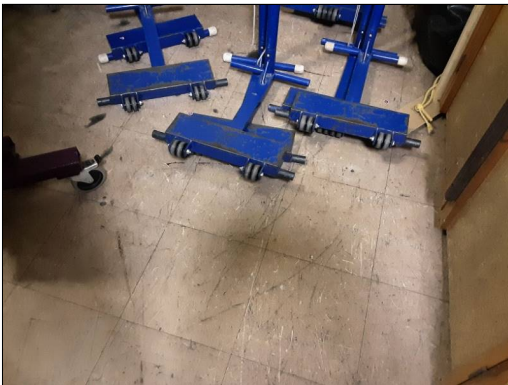
| Assessment details | | | | Comments | Photograph |
|---|---|---|---|---|---|
| Assessment no. | 0027 | Accessibility | Routinely disturbed | | |

| Building | Floor/<br>Room | Assessment<br>Number | Location/<br>position | Product<br>type | Surface<br>treatment | Condition | Extent | Accessibility | Level of<br>identification | Asbestos<br>type | Material<br>risk | Priority<br>risk | Action |
|---|---|---|---|---|---|---|---|---|---|---|---|---|---|
| School & Leisure Centre | Ground Floor / G117 | 0027 | Floor tiles with adhesive Floor | Thermoplastic Tiles | Completely Sealed | Low Damage | 8m <sup>2</sup> | Routinely disturbed | Strongly Presumed (025) | Chrysotile | ( 3 )<br>Very low | - | Manage |

| Assessment details | | | | Comments | Photograph |
|---|---|---|---|---|---|
| Building | School & Leisure Centre | Floor/ room | Ground Floor / G117 | Grey | |

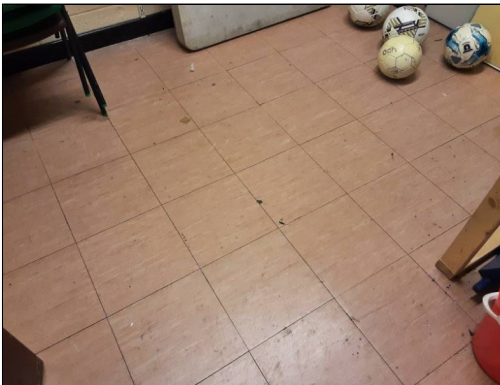
| Assessment details | | | | Comments | Photograph |
|---|---|---|---|---|---|
| Assessment no. | 0029 | Accessibility | Routinely disturbed | | |

| Building | Floor/<br>Room | Assessment<br>Number | Location/<br>position | Product<br>type | Surface<br>treatment | Condition | Extent | Accessibility | Level of<br>identification | Asbestos<br>type | Material<br>risk | Priority<br>risk | Action |
|---|---|---|---|---|---|---|---|---|---|---|---|---|---|
| School & Leisure Centre | Ground Floor / G118 | 0029 | Floor tiles with adhesive floor | Thermoplastic Tiles | Completely Sealed | Low Damage | 8m <sup>2</sup> | Routinely disturbed | Identified | Chrysotile | ( 3 )<br>Very low | - | Manage |

| Assessment details | | | | Comments | Photograph |
|---|---|---|---|---|---|
| Building | School & Leisure Centre | Floor/ room | Ground Floor / G118 | Grey | |

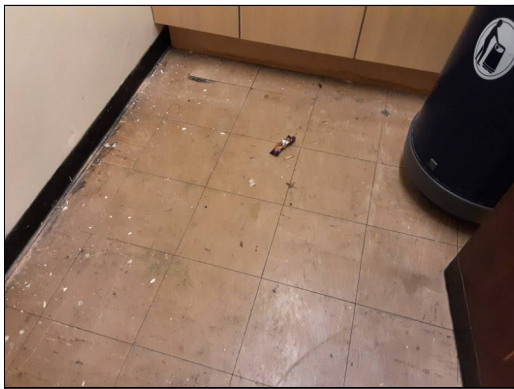
| Assessment details | | | | Comments | Photograph |
|---|---|---|---|---|---|
| Assessment no. | 0030 | Accessibility | Routinely disturbed | | |

| Building | Floor/<br>Room | Assessment<br>Number | Location/<br>position | Product<br>type | Surface<br>treatment | Condition | Extent | Accessibility | Level of<br>identification | Asbestos<br>type | Material<br>risk | Priority<br>risk | Action |
|---|---|---|---|---|---|---|---|---|---|---|---|---|---|
| School & Leisure Centre | Ground Floor / G119 | 0030 | Floor tiles with adhesive Floor | Thermoplastic Tiles | Completely Sealed | Low Damage | 4m <sup>2</sup> | Routinely disturbed | Strongly Presumed (025) | Chrysotile | ( 3 )<br>Very low | - | Manage |

| Assessment details | | | | Comments | Photograph |
|---|---|---|---|---|---|
| Building | School & Leisure Centre | Floor/ room | Ground Floor / G119 | Grey | |
