# GEO-ENVIRONMENTAL AUDIT

PHASE 1 Preliminary Risk Assessment

Proposed Commercial Development

2 Taylors Lane

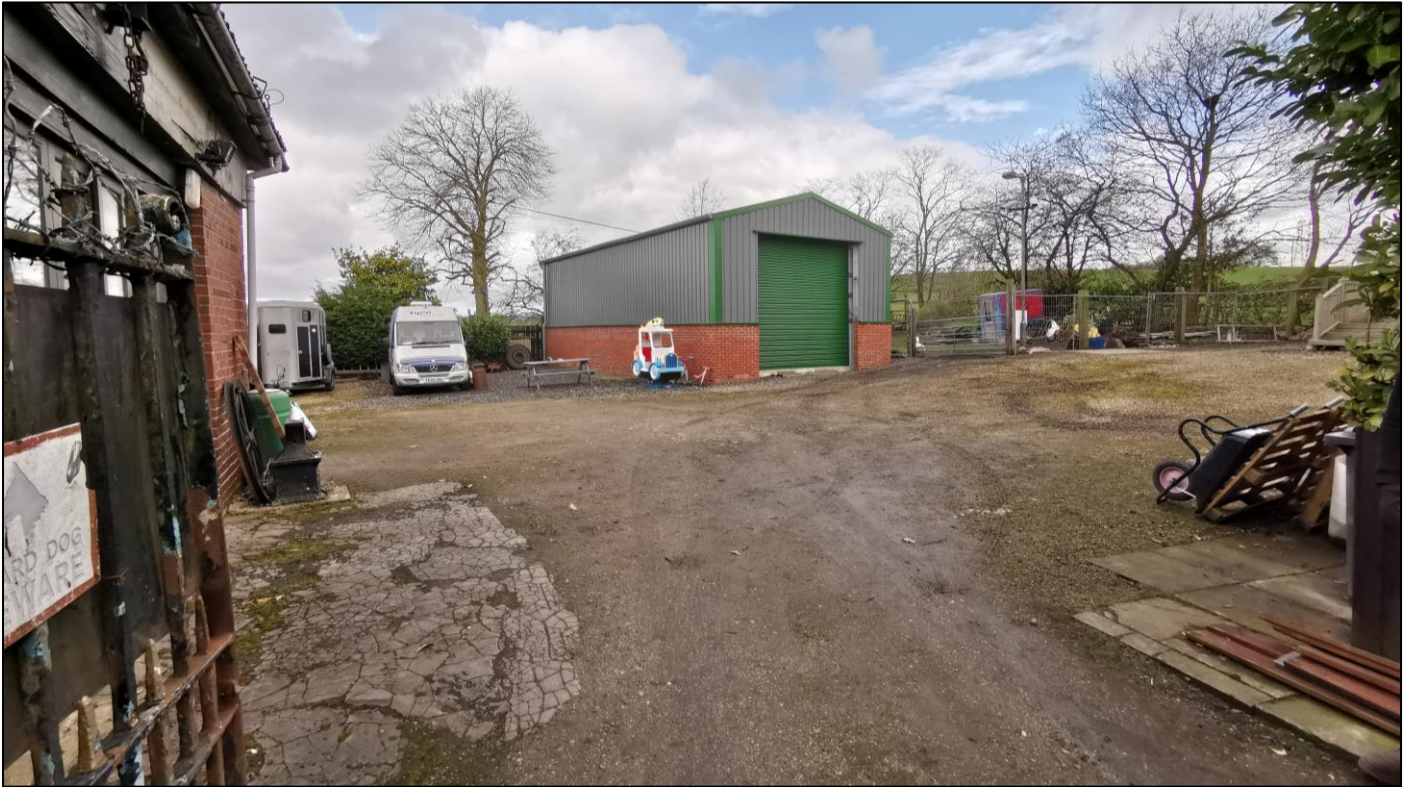
**Figure 1 – View north from Site entrance.**

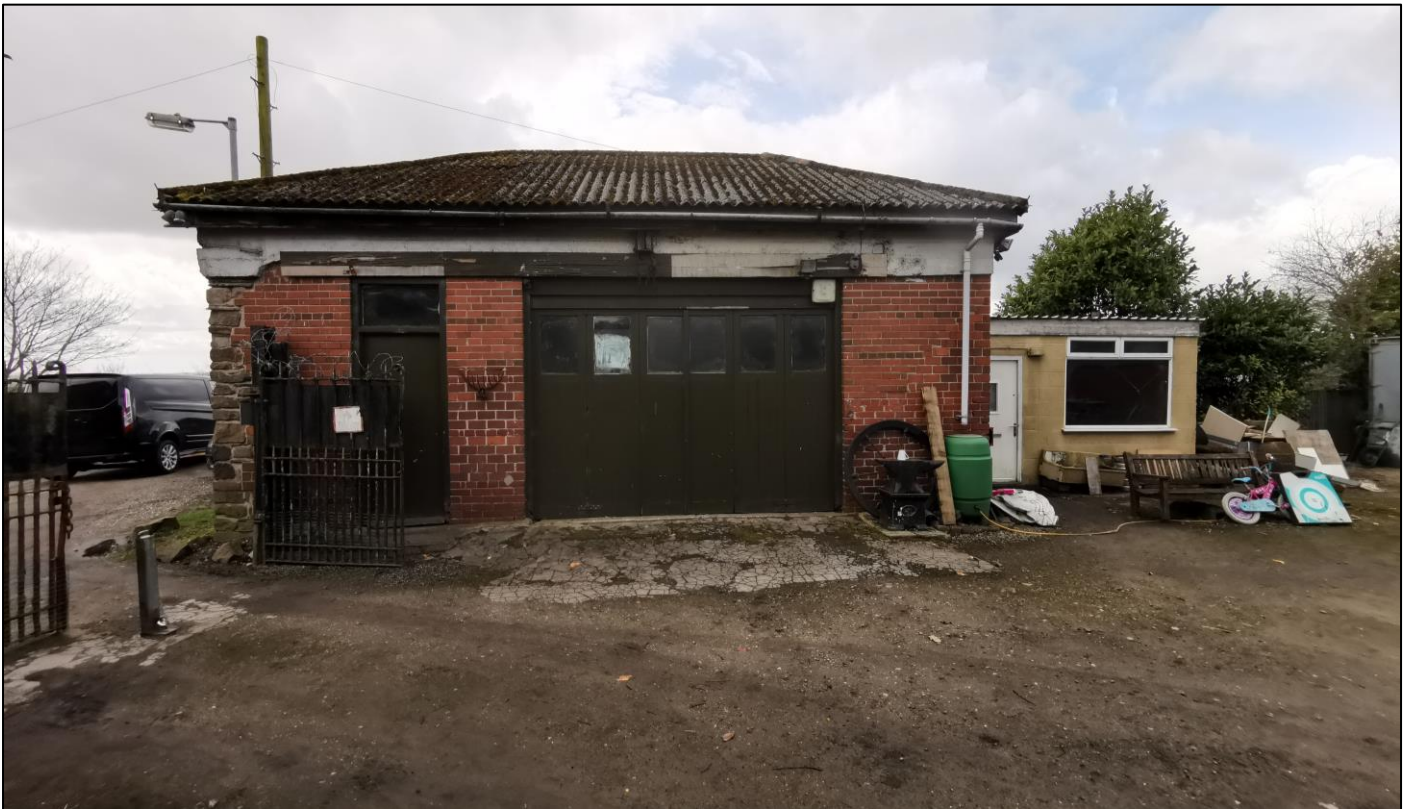
No visual contaminative risk was noted on-site apart from the potential ACM roof. However, the roof appeared to be in good condition, potentially mitigating pathways for pollutant linkages.

**Figure 2 – View west showing 'primary elevation' of existing workshop.**

Remedial measures are not required in general, however the ACM asbestos roof sheet must be carefully handled and taken away from Site in strict accordance with HSE guidance and protocols, and be disposed of to a suitable waste facility.

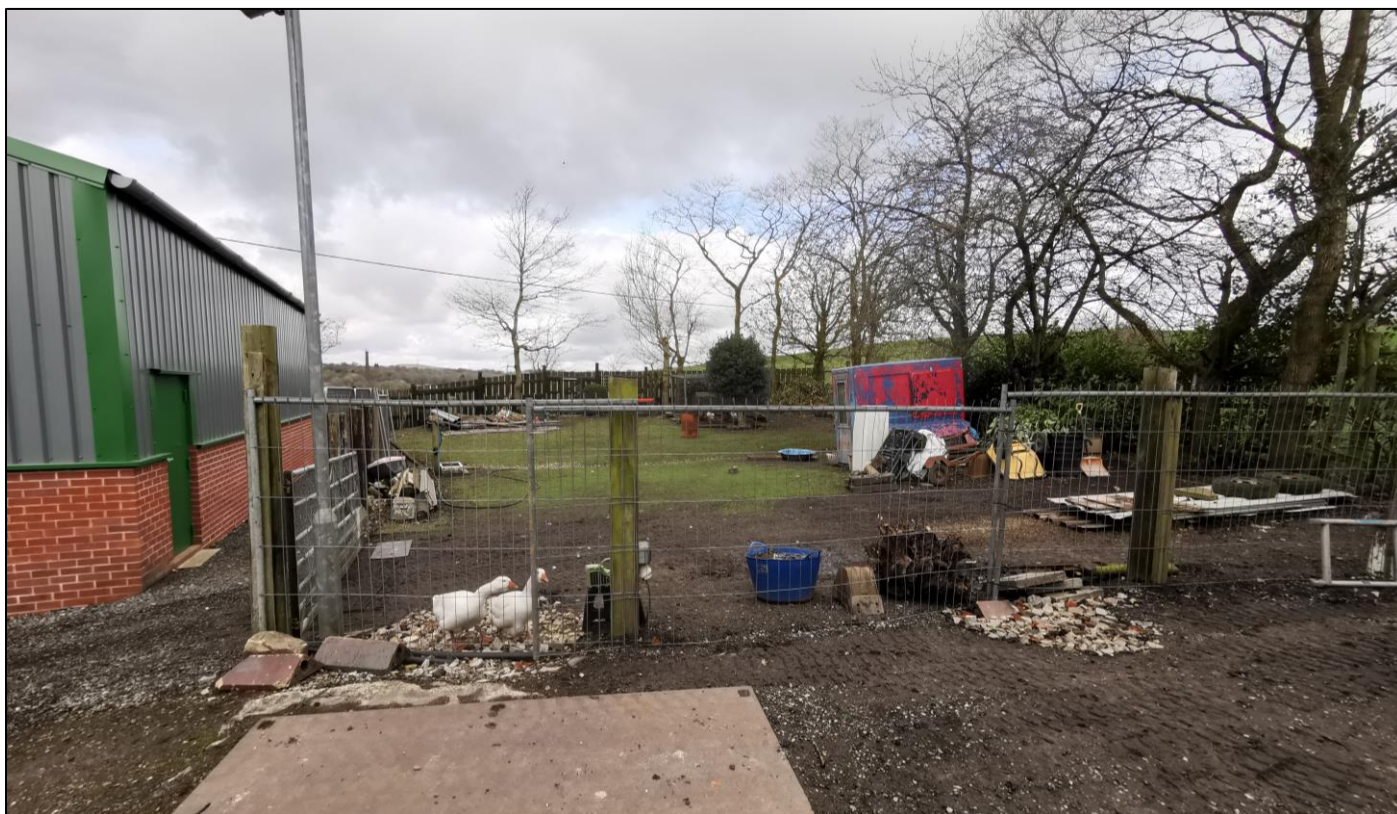
**Figure 3 – View to northeast corner showing paddock and chicken coop area.**

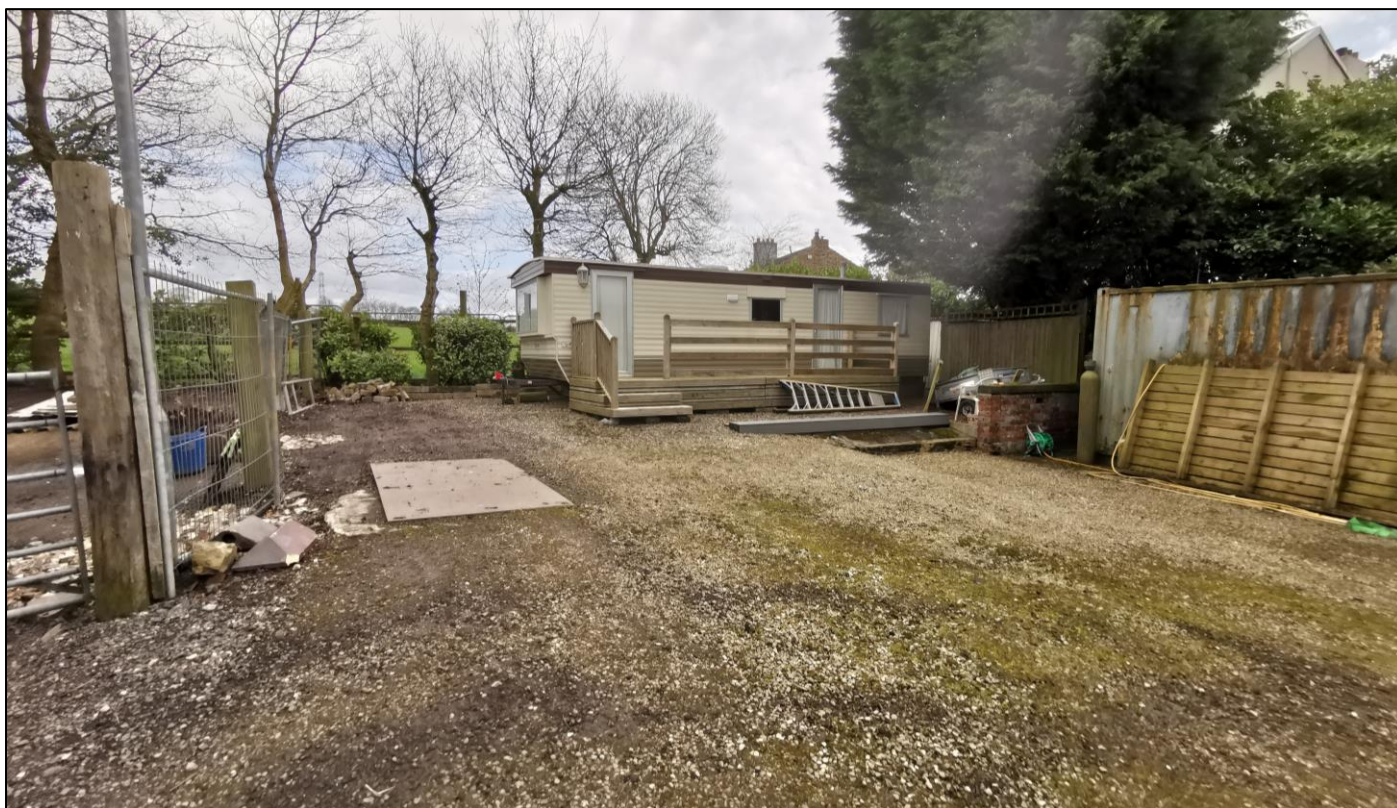
**Figure 4 – View to southeast corner showing static caravan area.**

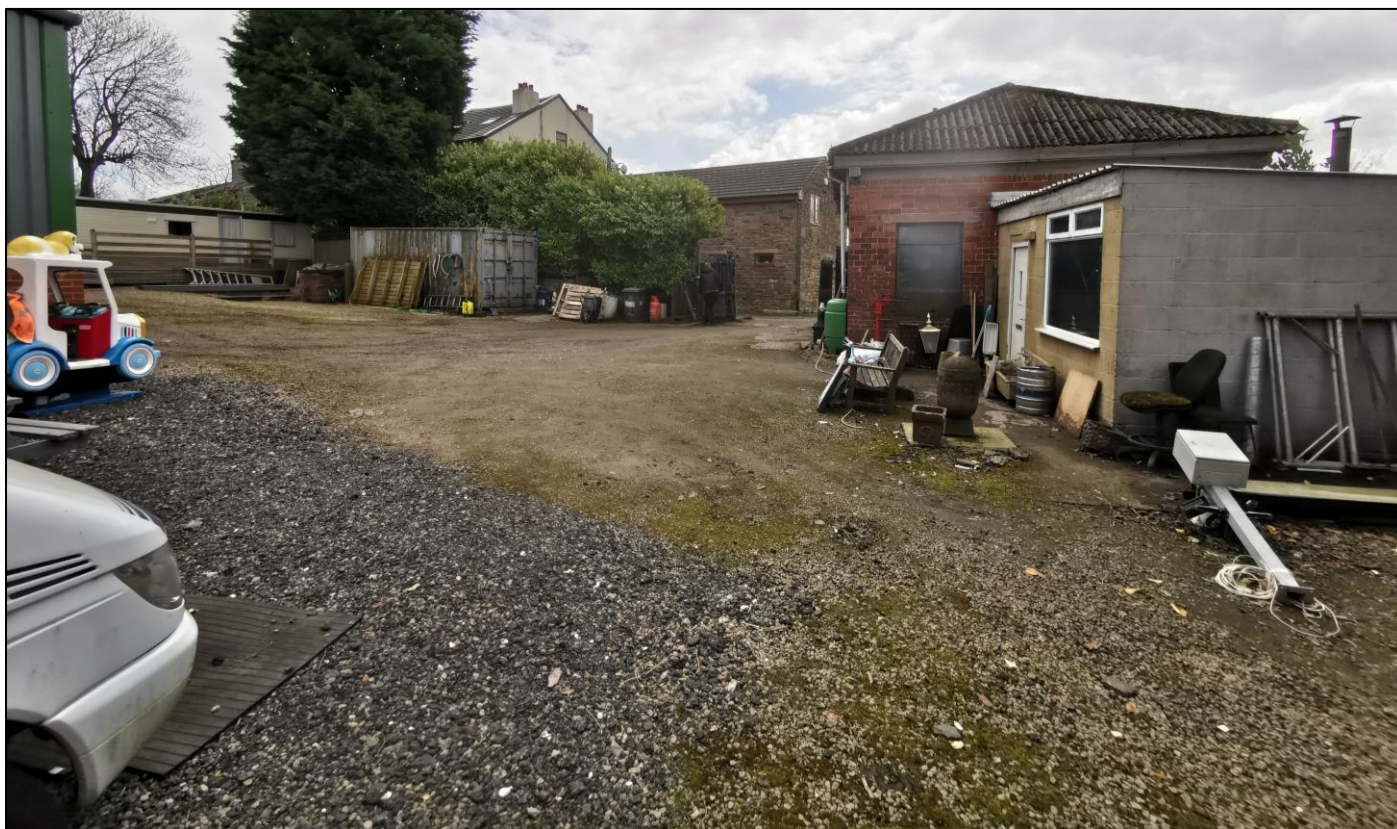
**Figure 5 – View to south boundary/entrance.**

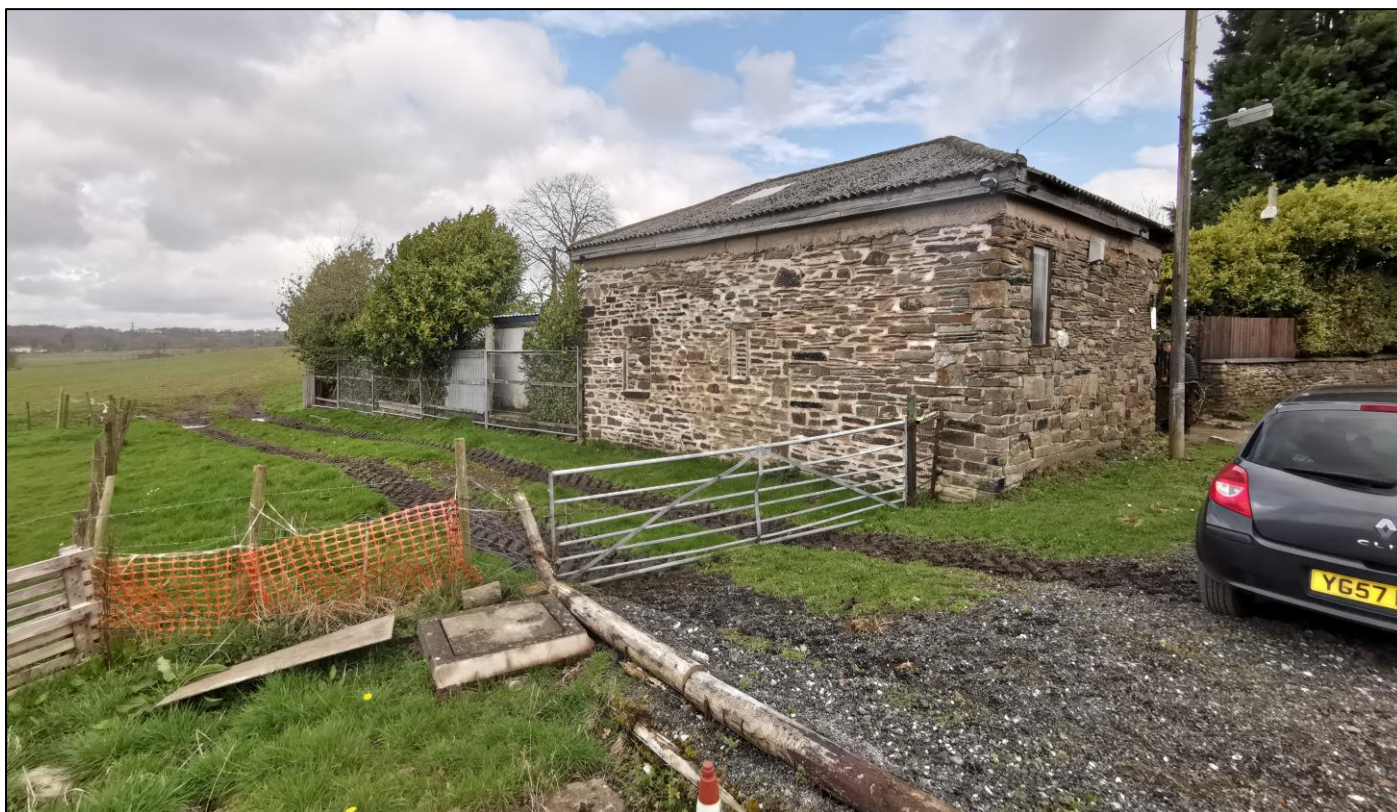
**Figure 6 – View towards the northeast & workshop outside of the Site.**
