CH.22.4.078.LW

| <b>Demolition</b> | X |

## Report on Survey of Asbestos Materials at

**Former TSB Bank  
Market Place  
Radcliffe  
Gtr. Manchester  
M26 1PN**

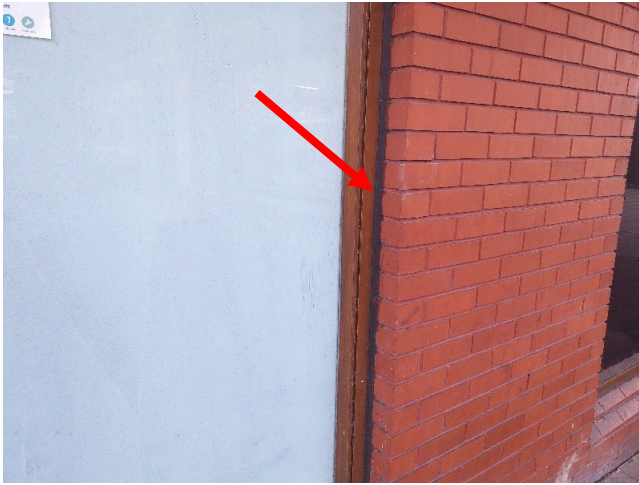
| Sample Number | Location | ACM Type | Condition | Recommendation |
|---|---|---|---|---|
| 22/3/B/22/PK10 | External - Windows | Mastic seal to frames | Fair | Remove |

Sample No: 22/3/B/22/PK10  
External  
Windows  
Mastic seal to frames containing:  
**Chrysotile**

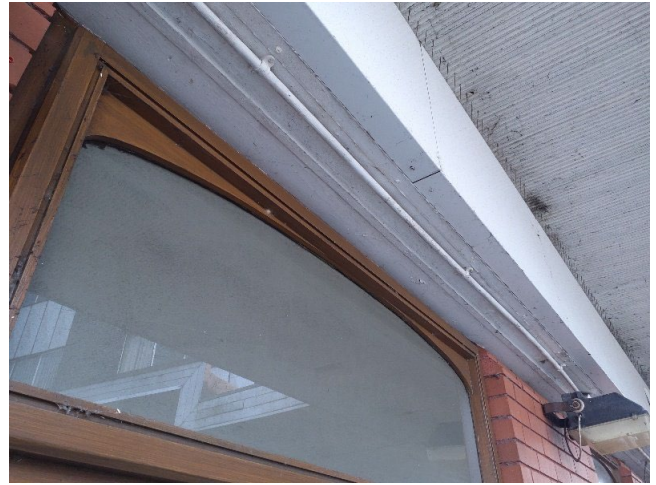
Sample No: 22/3/B/22/PK11  
External  
Soffit above windows  
Soffit panels  
**No Asbestos Detected**

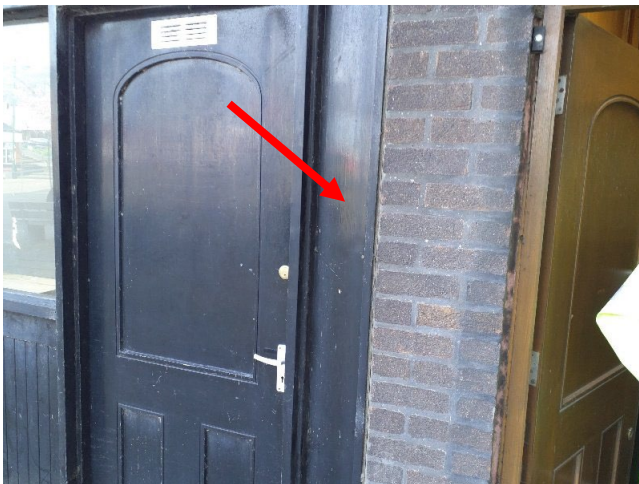
Sample No: 22/3/B/22/PK12  
External  
RHS of door  
Fascia panel  
**No Asbestos Detected**

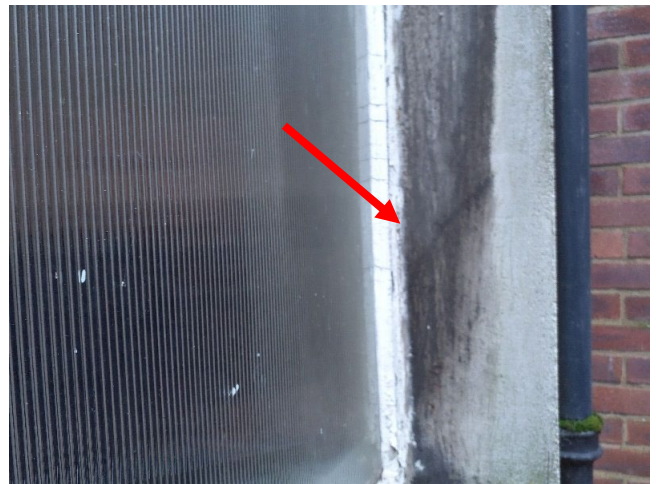
| Sample Number | Location | ACM Type | Condition | Recommendation |
|---|---|---|---|---|
| 22/4/B/4/PK19 | External - Windows | Mastic seal to window frames | Fair | Remove |

Sample No: 22/4/B/4/PK19  
External  
Windows  
Mastic seal to window frames containing:  
**Chrysotile**

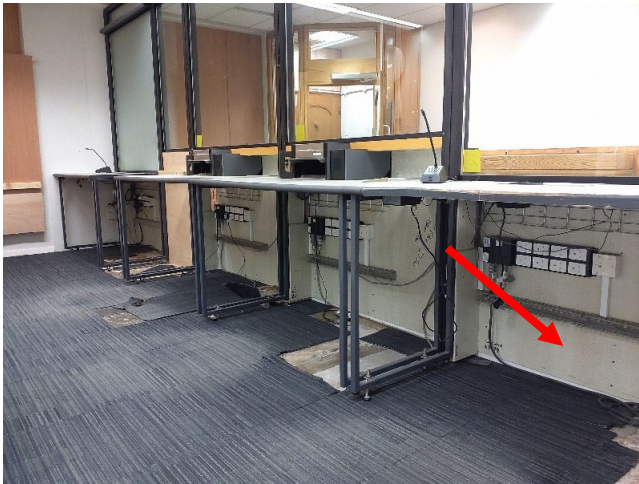
Sample No: 22/3/B/21/PK6  
G.07 Staff area  
Customer counter  
Fibrous lining panels to counter  
**No Asbestos Detected**

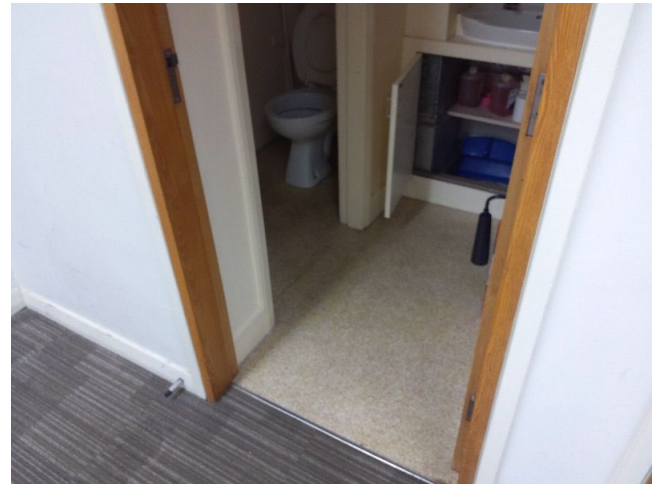
Sample No: 22/3/B/21/PK7  
G.08 Male WC  
Floor  
VFC  
**No Asbestos Detected**

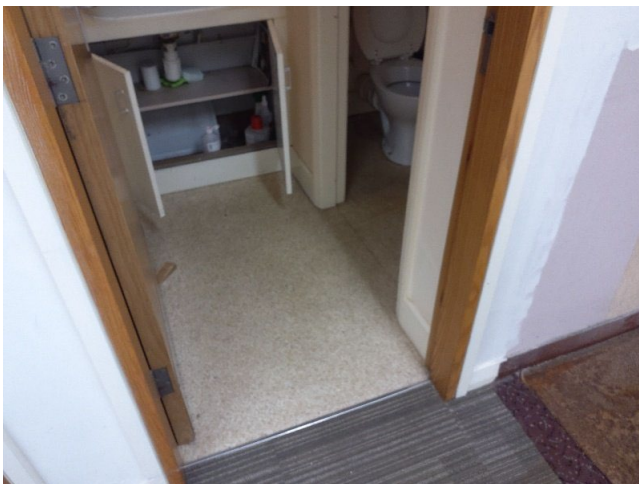
Sample No: Refer to Sample 22/3/B/21/PK7  
G.09 Female WC  
Floor  
VFC  
**No Asbestos Detected**

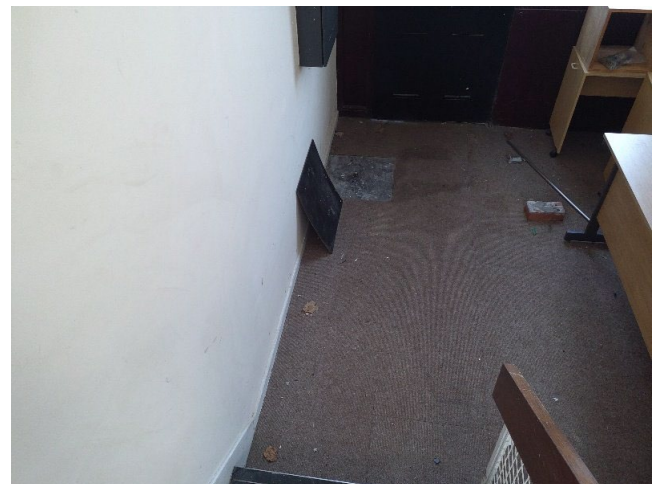
| Sample Number | Location | ACM Type | Condition | Recommendation |
|---|---|---|---|---|
| 22/3/B/22/PK13 | G.13 - 1st floor stairwell - Floor and stairwell | VFC and bitumen adhesive | Fair | Remove |

Sample No: 22/3/B/22/PK13  
G.13 1st floor stairwell  
Floor and stairwell  
VFC and bitumen adhesive containing:  
**Chrysotile (In bitumen only)**

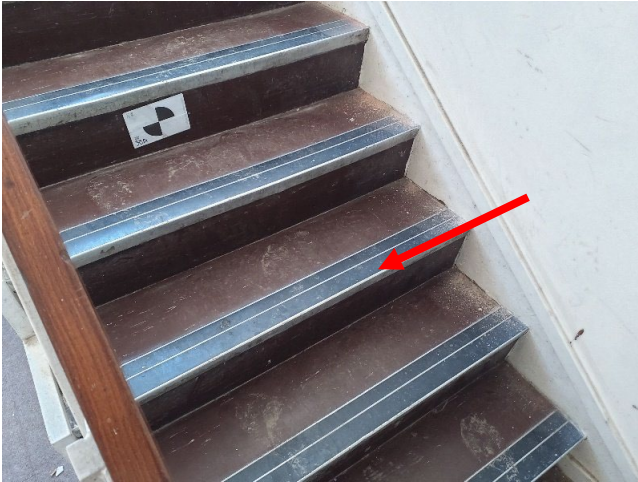
| Sample Number | Location | ACM Type | Condition | Recommendation |
|---|---|---|---|---|
| 22/3/B/22/PK14 | G.13 - 1st floor stairwell - Stairs | Vinyl stair nosings | Fair | Remove |

Sample No: 22/3/B/22/PK14  
G.13 1st floor stairwell  
Stairs  
Vinyl stair nosings containing:  
**Chrysotile**

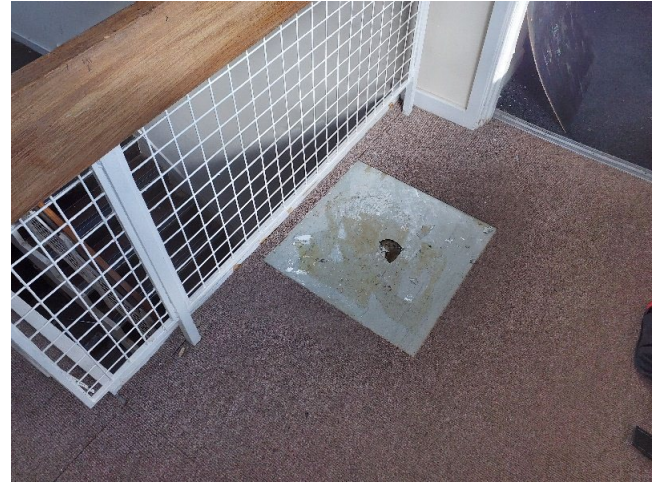
Sample No: 22/3/B/22/PK15  
1.01 Stairwell lobby  
Floor  
VFC  
**No Asbestos Detected**

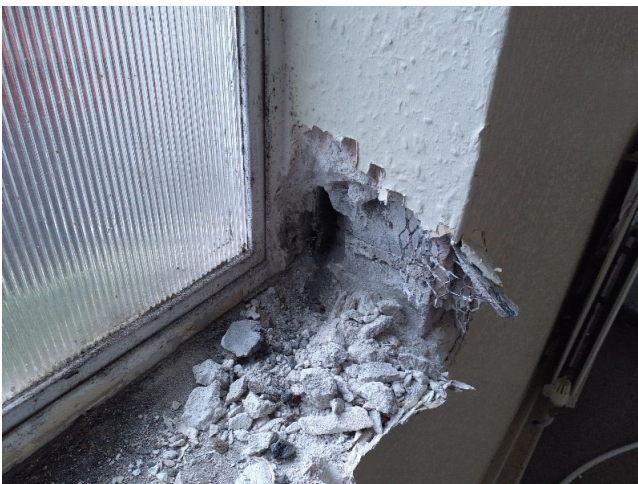
Sample No: 22/4/B/4/PK17  
1.02 Corridor  
External walls  
Bitumen vapour barrier  
**No Asbestos Detected**

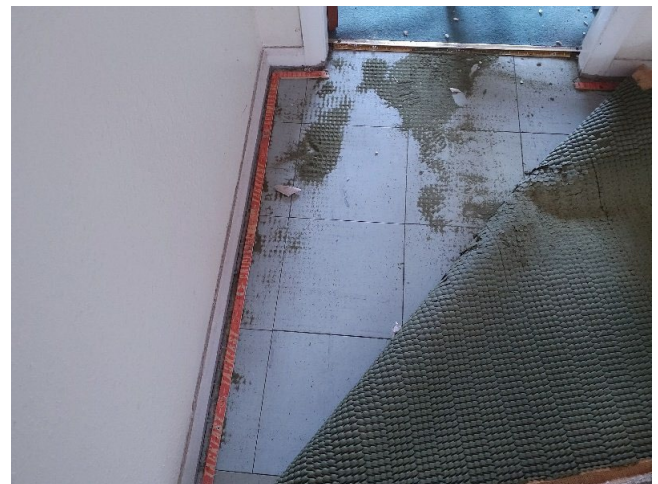
Sample No: Refer to Sample 22/4/B/4/PK16  
1.02 Corridor  
Floor  
VFTs below carpet  
**No Asbestos Detected**

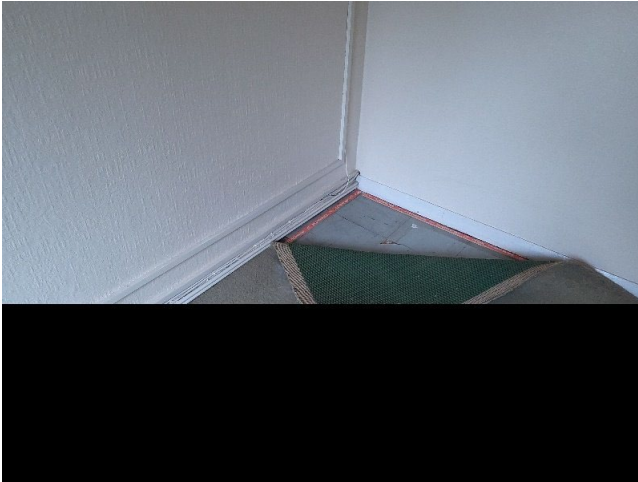
Sample No: 22/4/B/4/PK16  
1.03 Office  
Floor  
VFTs below carpet  
**No Asbestos Detected**

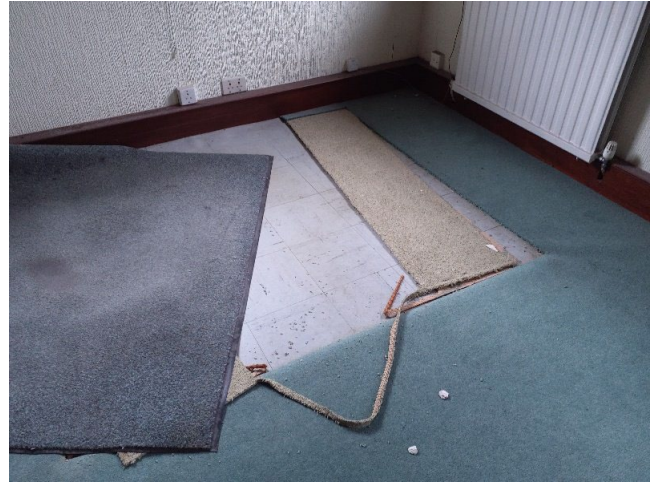
Sample No: Refer to Sample 22/4/B/4/PK16  
1.04 Office  
Floor  
VFTs below carpet  
**No Asbestos Detected**

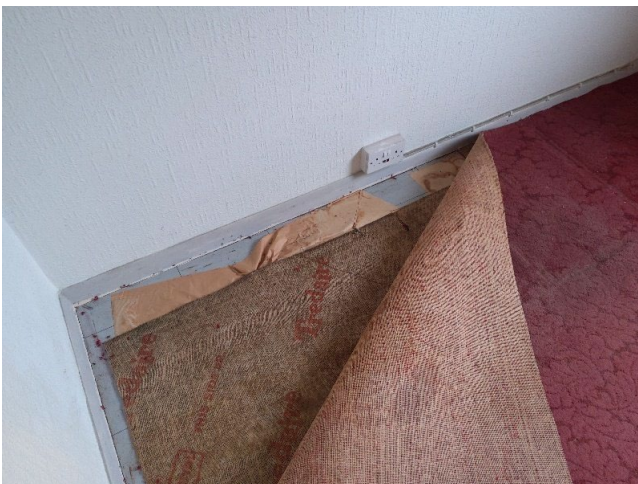
Sample No: Refer to Sample 22/4/B/4/PK16  
1.05 Office  
Floor  
VFTs below carpet  
**No Asbestos Detected**

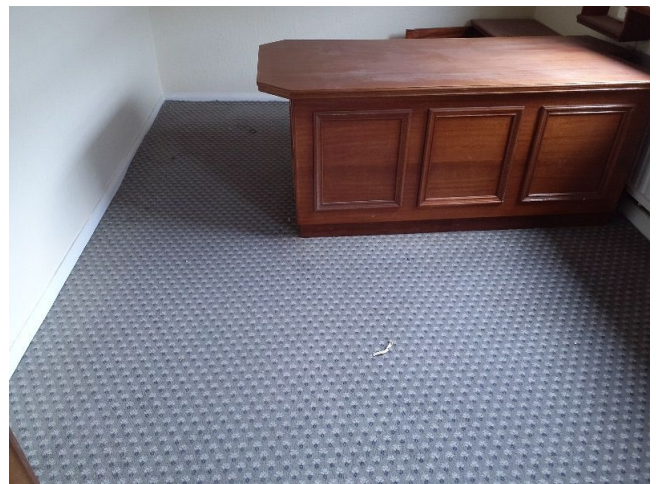
Sample No: Refer to Sample 22/4/B/4/PK16  
1.06 Office  
Floor  
VFTs below carpet  
**No Asbestos Detected**

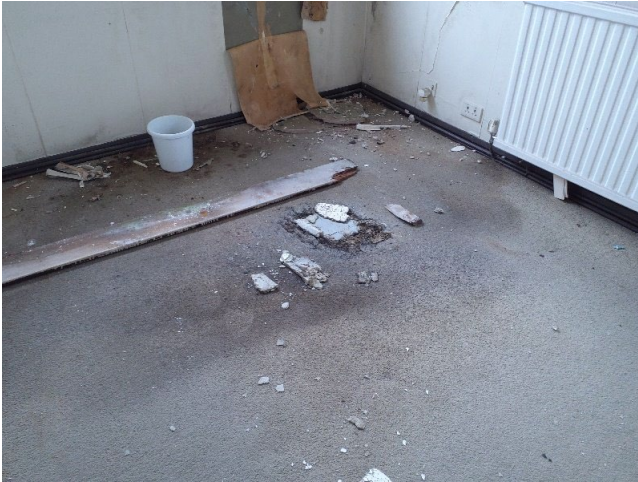
Sample No: Refer to Sample 22/4/B/4/PK16  
1.07 Office  
Floor  
VFTs below carpet  
**No Asbestos Detected**

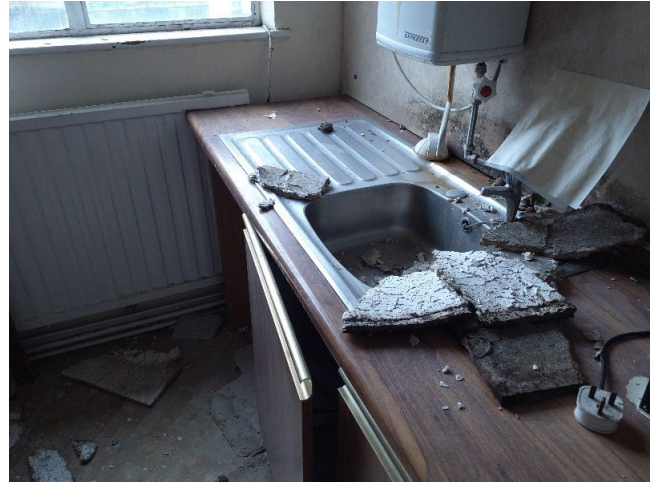
Sample No: 22/4/B/4/PK18  
1.08 Kitchen  
Sink  
Bitumen pad  
**No Asbestos Detected**

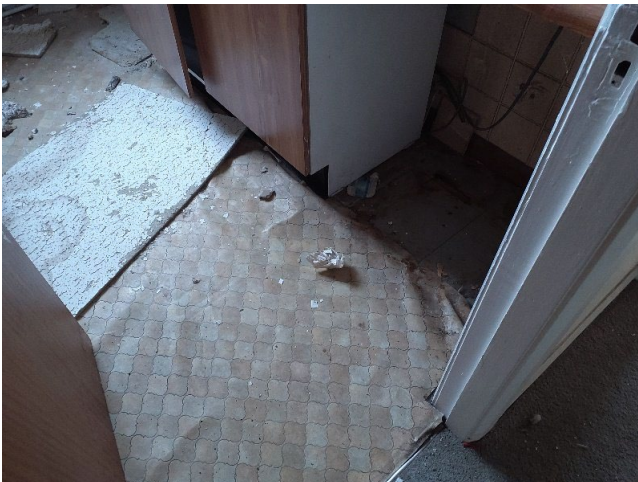
Sample No: Refer to Sample 22/4/B/4/PK16  
1.08 Kitchen  
Floor  
VFTs below modern vinyl flooring  
**No Asbestos Detected**

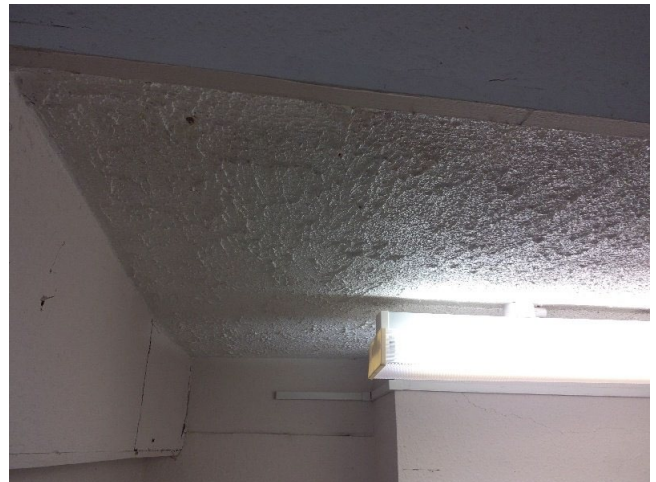
Sample No: 22/3/B/21/PK1  
B.01 Stairwell  
Ceiling  
Textured coating  
**No Asbestos Detected**

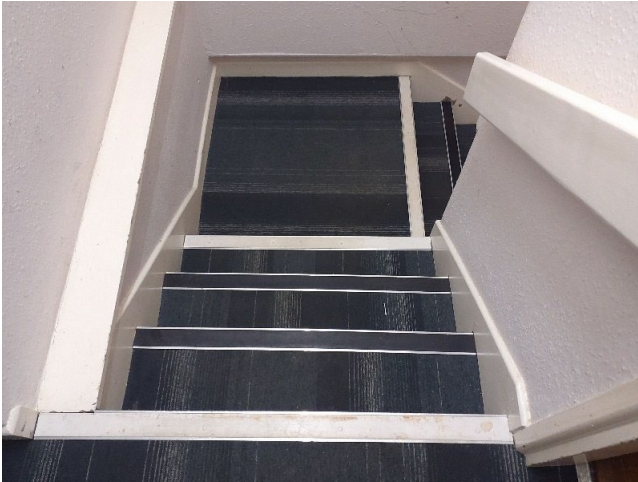
Sample No: 22/3/B/22/PK8  
B.01 Stairwell  
Stairs  
Vinyl stair nosings  
**No Asbestos Detected**

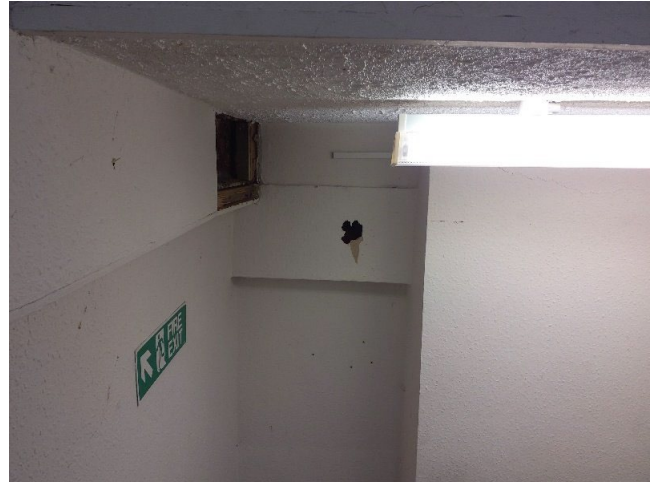
Sample No: 22/3/B/22/PK9  
B.01 Stairwell  
Wall  
Insulation board cladding  
**No Asbestos Detected**

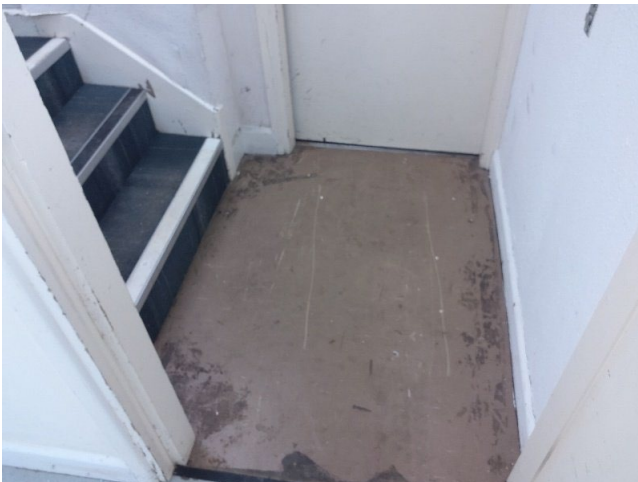
Sample No: 22/3/B/21/PK2  
B.02 Circulation  
Floor  
VFC  
**No Asbestos Detected**

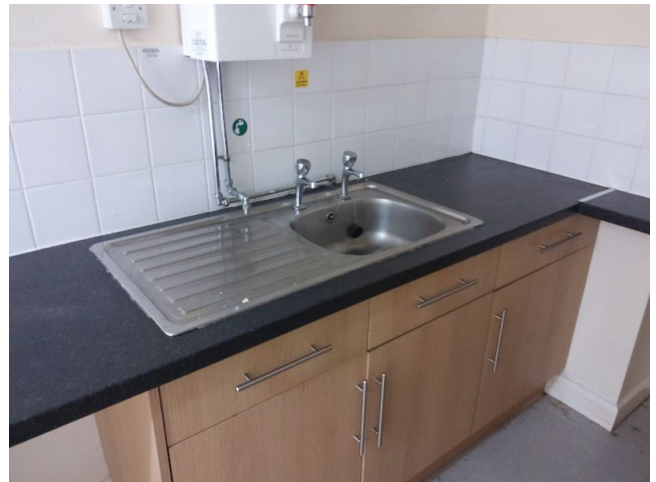
Sample No: 22/3/B/21/PK3  
B.03 Welfare / kitchen  
Sink  
Bitumen pad  
**No Asbestos Detected**

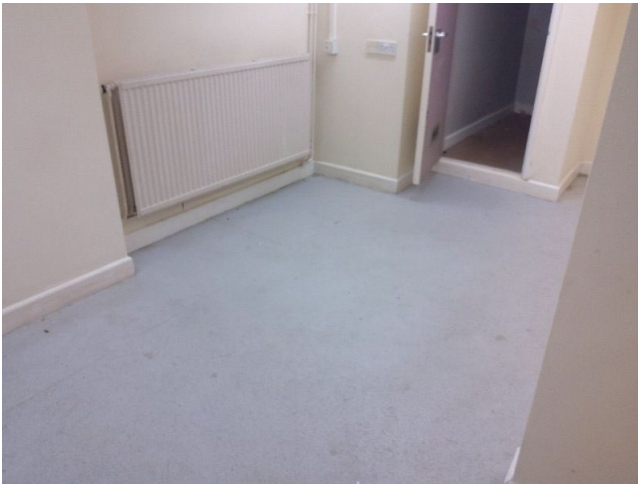
Sample No: 22/3/B/21/PK4  
B.03 Welfare / kitchen  
Floor  
VFC  
**No Asbestos Detected**

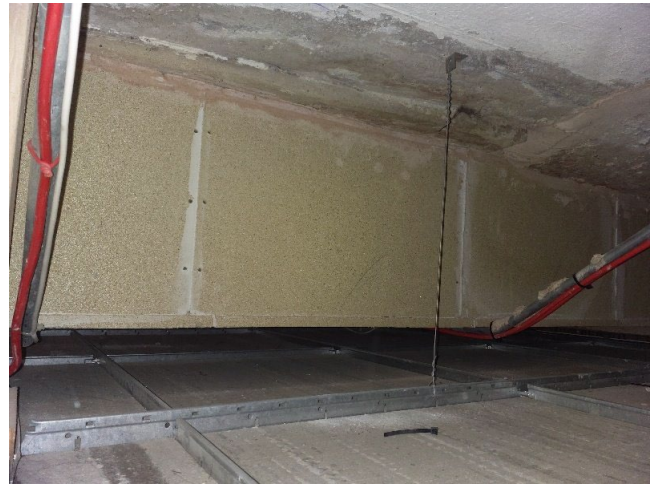
Sample No: Refer to Sample 22/3/B/22/PK9  
B.03 Welfare / kitchen  
Ceiling void  
Insulation board cladding to beams  
**No Asbestos Detected**

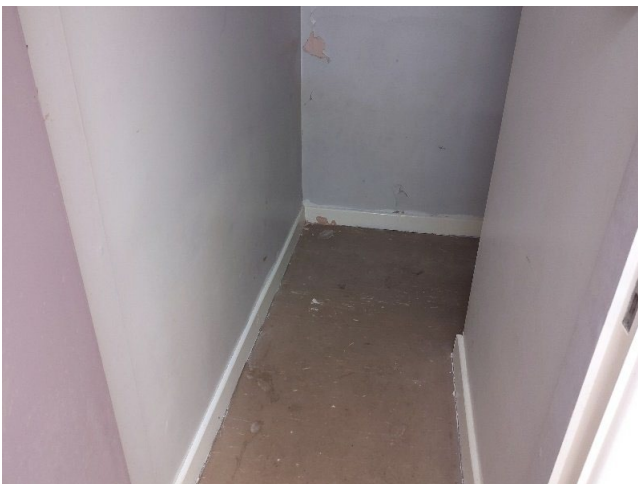
Sample No: Refer to Sample 22/3/B/21/PK2  
B.04 Under stair store  
Floor  
VFC  
**No Asbestos Detected**

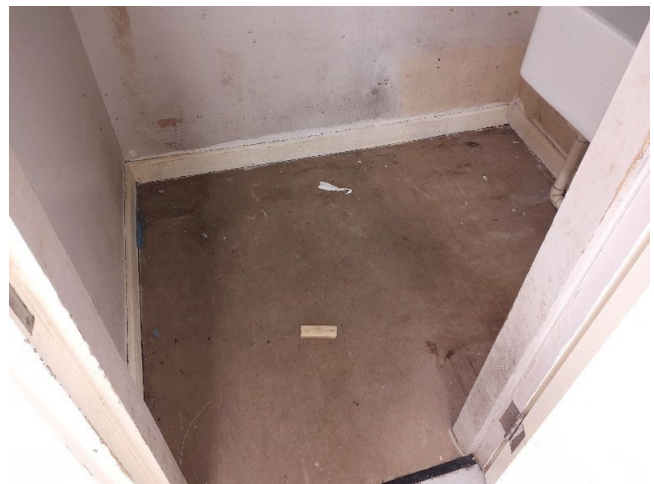
Sample No: Refer to Sample 22/3/B/21/PK2  
B.05 Store  
Floor  
VFC  
**No Asbestos Detected**

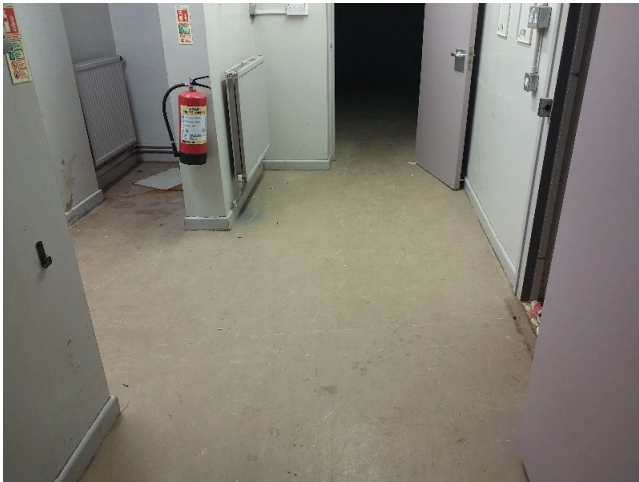
Sample No: Refer to Sample 22/3/B/21/PK2  
B.06 Circulation  
Floor  
VFC  
**No Asbestos Detected**

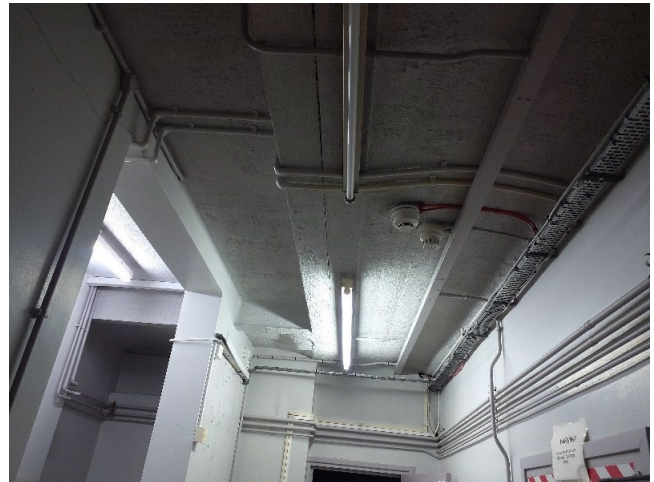
Sample No: Refer to Sample 22/3/B/21/PK1  
B.06 Circulation  
Ceiling  
Textured coating  
**No Asbestos Detected**

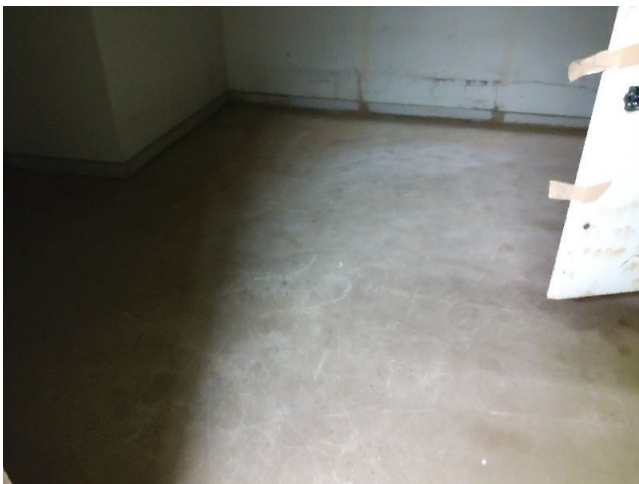
Sample No: Refer to Sample 22/3/B/21/PK2  
B.07 Strong room  
Floor  
VFC  
**No Asbestos Detected**

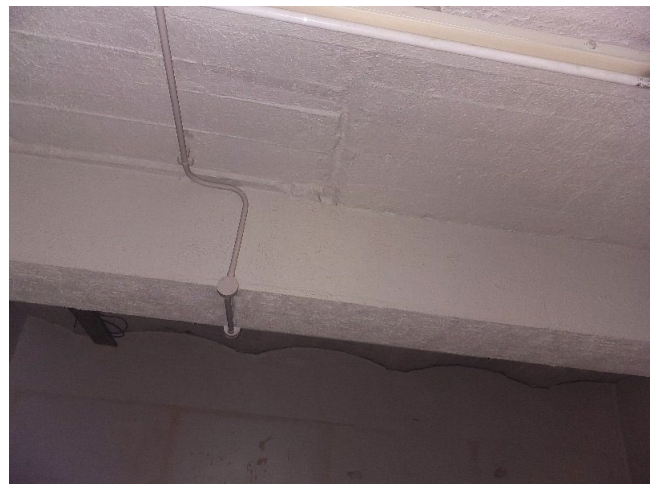
Sample No: Refer to Sample 22/3/B/21/PK1  
B.07 Strong room  
Ceiling  
Textured coating  
**No Asbestos Detected**

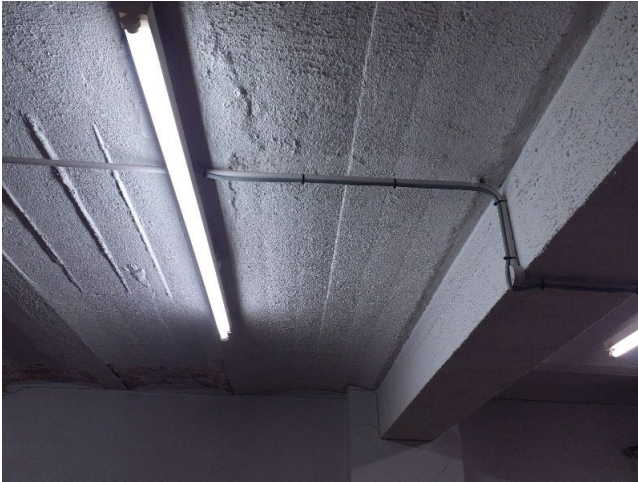
Sample No: 22/3/B/21/PK5  
B.08 Store  
Ceiling  
Textured coating  
**No Asbestos Detected**

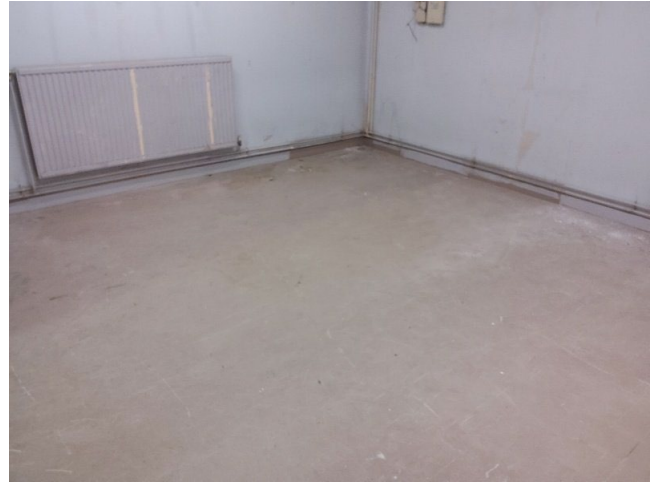
Sample No: Refer to Sample 22/3/B/21/PK2  
B.08 Store  
Floor  
VFC  
**No Asbestos Detected**

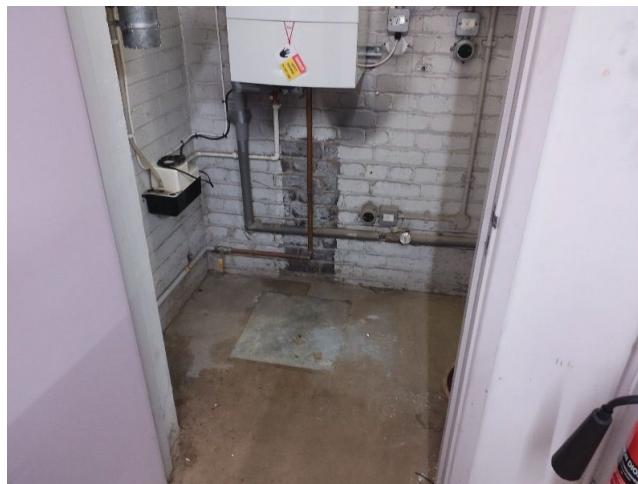
Sample No: Refer to Sample 22/3/B/21/PK2  
B.09 Boiler room  
Floor  
VFC  
**No Asbestos Detected**

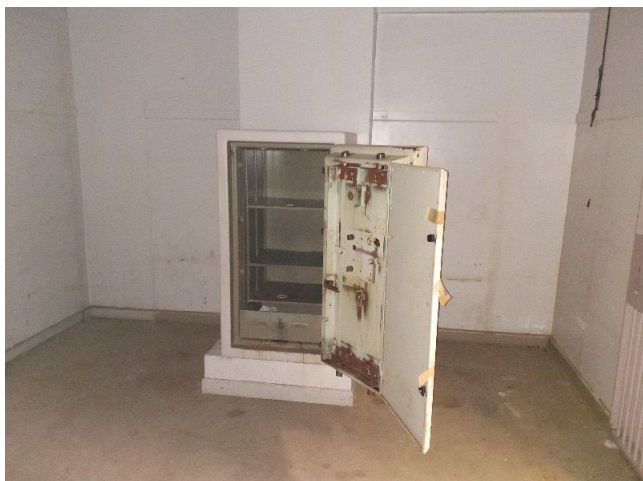
Safe in basement strong room (may have ACMs internally)

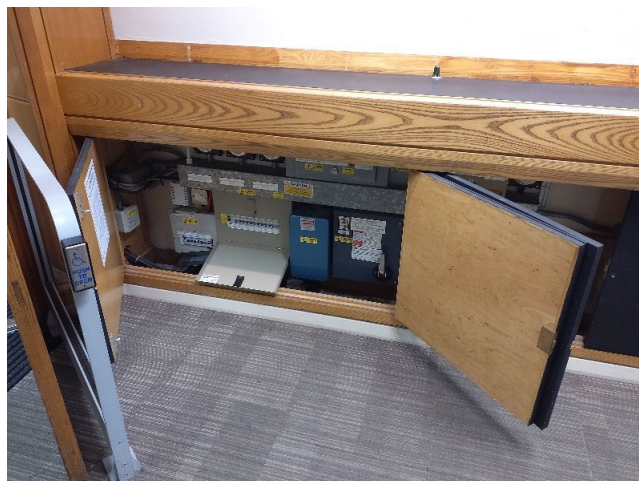
Modern electrics in G.02 customer area
