I. Linfoot  
D. Mills  
P. Keeling  
8<sup>th</sup> & 9<sup>th</sup> March 2022  
CH.22.3.590.LW  
20<sup>th</sup> March 2022

## Report on Survey of Asbestos Materials at

## Radcliffe Market Hall

11 Blackburn Street  
Radcliffe  
Manchester  
M26 1PN

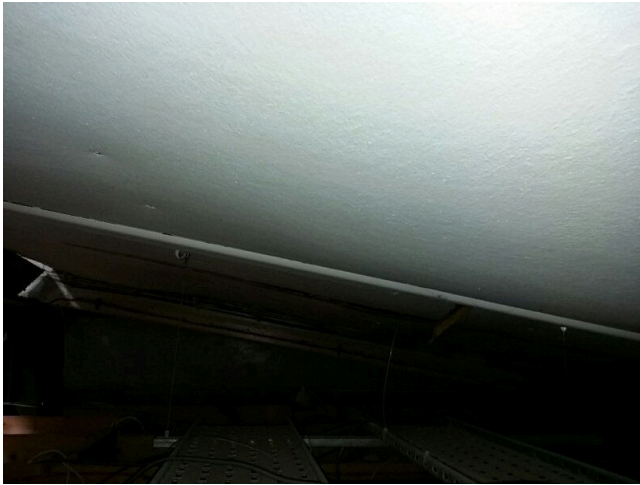
Sample No: 22/3/B/9/IL21.  
G.01 Entrance Lobby - Ceiling void.  
Fibreboard roof lining boards.  
**No Asbestos Detected.**

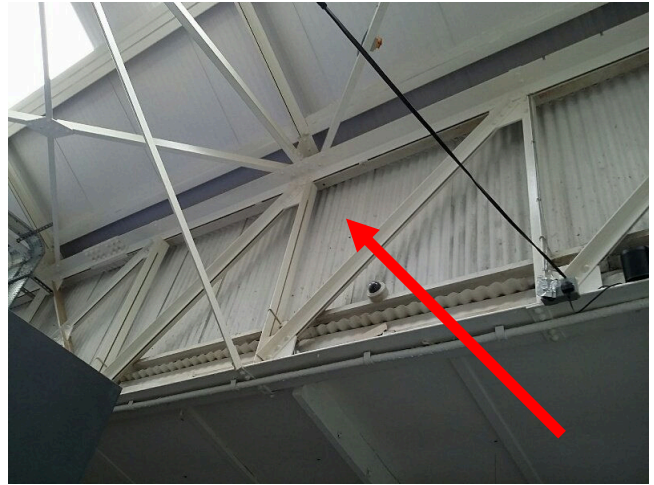
| Sample Number | Location | ACM Type | Condition | Recommendation |
|---|---|---|---|---|
| 22/3/B/9/IL22 | G.02 - Market Hall<br>Circulation Area - High level perimeter wall | Corrugated cement wall sheets | Fair | Manage & Review |

Sample No: 22/3/B/9/IL22.  
G.02 Market Hall Circulation Area - High level  
perimeter wall.  
Corrugated cement wall sheets containing:  
**Chrysotile.**

- Condition:** Fair.
- Recommendation:** These materials are in a fair condition and are unlikely to generate airborne asbestos fibre during normal occupation, provided that they remain undisturbed.  
We would recommend that these materials are either removed completely, or, if they are to remain in-situ they should be labelled for identification purposes, managed and periodically re-inspected on a regular basis as required by The Control of Asbestos Regulations 2012.  
These materials should remain undisturbed and any future remedial or removal works undertaken by either a licensed asbestos removal contractor, or suitably trained and equipped personnel only, working under the guidance of a safe working procedure and in accordance with the requirements of The Control of Asbestos Regulations 2012.  
If these materials are likely to be disturbed during the proposed refurbishment works then they should be removed and disposed of prior to these works commencing by either a licensed asbestos removal contractor, or suitably trained and equipped personnel only, working under the guidance of a safe working procedure and in accordance with the requirements of The Control of Asbestos Regulations 2012.

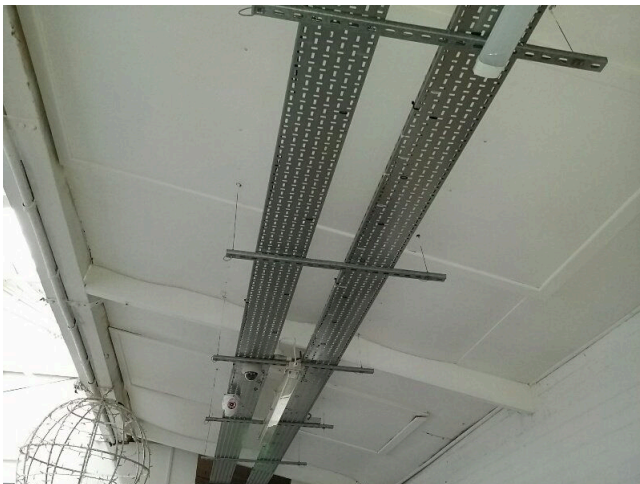
Refer to Sample 22/3/B/9/IL21.  
G.02 Market Hall Circulation Area – Ceiling.  
Fibreboard roof lining boards.  
**No Asbestos Detected.**

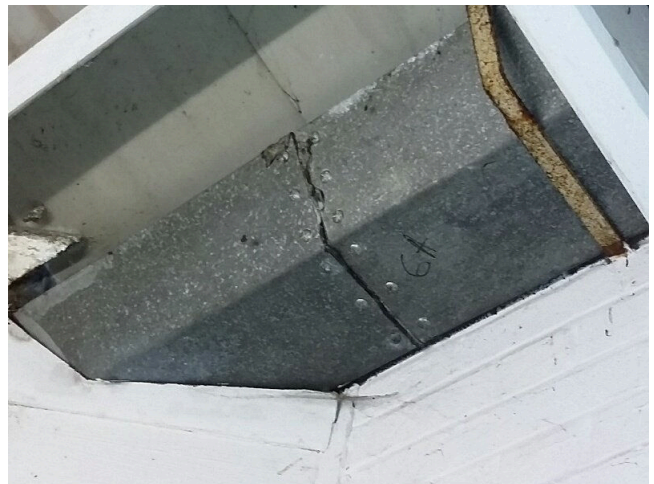
Sample No: 22/3/B/9/IL23.  
G.03 Corridor - Rainwater gutter.  
Mastic seal to joints.  
**No Asbestos Detected.**

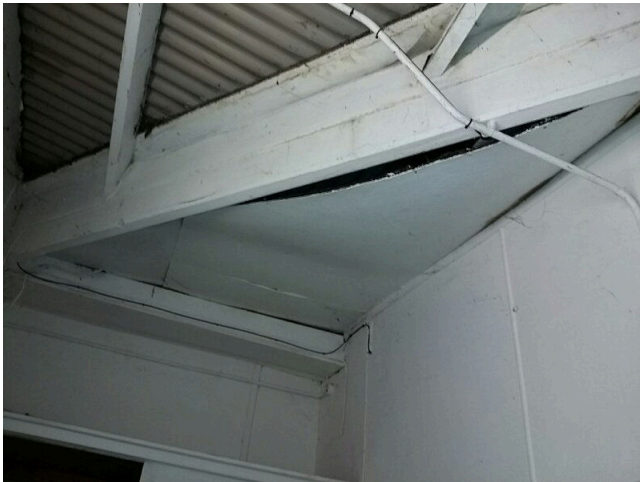
Refer to Sample 22/3/B/9/IL21.  
G.03 Corridor – Ceiling.  
Fibreboard roof lining boards.  
**No Asbestos Detected.**

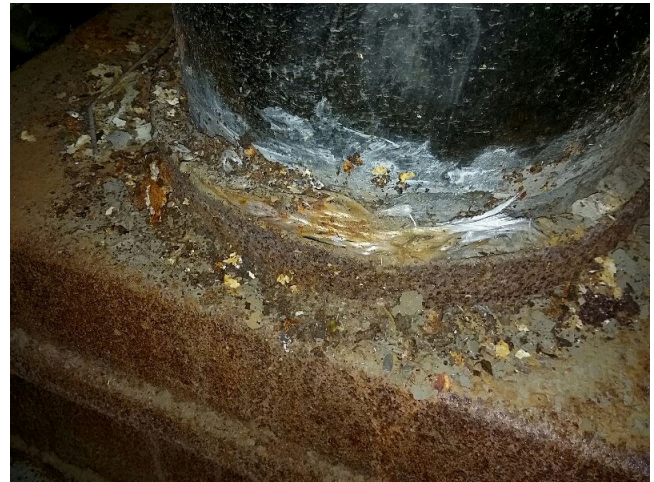
Sample No: 22/3/B/8/IL1.  
B.01 Basement Area 1 - Plant Corridor - Gas Boiler.  
Woven gasket & mastic seal to gas boiler / metal flue joint.  
**No Asbestos Detected**

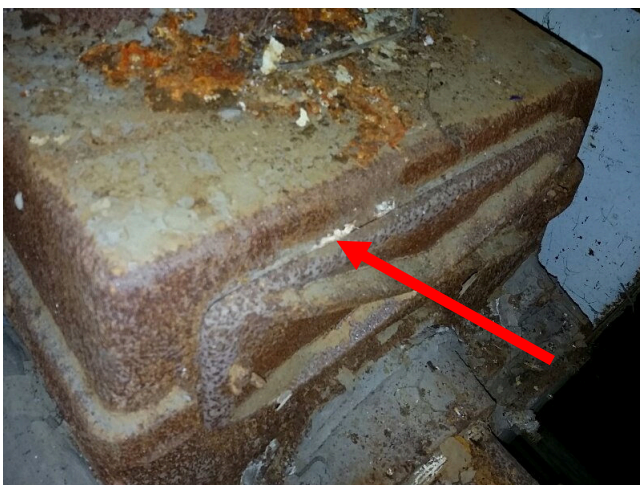
Sample No: 22/3/B/8/IL2.  
B.01 Basement Area 1 - Plant Corridor - Gas Boiler.  
Woven gaskets to boiler hatches containing:  
**Chrysotile.**

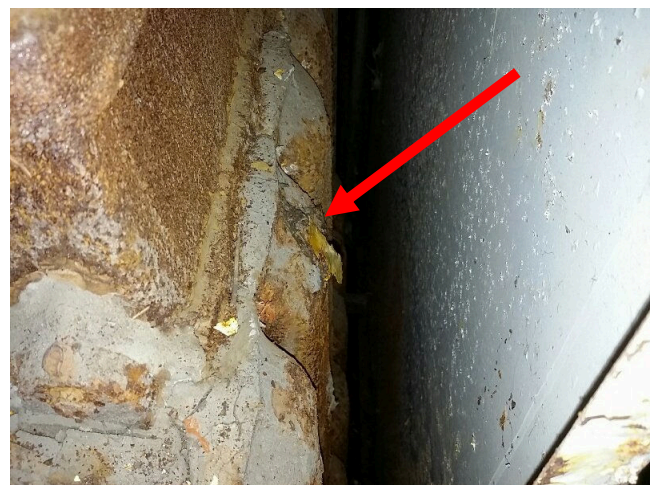
Sample No: 22/3/B/8/IL3.  
B.01 Basement Area 1 - Plant Corridor - Gas Boiler.  
Woven jointing gaskets to gas boiler joints / sections containing:  
**Chrysotile.**

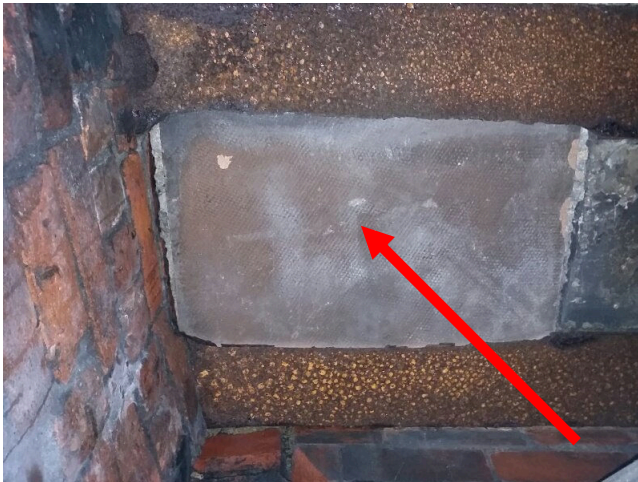
| Sample Number | Location | ACM Type | Condition | Recommendation |
|---|---|---|---|---|
| 22/3/B/8/IL4 | B.01 - Basement Area 1 -<br>Plant Corridor - Ceiling | Localised cement shuttering to ceiling | Fair | Manage & Review |

Sample No: 22/3/B/8/IL4.  
B.01 Basement Area 1 - Plant Corridor – Ceiling.  
Localised cement shuttering to ceiling containing:  
**Chrysotile.**

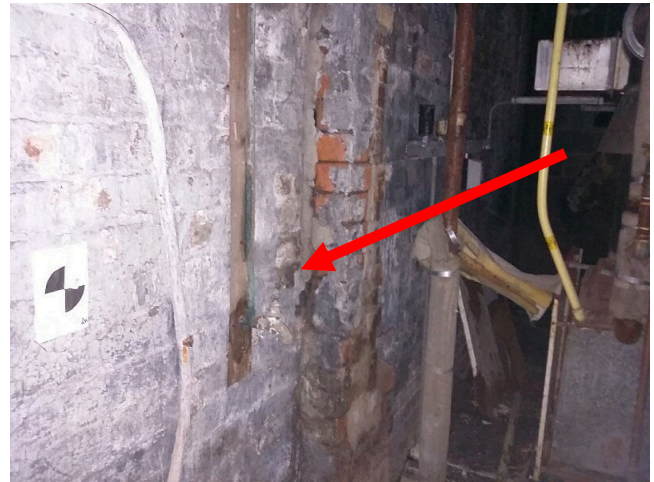
| Sample Number | Location | ACM Type | Condition | Recommendation |
|---|---|---|---|---|
| 22/3/B/8/IL5 | B.01 - Basement Area 1 -<br>Plant Corridor - Wall | Residual insulation to wall | Poor | Remove & Dispose |

Sample No: 22/3/B/8/IL5.  
B.01 Basement Area 1 - Plant Corridor – Wall.  
Residual insulation to wall containing:  
**Crocidolite & Chrysotile.**

- Condition:** Poor.
- Recommendation:** These materials are in a poor condition and therefore could generate airborne asbestos fibre if disturbed.  
We would recommend that these materials remain undisturbed and that access to this localised area is restricted to suitably trained and equipped personnel only.  
We would also recommend that these materials are programmed for removal, at the earliest possible opportunity, by a licensed asbestos removal contractor only, working under the guidance of a safe working procedure and in accordance with the requirements of The Control of Asbestos Regulations 2012.  
Notification may be required to The Health and Safety Executive (via an ASB5 Notification Form) prior to any works being carried out to these materials.

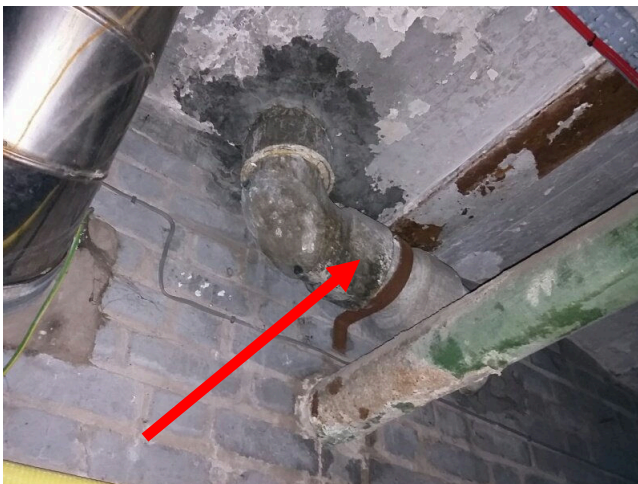
- 
- Location:** B.01 Basement Area 1 - Plant Corridor – Flue.
- Items & Content:** Cement flue pipe containing Chrysotile.  
Sample No: 22/3/B/8/IL6.
- Condition:** Fair.

Sample No: 22/3/B/8/IL6.  
B.01 Basement Area 1 - Plant Corridor – Flue.  
Cement flue pipe containing:  
**Chrysotile.**

- Recommendation:** These materials are in a fair condition and are unlikely to generate airborne asbestos fibre during normal occupation, provided that they remain undisturbed.  
We would recommend that these materials are either removed completely, or, if they are to remain in-situ they should be labelled for identification purposes, managed and periodically re-inspected on a regular basis as required by The Control of Asbestos Regulations 2012.  
These materials should remain undisturbed and any future remedial or removal works undertaken by either a licensed asbestos removal contractor, or suitably trained and equipped personnel only, working under the guidance of a safe working procedure and in accordance with the requirements of The Control of Asbestos Regulations 2012.  
If these materials are likely to be disturbed during the proposed refurbishment works then they should be removed and disposed of prior to these works commencing by either a licensed asbestos removal contractor, or suitably trained and equipped personnel only, working under the guidance of a safe working procedure and in accordance with the requirements of The Control of Asbestos Regulations 2012.

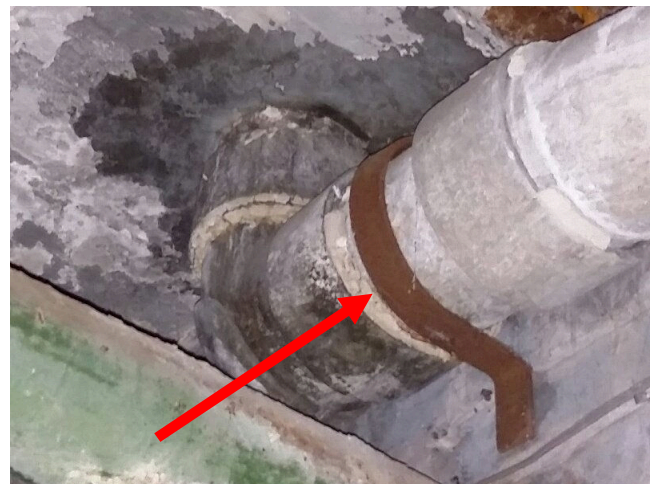
Sample No: 22/3/B/8/IL7.  
B.01 Basement Area 1 - Plant Corridor – Flue.  
Woven gaskets / seals to flue joints / sections  
containing:  
**Chrysotile.**

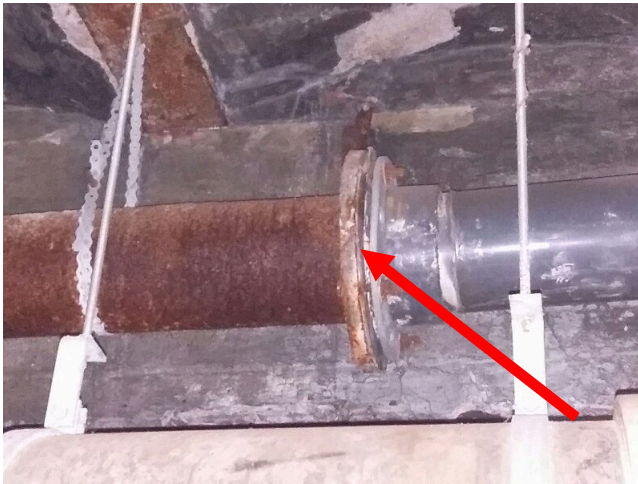
Sample No: 22/3/B/8/IL8.  
B.01 Basement Area 1 - Plant Corridor – Pipework.  
Pipework flange gaskets containing:  
**Chrysotile.**

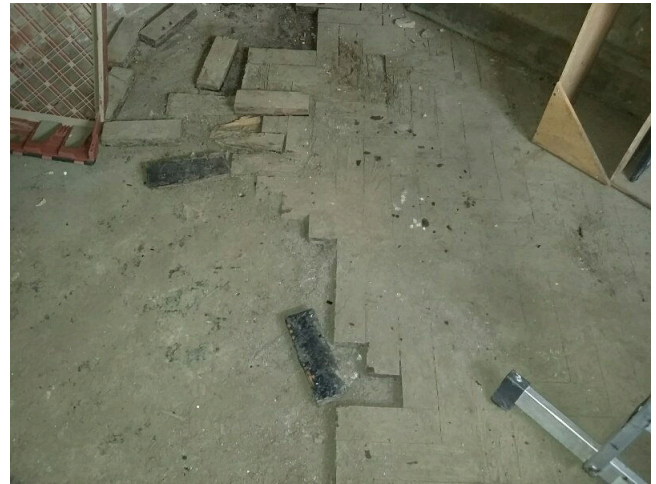
Sample No: 22/3/B/8/IL9.  
B.01 Basement Area 1 - Store – Floor.  
Bitumen adhesive to parquet flooring.  
**No Asbestos Detected.**

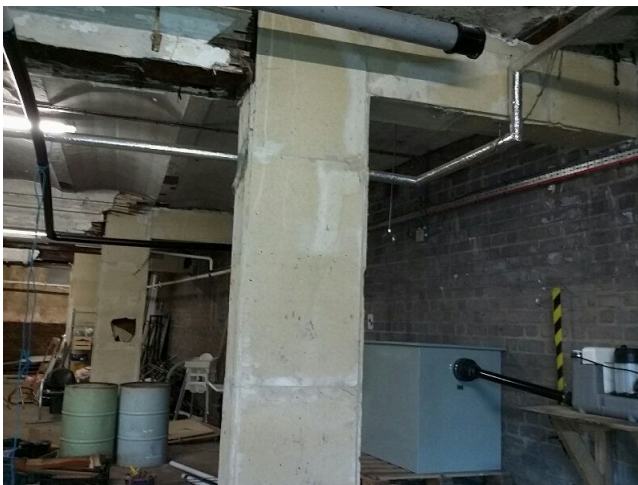
Sample No: 22/3/B/8/IL10.  
B.01 Basement Area 1 - Large Store - Structural  
steelwork.  
Insulating board cladding to columns & beams  
(Vicucad).  
**No Asbestos Detected.**

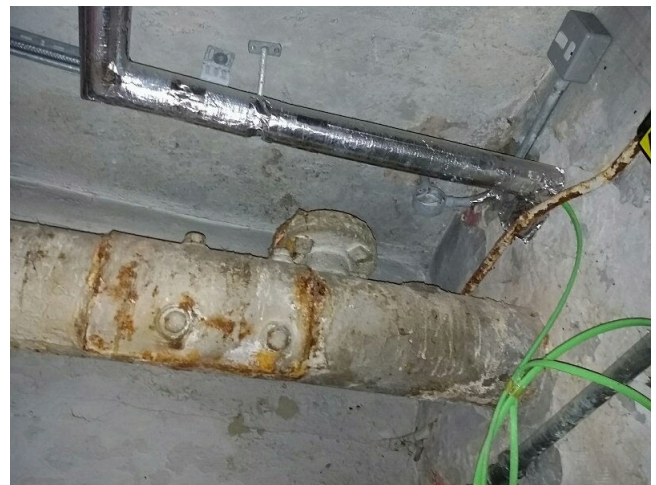
Sample No: 22/3/B/8/IL11.  
B.01 Basement Area 1 - Store – Pipework.  
Mastic sealant to pipework flanges.  
**No Asbestos Detected.**

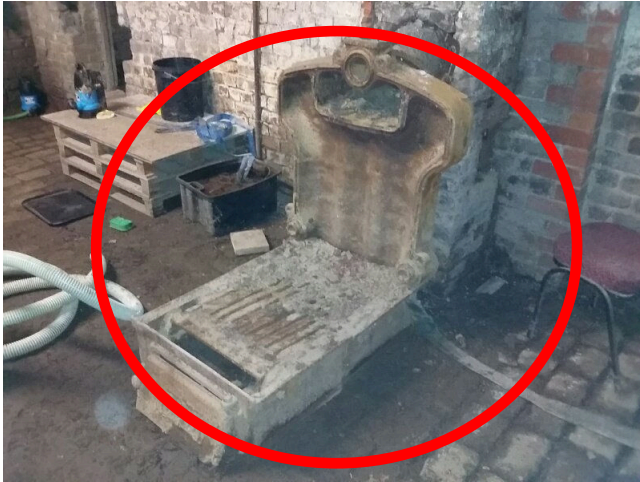
Sample No: 22/3/B/9/IL12.  
B.01 Basement Area 1 - Old Boiler Room - Redundant boiler.  
Residuals & debris to redundant boiler containing:  
**Amosite & Chrysotile.**

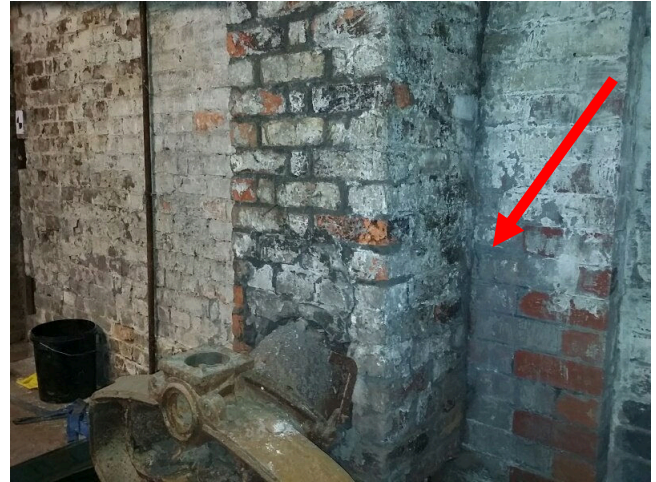
Sample No: 22/3/B/9/IL13.  
B.01 Basement Area 1 - Old Boiler Room – Wall.  
Residual insulation to wall containing:  
**Amosite & Chrysotile.**

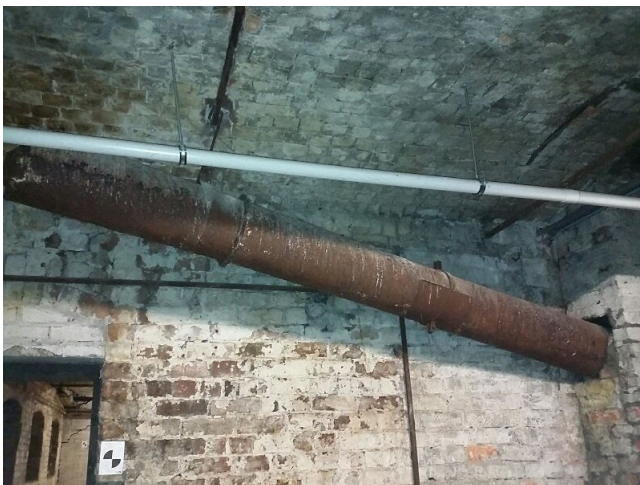
Sample No: 22/3/B/9/IL14.  
B.01 Basement Area 1 - Old Boiler Room - Redundant metal flue pipe.  
Residuals to flue pipe.  
**No Asbestos Detected.**

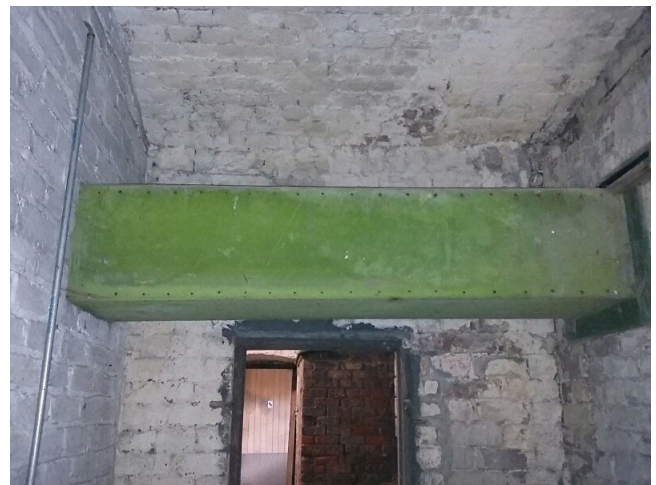
Sample No: 22/3/B/9/IL15.  
B.01 Basement Area 1 - Basement Shelter – Ducting.  
Organic ducting panels.  
**No Asbestos Detected.**

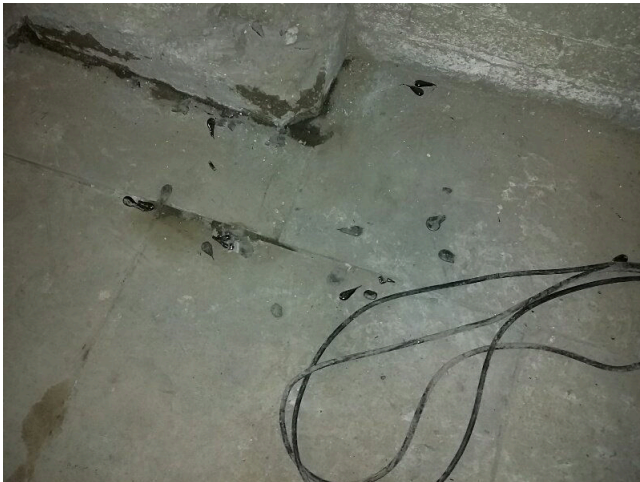
Sample No: 22/3/B/9/IL16.  
B.01 Basement Area 1 - Basement Shelter - Floor &  
Surfaces.  
Residual bitumen & debris.  
**No Asbestos Detected.**

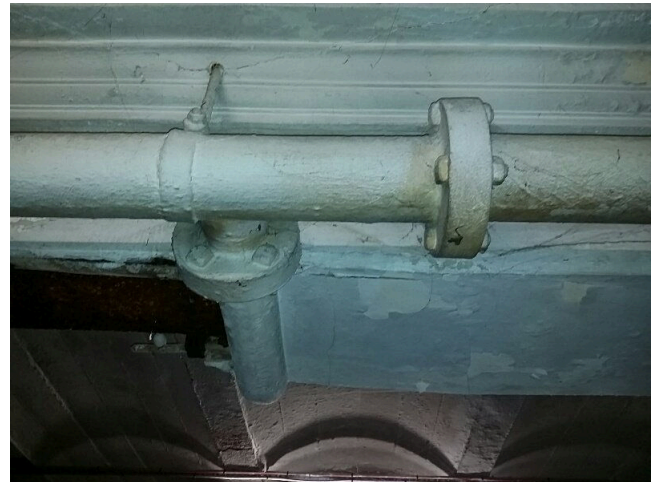
Refer to Sample 22/3/B/8/IL11.  
B.01 Basement Area 1 - Large Store – Pipework.  
Mastic sealant to pipework flanges.  
**No Asbestos Detected.**

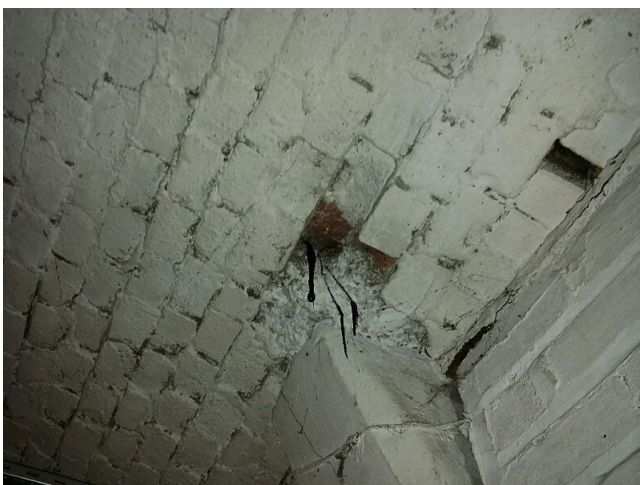
Refer to Sample 22/3/B/9/IL16.  
B.01 Basement Area 1 - Basement Shelter - Ceiling  
penetrations.  
Residual bitumen.  
**No Asbestos Detected.**

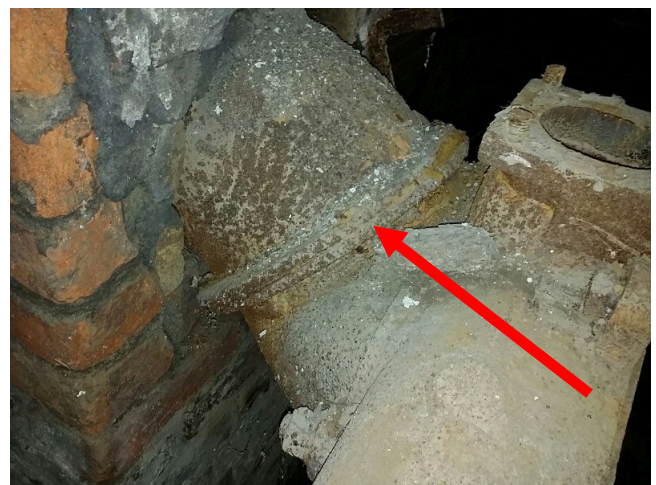
No Sample Taken.  
B.01 Basement Area 1 - Old Boiler Room - Boiler /  
flue joint.  
Flange gasket containing:  
**Chrysotile.**

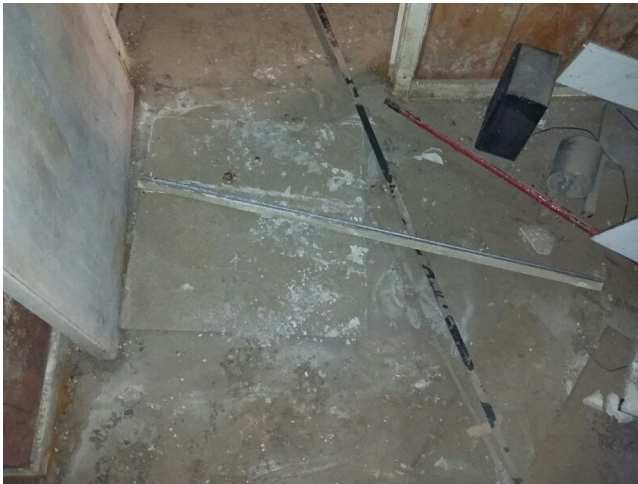
Sample No: 22/3/B/9/IL17.  
B.02 Basement Area 2 - Office – Floor.  
Vinyl floor covering & paper backing.  
**No Asbestos Detected.**

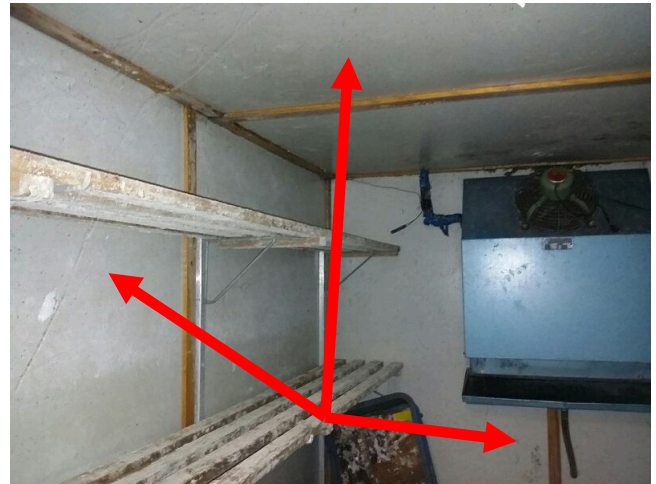
Sample No: 22/3/B/9/IL18.  
B.02 Basement Area 2 - Walk-in Fridge.  
Internal wall & roof linings containing:  
**Chrysotile.**

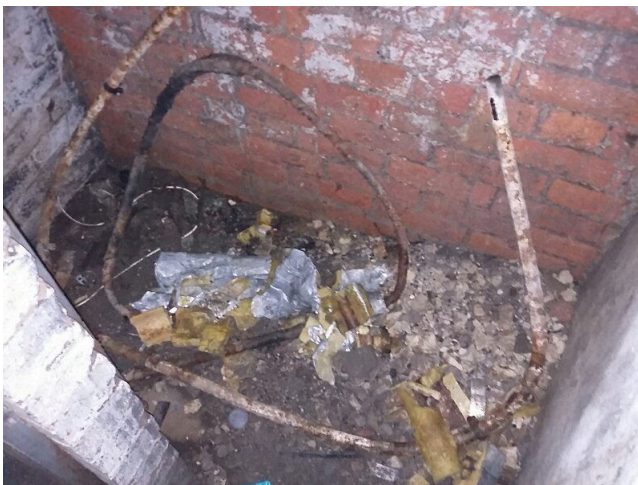
Sample No: 22/3/B/9/IL19.  
B.02 Basement Area 2 - Basement Store - Electric Cable.  
Woven insulation to redundant cable.  
**No Asbestos Detected.**

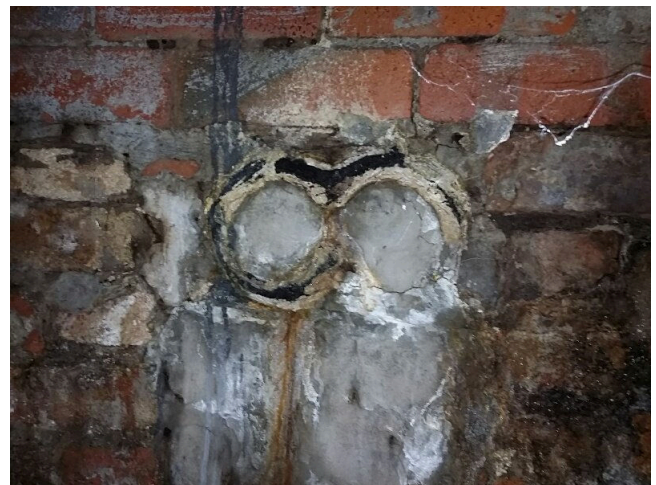
Sample No: 22/3/B/9/IL20.  
B.02 Basement Area 2 - Basement Circulation - Wall penetration.  
Thermoplastic & Composite linings.  
**No Asbestos Detected.**

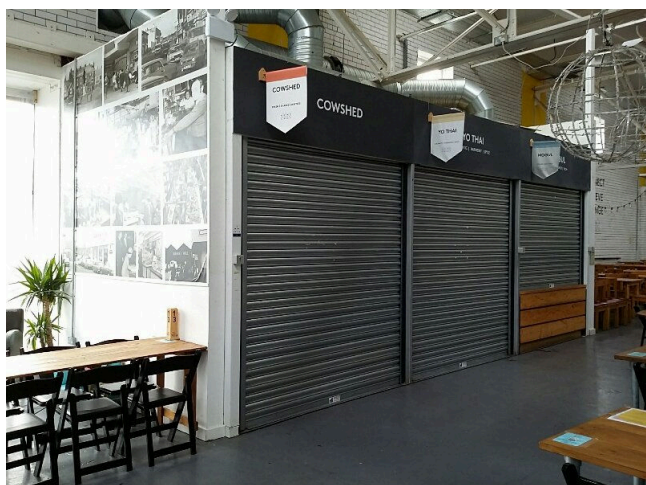
Areas not accessed - G.10 - Market Stalls / Units.
