**Lead Surveyor:**  
**Assistant Surveyor(s):**  
**Date of Survey(s):**  
**Report Reference:**  
**Date Report Issued:**  
**Purpose of Survey:**  
(Refer to Section 2.2  
of this report for  
clarification)

P. Keeling  
M. Crompton  
25 November 2021  
CH.21.12.030.LW  
13 December 2021

## Report on Survey of Asbestos Materials at

**Radcliffe Market Chambers**  
**Blackburn Street**  
**Radcliffe**  
**Gtr. Manchester**  
**M26 1NN**

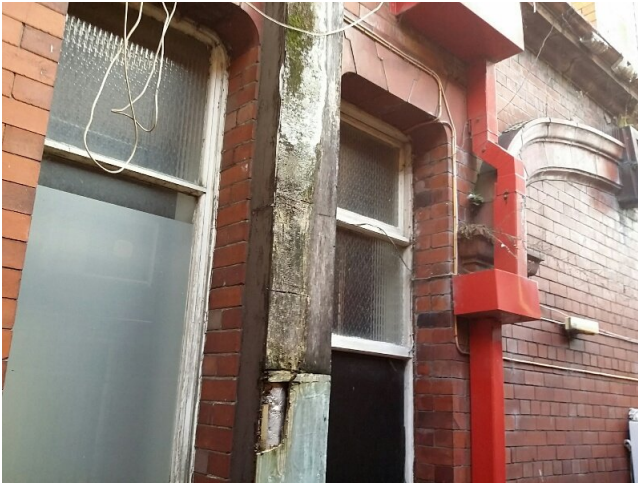
Sample No: 21/11/B/25/PK16  
External  
Court yard  
Insulation to pipe in boxing  
**No Asbestos Detected**

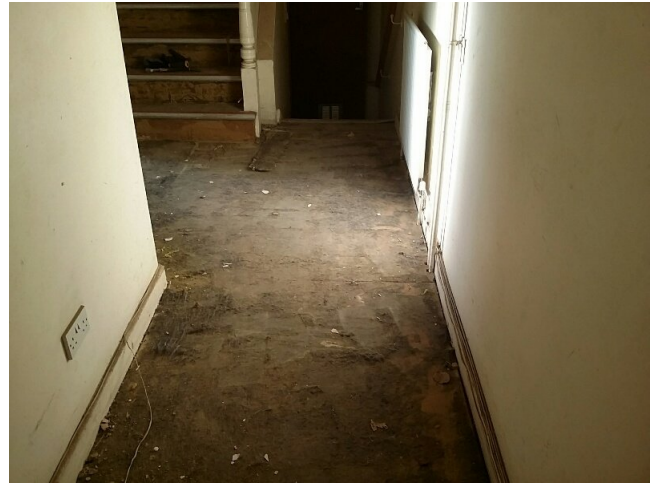
Sample No: Refer to Sample 21/11/B/25/PK1  
G.01 Circulation  
Floor  
Sheet vinyl flooring  
**No Asbestos Detected**

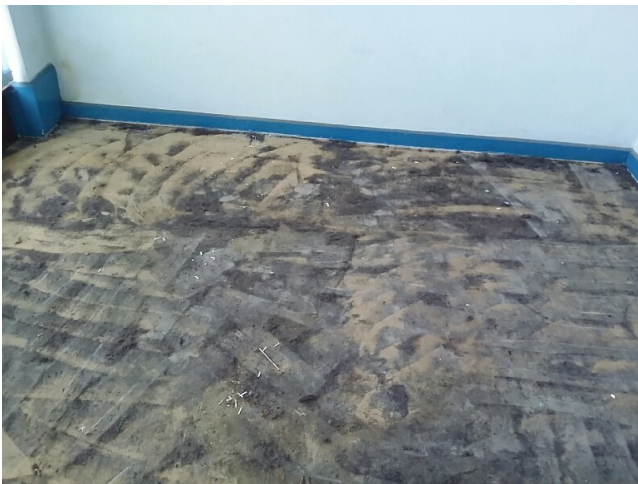
Sample No: 21/11/B/25/PK1  
G.02 Office  
Floor  
Sheet vinyl flooring  
**No Asbestos Detected**

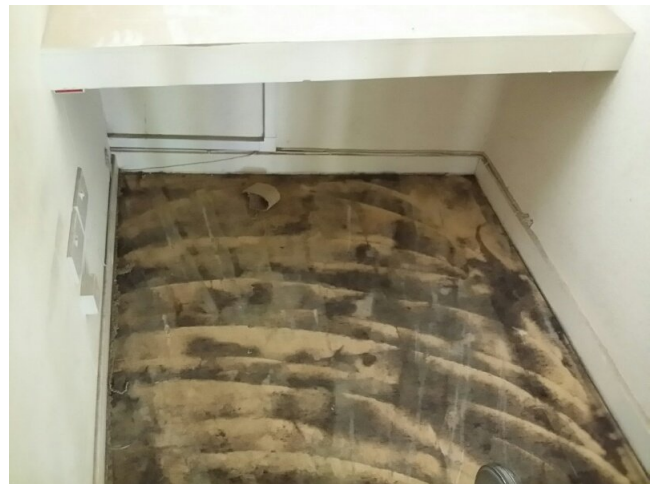
Sample No: Refer to Sample 21/11/B/25/PK1  
G.03 Office  
Floor  
Sheet vinyl flooring  
**No Asbestos Detected**

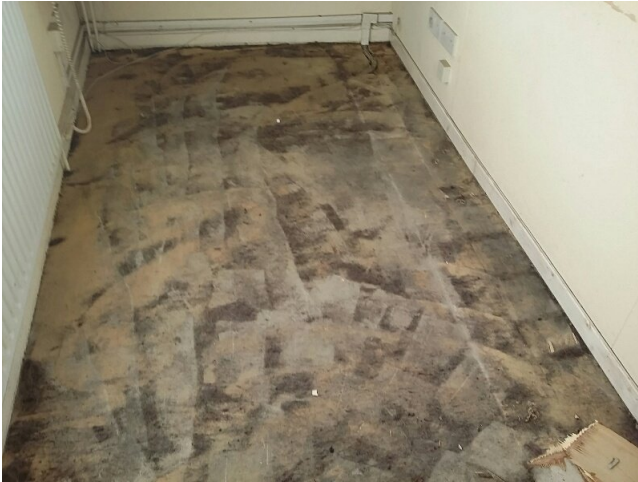
Sample No: Refer to Sample 21/11/B/25/PK1  
G.04 WC  
Floor  
Sheet vinyl flooring  
**No Asbestos Detected**

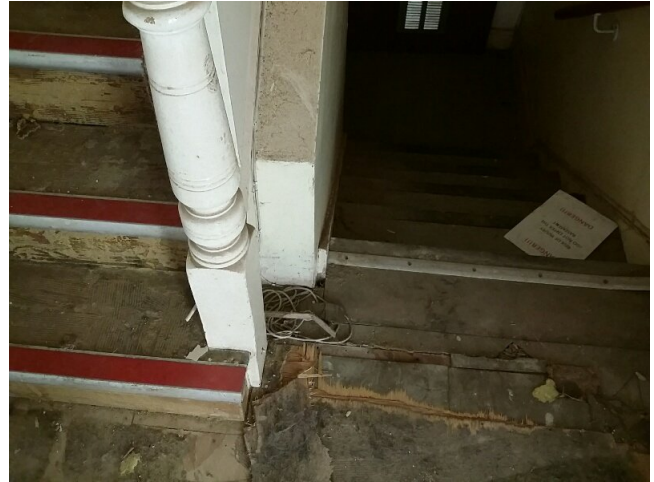
Sample No: 21/11/B/25/PK2  
G.05 Stairwell  
Stairs  
Vinyl nosings  
**No Asbestos Detected**

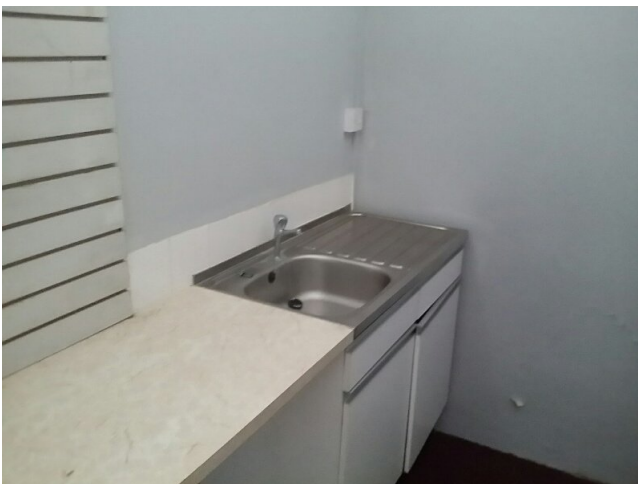
Sample No: 21/11/B/25/PK17  
G.06 Shop unit  
Sink  
Bitumen pad  
**No Asbestos Detected**

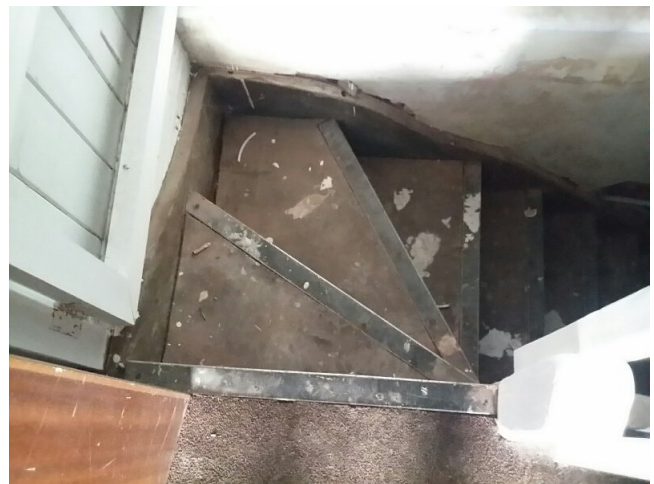
Sample No: 21/11/B/25/PK18  
G.07 Basement stairwell  
Stairs  
Vinyl nosing  
**No Asbestos Detected**

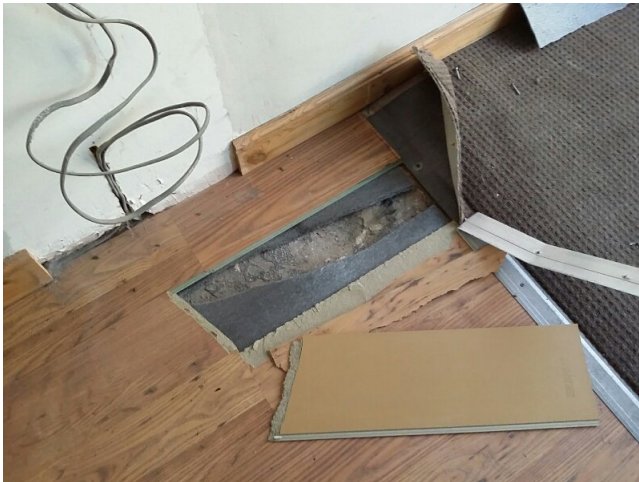
Sample No: 21/11/B/25/PK19  
G.08 Shop unit  
Floor  
Bitumen adhesive  
**No Asbestos Detected**

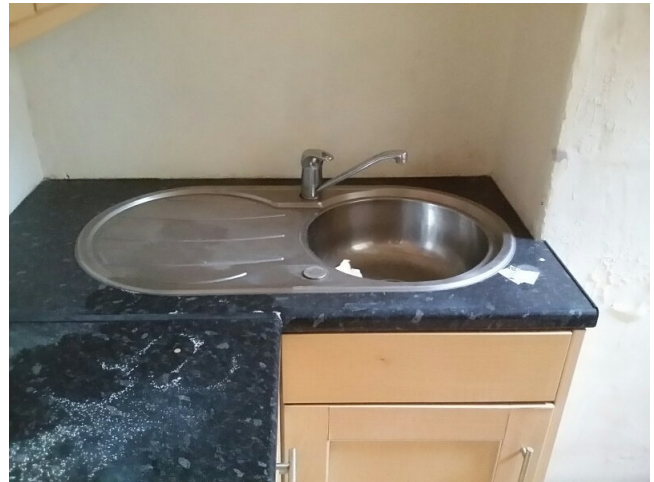
Sample No: 21/11/B/25/PK20  
G.09 Kitchen area  
Sink  
Bitumen pad  
**No Asbestos Detected**

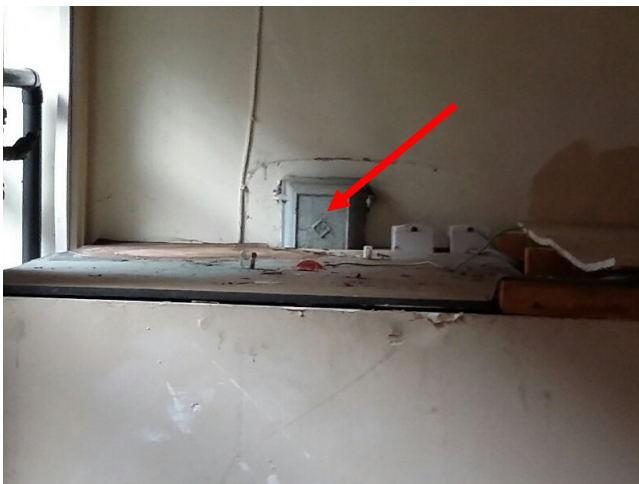
| Sample Number | Location | ACM Type | Condition | Recommendation |
|---|---|---|---|---|
| No Sample | G.09 - Kitchen area - Old fuse box above WC | Flash guards | Fair | Remove |

Sample No: No Sample  
G.09 Kitchen area  
Old fuse box above WC  
Flash guards containing:  
**Chrysotile**

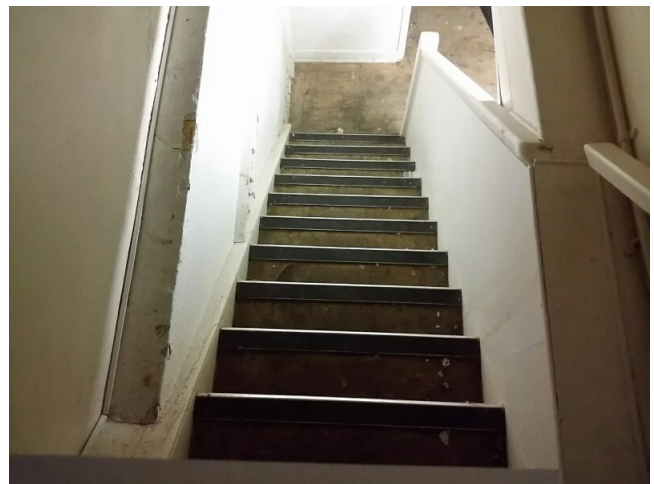
Sample No: 21/11/B/25/PK21  
G.13 Stairwell  
Stairs  
Vinyl covering  
**No Asbestos Detected**

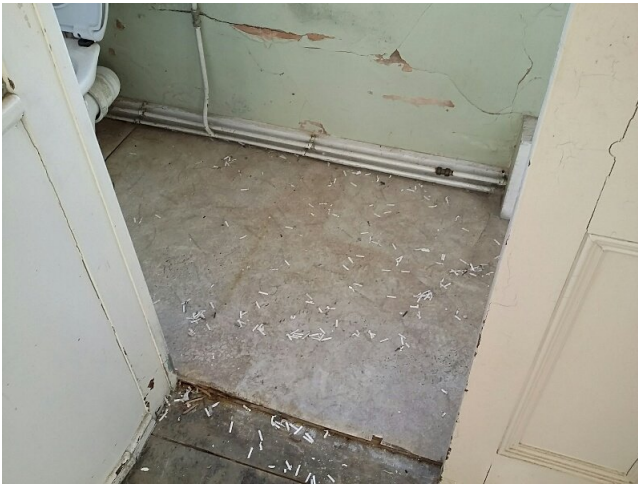
Sample No: 21/11/B/25/PK3  
1.09 WC  
Floor  
WC  
**No Asbestos Detected**

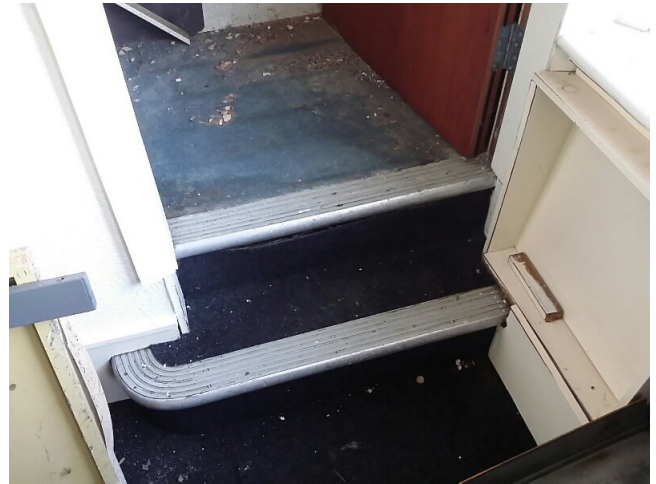
Sample No: 21/11/B/25/PK10  
1.10 Stairwell  
Stairs  
Vinyl nosings  
**No Asbestos Detected**

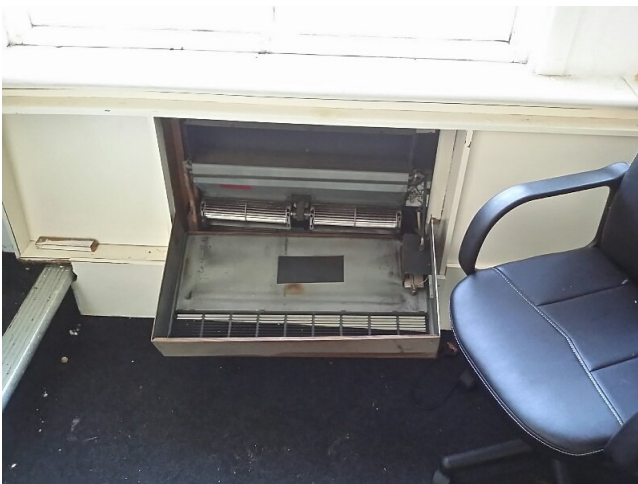
Sample No: 21/11/B/25/PK11  
1.11 Store  
Wall behind radiator  
Insulation board  
**No Asbestos Detected**

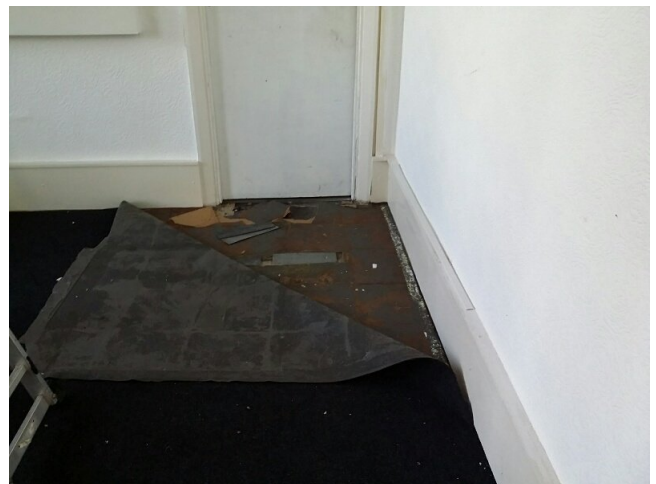
Sample No: 21/11/B/25/PK12  
1.11 Store  
Floor below carpet  
Vinyl floor tiles  
**No Asbestos Detected**

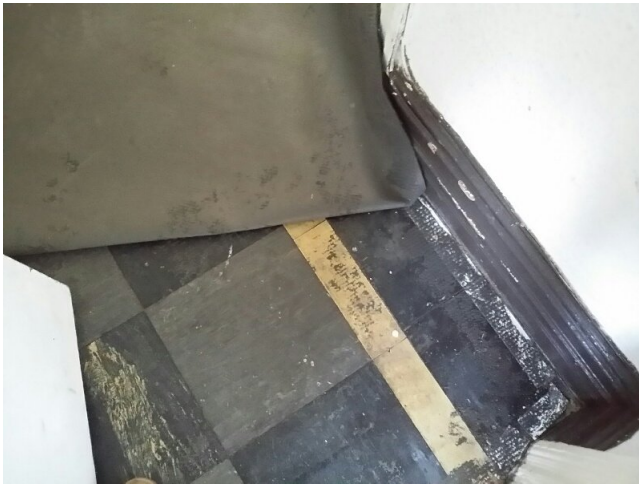
Sample No: Refer to Sample 21/11/B/25/PK12  
1.13 Circulation  
Floor below carpet  
Vinyl floor tiles  
**No Asbestos Detected**

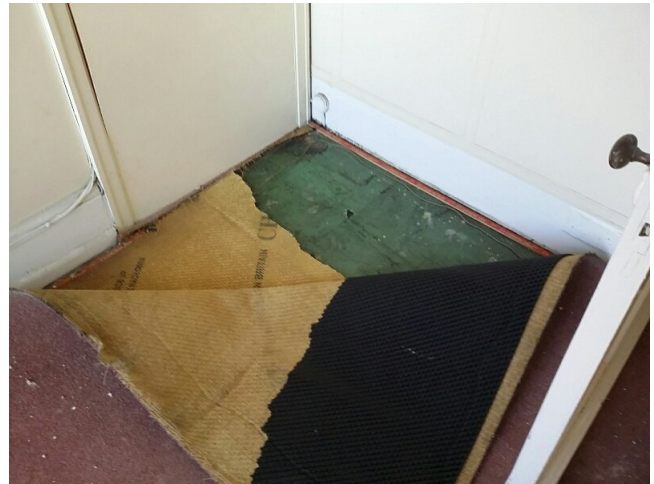
| Sample Number | Location | ACM Type | Condition | Recommendation |
|---|---|---|---|---|
| 21/11/B/25/PK13 | 1.14 - Office - Floor | Vinyl tiles below carpet | Fair | Remove |

Sample No: 21/11/B/25/PK13  
1.14 Office  
Floor  
Vinyl tiles below carpet containing:  
**Chrysotile (In bitumen only)**

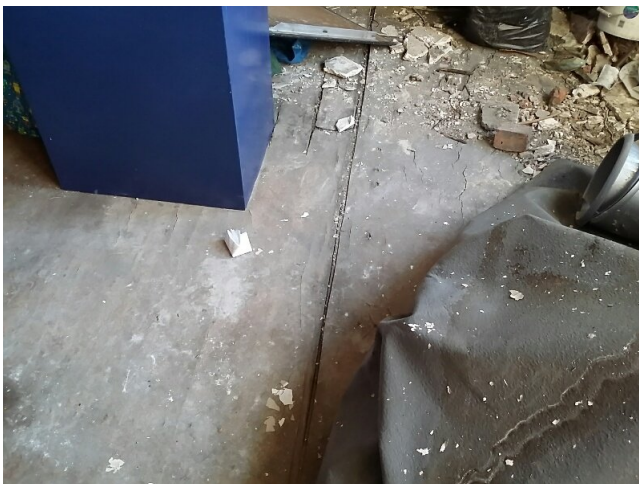
Sample No: 21/11/B/25/PK14  
1.16 Office  
Floor  
VFC  
**No Asbestos Detected**

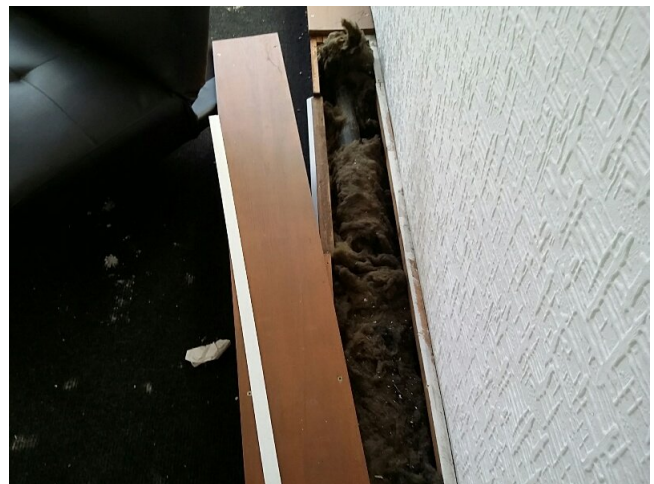
Sample No: 21/11/B/25/PK15  
1.18 Office  
Pipe boxing  
Insulation to pipework  
**No Asbestos Detected**

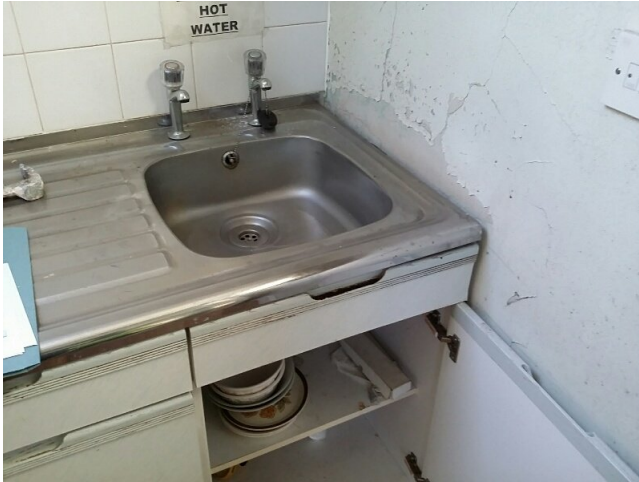
Sample No: 21/11/B/25/PK4  
2.01 Kitchen  
Sink  
Bitumen pad  
**No Asbestos Detected**

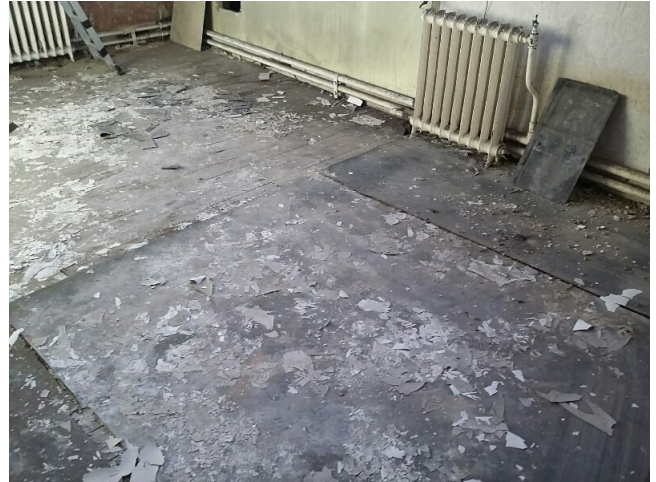
Sample No: 21/11/B/25/PK5  
2.02 Store  
Floor  
VFC  
**No Asbestos Detected**

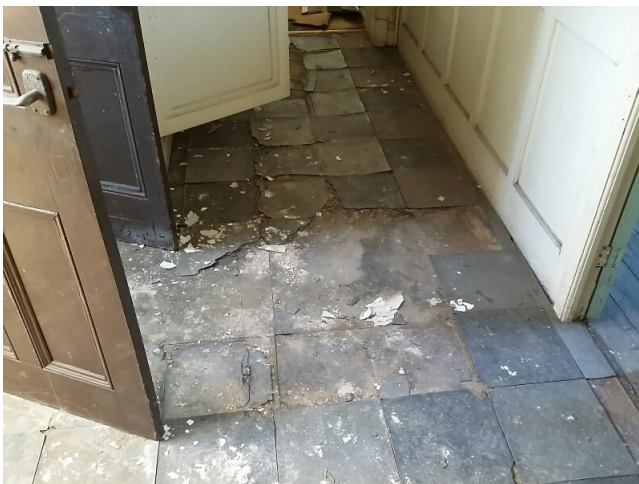
Sample No: 21/11/B/25/PK6  
2.04 Circulation  
Floor  
Vinyl floor tiles  
**No Asbestos Detected**

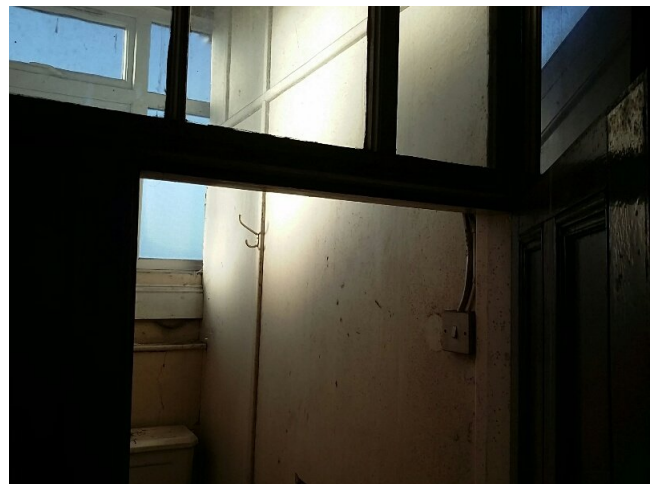
Sample No: 21/11/B/25/PK7  
2.06 WC  
Wall  
Wall panels  
**No Asbestos Detected**

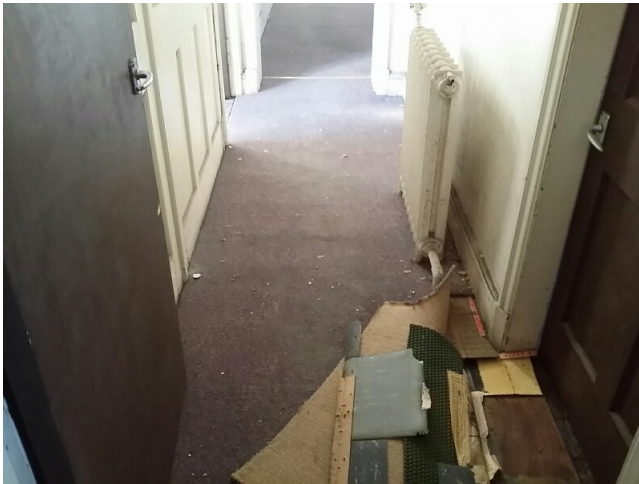
Sample No: 21/11/B/25/PK8  
2.08 Corridor  
Floor  
Core sample (various floor coverings)  
**No Asbestos Detected**

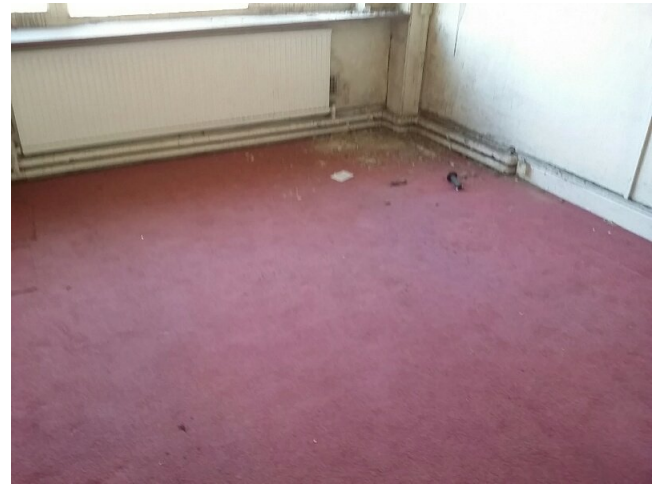
Sample No: 21/11/B/25/PK9  
2.09 Office  
Floor  
VFC below carpet  
**No Asbestos Detected**

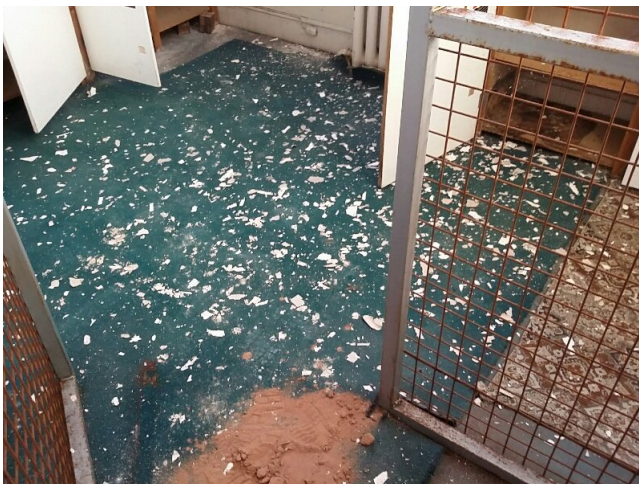
Sample No: Refer to Sample 21/11/B/25/PK5  
2.10 Store  
Floor  
VFC  
**No Asbestos Detected**

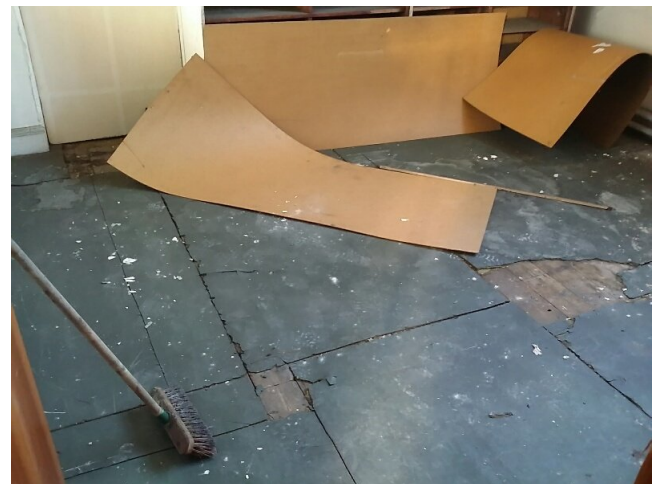
Sample No: Refer to Sample 21/11/B/25/PK5  
2.11 Store  
Floor  
VFC  
**No Asbestos Detected**

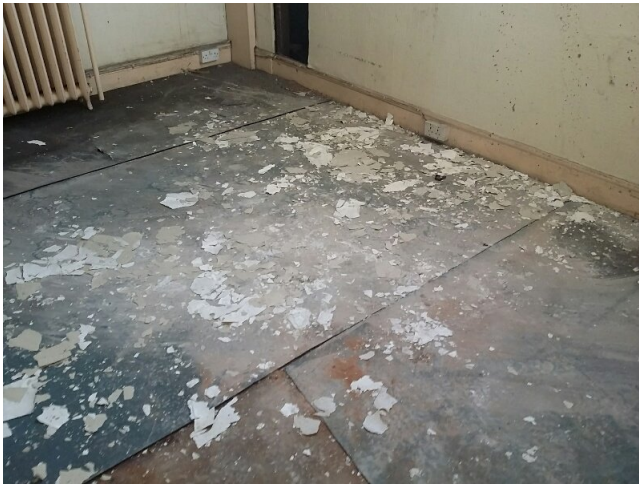
Sample No: Refer to Sample 21/11/B/25/PK5  
2.12 Store  
Floor  
VFC  
**No Asbestos Detected**

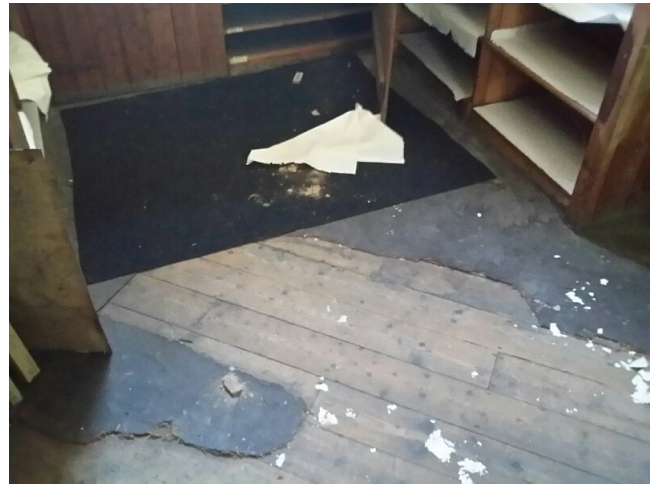
Sample No: Refer to Sample 21/11/B/25/PK5  
2.14 Store  
Floor  
VFC  
**No Asbestos Detected**

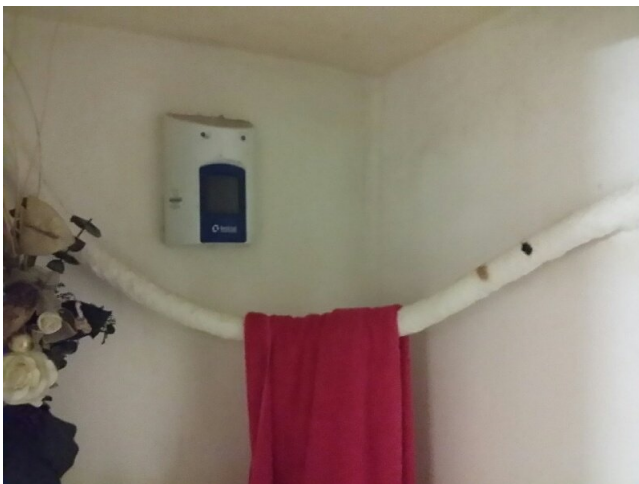
Sample No: 21/11/B/25/PK22  
B.05 WC  
Electrical cable  
Woven wrap  
**No Asbestos Detected**

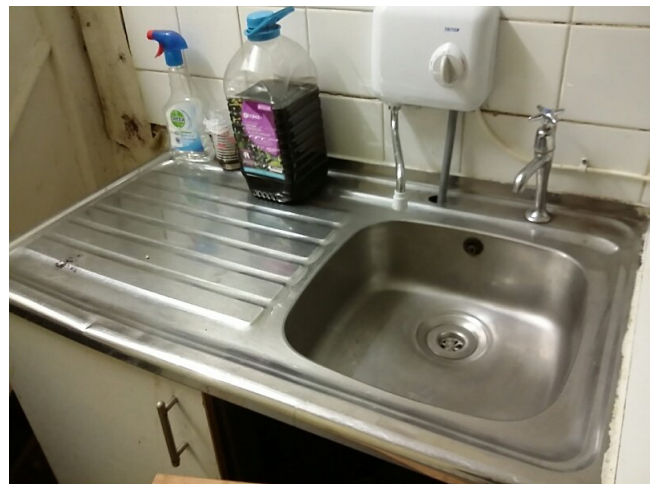
Sample No: 21/11/B/25/PK23  
B.08 Store  
Sink  
Bitumen pad  
**No Asbestos Detected**

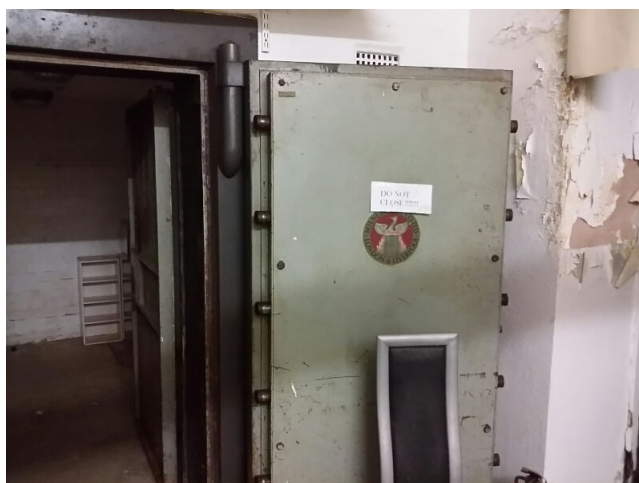
| <b>Location/Item</b> | <b>Reason for non-access</b> | <b>Client Agreed (Y/N)</b> |
|---|---|---|
| Internals to safe door in B.09 | No physical means of access | Yes |

Safe door to B.09 (may have ACMs internally)
