# **MOUNTEER LIMITED**

## **Building Survey**

**18 & 20 St Mary's Place**

**Bury**

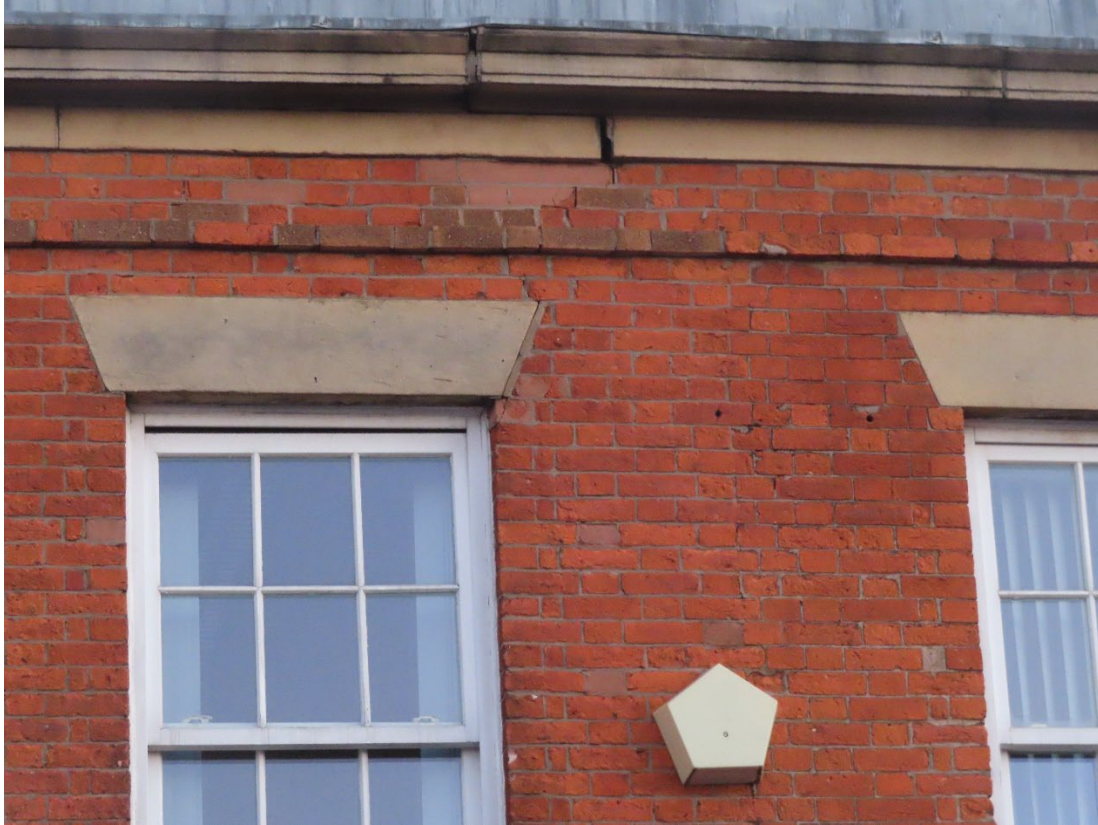
Photograph 1

The walls are free from major bulges or settlement, but there is a distinctive line of breakage the window to number 20 which is above the fan like window where there has obviously been some structural movement, possibly settlement of 30mm to 40mm.

This in my view has probably necessitated the rebuilding of the gable wall. There is no indications that the movement has progressed, although there is some minor cracking in the brickwork at that particular point it is not significant.

Old differential settlement to front wall party wall line to number 20.

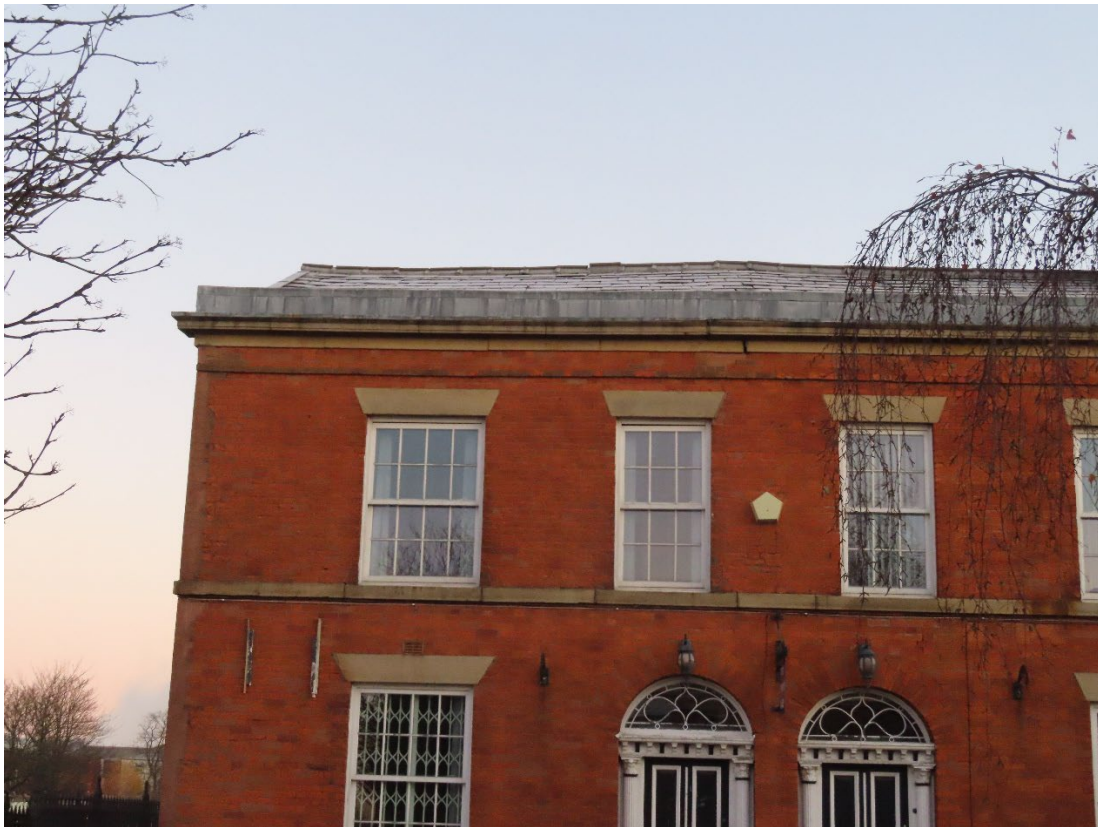
Photograph 2

There has been an obvious settlement to the gable wall in the past which can be seen by brickwork being air brick joint on the stone corbel being disturbed on the front elevation. This means that the ridge line drops to the new gable end from the party wall position between number 18 and number 20. There is no indications externally that this is continuing movement.

This is undulating due to the drop in the gable wall along the party wall line to number 18. The slates however appear in reasonable order.

Drop in ridge line due to settlement to number 20.

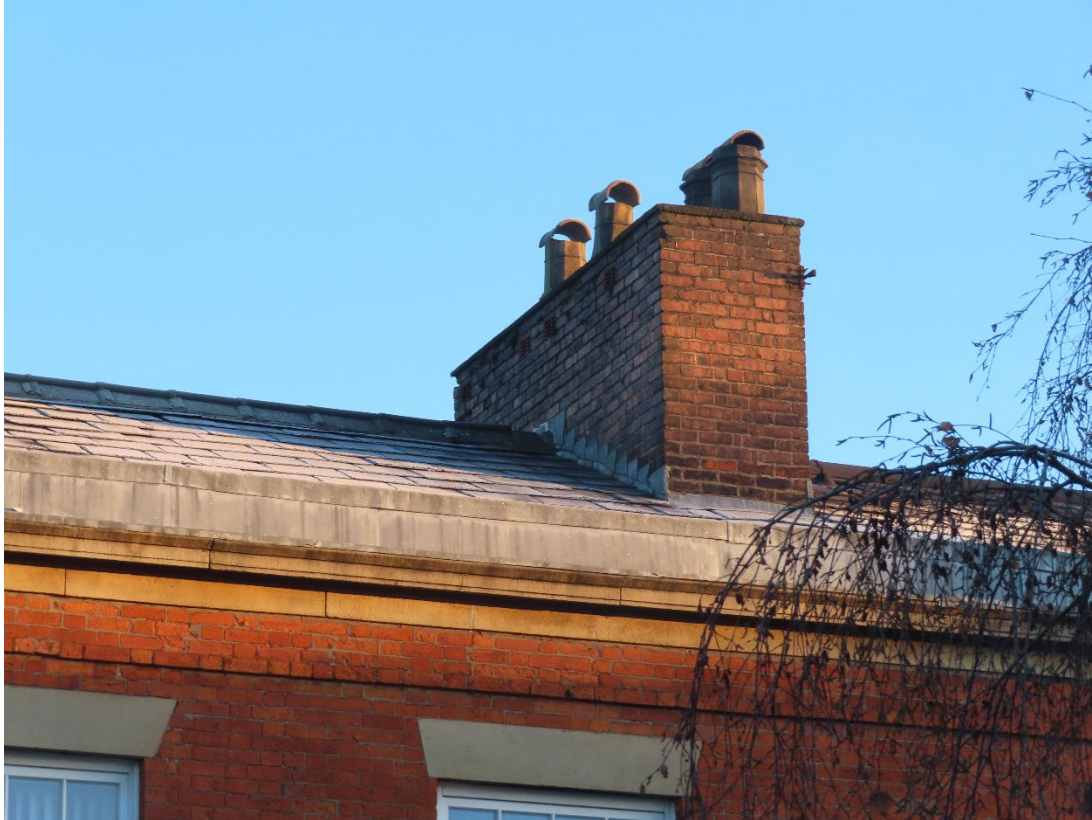
Photograph 3

Re-pointing of chimney stack to number 18.

| Item | Cost |
|---|---|
| Re-pointing of chimney breast | £500 |

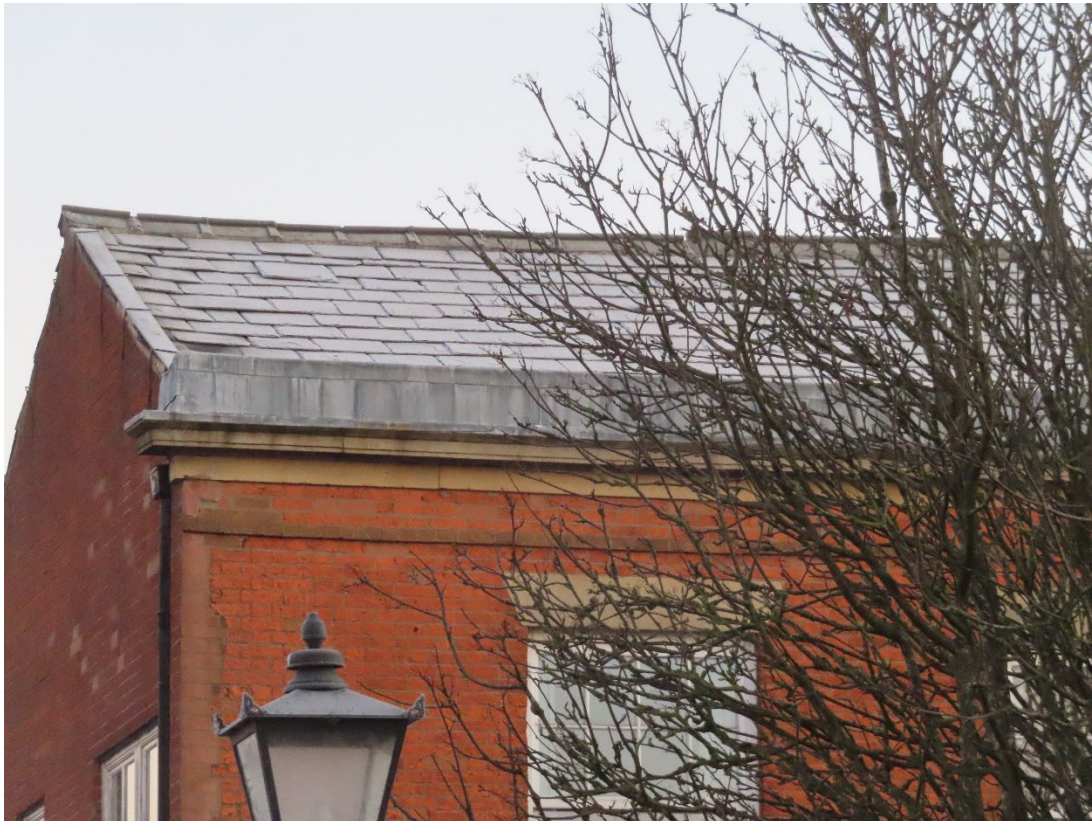
Photograph 4

The blue slate roof covering to the front elevation has one or two chipped slates that require renewal. There is also two clipped blue slates on the party wall position between the two properties.

Slipped slate to front roof of number 20.

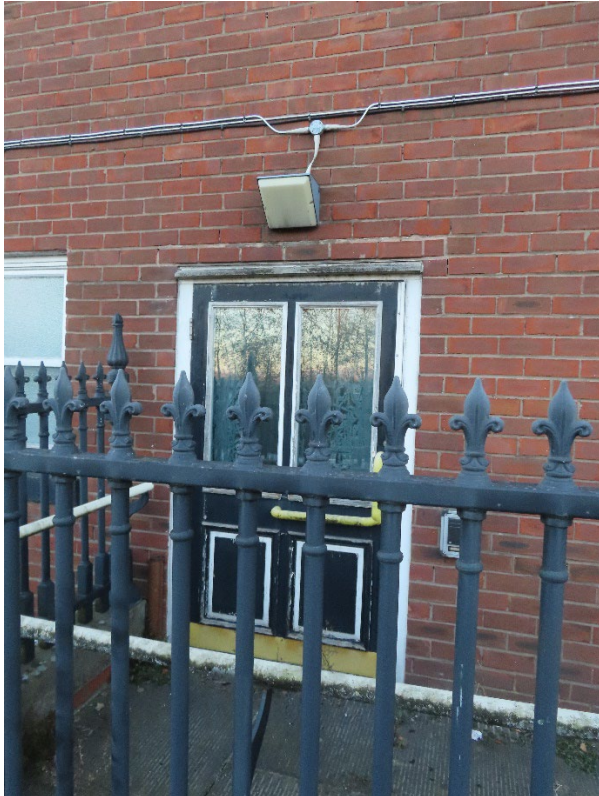
Photograph 5

The windows are free from major defects, although there is some minor wet rot to the ground floor window to the outrigger. The main issue of the windows is that they require the paintwork burning off and redecoration.

General poor external decorations

| Item | Cost |
|---|---|
| Redecoration of windows | £4,000 to £5,000 |

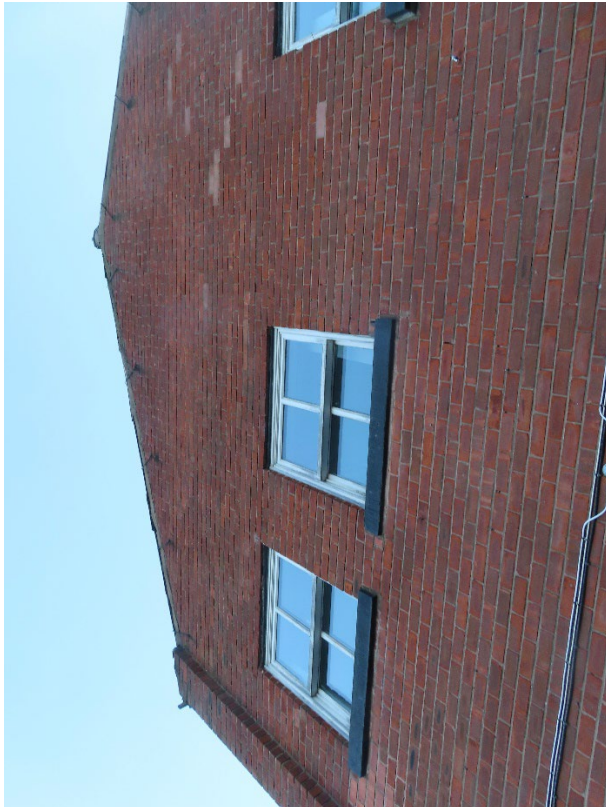
Photograph 6

The gable wall has been completely rebuilt to the property in normal cavity construction with cast concrete sills.

Rebuild gable to number 20.

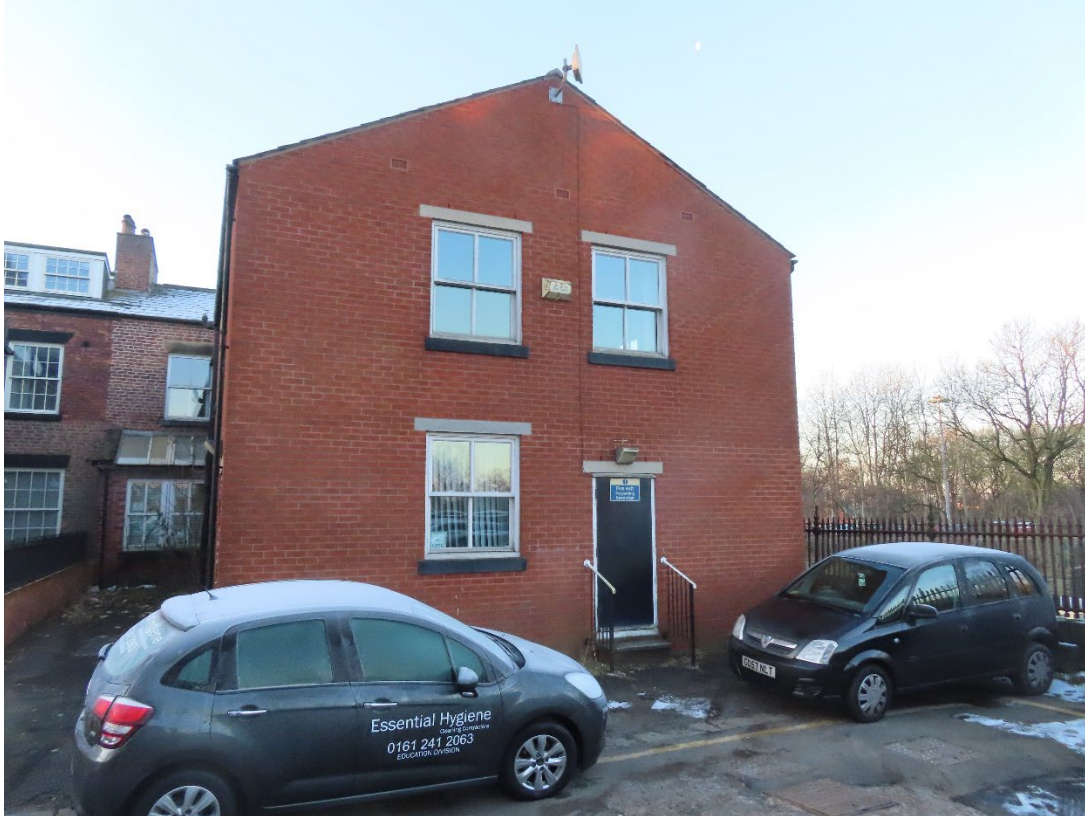
Photograph 7

Two storey extension to outrigger of number 18/20.

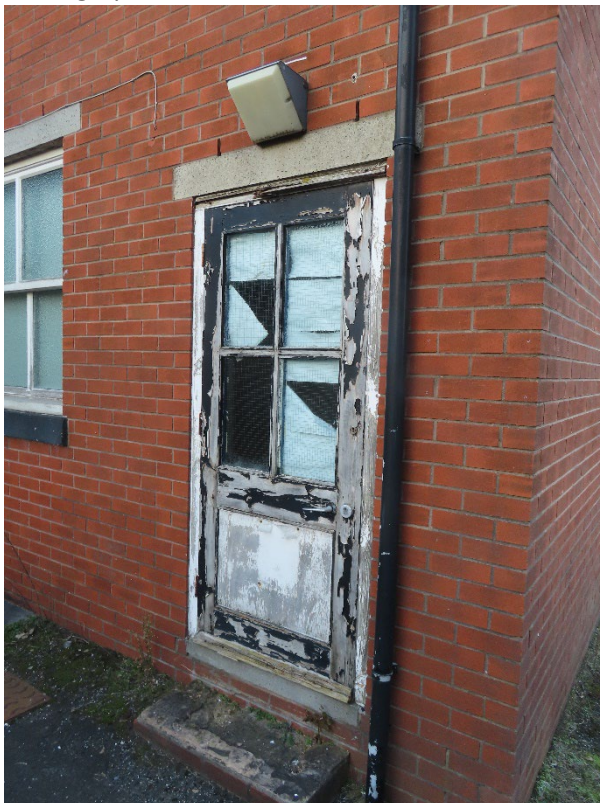
Photograph 8

The rear elevation fire door which is in the new extension has the threshold which has split and requires splicing works, the side door in the outrigger which has peeling paint but is at such a point that renewal should be considered.

Localised repairs to side door of extension to number 18.

| Item | Cost |
|---|---|
| Renew side door to outrigger | £500 |

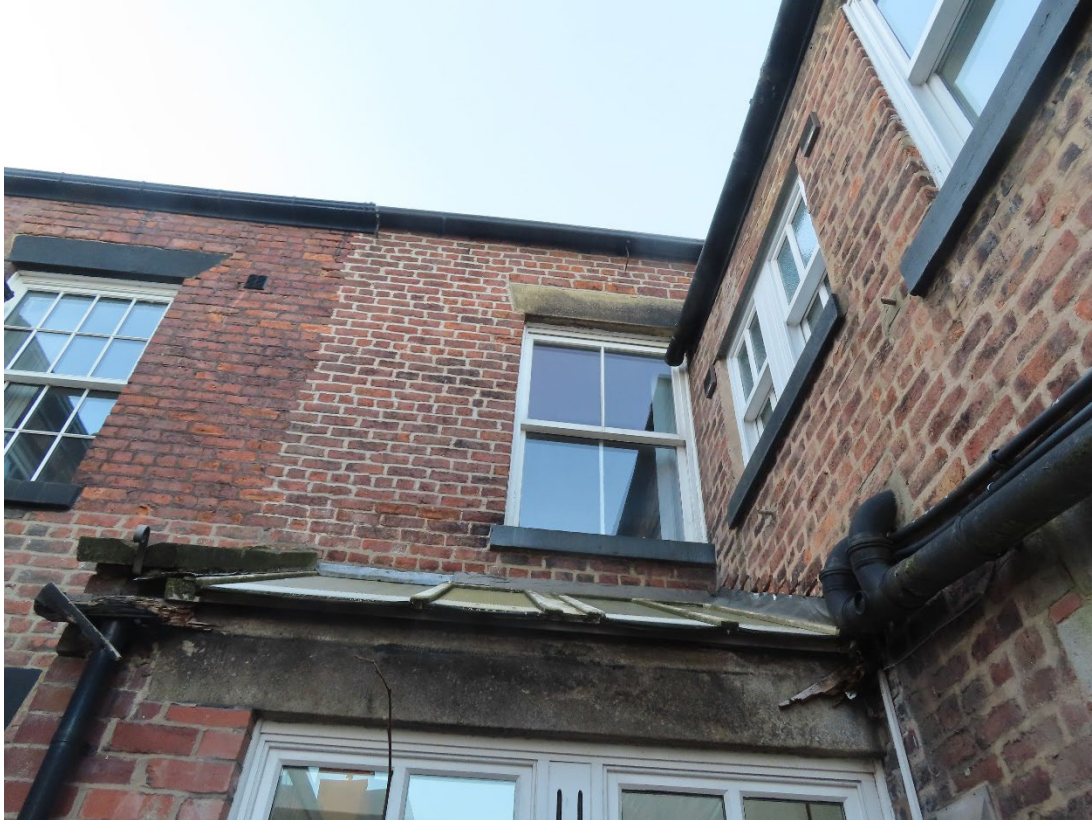
Photograph 9

The outshot to the rear has a timber gutter which has dropped off and requires refixing.

Gutter required to rear outshot of number 18.

| Item | Cost |
|---|---|
| Replacing timber gutter to rear single storey outshot | £500 |

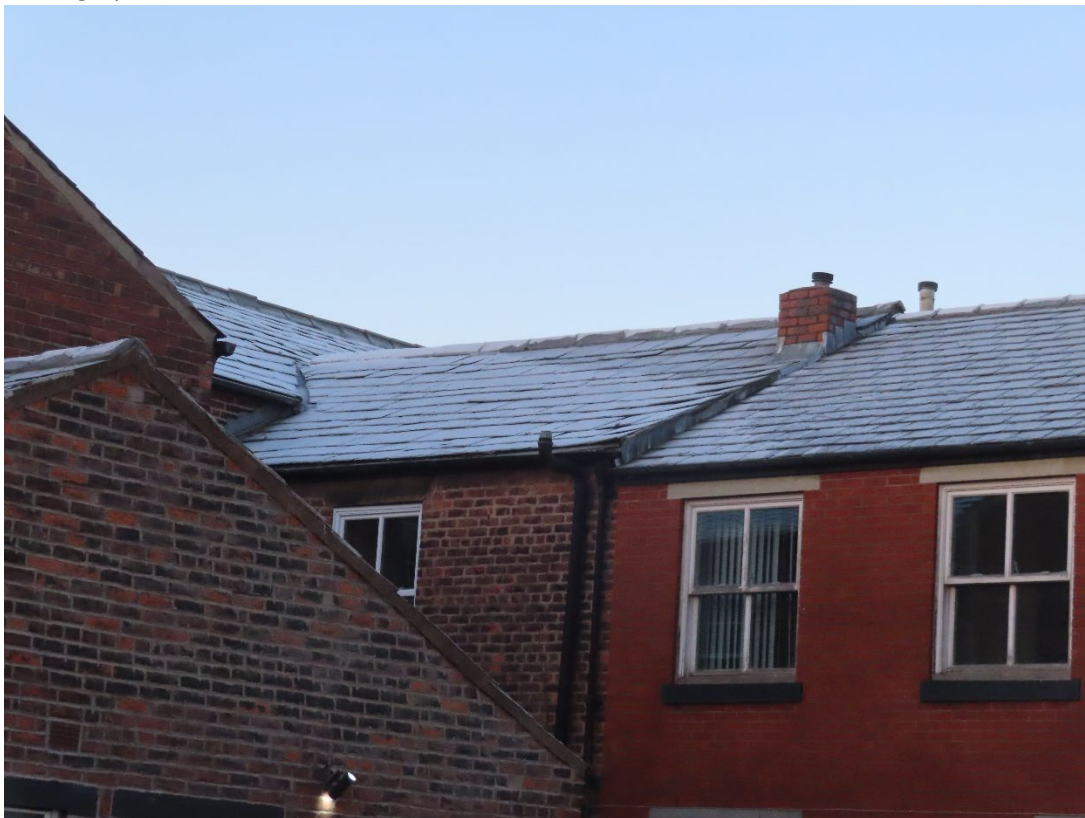
Photograph 10

Again, due to that movement there is some clips around the slates to the valley position.

Clipped slate to main rear roof and original outrigger to number 18.

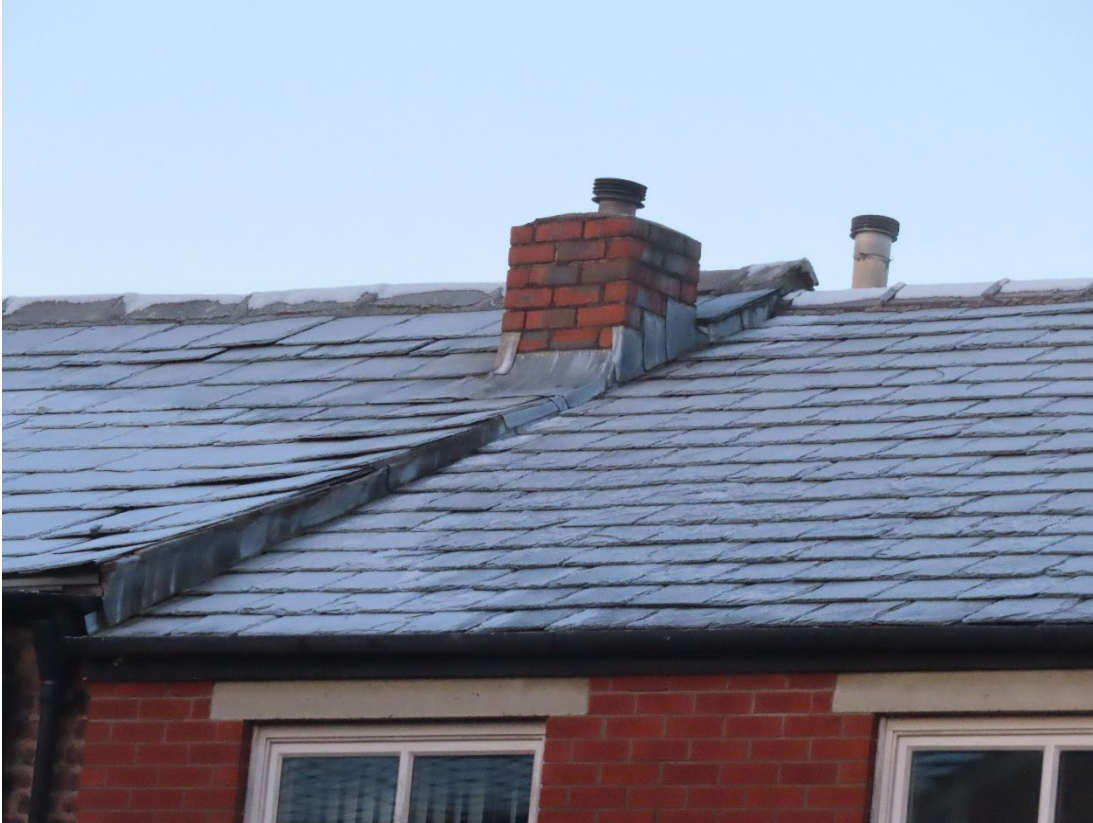
Photograph 11

Repair single stack to outrigger of number 18.

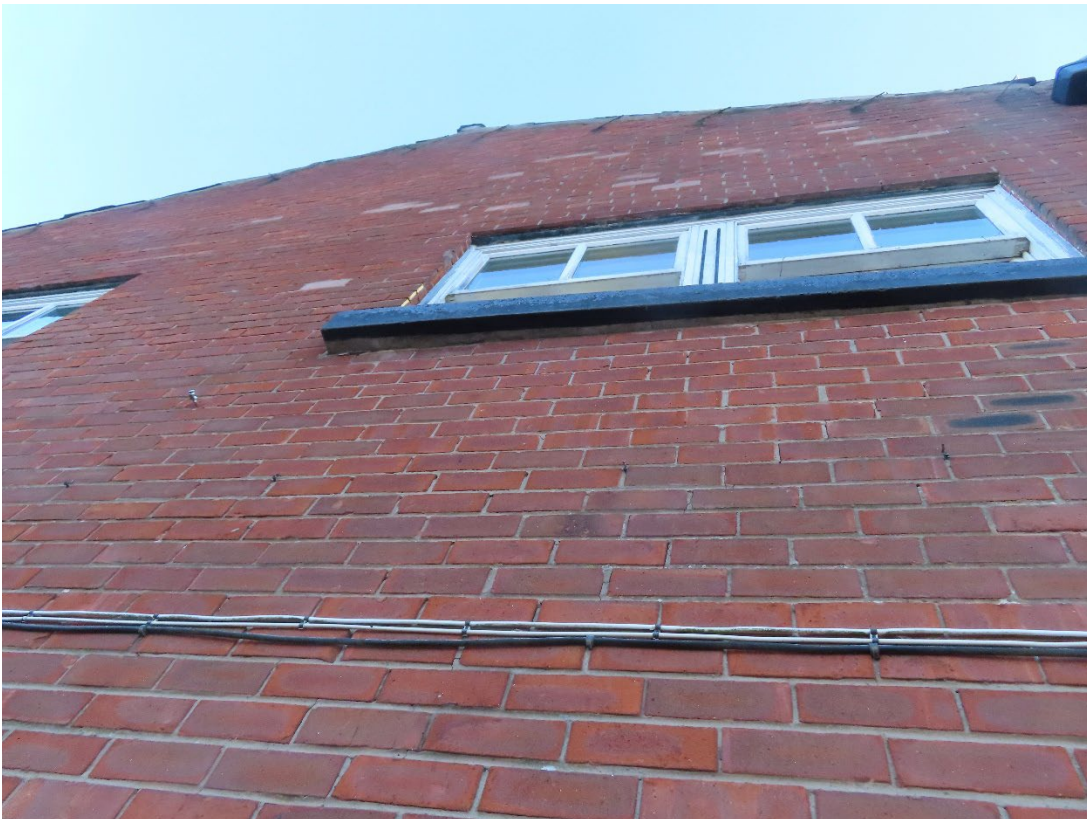
Photograph 12

The sill to the main window on the gable has been crudely laid so it projects out at an incorrect angle, but this does not affect structural stability.

Out of line sill to first floor sill to gable end.

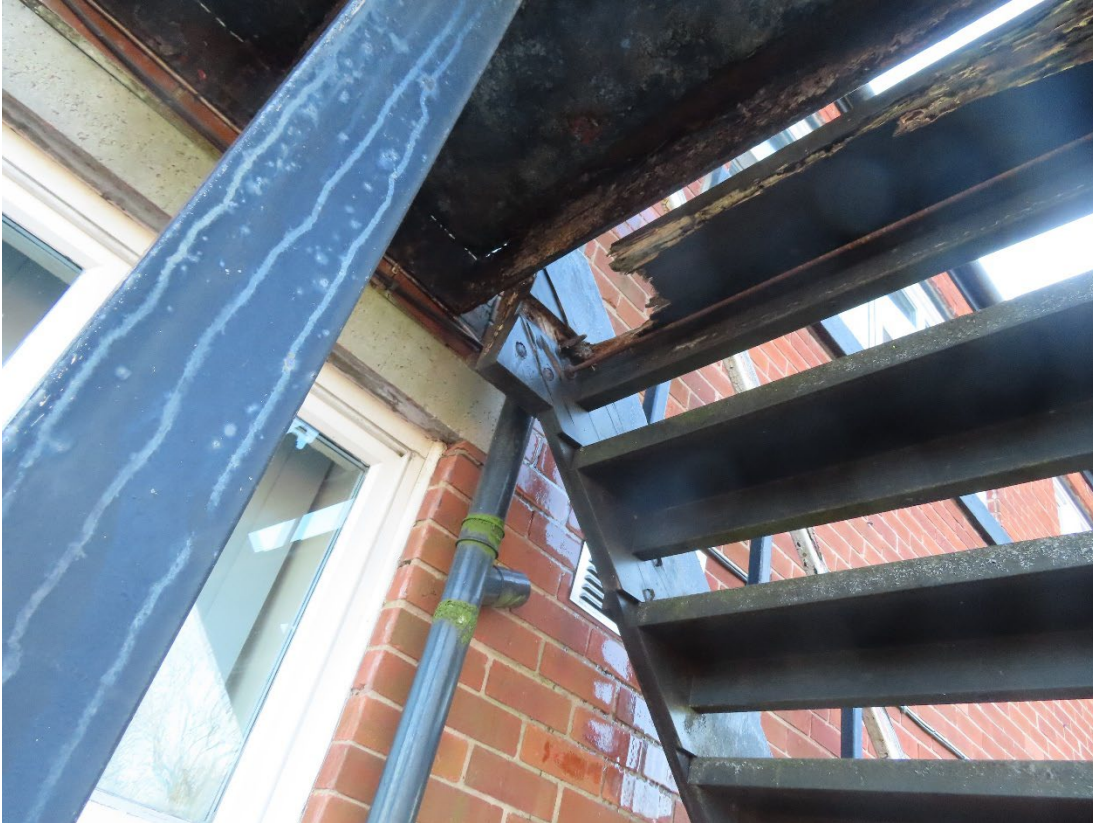
Photograph 13

A fire escape and staircase from the first floor of the outrigger has peeling paintwork, although the actual steel structure is probably reasonably safe. There is damaged and dangerous step going into the timber stringer. The timber stringer may also require some splicing works and may need additional support.

Dangerous tread to first floor fire escape to number 20, also check stringers.

| Item | Cost |
|---|---|
| Splicing work to stringer of staircase and tread and redecoration of fire escape | £1,000 |

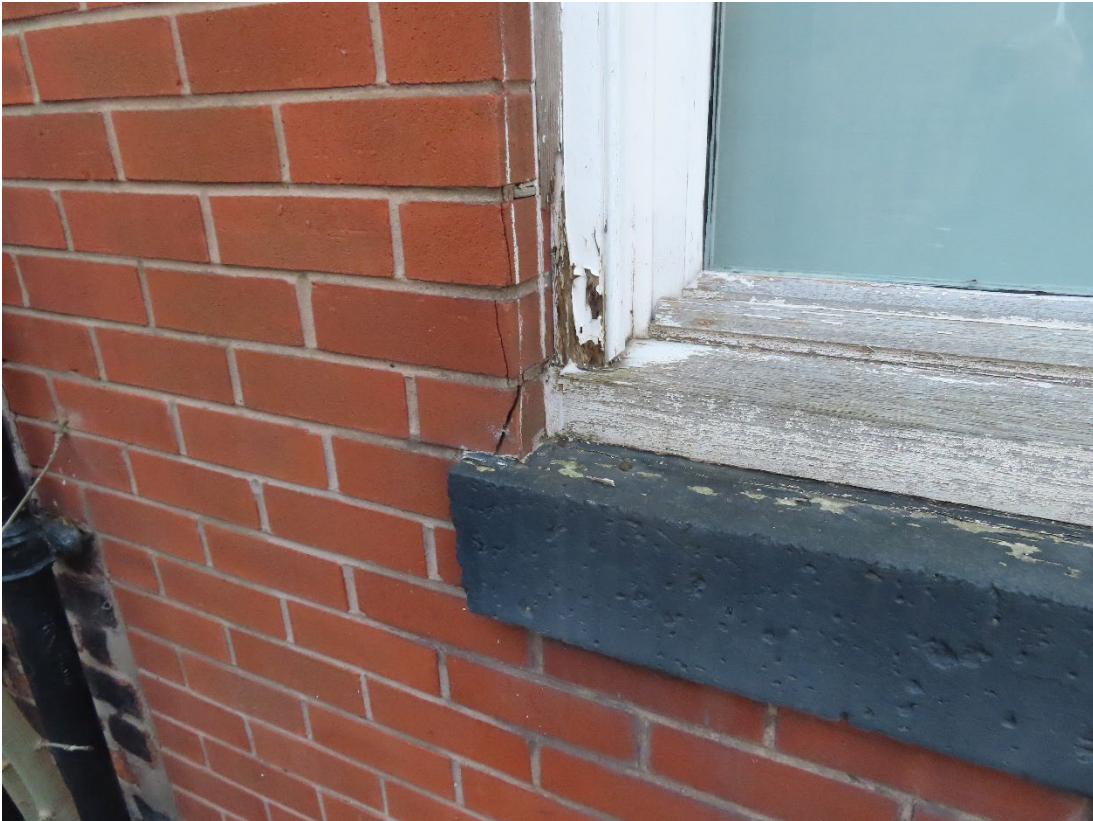
Photograph 14

Wet rot to box section of sliding sash window to wc ground floor extension to number 18.

| Item | Cost |
|---|---|
| Minor splicing work to windows | £300 to £400 |

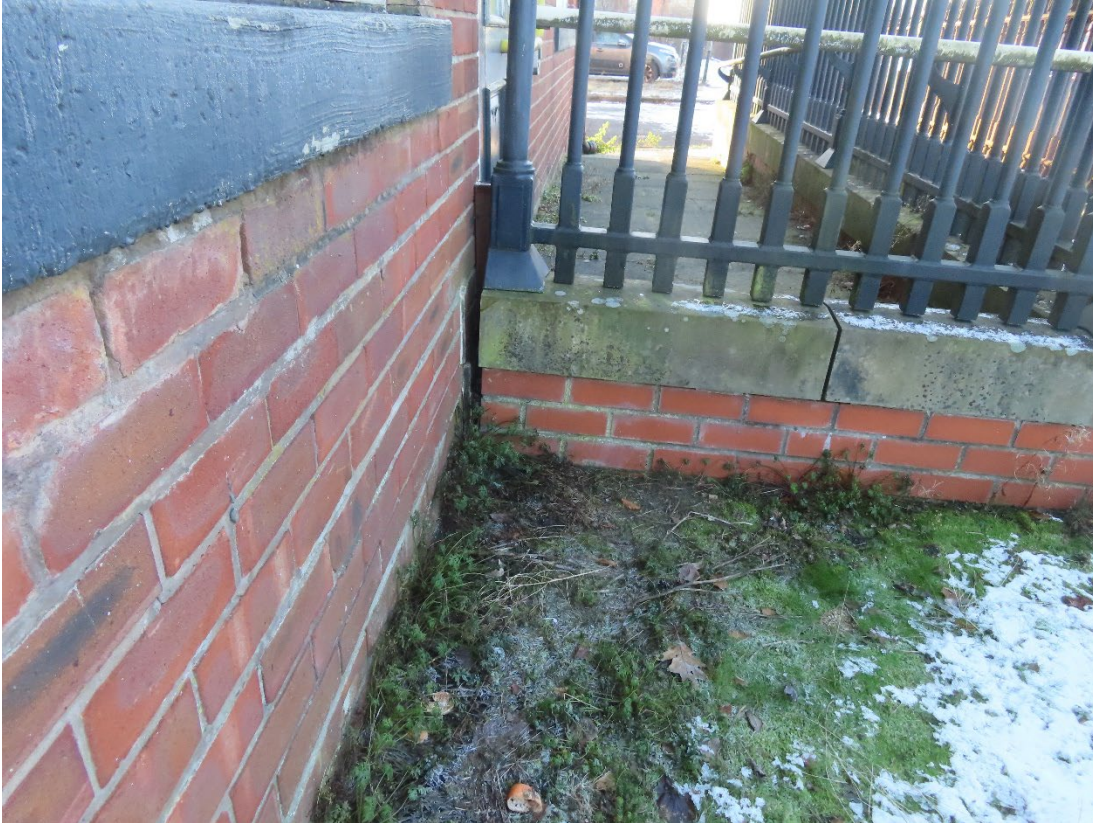
Photograph 15

There are a number of manholes surrounding the site, some of which could not be lifted. However, some of the manholes were heavy duty and as previously stated, whilst the ones that were inspected were free flowing, I am concerned regarding the drain particularly running along the new gable wall where there has been some differential settlement from the ramp detail. So therefore we would advise for a drain survey to be carried out.

Differential settlement to external ramp detail to rebuild gable to number 20.

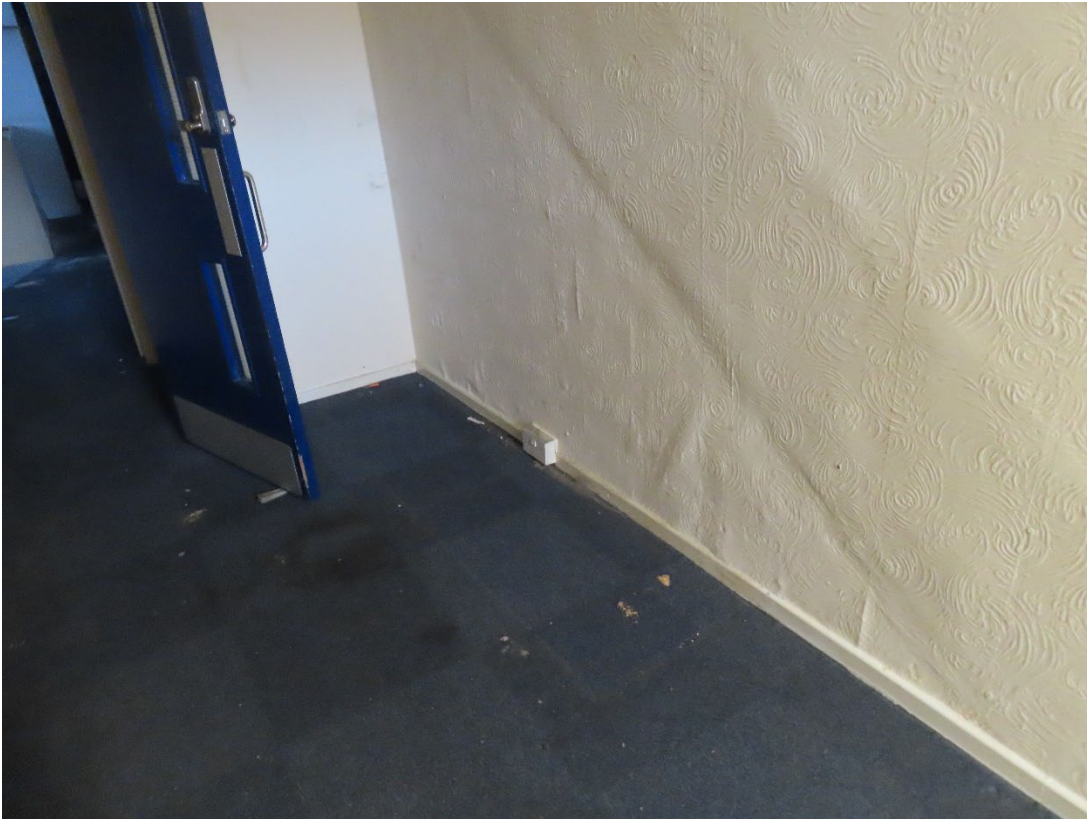
Photograph 16

Generally the floors are reasonably firm and level, however there is some unevenness in the solid floor where the staircase to number 20 used to be. I suspect this may still have the original floor without any damp proof membrane, so the area here as a minimum requires further investigations with regard to the relaying of that floor slab.

Outline of removed staircase to number 20 and area of dampness.

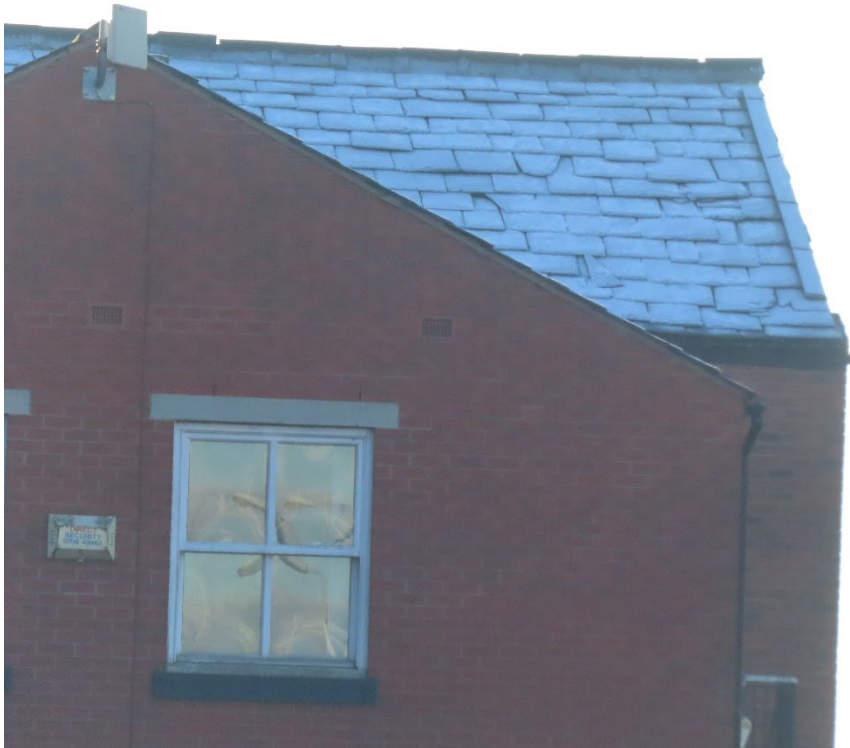
Photograph 17

General poor condition of slate roof to the rear of main building to number 20.

With regard to the roof, I am particularly concerned over the roof to the original main building of 18 and 20. It is not possible to confirm whether it has under felt, but with the installation of the 6 rooflights to the rear elevation, it would be beneficial to re-cover the roof.

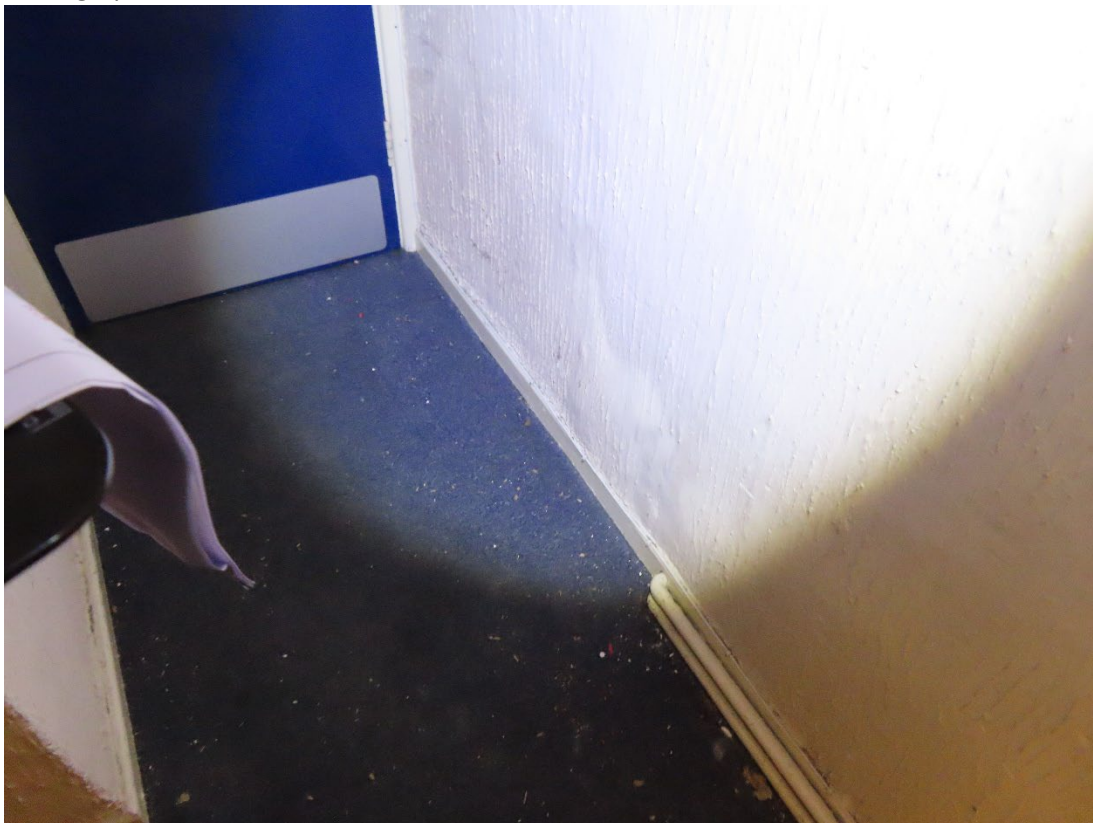
Photograph 18

Dampness was also recorded along the party wall position in the rear corridor between where the staircase has been removed to number 20 and on the original rear elevation wall behind the stairs down to the cellar in number 18.

Rising dampness to wall linking number 18/20 rear cellar steps to number 18.

We would therefore advise a cautionary timber and damp report in respect of that. Although it may be that the extent of the refurbishment means that the walls will be dry lined to comply with the upgrade in the U value.

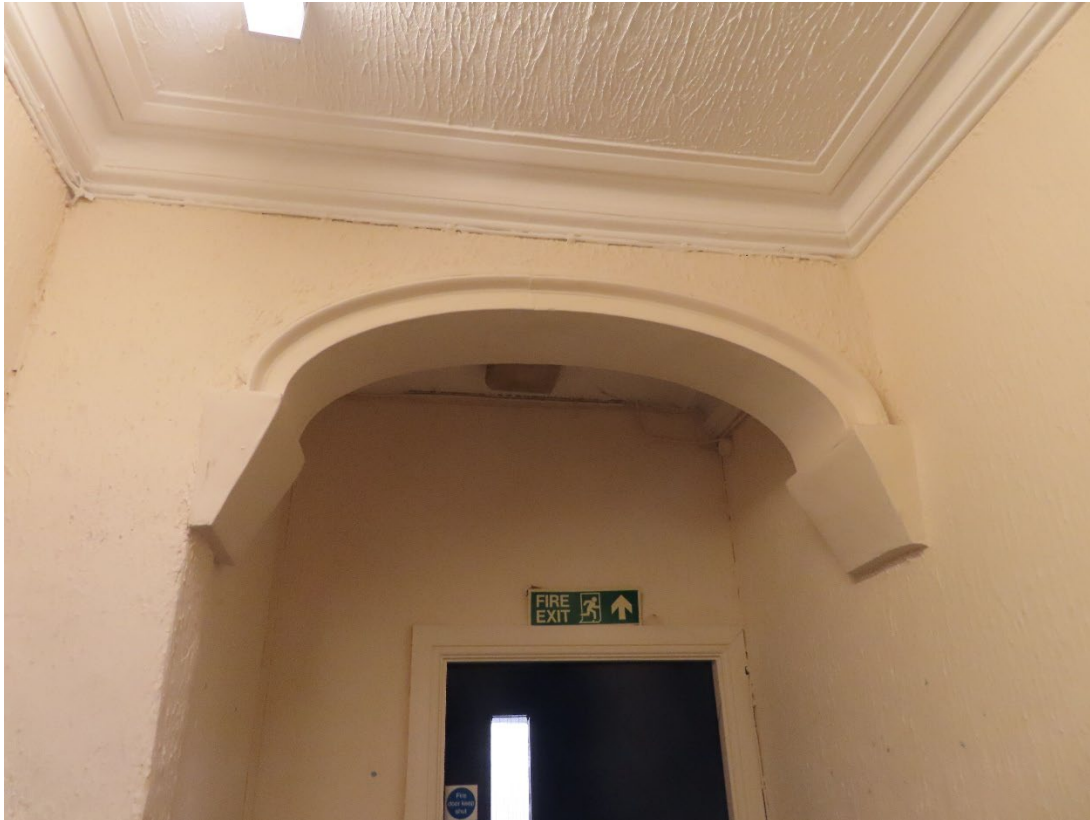
Photograph 19

On the first floor there is further artex/textured ceilings to the landing area of number 18 and to the office to number 18 on the front elevation. Considering the age of the artex and the amount of refurbishment, we would strongly advise that these be tested for asbestos content.

Heavy artexed wall and ceiling and staircase lobby to number 18.

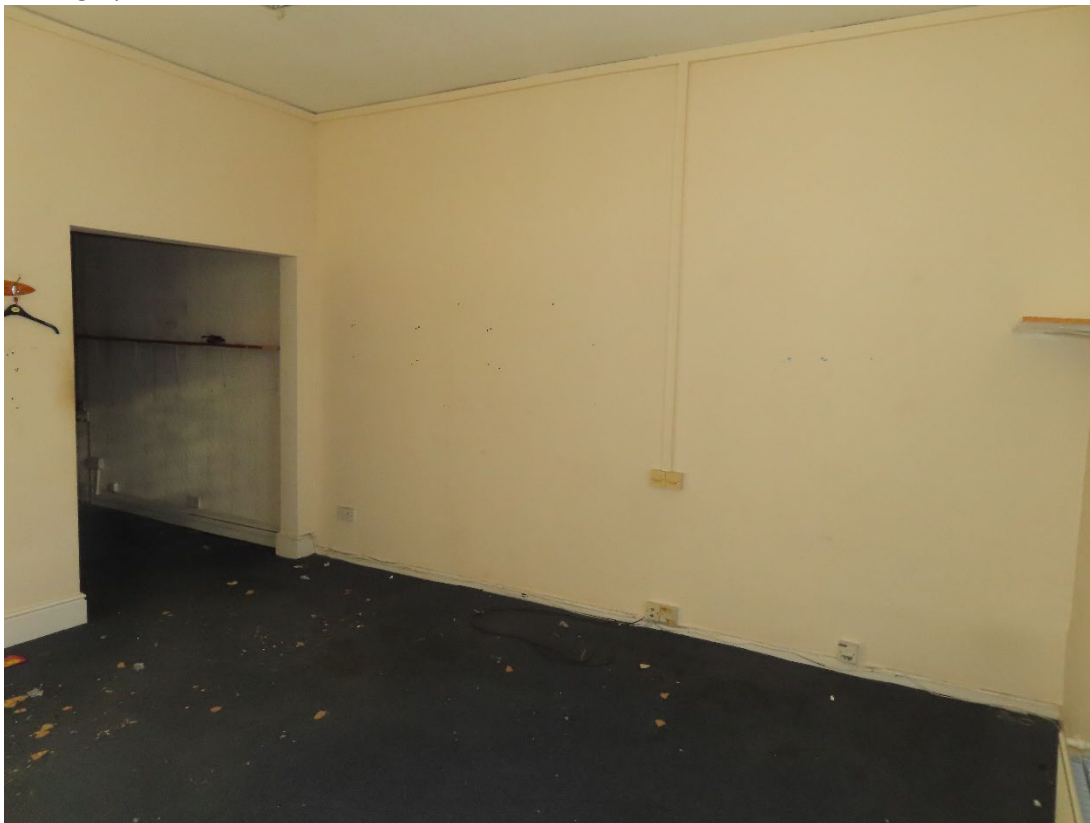
Photograph 20

On the rebuilding of the gable wall to number 20, the chimney breasts have been removed. However, the chimney breast still exist on the first floor on the party wall to number 16. There is however no evidence of support within the reception and office to number 18 on the ground floor, and therefore it is important to enquire as to whether building regulation approvals were given for the support of that chimney breast.

Chimney breast removed to reception office to number 18 (means of support?).

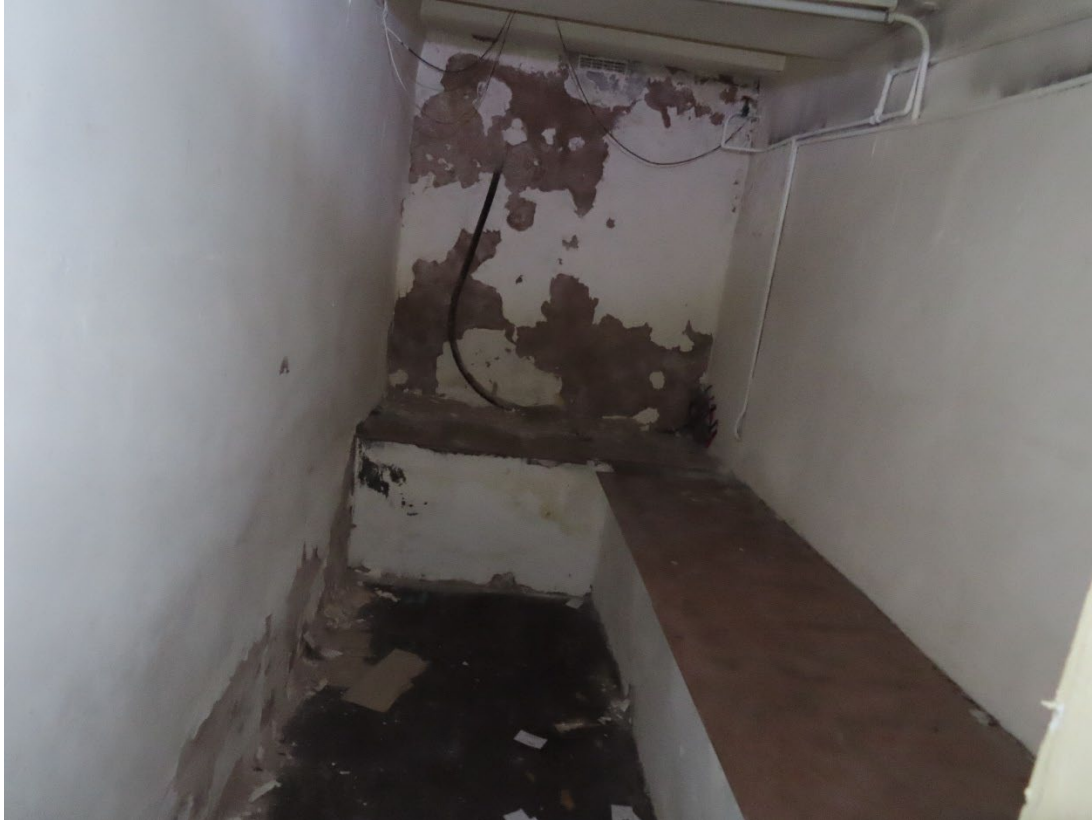
Photograph 21

General dampness to basement 3 cellar to number 20.

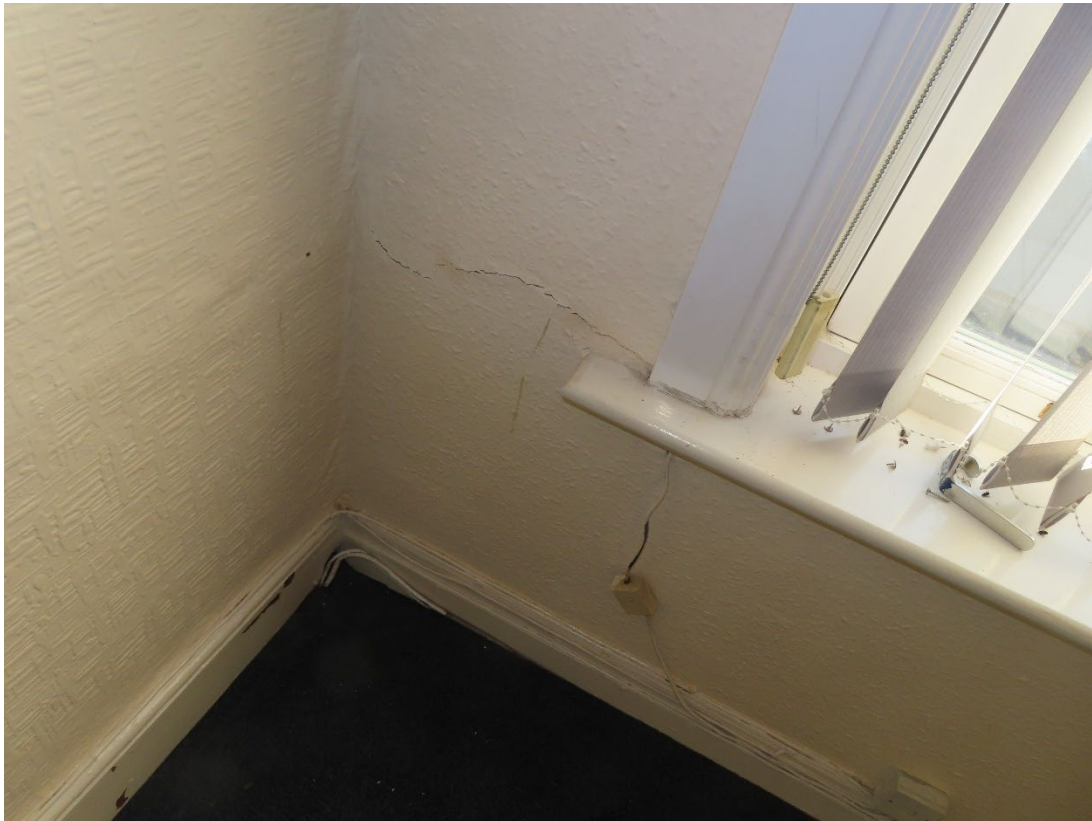
Photograph 22

Horizontal cracking to front wall to the first floor small office to number 20.

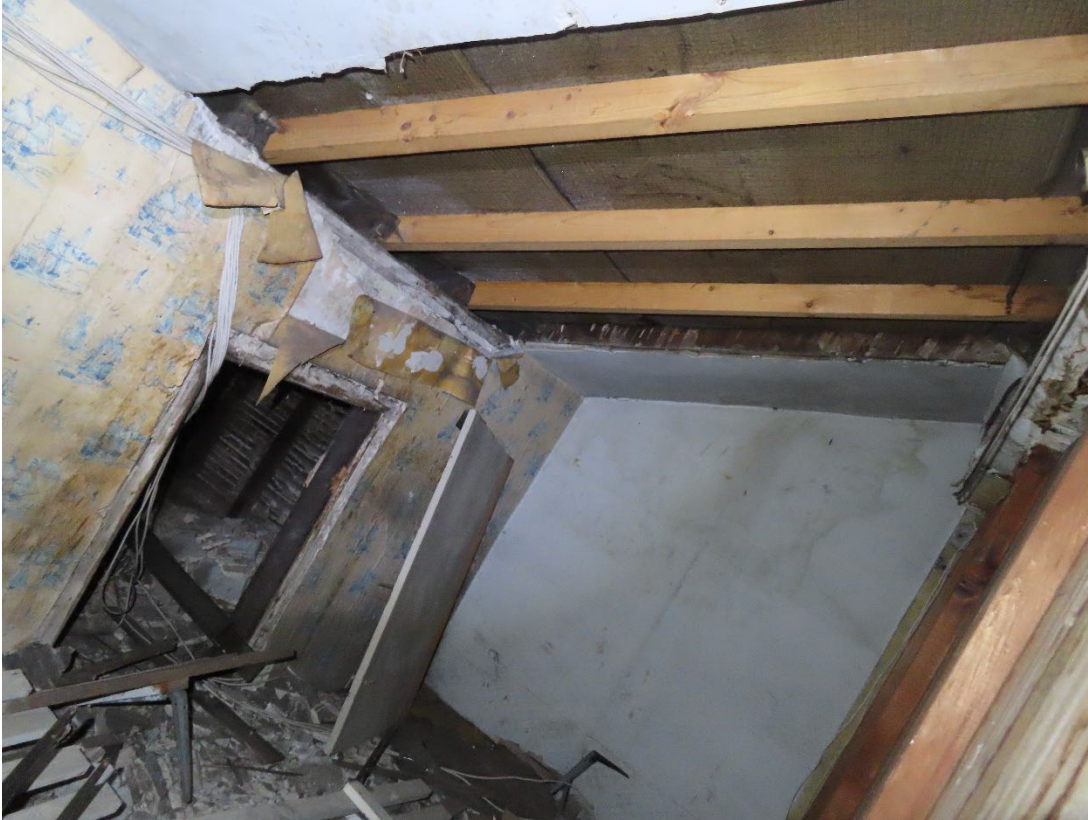
Photograph 23

Section of rafters replaced to main roof of number 20.

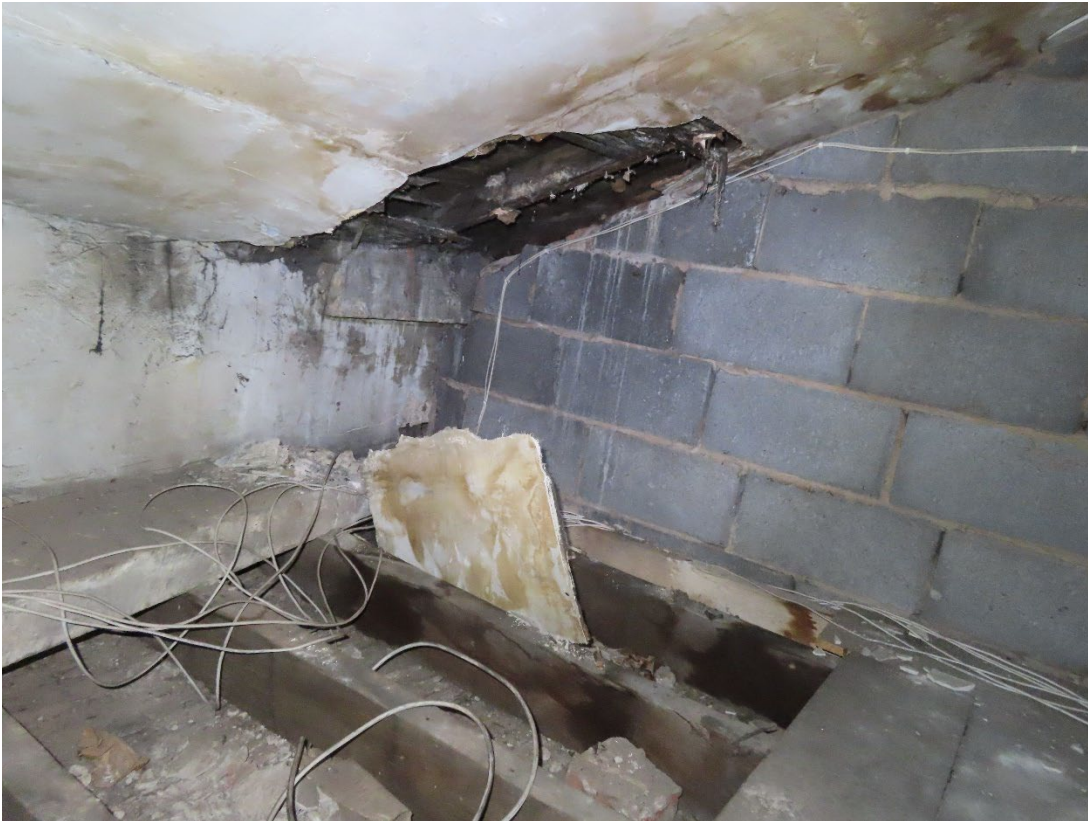
Photograph 24

It was not possible to confirm whether the rear elevation of the main buildings to number 18 and 20 do have roofing felt, as there is boarding on top of the rafters which would be typical of the original construction of that period. Areas could be seen to the front elevation, certainly number 20 that indicated that the roof had been under felted and was in reasonable order.

Rear roof of number 20 showing over boarding and rebuilt gable and rear wall.

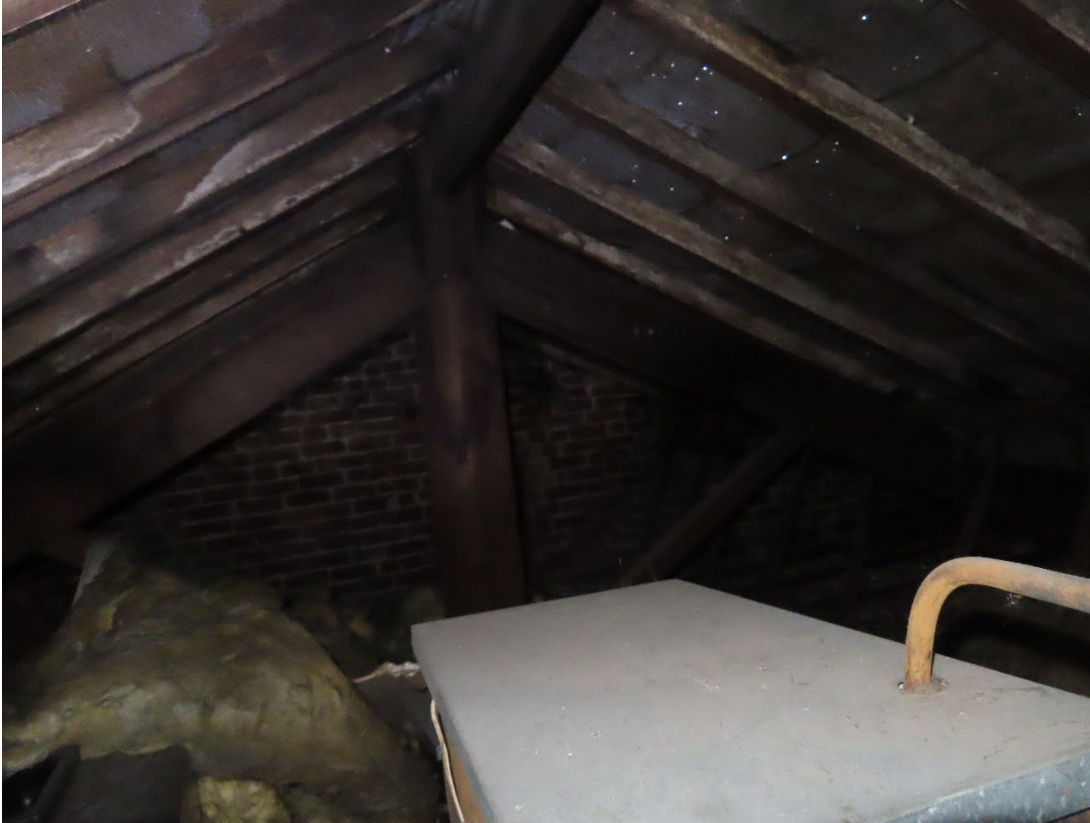
Photograph 25

There is currently a king post truss giving intermediate support to purlin beams supporting rafters. Whilst there is a slight deflection in the roof line which could be seen externally, this is not particularly extensive and not sufficient to warrant any remedial works.

King post truss to roof of outrigger to number 18/20.
