# **MOUNTEER LIMITED**

## **Building Survey**

**18 & 20 St Mary's Place**

**Bury**

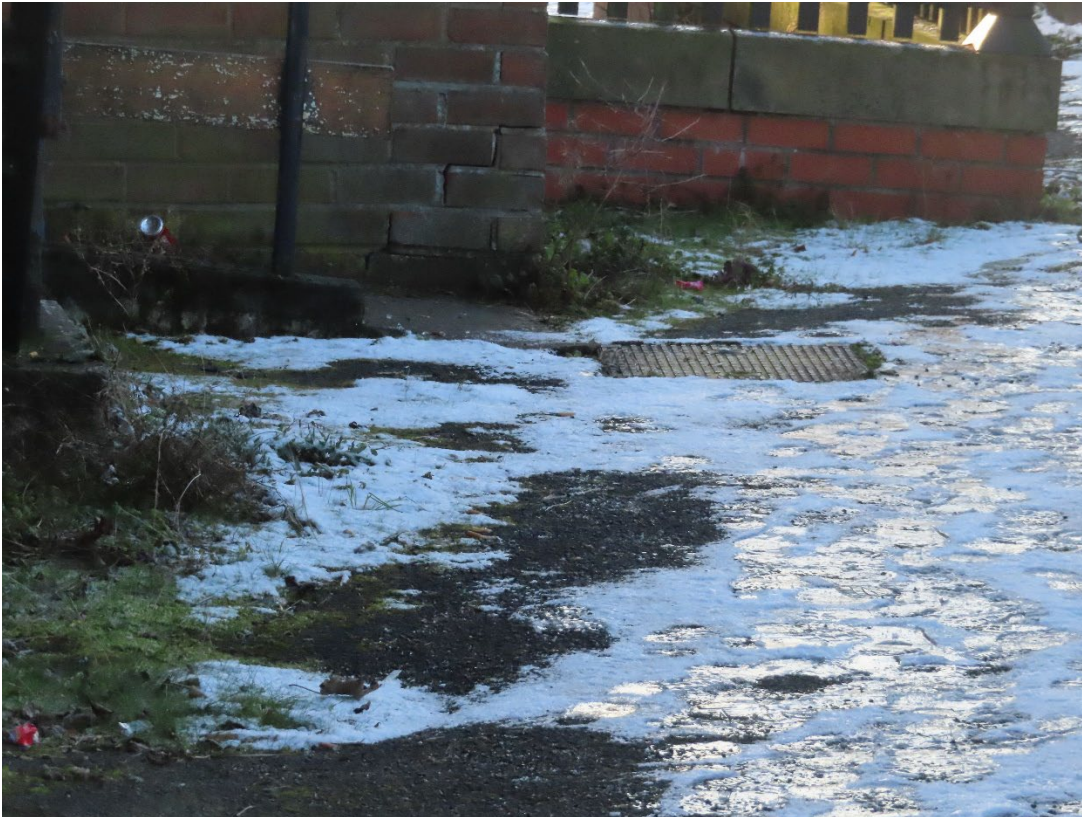
Photograph 26

Cracking to brick wall potential cause by drainage (drainage report required).

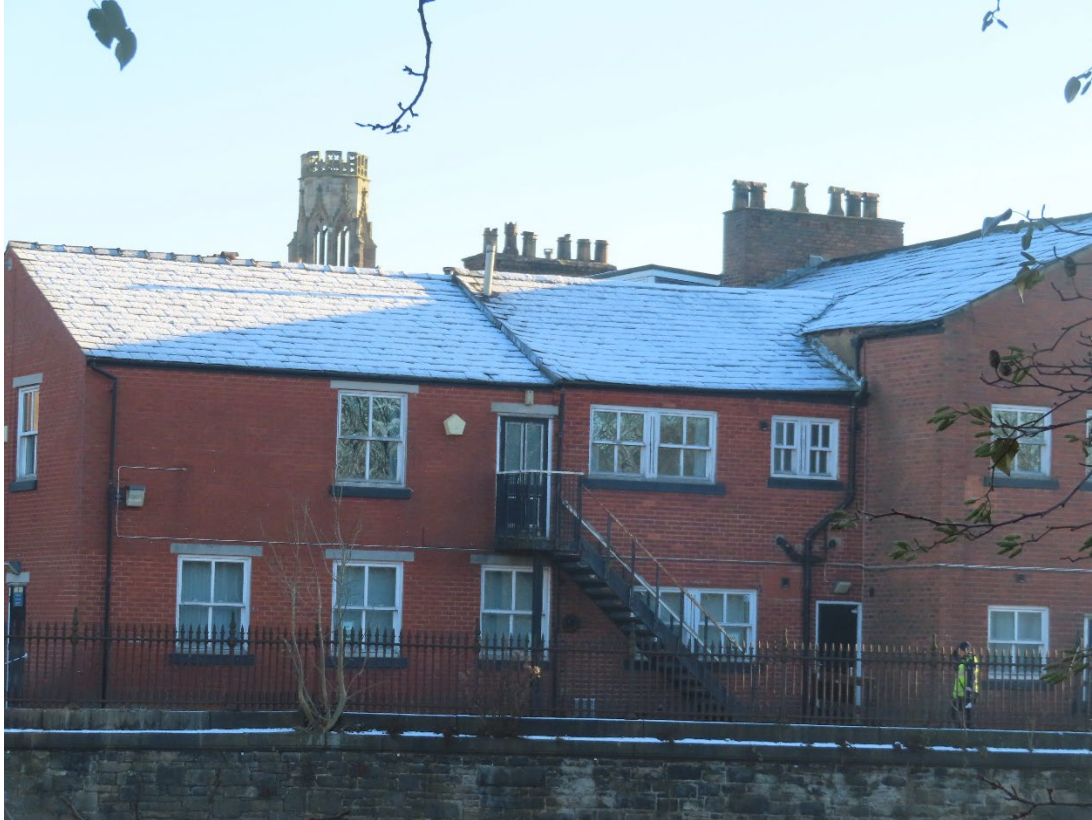
Photograph 27

The section which is a new outrigger roof is of blue slate in reasonable condition.

Roof of rebuilt outrigger extension to number 20 front roof covering.
