**STRUCTURAL APPRAISAL  
OF EXISTING DWELLING  
LAKE HILL, WALSHAW ROAD,  
BURY, BL8 1PU**

| <b>CONTRACT NO. B13977</b> | <b>JAMES CROSBIE ASSOCIATES LTD.<br/>CONSULTING CIVIL &amp; STRUCTURAL ENGINEERS<br/>37 CHORLEY NEW ROAD, BOLTON. BL1 4QR</b> |
| <b>JULY 2016</b> | <b>TEL. 01204 384585<br/>FAX. 01204 363358<br/>E-MAIL <a href="mailto:jca@james-crosbie.co.uk">jca@james-crosbie.co.uk</a></b> |

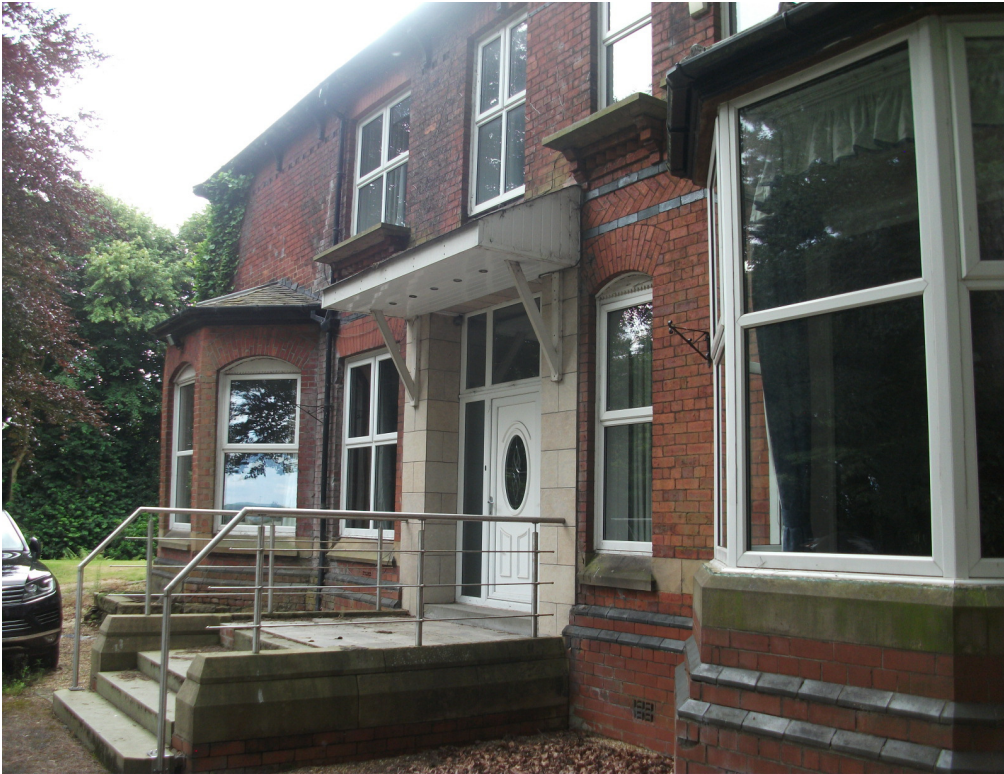
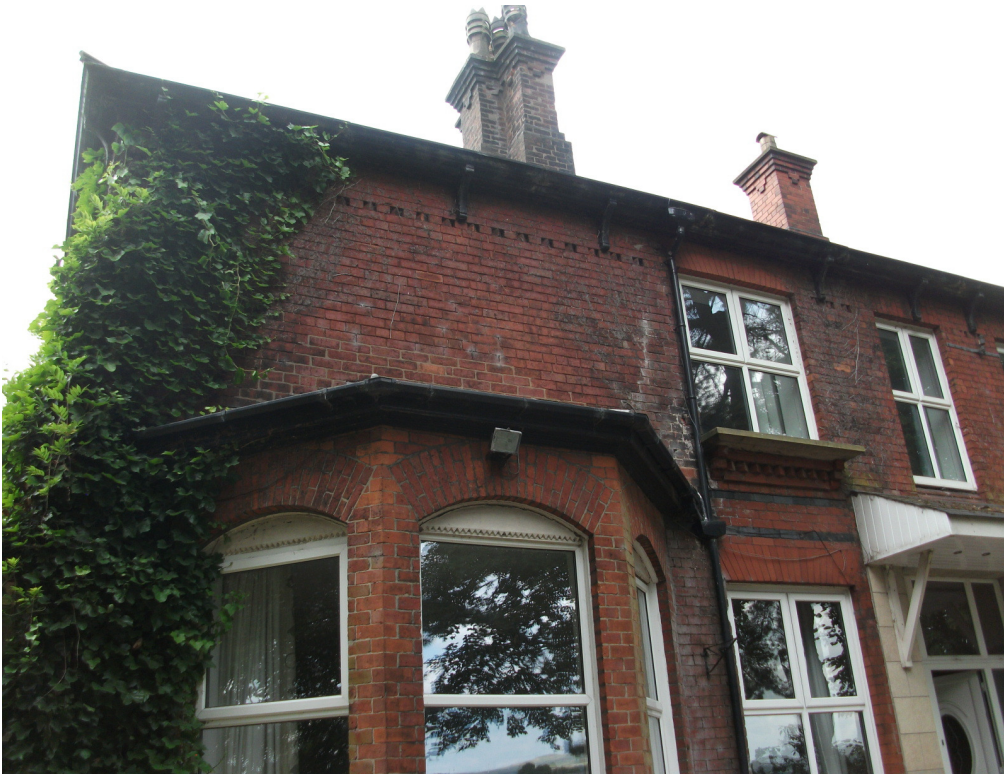
**FRONT ELEVATION**

The elevation was in general in a fair and reasonable condition except to the side of the left hand bay window where previous substantial water staining was evident likely from a leaking gutter or rainwater pipe. The wall was noted to be reasonably plumb within acceptable tolerance and the coursing was level.

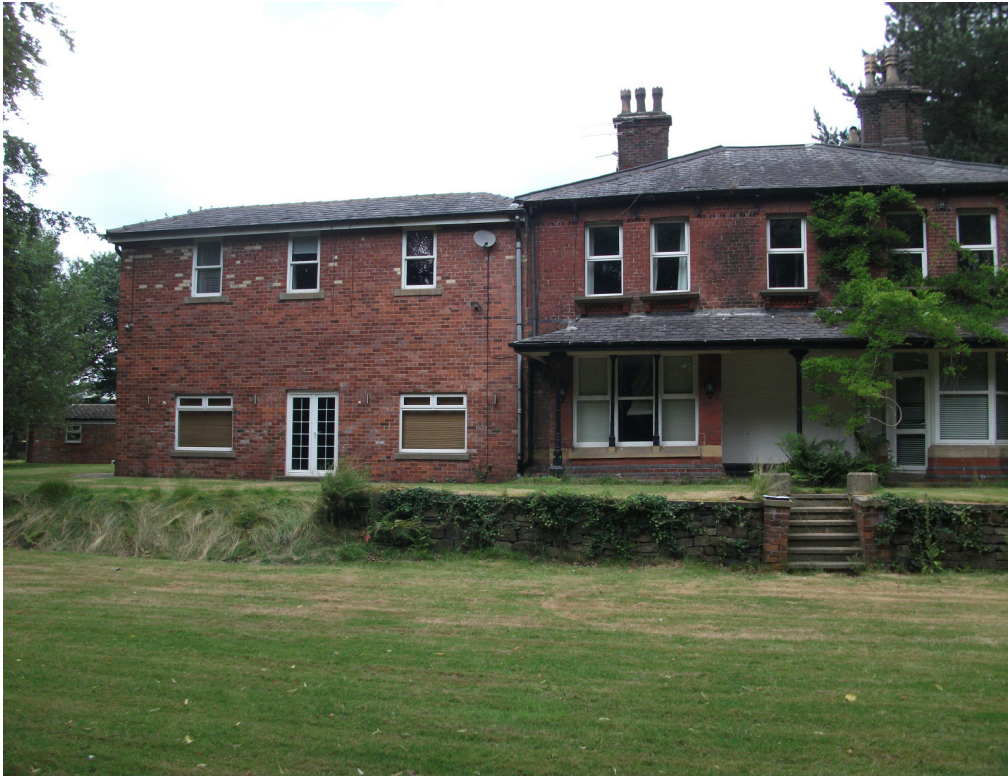
**LEFT HAND ELEVATION**

The wall to both the original house and extension was generally in a fair and reasonable condition except to the cill to the box bay which was noted to slope quite extensively downwards towards the rear. To the double doors to the extension the lintel was noted to have locally deflected downwards and the coursing was noted to be uneven and correspondingly dropped.

- 4.1** To the far corner of the box bay window the brickwork has locally dropped downwards and this is also at the same location as significant damp noted internally.

We would consider that the cause of the movement being noted may be as a result of a leaking drain having affected the foundations of the property.

In order to determine the cause of the damp penetration and movement noted it will be necessary for a number of trial pits to be undertaken to expose the foundations of the property and local drainage to determine whether the drains are leaking and having an effect on the foundations. This will determine whether the corner of the bay will require locally underpinning and for any drainage repairs to be undertaken.

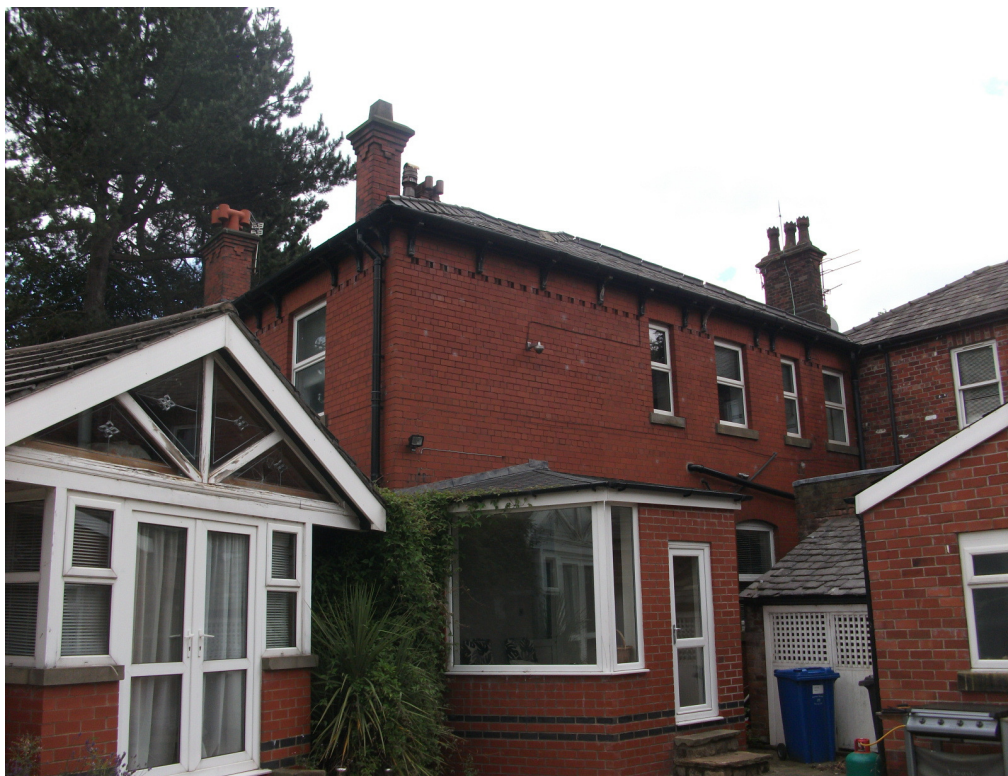
**REAR WALL OF ORIGINAL PROPERTY**

The main rear wall of the main house was mainly obscured as a result of the extensions. A cursory inspection of the upper levels did not reveal any evidence of any distress.

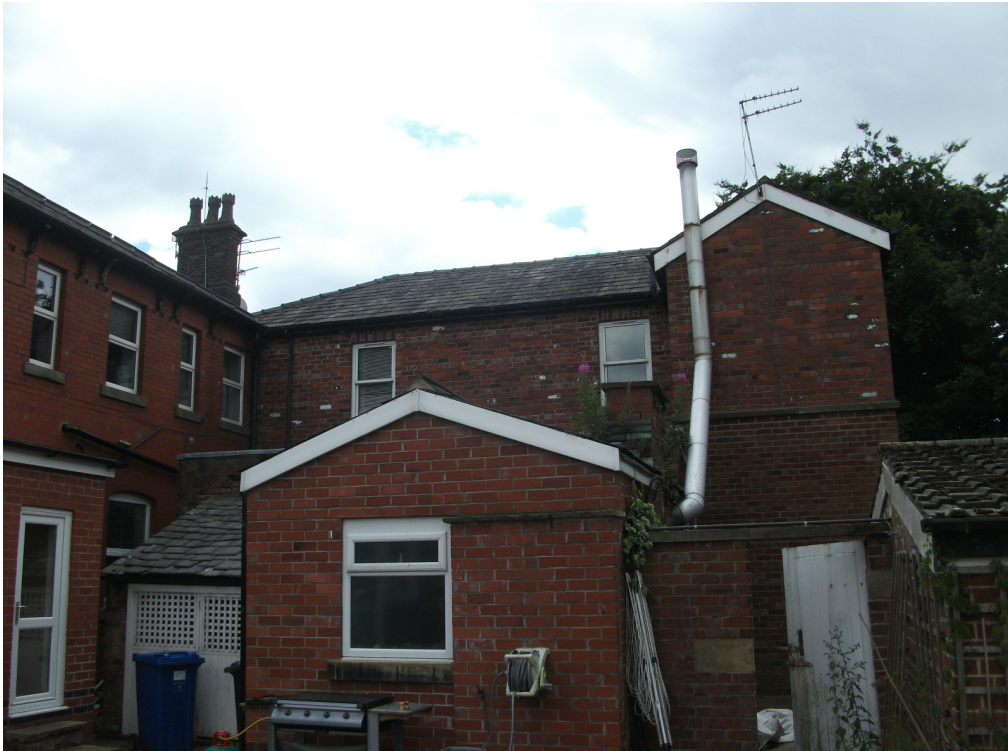
**RIGHT HAND WALL OF MAIN EXTENSION AND SINGLE STOREY  
EXTENSION**

To the right hand side of the two storey extension are further single storey extensions which are to be demolished as part of the proposed works. Externally these areas showed no evidence of any significant distress.

The main rear wall of the extension was mainly obscured as a result of the extensions. A cursory inspection of the upper levels did not reveal any evidence of any distress.

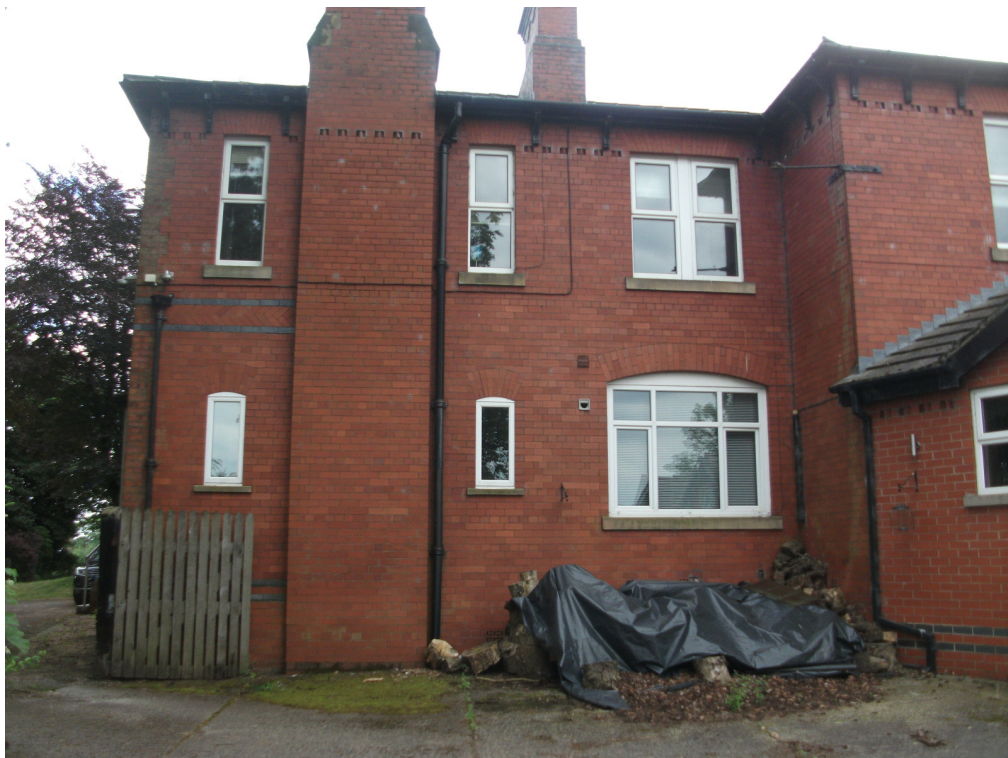
**RIGHT HAND WALL OF ORIGINAL HOUSE**

The wall was noted to be in general in a fair and reasonable condition with no evidence of significant structural distress.
