## BURY ART MUSEUM

Design, Access & Heritage Impact Statement.  
Chambers Conservation Ltd, January 2024 ISSUE 1.

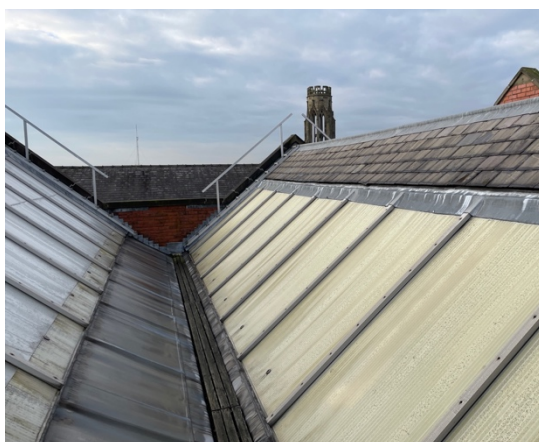
- The polycarbonate rooflights are starting to fail, especially around the seals and the panels are discoloured from long exposure to UV. There is evidence of protective (UV) film remaining in some areas. It is recommended that a section of the rooflight be removed to enable an inspection of the frame condition, condition of the seals etc, this would enable a proper appraisal about the works to the rooflights (*areas where rooflight renewal is required are noted in individual roof areas in Section 1 of the Schedule of Works*).

**03** Polycarbonate rooflights in Area 07 (2023)

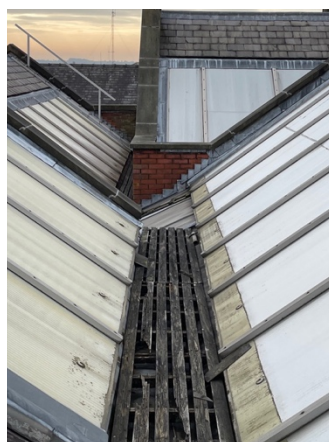
- To Roof Area 09 there are significant issues with the gutter and moisture retention in adjacent masonry. The flashing is pulled away, corresponding with significant water ingress to the main gallery below and there is corresponding staining in the ashlar below the parapet level (there is also a tree growing from above cornice level). This gutter should be re-laid to improved details in the short-term and with immediate, urgent, attention to repair the flashings. This also applies to the gutters of adjacent areas 11 and 08 where the parapet gutter discharges, the arrangements are poor, in poor condition and prone to leaks (*refer to drawings BART.02/002, 003, 802, 804, 806 and 901-902 and Section 1.11/1.12 in the Schedule of Works*).

**04** Timber duckboards in Area 09 (duckboards now removed) (2023)

Given the urgency, the Museum have undertaken urgent works which were completed after this inspection. The works include removal of duckboards in gutters to roof area 6 and roof area 9, alongside like-for-like holding repairs and cleaning out of the gutters. Following these urgent works, an overview of the issues and proposed works in each area is shown below.

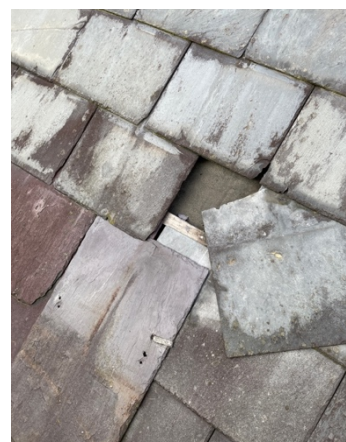
- There are a number of slipped slates which should be repaired (across all roofs) (*refer to individual roof areas in Section 1 of the schedule of works*).

**05** Slipped slates to the north of RL04 (2023)

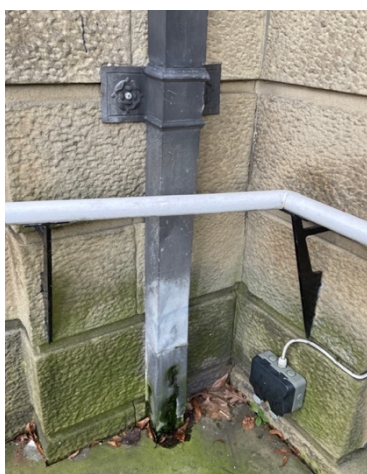
**06** Damage to leadwork of RWP01 at ground level (2023)

- The rainwater pipes and hoppers are in poor condition and have no overflow. Individual repairs/renewals are noted in section 1.17 of the Schedule of Works.
- The rainwater pipe configuration from roof area 09A needs reinstating (i.e. with greater capacity) (*Item 1.12.3 in the Schedule of Works*).
- All sumps and chutes need overflow to reduce risks of build-up in the parapet gutters, this is resulting in on-going water ingress in various location. Works involving new lead chutes and overflows are noted in individual roof areas in the Schedule of Works.

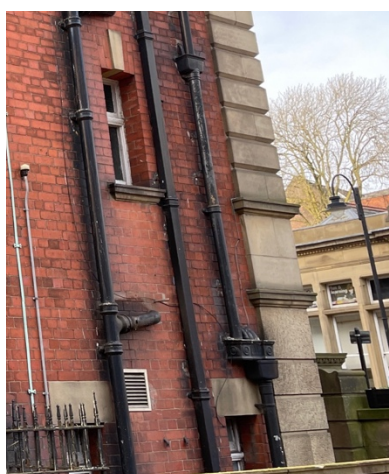
**07** Configuration of RWP02 which drains Roof Area 1 (2023)

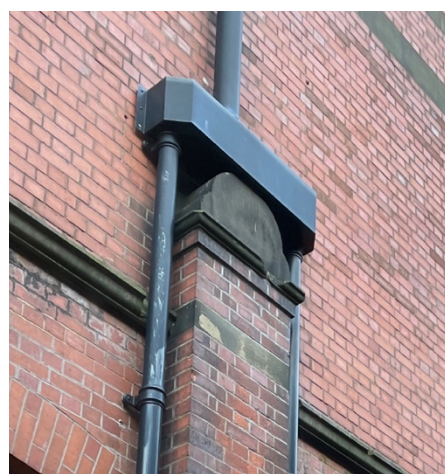
**08** RWP09 hopper and split above buttress (2023)

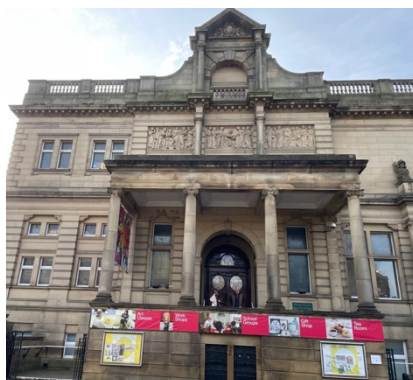
- The entrance portico has significant staining, and the stone is extensively friable. This can be associated with the retention of water on the roof and lack of cover flashings. There is deterioration around the capitals which has been exacerbated by the application of cement mortars. There is spalling masonry and loose stone between the capitals and cracking immediately adjacent which requires further investigation. This is significant especially as it sits above the main public entrance area. It is recommended the stone is protected with lead flashings over the blocking course and cornice, these would serve as a flashing to the roof. Some repairs to the stonework is also required (*refer to drawing BART.02/009, roof drawings 1201/1202 and Section 1.18 in the Schedule of Works*).

09 Portico and entrance (eastern end) (2023)

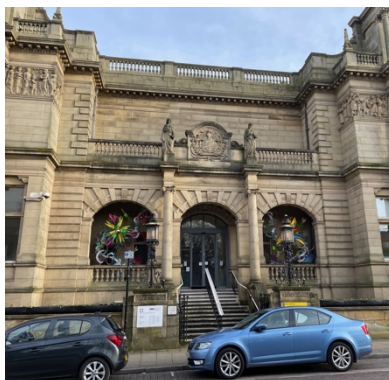
- There is some friable stone to the balusters either end of the balustrading above the library entrance, these are likely to require renewal at least in part (*refer to drawing BART.02/009 and Section 1.19 in the Schedule of Works*).

10 Library entrance (2023)

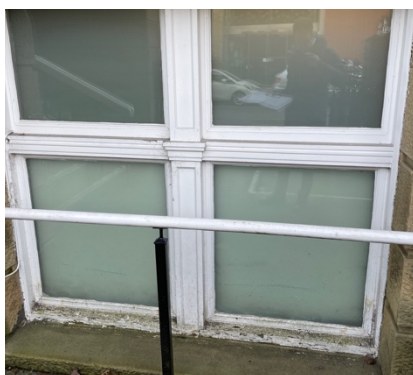
- The windows to the south elevation (at lower ground level) are heavily decayed around the cills and require splice repairs. These windows are blocked internally.
- There are various decayed cills to windows around the building which need attention (*individual window repairs noted in Section 1.22 in the Schedule of Works*).

12 Decayed timber cills on WLG06 (2023)

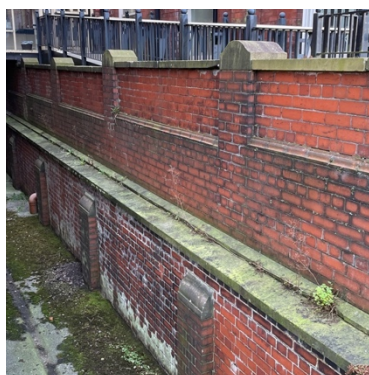
- To the retaining wall between the Library and the former Textile Hall there is growth from the projecting plinth, and there is a coping stone near the link bridge which has been significantly displaced and is in danger of falling. The growth in these areas should be removed and the areas made good. They then should then be treated to prevent further growth from occurring (*Item 1.23.12 in the Schedule of Works*).

**15** Growth on retaining wall and plinth (2023)

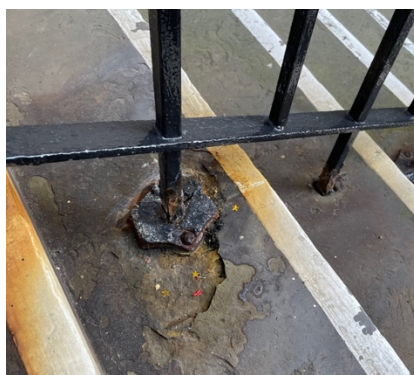
**16** Corrosion in handrails (2023)

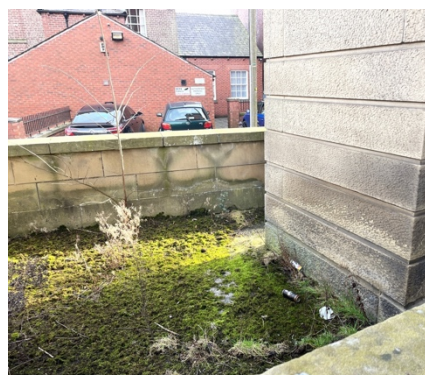
- There is accumulation of moss, plant growth and debris around the building in various areas. This is now causing moisture to be retained in adjacent stonework and should be removed and the areas treated as soon as possible (*individual areas noted in Section 1.23 in the Schedule of Works*).

**17** Saturation, growth of moss etc. leading to growth of larger plants (2023)

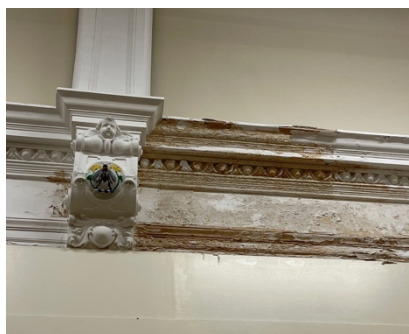
- The primary first floor galleries (F0006, F0013, F0015), the Art Shop F0014 and the Staircase F0001).
  - Further water ingress is evident in the Staff Room/Kitchenette (G0013), Office G0009 and Archive Store LG0024.

**19** Significant water ingress to F0015 and consequent damage to plasterwork (2023)

- There are a number of internal issues associated with water ingress (*individual areas noted in Section 2.0 of the Schedule of Works*). These areas should be repaired as described in the schedule of works, including the repair of decorative mouldings. Some areas noted include:

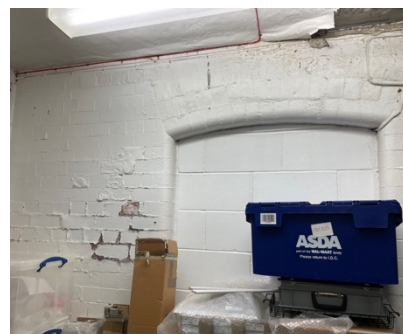
**20** Water ingress and failing finishes in LG0021 (2023)
