## BURY ART MUSEUM, BURY

**Condition Survey**  
Chambers Conservation Ltd.

Issues: - **Issue 4 31<sup>st</sup> July 2023**

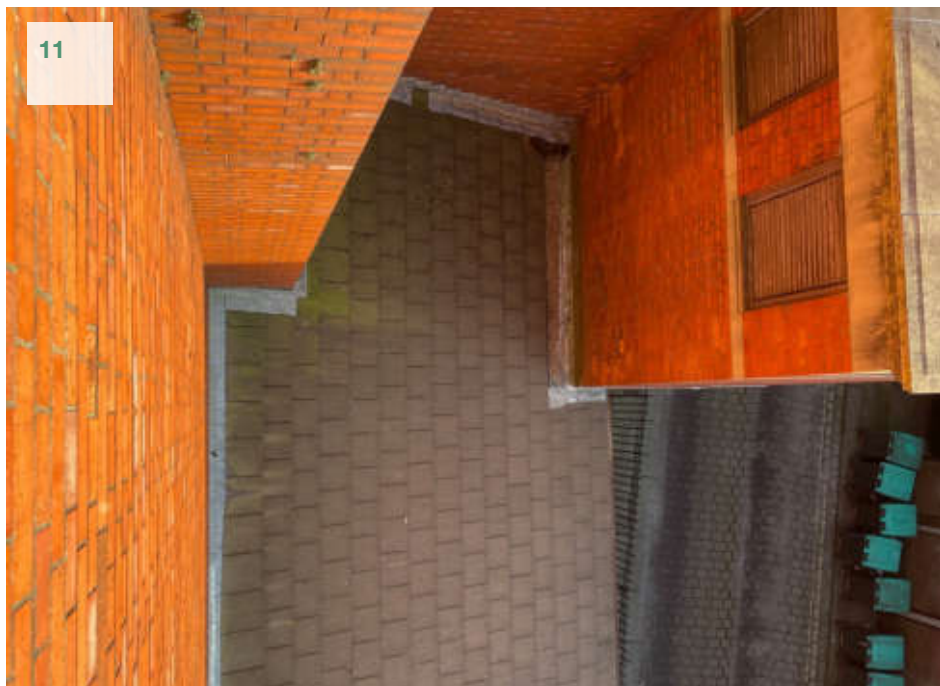
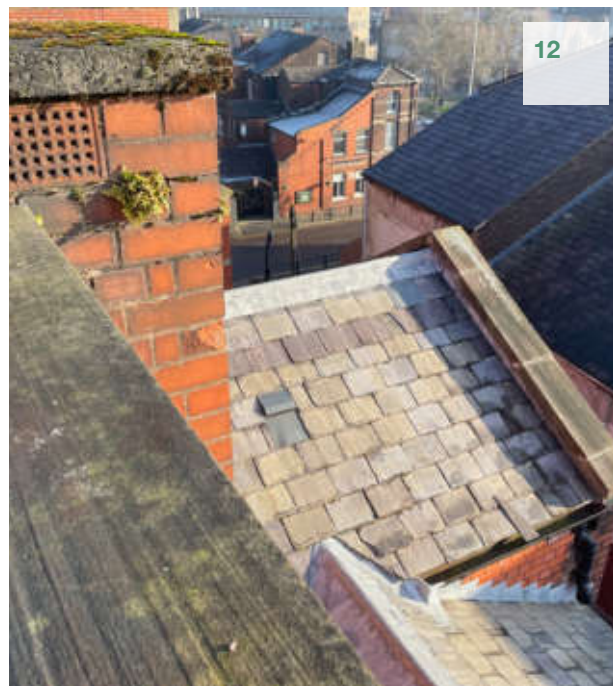
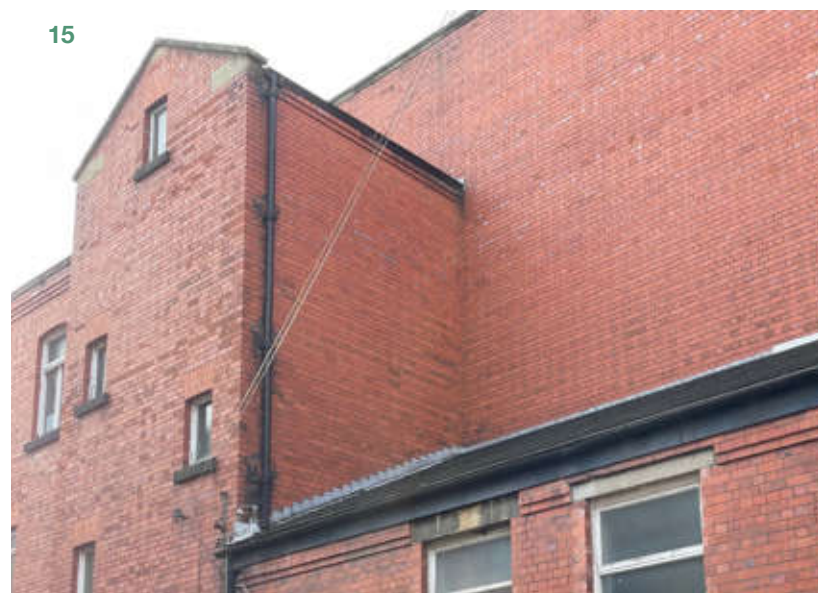
### Roof Area 03, 04 & 05

**11.** View down onto Roof 03 from Roof 06, note back gutter.

**12.** CH03 and looking towards junction of Roof areas 04 and 05. Note damp in high level of CH03 and broken slate.

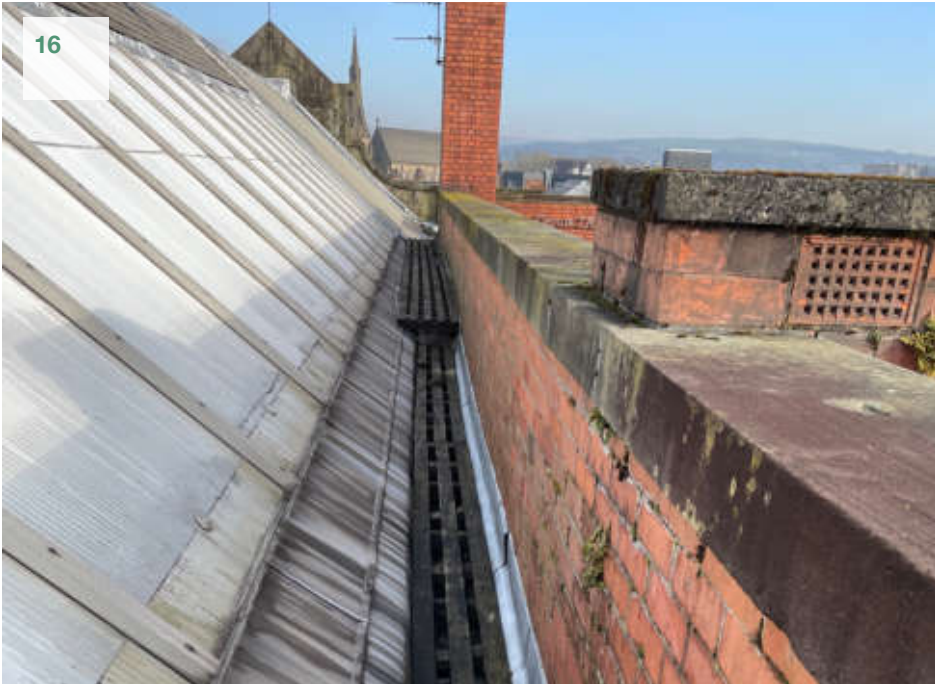
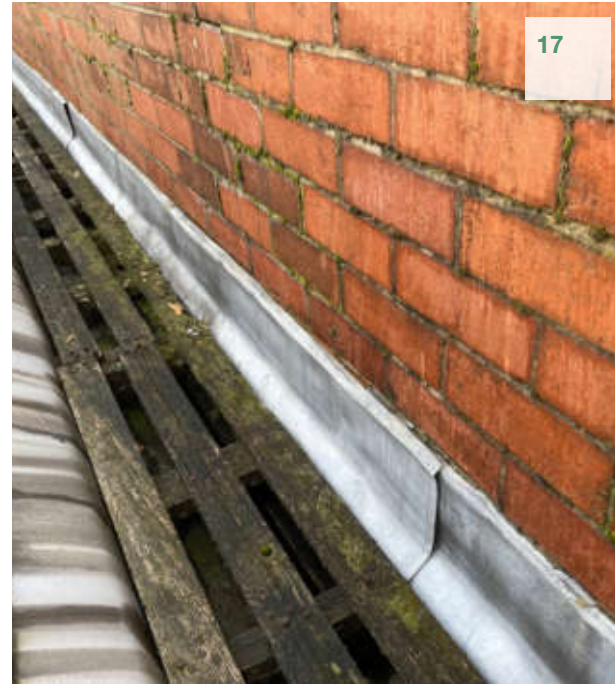
## Roof Area 06

**16.** View down E gutter looking north. Note damp in parapet adjacent to CH03.

**17.** Loose flashings, just north of CH03.

**18.** Mastic repair and crack below valley gutter between RL05 & 06.

**20.** Evidence of possible dry-rot in the gutter boards to the valley between RL05 & 06.

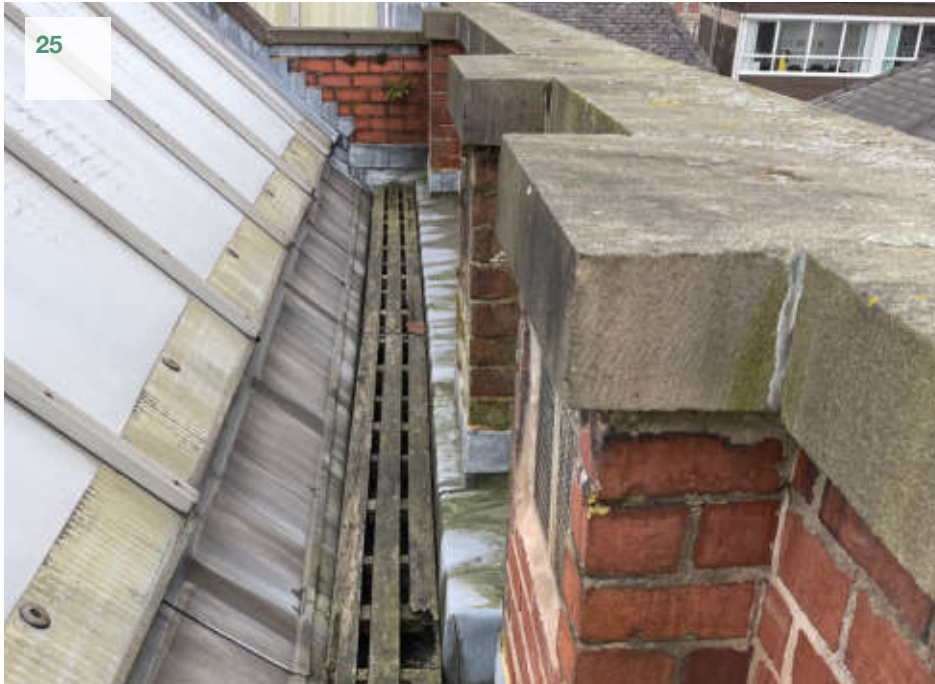
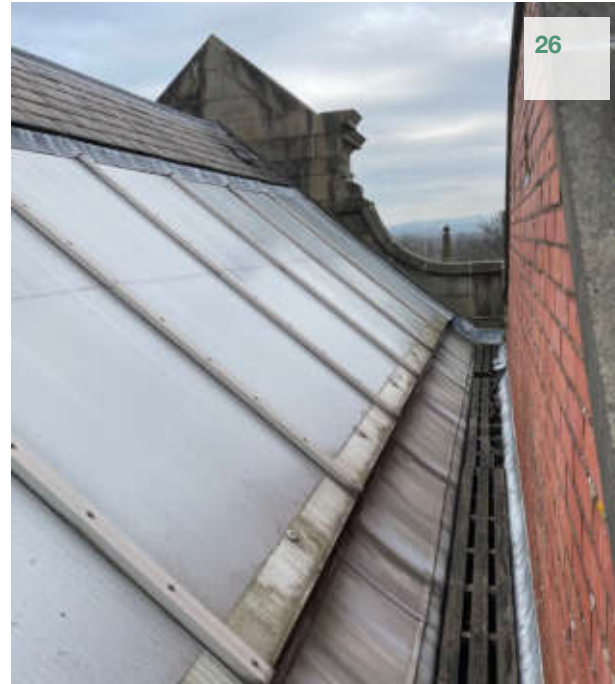
### Roof Area 08 & 08A

- 25.** General view of gutter to Roof Area 08 (south). (looking east).
- 26.** General view of gutter (north). Gable of roof area 09 on right.
- 27.** Outlet from Gutter to Roof Area 09, note iron lining, zinc, lead etc.
- 28.** View from Roof 11 (parapet to Roof 09 on left). Showing lead downpipe (RWP 12) taking water from Roof 08. Note the lead channel in the parapet which takes water from roof area 08A.
- 29.** Area 08A looking down from 08.
- 30.** Area 08A sump and channel outlet (lead-lined) in cornice.

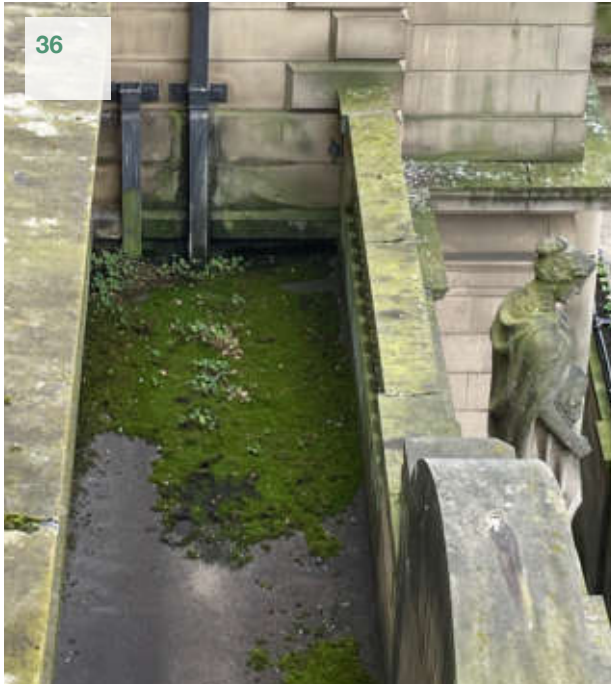
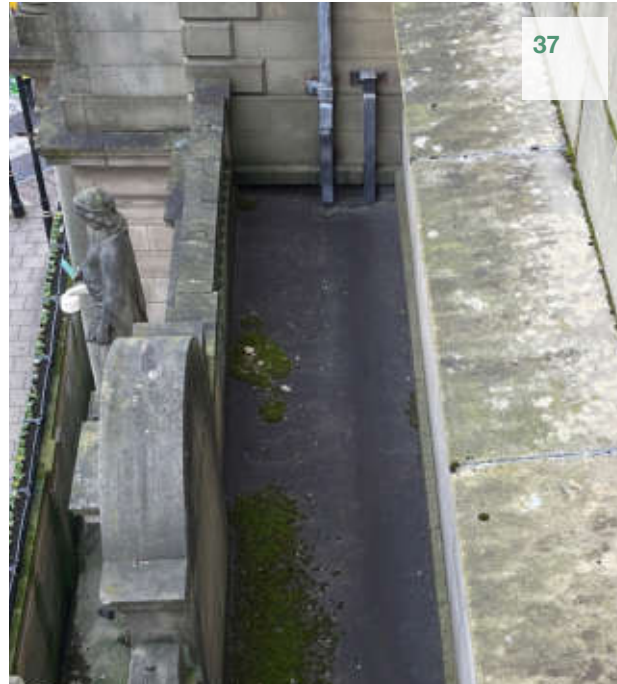
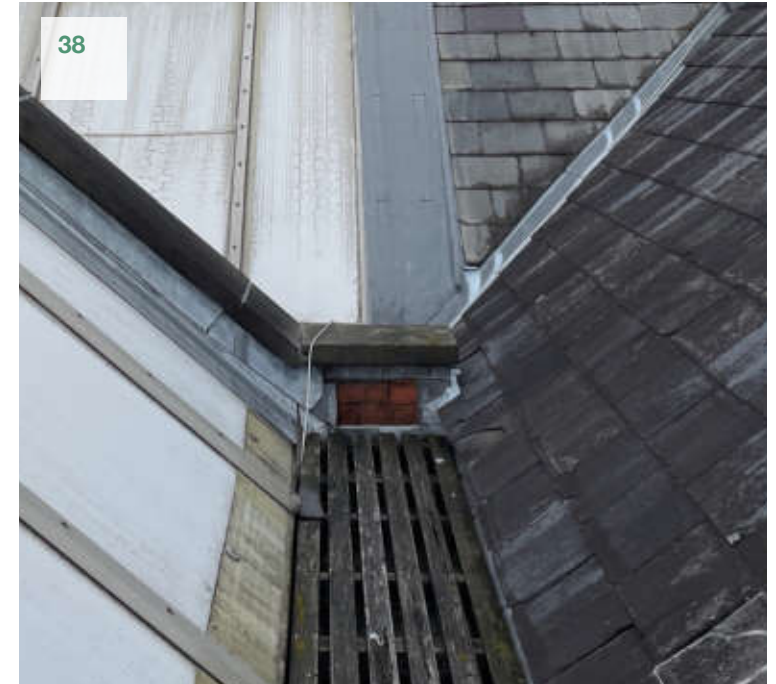
### Roof Area 09A & 10

- 36.** Roof 09A over library entrance looking south. Note curtailed pipe and accumulation of moss/growth.
- 37.** Roof 09A over library entrance looking north. Corresponding pipes, again curtailed below.
- 38.** The valley between area 09 and 10 is terminated in a small parapet.
- 39.** Mix of materials and awkward junction (detail) as noted above.

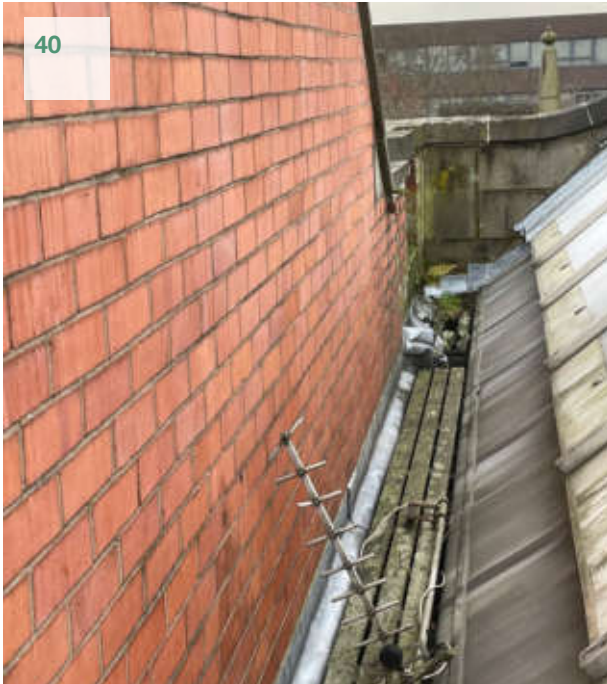
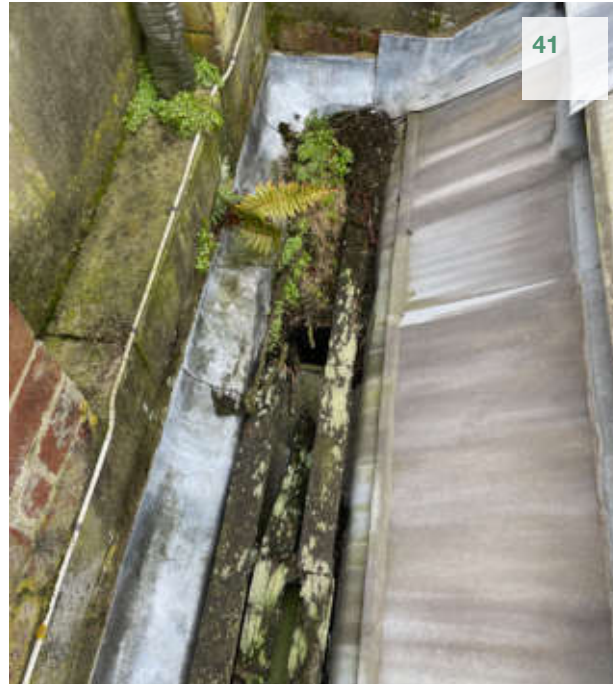
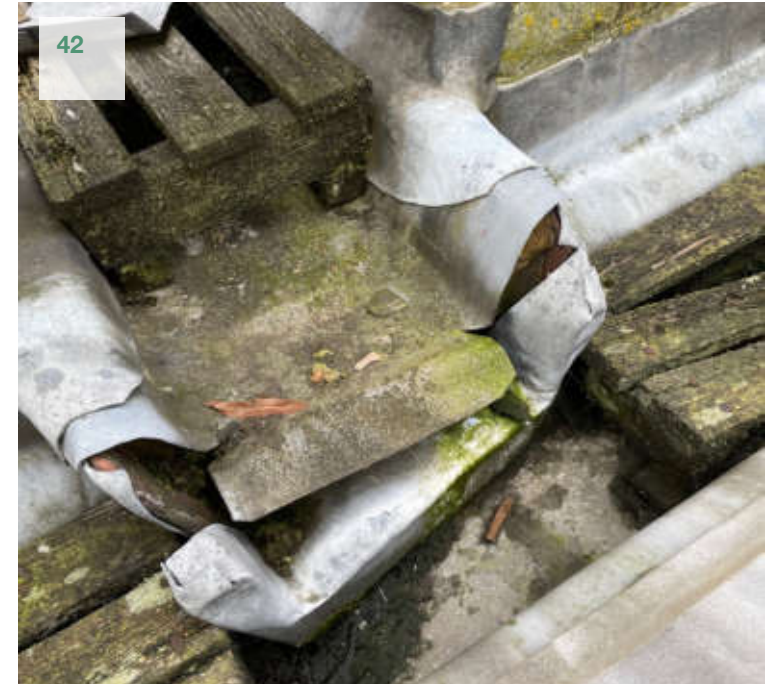
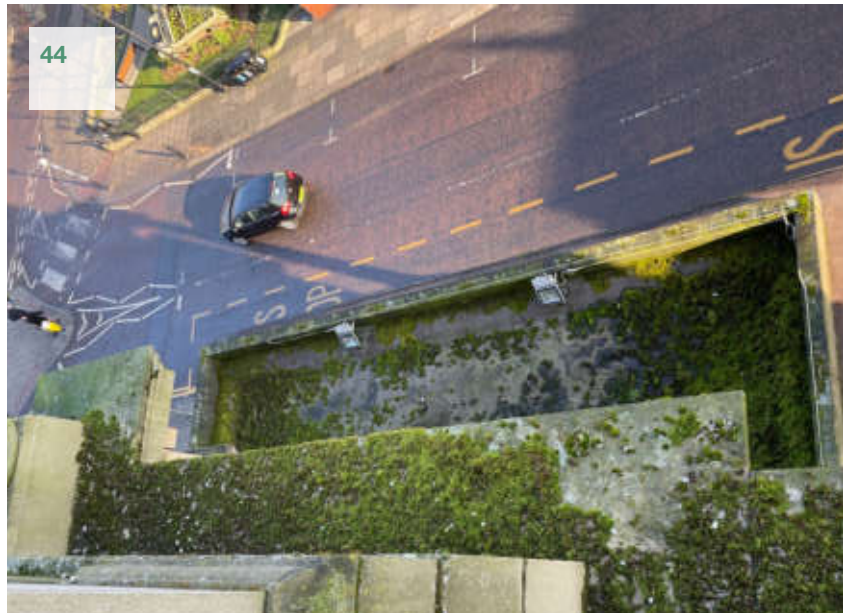
### Roof Area 11, 11A & 12

- 40. General view of (south) gutter, looking west.
- 41. Outlet (to RWP13) showing build-up of debris, general saturation of parapet etc.
- 42. Outlet from west gutter to area 09, in poor condition.
- 43. Outlet and overflow. The overflow is above the point where water would enter the building and is therefore ineffective.
- 44. Roof 12 general view from above.

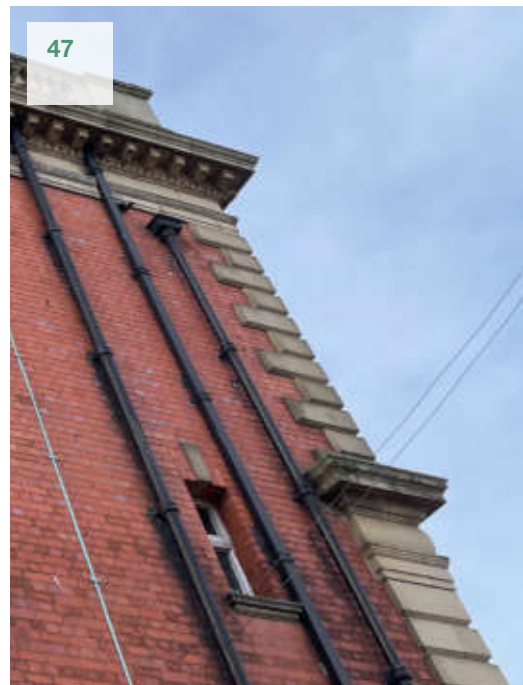
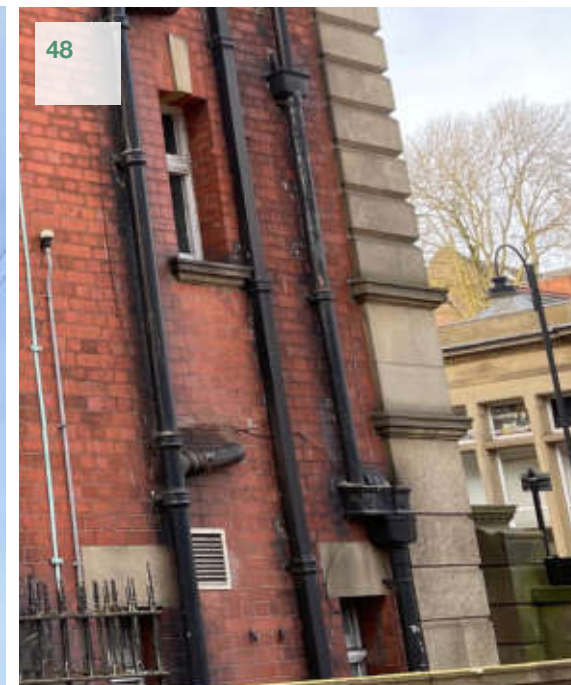
## Rainwater Goods, Sheet 1

- 45. RWP01
- 46. Damage to leadwork of RWP01 at ground level.
- 47. RWP02 (upper)
- 48. RWP02 (lower)
- 49. RWP03 (upper)
- 50. RWP03 (lower)
- 51. RWP04

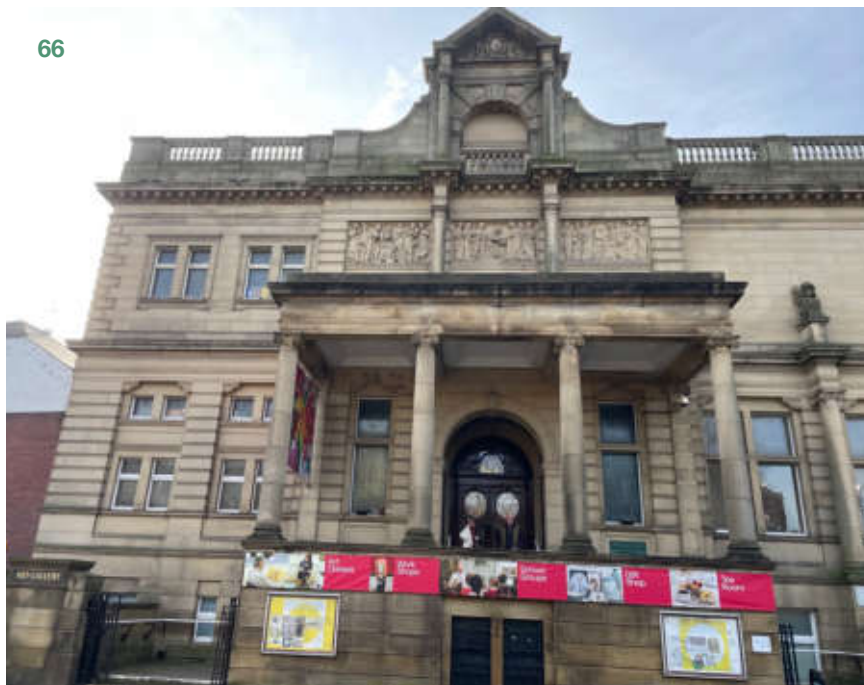
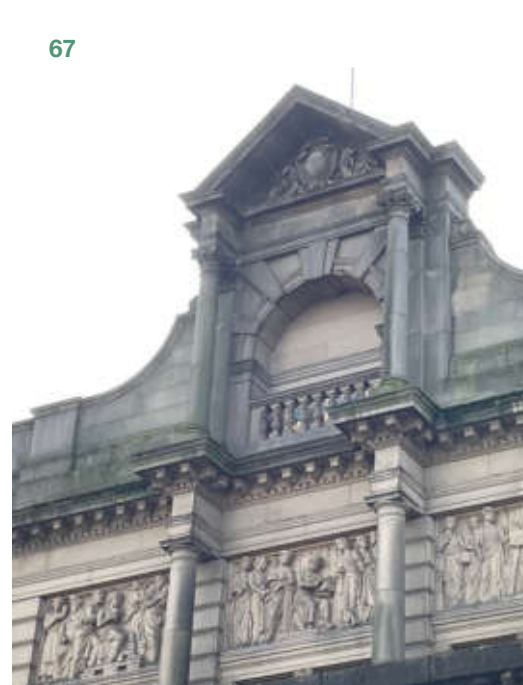
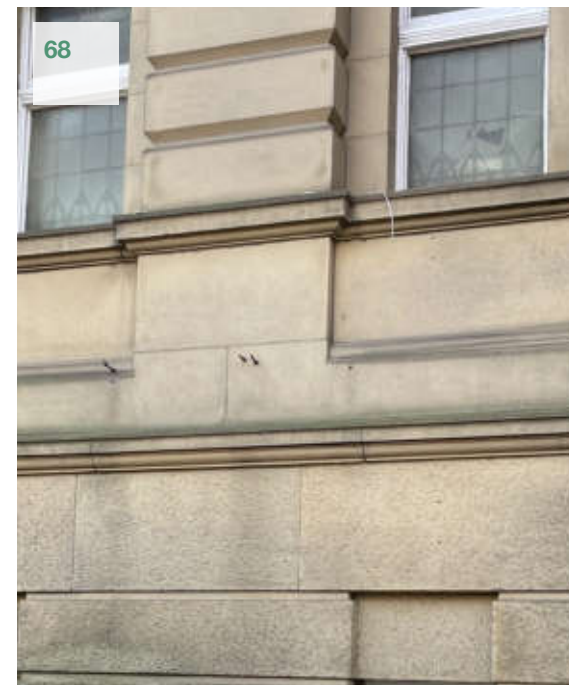
### Moss Street Elevation (North)

- 66. Portico and entrance (eastern end)
- 67. Staining at high level above the cornice to the raised pediment and swept parapets.
- 68. Fixings in stonework to east of the entrance.
- 69. Staining, spalling stone and crack above the columns to the entrance portico.
- 70. Staining, spalling stone and crack above the columns to the entrance portico.
- 71. Staining, spalling stone and crack above the columns to the entrance portico.

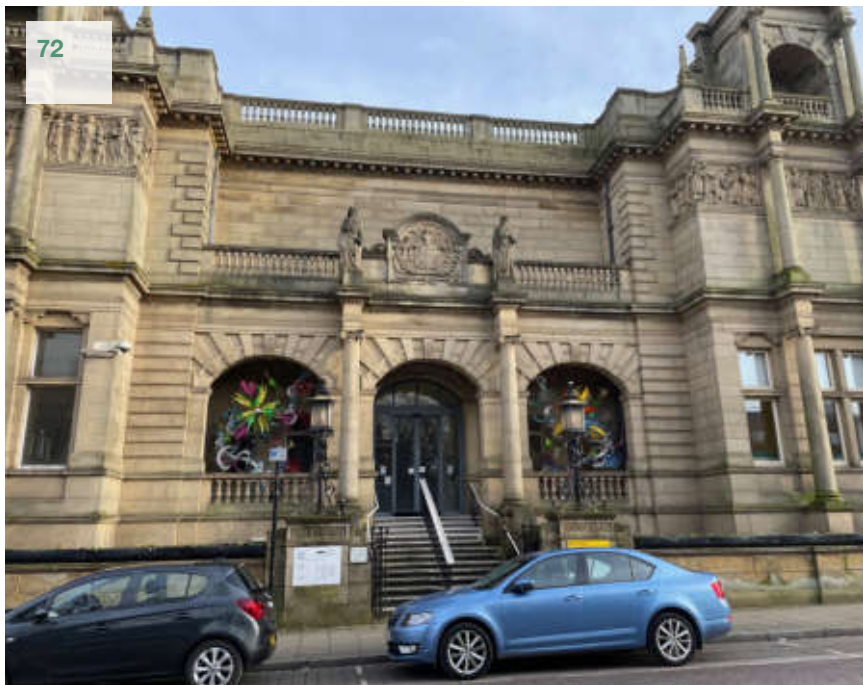
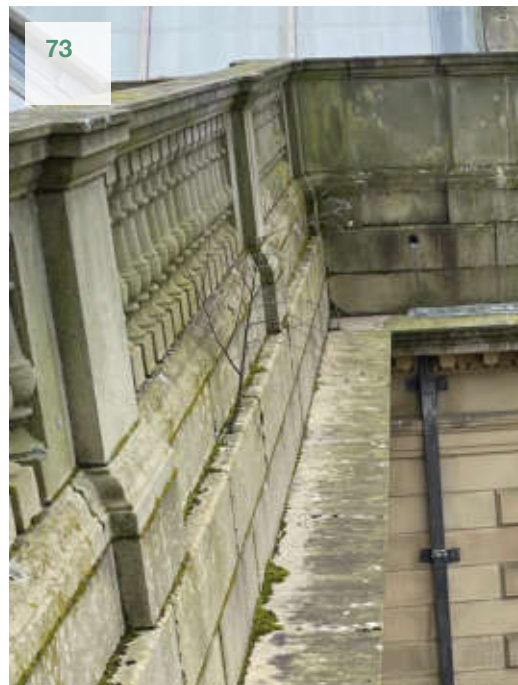
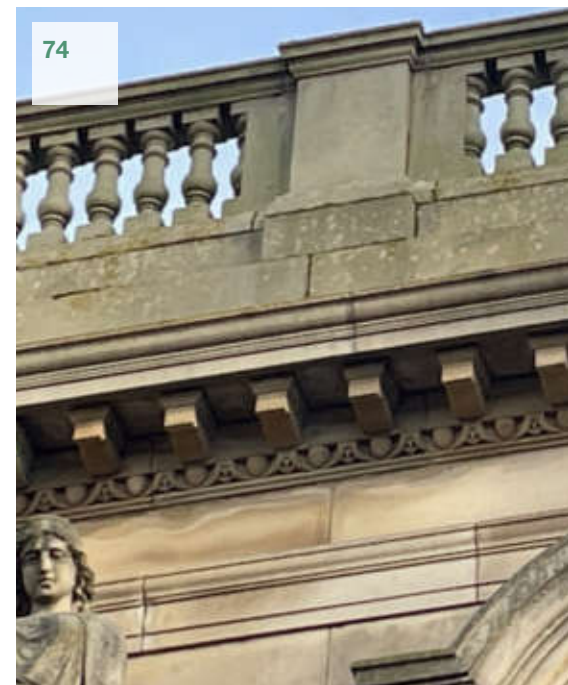
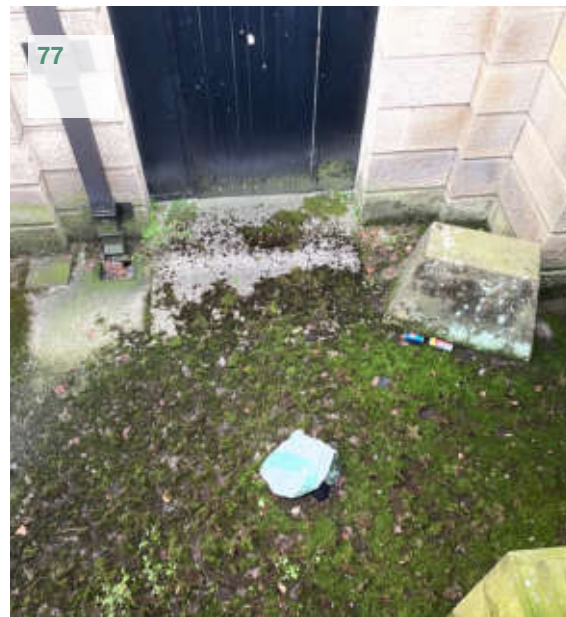
### Manchester Road Elevation (West)

- 72. Library Entrance
- 73. Growth above cornice level.
- 74. Staining from leaking parapet gutter.
- 75. Friable stone to balusters.
- 76. Blistering to frieze above arches.
- 77. Extensive moisture retention at low-level caused by concrete surfacing and ineffectual drainage provision.

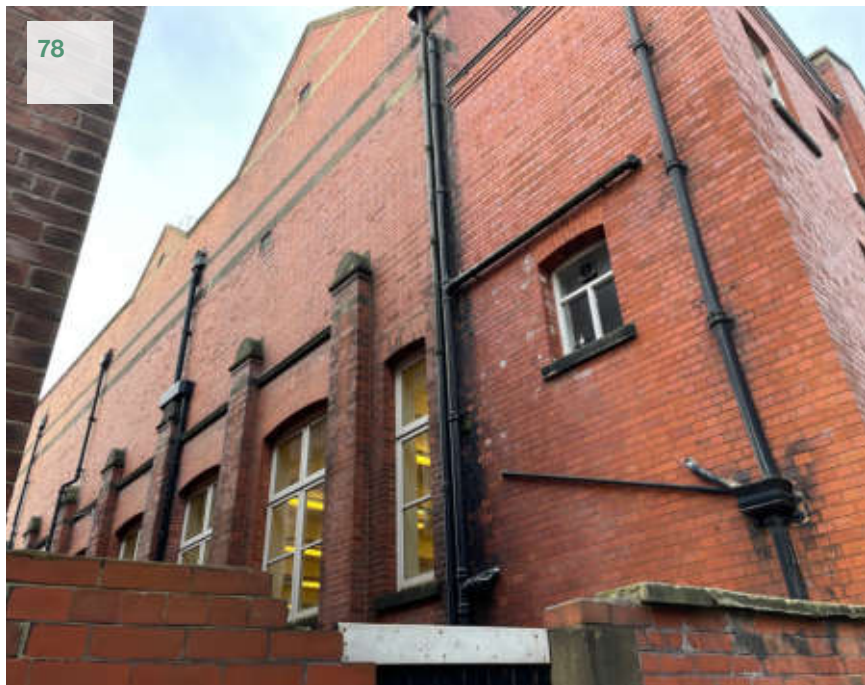
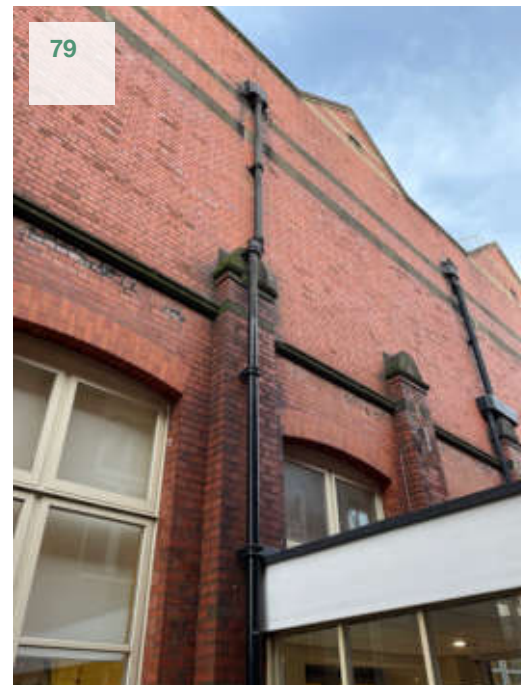
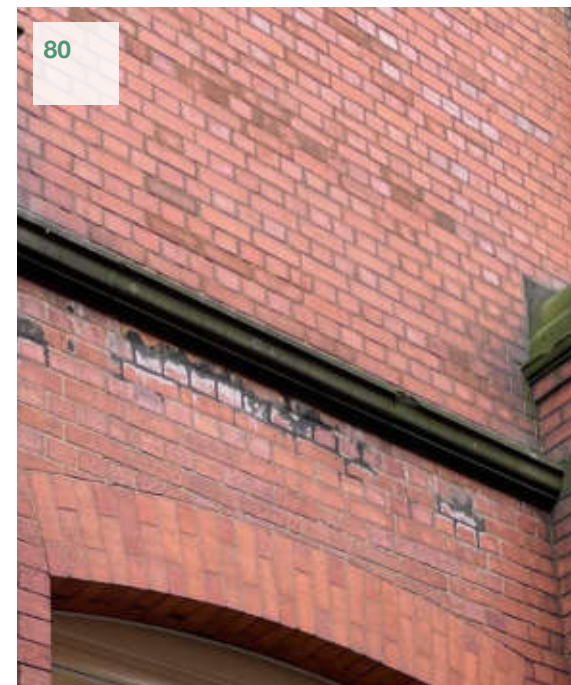
### Elevation Facing Former Textile Hall (South)

- 78. General view from Back Knowsley Street.
- 79. Junction with connecting bridge.
- 80. Staining below the string course.
- 81. Wall extending into the light well, there is moisture retention in the brickwork at low level.

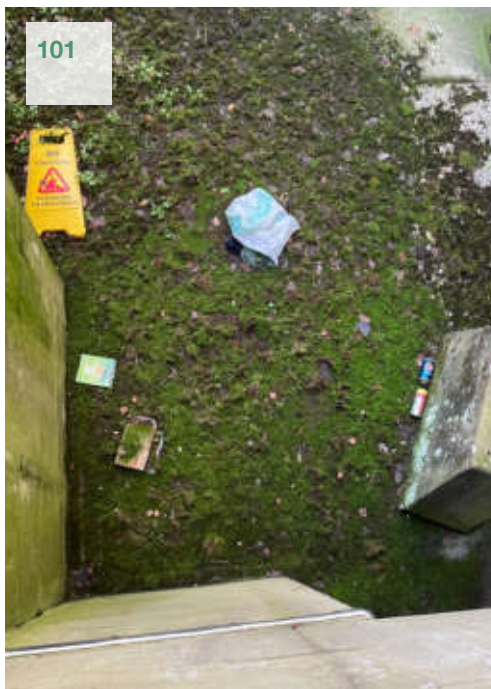
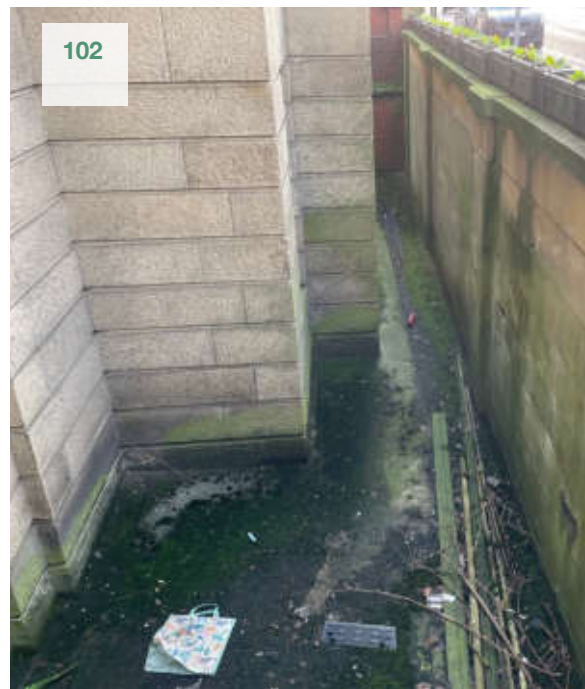
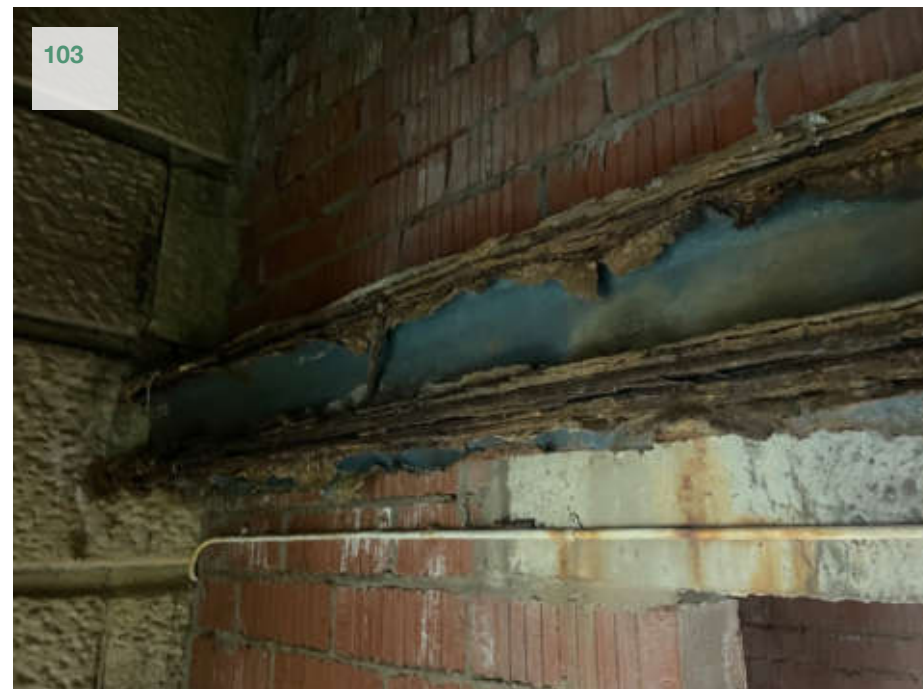
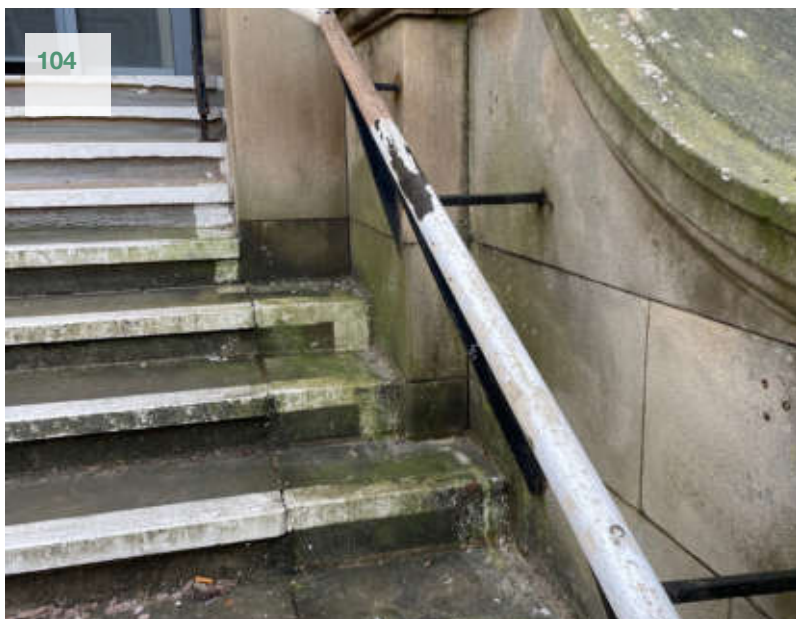
### External Areas & Boundaries. (W)

- 101.** Saturation and growth in light-well.
- 102** Debris and saturation in light well.
- 103** Corroded beams below steps.
- 104** Coating to steps and corroding handrail.

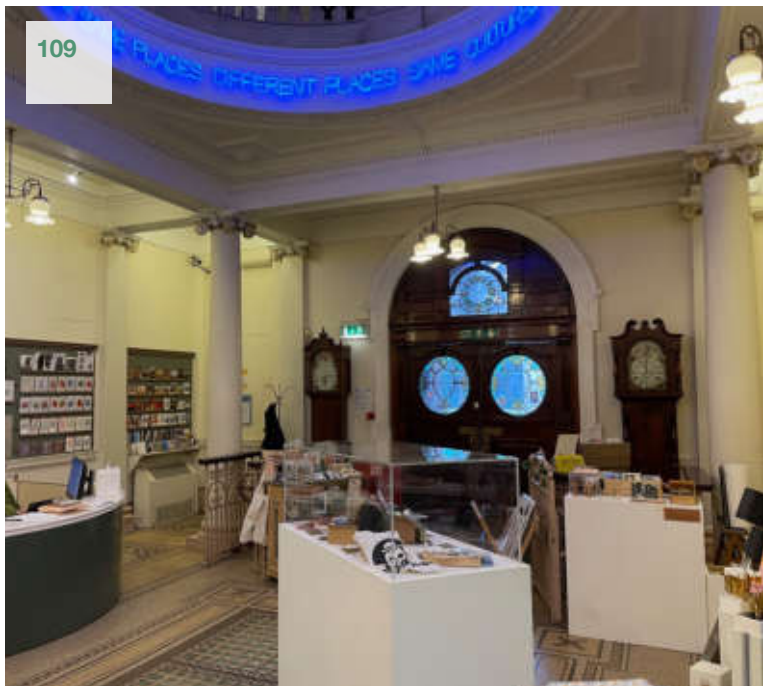
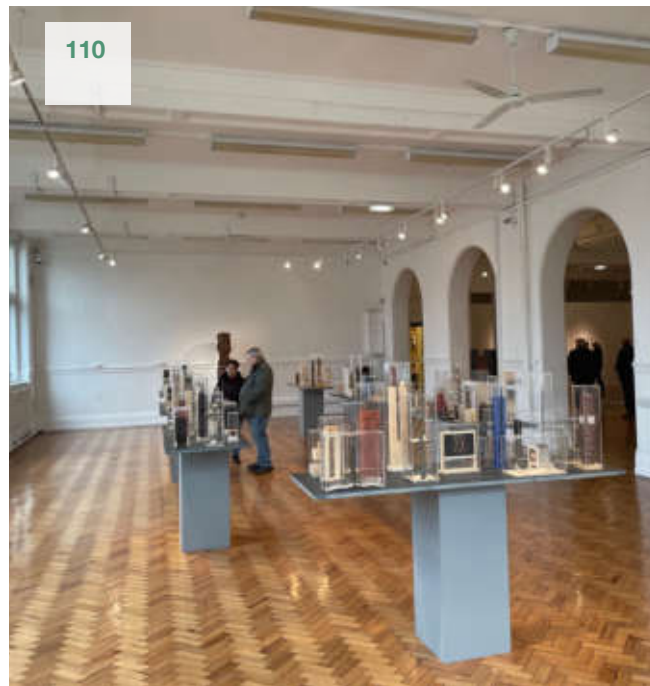
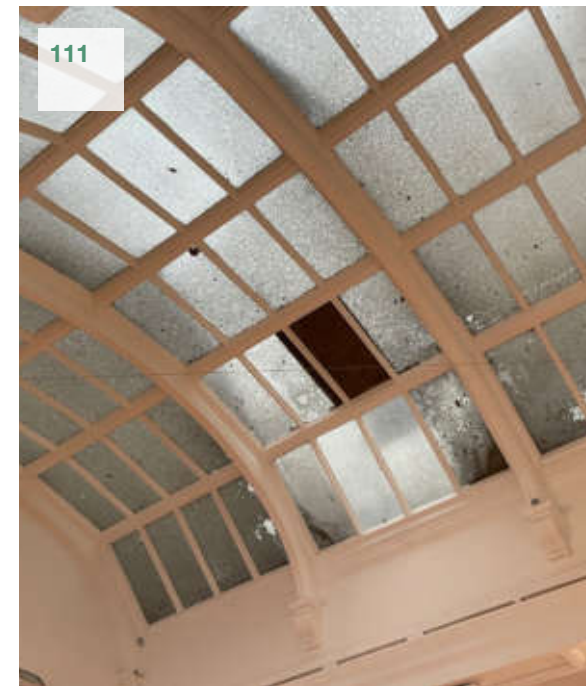
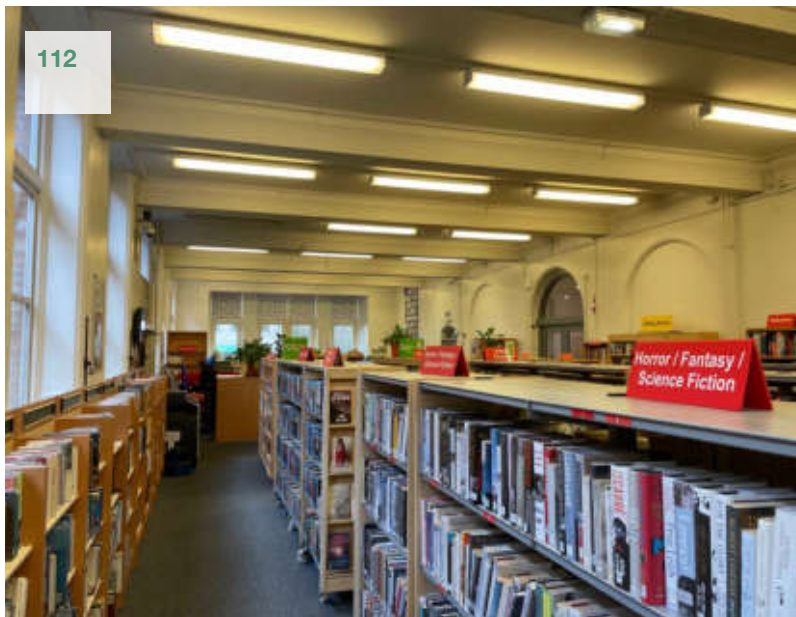
## Ground Floor Interior, 1

- 109.** Entrance Hall, General View
- 110.** Sculpture Gallery, General View (G0016)
- 111.** Sculpture Gallery, Lantern (G0015).
- 112.** Library, General View (G0014)
- 113.** Library, Water ingress & consequent migrating salt damage

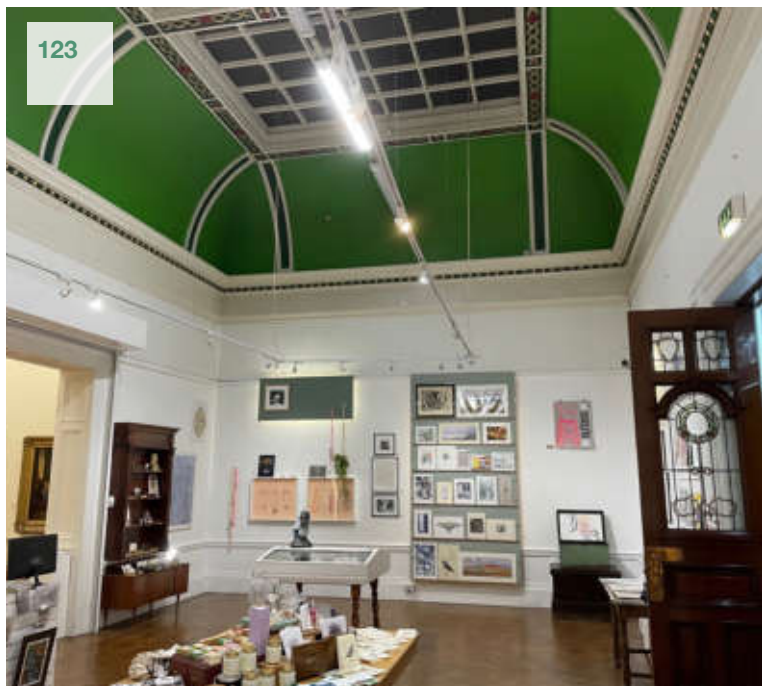
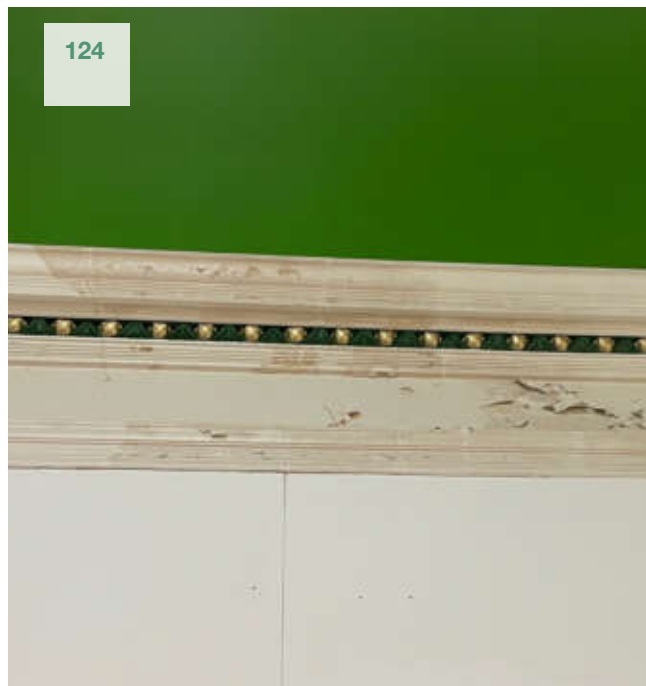
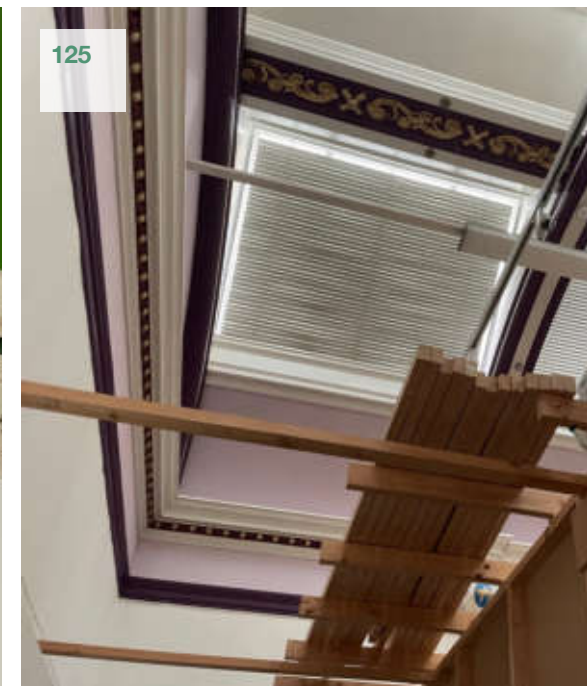
### First Floor Interior, 1

- 123.** Art Shop, General View
- 124.** Art Shop, Water Ingress
- 125.** False Ceiling and Original Over, F0011.
- 126.** Water ingress F0011
- 127.** WC and internal window lining F0010
- 128.** Internal window lining F0010 prevents operation of the original window.

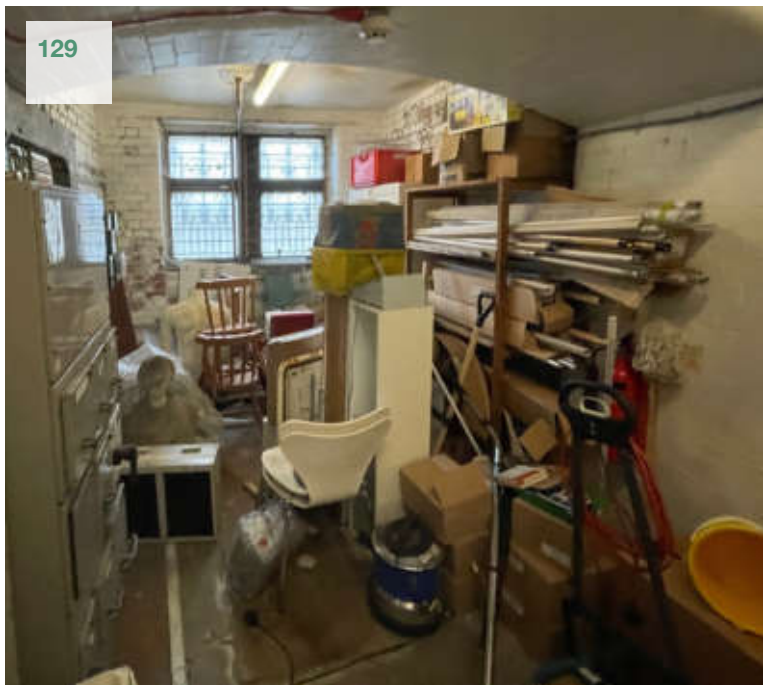
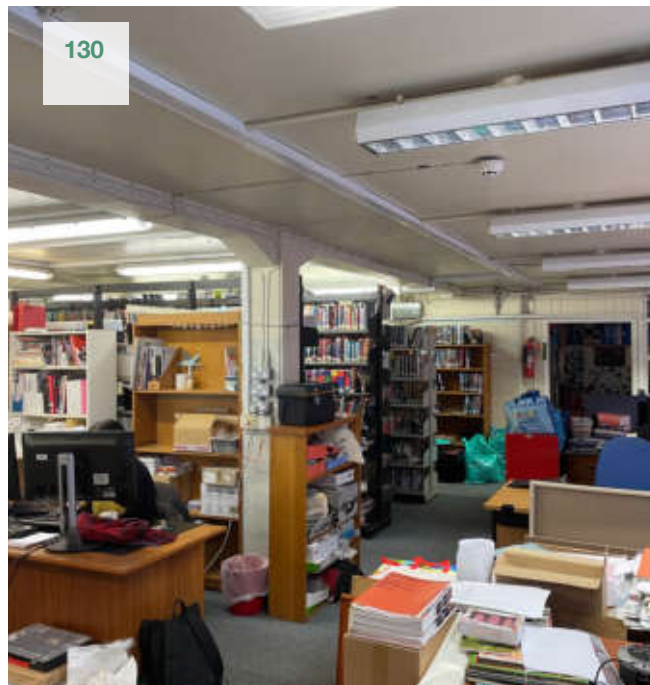
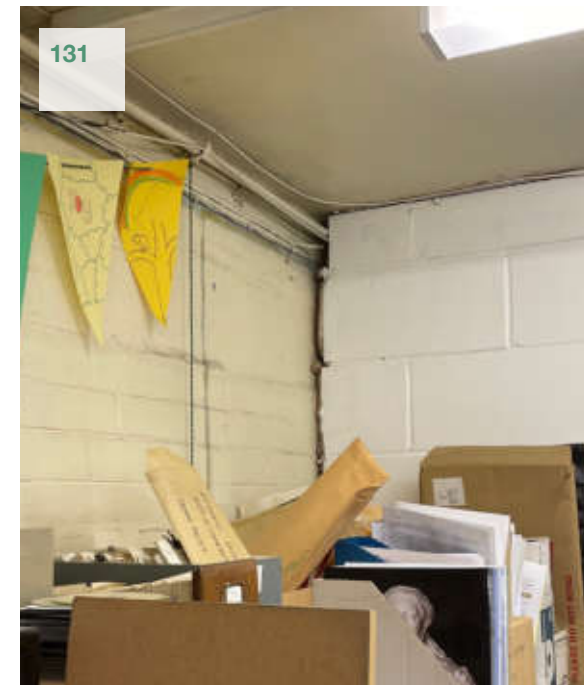
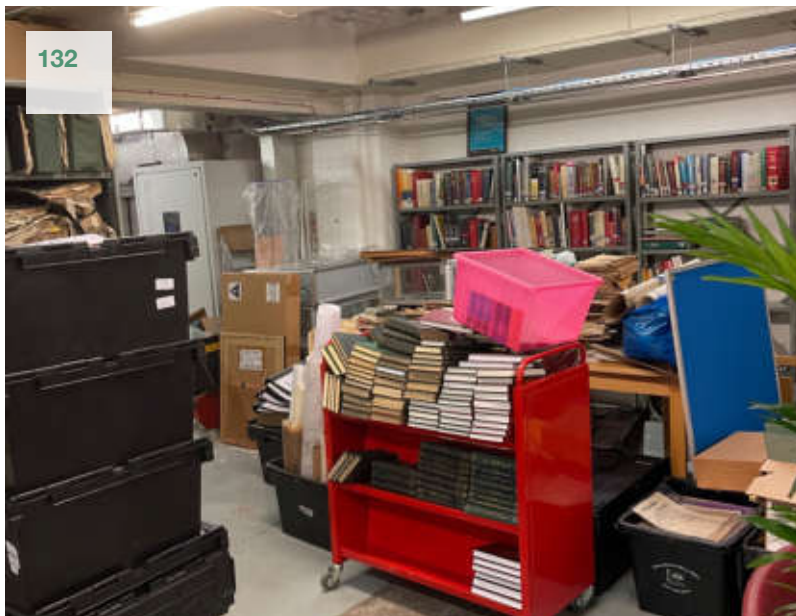
### Lower Ground Interior, 1

- 129.** Store/Electric Room under entrance stairs (LG0009).
- 130.** Office General view LG0013
- 131.** Gap around modern lobby LG0013
- 132.** Store/Work Room General view. LG0025
- 133.** Crack to floor LG0025
