**Full application for the restoration of Windy Bank farmhouse, Church Road,  
Shuttleworth, Bury**

Planning application No 72471

**Structural Report**

Ref: JB.051125.A

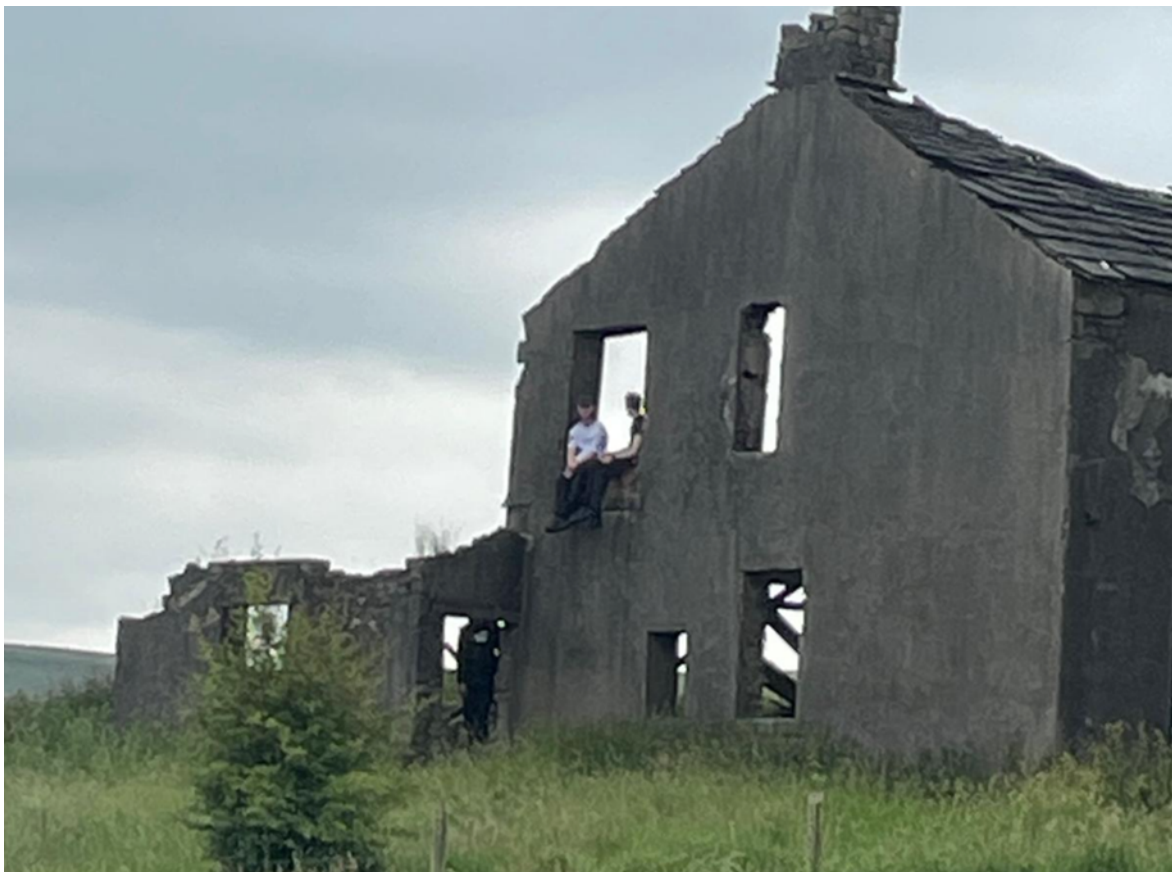
However, external walls remain which include those to ridge height: -

External walls are of natural stone. Some elevations, as above, have been rendered.

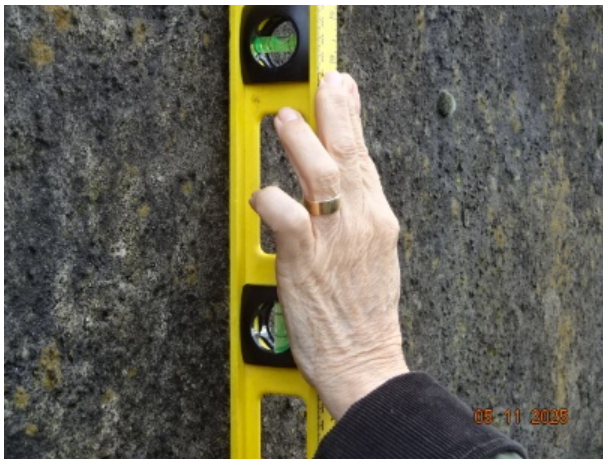
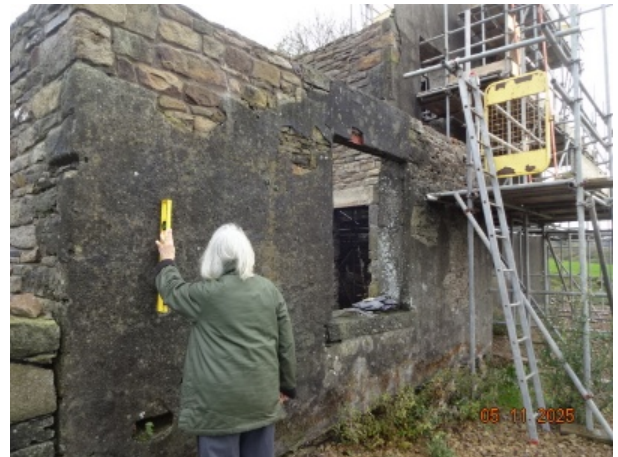
## Photos. Position 1

All the external walls (and mirrored on the inside) are plumb , with only photos No 4 showing a minor, insignificant amount of bowing. No walls demonstrate subsidence, other movement or significant cracking despite their longevity.
