# DILAPIDATION SURVEY

## Dilapidation Survey – Victoria Court Development, Bury BL8 3GY

- **Survey Date:** 21/04/2026
- **Survey Completed By:** David Dolan-Davis
- **Weather Conditions:** Dry/Sunny
- **Route Covered:** Ryecroft Avenue (adopted highway) → Private Access to Victoria Court → Site Entrance
- **Purpose:** To record the pre-construction condition of the highway and shared access for reinstatement comparison.

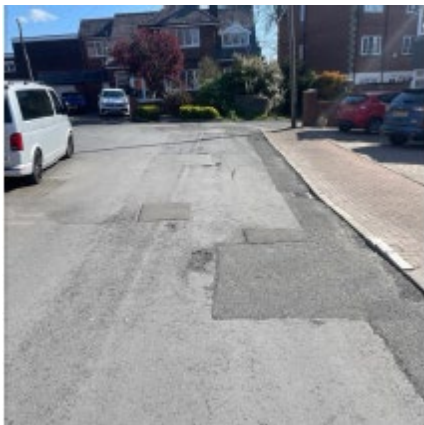
### Photo 1 - Ryecroft Avenue Carriageway

| Photo No. | Location | Direction Facing | Notes |
|---|---|---|---|
| 1 | Adjacent No. 33 Ryecroft Avenue | Towards Victoria Court | Patch repairs, uneven surface, raveling, depressions |

- **Location:** Adjacent No 33 Ryecroft Ave
- **Direction Facing:** towards Victoria Court
- **Condition Notes:**
  - Drainage cover appears **level with surrounding surface** with no visible rocking or displacement.
  - Surrounding asphalt shows **multiple patch repairs** of varying ages.
  - **Surface cracking and fretting** present around older reinstatements.
  - Minor **edge deterioration** around the drainage frame but no structural failure visible.
  - Carriageway shows **general wear**, with localised depressions and unevenness.
  - No standing water observed (dry conditions).

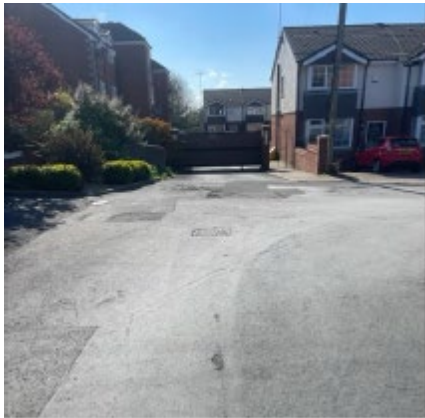
## Photo 2 - Ryecroft Avenue Carriageway

| Photo No. | Location | Direction Facing | Notes |
|---|---|---|---|
| 2 | Ryecroft Avenue | Towards Victoria Court frontage | Patch repairs, cracking, fretting, minor depressions |

- **Location:** Ryecroft Avenue
- **Direction Facing:** Towards gates of Victoria Court
- **Condition Notes:**
  - Carriageway surface shows **general wear** with visible **historic patch repairs**.
  - Localised **surface depressions** present along the wheel tracks.
  - Minor **cracking and fretting** around older reinstatements.
  - No potholes visible, but **surface deterioration** is evident.
  - Kerblines appear intact with **no displacement** observable from this angle.
  - Vegetation and boundary features well maintained; no encroachment onto the carriageway.
  - No standing water; surface dry and free from debris.

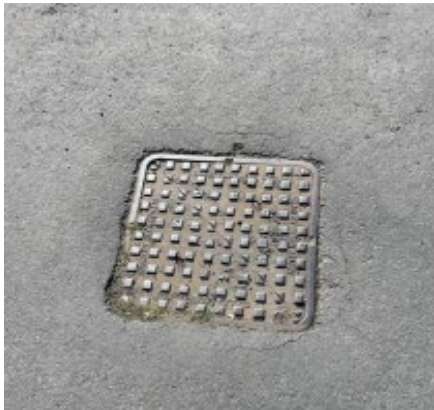
## Photo 3 - Drainage Cover (Ryecroft Avenue)

| Photo No. | Location | Direction Facing | Notes |
|---|---|---|---|
| 3 | Ryecroft Avenue | Towards bend leading to Victoria Court | Level cover, patch repairs, cracking, edge wear |

- **Location:** Rycroft Ave
- **Direction Facing:** Towards Victoria Court, centre of carriageway
- **Condition Notes:**
  - Drainage cover appears **secure and seated correctly** within the frame.
  - Surrounding asphalt shows **surface wear** and **minor edge deterioration**.
  - No visible cracking radiating from the frame.
  - No displacement, rocking, or settlement evident.
  - Light debris and minor vegetation present around edges but **no obstruction** to drainage.
  - Carriageway

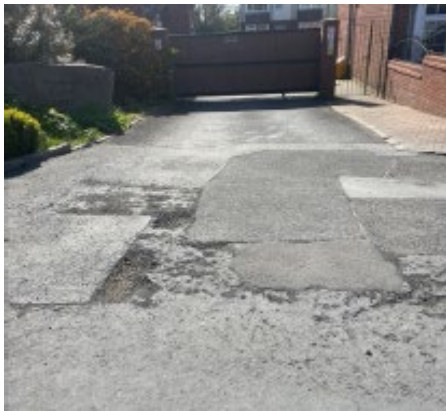
## Photo 4 - Carriageway Ryecroft Avenue

| Photo No. | Location | Direction Facing | Notes |
|---|---|---|---|
| 4 | Approach to Victoria Court | Towards gated entrance | Wear, patch repairs, depressions, fretting |

- **Location:** Approach to Victoria Court
- **Direction Facing:**
- **Condition Notes:**
  - Surface shows **multiple historic patch repairs** of varying sizes and ages.
  - **Cracking and fretting** visible across the carriageway, particularly around reinstatements.
  - Localised **surface depressions** and unevenness present along the wheel path.
  - No potholes visible, but **general deterioration** consistent with ageing asphalt.
  - Edges of the carriageway remain intact with **no kerb displacement** visible.
  - Vegetation and boundary walls stable; no encroachment onto the access route.
  - No standing water; surface dry and unobstructed.

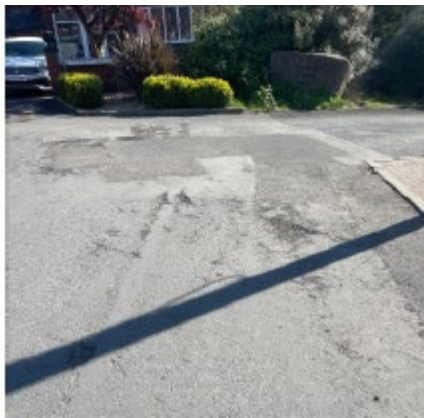
## Photo 5 – Carriageway Ryecroft Avenue

| Photo No. | Location | Direction Facing | Notes |
|---|---|---|---|
| 5 | Approach to Victoria Court | Towards Victoria Court | Secure cover, minor edge wear, surface ageing |

- **Location:** Approach to Victoria Court
- **Direction Facing:**
- **Feature:**
- **Condition Notes:**
  - Asphalt surface shows multiple patch repairs of differing ages.
  - Cracking and surface fretting visible around older reinstatements.
  - Localised crazing and minor depressions present across the carriageway.
  - No evidence of potholes, but surface wear is clearly established.

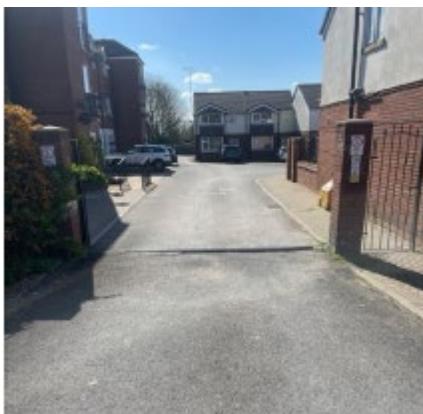
## Photo 6 - Shared Private Access Surface

| Photo No. | Location | Direction Facing | Notes |
|---|---|---|---|
| 6 | Shared Private Access | Towards gated entrance | Patch repairs, cracking, depressions, general deterioration |

- **Location:** Main entrance gates
- **Direction Facing:**
- **Feature:** Carriageway Surface
- **Condition Notes:**
  - No potholes visible, but deterioration consistent with an ageing private access surface.
  - Edges of the access route remain intact with no kerb displacement visible.
  - Boundary walls and structures appear stable with no visible movement or cracking.
  - No standing water; surface dry and unobstructed.

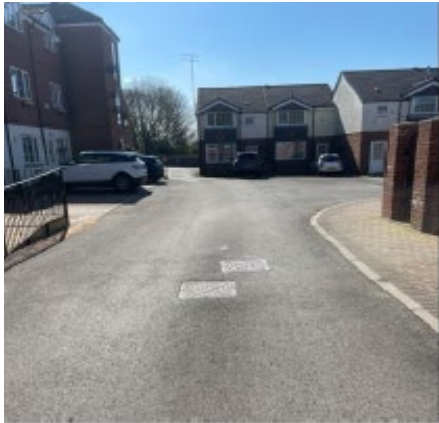
## Photo 7 - Site Entrance Surface

| Photo No. | Location | Direction Facing | Notes |
|---|---|---|---|
| 7 | Site Entrance | Towards internal courtyard | Wear, patch repairs, cracking, depressions |

- **Location:**
- **Direction Facing:**
- **Condition Notes:**
  - Boundary walls on both sides appear **structurally sound** with no visible cracking, movement, or displacement.
  - Kerblines appear **intact and aligned**, with no uplift, settlement, or damage visible.
  - Carriageway surface shows **general wear**, including minor cracking and historic patch repairs.
  - Localised **surface depressions** present along the wheel path but no potholes visible.
  - No vegetation encroachment onto the kerblines or carriageway.
  - No standing water; surface dry and unobstructed.

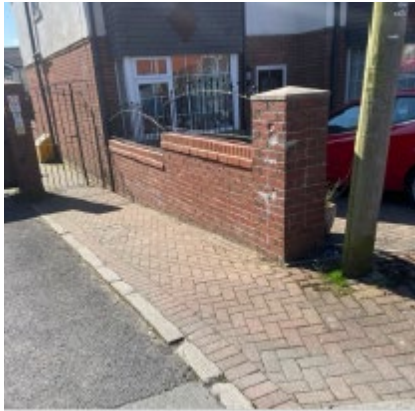
## Photo 8 - Site Entrance Boundary Wall/Kerbs

| Photo No. | Location | Direction Facing | Notes |
|---|---|---|---|
| 8 | Entrance to Victoria Court | Towards internal courtyard | Sound walls, intact kerbs, surface wear |

- **Location:** Entrance to Victoria Court
  - **Direction Facing:** Towards Gated entrance
  - **Condition Notes:**
    - Brick boundary wall appears **structurally sound**, with no visible cracking, bulging, or displacement.
    - Metal railings fixed to the wall show **no distortion or corrosion** visible from this angle.
    - Kerbline at the corner appears **intact and aligned**, with no uplift, settlement, or damage.
    - Footway block paving is **level and free from trip hazards**, with no visible displacement.
    - Adjacent carriageway surface shows **general wear** but no significant defects in this section.
    - No vegetation encroachment onto the wall, kerbline, or footway.
    - No standing water or drainage issues observed.
