## Verification Completion Report for Ground Gas Protection Systems

| Project Title | 137 The Rock |
| Date | 26.02.24 RN1507 |
| Plot Numbers | 11, 12 & 13 |

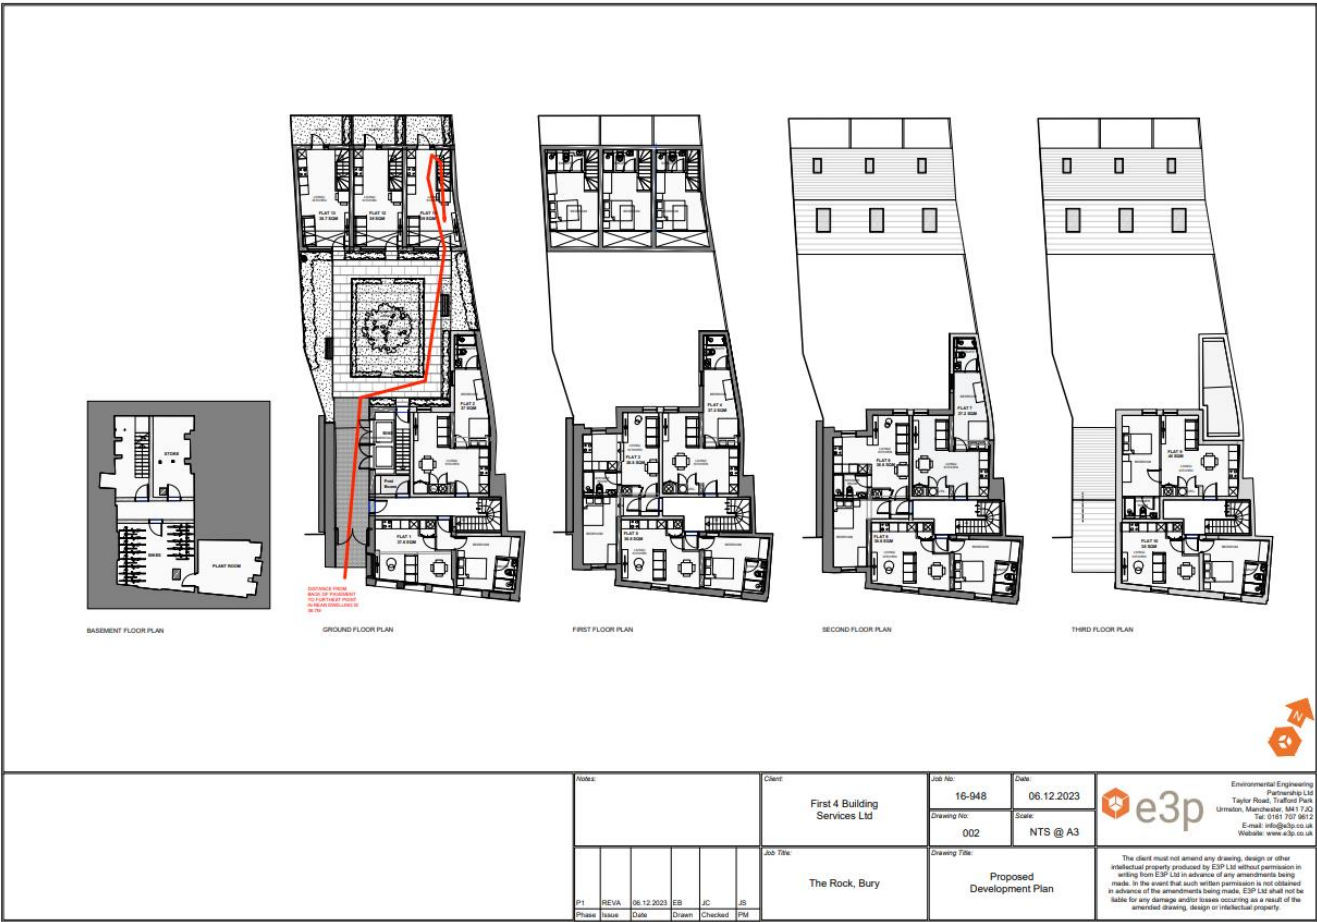
On the 26<sup>th</sup> February 2024 the installed membrane at 137 The Rock, Bury was checked using pick testing, visual inspection and air lancing.

The installed membrane was a Visqueen Ultimate HC Blok with Visqueen Pro Detailing Strip used for corner and pipe detailing as well as repair patches.

The plot was a combination of machine and hand welded. The weather is cloudy and overcast. 15 outlets 10 air bricks. Other than a few (4) minor faults which the installers fixed there and then neat and tidy job.

All the corners and door entries were sealed with sufficient overlaps.

The pipe penetrations were all sealed in situ with detailing tape.

All welds were air lanced at a constant 50 psi.

The work was carried out to a high standard and passed inspection.
