**Prestwich North Car Park  
Prestwich  
Manchester  
M25 1BT**

**Supplementary Ground Investigation**

The Prestwich Regeneration LLP

J23254A  
Rev 1

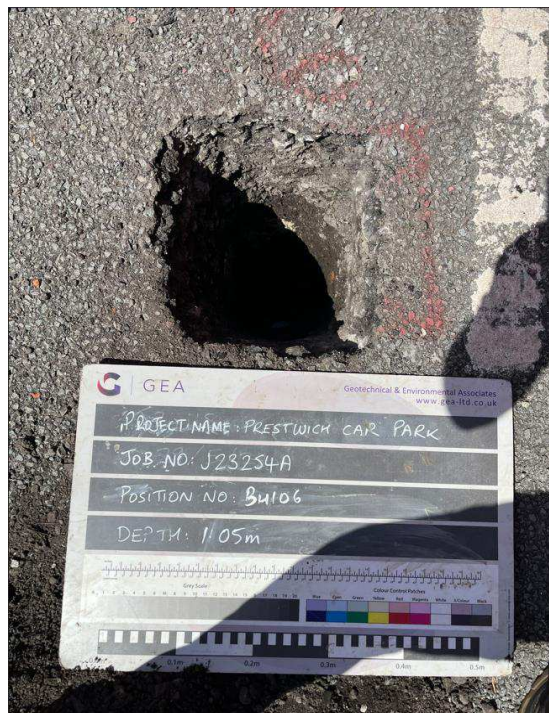
*BH106 - terminated at a depth of 1.05 m on concrete obstruction*

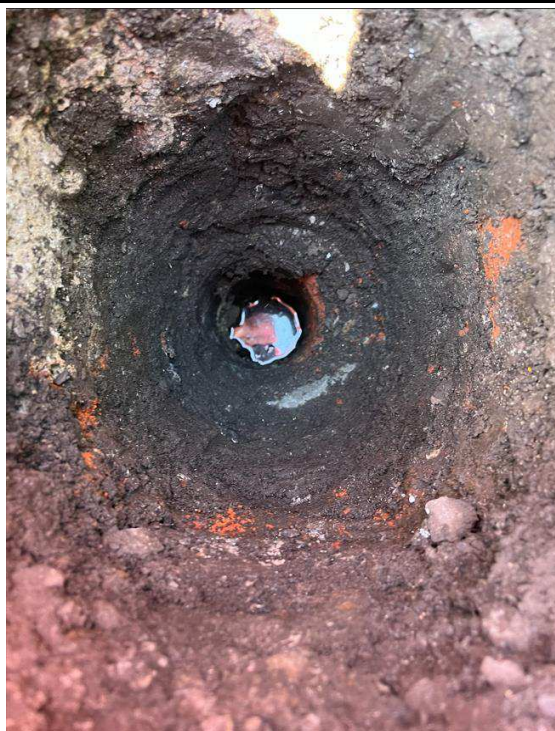
*BH106 - perched water sitting on obstruction*

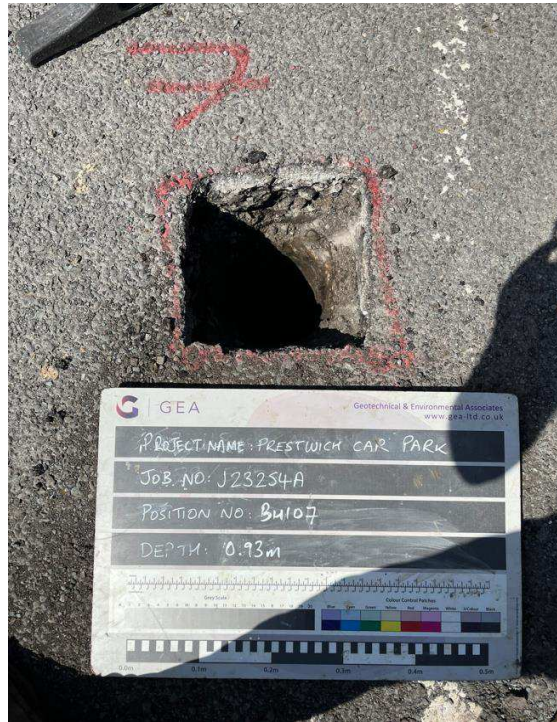
*BH107 - terminated at a depth of 0.93 m on concrete obstruction*

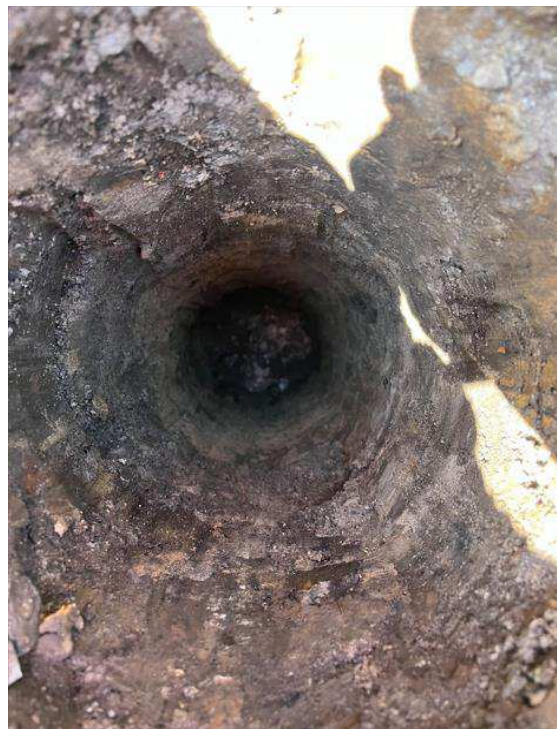
*BH107 - Closer view of obstruction*

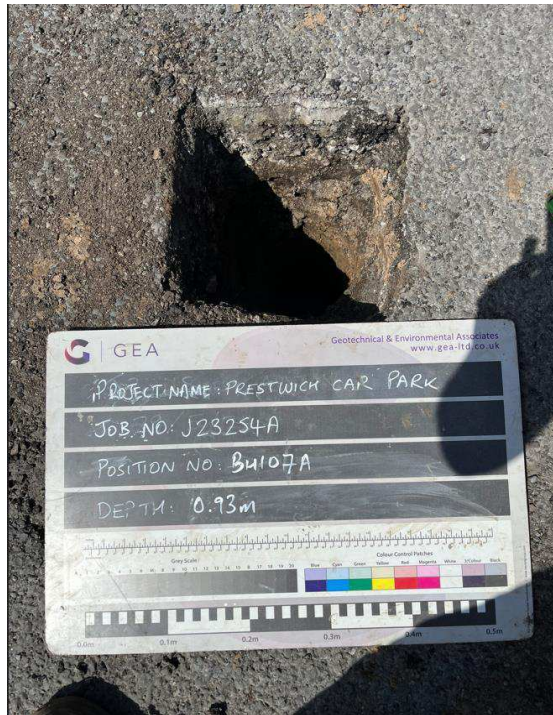
*BH107A - terminated at a depth of 0.93 m on concrete obstruction*

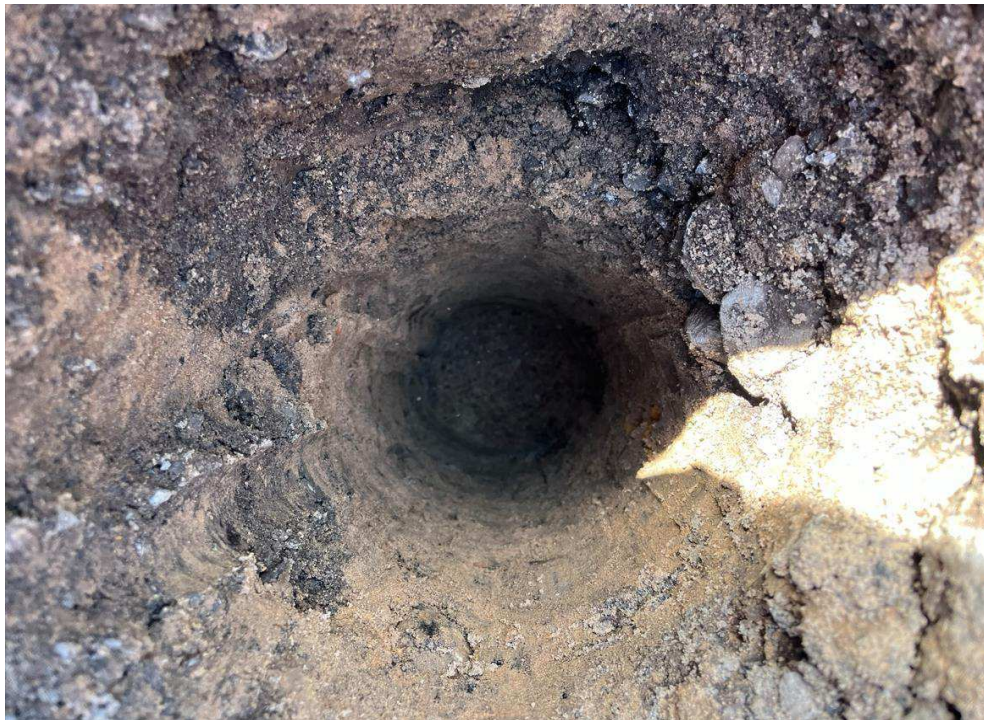
*BH107A - Closer view of obstruction*

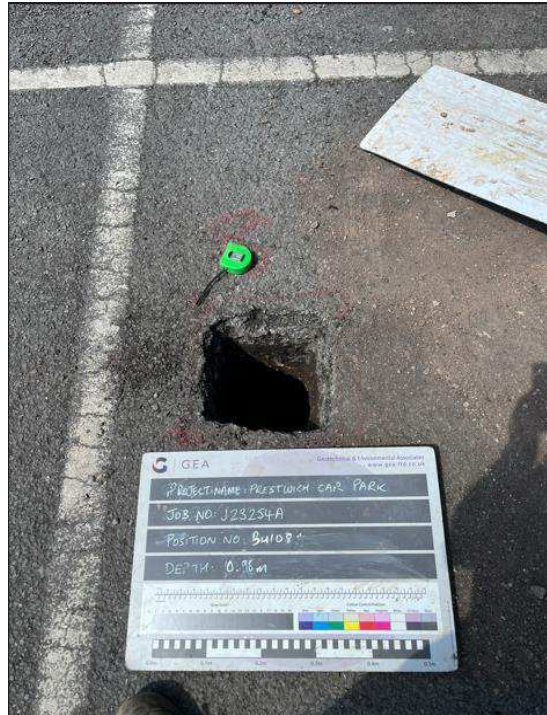
*BH108 - terminated at a depth of 0.98 m on concrete obstruction*

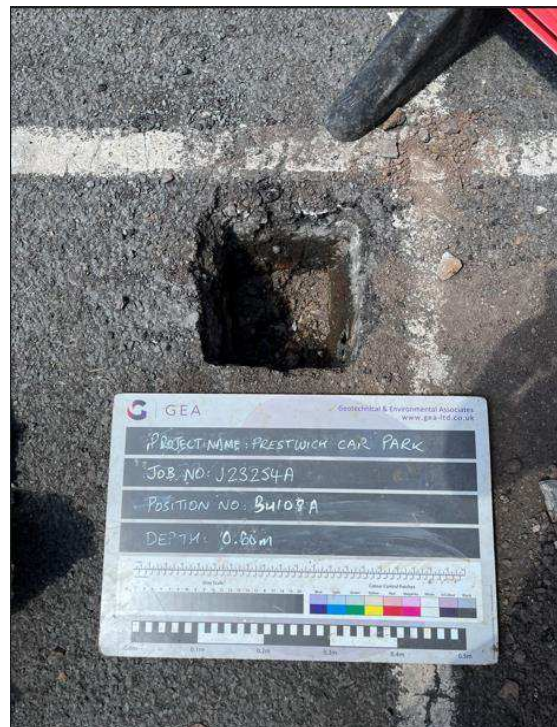
*BH108A - terminated at a depth of 0.60 m due to the possible presence of asbestos*

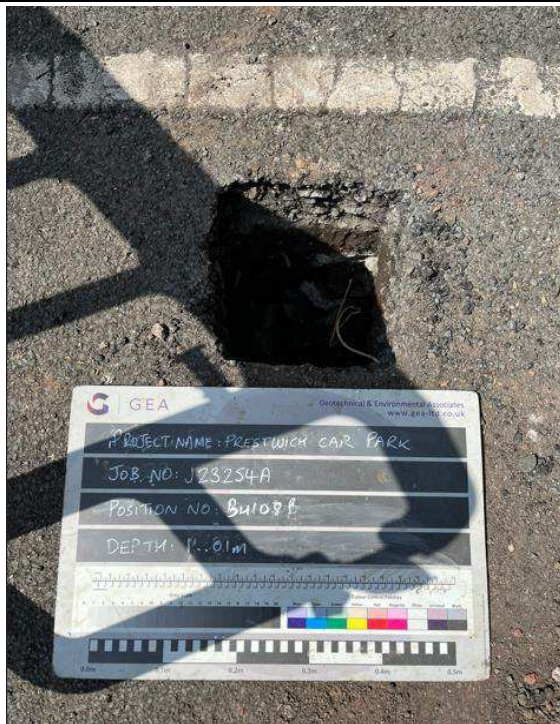
*BH108B - terminated at a depth of 1.01 m on concrete obstruction*

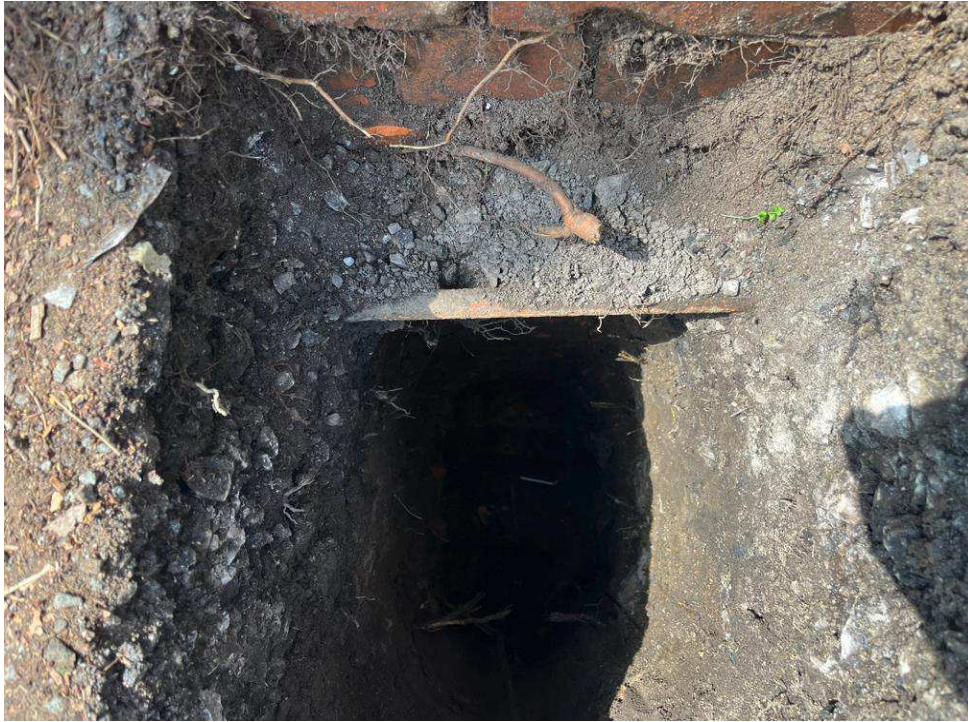
*TP101 - Metal pipe encountered at a depth 0.16 m running parallel with the wall.*

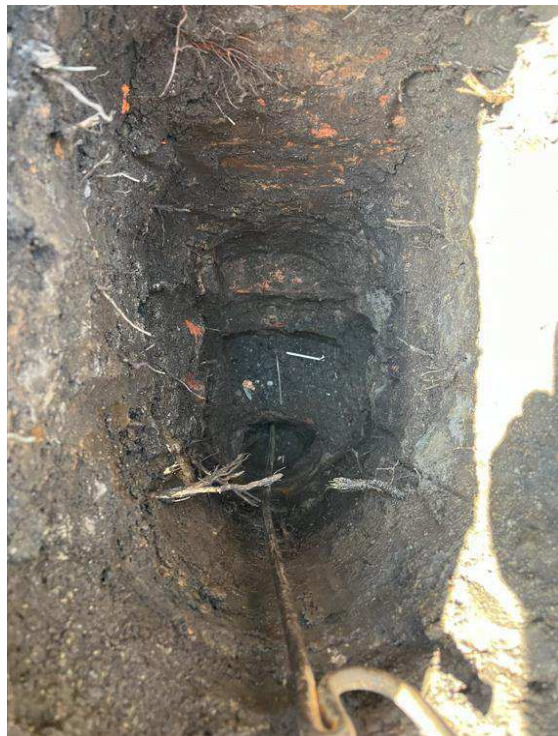
| Hand Pit No | Structure | Foundation detail | Bearing Stratum |
|---|---|---|---|
| 101 | Western boundary wall within the south of the site | Stepped brick structure onto concrete strip<br>Top of brick 960 mm<br>Top of concrete 1080 mm<br>Base 1250 mm<br>Lateral projection 270 mm | Greyish brown silty SAND with possible fragments of decaying organic matter. |

*TP101 - Closer view of foundation*

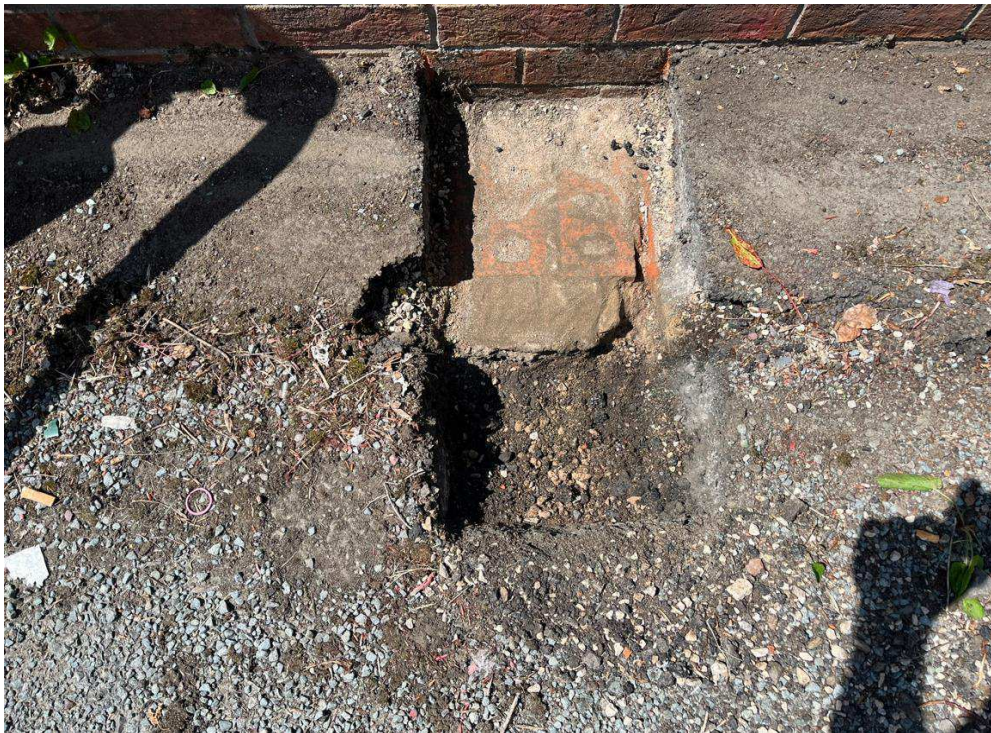
| Hand Pit No | Structure | Foundation detail | Bearing Stratum |
|---|---|---|---|
| 102 | Western boundary wall within the centre of the site | Inconclusive.<br>Layer of concrete and bricks encountered at 420 mm depth and locally broken out to 530 mm. The proximity of adjacent buried services resulted in the termination of the trial pit. | Not determined. |

TP102 - View of footing

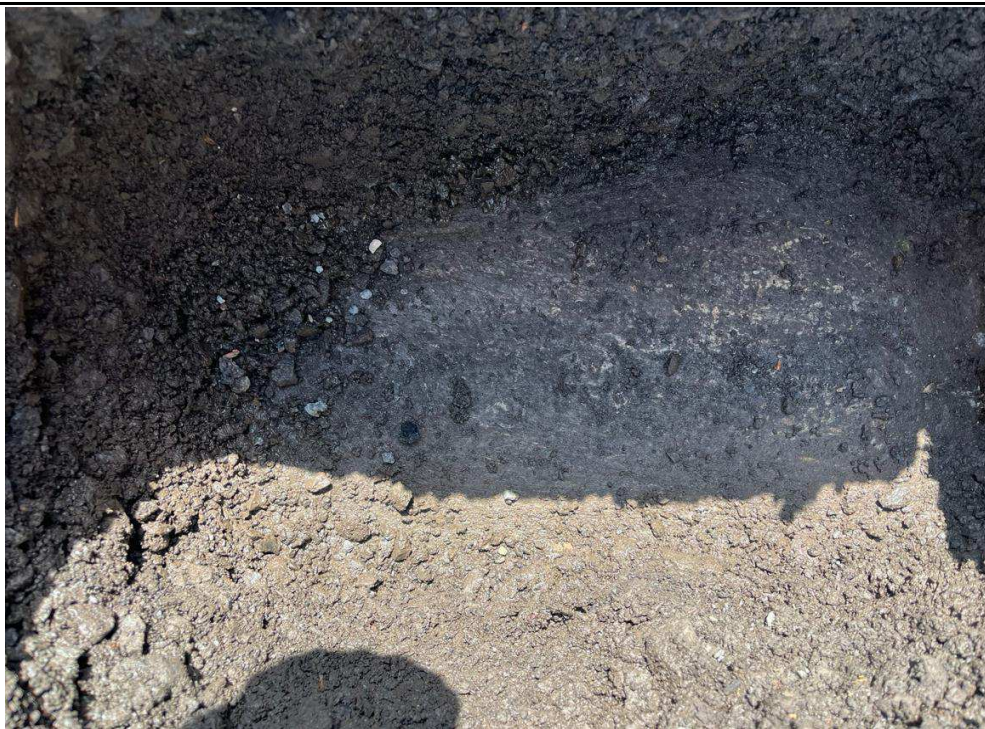
TP102 - Closer view of concrete slab
