## Service Trench Photographs

**Site** Prestwich North Car Park, Fairfax Road, Prestwich, Manchester, M25 1BT

**Client** The Prestwich Regeneration LLP

**Job Number**  
J23254A

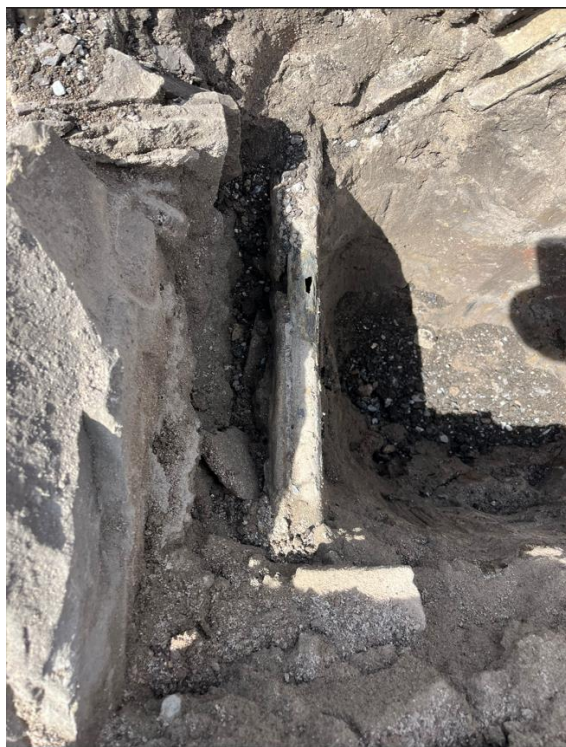
*TS01 - Timber-clad within the eastern part of the excavation*

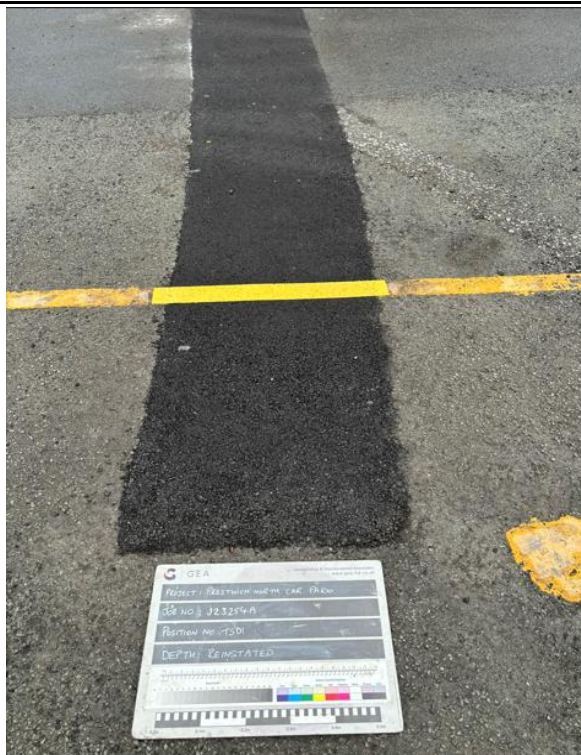
*TS01 - Reinstated*

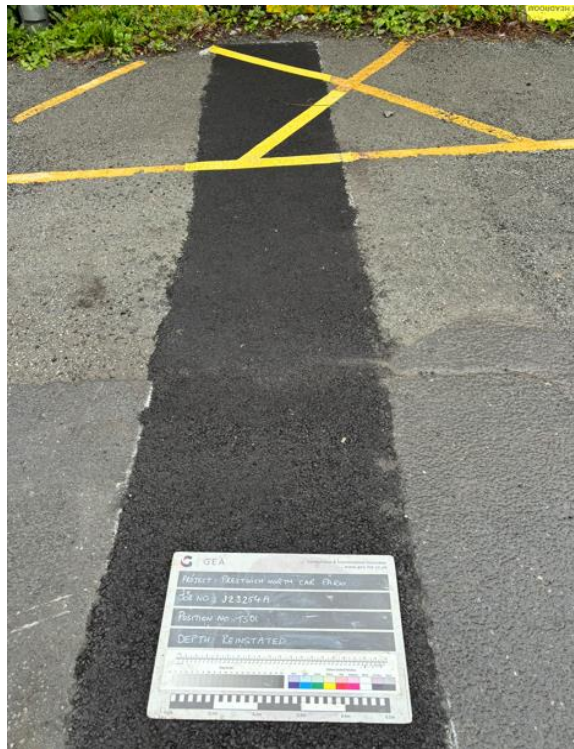
TS01 - Reinstated

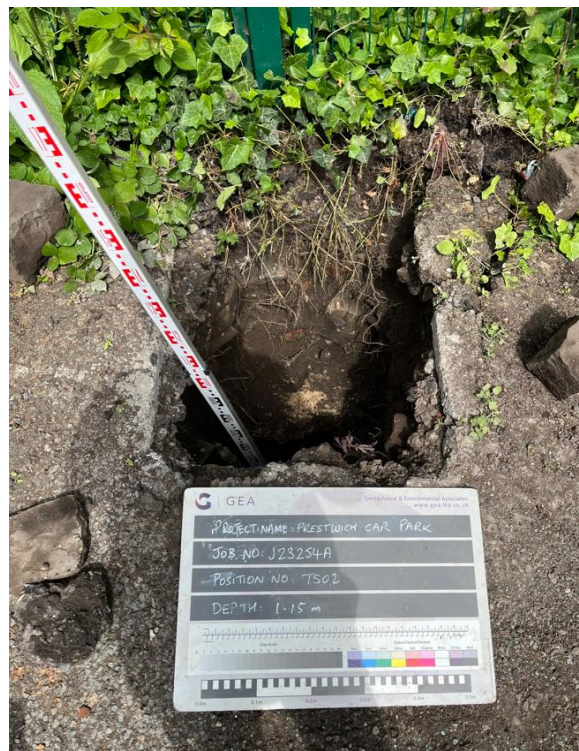
TS02 - Excavation to a depth of 1.15 m looking northeast

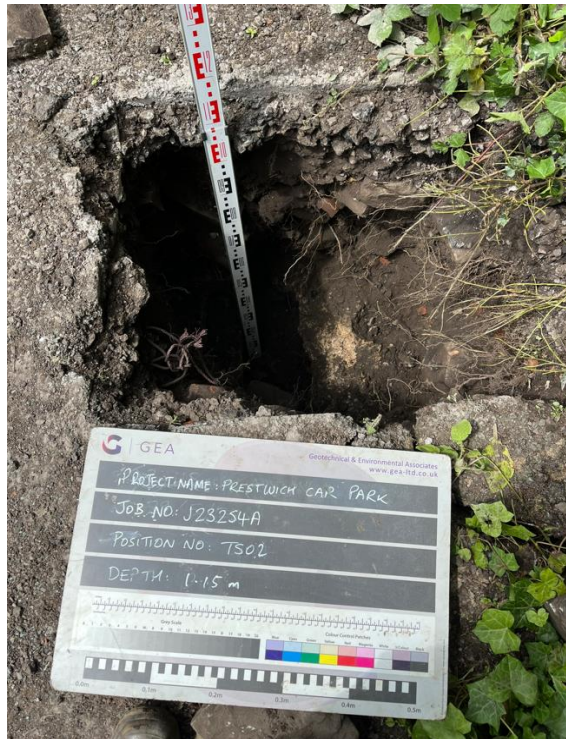
TS02 - Excavation to a depth of 1.15 m looking northwest - no services encountered

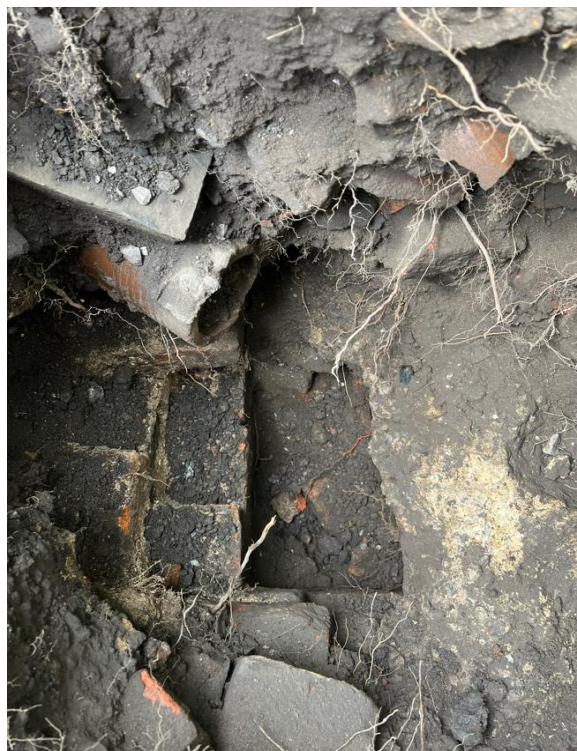
TS02 - Closer view of the pit

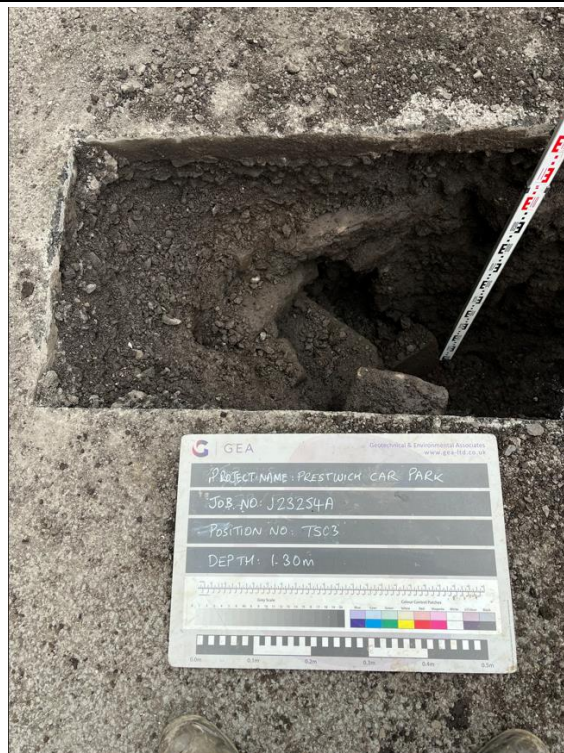
TS03 - Excavation to a depth of 1.30 m looking southeast

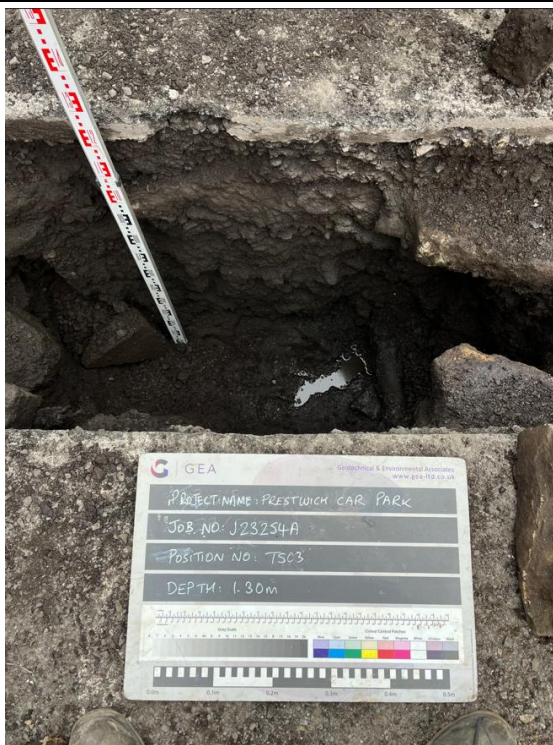
TS03 - Excavation to a depth of 1.30 m looking southeast

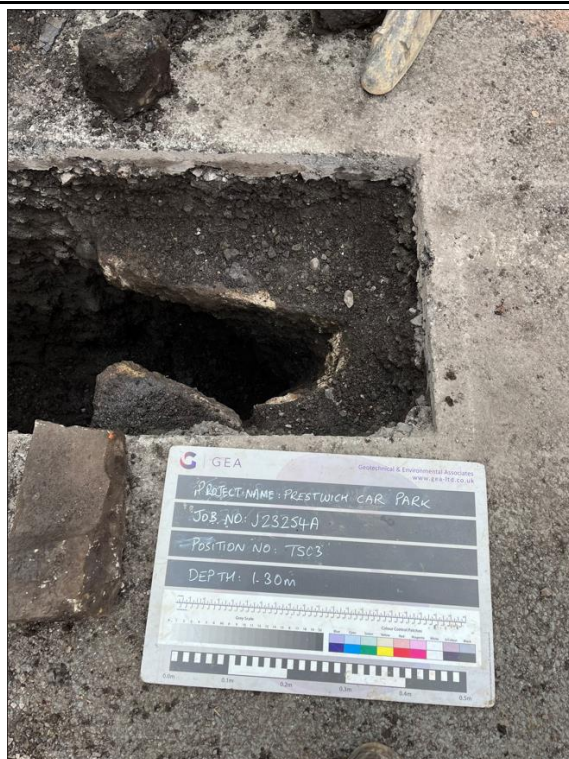
TS03 - Excavation to a depth of 1.30 m looking southeast

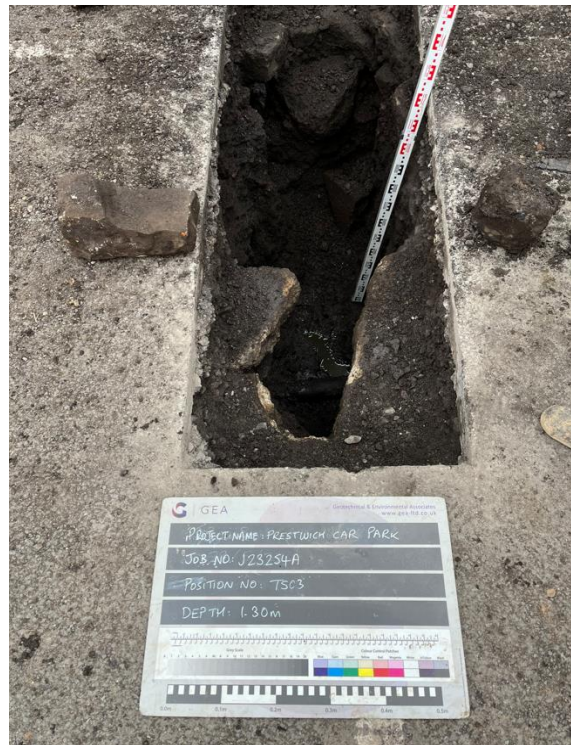
TS03 - Excavation to a depth of 1.30 m looking northeast

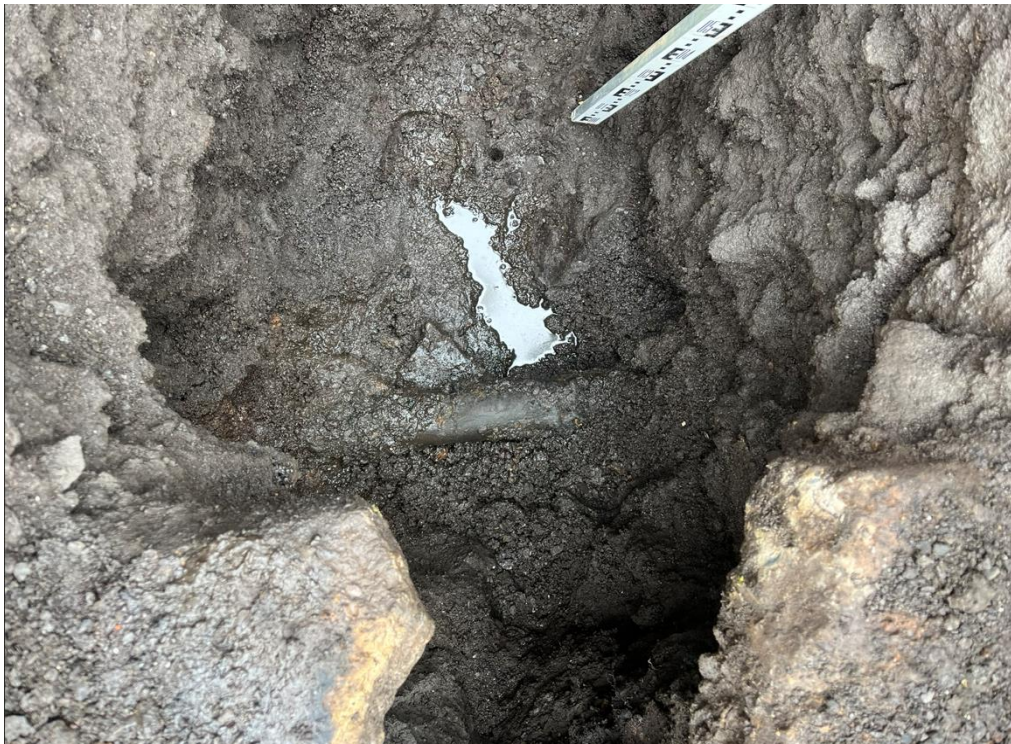
TS03 - Cast iron pipe at base of the excavation

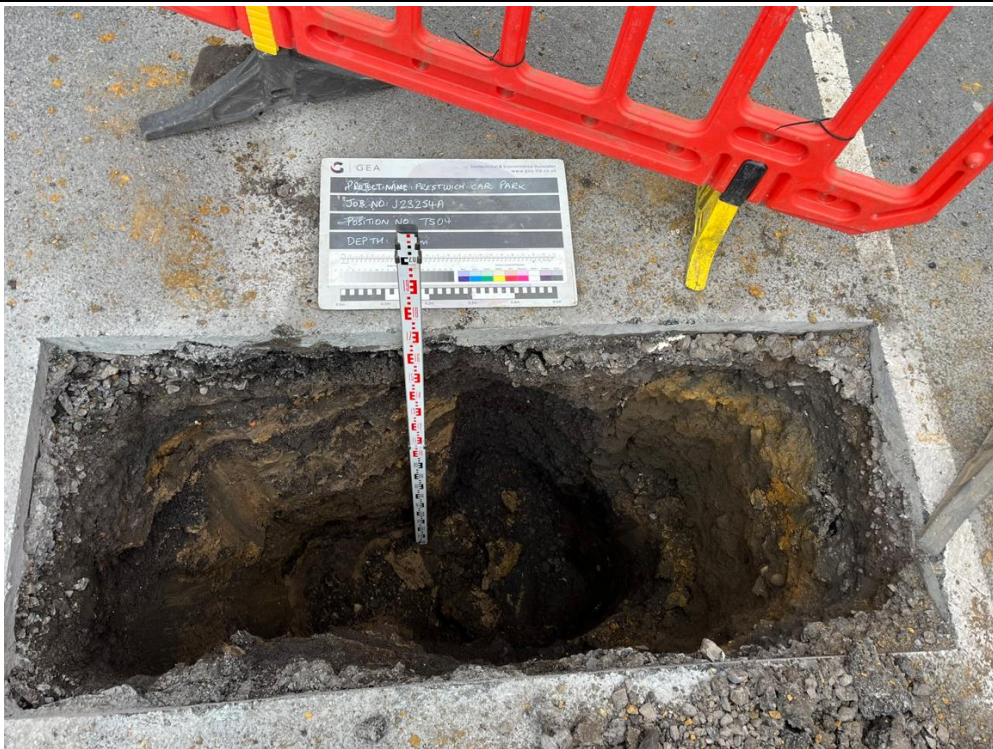
TS04 - Excavation to a depth of 1.80 m looking southeast - drainage pipe encountered

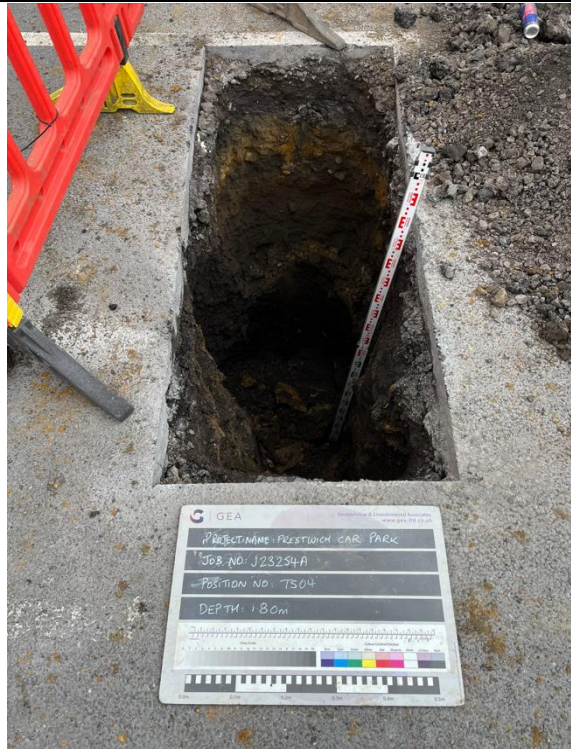
*TS04 - Excavation to a depth of 1.80 m looking northwest - drainage pipe encountered*

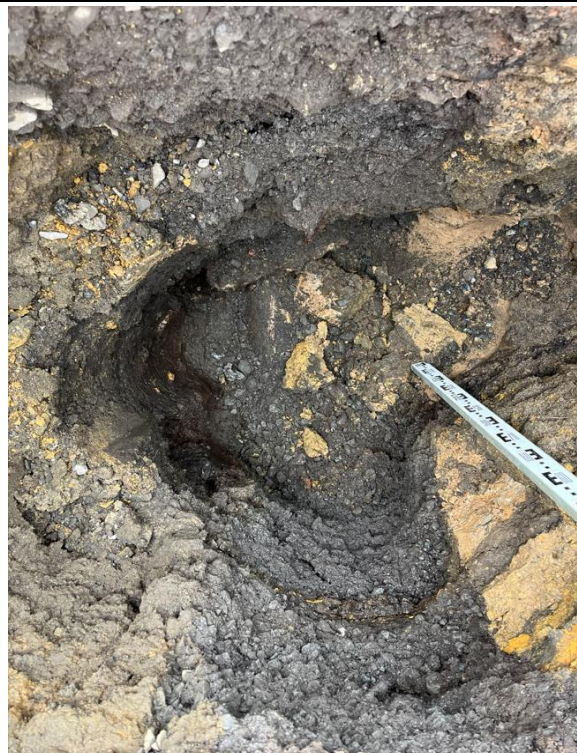
*TS04 - Closer view of drainage pipe*

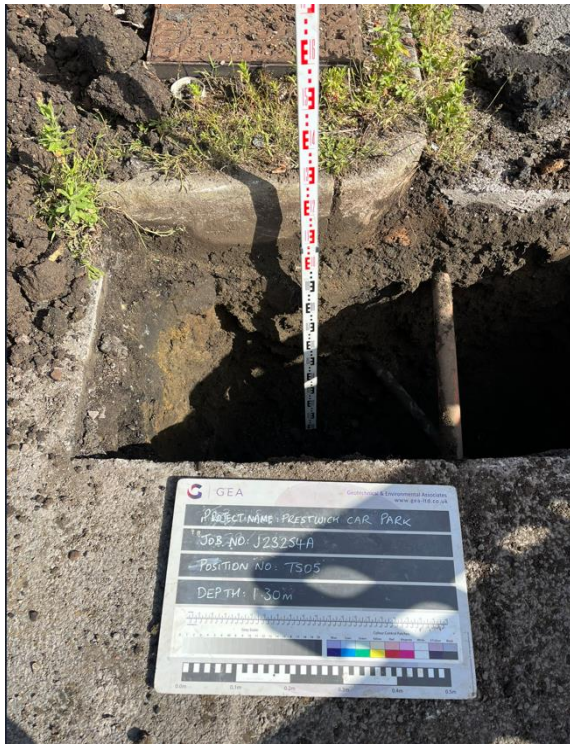
TS05 - Excavation to a depth of 1.30 m looking northwest - low voltage electric and BT ducts encountered

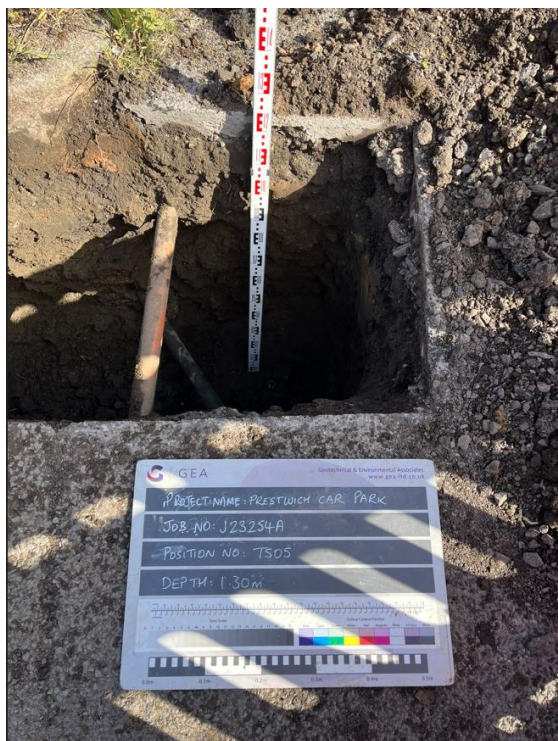
TS05 - Excavation to a depth of 1.30 m looking northwest - low voltage electric and BT ducts encountered

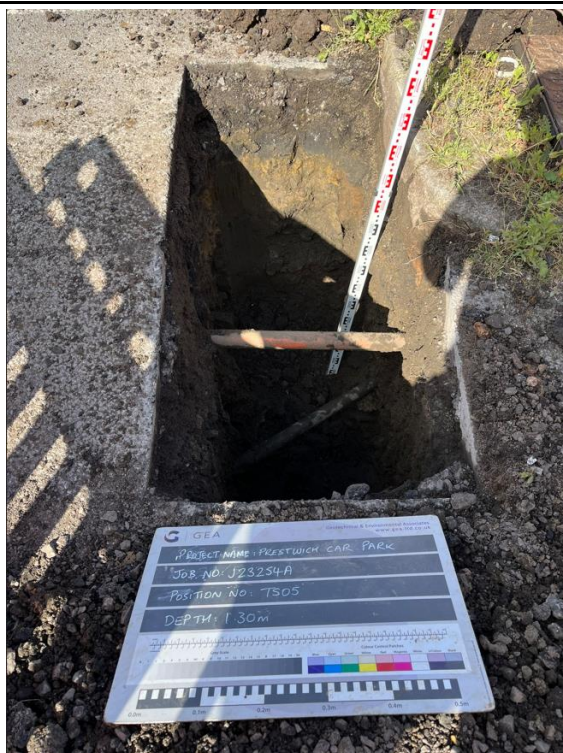
TS05 - Excavation to a depth of 1.30 m looking southwest - low voltage electric and BT ducts encountered

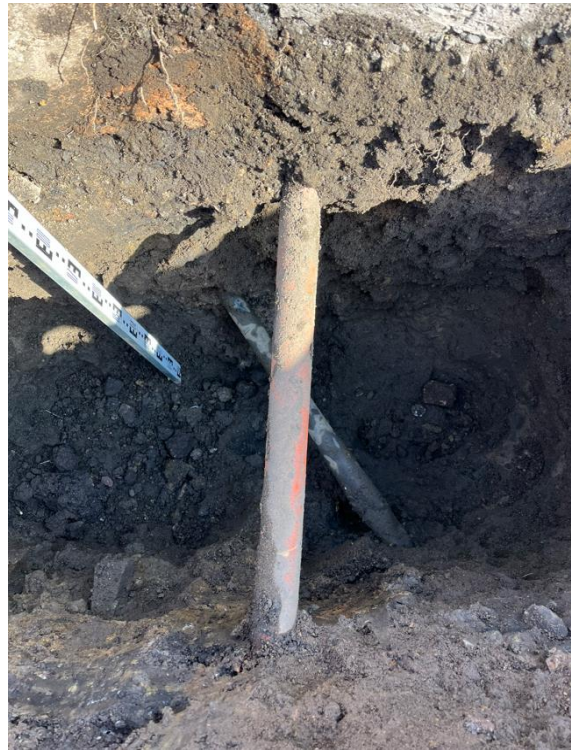
*TS05 - Closer view of low voltage electric duct*

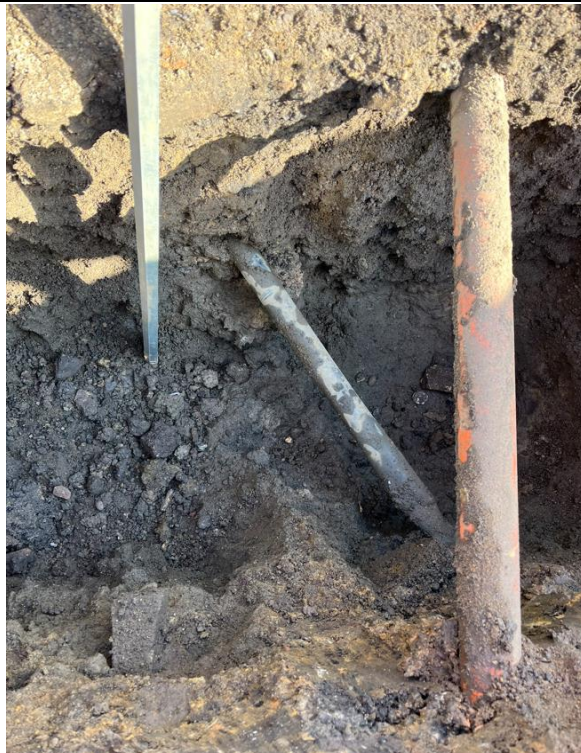
*TS05 - Closer view of BT duct*

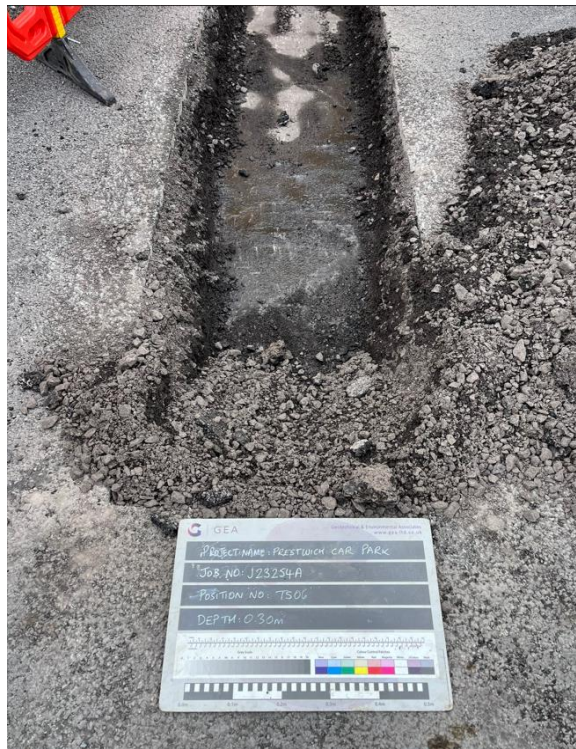
TS06 - Excavation to a depth of 0.30 m looking northwest - concrete encountered

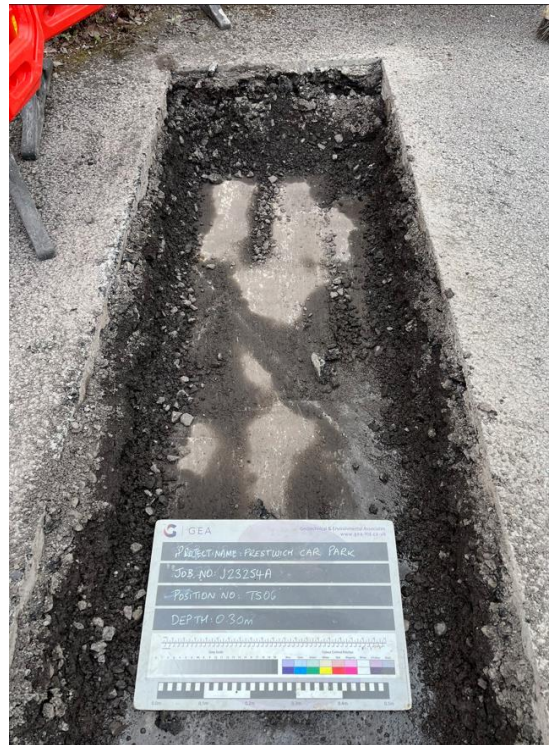
TS06 - Excavation to a depth of 0.30 m looking northwest - concrete encountered

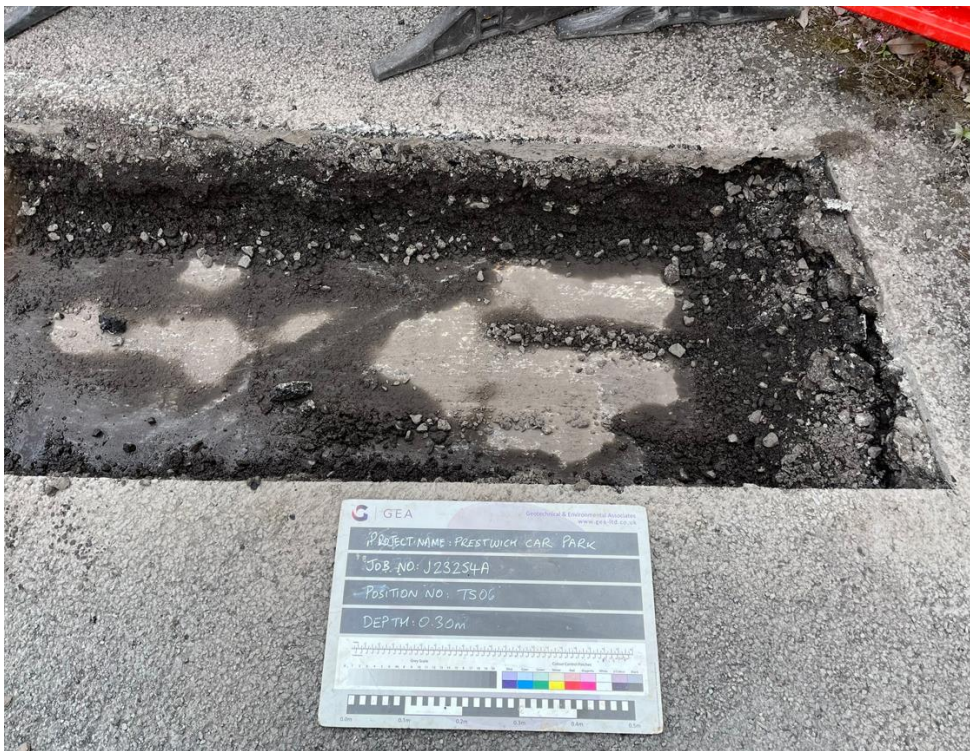
TS06 - Excavation to a depth of 0.30 m looking southwest - concrete encountered

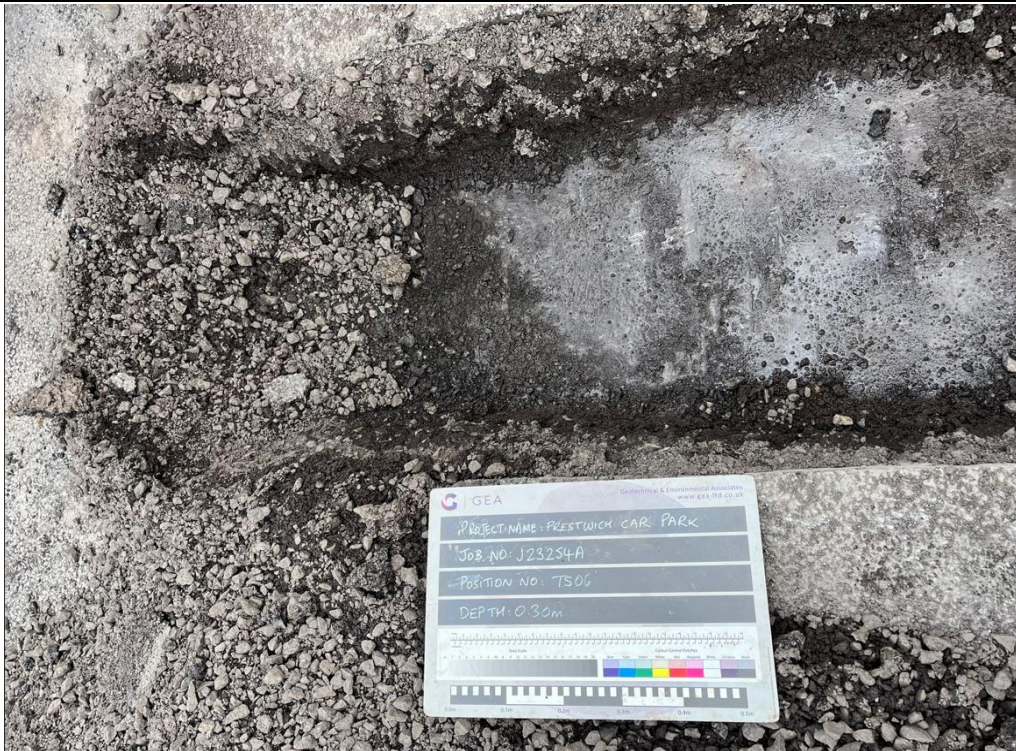
TS06 - Excavation to a depth of 0.30 m looking southwest - concrete encountered

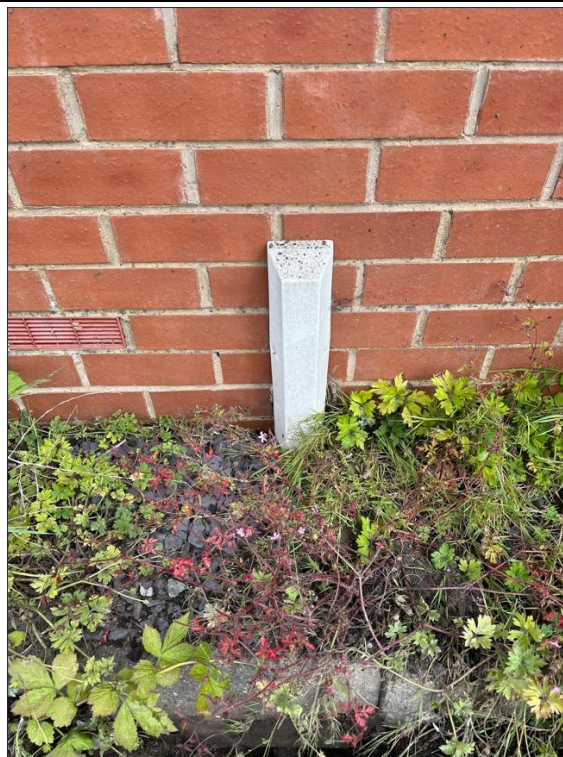
TS07 - Electric supply against exterior wall

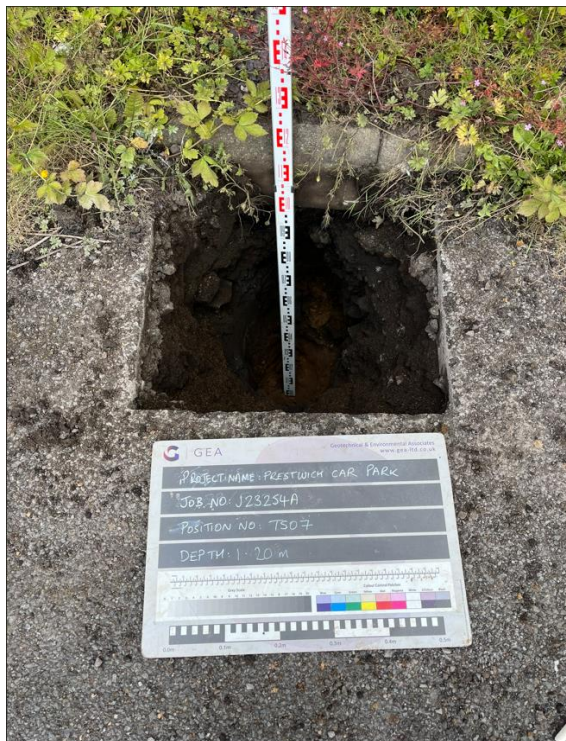
TS07 - Excavation to a depth of 1.20 m looking northwest - no services encountered

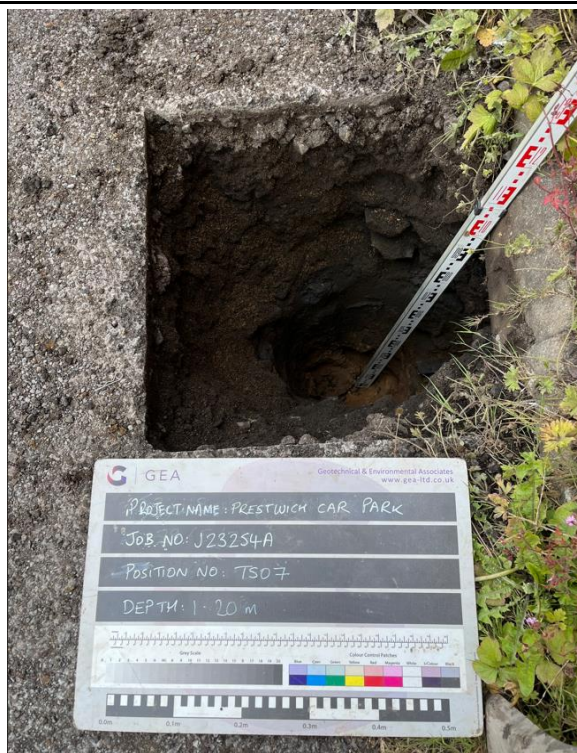
TS07 - Excavation to a depth of 1.20 m looking southwest - no services encountered

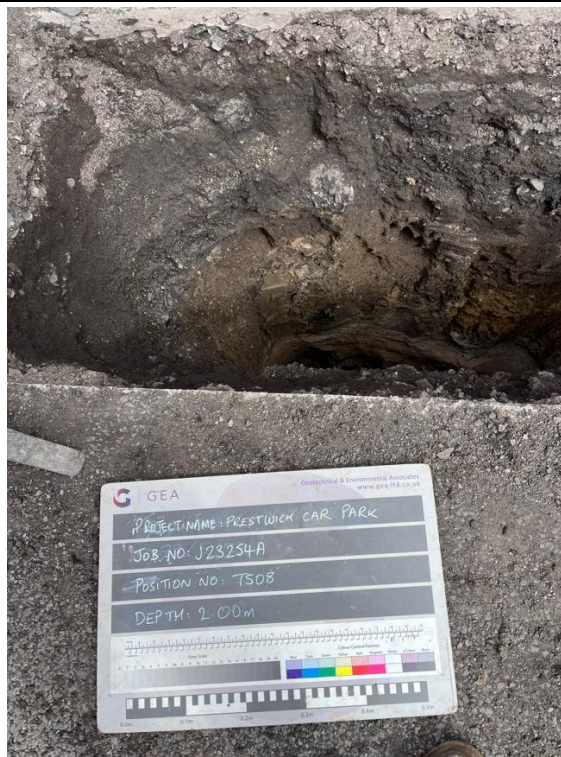
TS08 - Excavation to a depth of 2.00 m looking northwest - no services encountered

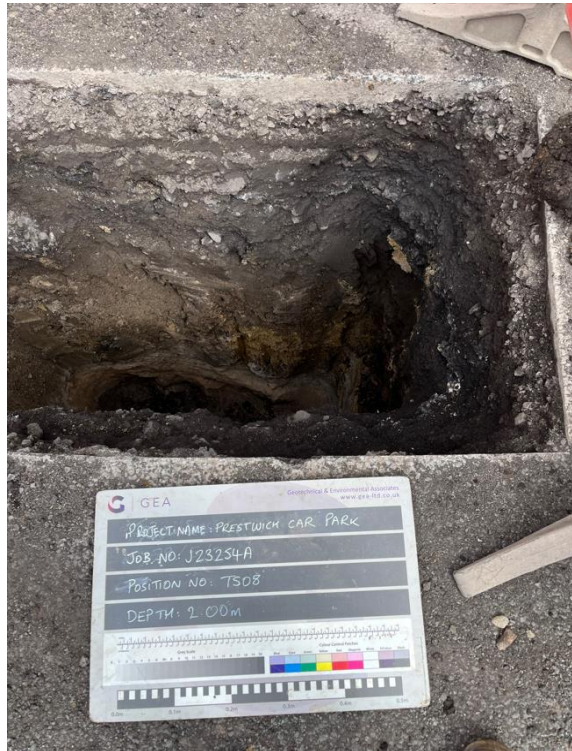
TS08 - Excavation to a depth of 2.00 m looking northwest - no services encountered

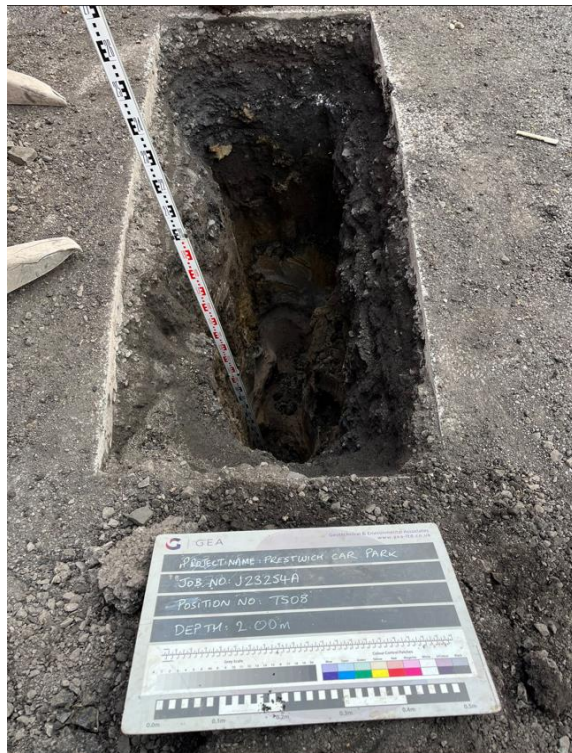
TS08 - Excavation to a depth of 2.00 m looking southwest - no services encountered

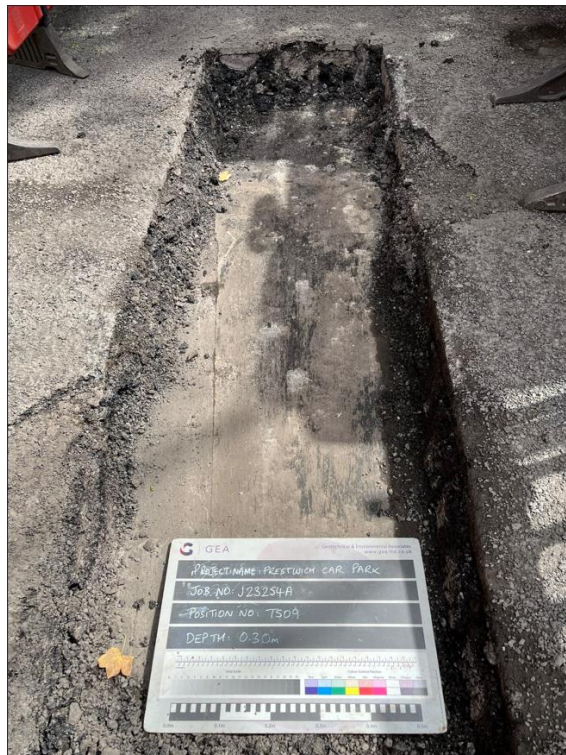
TS09 - Excavation to a depth of 0.30 m looking northeast - concrete encountered

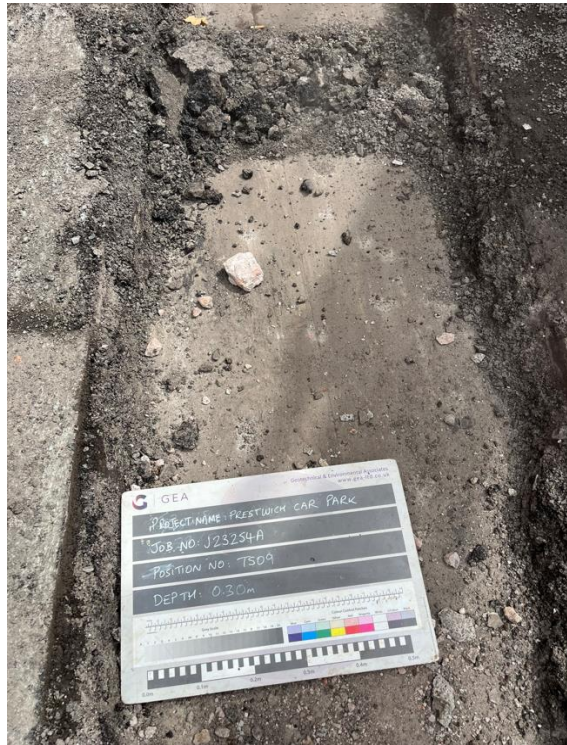
*TS09 - Excavation to a depth of 0.30 m looking northeast - concrete encountered*

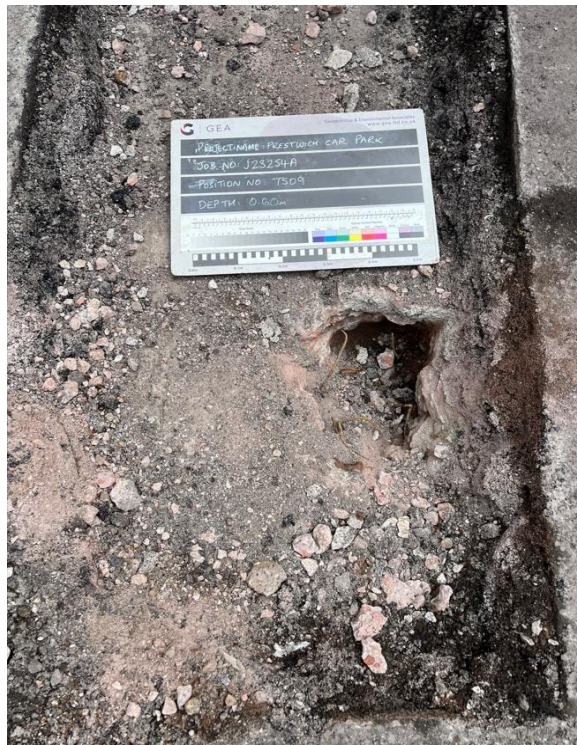
*TS09 - Excavation locally to a depth of 0.60 m looking northeast*

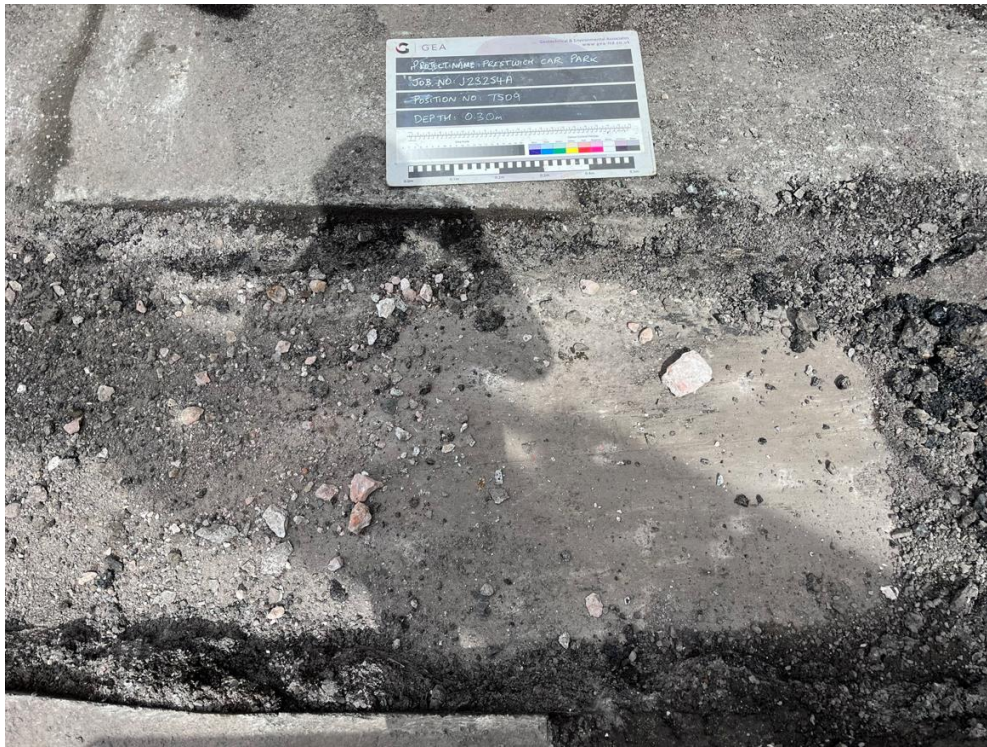
TS09 - Excavation to a depth of 0.30 m looking northwest - concrete encountered

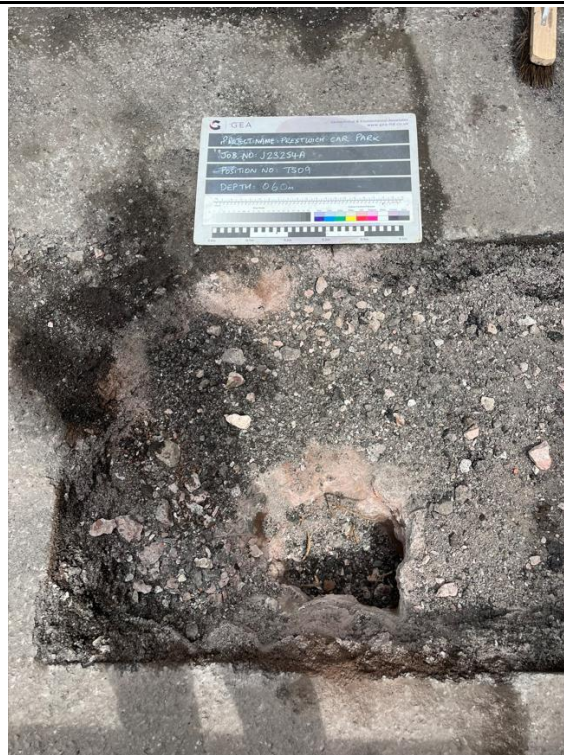
TS09 - Excavation locally to a depth of 0.60 m looking northwest
