# EXTENDED PHASE 1 HABITAT SURVEY & DAYTIME BAT SURVEY

## LAND AT MILLER STREET, RADCLIFFE, BURY

JANUARY 2021

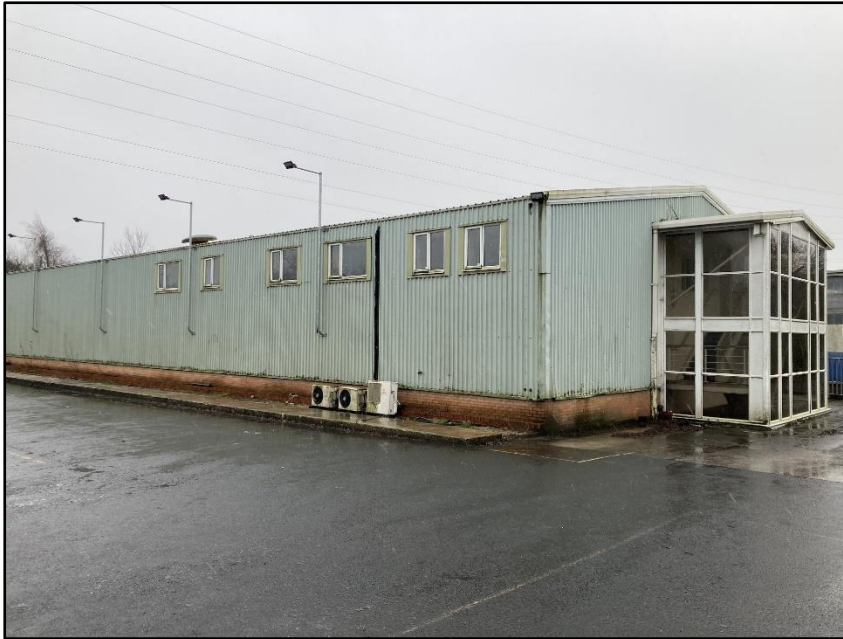
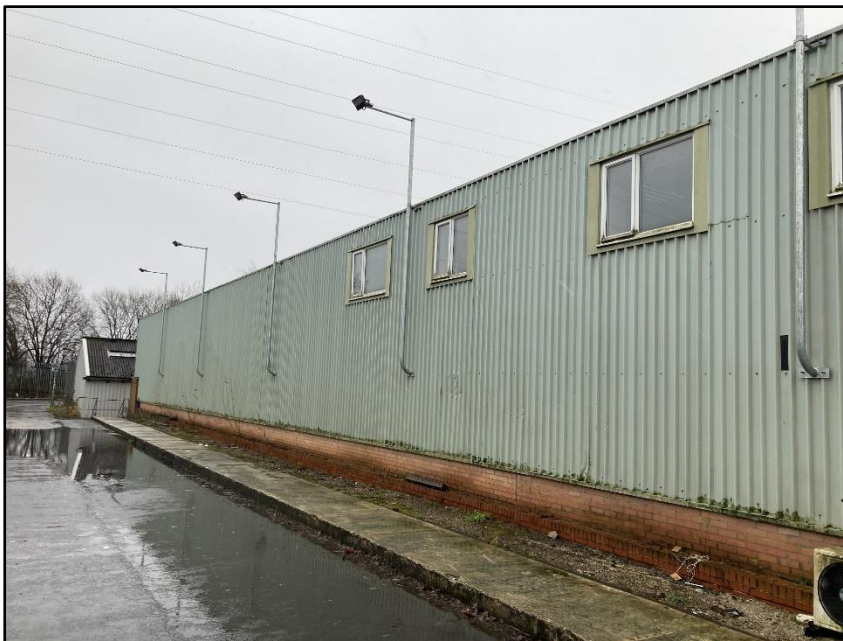
- 3.13 This building is a large two-storey industrial building constructed from a steel frame, clad with corrugated metal sheets (see Photograph 7). The cladding is in good condition and fitted flush with one another. A small brick wall is located along the bottom of the external walls. The masonry is in good condition and well-sealed with mortar (see Photograph 8). The pitched roof is covered with corrugated metal sheets and fibreglass roof windows. These appear in good condition with no evidence of water ingress internally. A glazed entrance lobby is located on the northern elevation of the building (see Photograph 7). This is in excellent condition with no potential entry points located.

*Photograph 7 showing Building 1*

*Photograph 8 showing Building 1*

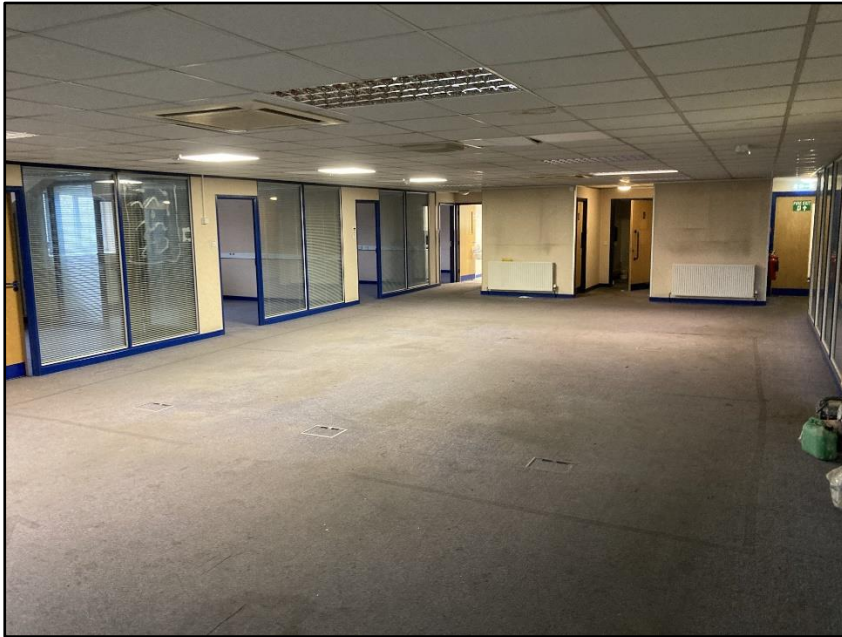
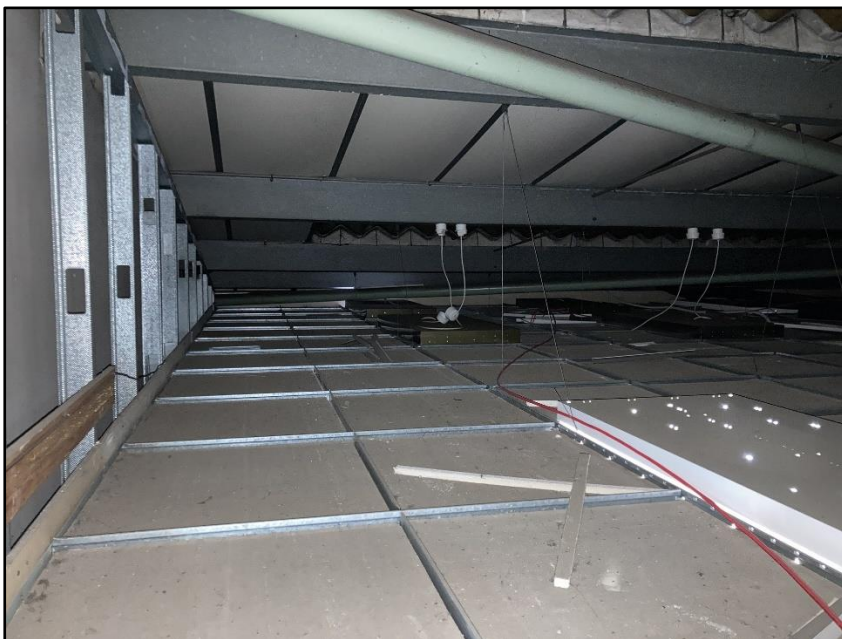
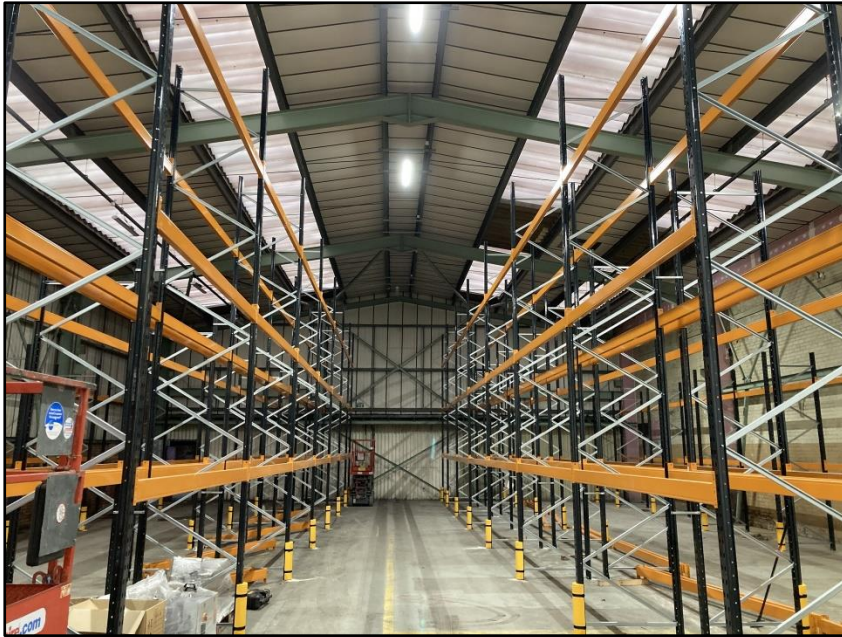
- 3.14 The relatively small first floor space of the building consists well-finished office spaces (see Photograph 9). Suspended ceilings are located above, with a void space present (see Photograph 10). The void space is open to the underside of the roof. The walls are plastered to the underside of the roof. The space is cool and dusty. No features associated with roosting bats was found, nor any evidence of bat activity or occupancy. The main body of Building 1 consists a double height warehouse (see Photograph 11). This is open to the underside of the roof with no roof void spaces present. The space is light and airy with automatic lighting present that switches on with movement. The warehouse does not provide any suitable bat roost features. No evidence of bat activity

or occupancy was found in Building 1 and it is considered Building 1 offers **negligible** bat roost suitability.

*Photograph 9 showing the office spaces in Building 1*

*Photograph 10 showing the void space between the suspended ceiling and the underside of the roof in Building 1*

*Photograph 11 showing the warehouse section of Building 1*

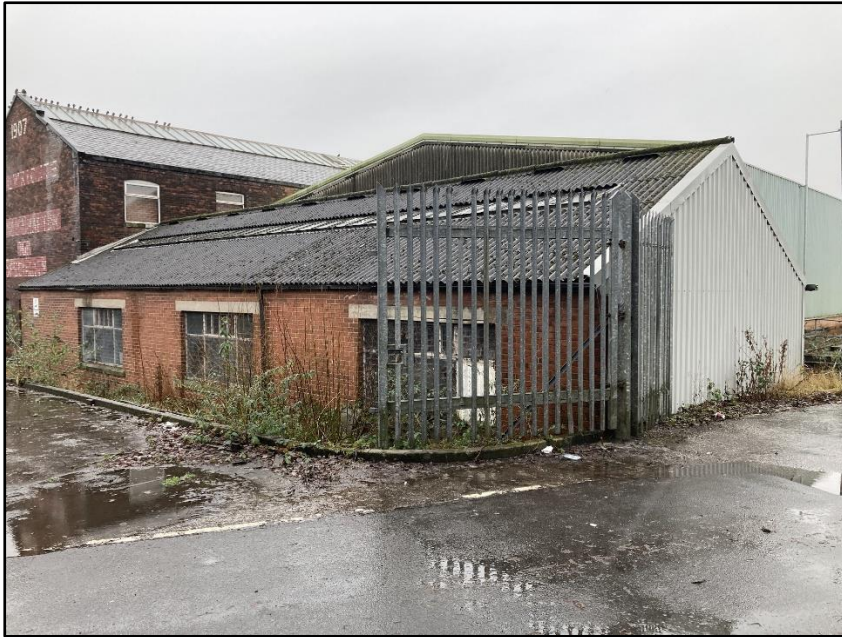
- 3.15 Building 2 is attached to Building 1 on its southern elevation (see Photograph 12). The building is single storey and constructed from brick. The brickwork is in good condition and well-sealed with mortar. Concrete lintels and sills are found across the southern elevation. These are in good condition. However, a crack is present across one of the lintels (see Photograph 13). This was inspected further with the use of an endoscope and found to be to wedge shaped, resulting in a narrow and shallow feature and unsuitable for bats to exploit with no evidence of bats found. The wood window and doorframes are well-sealed to the surrounding masonry and covered with metal mesh. The pitched roof is covered with corrugated cement roof sheets and glass roof windows (see Photograph 14). The roof is in good condition and finished at the gable ends with edge capping and lead flashings. No potential entry points were located.

*Photograph 12 showing Building 2*

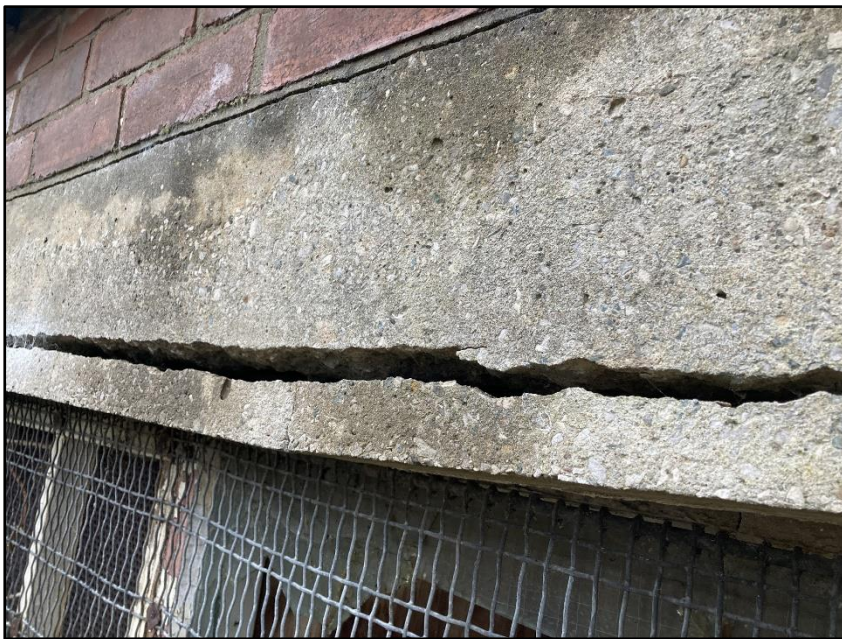
*Photograph 13 showing the crack in the lintel on Building 2*

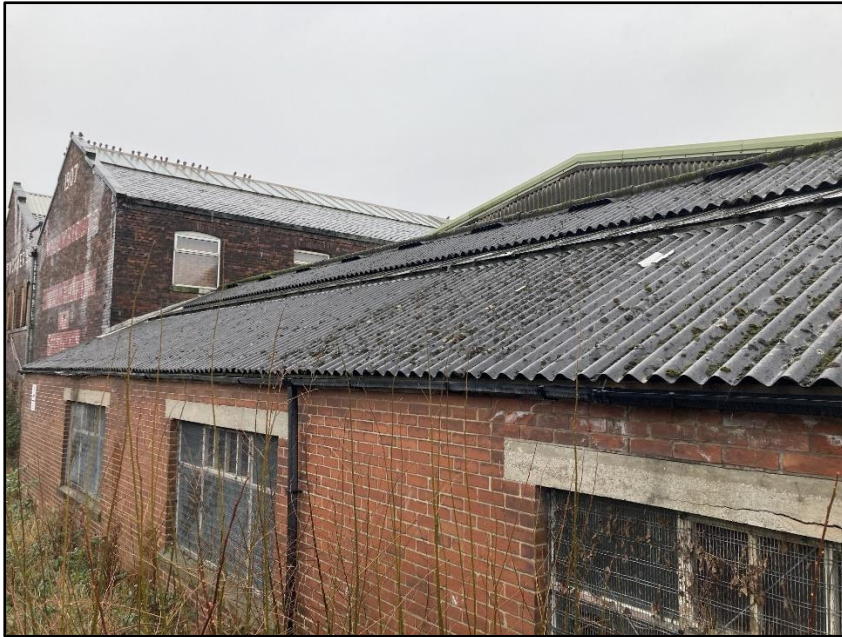
*Photograph 14 showing the roof of Building 2*

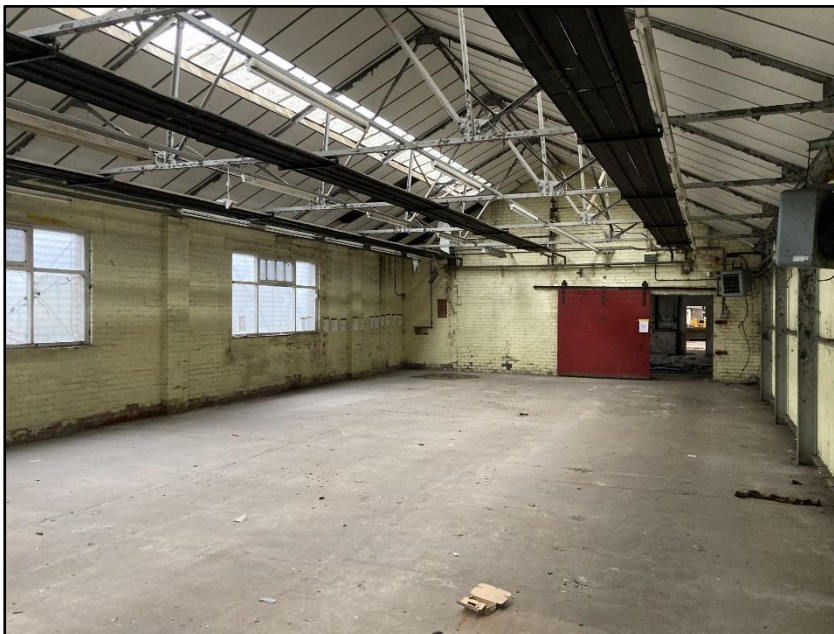
- 3.16 The internal masonry is in good condition, well-sealed with mortar and painted. The internal space is open to the underside of the roof with no roof void spaces present (see Photograph 15). The metal roof frame is in good condition with no gaps or crevices bats may exploit. No evidence of bat activity or occupancy was found, and it is considered Building 2 has **negligible bat roost suitability**.

*Photograph 15 showing the interior of Building 2*

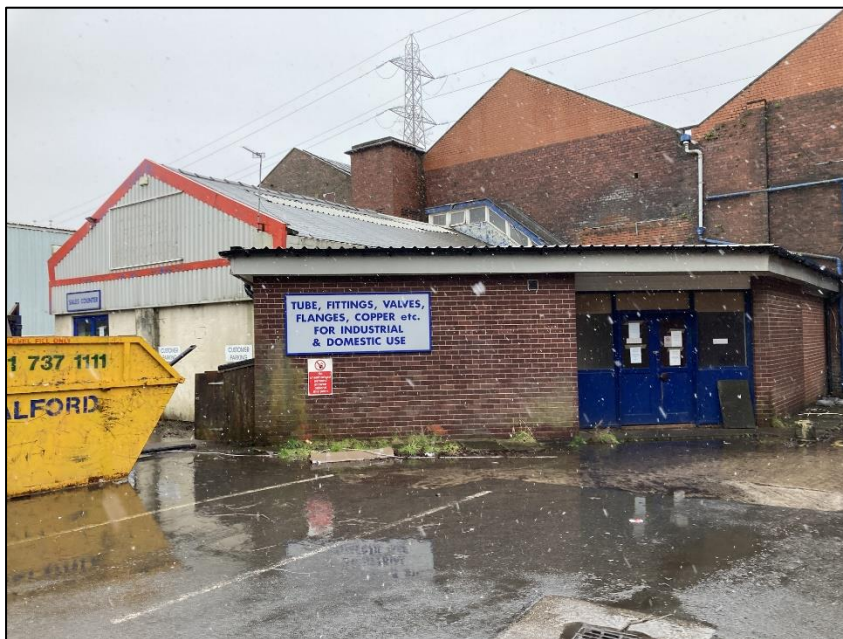
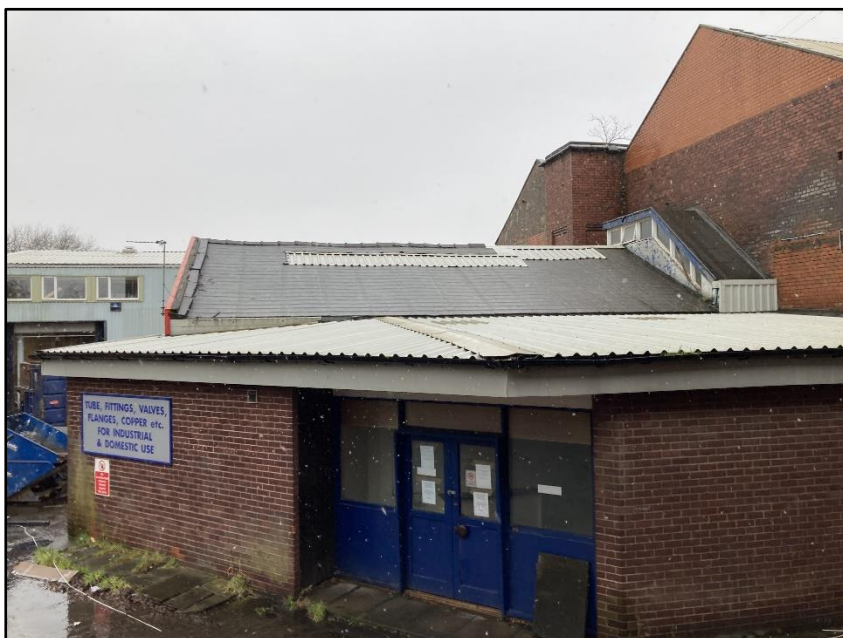
- 3.17 This building forms part of Building 4 and serves as the shop front/reception area (see Photograph 16). The building is single storey and constructed from a combination of

brick, or which sections are rendered, and corrugated metal cladding. The brickwork is in good condition and well-sealed with mortar. The render, where present, is free from cracks and crevices and painted. The metal cladding is also in good condition and fitted flush to the surrounding masonry with no potential entry points located. The sloped roof is covered with corrugated metal roof sheets and the pitched section with slate roof tiles and glass roof windows (see Photograph 17). Both roofs are in reasonable condition with no potential entry points located.

*Photograph 16 showing Building 3*

*Photograph 17 showing the sloped and pitched roofs of Building 3*

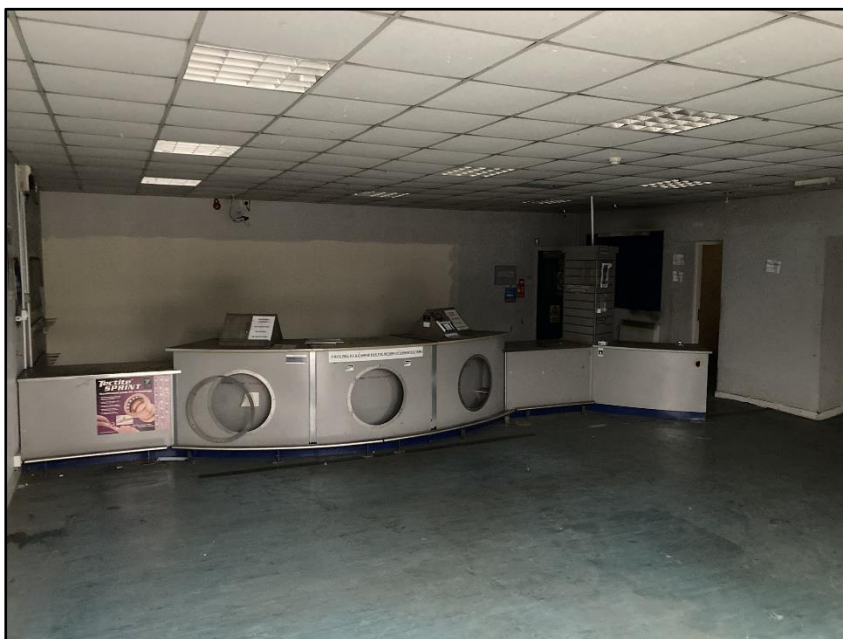
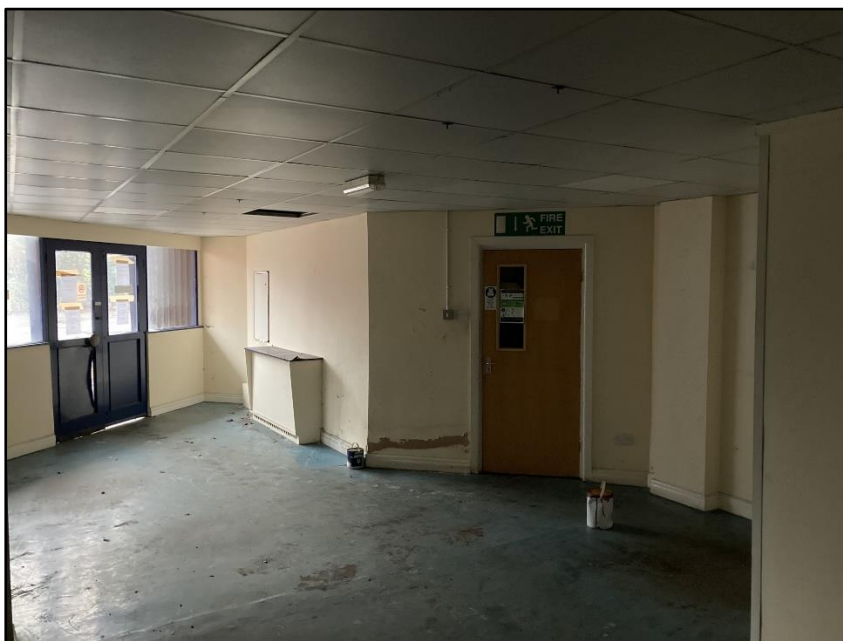
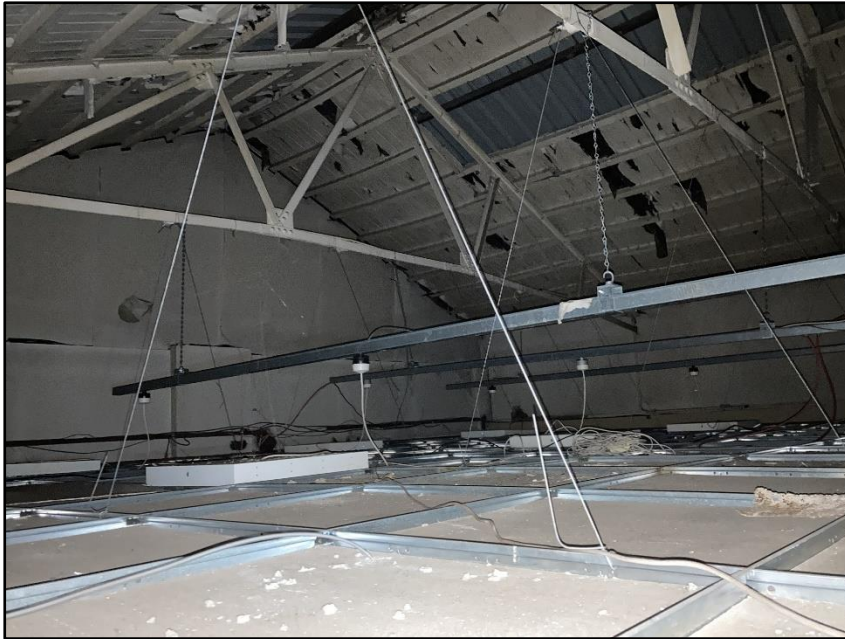
- 3.18 The internal spaces of Building 3 are well-finished with no habitat associated with roosting bats present (see Photographs 18 and 19). Suspended ceilings are present with roof void spaces above (see Photograph 20). The space below the pitched roof section is light and airy due to the roof windows. The walls are finished with boards, free form gaps and cracks. The void below the sloped roof section is small and like the other void, consists of services such as ducting and light fittings. No potential entry points, roosting habitat or evidence of bat activity or occupancy was found, and it is considered Building 3 has **negligible bat roost suitability**.

*Photograph 18 showing the interior of Building 3*

*Photograph 19 showing the interior of Building 3*

*Photograph 20 showing the roof void in Building 3*

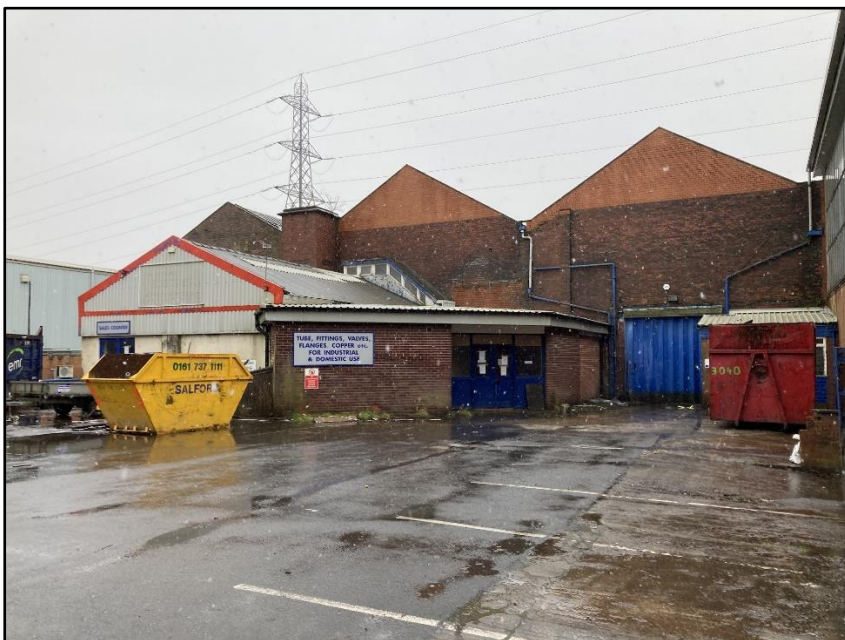
- 3.19 Building 4 is a large, brick-built, double-height structure with an 'M-shaped' roof (see Photograph 21). The brick walls are in good condition and the tight mortar beds are well-sealed with mortar. The roofs are covered with slate roof tiles and glass roof windows. The roof appears to be in good condition and the peripheries are finished with coping stones with are well-sealed with mortar.

*Photograph 21 showing Building 4*

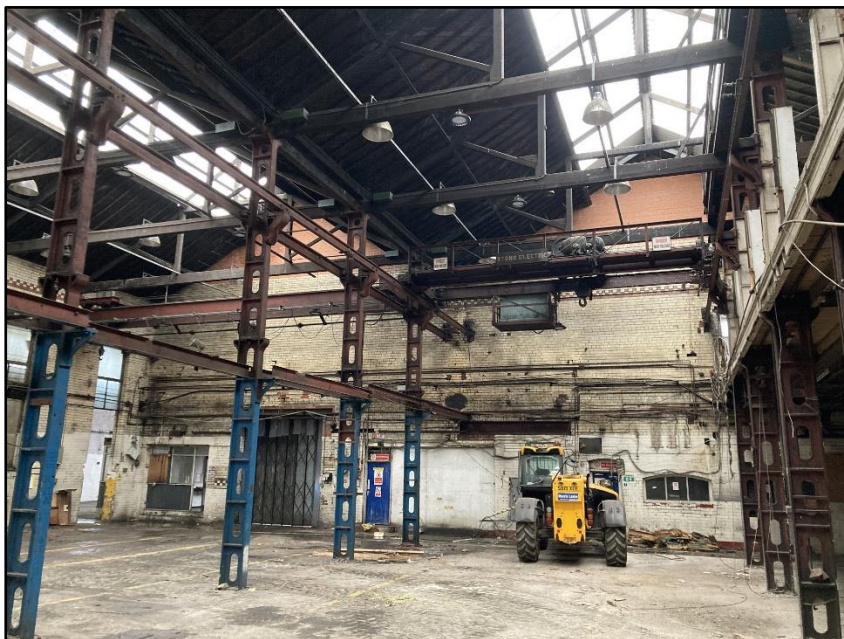
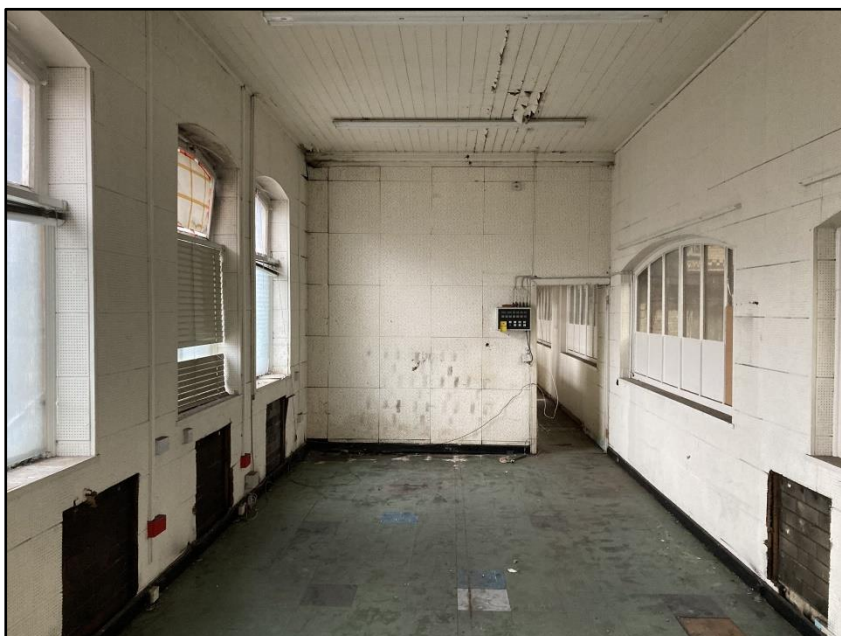
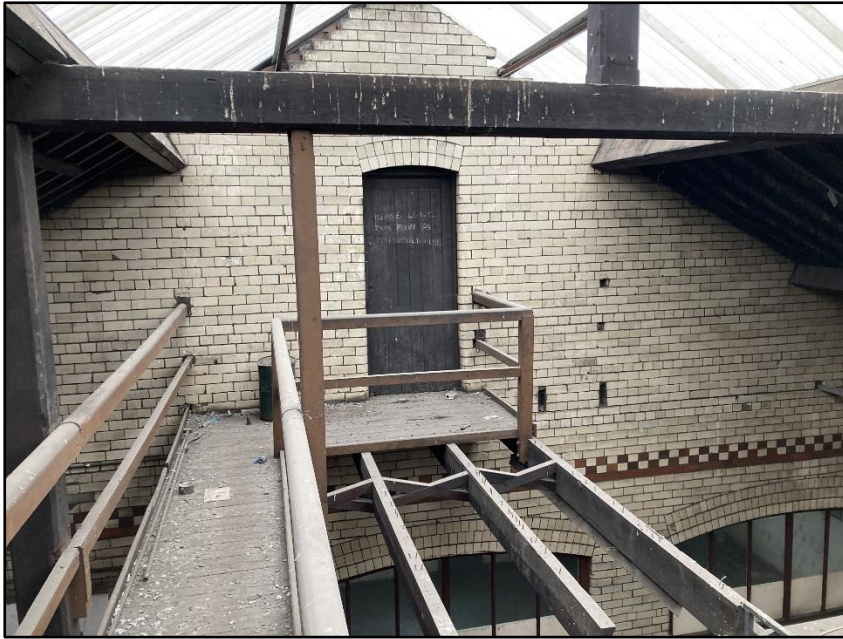
- 3.20 The large internal spaces are open to the underside of the roof with no roof void spaces present (see Photograph 22). The brick walls are in good condition, as is the associated

mortar. A small, first-floor office space is located at the southern end of the building (see Photograph 23). The office space is in reasonable condition with no potential entry points or evidence of roosting bats found. A small roof void accessed via a gantry is located above the office space (see Photograph 24). This is open to the underside of the roof with no sealed void spaces present. No evidence of bat activity or occupancy was found anywhere in Building 4 and it is considered the building has **negligible bat roost suitability**.

*Photograph 22 showing the interior of Building 4*

*Photograph 23 showing the interior of the office space in Building 4*

*Photograph 24 showing the small room above the office space in Building 4*

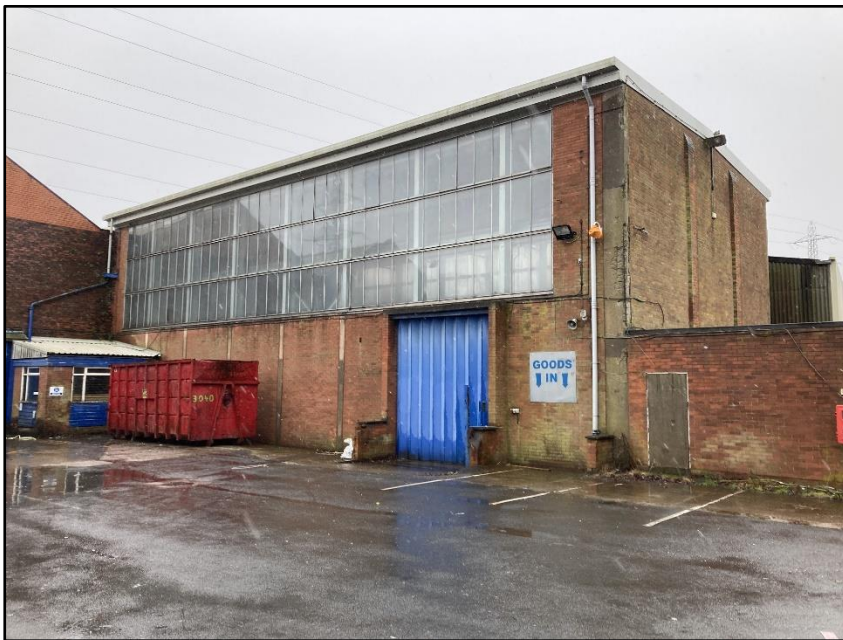
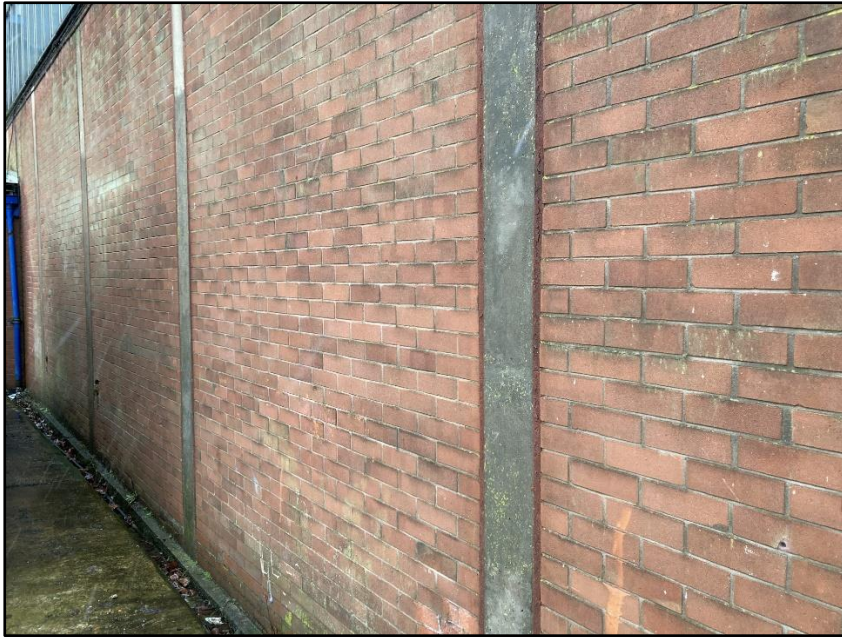
- 3.21 This building is double-height and constructed from brick and a steel frame (see Photograph 25). The masonry is in good condition and well-sealed with mortar (see Photograph 26). The eastern elevation of the building has a large glazed upper wall. The glazing is complete with no smashed or damaged windowpanes. The gently pitched roof is covered with corrugated metal roof sheets. The roof appears to be in good condition and finished at the gable ends with capping with are flush to the surrounding masonry.

*Photograph 25 showing Building 5*

*Photograph 26 showing the exterior masonry of Building 5*

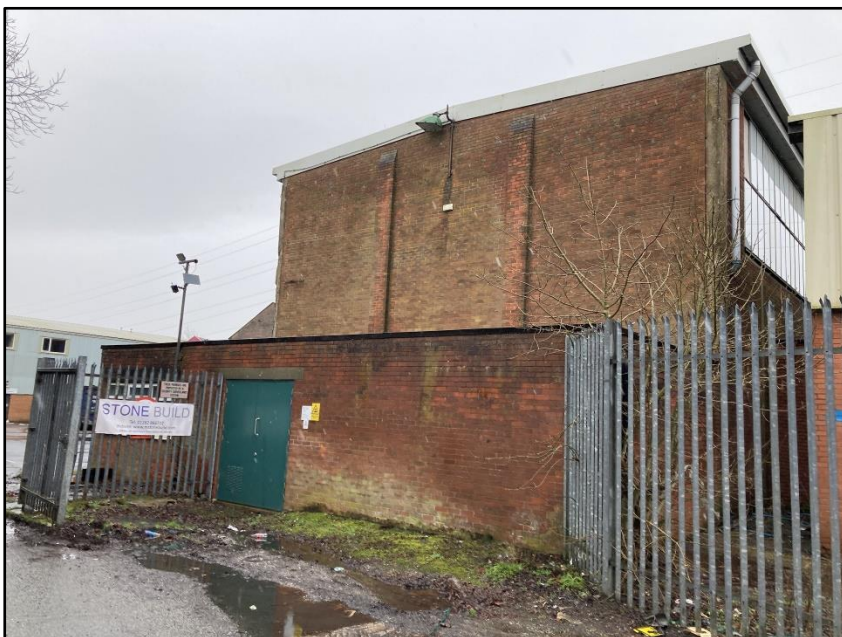
- 3.22 A small single storey plant room is attached to the northern elevation of the building (see Photograph 27). The masonry is in excellent condition and well-sealed with mortar. The flat roof is covered with a bitumen-based membrane. This is in good condition and well-sealed with no cracks or folds bats may exploit.

*Photograph 27 showing the single-storey part of Building 5*

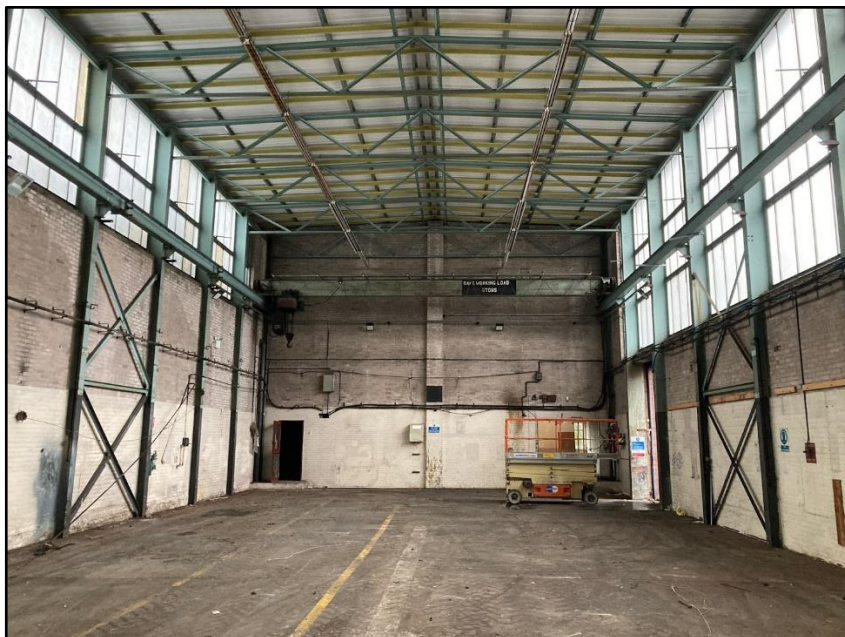
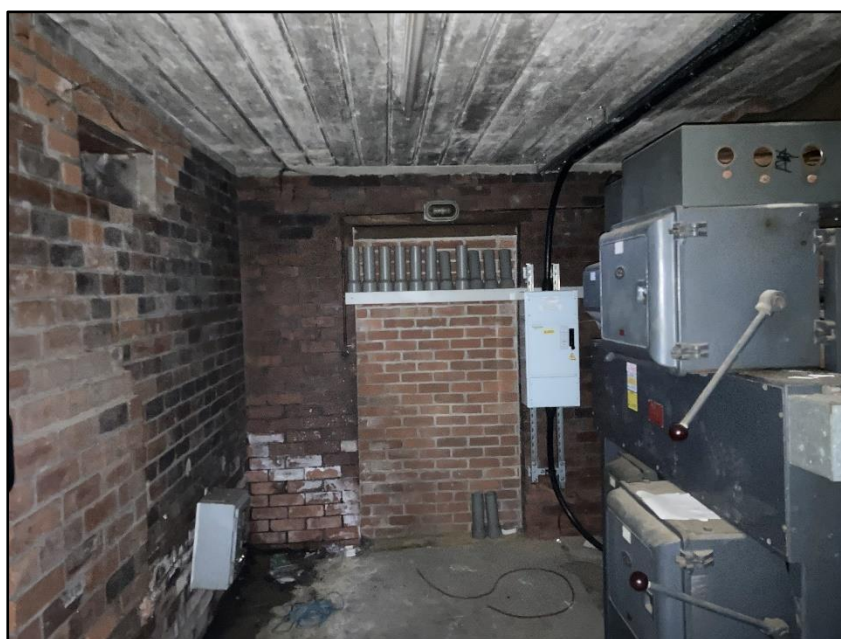
- 3.23 The Internal spaces are open to the underside of the roof with no roof void spaces present (see Photographs 28 and 29). The internal masonry is in excellent condition and partially painted white. The interior space of Building 5 is largely airy and well-lit due to the extensive windows present. No suitable bat roosting habitat or entry points

were located. Furthermore, no evidence of bat activity or occupancy was found, and it is considered Building 5 has **negligible bat roost suitability**.

*Photograph 28 showing the internal space of Building 5*

*Photograph 29 showing the internal space of the plant room in Building 5*

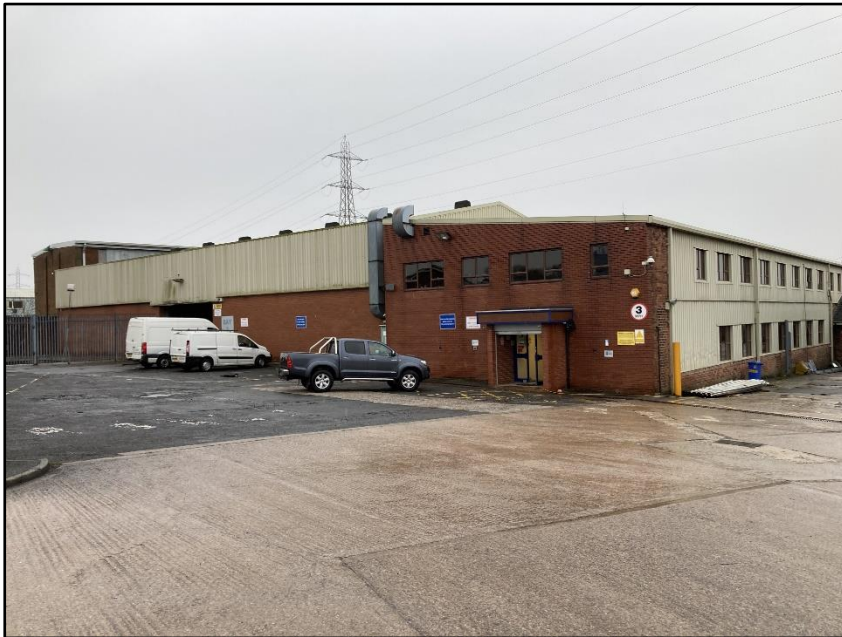
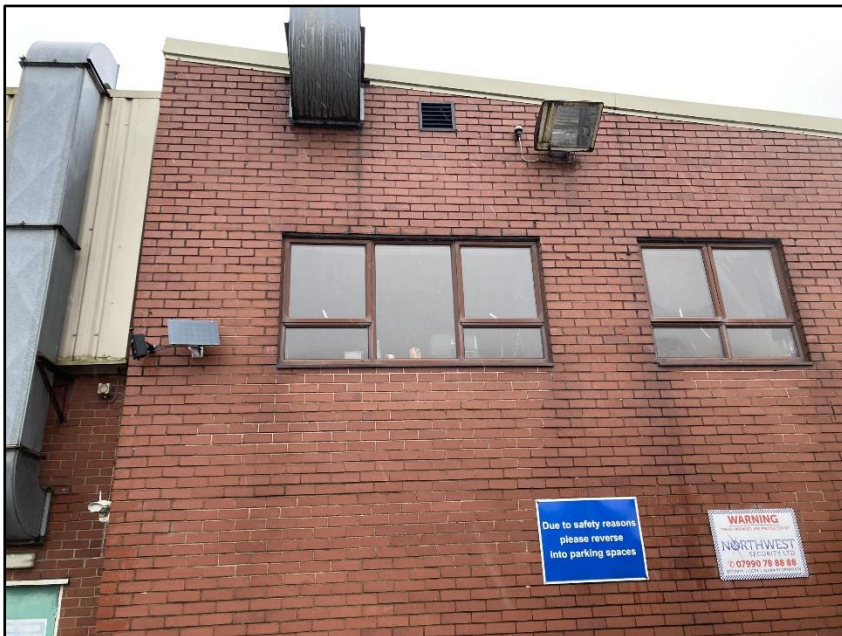
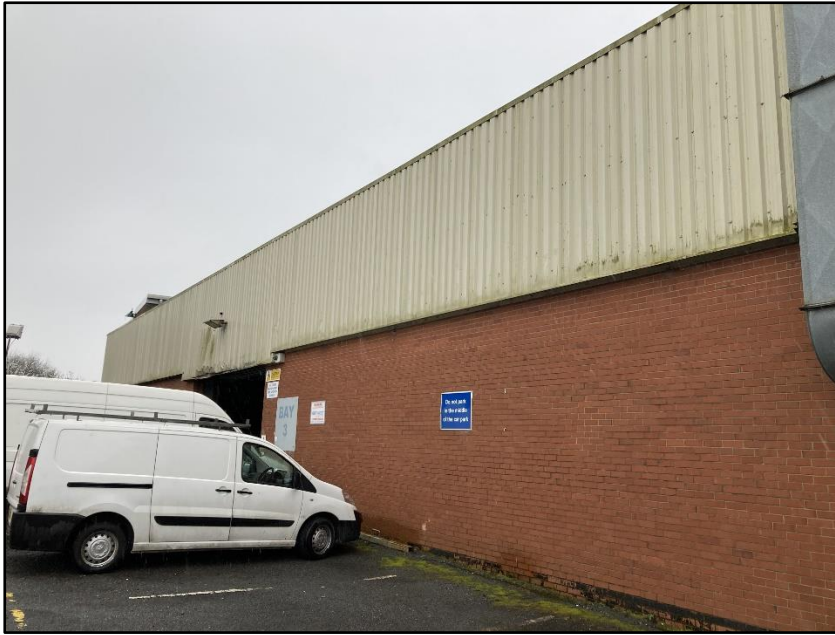
- 3.24 Building 6 is set over two-stories and constructed from a steel frame, clad with corrugated metal sheets and brick walls (see Photograph 30). The external masonry is in good condition and well-sealed with mortar (see Photograph 31). The uPVC window and doorframes are in excellent condition and well-sealed to the surrounding masonry. The external cladding is also in good condition and well-sealed to the surrounding

masonry (see Photograph 32). The sloped and pitched roofs are covered with corrugated metal roof sheets. The roof appears to be in good condition with no bat entry points located.

*Photograph 30 showing Building 6*

*Photograph 31 showing a section of Building 6's exterior*

*Photograph 32 showing a section of Building 6's exterior*

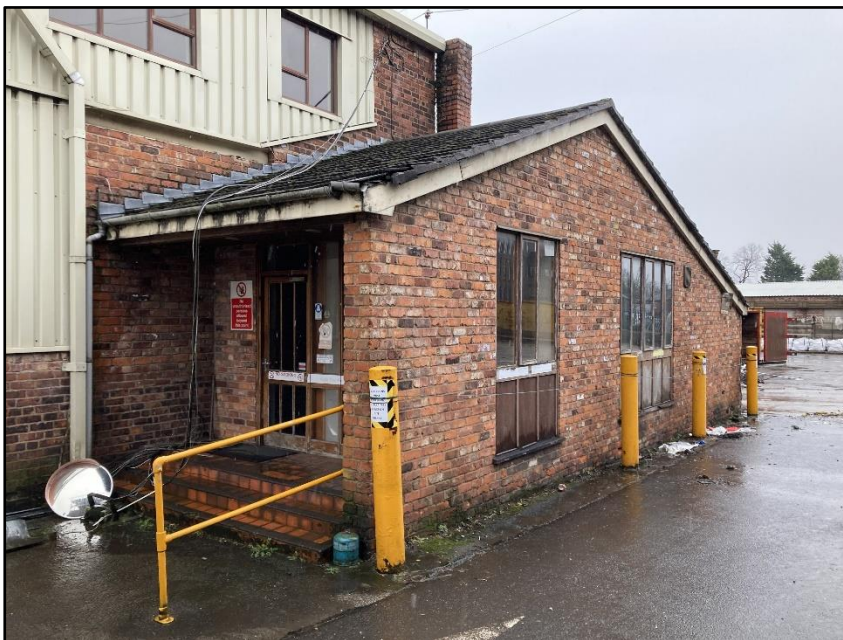
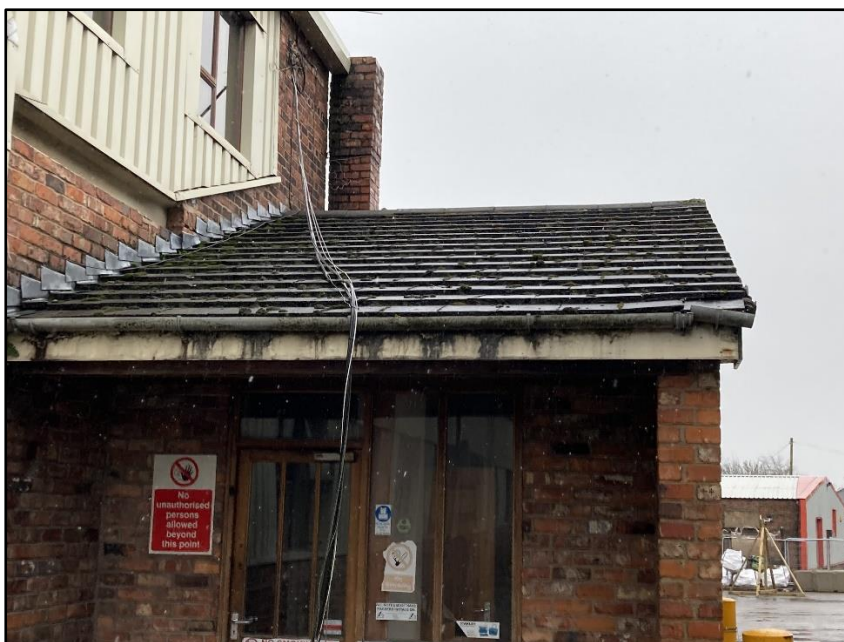
- 3.25 A single storey entrance is present on the southern elevation of Building 6 (see Photograph 33). The masonry is in excellent condition, as are the wood window and door frames, with no potential entry points located. The pitched roof is covered with concrete roof tiles (see Photograph 34). The tiles are all present and fitted flush to one another. The associated flashings are also in good condition and flush to the surrounding masonry and roof tiles.

*Photograph 33 showing the single storey entrance on Building 6*

*Photograph 34 showing the roof*

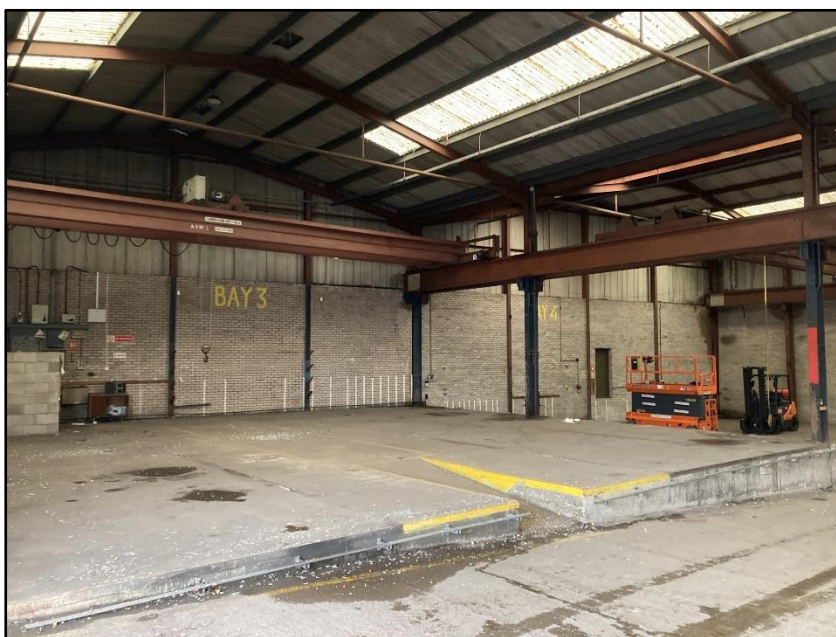
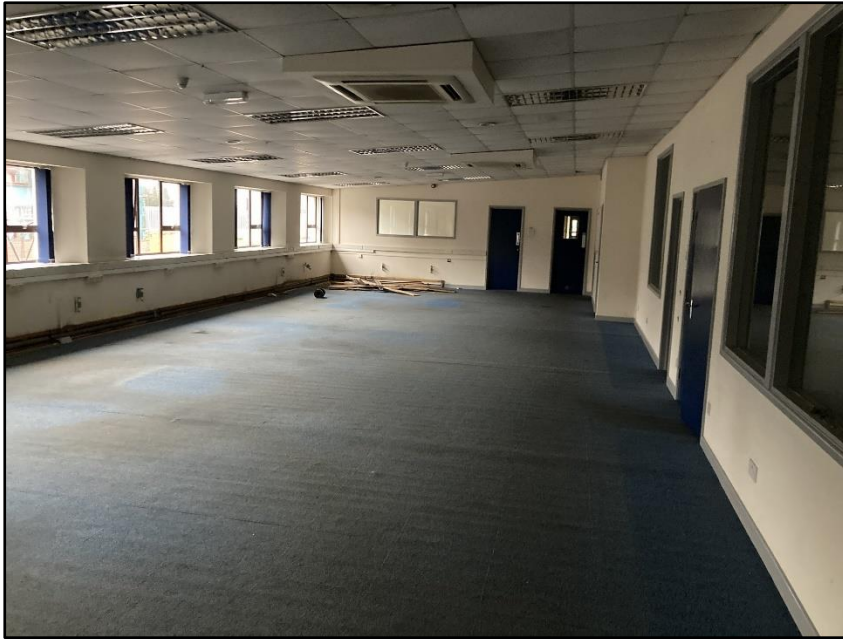
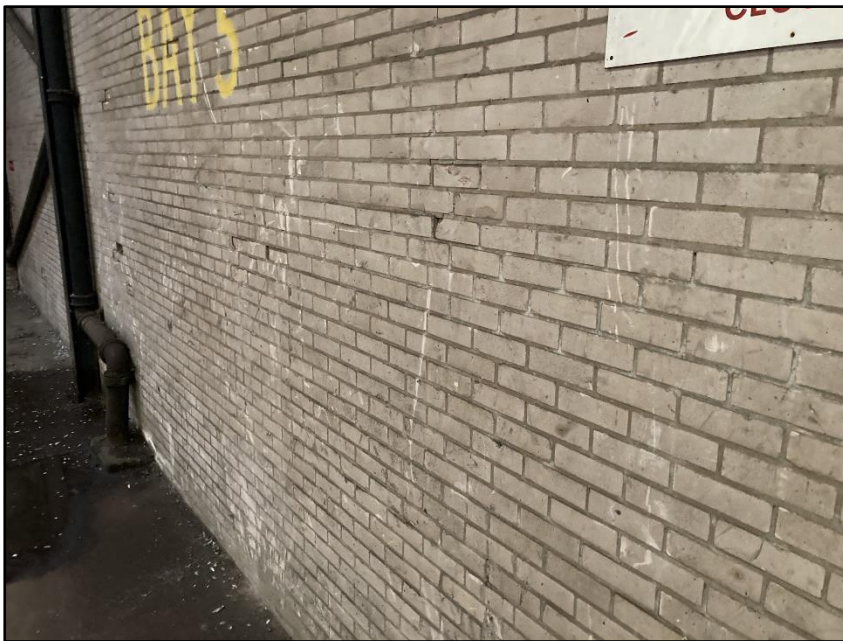
- 3.26 The interior of Building 6 is split into two distinct areas, A large, open industrial warehouse and office space (see Photographs 35 and 36). The warehouse space is open to the underside of the roof with no roof void spaces present. The internal masonry in good condition, free from cracks and gaps suitable for bats (see Photograph 37).

*Photograph 35 showing in the interior of Building 6*

*Photograph 36 showing the interior of Building 6*

*Photograph 37 showing the interior of Building 6*

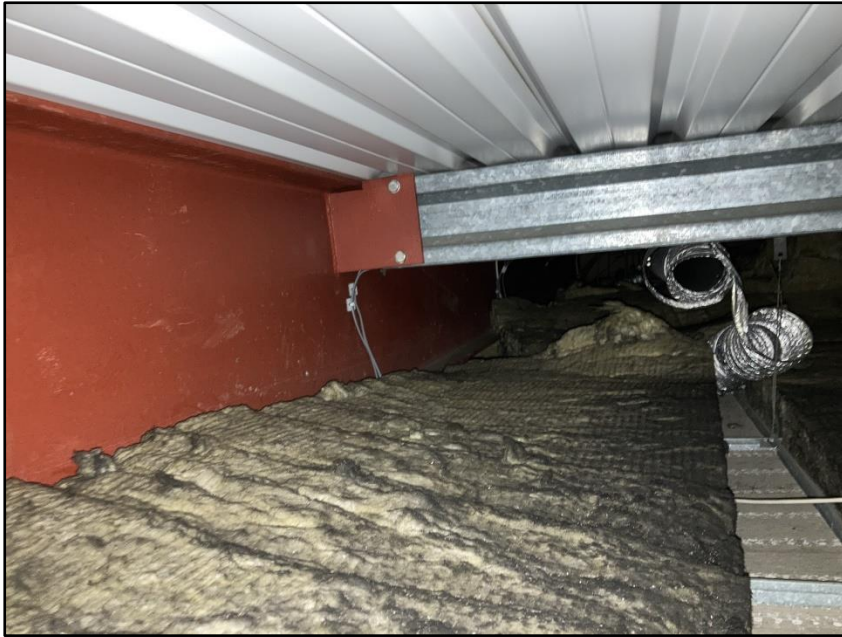
- 3.27 The interior of the office spaces are well-finished and do not supports suitable roosting habitat for bats. A suspended ceiling is found below the sloped roof with a void space present (see Photograph 38). The void spaces are small, well-sealed and contain services such as ducting and light fittings. No suitable roosting habitat or evidence of bat occupancy was found in Building 6 and it is considered the building offers **negligible bat roost suitability**.

*Photograph 38 showing the small roof void space in Building 6*

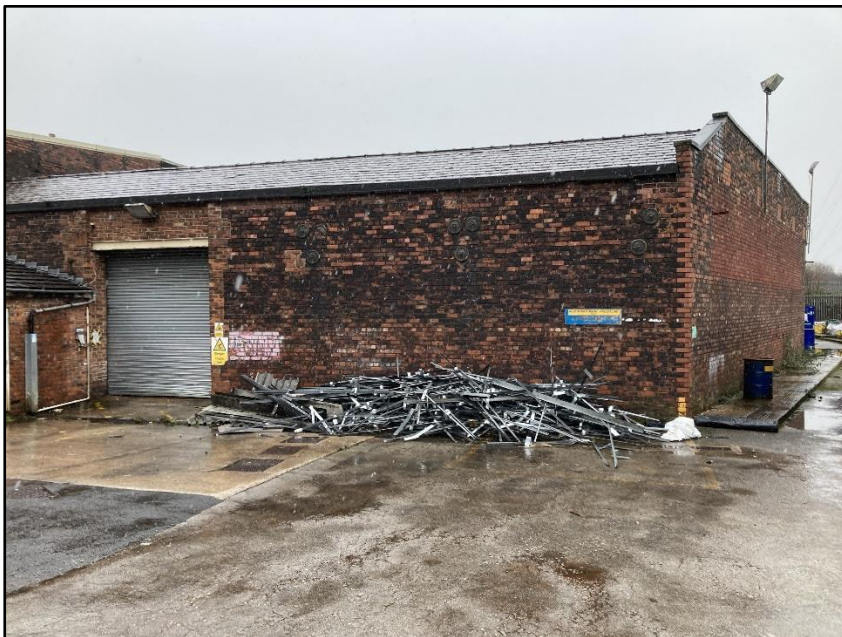
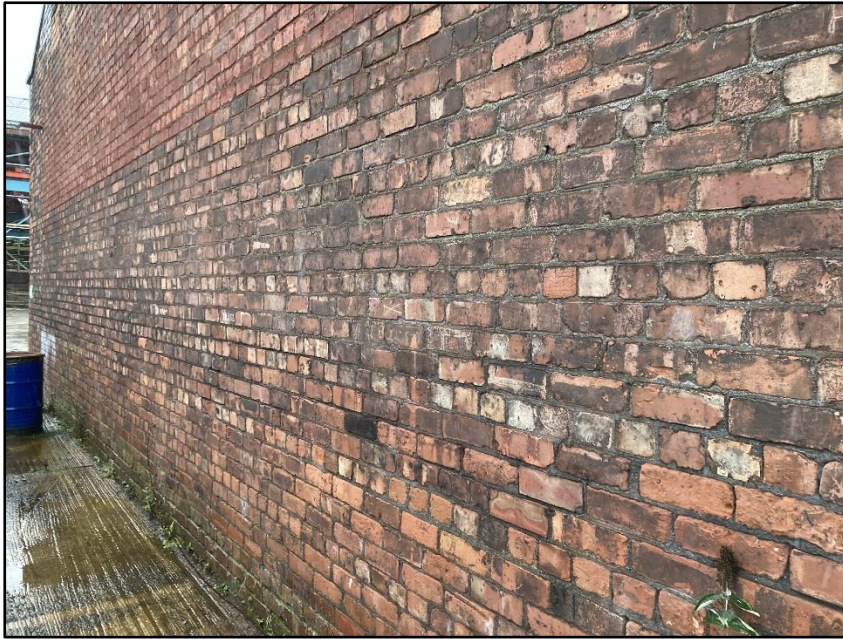
- 3.28 This building is attached to Building 6 along its southern elevation and consists a single-storey industrial building constructed from brick with an 'M-shaped' roof (see Photograph 39). The masonry is showing signs of age, however, it is in good condition and well-sealed with mortar (see Photograph 40). The coping stones along the roof edges are also in good condition, free from gaps or cracks bats may exploit. The roofs are covered with slate roof tile and glass roof windows. These appear to be in good condition with no potential entry points located.

*Photograph 39 showing the exterior of Building 7*

*Photograph 40 showing the exterior of Building 7*

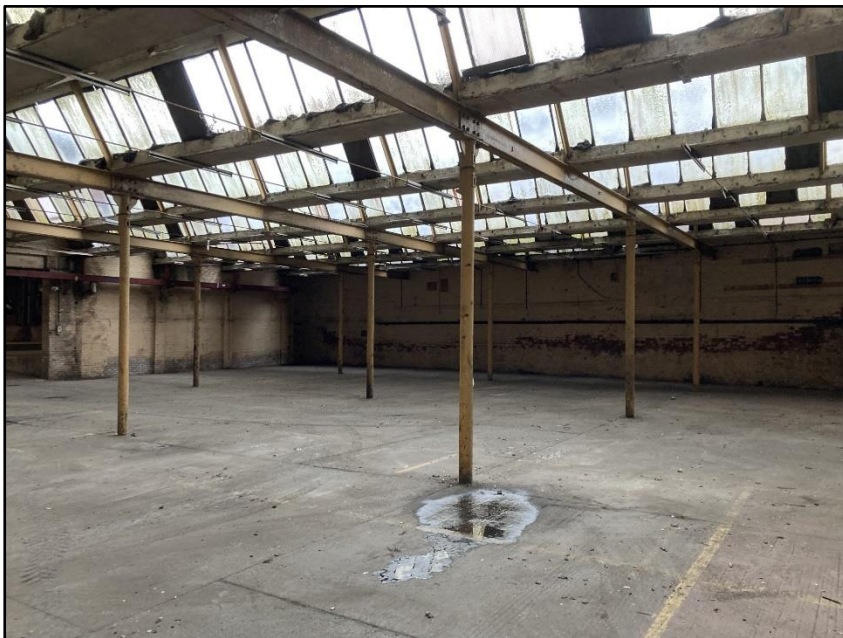
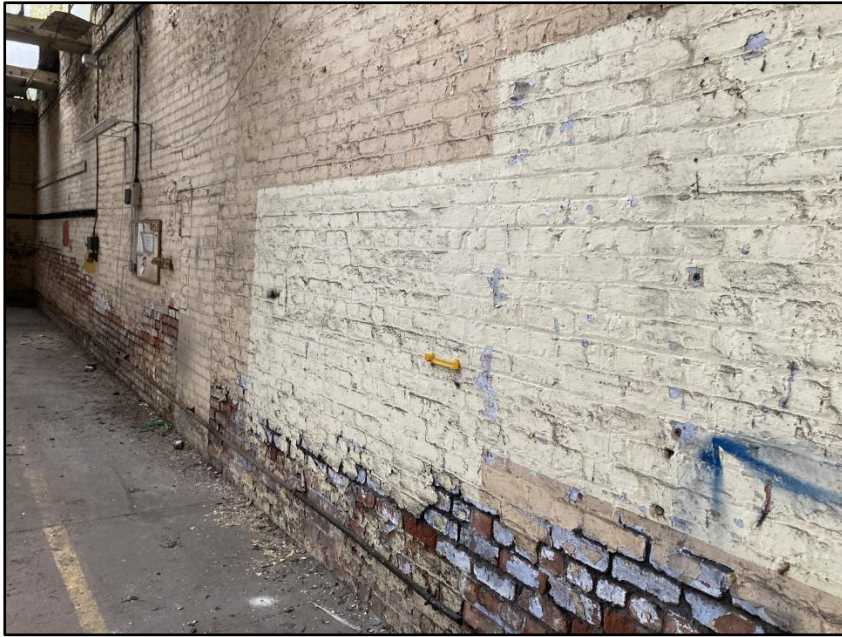
- 3.29 The interior of Building 7 is open to the underside of the roof with no roof void spaces present (see Photograph 41). The interior is well-lit due to the extensive roof windows. The internal brick walls are in good condition and painted (see Photograph 42). No suitable bat roosting habitat was found in Building 7, nor evidence of bat activity or occupancy. Therefore, it is considered Building 7 offers **negligible bat roost suitability**.

*Photograph 41 showing the interior of Building 7*

*Photograph 42 showing the interior of Building 7*
