# EXTENDED PHASE 1 HABITAT SURVEY & DAYTIME BAT SURVEY

## LAND AT MILLER STREET, RADCLIFFE, BURY

JANUARY 2021

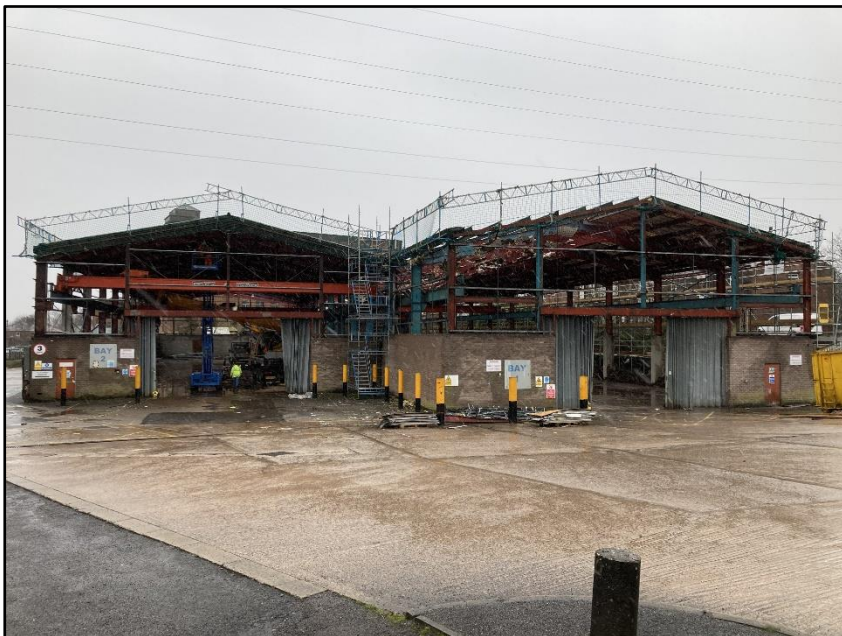
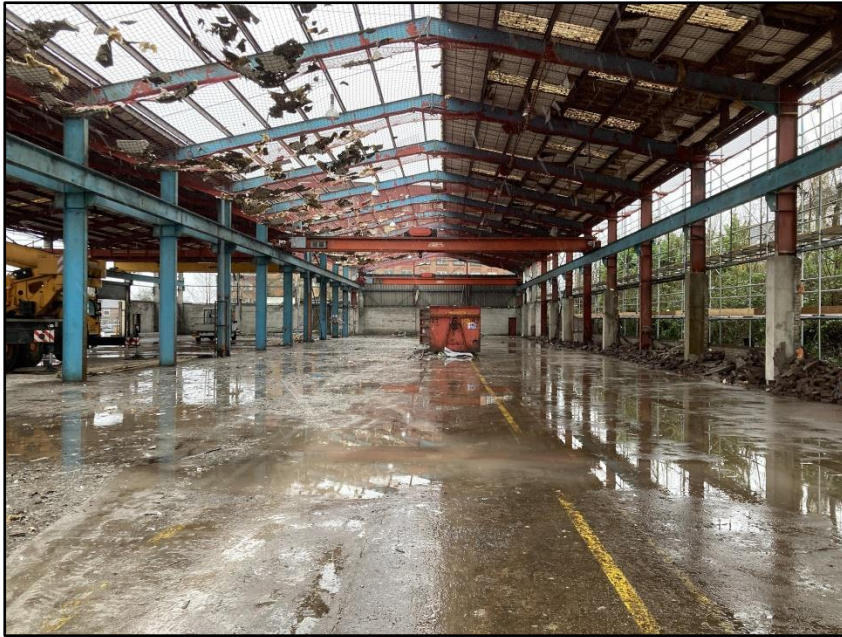
- 3.30 Building 8 is a large warehouse building currently being stripped of its internal fittings and external cladding with only the steel frame, brickwork and roof currently present (see Photograph 43). The masonry is in excellent condition and well-sealed with mortar. The internal spaces are open, resulting in damp and cold conditions (see Photograph 44). No suitable bat roost habitat was found at Building 8 and it is considered Building 8 offers **negligible bat roost suitability**.

*Photograph 43 showing Building 8*

Photograph 44 showing Building 8

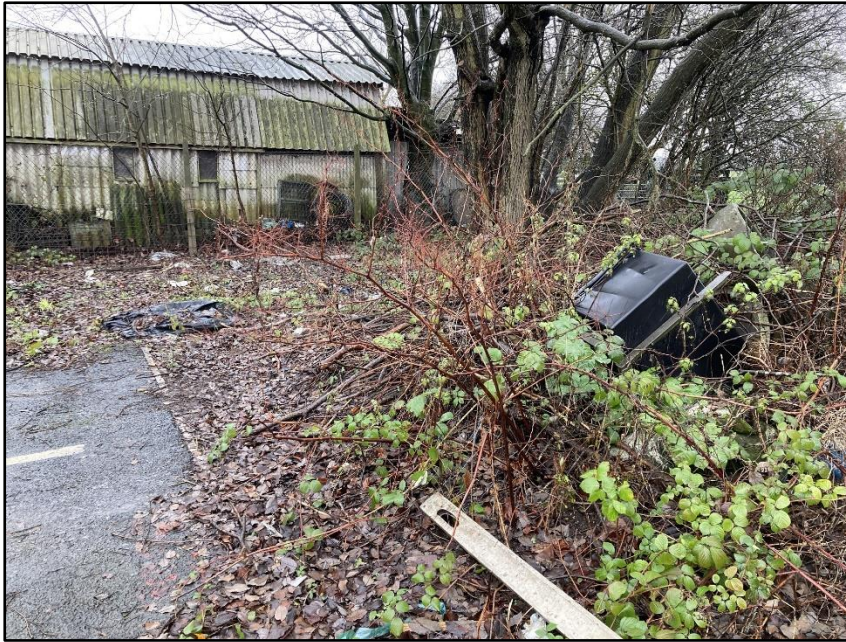
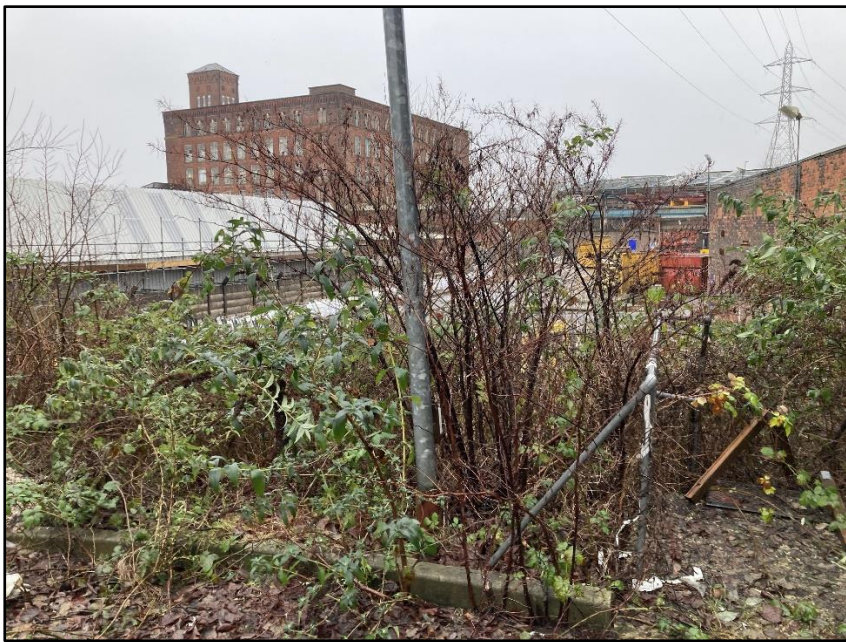
- 3.36 Japanese Knotweed is located on site (see Photographs 45 and 46). This is a non-native, invasive species listed on Schedule 9 Part II (plants) of the Wildlife and Countryside Act 1981 (as amended).

*Photograph 45 showing the Japanese Knotweed located in the northern corner of the site*

*Photograph 46 showing Japanese Knotweed located on site*

- 4.10 Japanese Knotweed is located on site. This is a non-native, invasive species listed on Schedule 9 Part II (plants) of the Wildlife and Countryside Act 1981 (as amended). It is recommended this species is eradicated from the site with the use of a recognised methodology prior to works commencing.

- 5.2 The Japanese Knotweed should be carefully removed from site using a recognised methodology. This should be either long-term herbicide application or short-term digging out and removal off-site to a licensed landfill or digging out and deep burial with a suitable barrier membrane on-site.
