# **Bury Hospital Gate House Demolition**

## **Arboricultural Impact Assessment and Method Statement**

Report Ref: 439/R/200

November 2025

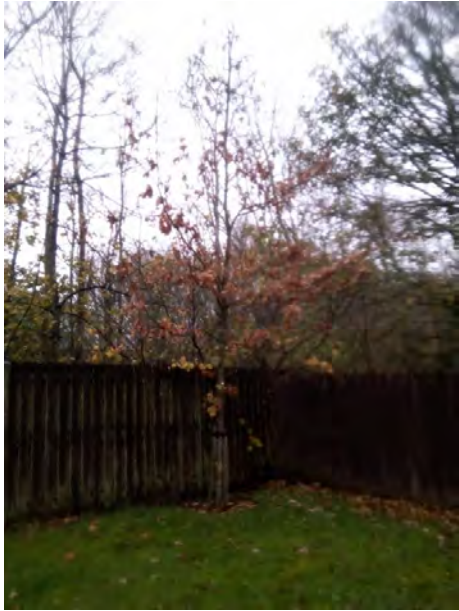
| Tree ref<br>(tags 542 to 552 inclusive) | Species<br>Common name | Height<br>(m) | Number<br>of<br>stems | Stem dia.<br>(mm)<br><i>estimated<br/>dbh in<br/>italics</i> | Crown spread<br>N E S W | | | | Height of<br>crown<br>clearance<br>(m) | Direction<br>and height<br>of lowest<br>branch (m) | Maturity | Structural<br>condition | Physiological<br>condition | Comments on form condition,<br>health and significant defects | BS5837<br>Tree<br>Quality<br>Category<br>A, B, C, U | 1,2,3 | Radius<br>of<br>RPA<br>(m) | Management<br>recommendations<br>Reinspect all retained<br>trees two years from<br>survey date | Estimated<br>remaining<br>contribution |
|---|---|---|---|---|---|---|---|---|---|---|---|---|---|---|---|---|---|---|---|
| T546 | Pedunculate oak | 10 | 1 | 180 | 4.5 | 2 | 3 | 0.5 | 2 | E2 | Young | Good | Good | Tree of good form and condition<br>and potential to develop into<br>tree of higher category rating | B | 2 | 2.16 | | 20-40 |

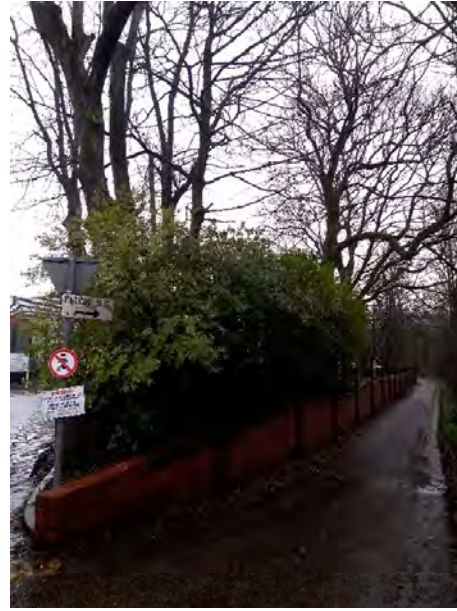
Hedge and trees opposite gate house building

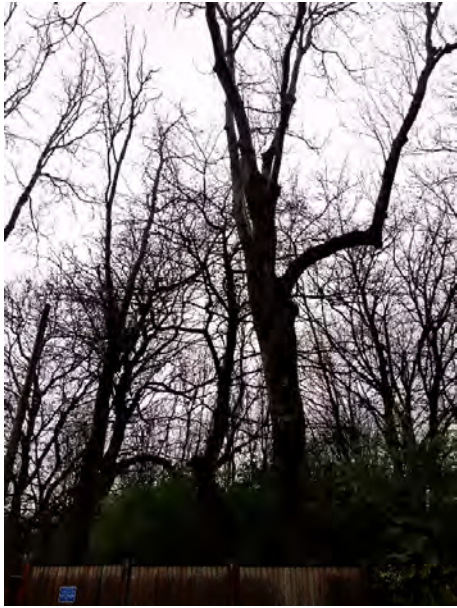
T548, T549, T550

| Tree ref<br>(tags 542 to<br>552<br>inclusive) | Species<br>Common name | Height<br>(m) | Number<br>of<br>stems | Stem dia.<br>(mm)<br><i>estimated<br/>dbh in<br/>italics</i> | Crown spread<br><br>N E S W | | | | Height of<br>crown<br>clearance<br>(m) | Direction<br>and height<br>of lowest<br>branch (m) | Maturity | Structural<br>condition | Physiological<br>condition | Comments on form condition,<br>health and significant defects | BS5837<br>Tree<br>Quality<br>Category<br>A, B, C, U | 1,2,3 | Radius<br>of<br>RPA<br>(m) | Management<br>recommendations<br>Reinspect all retained<br>trees two years from<br>survey date | Estimated<br>remaining<br>contribution |
|---|---|---|---|---|---|---|---|---|---|---|---|---|---|---|---|---|---|---|---|
| T549 | Ash | 17 | 1 | 390 | 3 | 2.5 | 4 | 8 | 6 | S5 | Early<br>mature | Fair | Poor | In planting bed with stem at kerb edge; etiolate form; bifurcate at 6m with epicormic growth/shooting at pruning cuts up stem; die back in crown; reinspect in spring to assess crown condition | C | 1 | 4.68 | | less than<br>10 years |

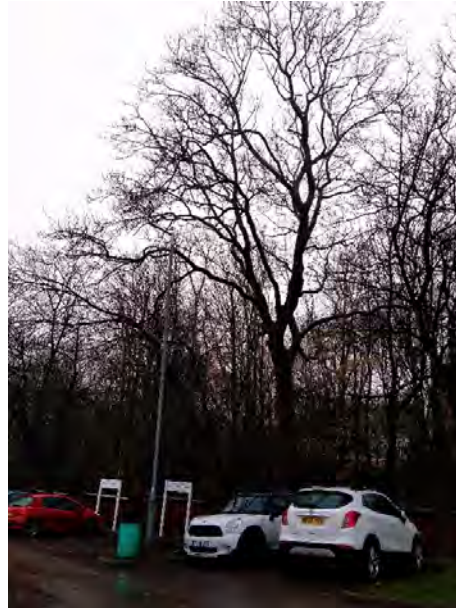
Group to west along access to reservoir
