**ARBORICULTURAL IMPACT ASSESSMENT  
to BS 5837:2012**

**at  
34 Ringley Road  
Whitefield  
Prestwich  
Greater Manchester  
M45 7LE**

21926-A/AJB

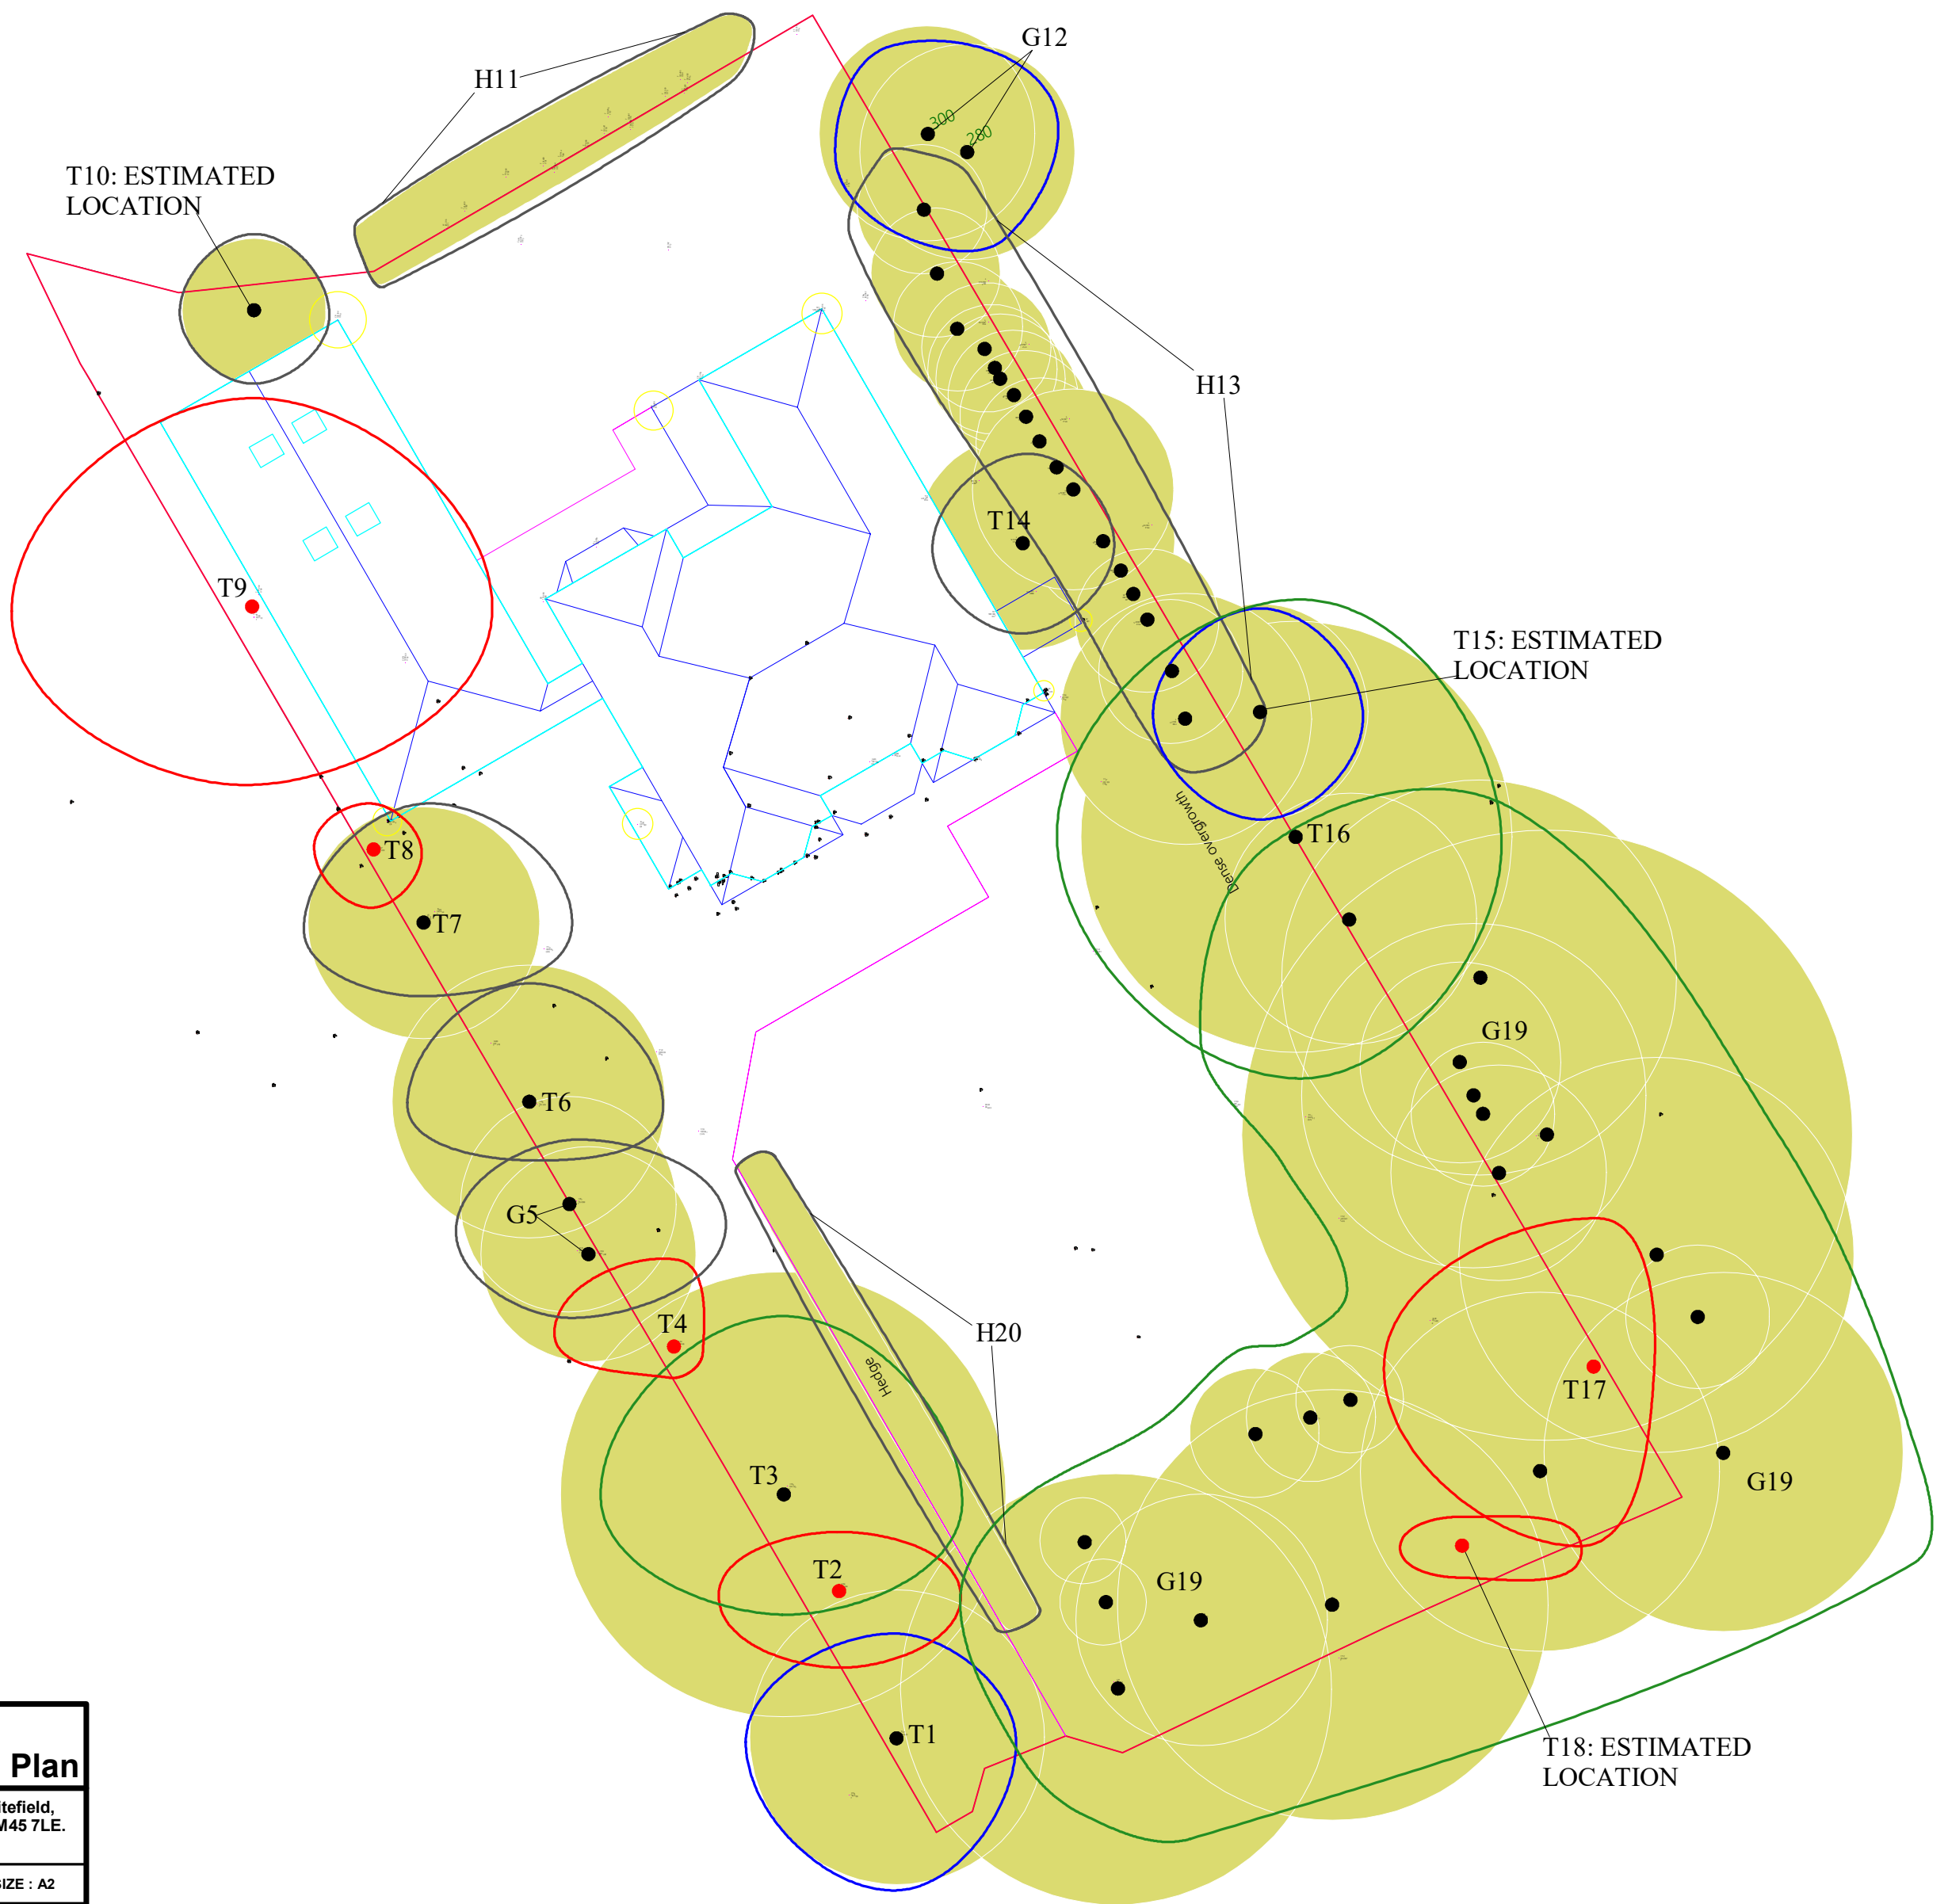
**Appendix 5:  
Tree Constraints Plan**

- 2.1 The tree information recorded during the original survey is detailed in the tables at **Appendix 1**. A full explanation of the tables can be found at **Appendix 2**. Please refer also to the Tree Constraints Plan at **Appendix 5** for tree locations.

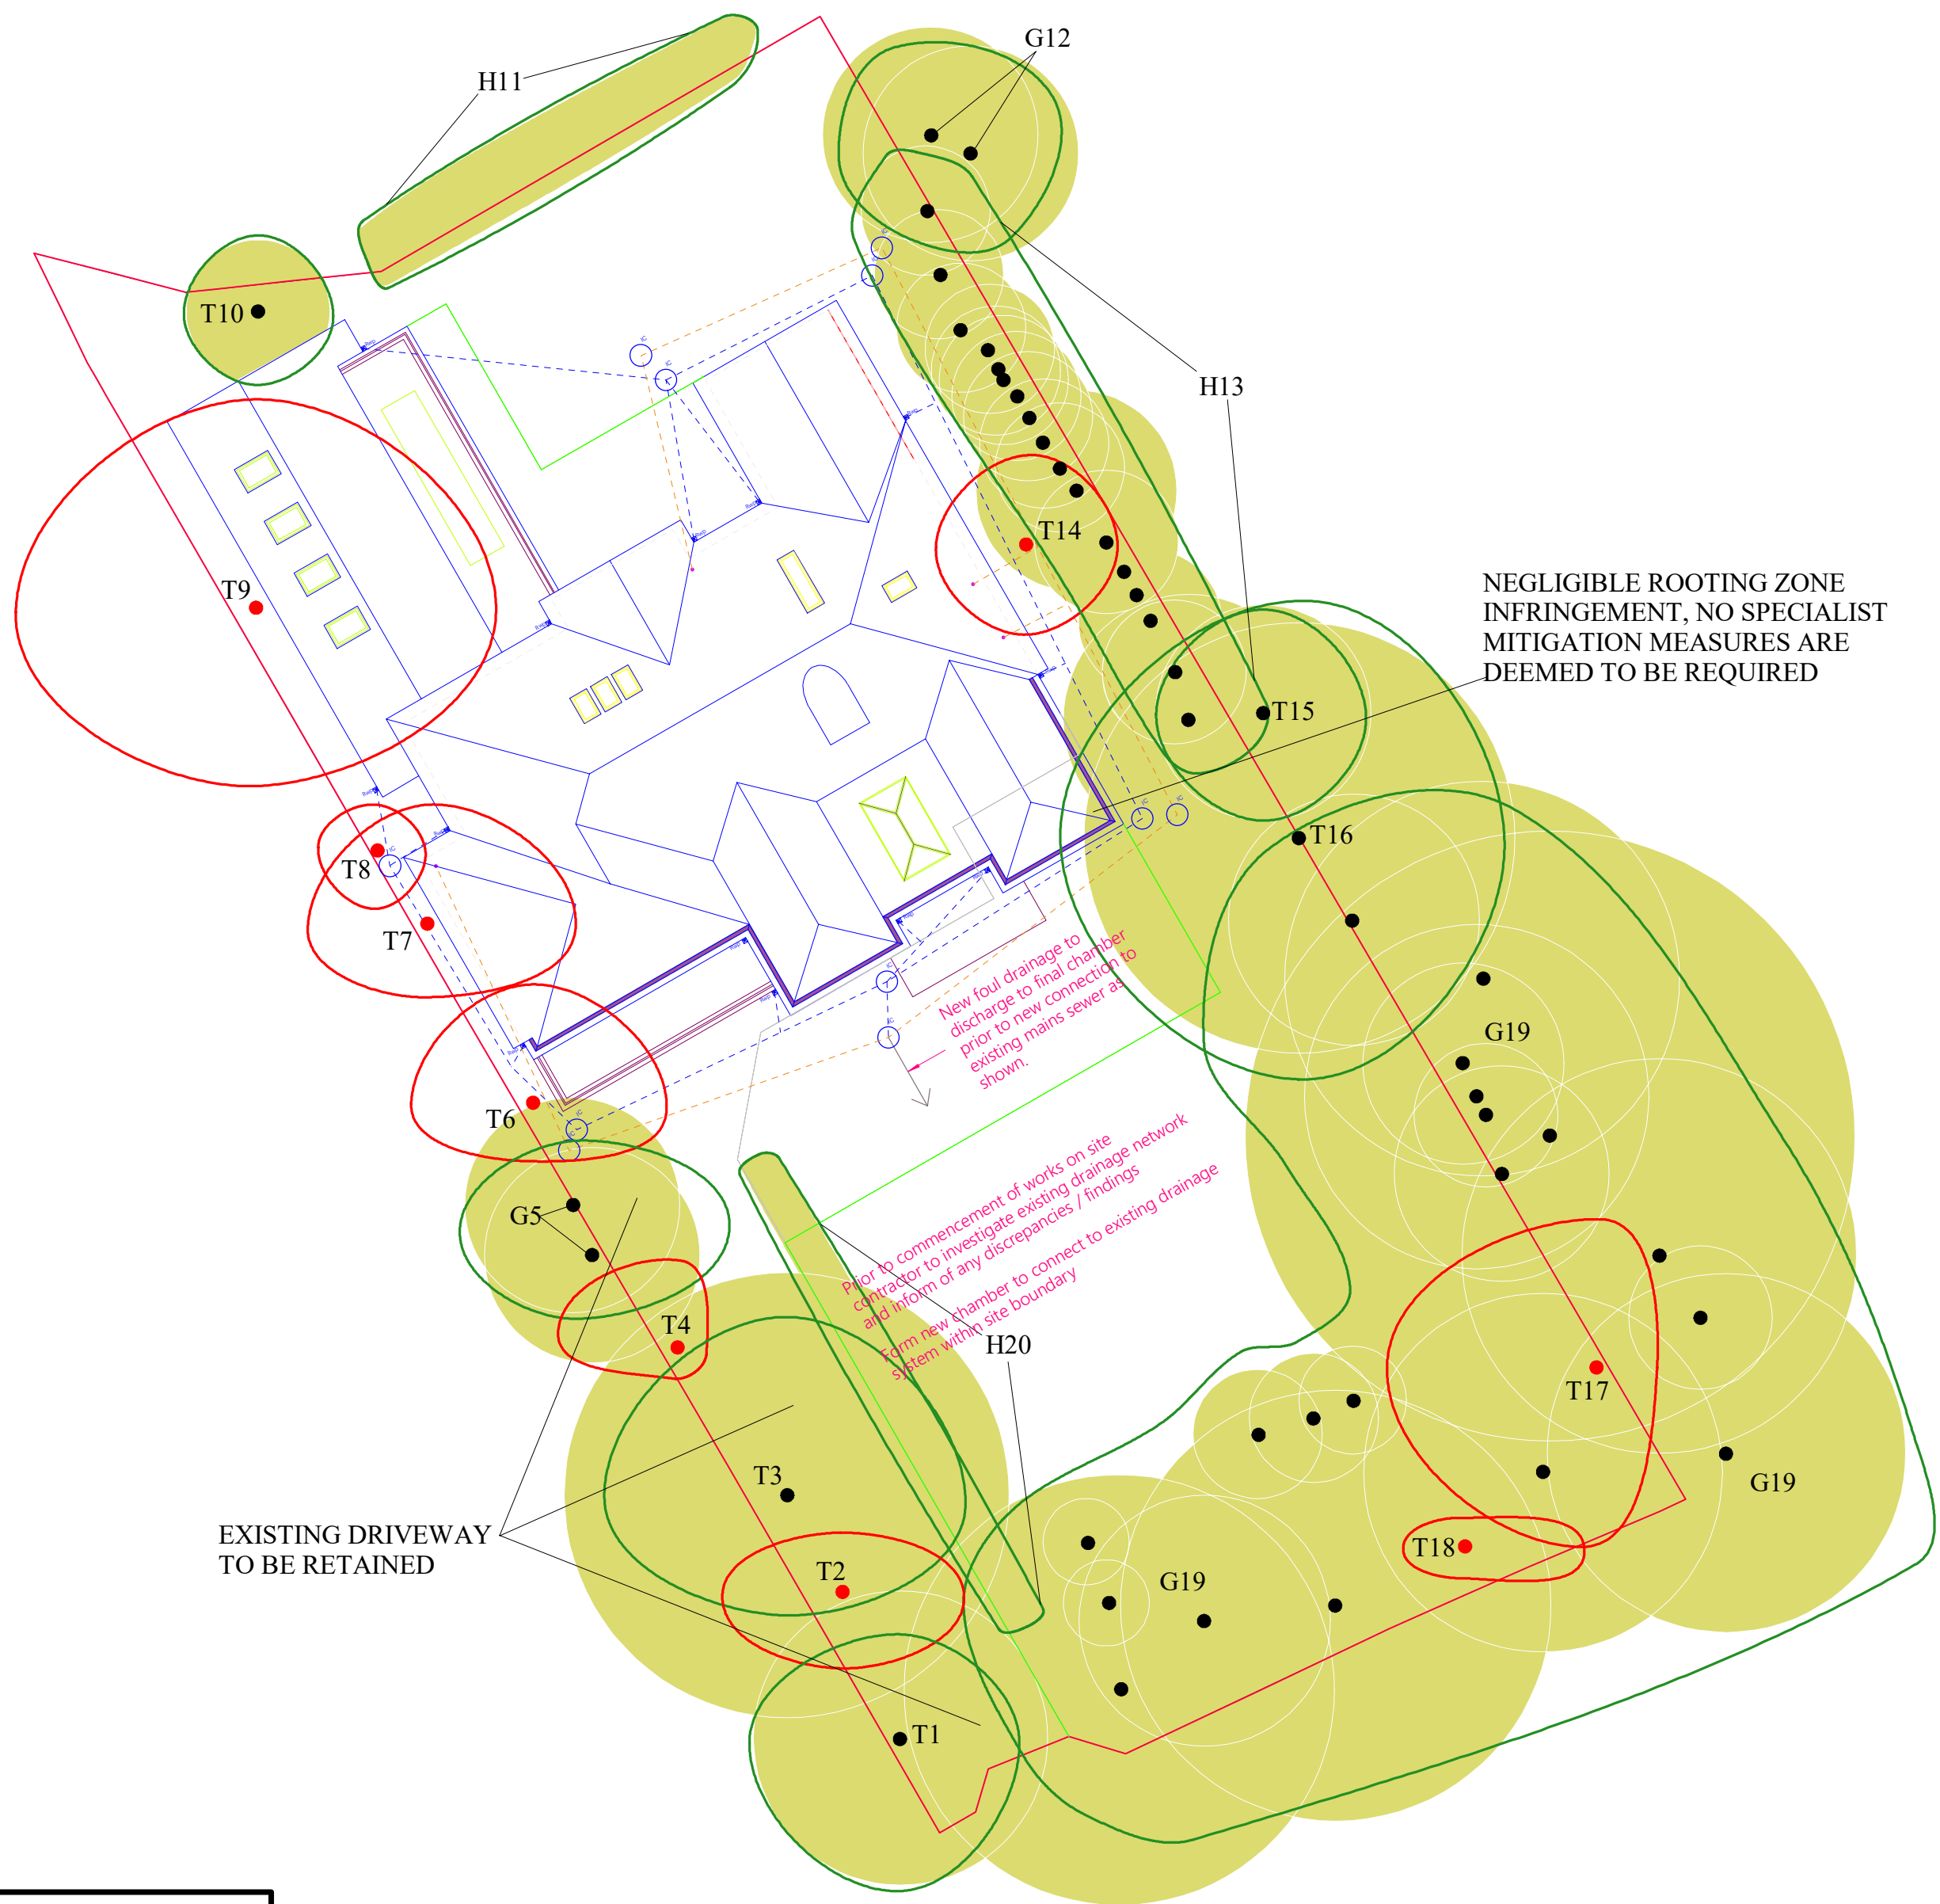
**Appendix 6: Arboricultural Implications Plan**

- 3.5.1.1 To the knowledge of JCA and with the exception of a negligible infringement within the rooting zone of **T16** (as annotated on the plan at **Appendix 6**) no construction activities are required within the rooting zones of trees to be retained at this site.

- 3.5.4.1 With the exception of a negligible infringement within the rooting zone of **T16** (as annotated on the plan at **Appendix 6**) the footprint of the proposed extension does not incur the RPA of retained trees. As such no specialist construction or foundation methods are considered necessary for the sole purpose of preventing damage to trees.
- 3.5.4.2 Despite this, specialist foundation designs may still be required for other reasons, and advice should always be sought from a suitably qualified structural expert. The water demand of trees can be an important consideration when determining the appropriate foundation design. Because of this, water demands for the trees identified on this site are included at **Appendix 1**, in accordance with **NHBC Standards**, for use by the appointed structural expert.

- 3.2.1 In order to facilitate the proposed development, it will be necessary to remove **T6, T7** and **T14**, each of which are considered to be low value trees which fall into retention category 'C'. It should be noted that due to the relatively young age of these trees, they are unlikely to be protected by the Area Tree Preservation order which was confirmed in 1989.
