## **GEOENVIRONMENTAL APPRAISAL**

**RADCLIFFE HUB, RADCLIFFE**

**BURY COUNCIL**

**Report No. 5238-G-R001**

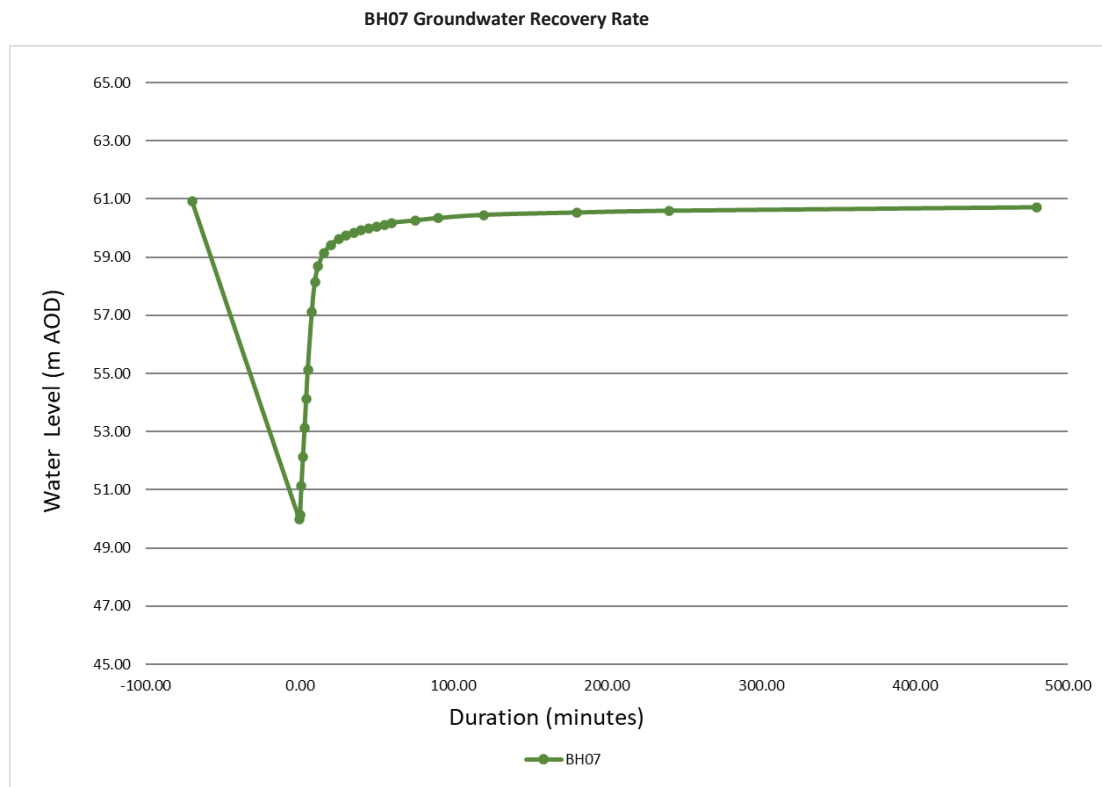
11.6.2 The groundwater recovery observed in BH07 are presented in Appendix G and shown in the figure below.

- 11.6.3 Review of the figure above indicates the water level in BH07 dropped almost 11 metres during the purging of the borehole with a rapid recovery (8.14m) recorded in the first 10 minutes after pumping ceased and a relatively slow recovery thereafter.
- 11.6.4 At the end of the test (8 hours) the groundwater level in BH07 was 0.22m lower than its resting level prior to purging.
- 11.6.5 The rapid groundwater recovery observed in BH07 is considered to be a result of secondary permeability (i.e. infiltration through fissures) in the PMCM strata which is supported by the highly fractured state of the recovered rock cores.

- 14.6.3 IDG therefore recommend the well installed in BH07 be decommissioned (i.e. removed and grouted up) as part of the preparatory works for the site to remove a pathway for groundwater within the PMCM to enter any deep excavations made during redevelopment of the site (i.e. excavation for the construction of the basement areas) and also to mitigate any long term groundwater issues to the proposed development from the borehole.
