# **Site Tree Appraisal**

***Moorfield Care Home 388 Tottington Road, Bury BL8 1TU***

**‘BS 5837 2012: Trees in Relation to Design, Demolition and Construction – Recommendations’**

Ref: RTS/07022024

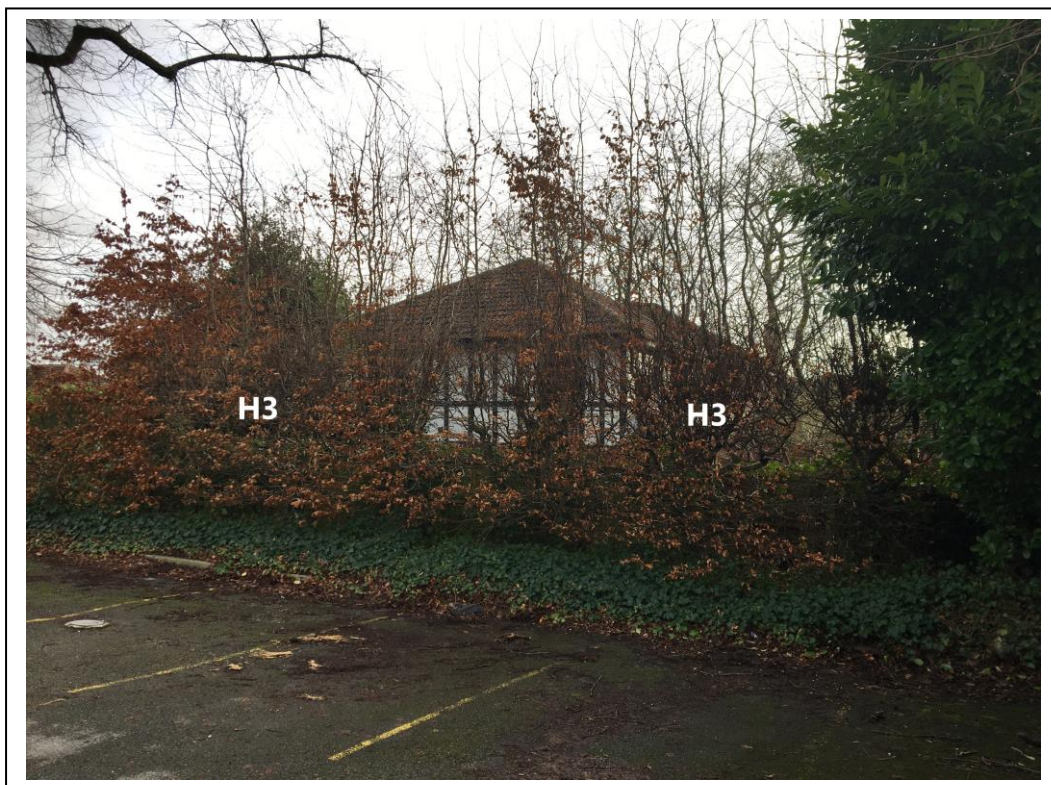
Photo 02:

**3.4** No tree works will be required to facilitate the parking bay extensions, save cutting back of the mixed hedgerow (H3), photo 02. General management pruning of the two Lime trees (T1 and T2), however, is recommended to abate nuisance of dead branch fall and low epicormic sucker growth. The tree work recommendations are noted in Table 1 section 5 of the report.

| Tree No | Species | Height (M) *<br>Crown Height above GL | DBH (mm) * | Crown Spread (M) * | Height to Lowest Branch (M)<br>Direction of Lowest Branch | Age Range | Condition | RPA Radius (M) | RPA Square metres | BS 5837 Category<br>Rating | Observations and Comments |
|---|---|---|---|---|---|---|---|---|---|---|---|
| H3 | <b>Beech</b><br><i>Fagus sylvatica</i><br><b>Laurel</b><br><i>Prunus laurocerasus</i> | <u>6.0</u><br>0.5 | 150<br>Average | A linear hedgerow<br>3.0 metres wide | <u>0.5</u><br>N | Mature | Good | 1.8 | 10 | C2 | A mixed linear hedgerow that provides good screening between two properties. |

| Tree | Tree Work | Priority |
|---|---|---|
| H3 | Cut back the north west side of the hedgerow (carpark side) to obtain a final north west spread of approximately 300mm. Reduce the hedgerow height to obtain a final height of approximately 3 metres. | Prior to any other site works |
