# Preliminary Roost Assessment

3 Sunningdale Ave  
Whitefield  
Bury  
M45 7GW

For  
Archirama Ltd

# Gritstone Ecology

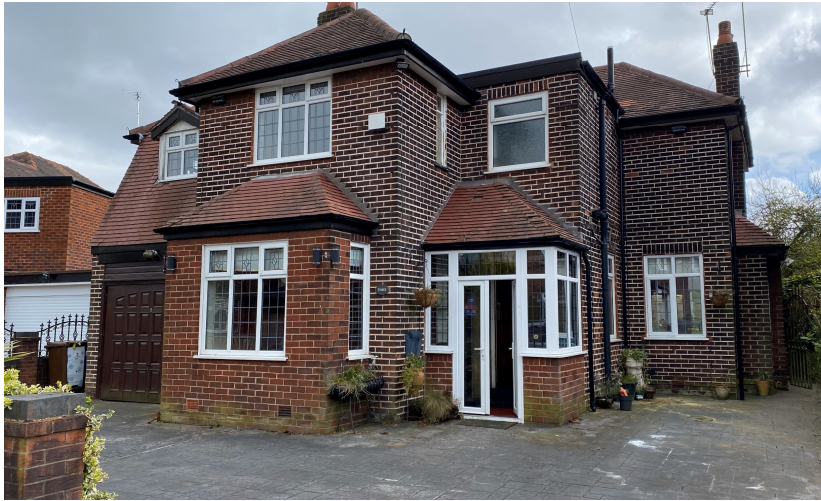
#### 3.1a – The front of the house.

No.3 Sunningdale Avenue is a pre-1950's detached house, which is currently unoccupied. Its main roof is hipped and covered with rosemary roof tiles. To the front there is a mansard style roof over the garage which has a small, pitched roof dormer. There are smaller hipped roofs over the front porch, bay window and side inglenook.

The building has been previously well maintained, and in good condition. Ridge tiles are fixed tightly, there are no damaged or missing ridge tiles. There are no damaged, slipped, or missing roof tiles. Roof tiles are tightly fitted, with no gaps between tiles. UPVC fascia boards and boxed soffits are fitted tightly against the walls gaps are filled with sealant. Walls are in good condition, with no missing mortar or cracks.

There are no features externally which are likely be used by roosting bats, and no evidence of use by bats was present during the inspection.

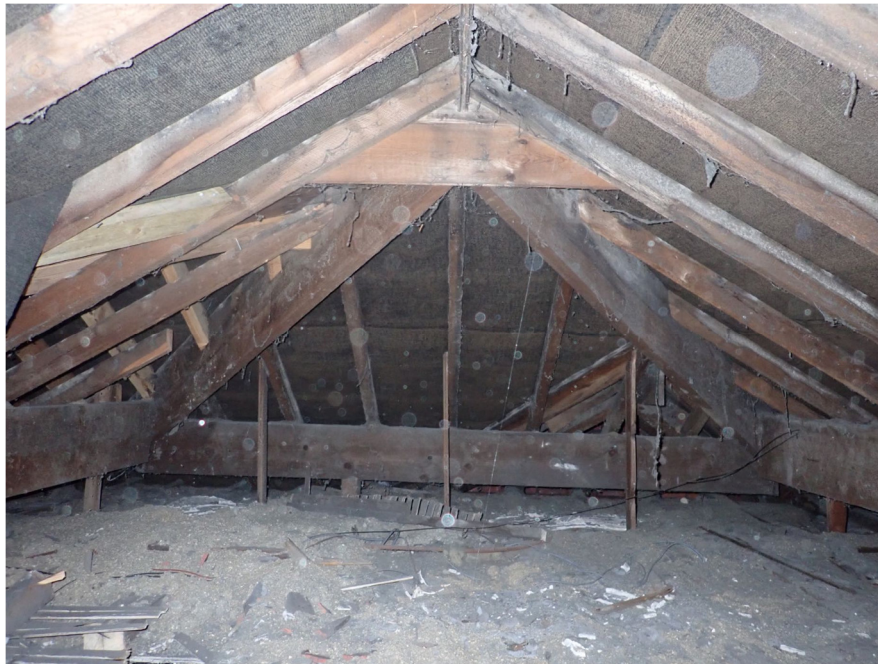
3.2a – Typical main roof void.

The house has a hipped roof spanning in different directions but with single void, which is not used for storage, and is accessed infrequently for essential maintenance. There was access across the main voids by climbing over the purlins.

The roof has a timber rafter and purlin structure, lined with bitumen felt, and insulated with mineral wool between the ceiling joists. The roof lining is in good condition with no tears, or gaps.

The wall cavity has been filled with insulation and was inspected at the wall plate using an endoscope. There are no gaps at the wall-plate; and there are no gaps which give direct access to the roof void from the outside. Boxed soffits open into the roof void and were inspected from above.

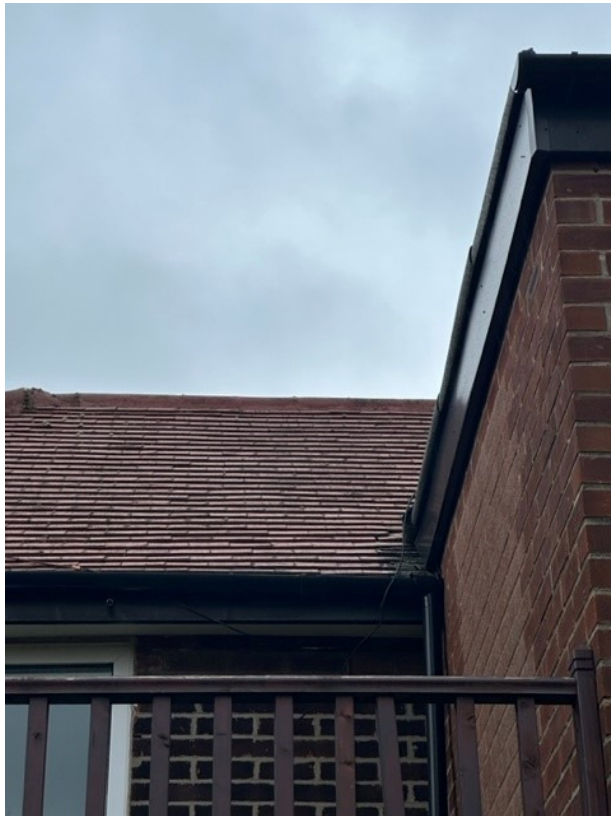
Roof and ridge tiles are in good condition, ridge tiles are sealed with cement. There are no gaps between roofing materials which could be used by roosting bats.

3– Roof and ridge tiles are in good condition with no suitable gaps.

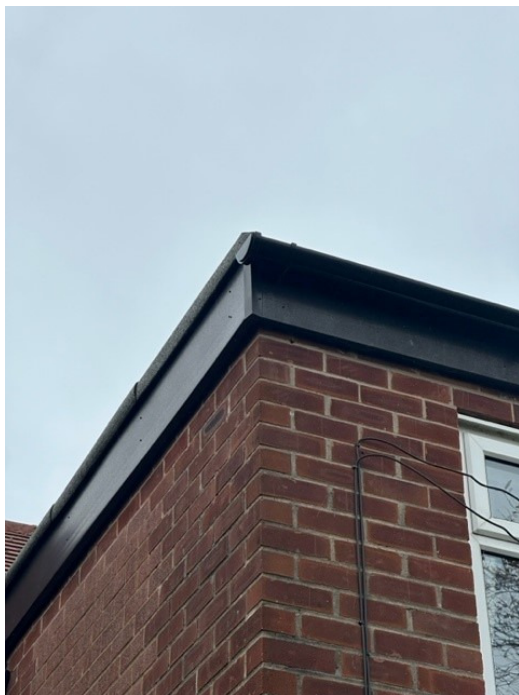
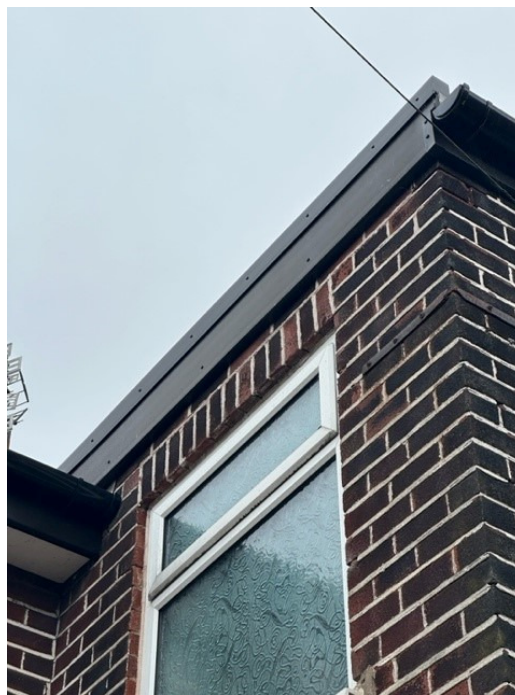
Window and door frames are fixed into the brickwork, gaps are filled with sealant, and offer no suitable roosting opportunities.

UPVC fascia boards and boxed soffits at the eaves are fixed tightly against brickwork, with no suitable gaps; wall cavities and boxed soffits open into the roof void, and were inspected from above.

4– UPVC fascia boards and soffits at the eaves are fixed tightly against brickwork. UPVC windows are all in good condition and tightly fixed with silicone sealant.

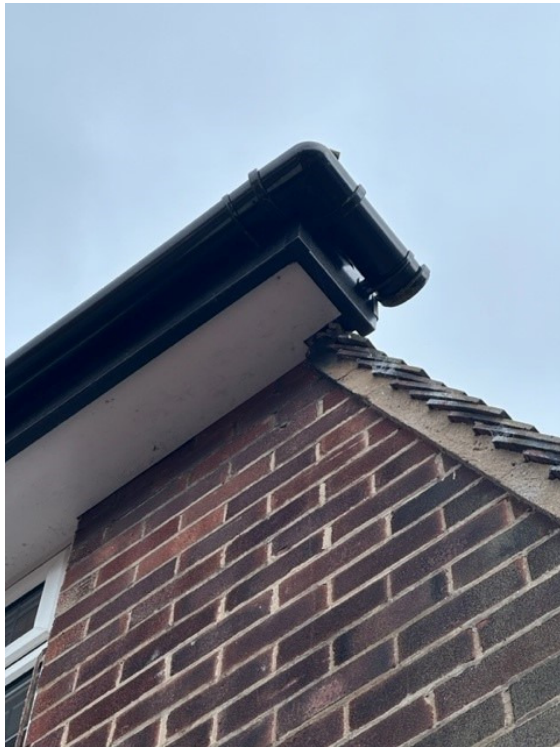
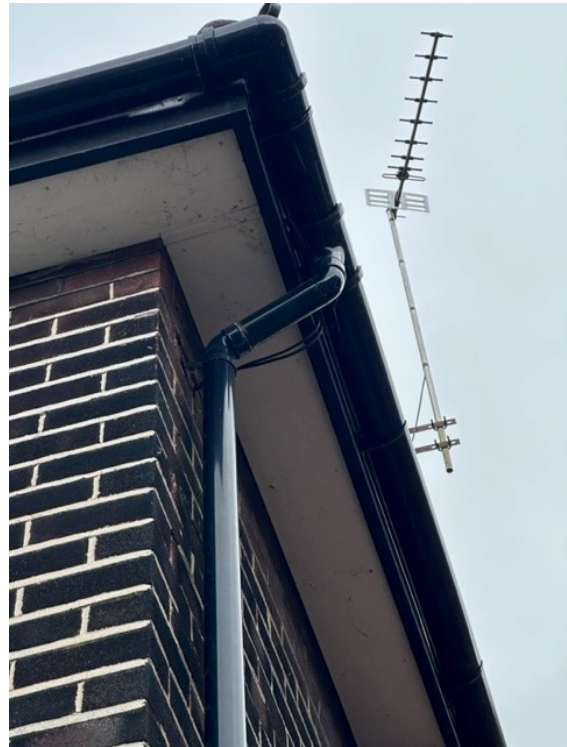
The walls are brick with an insulating cavity. The wall cavity has been filled with insulation. Walls are in good condition, with no cracks, or missing mortar which could be used by crevice dwelling bats.

5 – Brickwork and mortar and boxed eaves are in good condition with no suitable gaps.

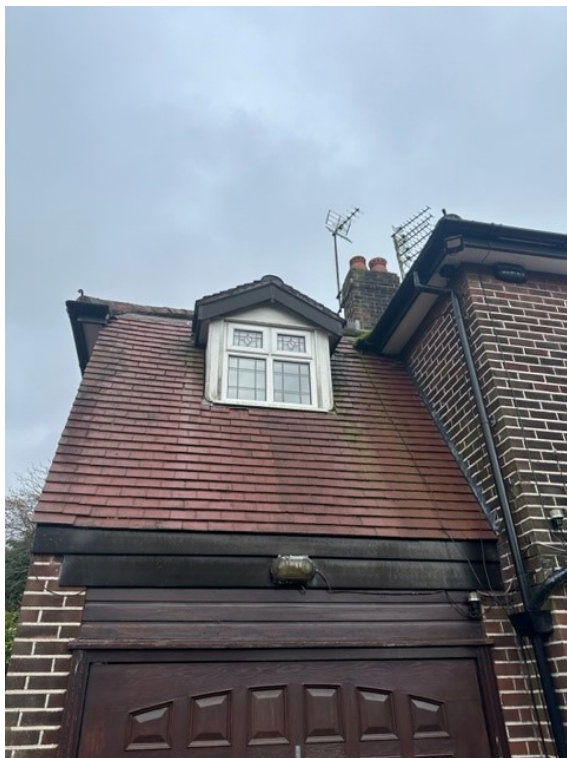
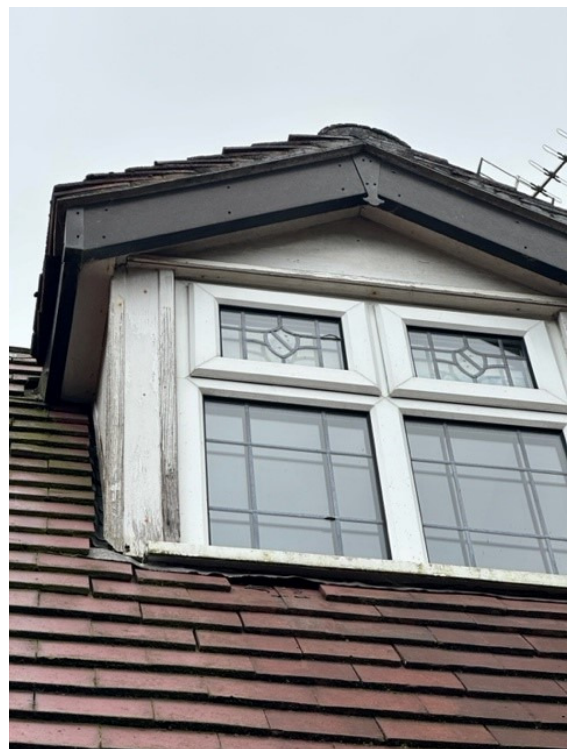
6 – Front tiles are in good condition. There are some small gaps around the dormer but there is lead flashings and felt behind. Fascias and soffits are all closed UPVC construction.

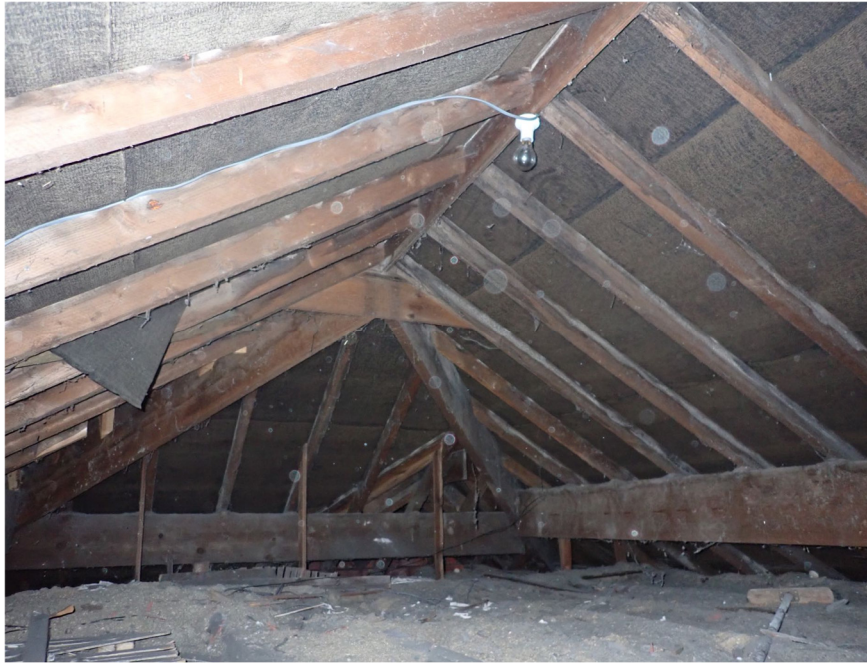
7 – No gaps in felt and eaves in pitched roof void and was not being used for storage.

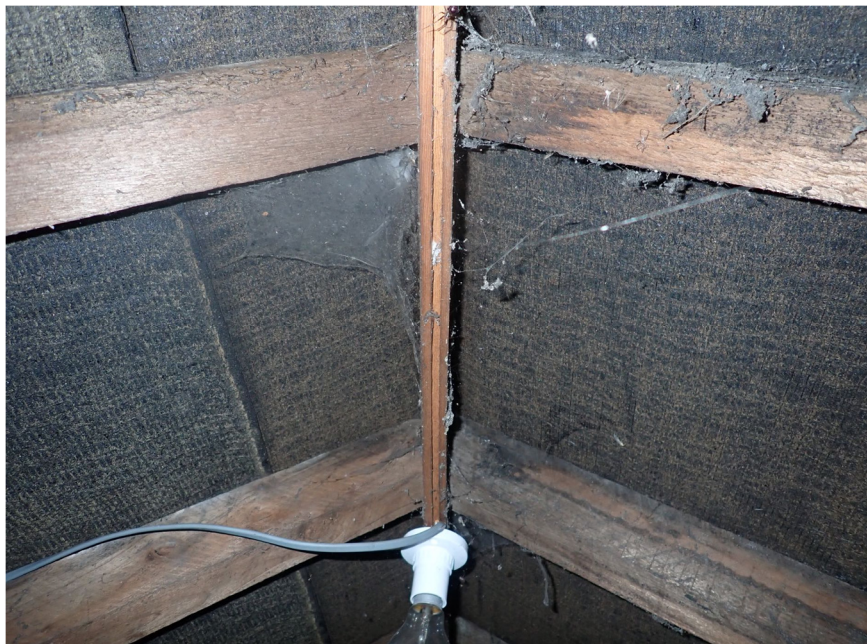
8 – Roof timbers are covered with dusty cobwebs.
