**CONSTRUCTION TRAFFIC  
MANAGEMENT PLAN (CTMP)  
IN RELATION TO CONDITION 31 OF  
PLANNING REF:71426/24**

**Land adjacent to Bealey Industrial Estate,  
Dumers Lane, Radcliffe**

# **HIGHWAY DILAPIDATION SURVEY**

**PHOTOS TAKEN 25<sup>TH</sup> MARCH 2026  
KATIE STEWART – ASSISTANT ENGINEER**

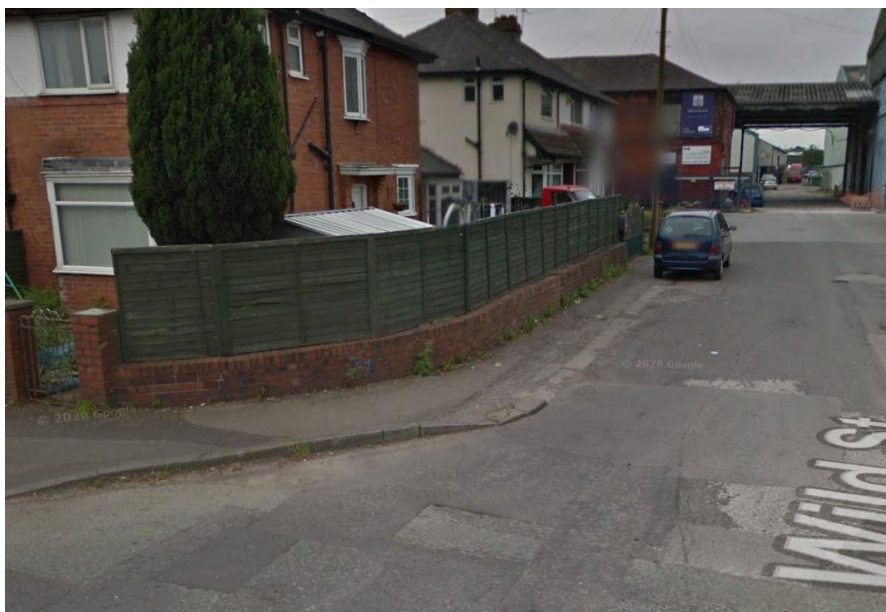
Fig 4: Southern edge of Wild Street with demarked pedestrian route but now kerb upstand to differentiate for vehicles

Temporary signage will be employed to encourage pedestrians to use this as a route. This will be monitored by the site management team and if an alternative pedestrian access on the northern edge of the Wild Street corridor, this will be provided with a suitably safe and level hard surface, with associated signage.

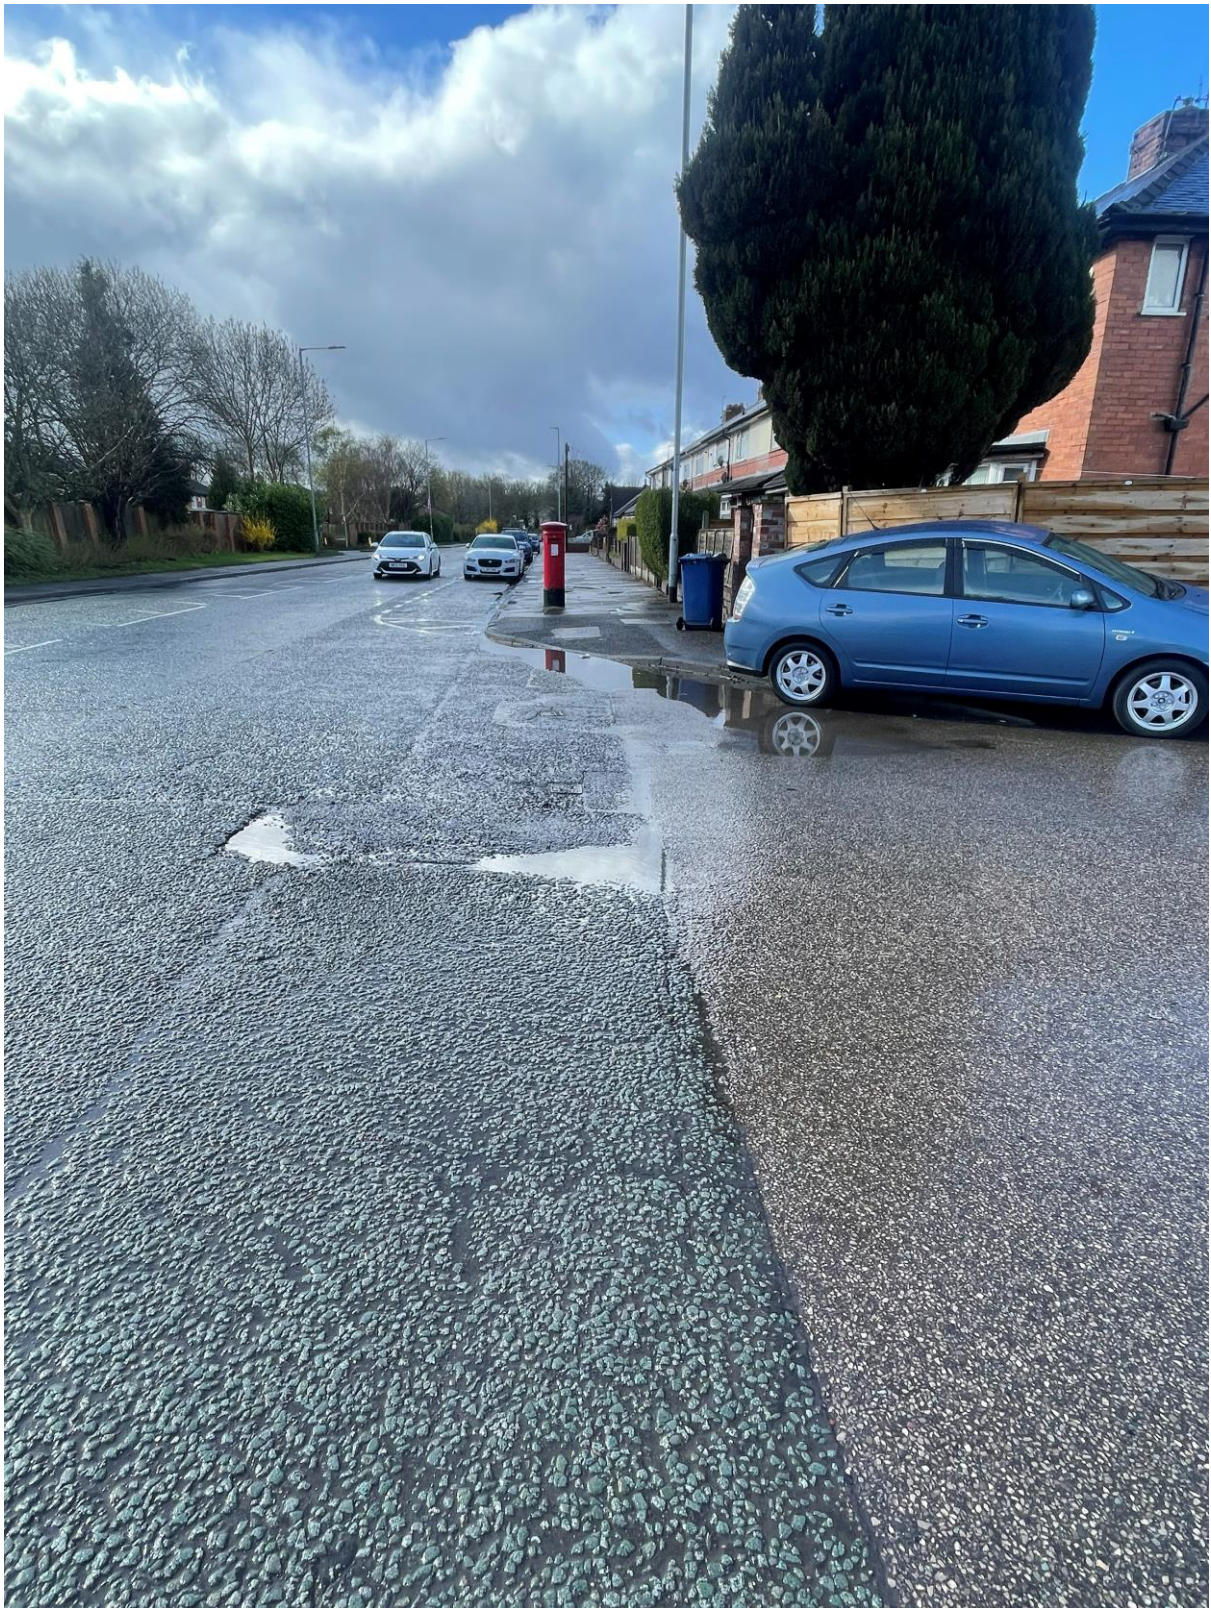
FRAME 2

| <b>FRAME</b> | <b>KERB<br/>CONDITION</b> | <b>FOOTPATH<br/>CONDITION</b> | <b>CARRIAGEWAY<br/>CONDITION</b> | <b>GENERAL<br/>CONDITION</b> |
|---|---|---|---|---|
| <b>2</b> | N/a | N/a | Surface in poor condition with potholes, patches, stress fractures with ponding in the middle of junction. | Carriageway showing signs of wear and deterioration. |

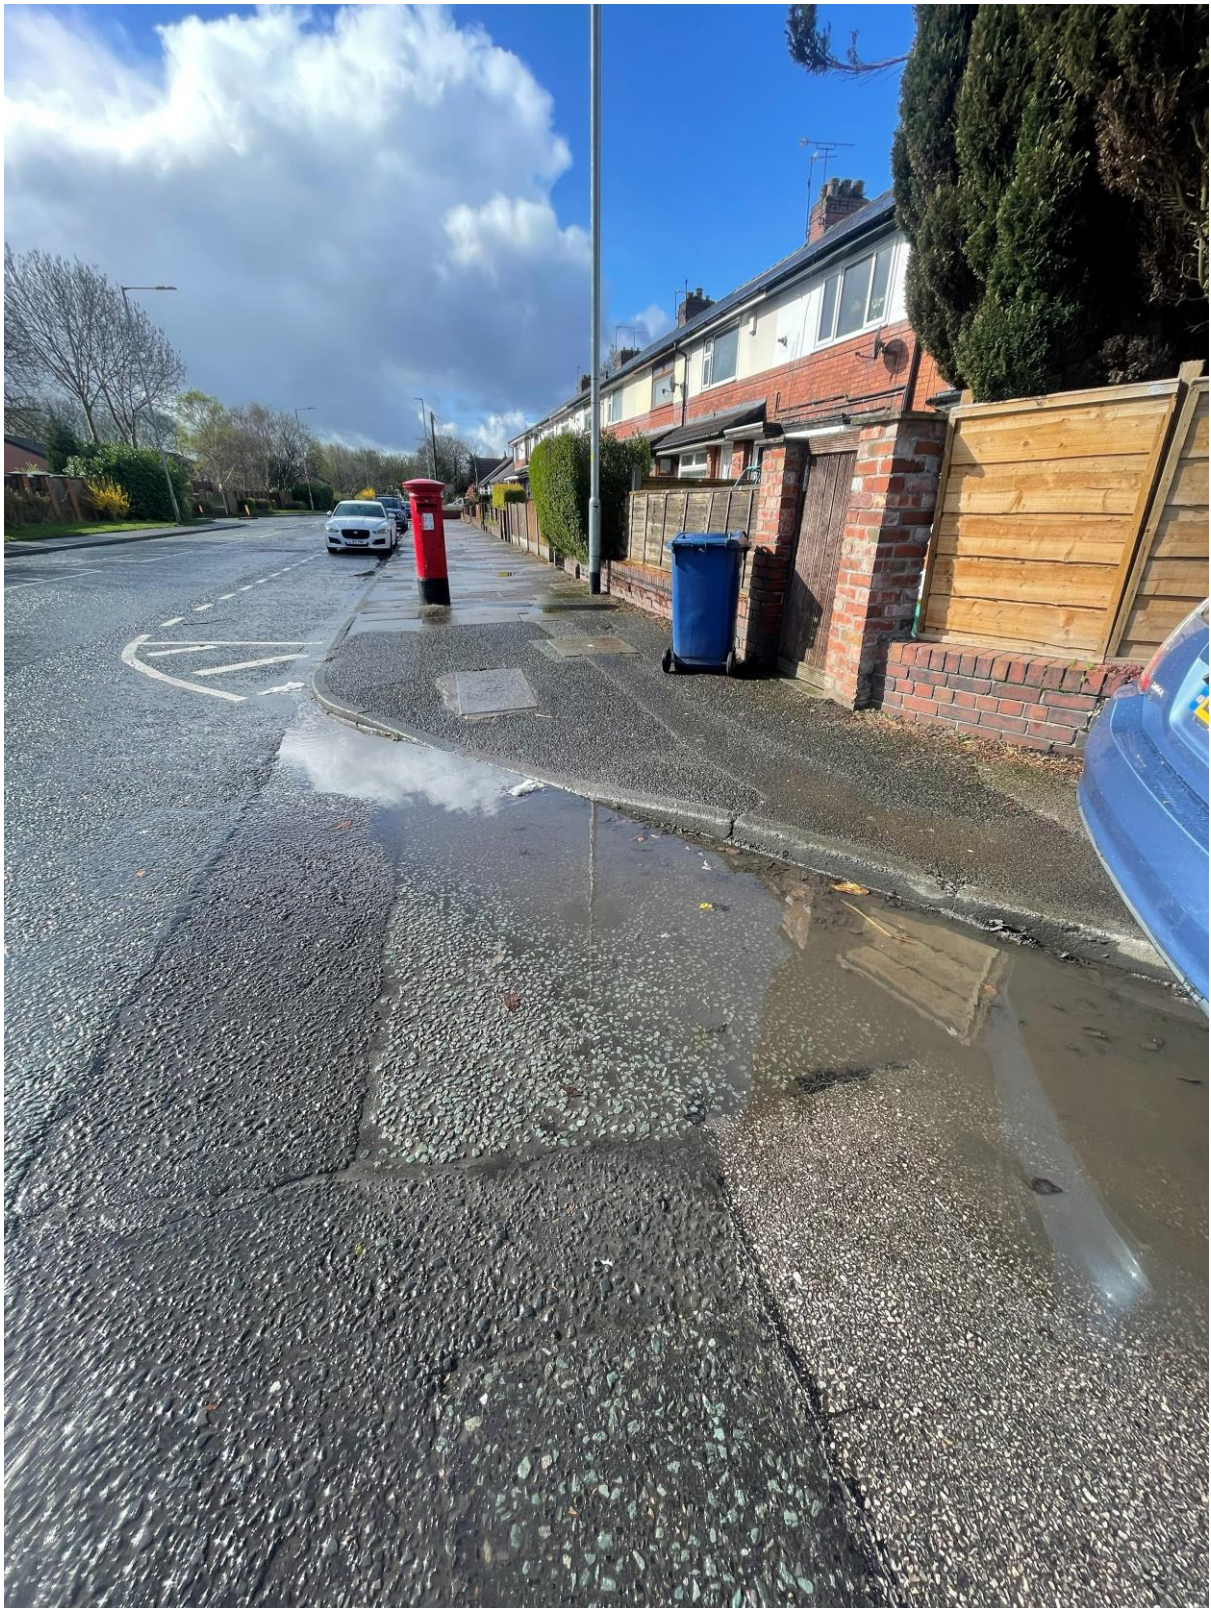
FRAME 3

| <b>FRAME</b> | <b>KERB<br/>CONDITION</b> | <b>FOOTPATH<br/>CONDITION</b> | <b>CARRIAGEWAY<br/>CONDITION</b> | <b>GENERAL<br/>CONDITION</b> |
|---|---|---|---|---|
| <b>3</b> | Kerbs damaged and poor condition. | Tarmac Poor condition. Various scars associated with patch utilities repairs. | Large amount of ponding on junction around kerbs and leading into site. | Footpath in poor condition. Carriageway showing signs of wear and deterioration. |

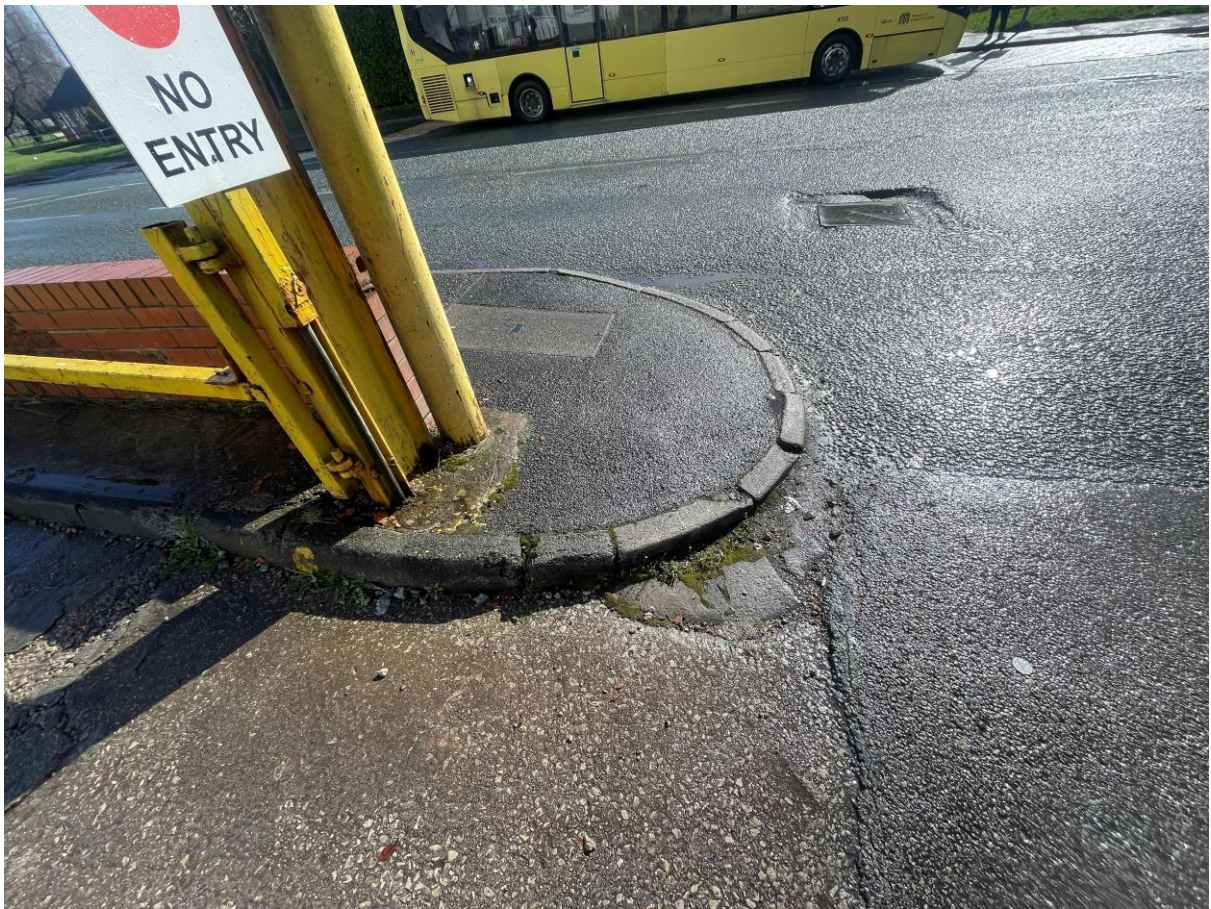
FRAME 7

| <b>FRAME</b> | <b>KERB<br/>CONDITION</b> | <b>FOOTPATH<br/>CONDITION</b> | <b>CARRIAGEWAY<br/>CONDITION</b> | <b>GENERAL<br/>CONDITION</b> |
|---|---|---|---|---|
| <b>7</b> | Radius kerbs damaged, poor condition and level inconsistent. | Medium condition tarmac footpath, well-worn with BT box positioned in footpath. | Weeds around kerb line. Change of surfacing, poor condition. | Carriageway entering car wash – poor condition. |

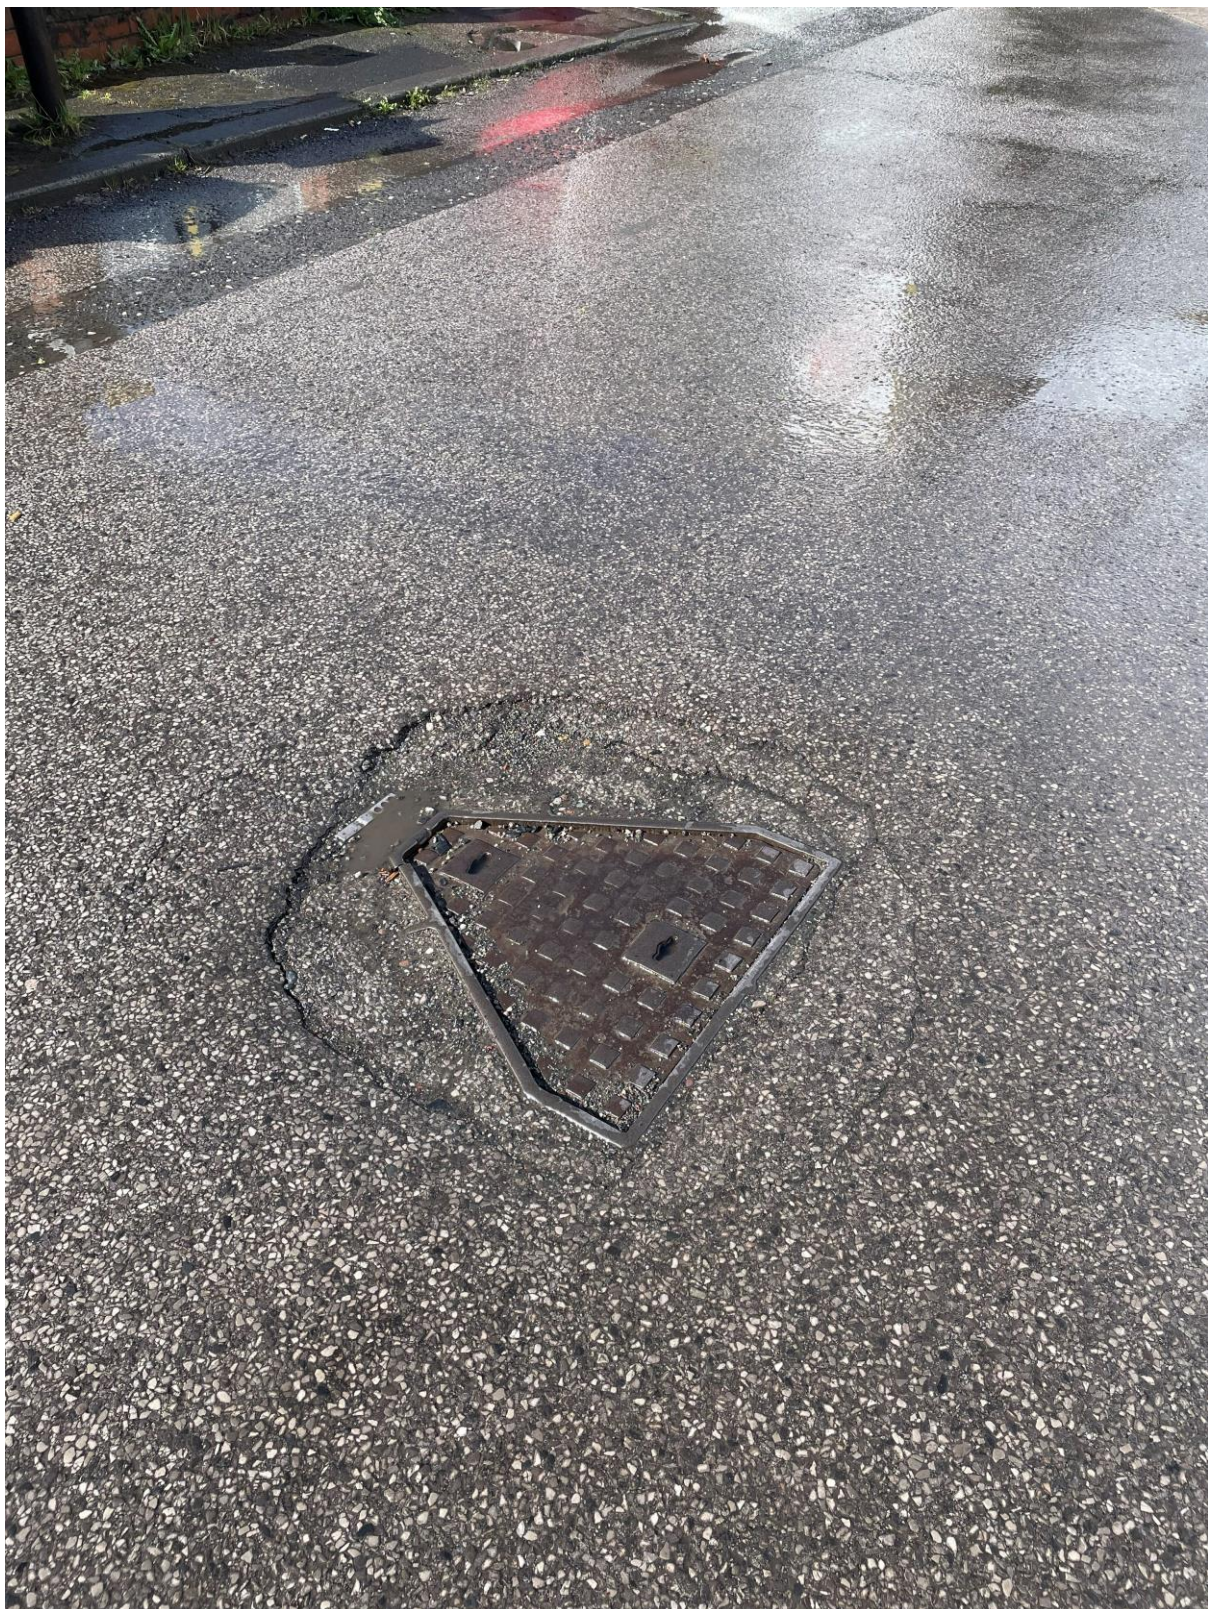
FRAME 16

| 16 | N/a | N/a | Carriageway settled around Manhole. | Manhole lid is reasonable condition. |

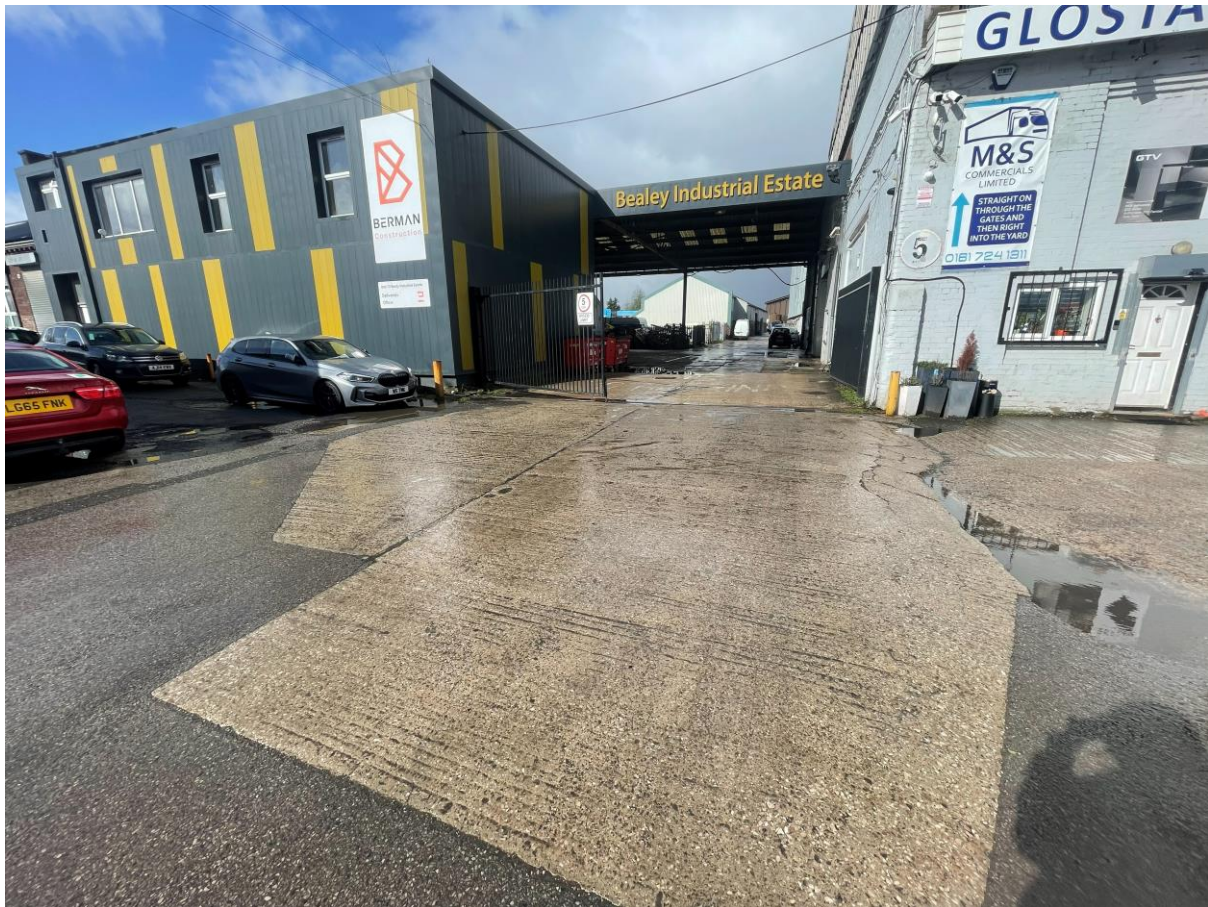
FRAME 19

| <b>19</b> | N/a | N/a | Carriageway surfacing material changed, cracking and ponding due to level change. | Poor condition |

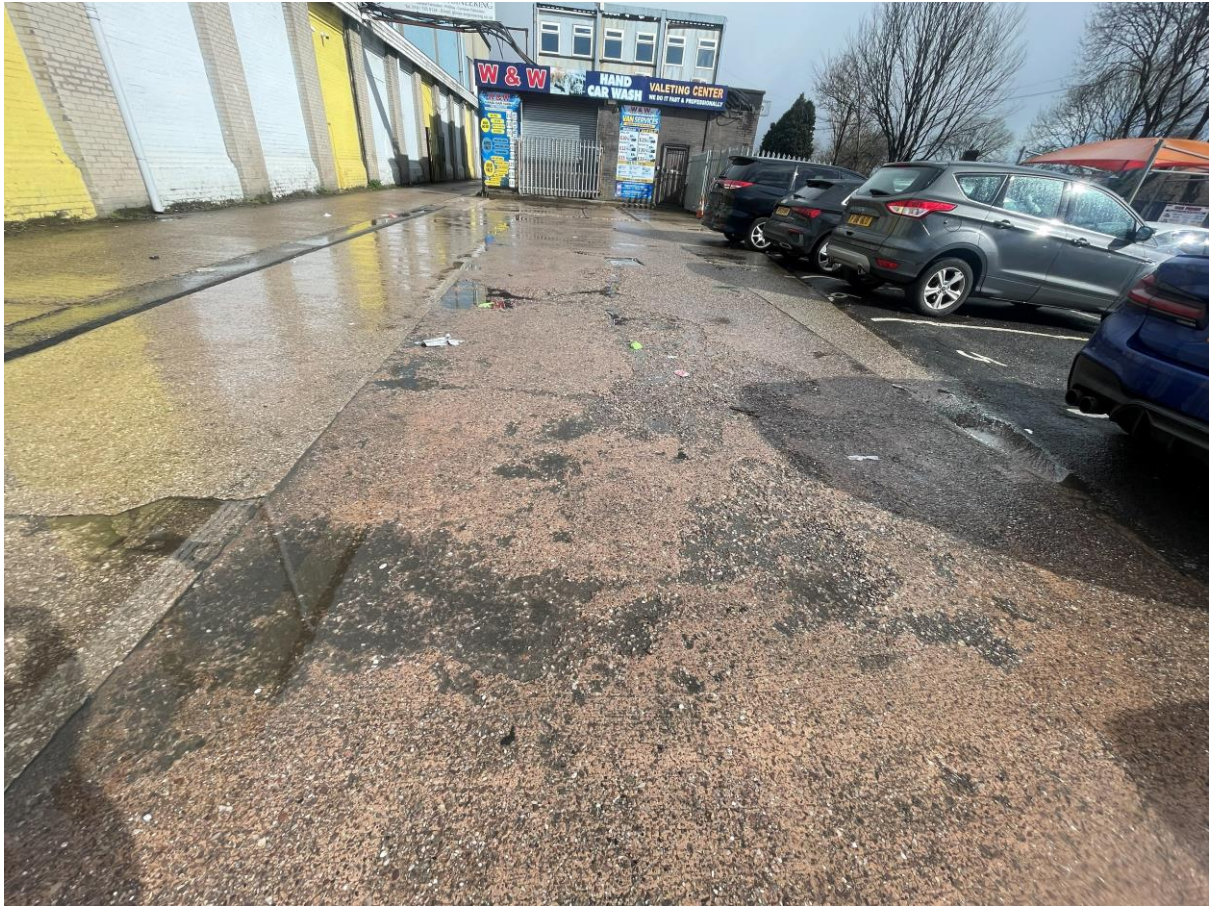
FRAME 24

| <b>24</b> | N/a | N/a | Tarmacked Car park to the right-hand side. Potholes and ponding with patched surfacing. | Poor condition |

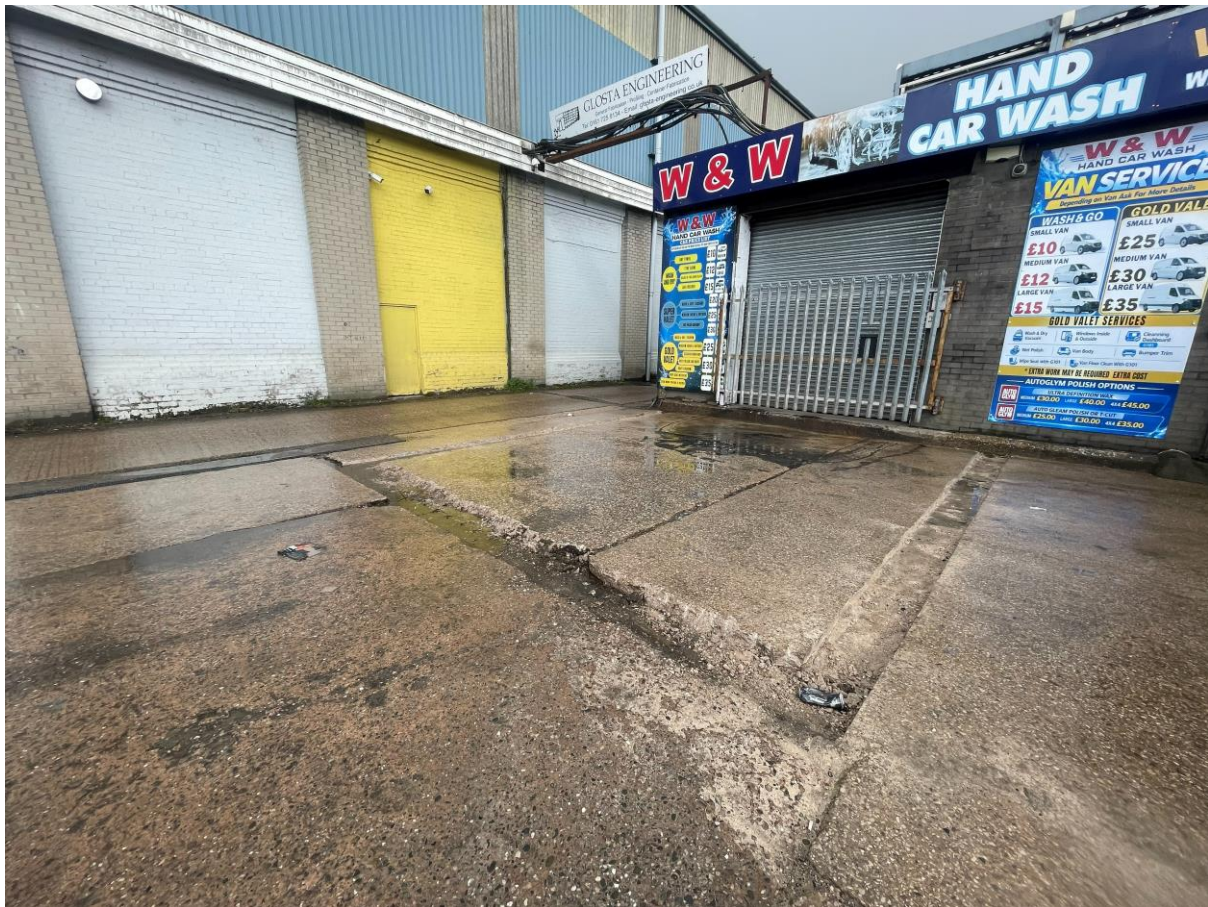
FRAME 26

| <b>26</b> | N/a | N/a | Surfacing in poor condition, uneven surfacing, cracking in material with ponding. | Poor condition |
