# **Site Tree Appraisal**

***Manchester Mesivta School, Charlton Avenue, Prestwich M25 0PH***

**“BS 5837 2012: Trees in Relation to Design, Demolition and Construction – Recommendations”**

Ref: RTS/29052023

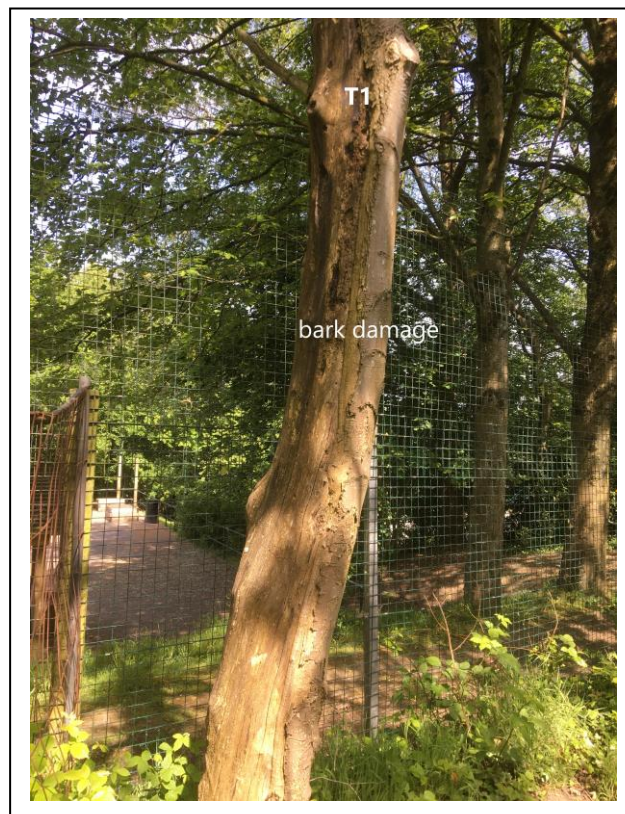
Photo 02:

- 3.6** Tree T1 is close to the boundary fence and has significant bark damage to the west side of the trunk up to a height of approximately 3.5 metres (photo 02). Longevity of T1 is expected to be limited.

| Tree No | Species | Height (M) *<br>Crown Height above GL | DBH (mm) * | Crown Spread (M) * | Height to Lowest Branch (M)<br>Direction of Lowest Branch | Age Range | Condition | RPA Radius (M) | RPA Square metres | BS 5837 Category Rating | Observations and Comments |
|---|---|---|---|---|---|---|---|---|---|---|---|
| T1 | <b>Sycamore</b><br><i>Acer pseudoplatanus</i> | <u>15.0</u><br>3.5 | 310 | N – 2.0<br>S – 6.0<br>E – 3.0<br>W – 2.5 | <u>3.0</u><br>S | Early mature | Poor to Fair | 3.7 | 43 | C1 | Significant bark damage to the west side of the trunk up to a height of approximately 3.5 metres. |

| Tree | Tree Work | Priority |
|---|---|---|
| T1, T21, T22, T23, T24, T25, T26, T27, T28, T29, T30, T31, T32, T32a, T32b, T34, T35, T35a, T36, T37 and T39 | Fell to ground level and dig out the remaining stumps | Prior to any other site works |
