Tyler Grange Ref. 15807\_R05a\_Arboricultural Addendum Note\_BV\_JJ

## Prestwich Village - Travel Hub Construction: Tree Work Specifications

Project title  
Prestwich Village

Drawing title  
Tree Constraints Plan - Sheet 1 of 3

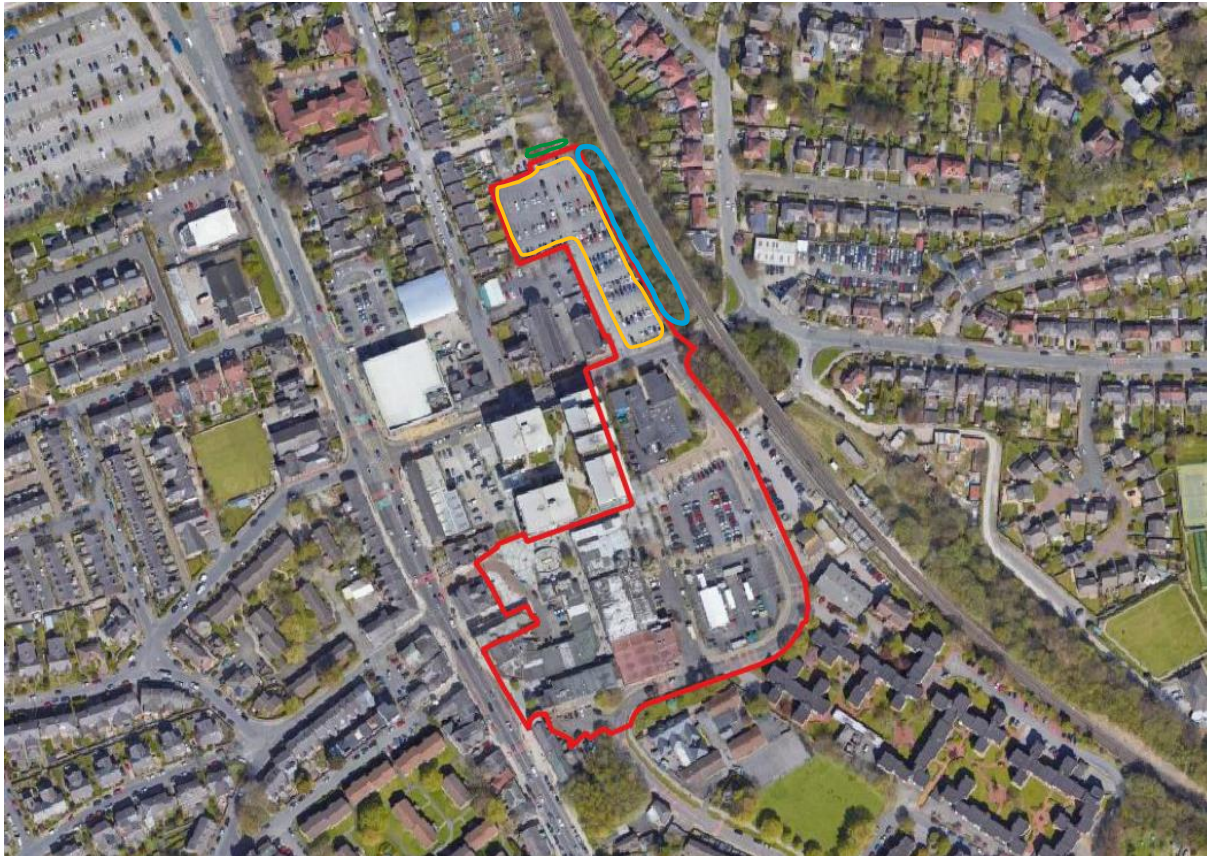
Figure 1: Location of trees within W45 (circled blue) and other trees adjacent to the site (circled green) with indicative red line planning application boundary and approximate extent of the proposed multistorey car park (yellow line) (Google Earth ©).

- 1.7. Figure 1 highlights the trees in question (blue line) in context with the wider red-line site application boundary for the entire development scheme. The extent of the proposed multistorey car park development (within the Travel Hub) is circled indicatively in yellow.

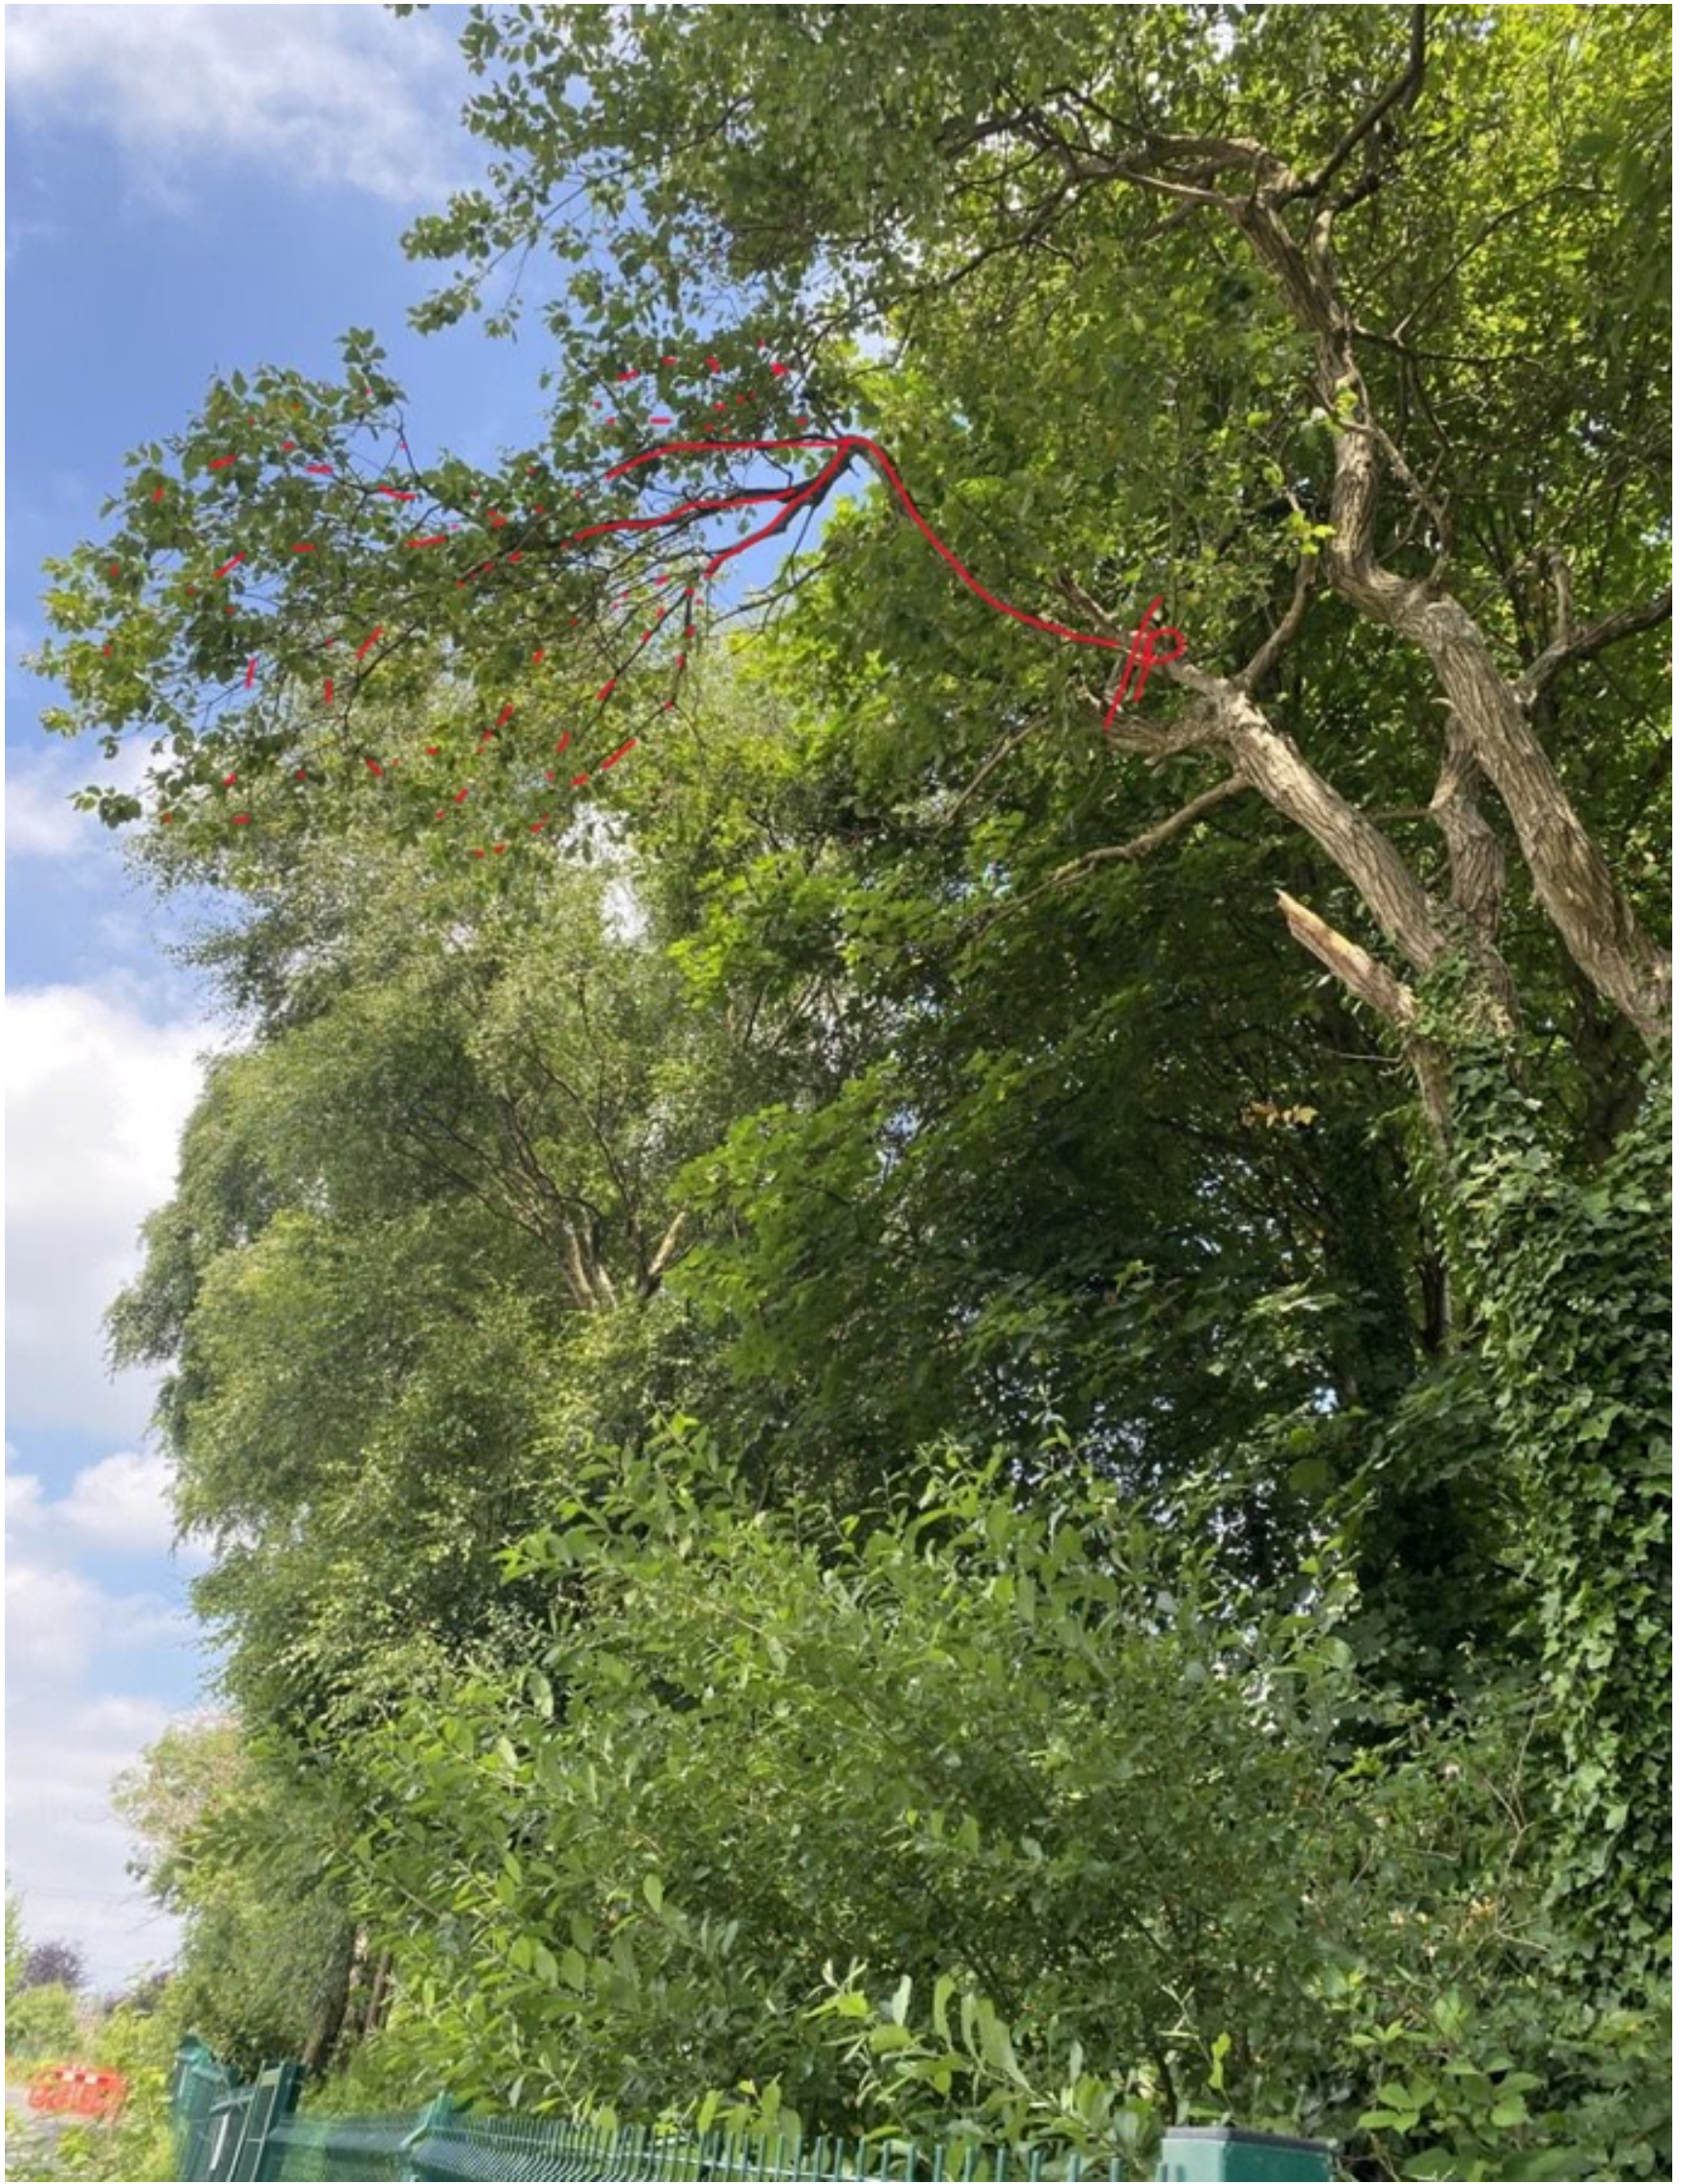
Appendix 6: Illustration of the Required Pruning Works to T45.19.

| T45.19 | Multistemmed with stem bifurcations at various heights. Unbalanced canopy formation. | 3m | Prune specific branches as shown in Appendix 6, resulting in appropriate canopy reduction (no canopy overhang with fence). | |
