# **Site Tree Appraisal**

***Stand Cricket Club, Hamilton Road, Whitefield M45 7WE***

**“BS 5837 2012: Trees in Relation to Design, Demolition and Construction – Recommendations”**

Ref: RTS/04012024

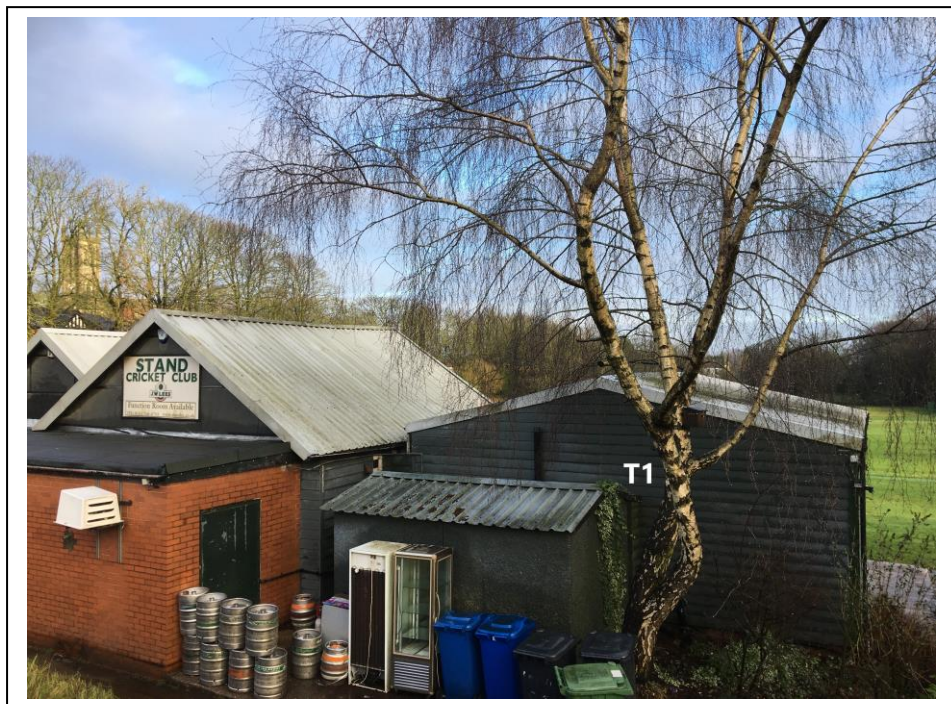
Photo 01:

**3.3.1** The Silver Birch tree T1 is very close to the existing building structure and its drainage system (photo 01). Further growth of this tree is expected to become problematic to the building, tree removal would shortly be recommended irrespective of the extension proposal.

| Tree No | Species | Height (M) *<br>Crown Height above GL | DBH (mm) * | Crown Spread (M) * | Height to Lowest Branch (M)<br>Direction of Lowest Branch | Age Range | Condition | RPA Radius (M) | RPA Square metres | BS 5837 Category Rating | Observations and Comments |
|---|---|---|---|---|---|---|---|---|---|---|---|
| T1 | <b>Silver Birch</b><br><i>Betula pendula</i> | <u>12.5</u><br>2.5 | 445 | N – 5.5<br>S – 7.0<br>E – 7.0<br>W – 6.0 | <u>1.0</u><br>S | Mature | Good | 5.3 | 88 | B1 | Included bark union between the south limb and trunk at approximately 1 metre above ground level. |

| Tree | Tree Work | Priority |
|---|---|---|
| T1 and T3 | Fell to ground level and dig out the remaining stumps | Prior to any other site works |

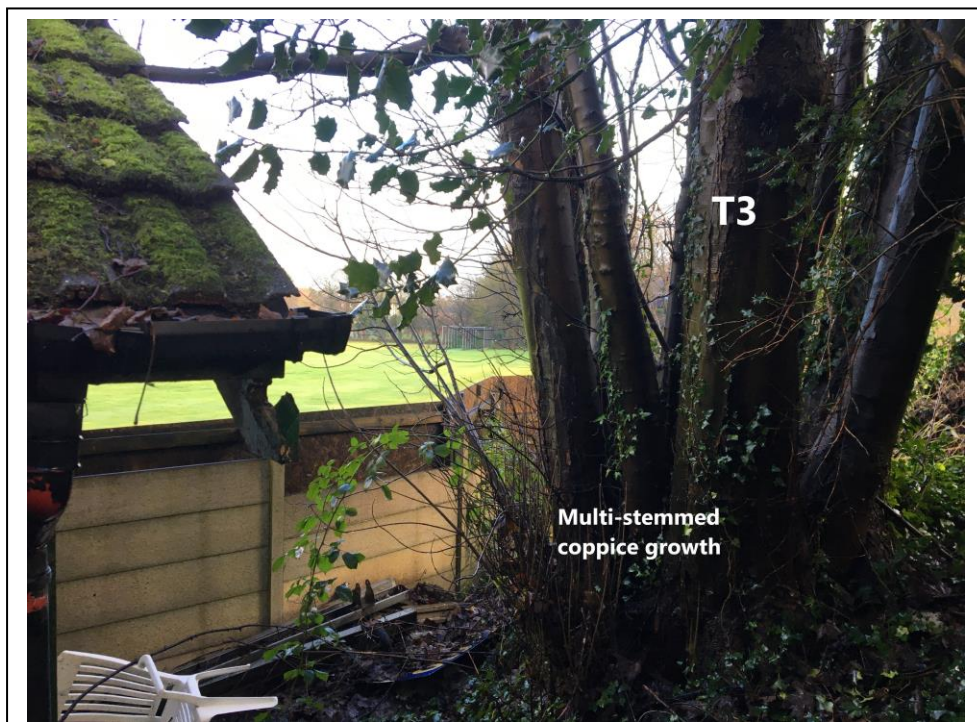
Photo 02:

**3.3.2** Sycamore tree T3 is a multi-stemmed tree, very likely a result of historic coppice cutting (photo 02). A number of the coppice stems are showing bark necrosis (photo 03) and there is some die-back of the upper crown area. T3 is proposed to be removed due to its reduced fair condition and it being located at the site of the proposed septic tank.

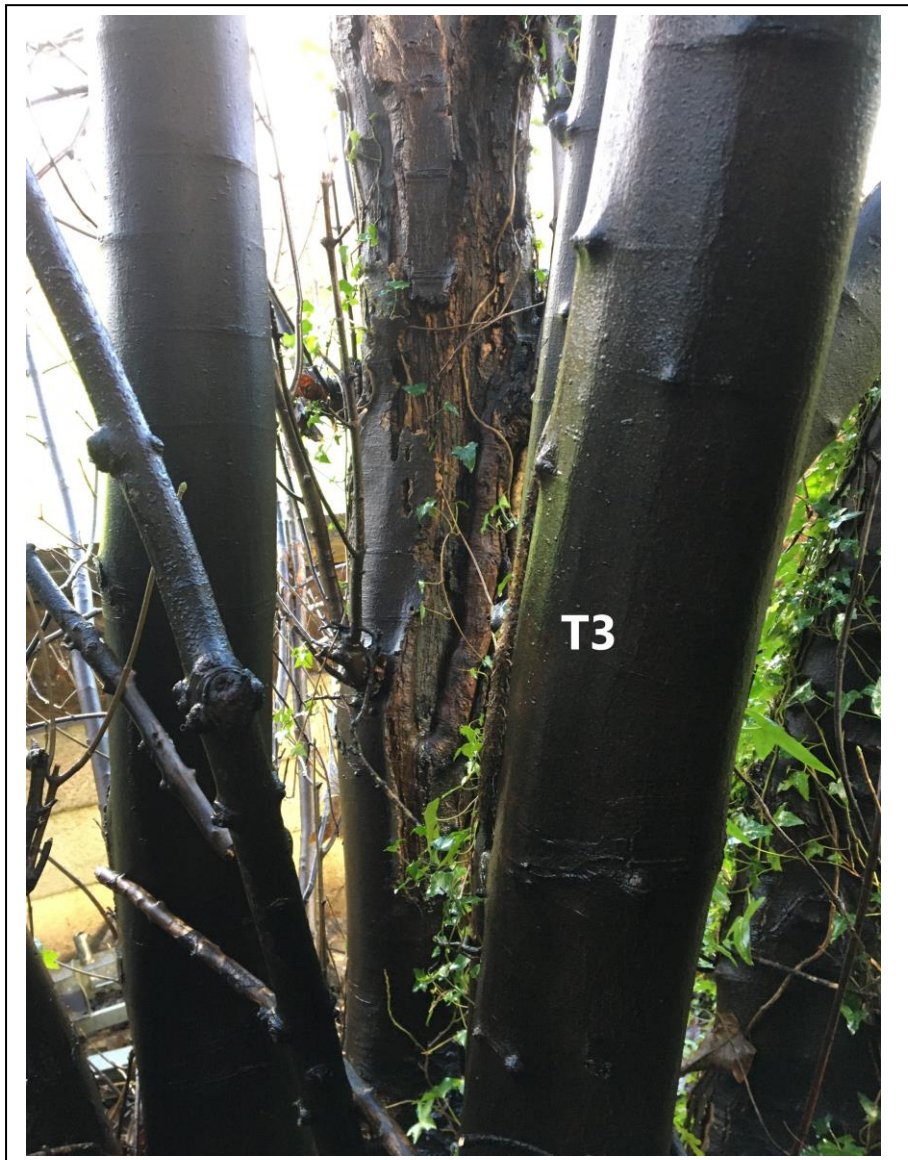
**Photo 03:**

| Tree No | Species | Height (M) *<br>Crown Height above GL | DBH (mm) * | Crown Spread (M) * | Height to Lowest Branch (M)<br>Direction of Lowest Branch | Age Range | Condition | RPA Radius (M) | RPA Square metres | BS 5837 Category Rating | Observations and Comments |
|---|---|---|---|---|---|---|---|---|---|---|---|
| T3 | <b>Sycamore</b><br><i>Acer pseudoplatanus</i> | <u>16.0</u><br>4.0 | 1027<br>combined | N – 7.0<br>S – 5.5<br>E – 6.0<br>W – 7.0 | <u>2.0</u><br>W | Mature | Fair | 12.3 | 475 | C1 | A multi-stemmed tree, some bark necrosis to a number of the stems; Some die-back of the upper crown area. |
