MURRAY  
TREE CONSULTANCY

ARBORICULTURAL REPORT  
(BS 5837:2012)

ST JOHN IN THE WILDERNESS  
26-28 WHALLEY ROAD  
SHUTTLEWORTH  
RAMSBOTTOM  
BL0 0EH

June 2020

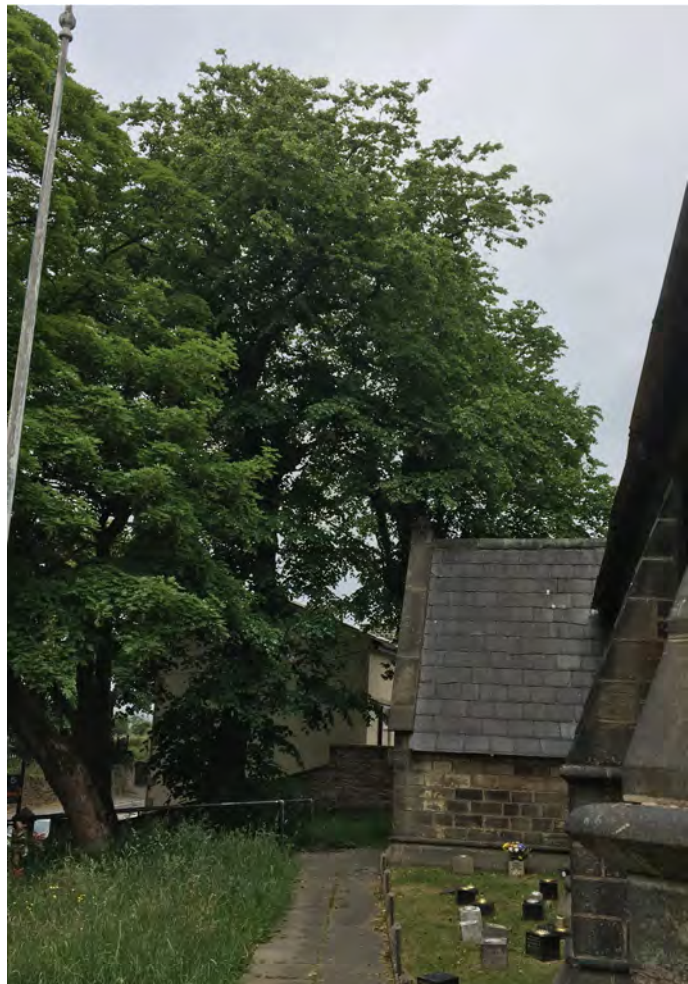
| Arboricultural Data Sheet: St Johns, 26-28 Whalley Road, Shuttleworth, Ramsbottom, BLO OEH | | | | | | | | | | | | | | | | | Date of Survey: 08/06/20 | | Weather: Warm and sunny | | Surveyor: PM | |
|---|---|---|---|---|---|---|---|---|---|---|---|---|---|---|---|---|---|--|---|--|---|--|
| T1 | Lime | 600 | 15 | M | 7 | 6 | 5 | 6 | 4 | B | A co-dominant specimen located adjacent to recently rebuilt boundary wall, some minor root damage present. Stem swamped in Ivy. Significant impact on adjacent property. Minor deadwood present. Reasonable form and vigour. | Sever Ivy at base. | 20+ | B2 | 162.86 | 7.20 | | | | | | |

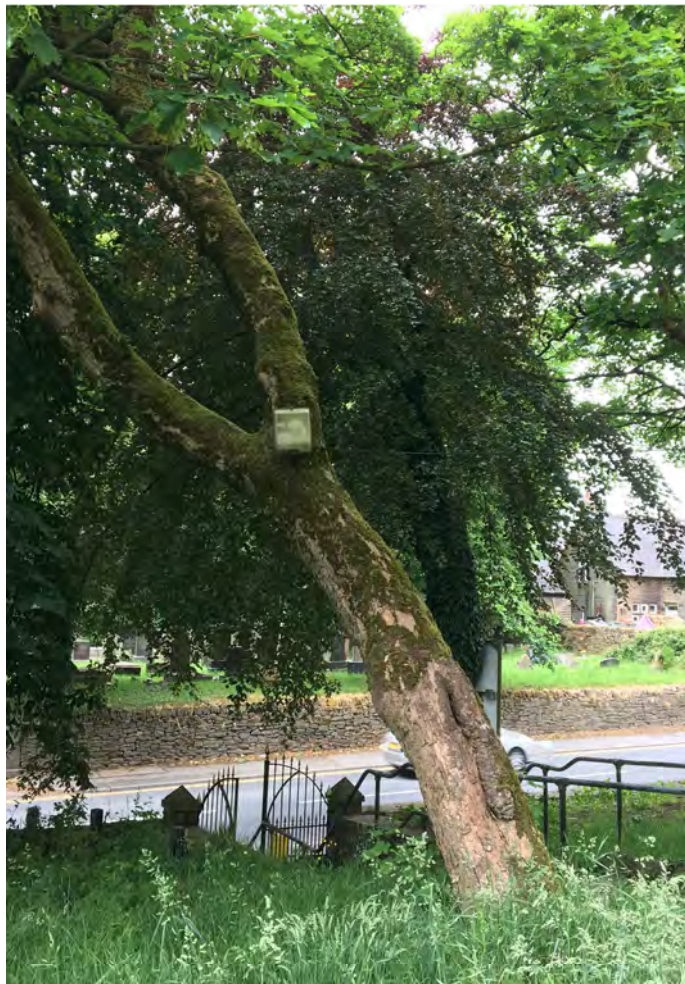
| Arboricultural Data Sheet: St Johns, 26-28 Whalley Road, Shuttleworth, Ramsbottom, BLO OEH | | | | | | | | | | | | | | | | | Date of Survey: 08/06/20 | | Weather: Warm and sunny | | Surveyor: PM | |
|---|---|---|---|---|---|---|---|---|---|---|---|---|---|---|---|---|---|--|---|--|---|--|
| T3 | Sycamore | 570 | 12 | M | 3 | 2.5 | 8 | 9 | 3 | B/C | A poor specimen located close to the front of the building entrance. The stem has a severe western lean and the crown is affecting the better trees on the front of the site. There is cavity on the eastern side at 1.5m with some decay present. Forked at 3m. Security light on the stem. Minor deadwood present. | Fell and grind stump to improve site and other trees. | 10+ | C2 | 146.98 | 6.84 | | | | | | |
