**Site Tree Appraisal**  
***29 Bland Road, Prestwich M25 9NW***

**‘BS 5837 2012: Trees in Relation to Design, Demolition and Construction – Recommendations’**

Ref: RTS/12122025

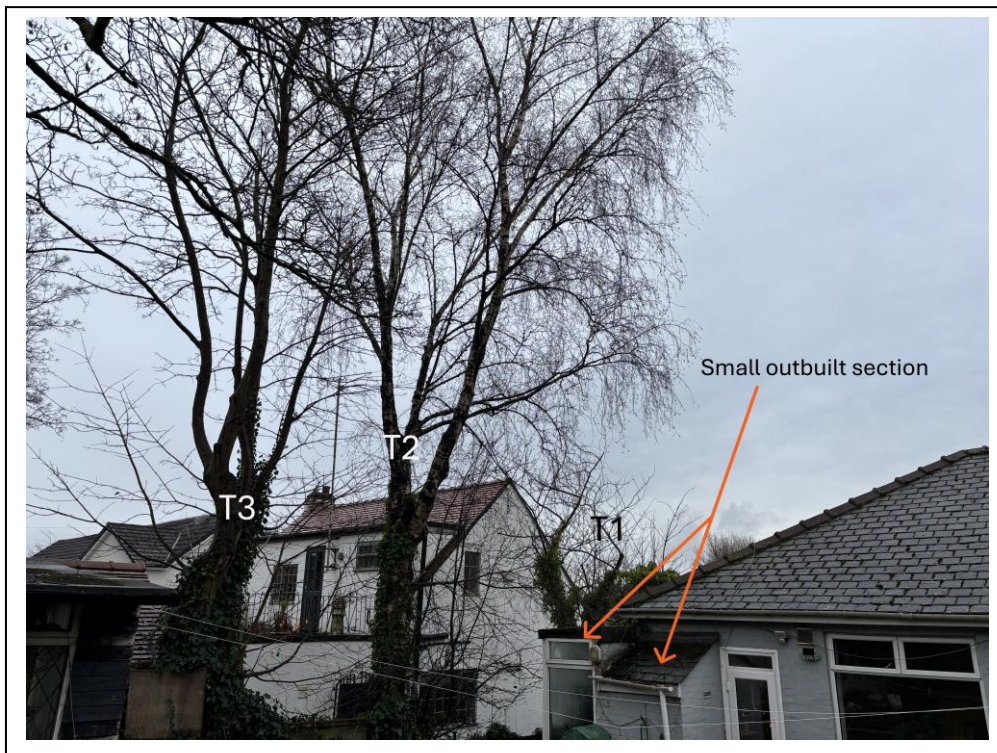
Photo 01:

- 3.1 Relevant references:** ‘BS 5837:2012 Trees in Relation to Design, Demolition and Construction-Recommendations’.
- 3.2 Arboricultural Impact Assessment (AIA):** The proposal is to demolish the small single storey outbuilt section of the bungalow at its rear northeast corner (photo 01) and construct an additional first-floor storey on top of the existing bungalow. The foundation footprint of the bungalow is to remain as existing. At this stage I have not been made aware of the need to alter or install new underground drains or other utility services.

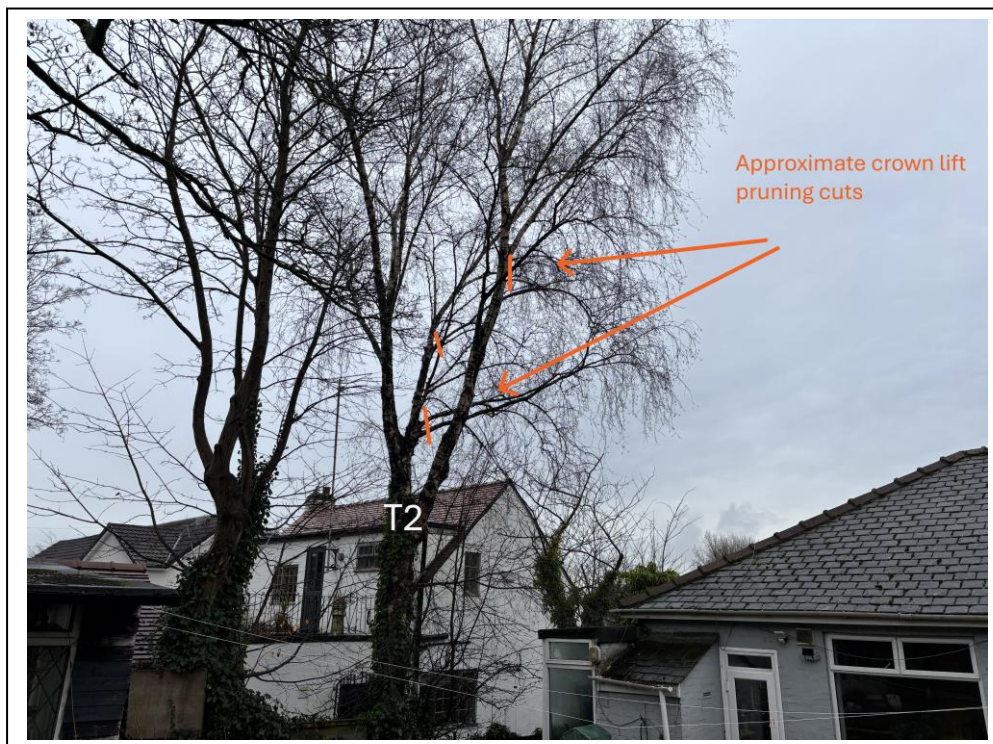
Photo 02:

- 3.4** To facilitate the bungalow’s first-floor extension minor crown lift pruning will be required to tree T2 (photo 02). The tree pruning specifications are noted in the Recommendations, section 5 of the report. No other tree works will be required.

| Tree No | Species | Height (M) *<br>Crown Height above GL | DBH (mm)<br>* | Crown Spread (M) * | Height to Lowest Branch (M)<br>Direction of Lowest Branch | Age Range | Condition | RPA Radius (M) | RPA Square metres | BS 5837 Category Rating | Observations and Comments |
|---|---|---|---|---|---|---|---|---|---|---|---|
| T2 | <b>Silver Birch</b><br><i>Betula pendula</i> | <u>18.5</u><br>5.0 | 400 | N – 6.5<br>S – 5.0<br>E – 5.0<br>W – 5.0 | <u>4.0</u><br>W | Mature | Good | 4.8 | 72 | B1 | Neighbour's side tree; Ivy climber ascending the trunk. |

| Tree | Tree Work | Priority |
|---|---|---|
| T2 | Crown lift the west to northwest side of the tree's crown (over the existing bungalow) to obtain an approximate 4.5 metres clearance above the existing bungalow roof. See photo 02 as a guide to crown lift pruning height. | Prior to any other site works |
