## ARBORICULTURAL REPORT (BS 5837:2012)

FOR  
PROPOSED DEVELOPMENT

FORMER WATERSIDE PUB  
KAY STREET  
SUMMERSEAT  
BURY

December 2018

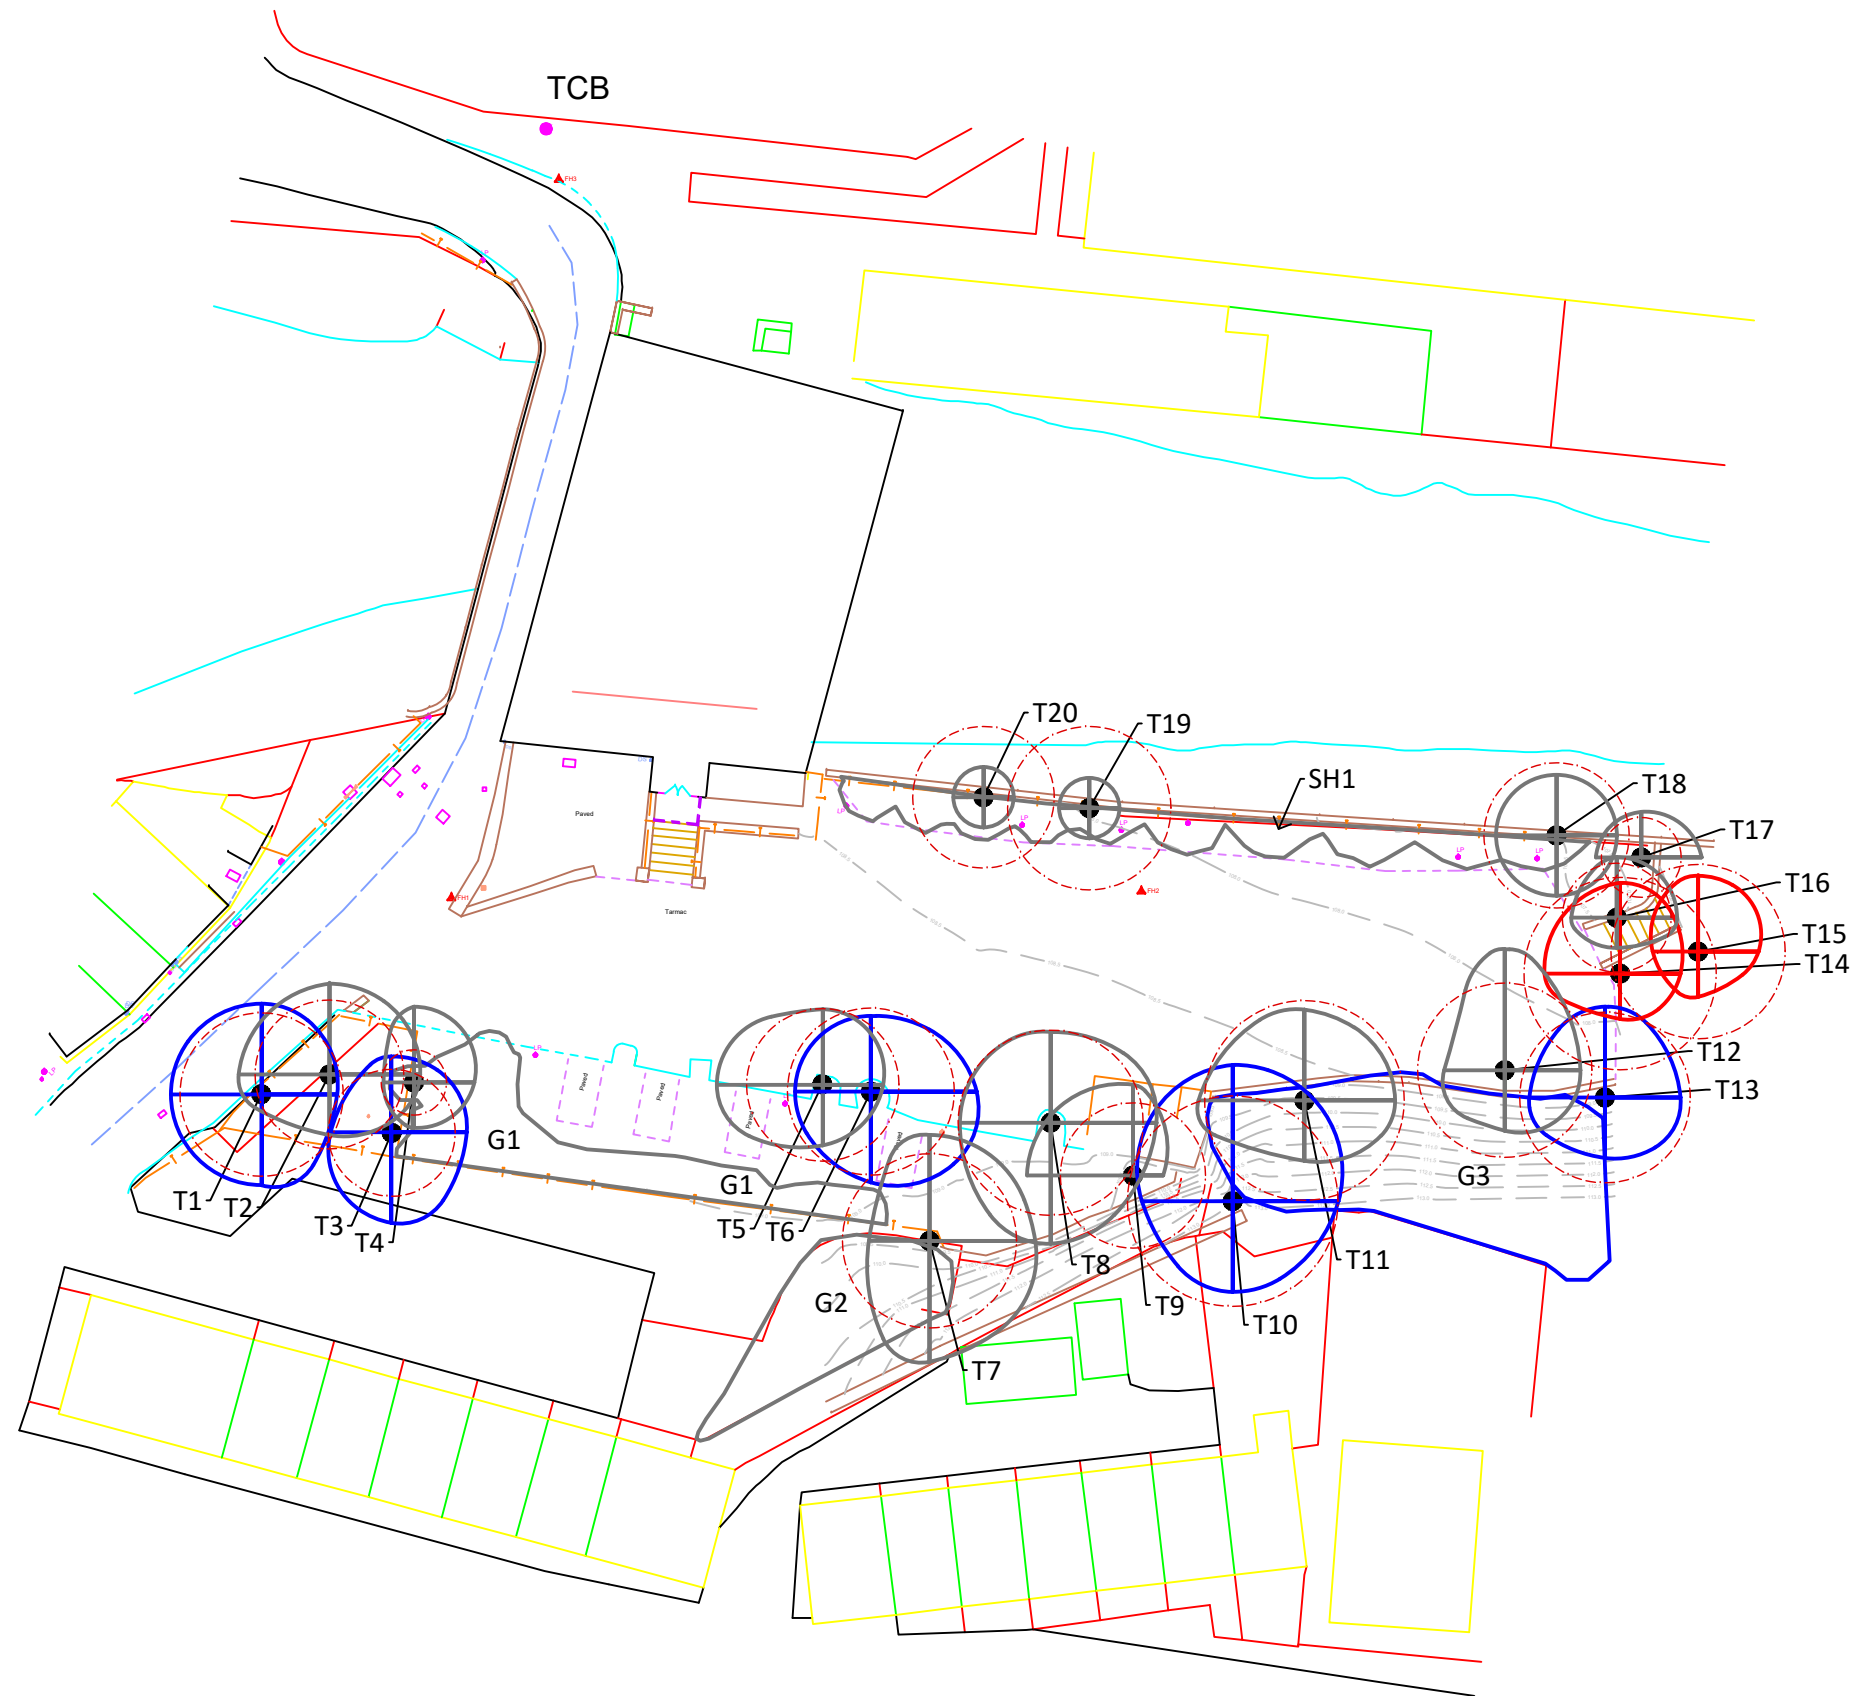
**Tree Protection Plan**

- 5.2.2 However, with regard to T3 (Sycamore) the proposed surfacing affects less than 20% of its overall RPA and affects one side of the tree only. In addition the majority of roots encountered will no doubt belong to T4, which is to be removed. The new surfacing is considered far enough away from the buttress not to cause structural damage.

- 5.2.3 There is new surfacing proposed within the RPA of T7 (Goat Willow). In this area it is proposed to employ the use of geo-textile materials, such as 'Geoweb' and 'Cellweb' to construct a permanent 'no dig' surfacing. In this instance the existing levels should allow this type of construction to be used. An example of this can be found in Appendix F of this report.

6.2.3 In this circumstance the location for the protective fencing should be as shown on the Tree Protection Plan of Appendix G and of the following specification:
