## Bury Market

# Stage 1 and 2 Arboricultural Impact Assessment Report.

2484105

AUGUST 2022

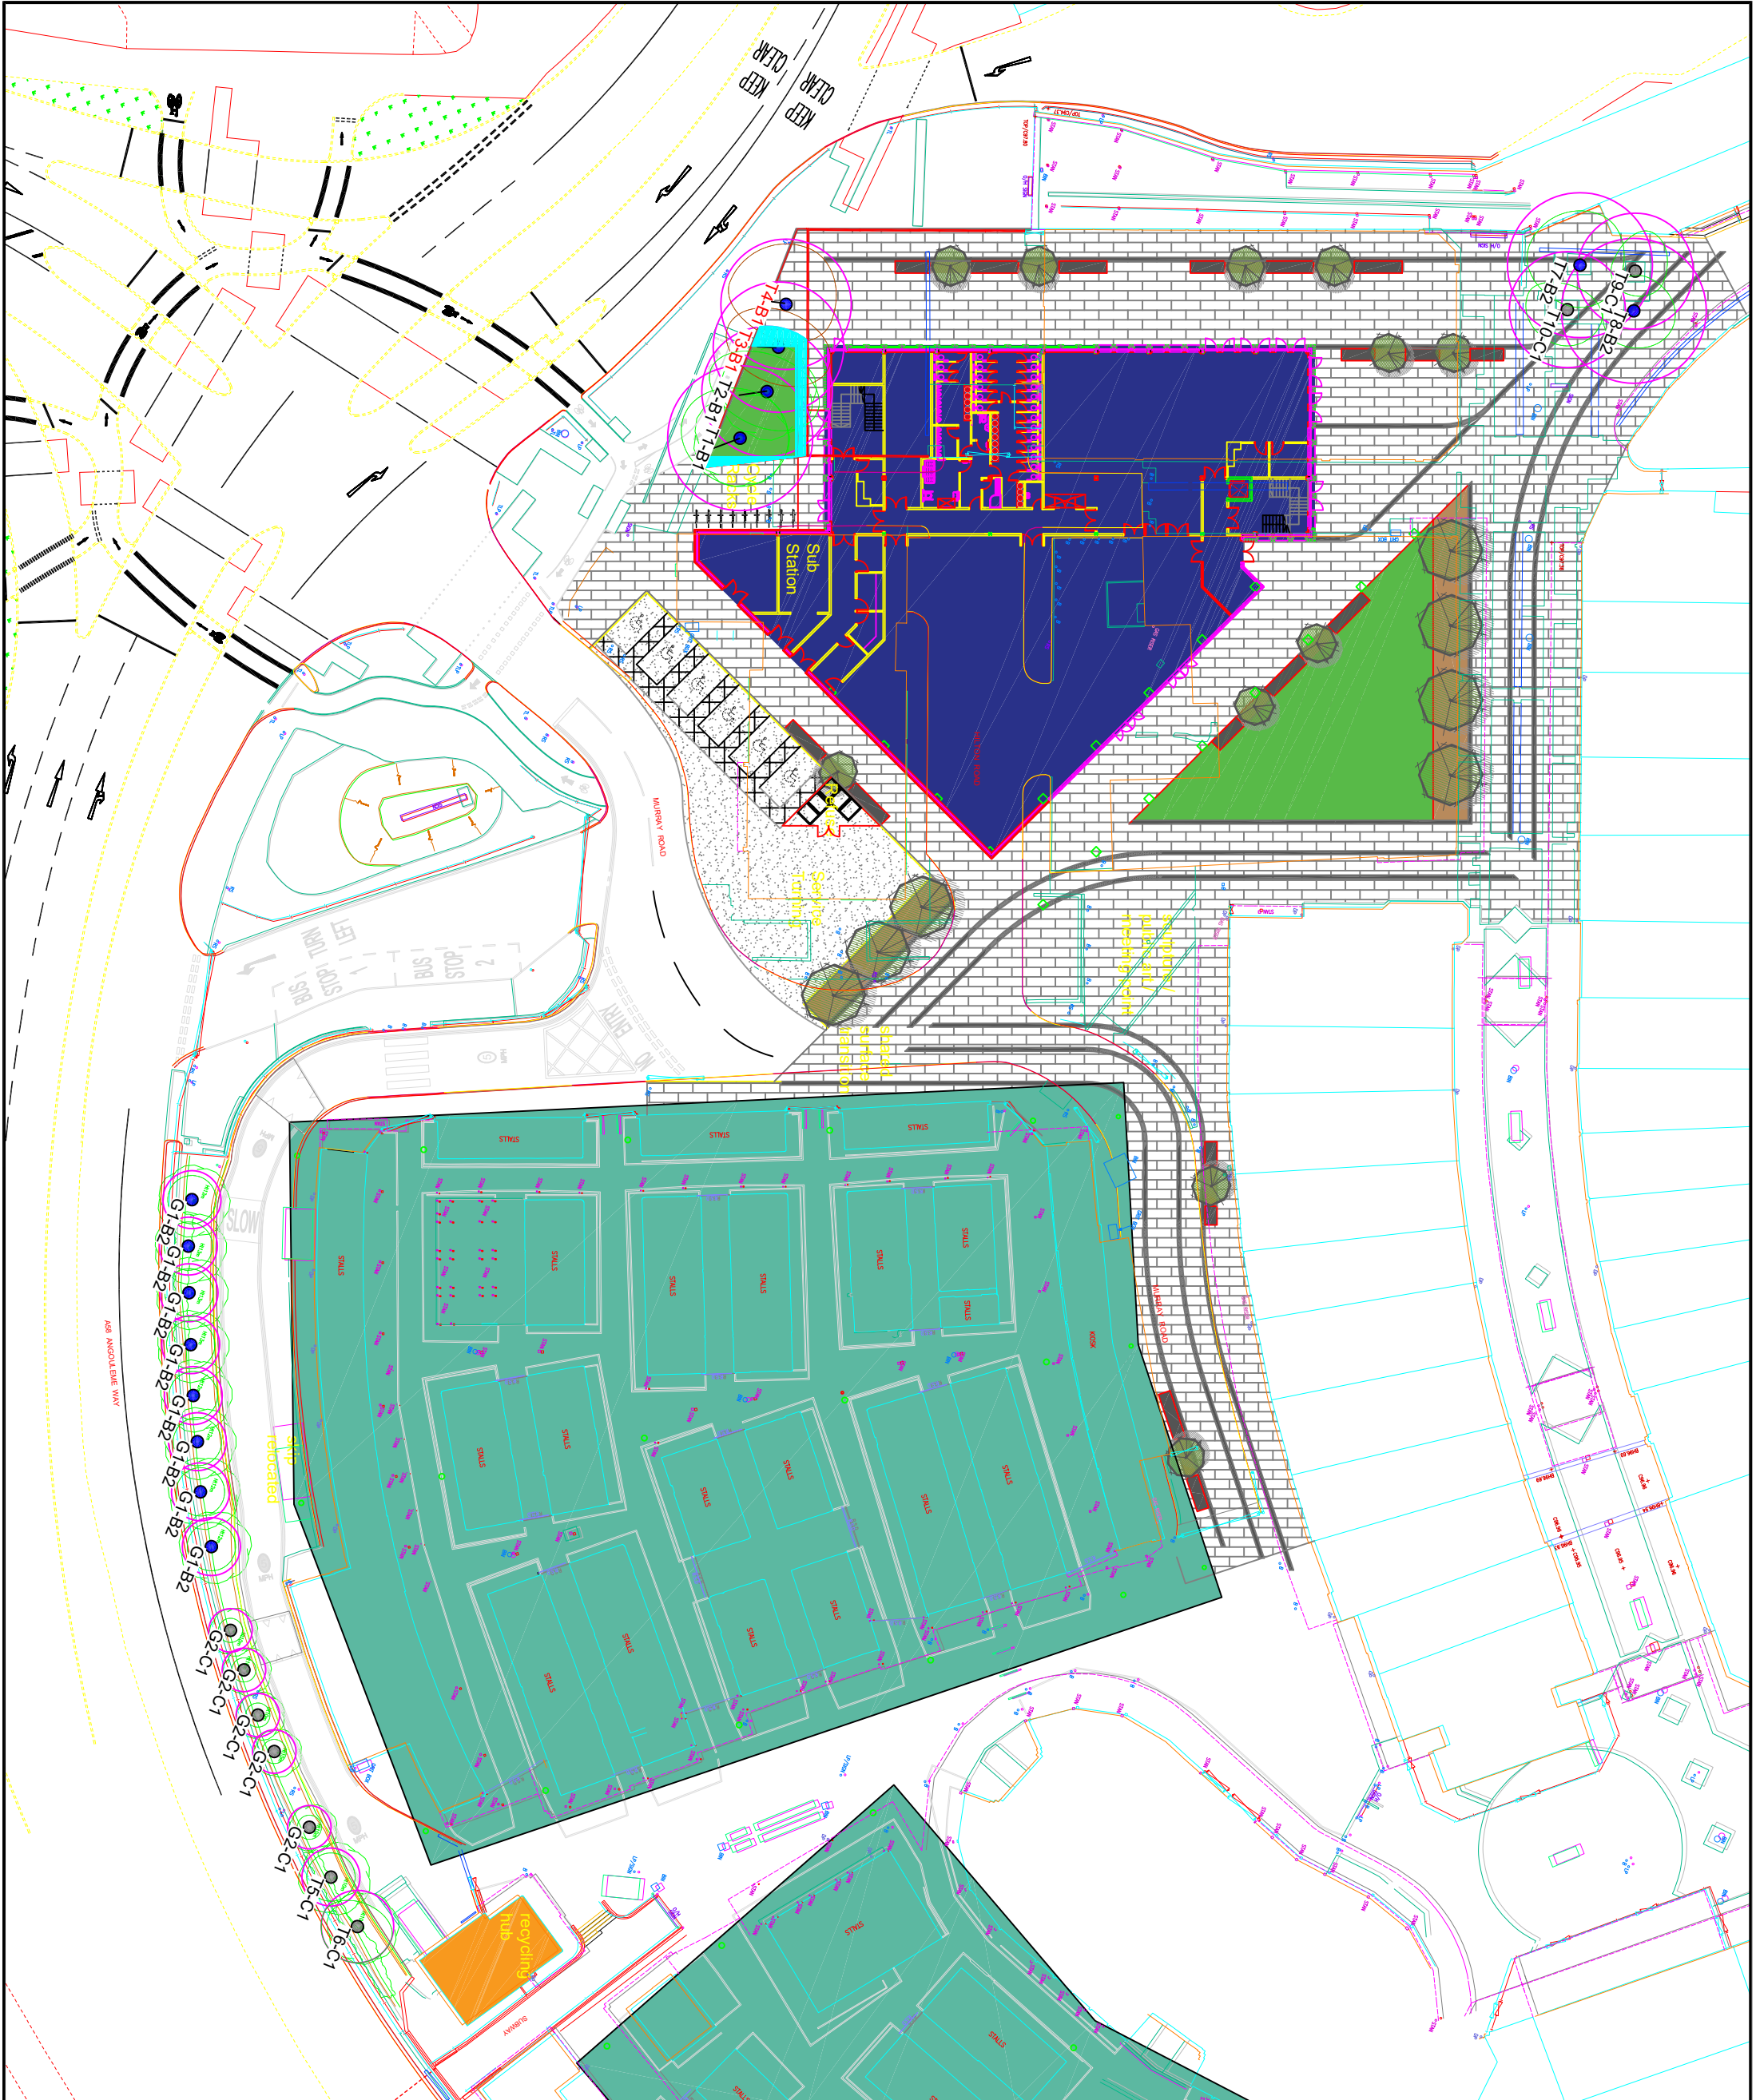
## **APPENDIX 4: FIGURE 2 TREE RETENTION PLAN**

Under the current proposed layout, two trees are required for removal as well as potential for some impacts to RPA's as shown in Table 2.2 (below) and on the tree retention plan (TRP; Appendix 5).

| Tree id | Species | BS5837:2012 Categories | Reason for <b>removal</b> and <b>impact</b> |
|---|---|---|---|
| T3-4 | <i>Sorbus intermedia</i><br>(Swedish Whitebeam) | B | Conflict with new building proposal sight lines and hard surfacing layout. Removal required. |

All trees and groups apart from T3 and T4 are able to be retained.

Protective fencing will be required around the retained trees and groups, and this should be to a sufficiently robust specification to ensure protection of its surrounding ground conditions. Site hoarding around the development footprint will provide suitable protection for other trees adjacent the site.
