**Site Tree Report and Appraisal**  
***33 Bland Road, Prestwich, M25 9NW***

**“BS 5837 2012: Trees in Relation to Design, Demolition and Construction – Recommendations”**

Date: 25<sup>th</sup> June 2024  
Ref: RTS/13102020 02  
Revision: 002

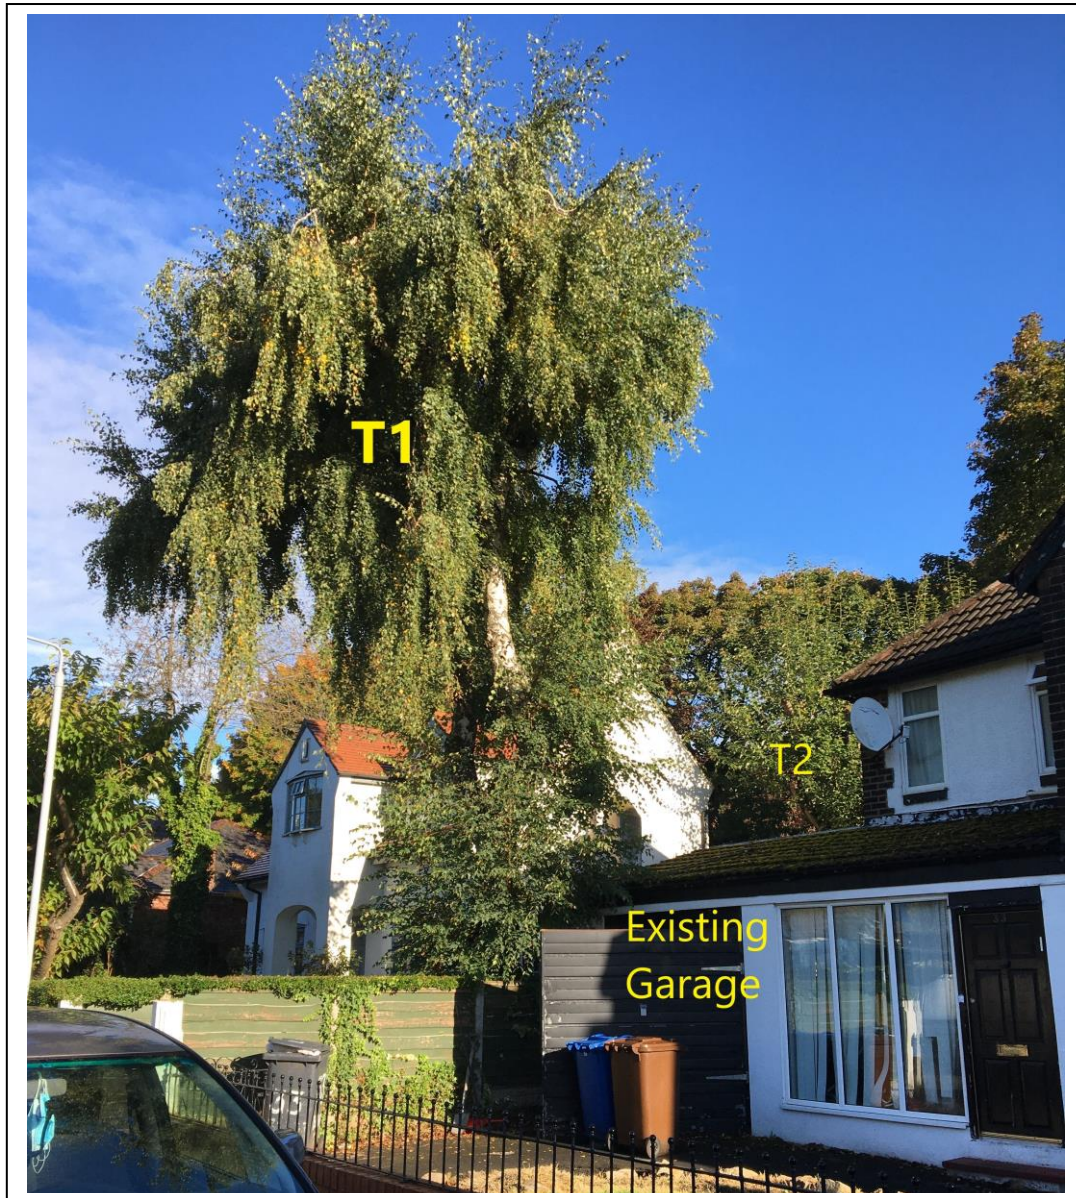
Photo 01:

| Tree No | Species | Tree Height (M) *<br>Crown Height Above GL | DBH (mm) * | Crown Spread (M) * | Height to Lowest Branch (M) | Age | Condition | RPA Radius (M) | RPA Square metres | BS 5837 Category Rating | Observations and Comments |
|---|---|---|---|---|---|---|---|---|---|---|---|
| T1 | <b>Silver Birch</b><br><i>Betula pendula</i> | <u>15.0</u><br>2.0 | 580 | N – 7.0<br>S – 6.0<br>E – 5.0<br>W – 6.5 | 4.0 | Mature | Fair | 6.9 | 149 | C1 | Neighbour's tree close to the boundary fence; epicormic shoots to the lower section of the trunk; the tree has been topped in the recent past. Ivy ascending the trunk. |

**T1: - 2020; Bushy growth form with loss of crown apical dominance. Poor visual amenity.**

| Tree | Tree Work | Priority |
|---|---|---|
| T1 | Fell to ground level and grind out the remaining stump. | Prior to any other site works |

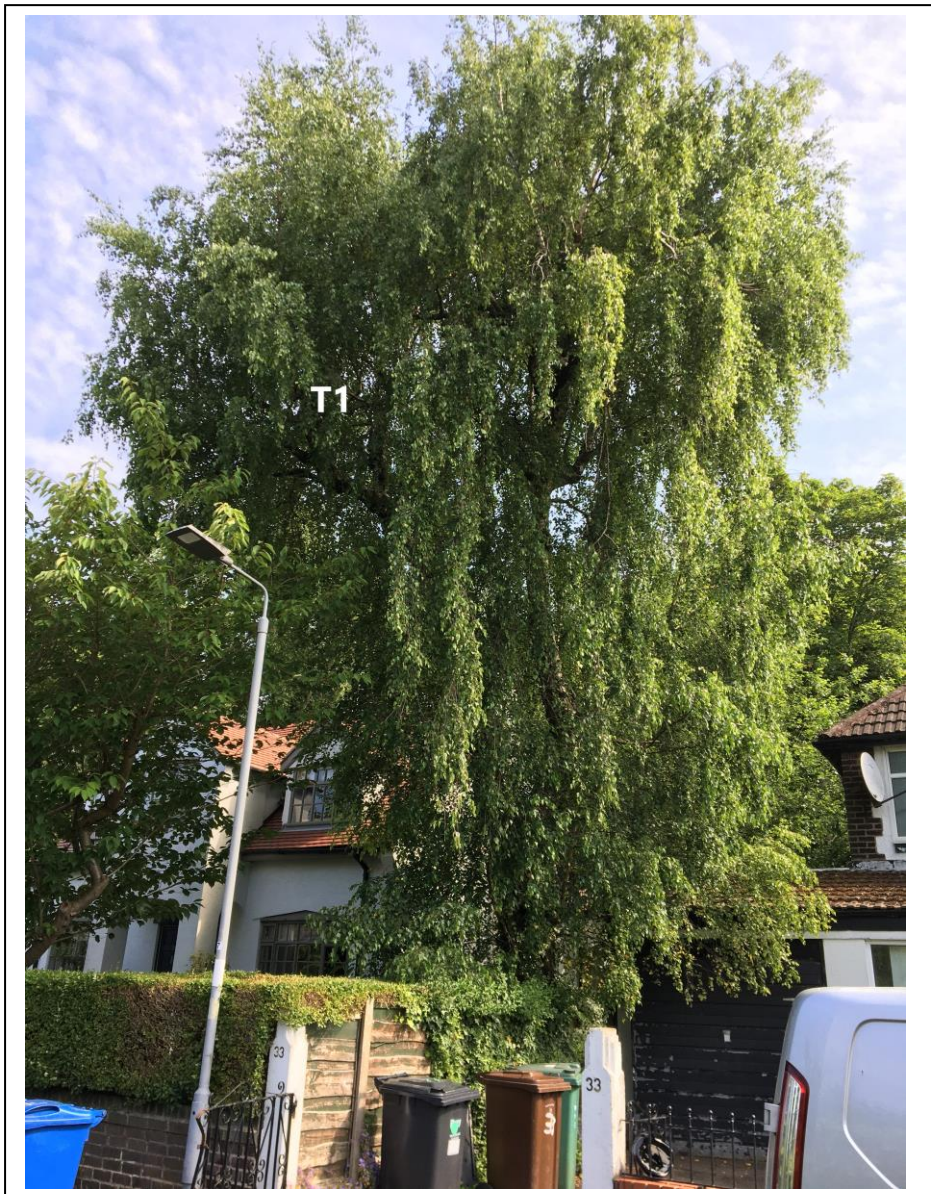
**Photo 02:**

**T1: - 2024;**

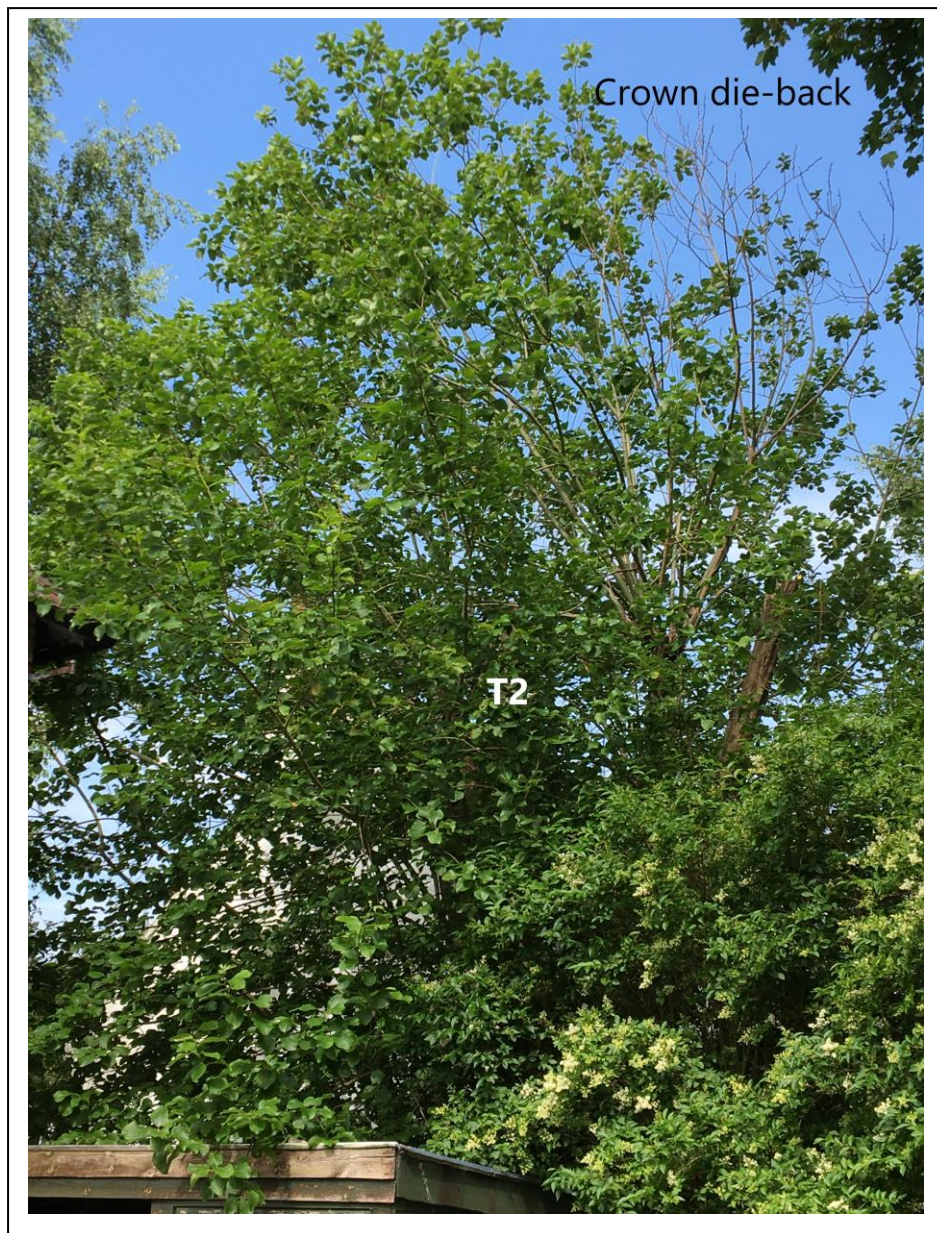
**Photo 03:**

**3.3.1** Goat willow T2 is also included within the Area TPO and has also been subjected to poor arboricultural work. T2 is also noted to have some crown die back, photo 03. Given its poor condition, size and location between the two buildings (31 and 33 Bland Road), T2 is considered to be an intolerable nuisance to the normal and reasonable use of the two properties and therefore, its removal is suggested irrespective of the proposed extension works.

| Tree No | Species | Tree Height (M) *<br>Crown Height Above GL | DBH (mm) * | Crown Spread (M) * | Height to Lowest Branch (M) | Age | Condition | RPA Radius (M) | RPA Square metres | BS 5837 Category Rating | Observations and Comments |
|---|---|---|---|---|---|---|---|---|---|---|---|
| T2 | <b>Goat Willow</b><br><i>Salix caprea</i> | <u>9.5</u><br>2.5 | 650 | N – 4.0<br>S – 5.0<br>E – 2.5<br>W – 4.5 | 3.0 | Mature | Fair to Poor | 7.8 | 191 | C1 | Neighbour's tree close to the boundary fence; epicormic shoots to the lower section of the trunk; the tree has been topped in the recent past. Some die-back of the upper crown. |

| Tree | Tree Work | Priority |
|---|---|---|
| T2 | Fell to ground level and grind out the remaining stump. | Prior to any other site works |
