**Job title:** New Office Block, Bury

**Report type:** Coal Mining Risk Assessment

**Prepared for:** JD Sports

| Document Control Form | |
|---|---|
| REPORT REFERENCE | GRO-21438-3119 |

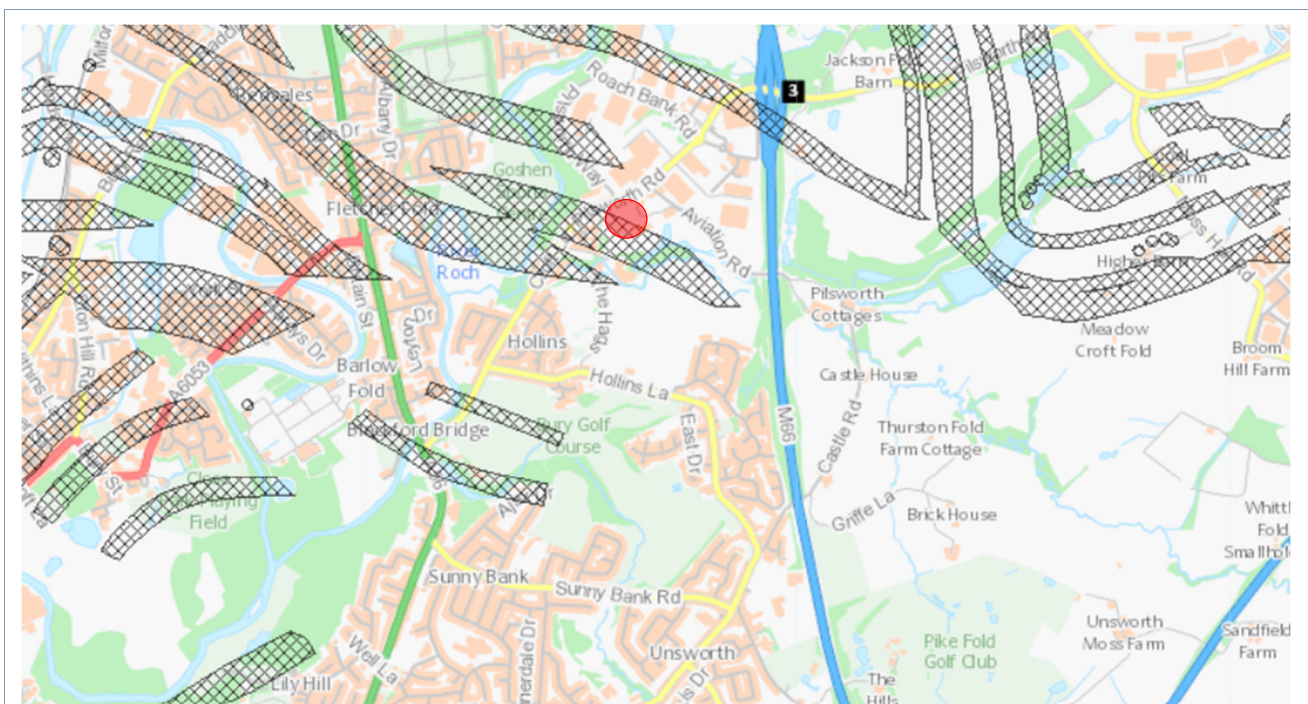
Coal Authority Interactive Map - Development High Risk Areas

The southern half of the site, to the south of the coal seam bisecting the site is indicated to be within the Development High Risk Area.

Probable unrecorded shallow coal mine workings are indicated in the south of the site in the area indicated to be within the Development High Risk Area.

A coal seam subcrop is indicated running across the site trending north west to south east.

| Issue | Hazard | Site Affected - Yes/ No | Consequence | Recommended Mitigation Measures |
|---|---|---|---|---|
| Unrecorded Coal Workings | <ul style="list-style-type: none"> <li>• Ground subsidence.</li> <li>• Ground instability.</li> </ul> | <b>Yes</b> – Probable shallow unrecorded coal workings are indicated to be present underlying the south of the site from the Coal Authority Interactive Map. A coal seam is present subcropping beneath the site and is anticipated to extend beneath the southern area of the site | Ground subsidence associated with historic mine workings can give rise to levels of damage to the built environment that may affect both serviceability and design life of a structure. | <p>The depth to bedrock is not known as no records are present on the site.</p> <p>An intrusive investigation is recommended to assess the risk from</p> |
