MURRAY  
TREE CONSULTANCY

ARBORICULTURAL REPORT  
(BS 5837:2012)

PILSWORTH LAKE  
MOSS HALL ROAD  
PILSWORTH  
BURY

January 2024

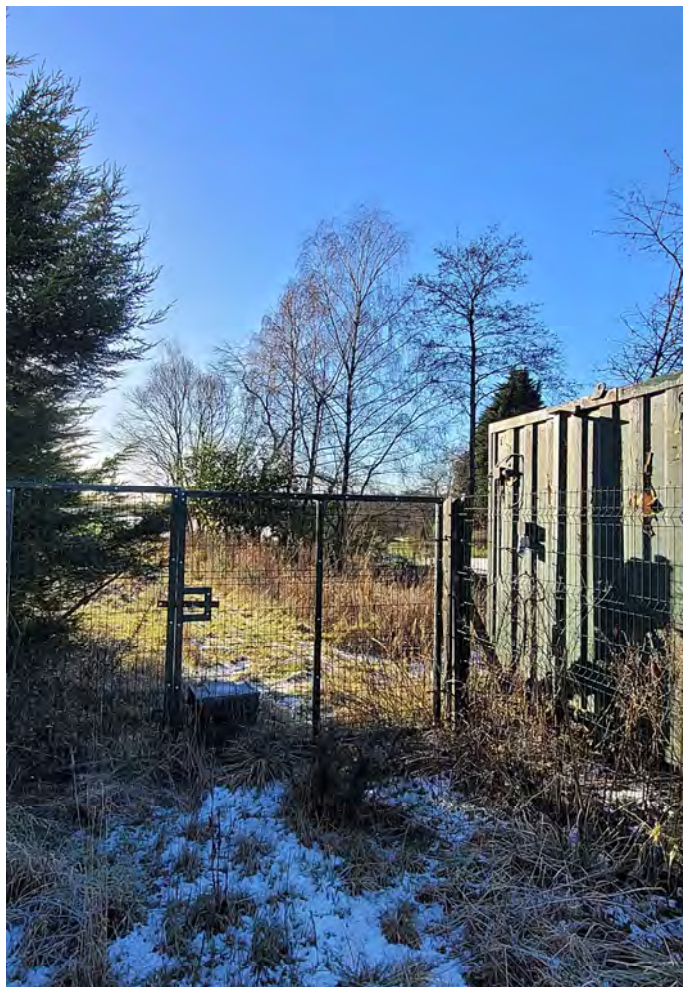
| Tree No. | Species | Dbh (mm) | Height (m) | Age | Crown Spread | | | | Crown C | Cond R | Observations and Comments | Preliminary Recommendations | ERC (Yrs) | TQC R | RPA (m²) | RPA Circle Radius (m) |
|---|---|---|---|---|---|---|---|---|---|---|---|---|---|---|---|---|
| G5 | Group - Alder & Silver Birch | 300 | <12 | SM-EM | 3 | 3 | 3 | 3 | 2 | B | A linear group, no access to bases near lake. | n/a | 20+ | B2 | 40.72 | 3.60 |

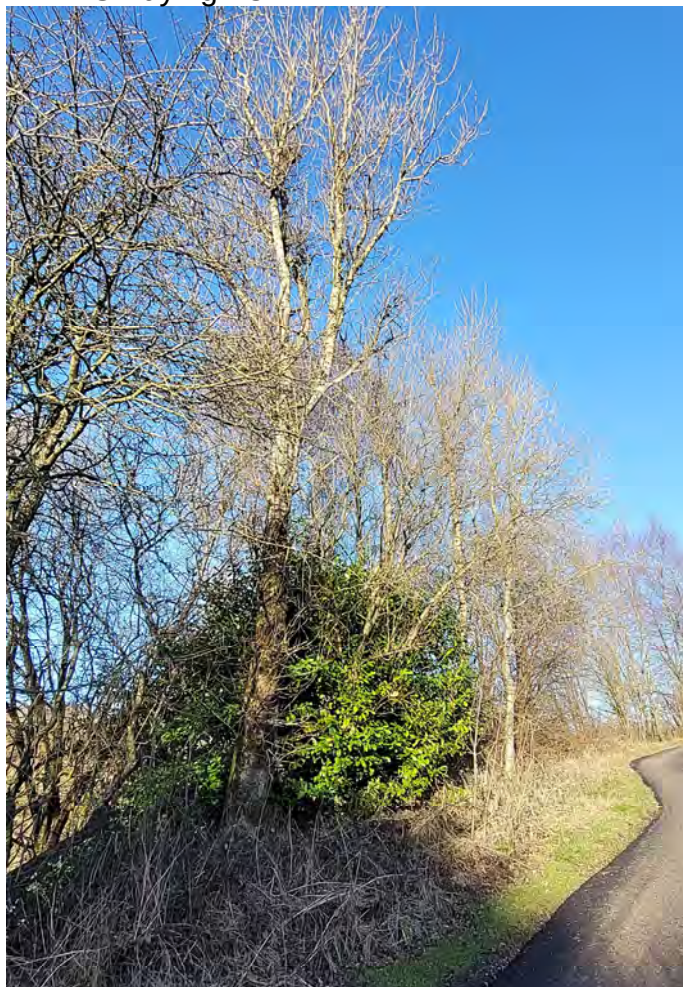
G4 dying Ash

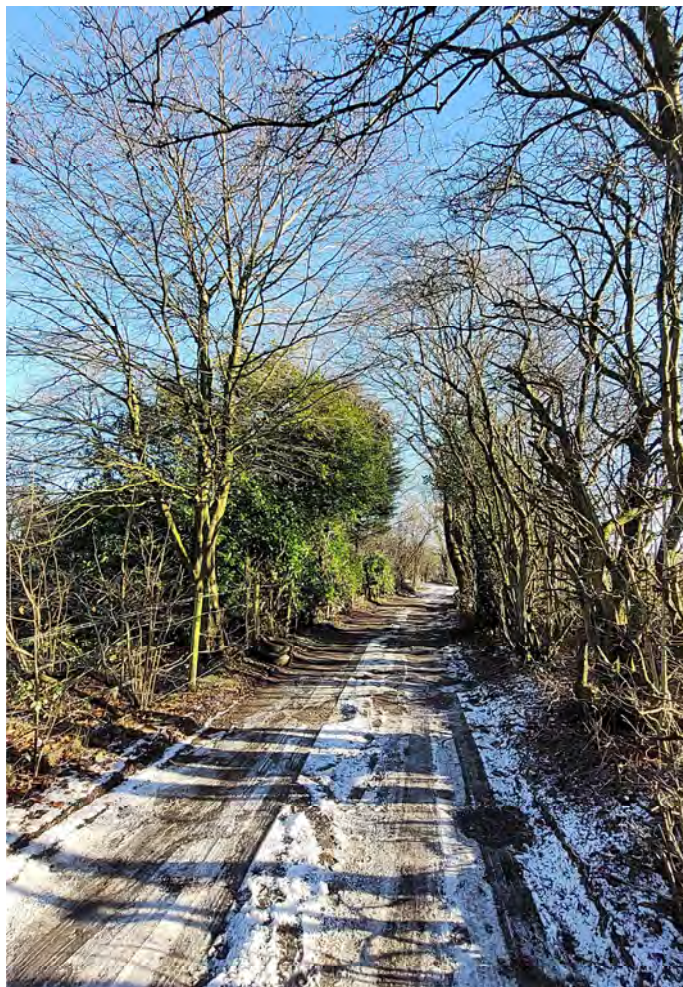
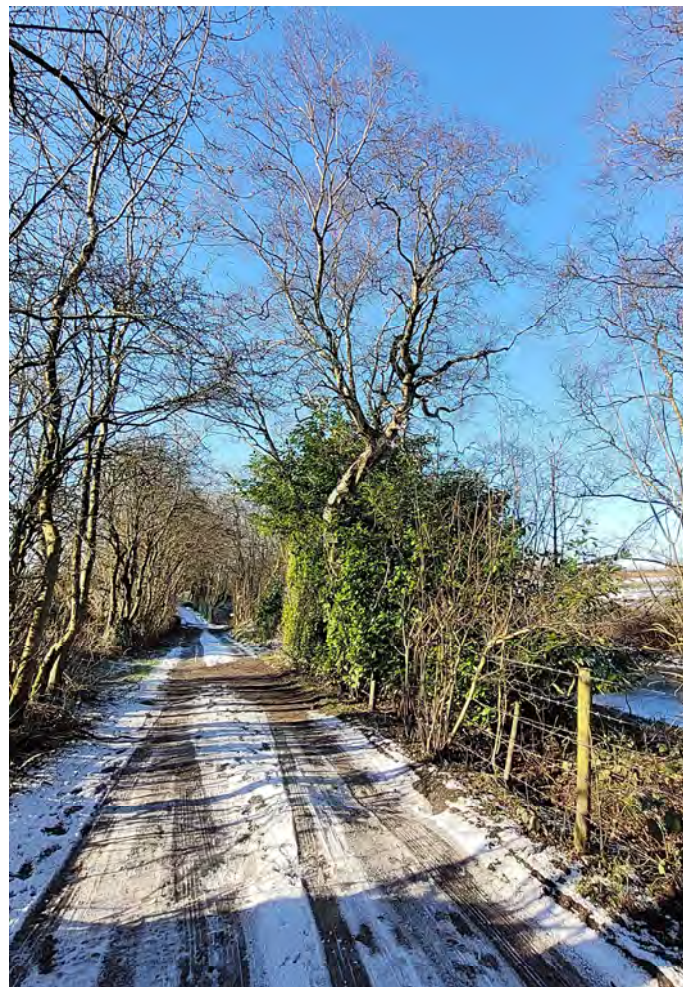
| Tree No. | Species | Dbh (mm) | Height (m) | Age | Crown Spread | | | | Crown C | Cond R | Observations and Comments | Preliminary Recommendations | ERC (Yrs) | TQC R | RPA (m²) | RPA Circle Radius (m) |
|---|---|---|---|---|---|---|---|---|---|---|---|---|---|---|---|---|
| T7 | Silver Birch | 650 | 14 | M | 9 | 5 | 5 | 7 | 6 | B/C | Located on northern side of road within Laurel shrub area. Crooked stem forked at 2m. Southern stem has major decay present from previous failure. Lower limb damage over road. Biased to the north away from road. | n/a | 10+ | C2 | 191.1<br>3 | 7.80 |

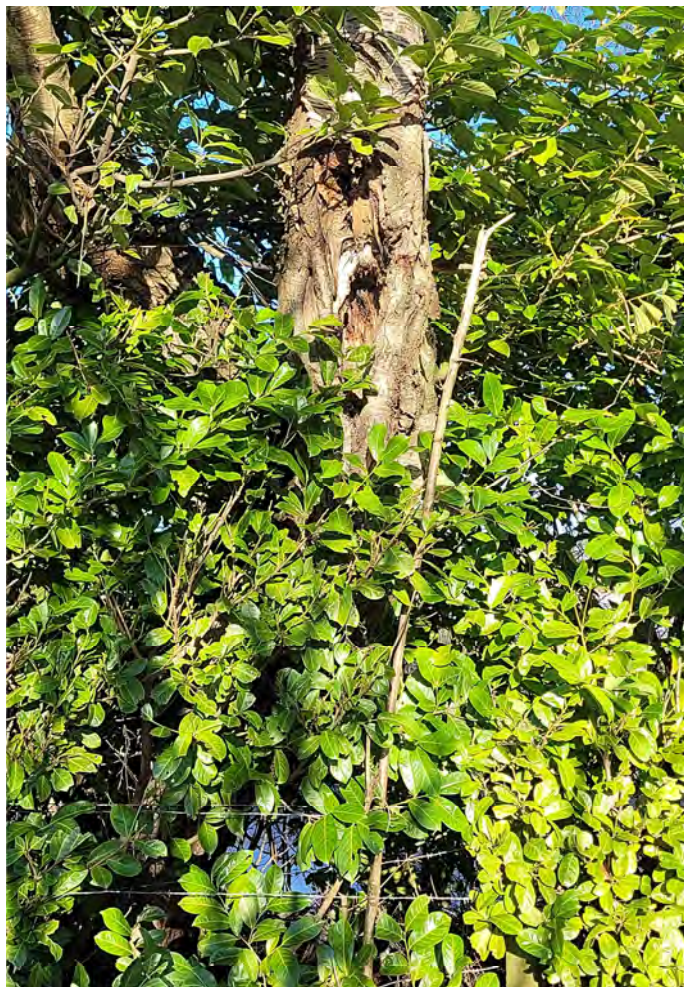
| Tree No. | Species | Root Protection Area (m <sup>2</sup> ) | Circle Radius (m) | Distance to any proposed construction or surfacing (m) | Can the Tree be Successfully Retained |
|---|---|---|---|---|---|
| T8 | Ash | 113.10 | 6.00 | Remove for condition | |

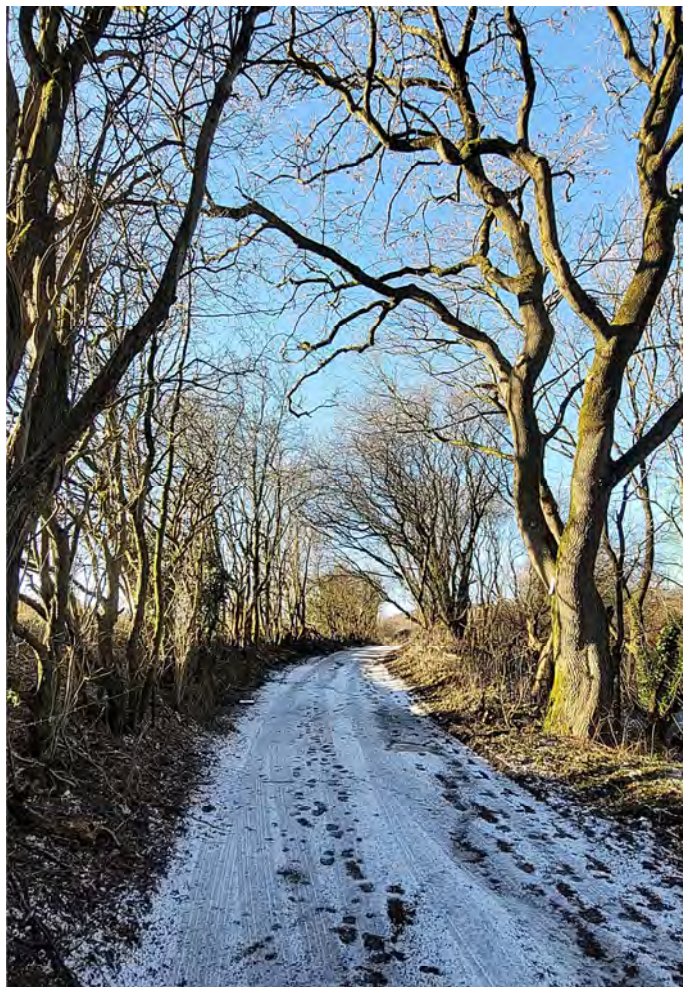
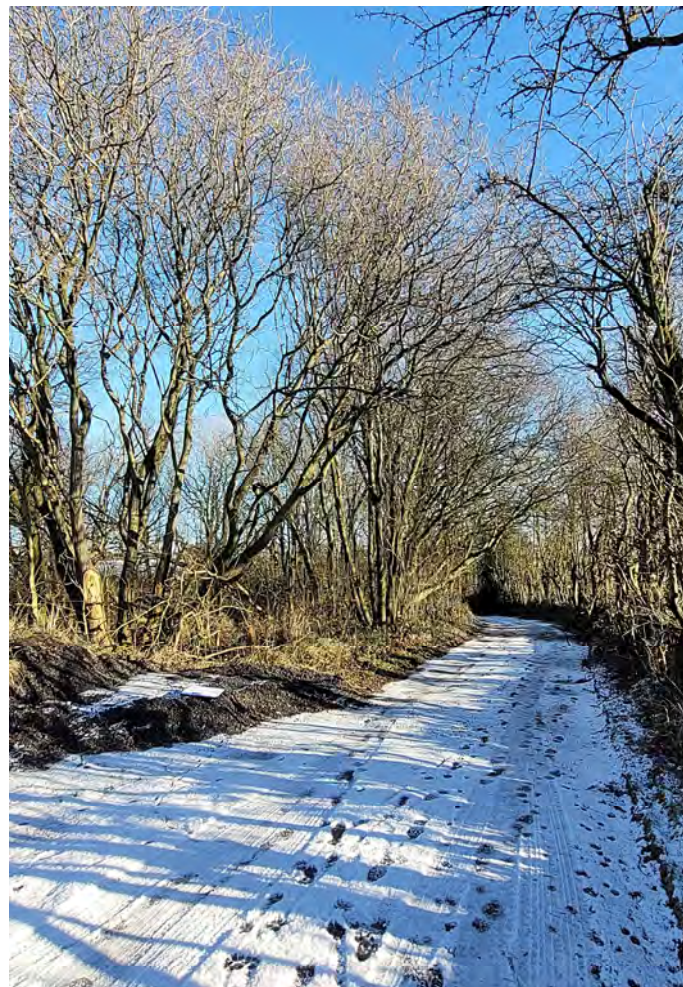
| Tree No. | Species | Dbh (mm) | Height (m) | Age | Crown Spread | | | | Crown C | Cond R | Observations and Comments | Preliminary Recommendations | ERC (Yrs) | TQC R | RPA (m²) | RPA Circle Radius (m) |
|---|---|---|---|---|---|---|---|---|---|---|---|---|---|---|---|---|
| G3 | Group -Goat Willow | 300 | <10 | M | 6 | 6 | 6 | 6 | 2.5 | B/C | A group of multi-stemmed scrub trees on northern side of access road. Lower branch damage from passing vehicles and lower branch damage. | Crown lift over access road to approx. 4-5m. Consider coppicing group. | 10+ | C2 | 40.72 | 3.60 |
