# Preliminary Roost Assessment

The Old Ambulance Station  
Cemetery Road  
Ramsbottom  
BL0 9PU

## Gritstone Ecology

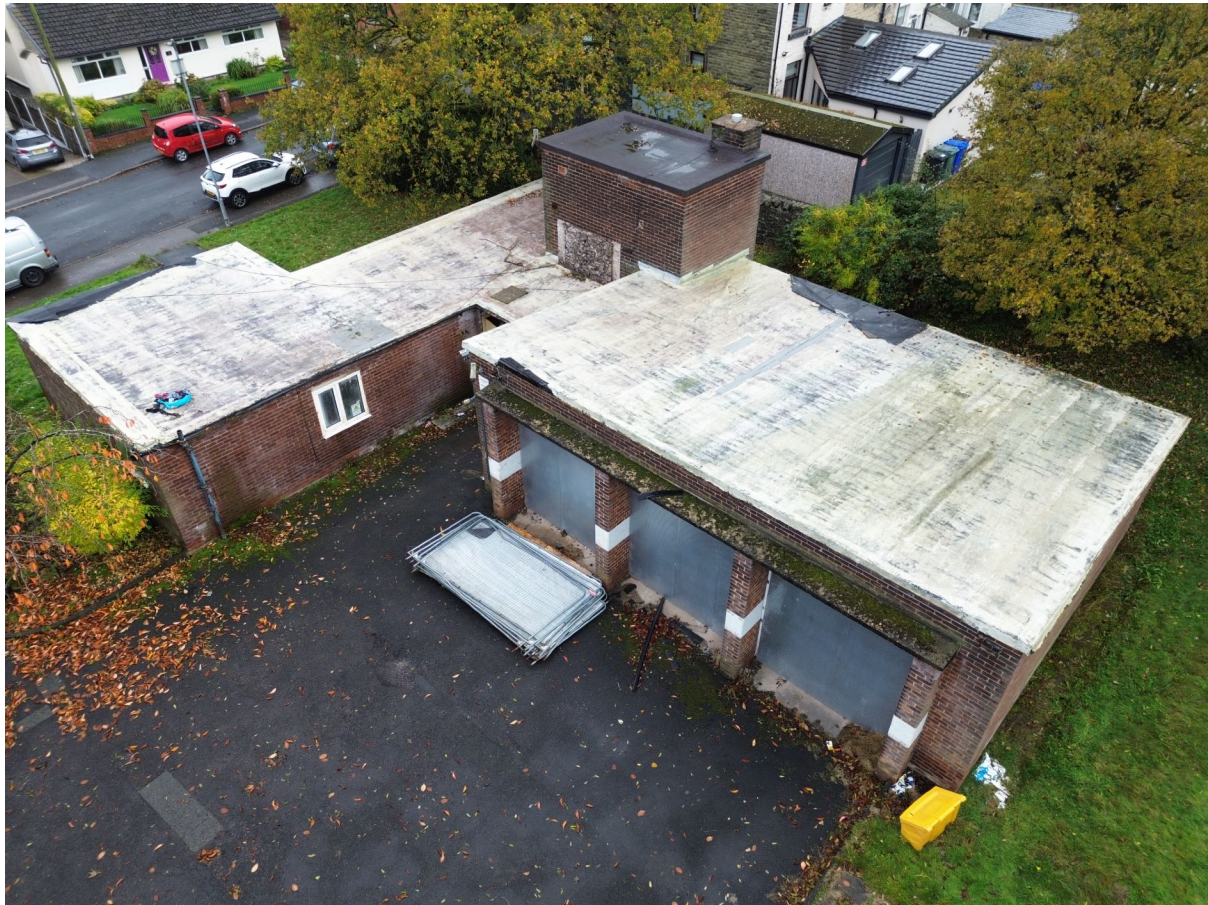
3.1a – Looking west toward the building.

The Old Ambulance Station, Ramsbottom, is a pre-1970's built former ambulance station, which is currently unused, and has been unoccupied for a number of years. It has a flat concrete roof, covered with bitumen felt. Bitumen flashing is fitted at the base of chimneys & flues. There are no fascia boards or soffits fitted at the eaves.

The building is in deteriorating condition. Roofing felt has become damaged in some areas, although there are no holes or gaps which could give access to the inside of the building or into wall cavities. There are no gaps between the underside of the concrete roof and brickwork. Walls are in generally good condition with no missing mortar or cracks in brickwork. Window and door frames are securely fitted, gaps around the frames are filled with sealant.

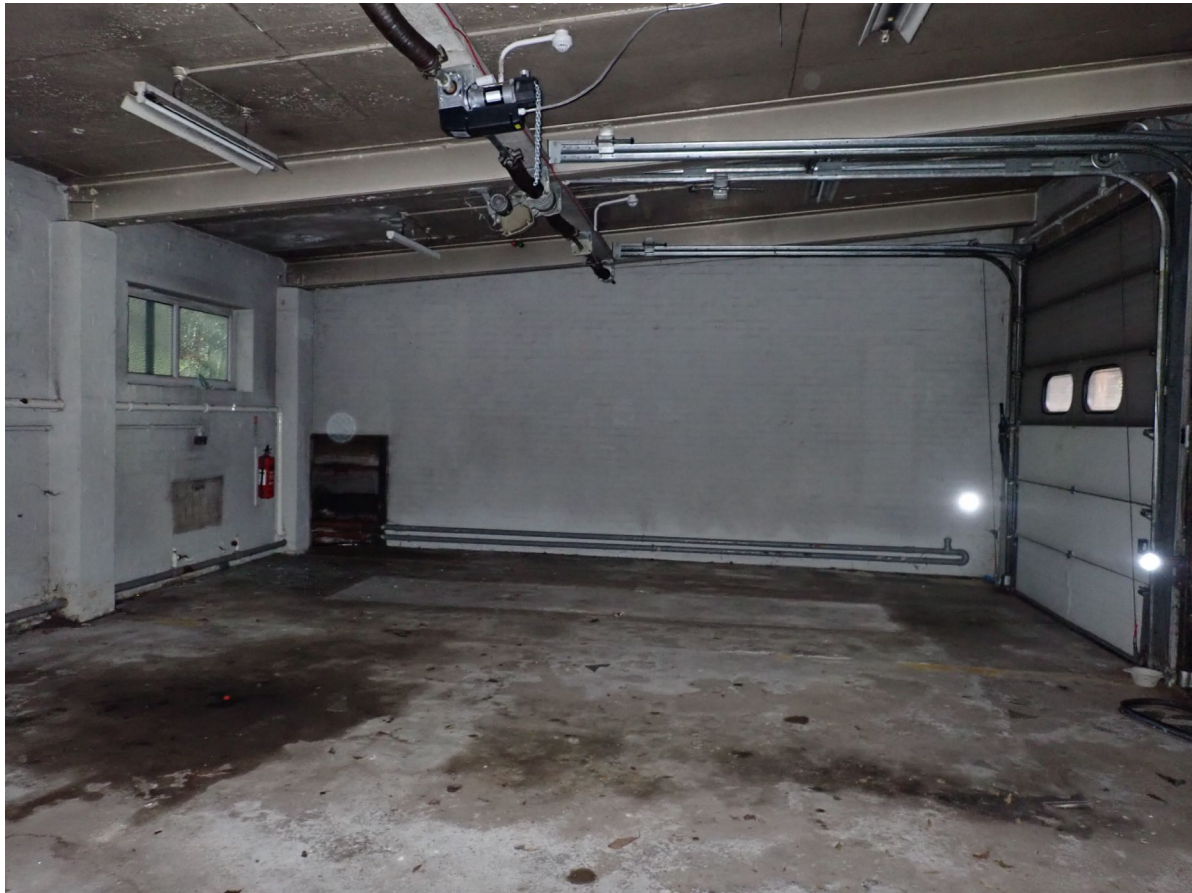
3.2a – Inside the ambulance bays.

The ambulance bays are a single open space with painted brick walls, and a concrete roof with supporting steel beams, and no enclosed areas. The boiler room has bare brick walls, and a concrete roof, with no enclosed areas. The offices have painted brick walls, and are divided into a number of rooms which are well lit by natural light.

Damage to the roof has allowed water ingress into the building and internally the building is in poor condition. However, there are no voids or crevices which are suitable for use by roosting bats.

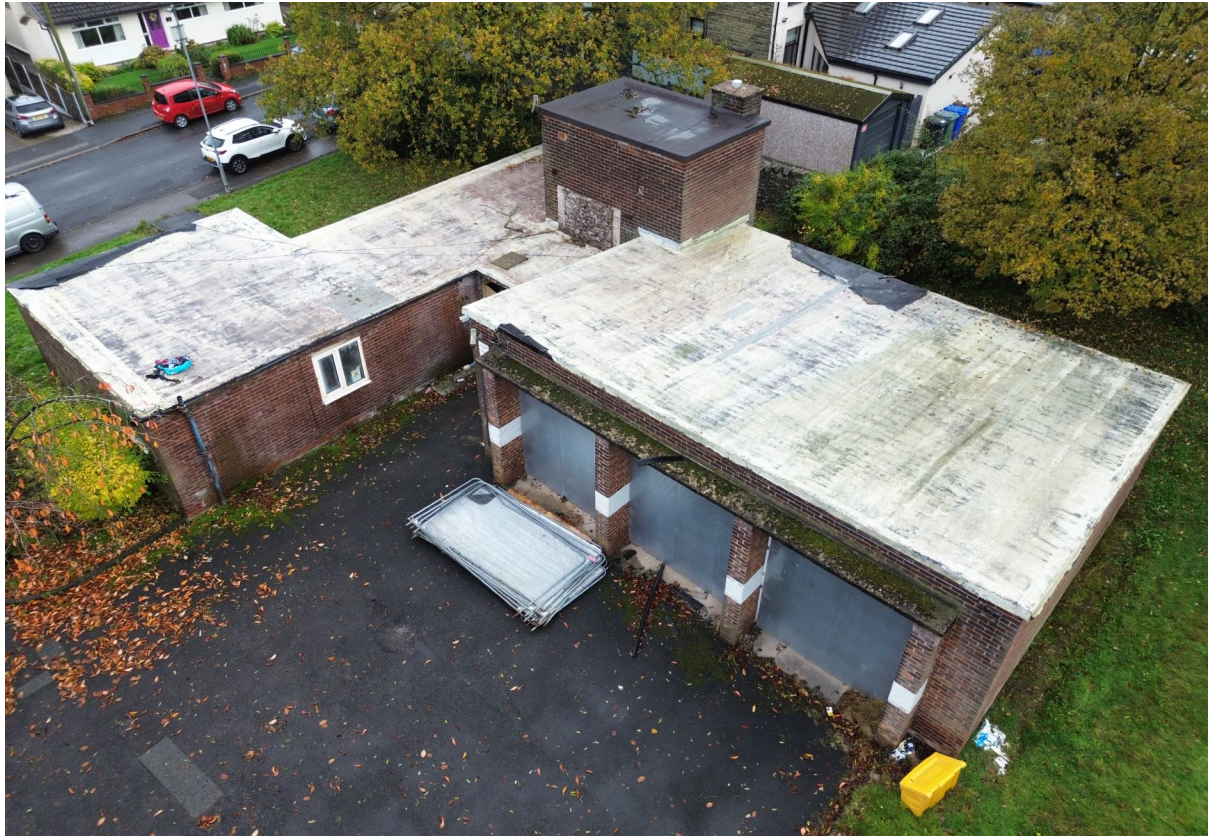
1 – The east side of the building.

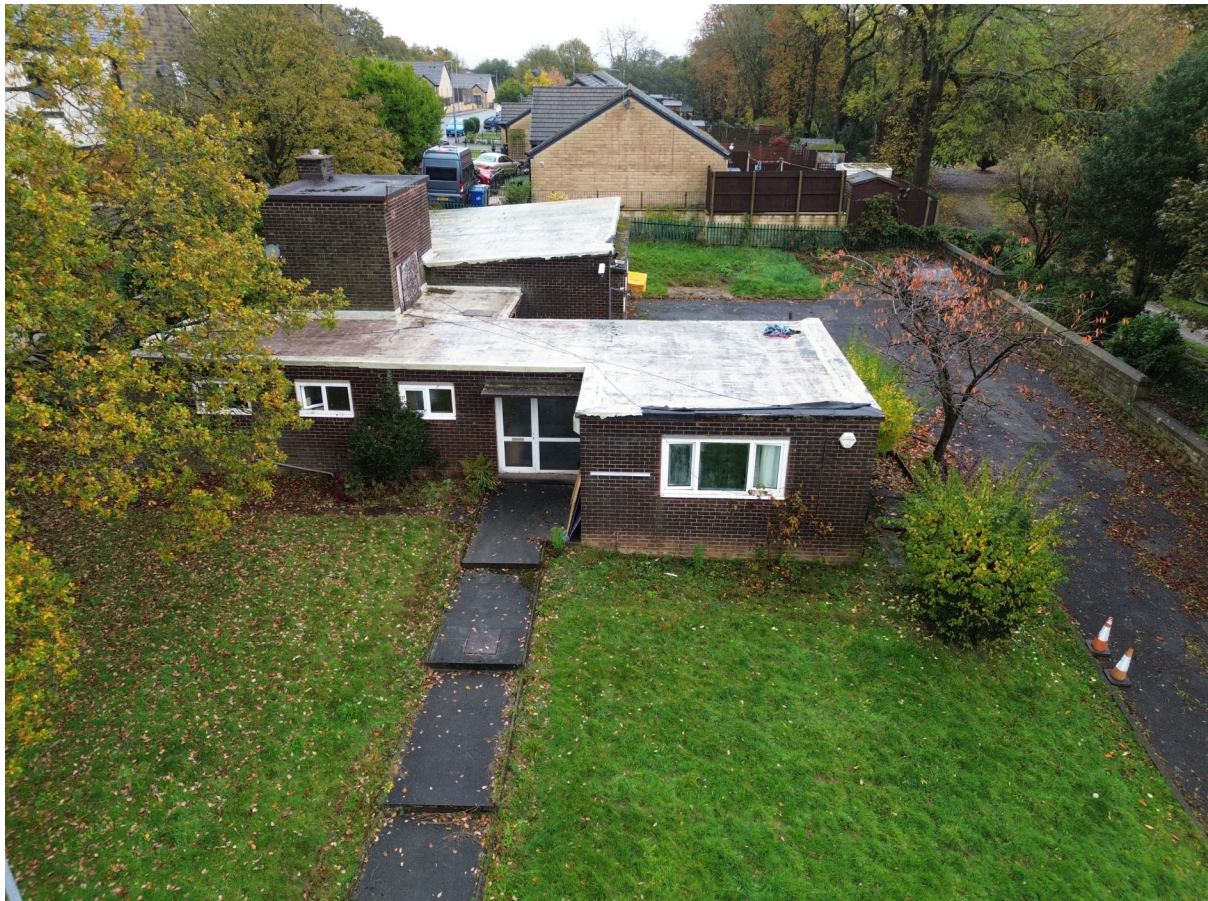
2 – The south side of the building, from Cemetery Road.

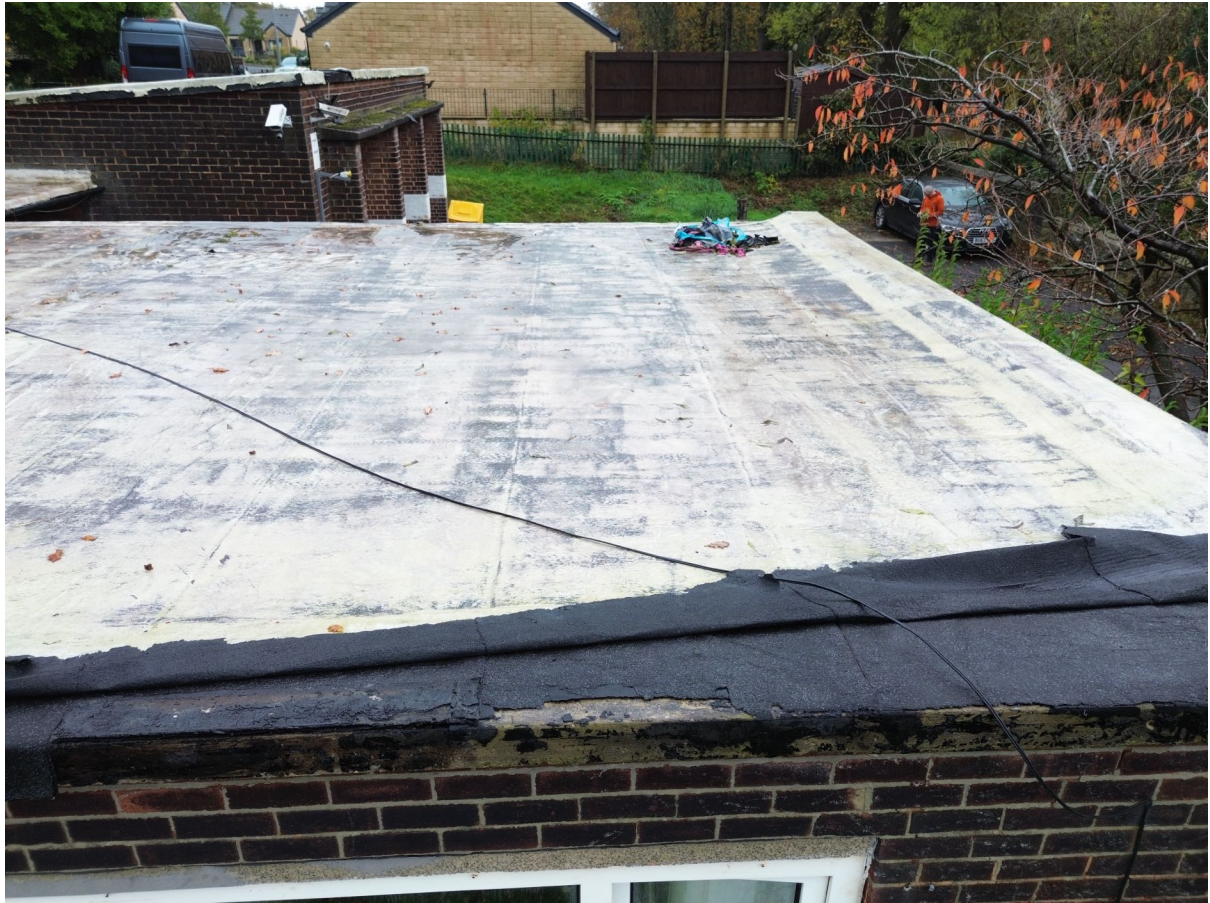
The building has a solid concrete roof, covered with bitumen felt. Roofing materials are in generally good condition, although there are some areas of damaged felt. However, there are no gaps between roofing materials which could be used by roosting bats.

3 – There are small areas of damaged roofing felt but no viable gaps between materials.

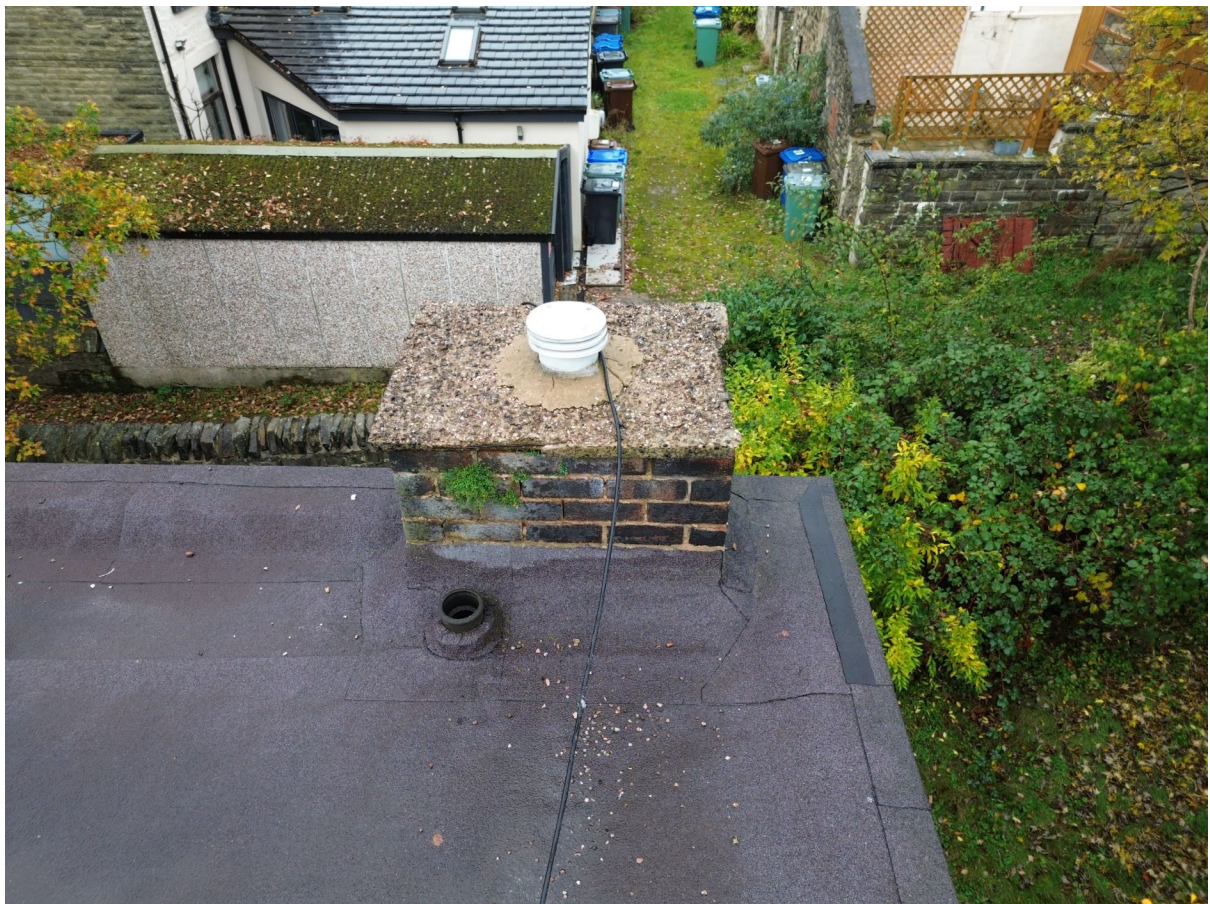
4 – Bitumen flashing is fitted tightly around chimneys and flues with no suitable gaps.

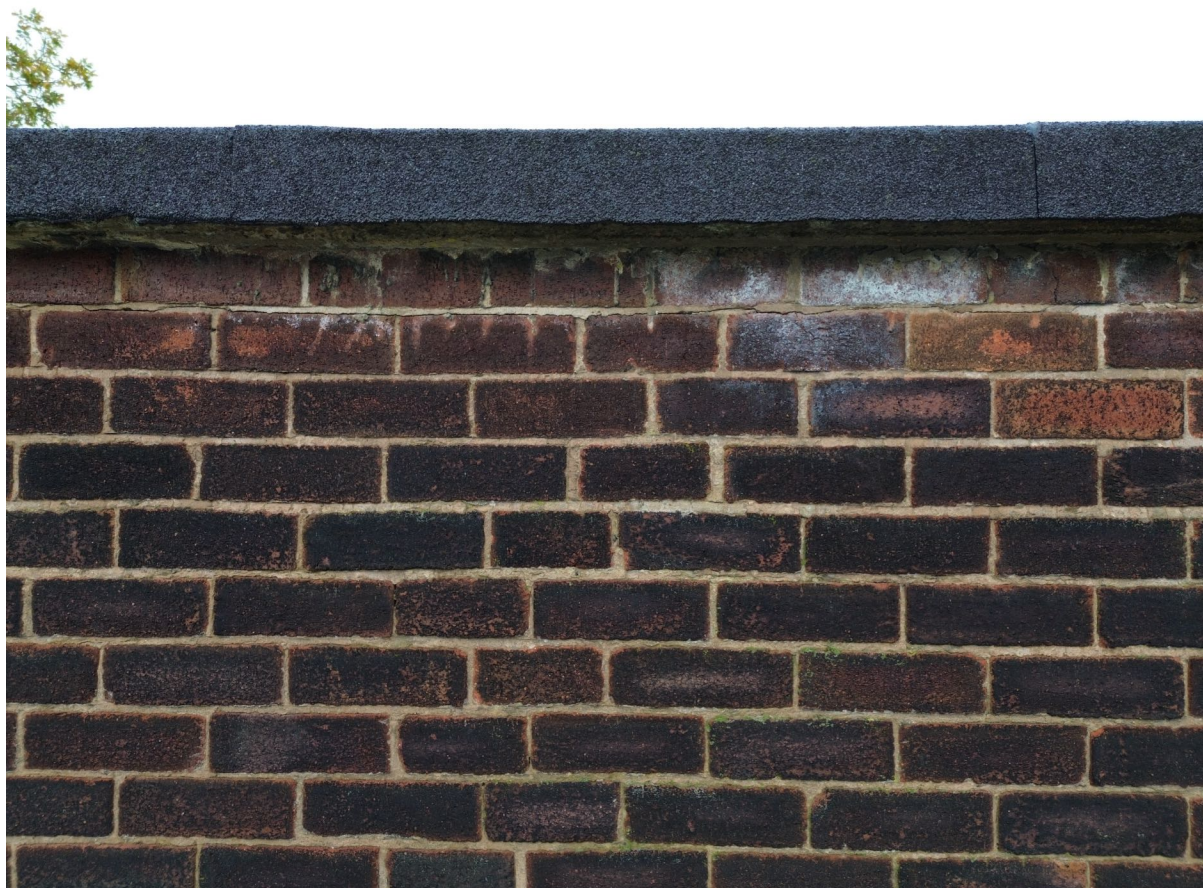
5 – There are no fascia boards at the eaves.

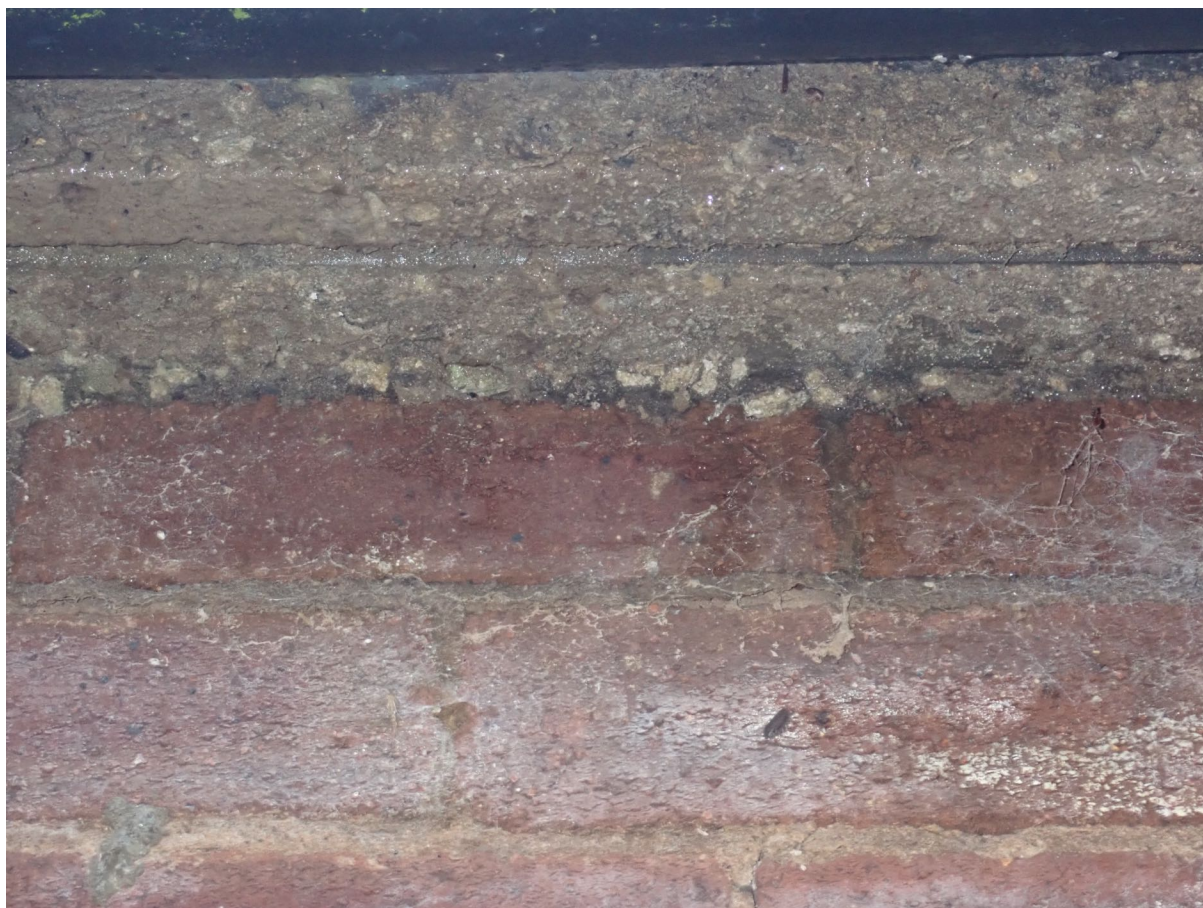
The concrete roof is sealed tightly against brickwork at the eaves, with no suitable gaps between materials.

6 – There are no gaps between brickwork and the concrete roof.

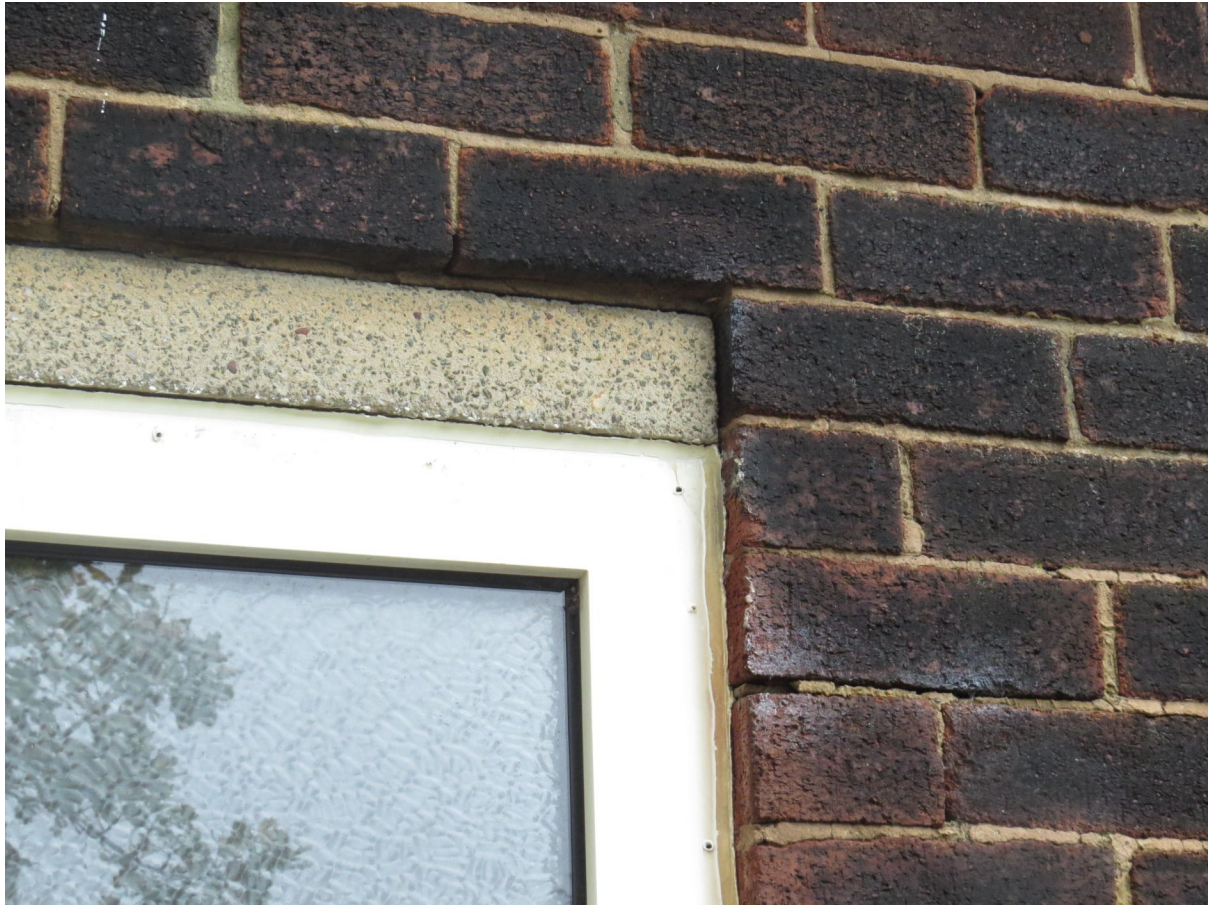
Window and door frames are fixed into the walls, gaps are filled with sealant, and offer no suitable roosting opportunities.

7 – Window and door frames are tightly sealed into walls with no suitable gaps.

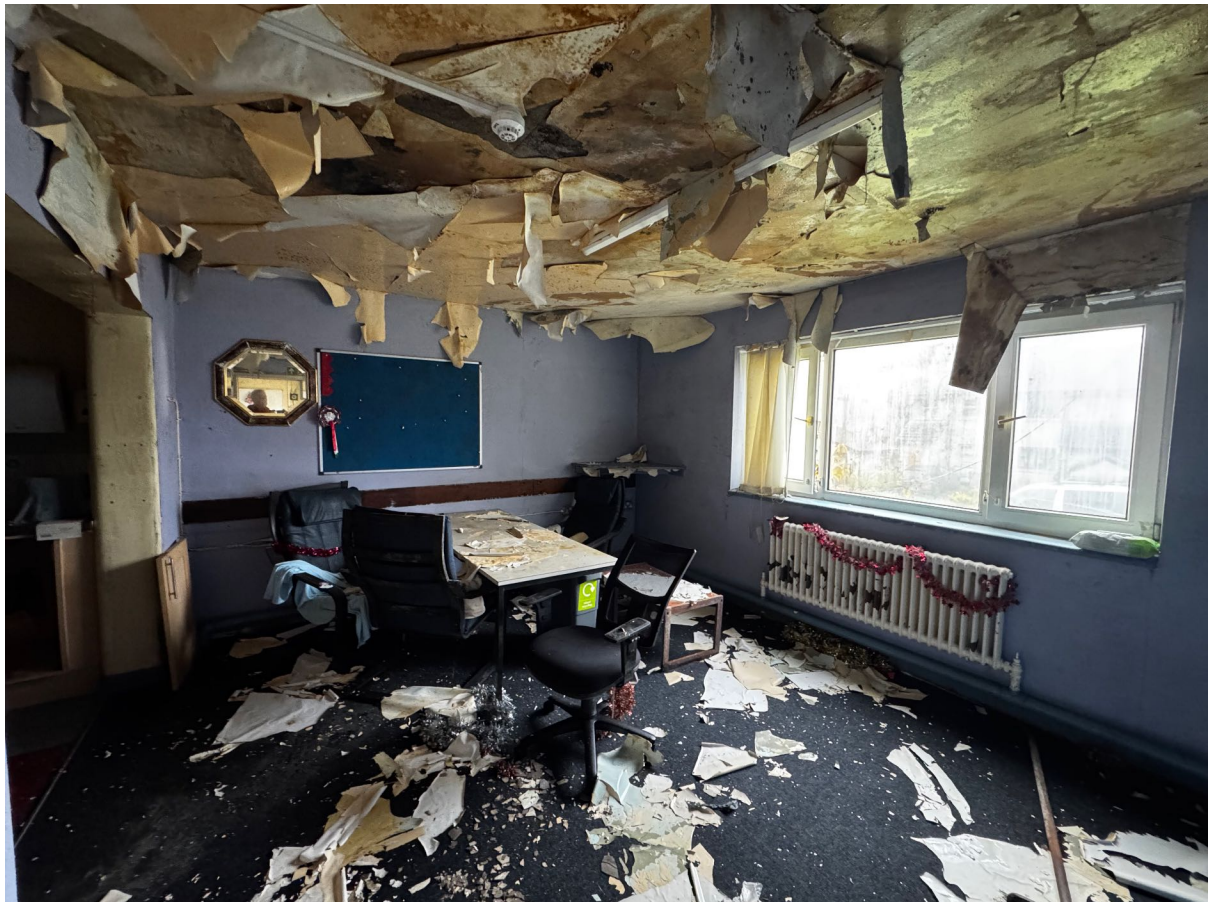
8 – Internally the offices are well lit by natural light and have been damaged by water.

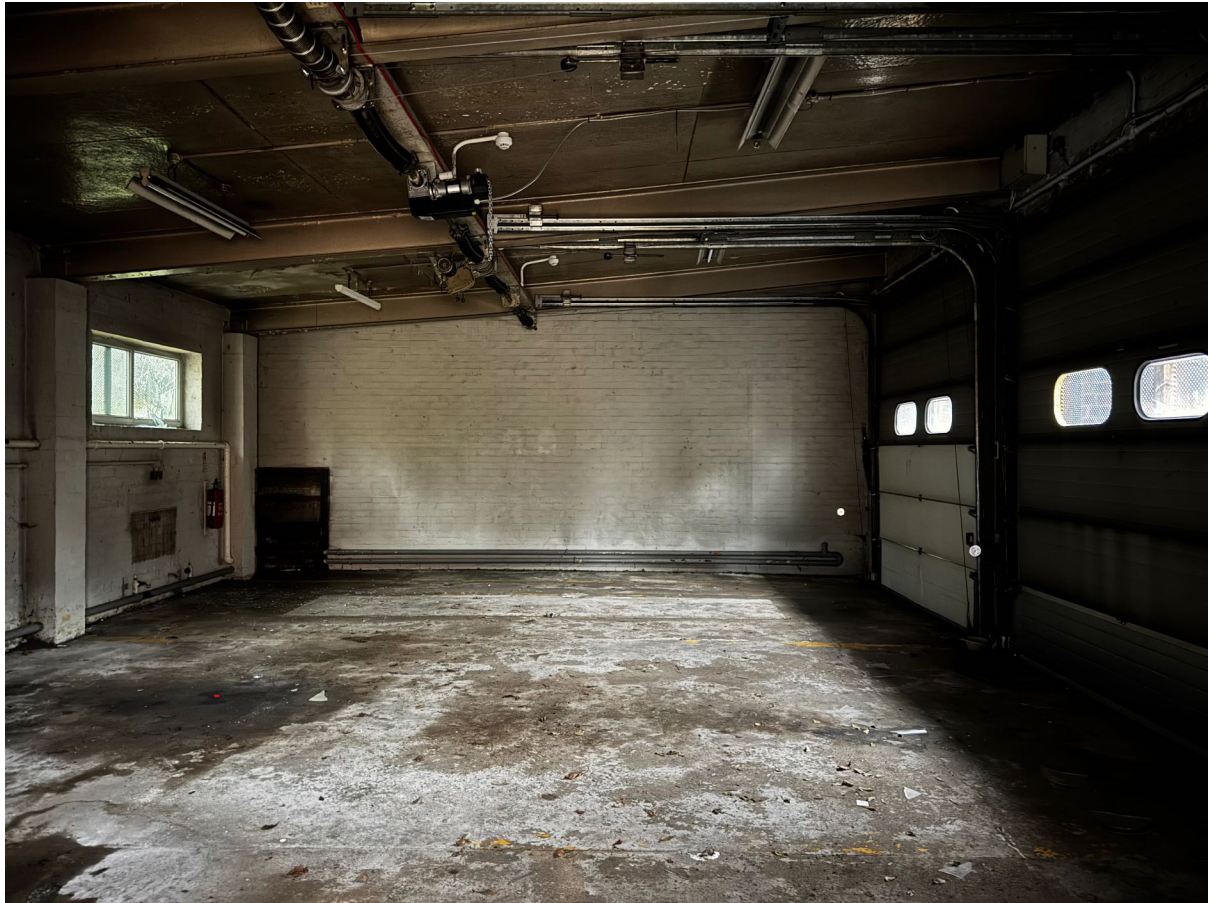
9 – The ambulance bays have painted brick walls with no roof void.

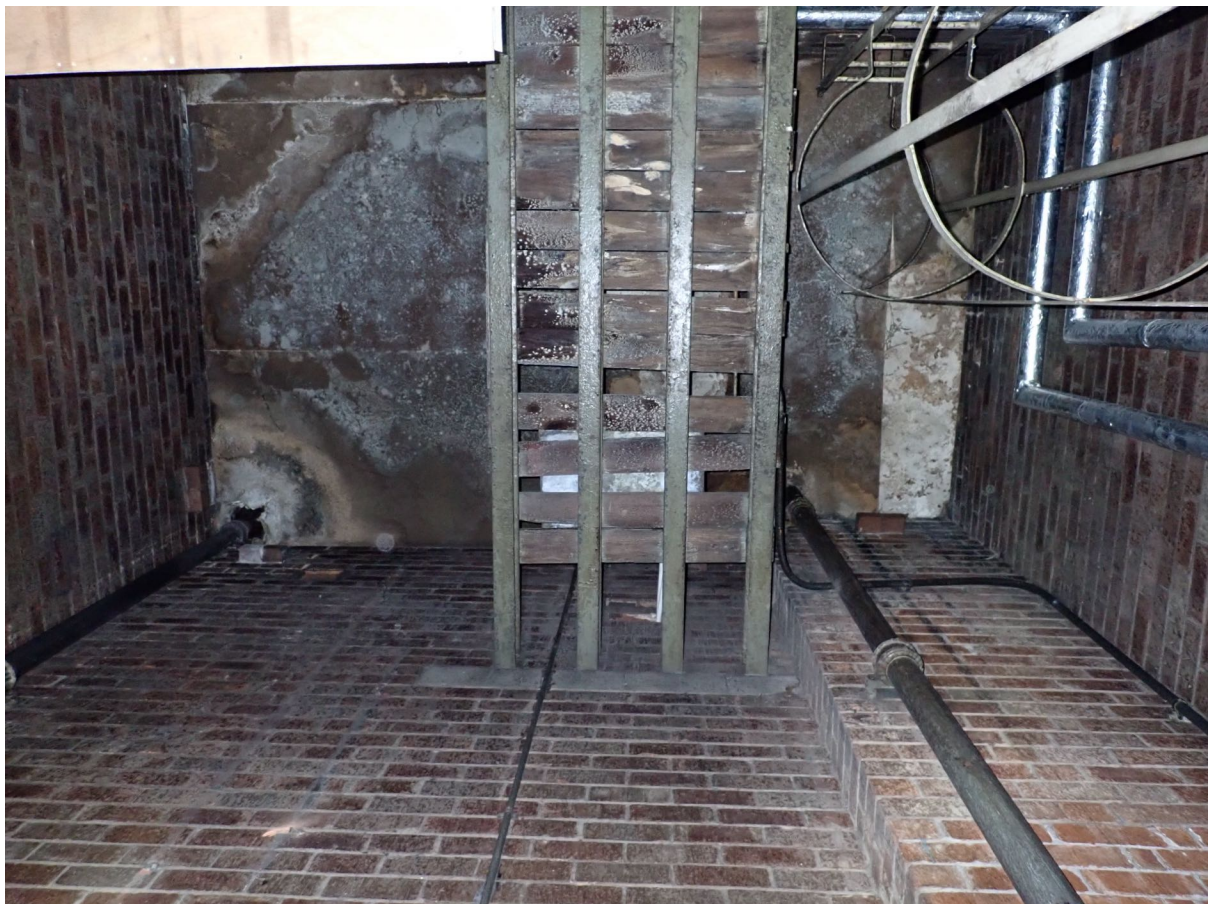
10 – The boiler room has bare brick walls, and a concrete roof.
