# Contaminated Land Phase One Desk Study for proposed replacement Mosque at Masjid Al Bilal, Bury Old Road, Prestwich, M25 0ER.

February 2024

This report consists of a phase one contaminated land desk study produced in support of planning application for the redevelopment of Masjid Al Bilal, Bury Old Road, Prestwich, M25 0ER.

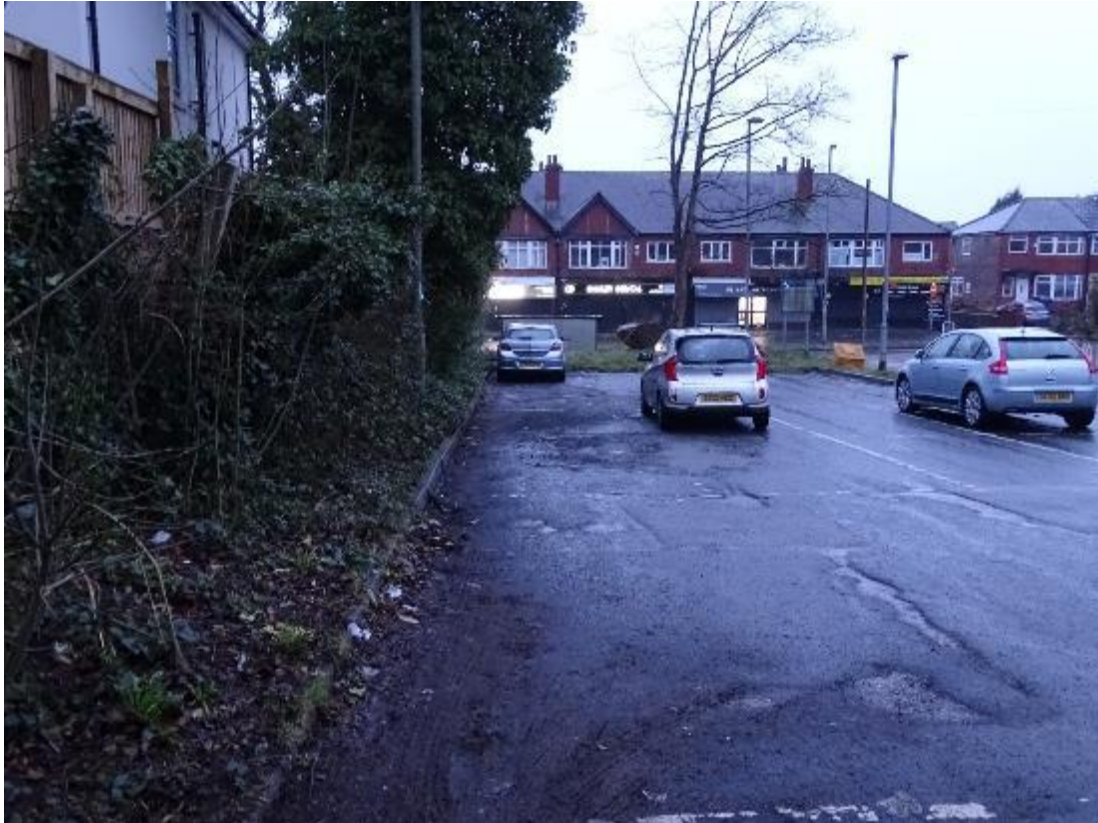
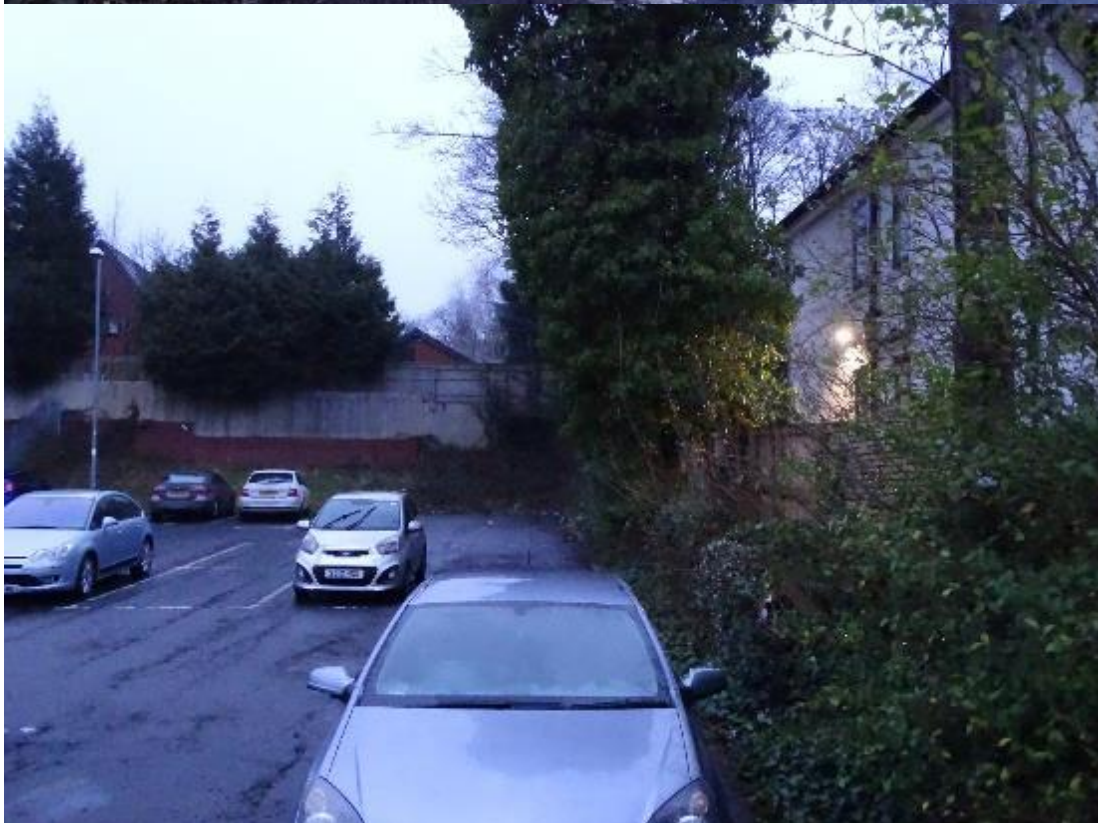
Southern boundary looking west then east

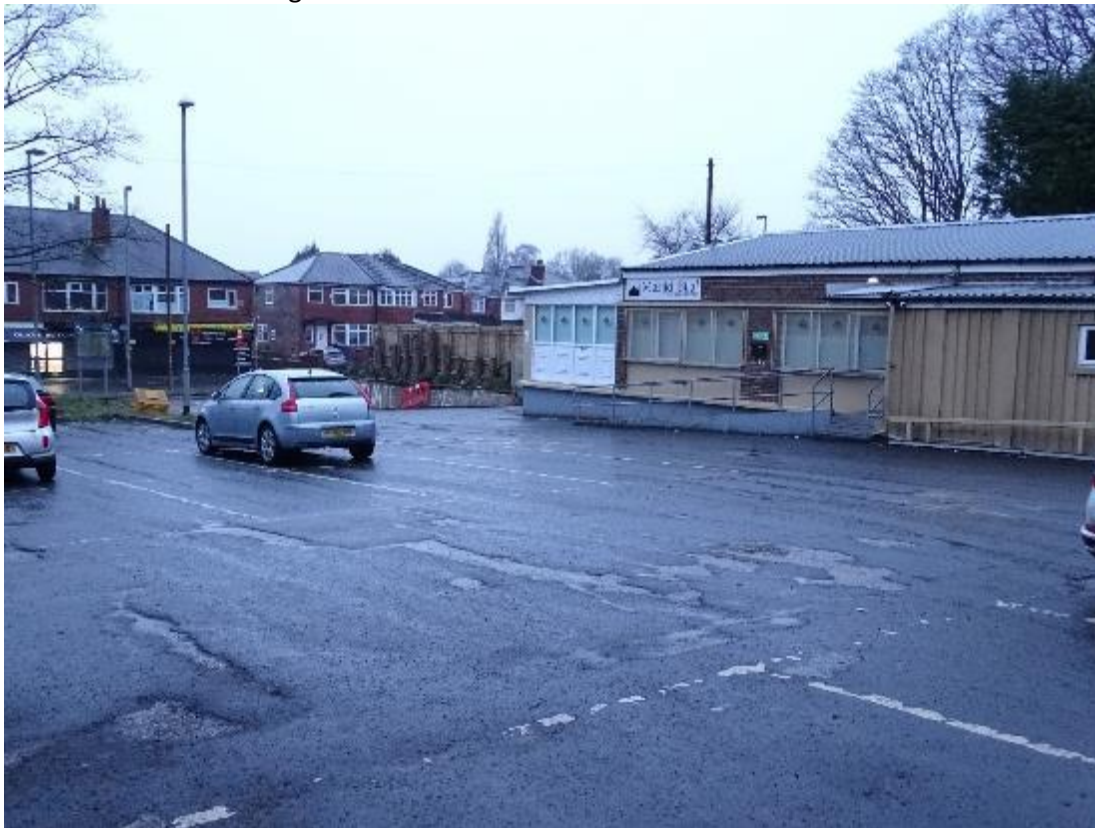
Southeast corner looking across site.

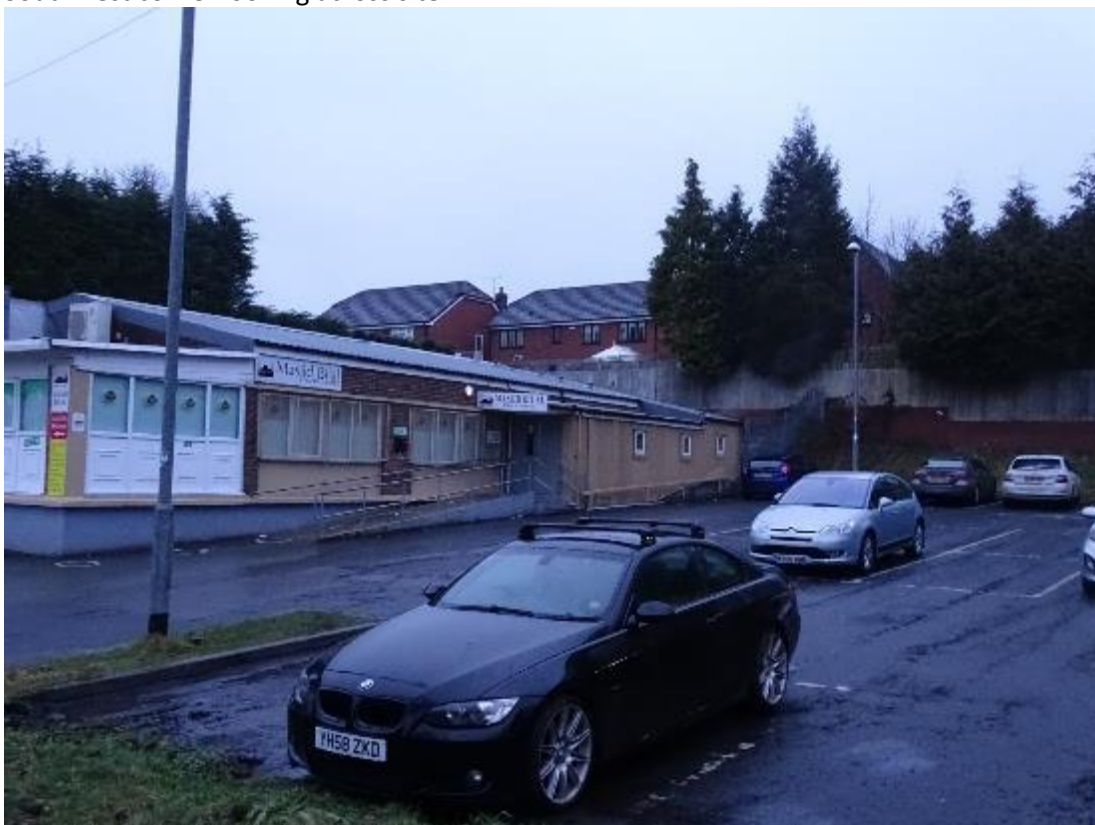
Southwest corner looking across site.

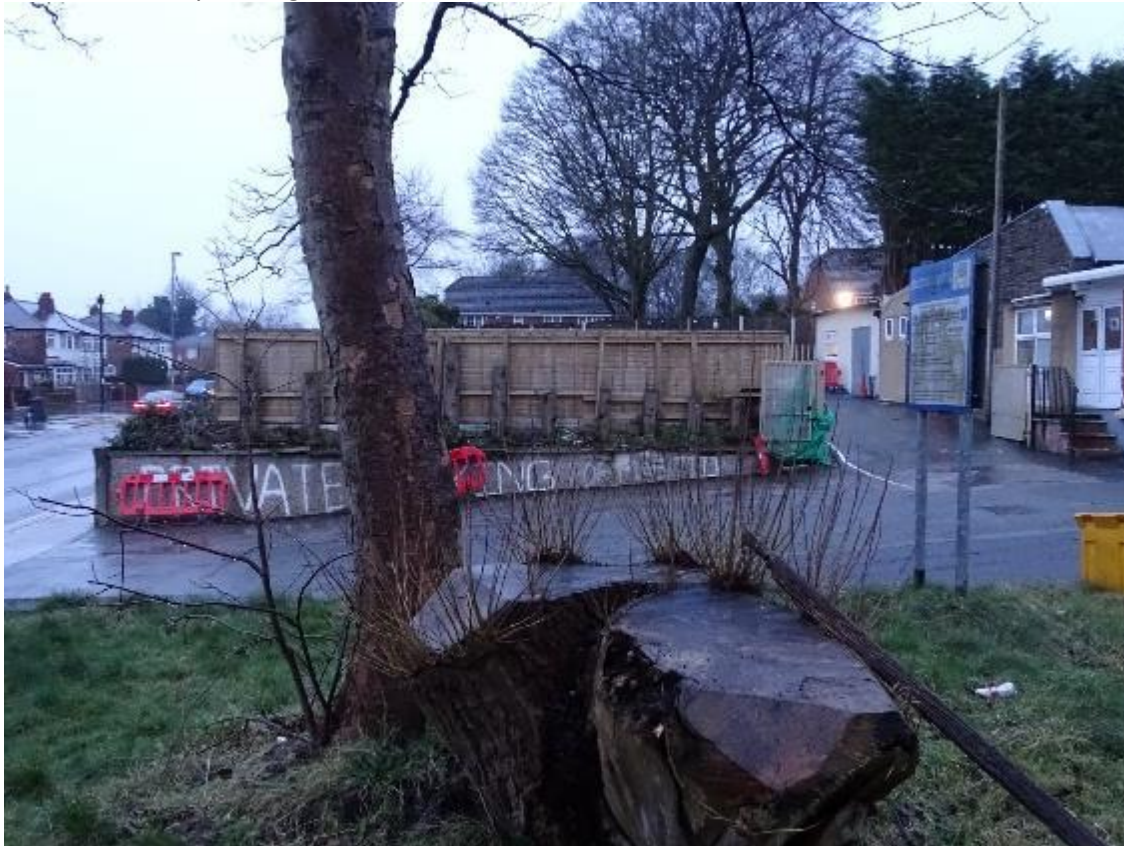
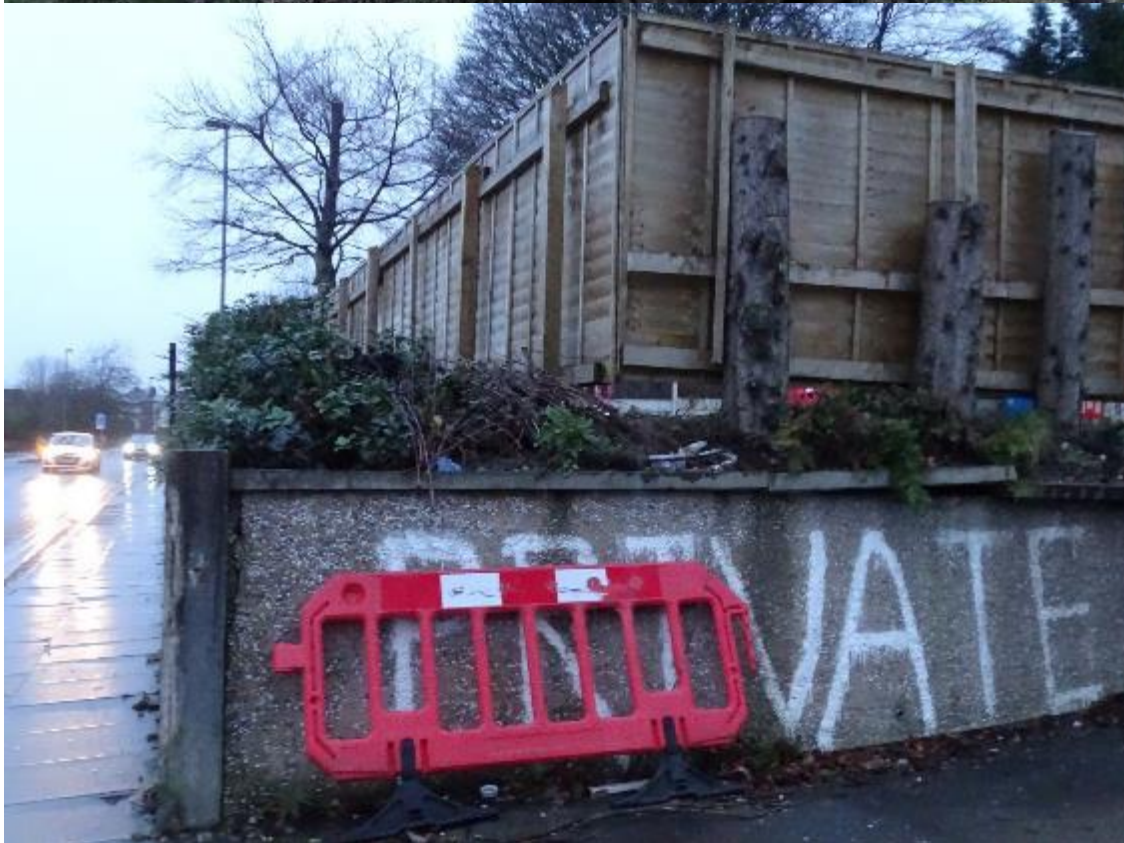
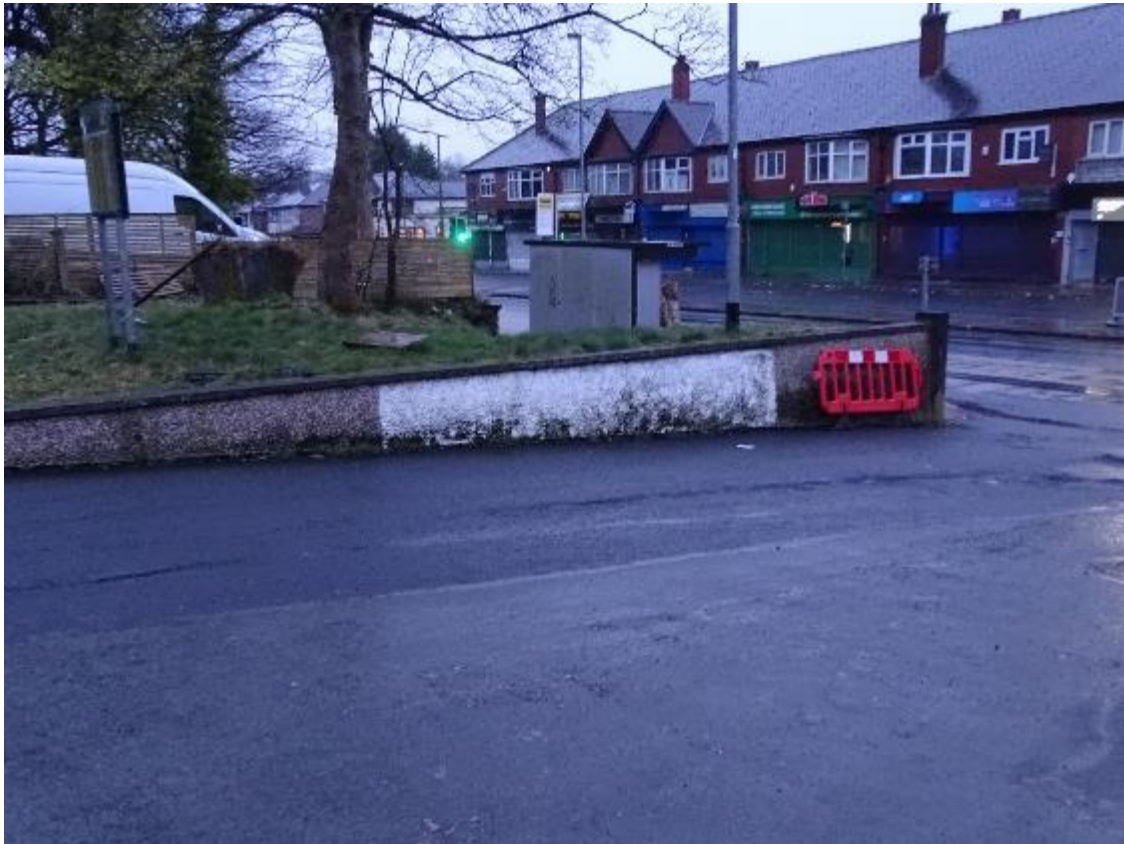
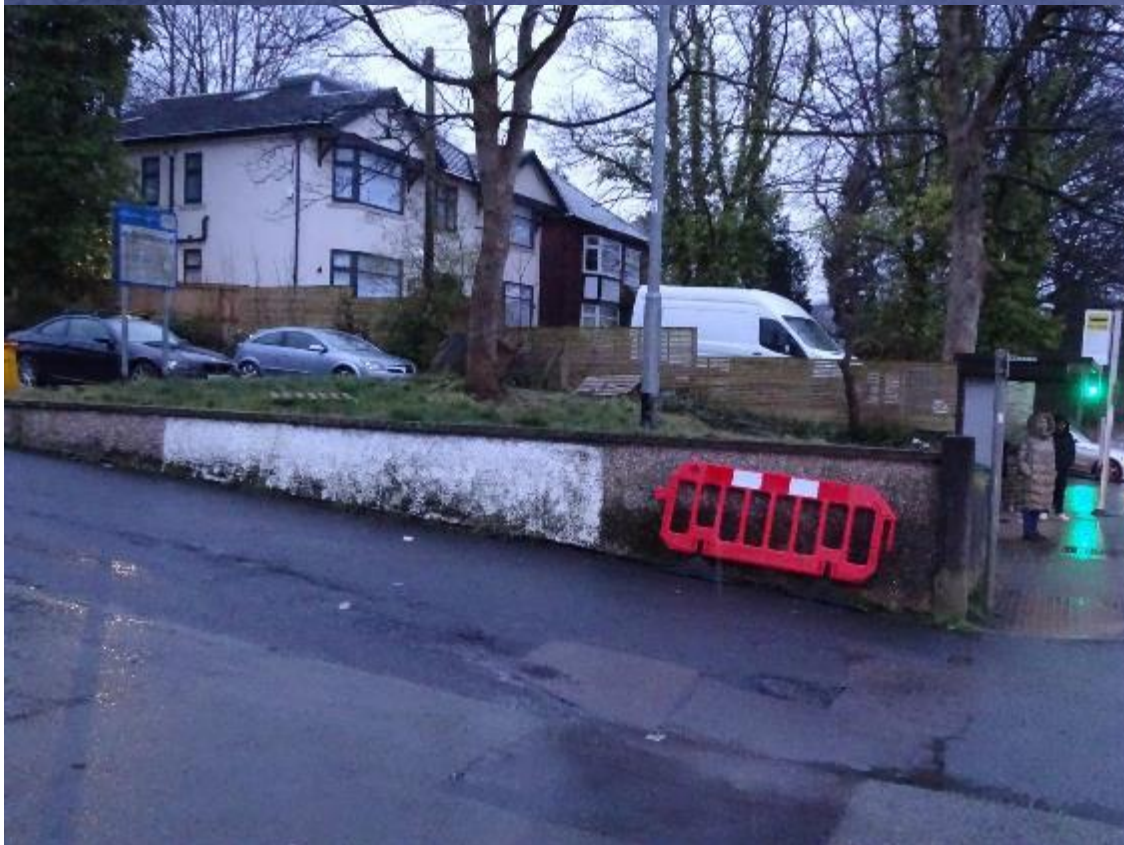
western bodnary looking north then south.

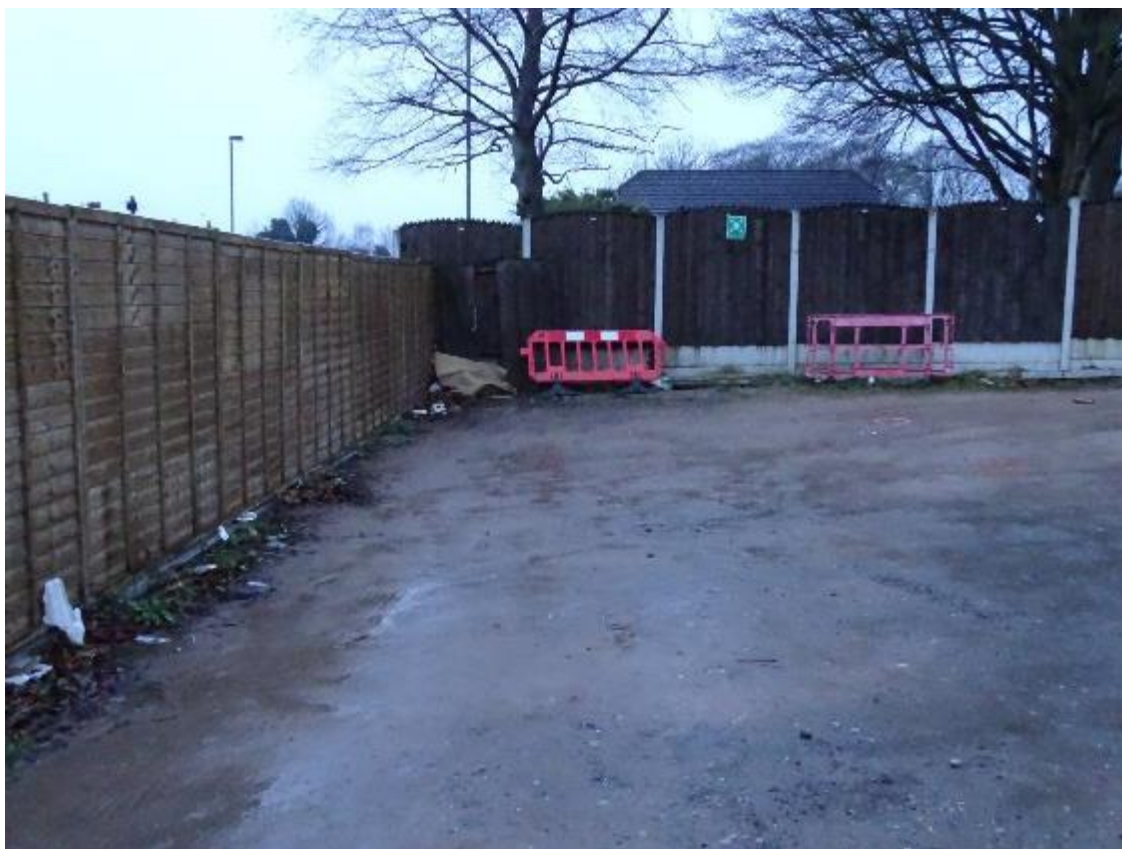
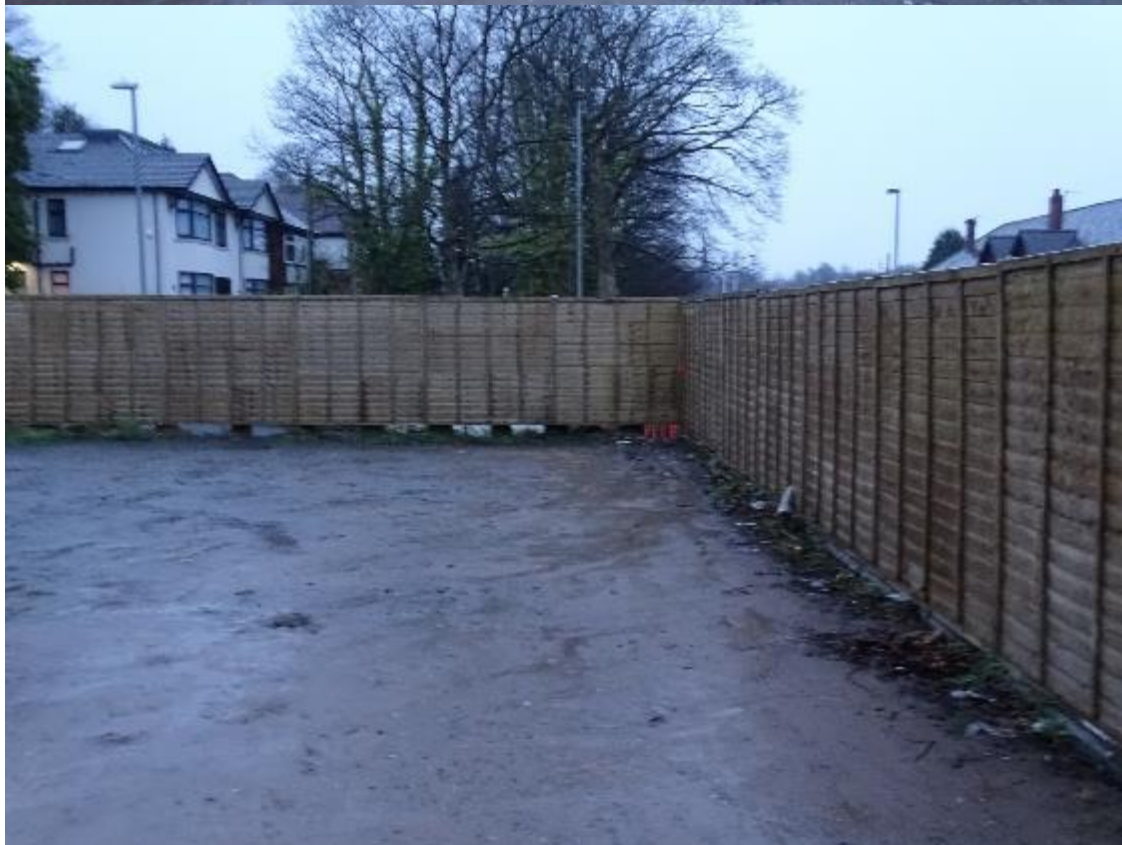
northwestern carpar area looking north then south along western boundary

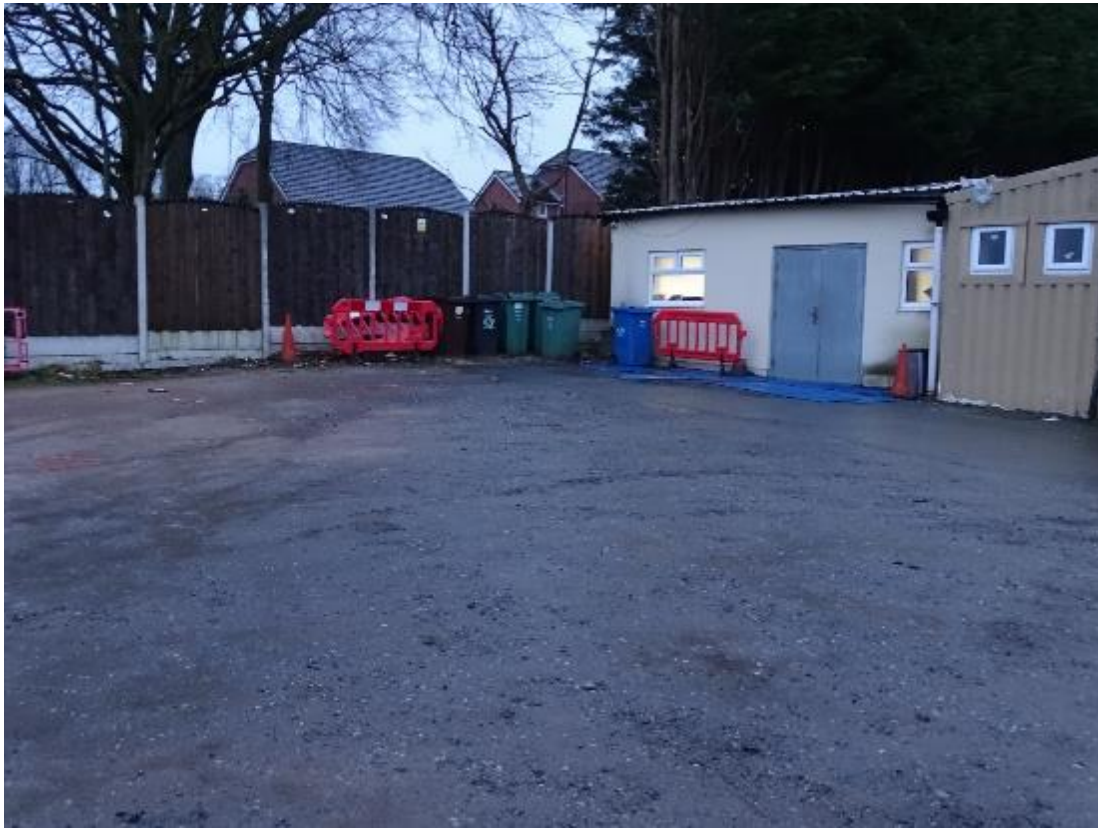
Looking across the area southwest to north east

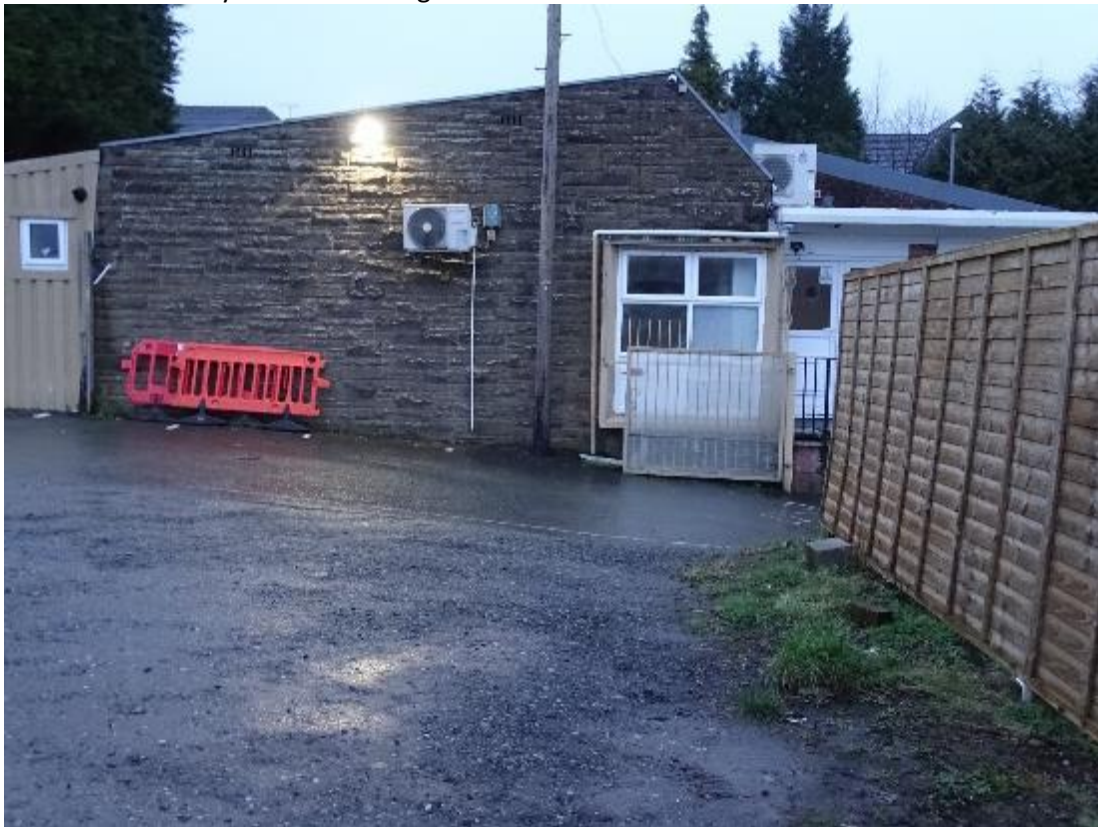
southern boundary of area looking east

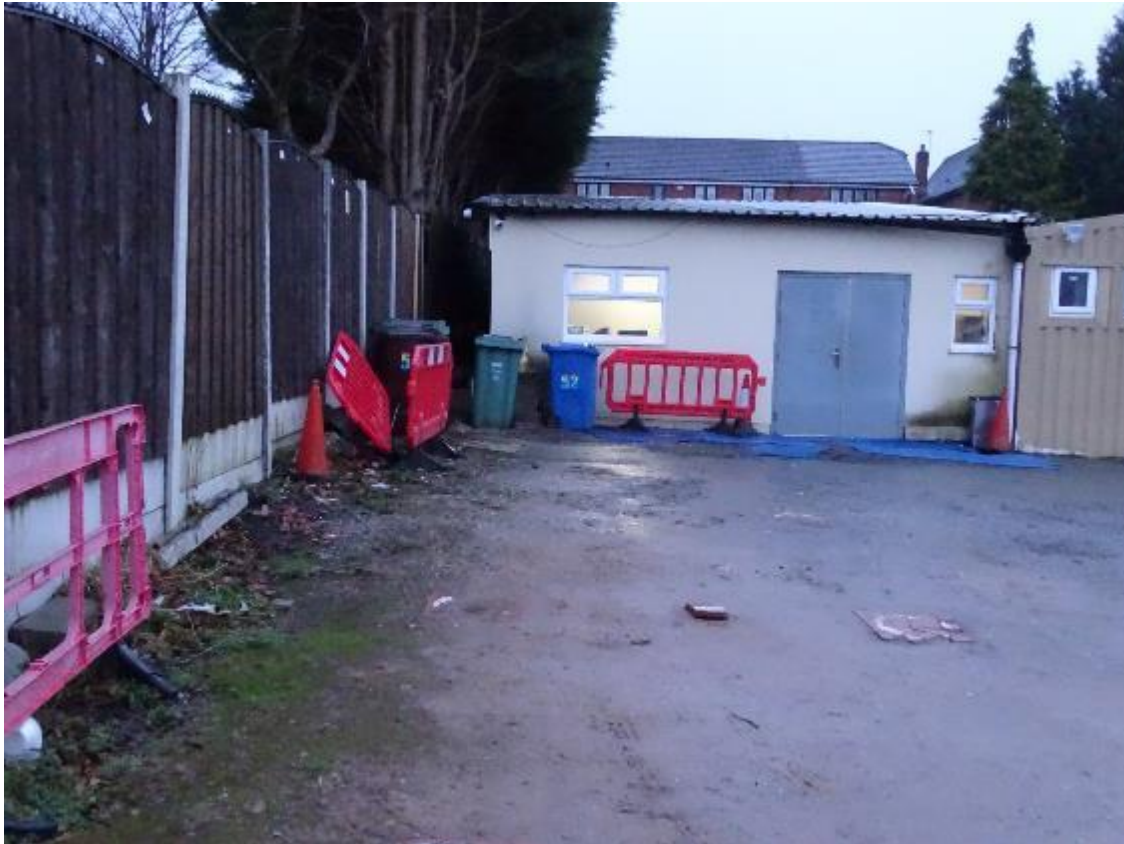
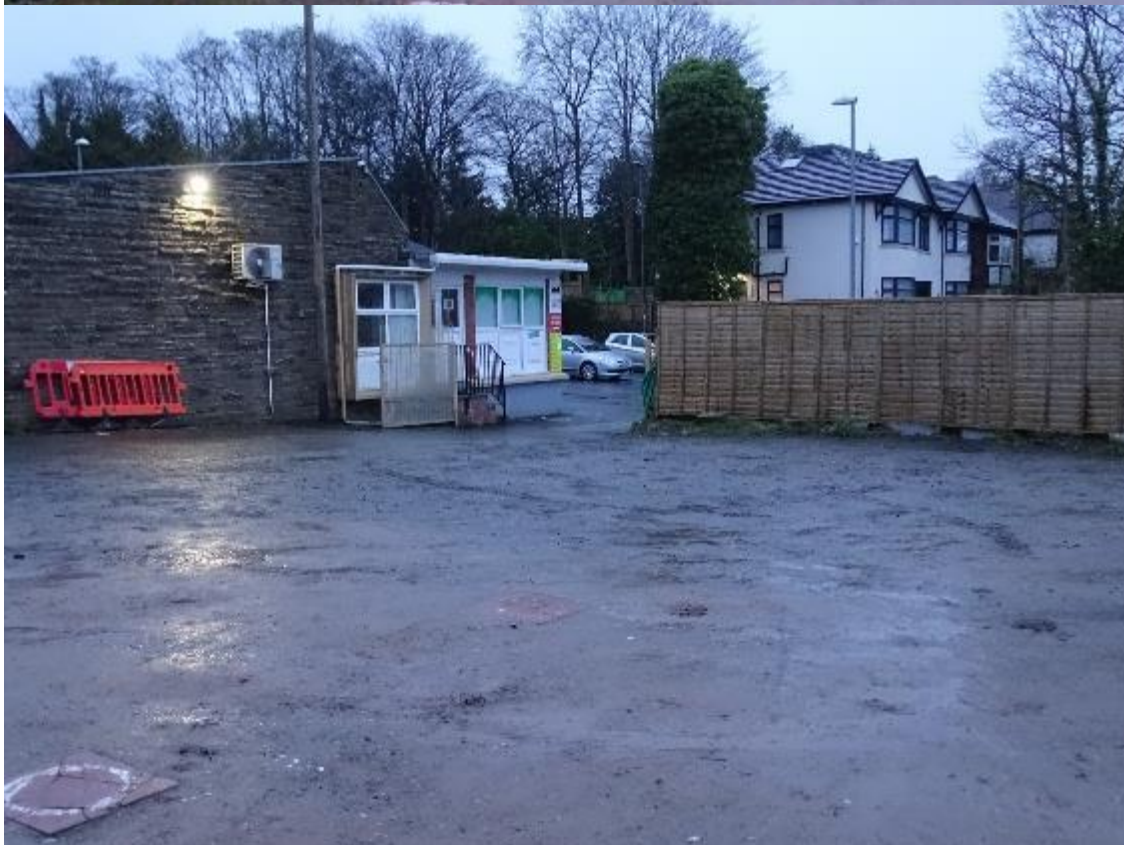
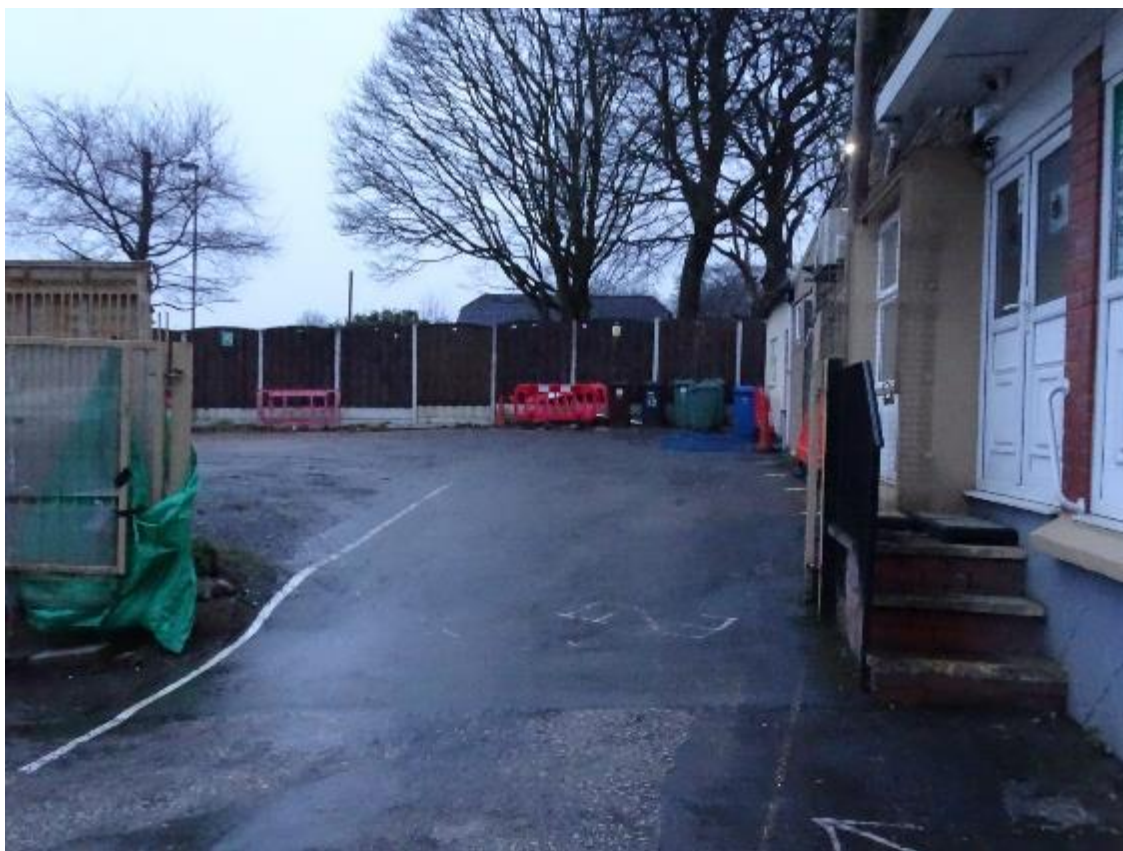
Nrthern boundary of area

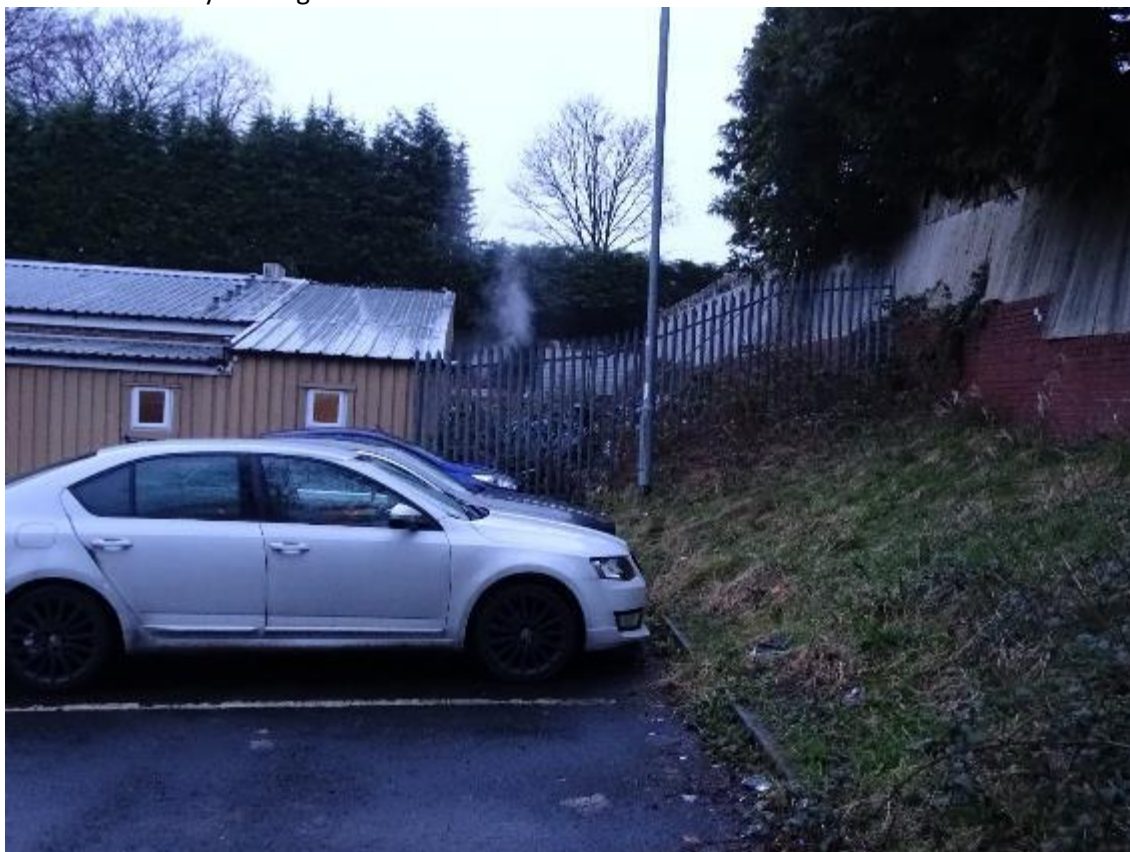
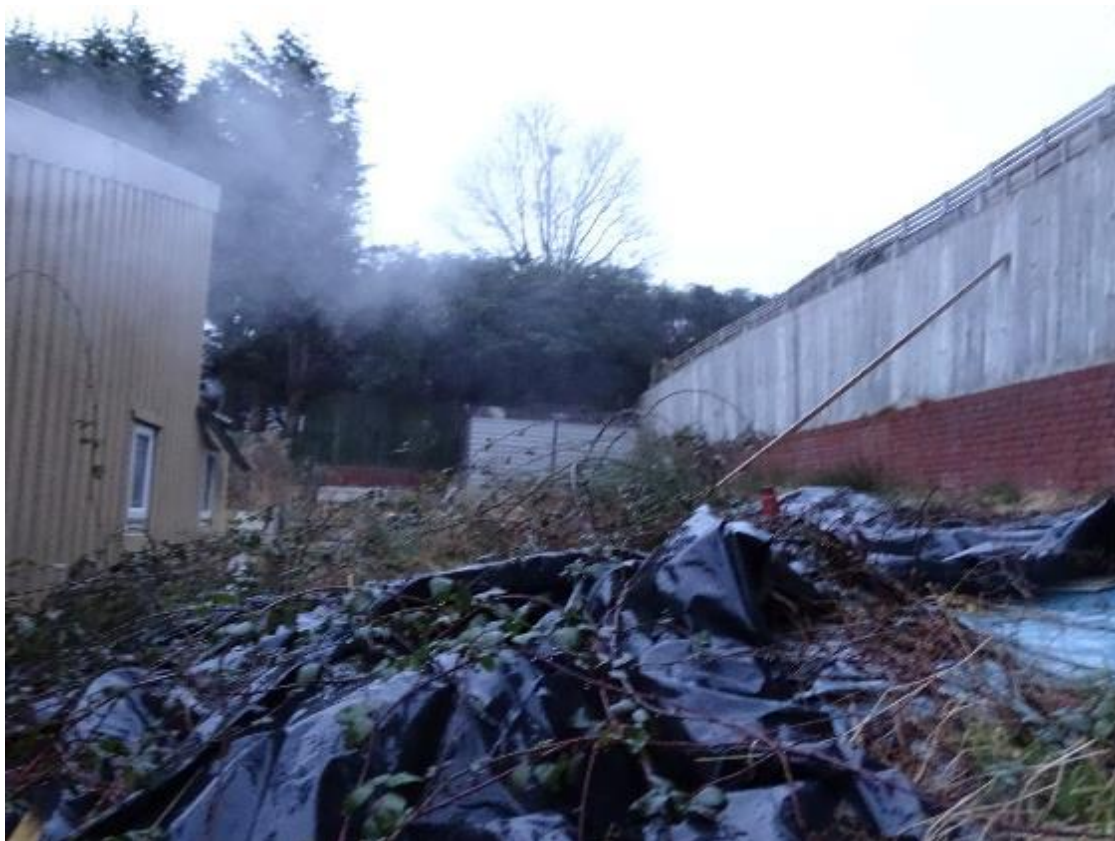
Eastern boundary looking north

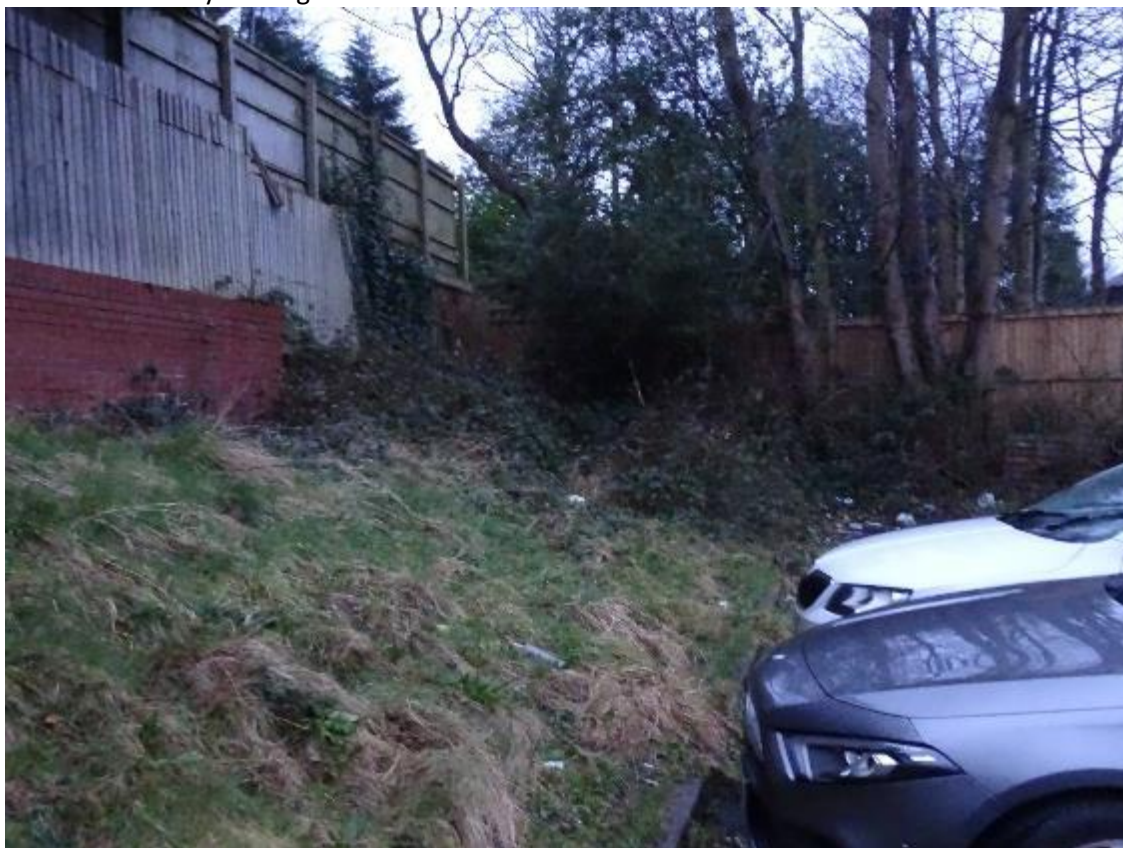
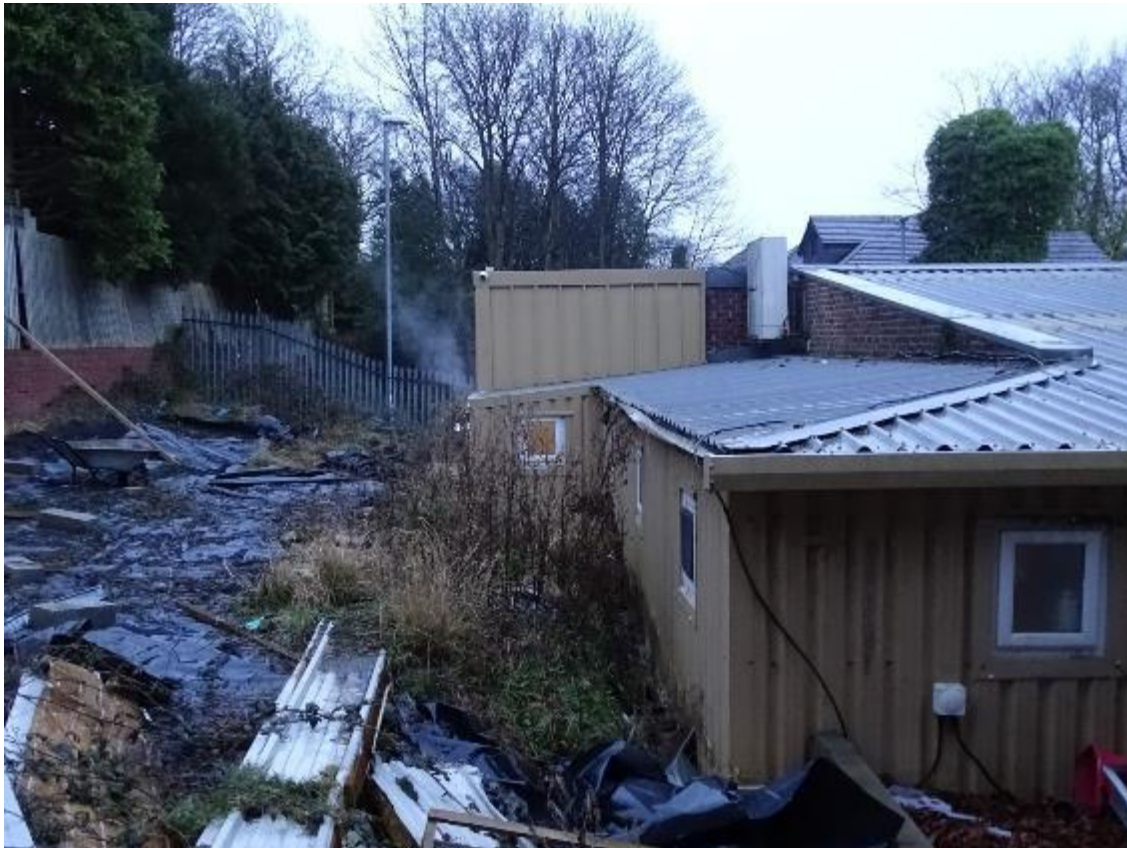
Eastern boundary looking west

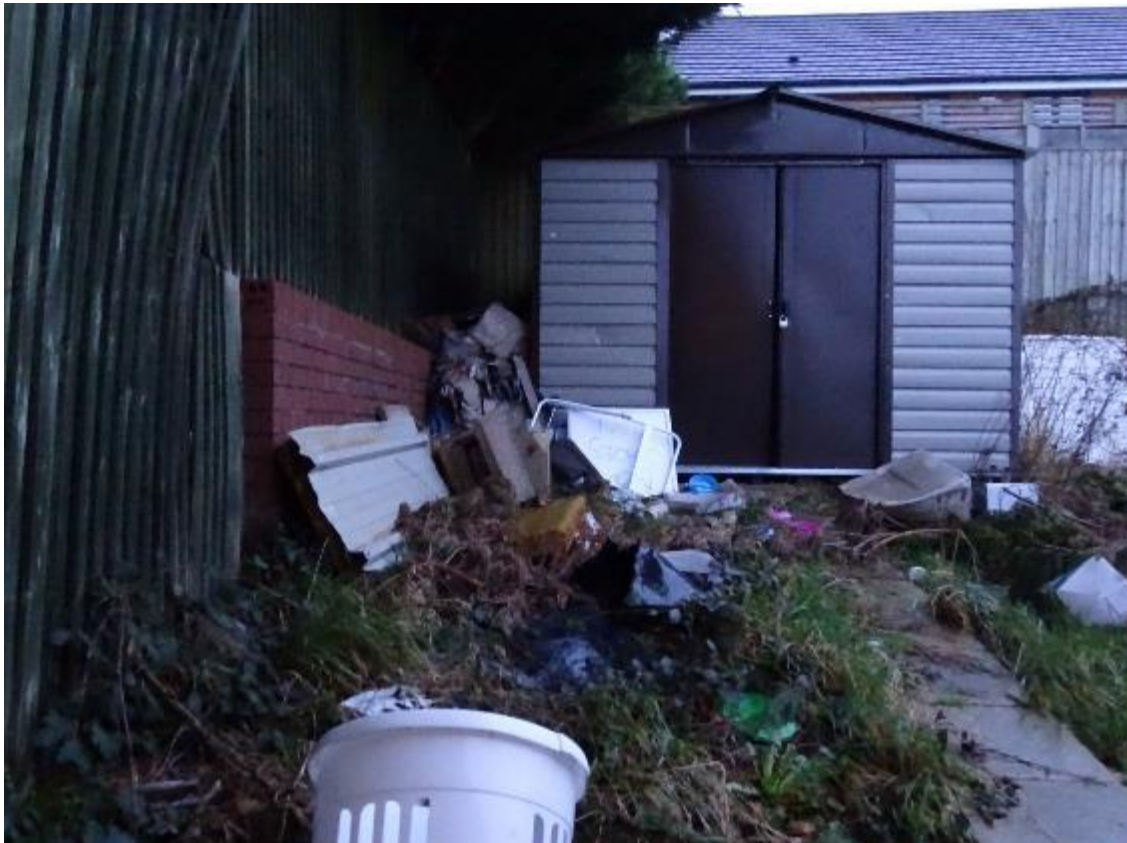
To the northeast of the site is located the existing single storey building. Constructed from brick, block, metal profile sheeting the building is gas centrally heated. To the northern corner a metal shed used for storage of inert equipment.

Shed in north east corner
