## **BAT PRESENCE / ABSENCE SURVEY**

**Higher House**

Moor Road  
Holcombe  
BL8 4NX

| UES reference: | UES03580/01 |

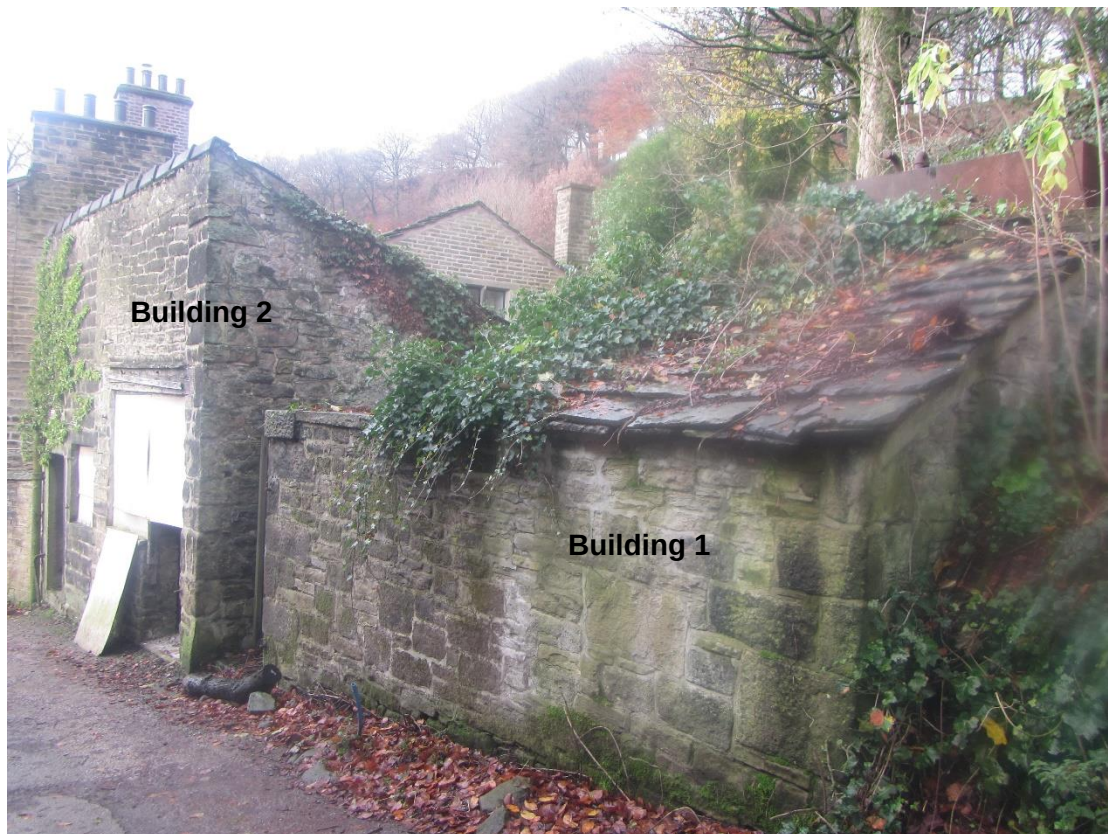
Photograph 1 – South-eastern aspects of Building 1 and Building 2.

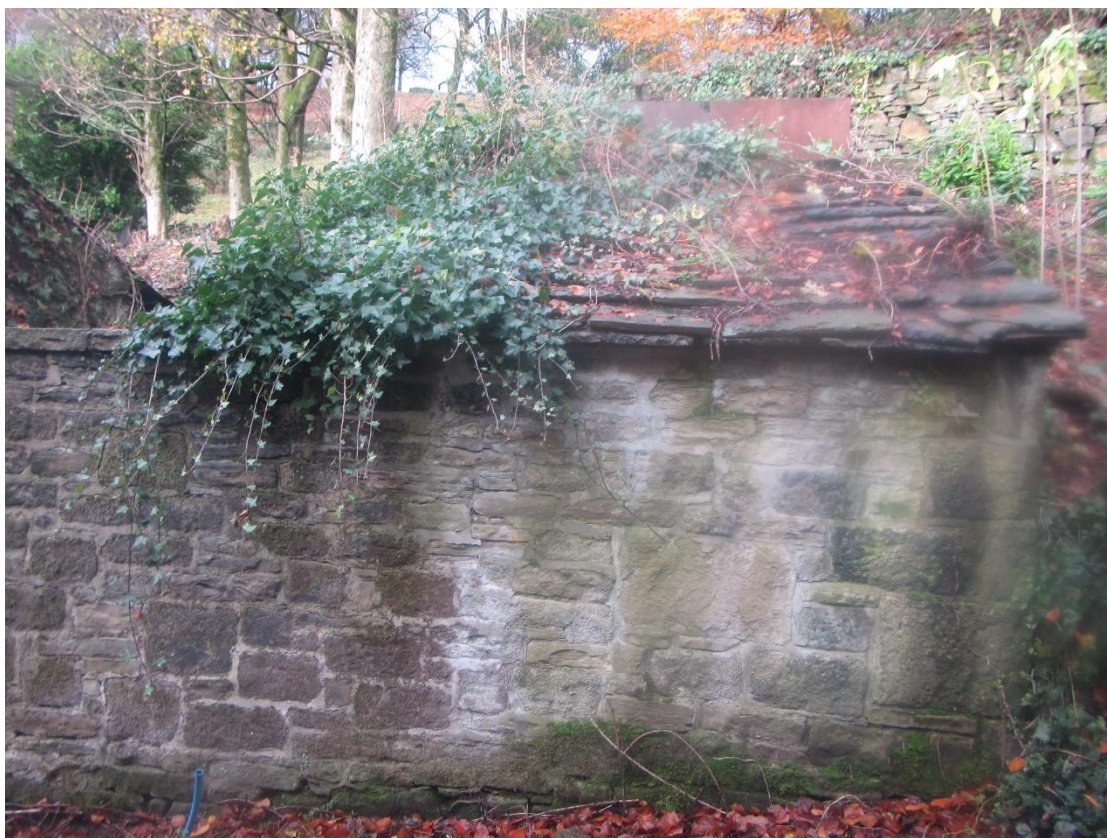
Photograph 2 – The eastern aspect of Building 1.

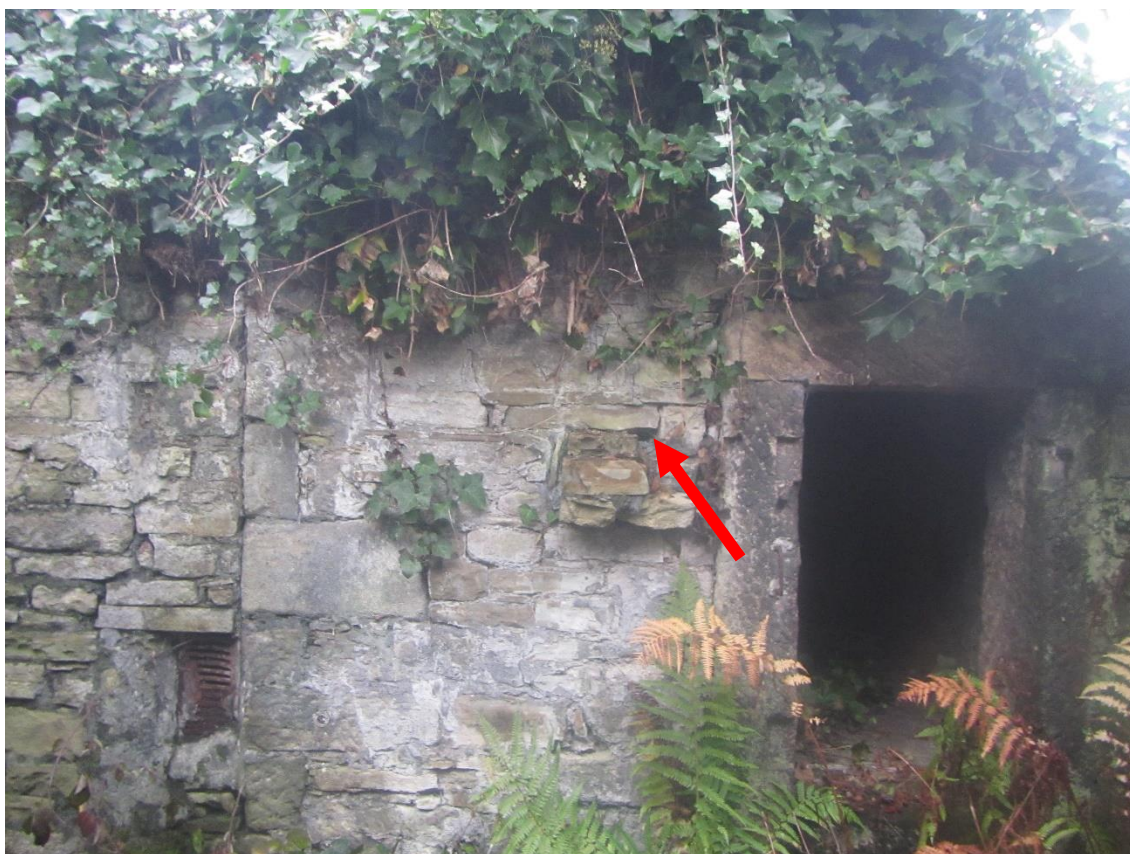
**Building 1** is a small stone-built rectangular building with a mono-pitched roof, located within the north-eastern section of the site, see Appendix 3, Photographs, Photograph 1. The roof is clad with stone roof and ridge tiles (Photograph 2) and there are several gaps where the roof tiles are lifted on the south-eastern aspect of the building. Although, several of the gaps were inspected using an endoscope and no evidence of roosting bats was recorded, but the features are considered suitable for use by bats occasionally. Furthermore, mortar is missing from a small number of the ridge tiles on the south-eastern aspect. In addition, ivy is present on a large proportion of the roof, although it is not dense enough for roosting bats, it does have the potential to support breeding birds (Photograph 2). The walls of the building are generally in good condition, but there a small number of gaps present on the south-western aspect of the building (Photograph 3). However, they were fully inspected using an endoscope, and no evidence of bats was recorded. Furthermore, the structure has no windows, but one open doorway is present on the south-western aspect of the building, providing access into the building (Photograph 3).

Photograph 3 – Southern aspect of Building 1, arrow pointing to gap in stonework.

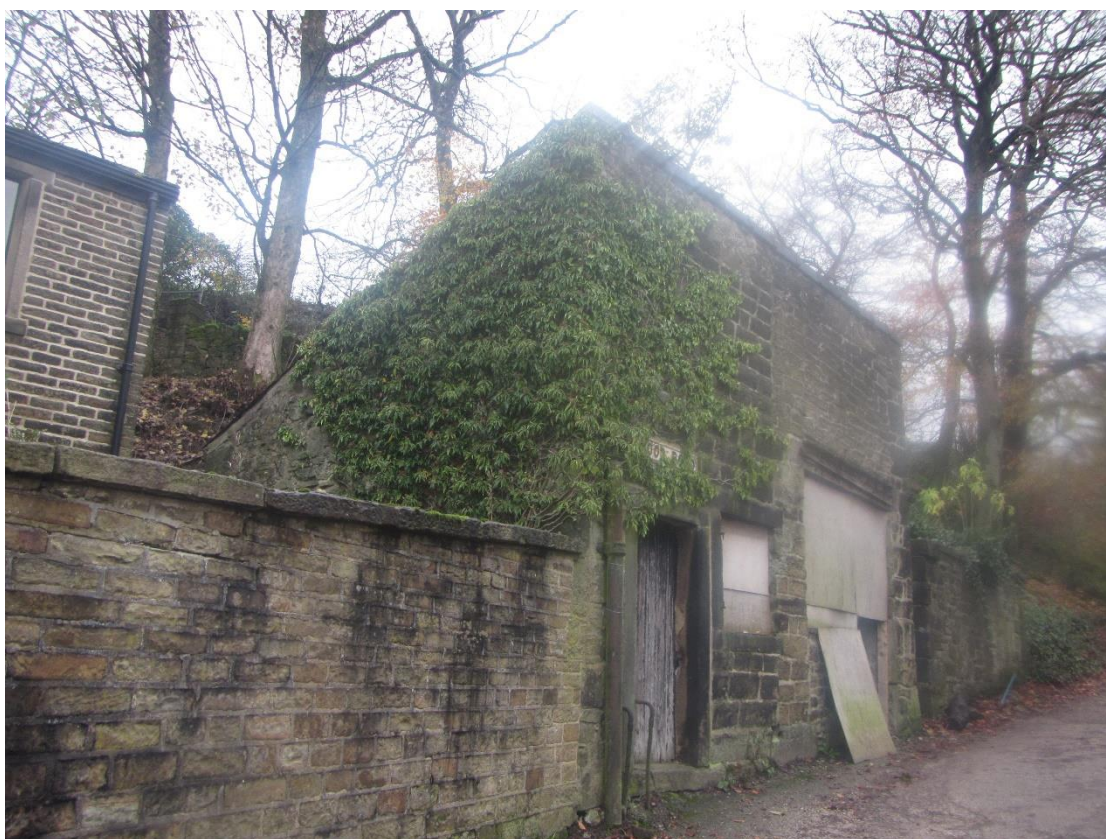
Photograph 4 – South-eastern aspect of Building 2.

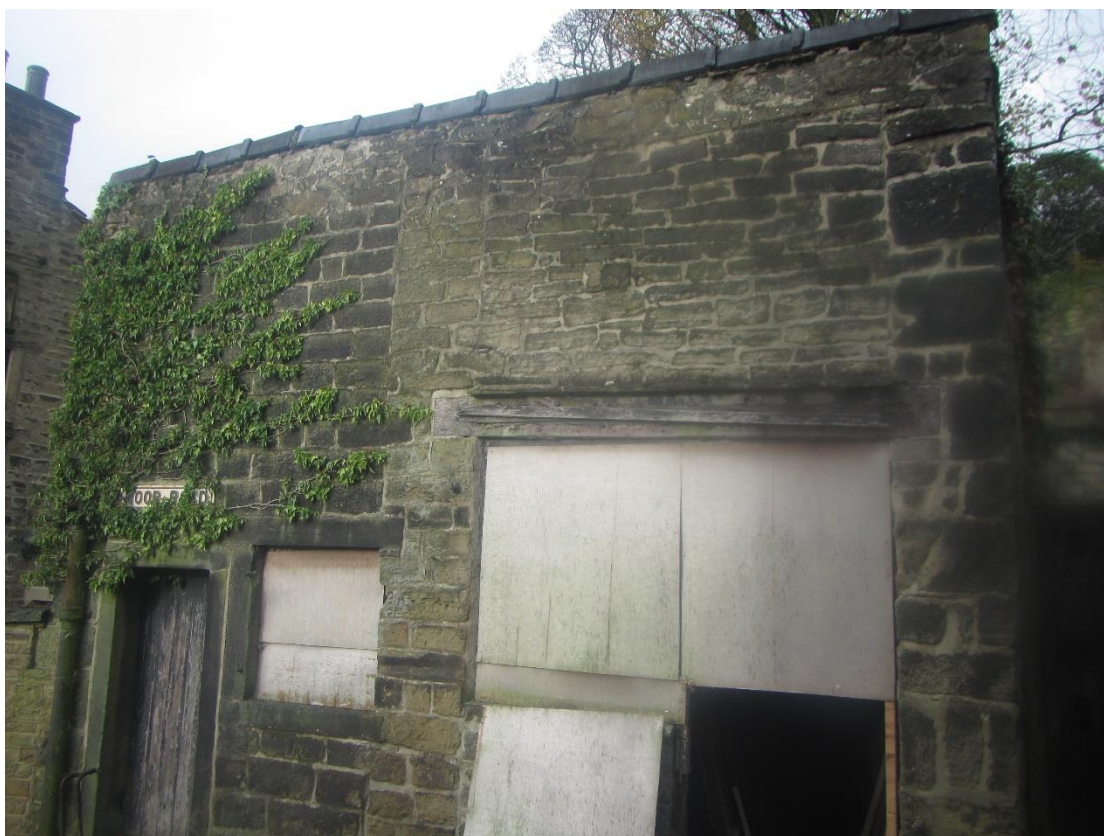
Photograph 5 – Eastern aspect of Building 2.

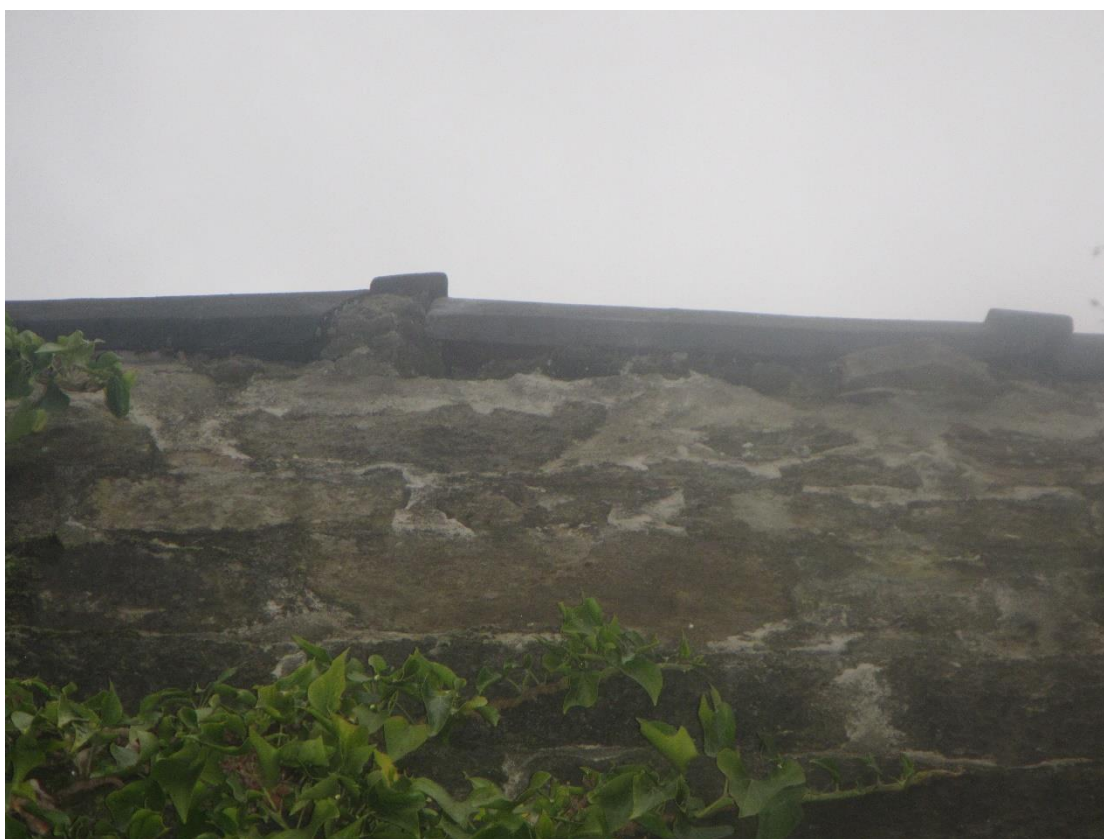
Photograph 6 – Gaps where mortar is missing underneath the ridge tiles on Building 2.

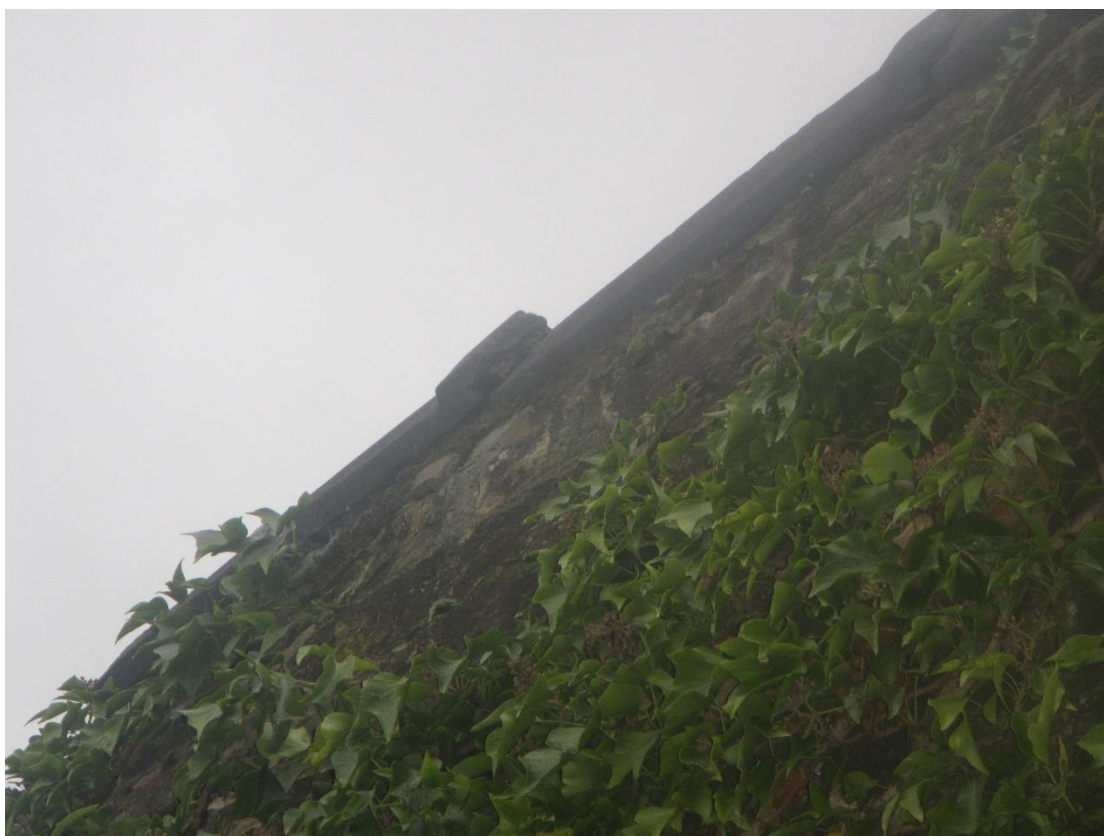
Photograph 7 – Example gap on the ridge tile on Building 2 where mortar is missing.

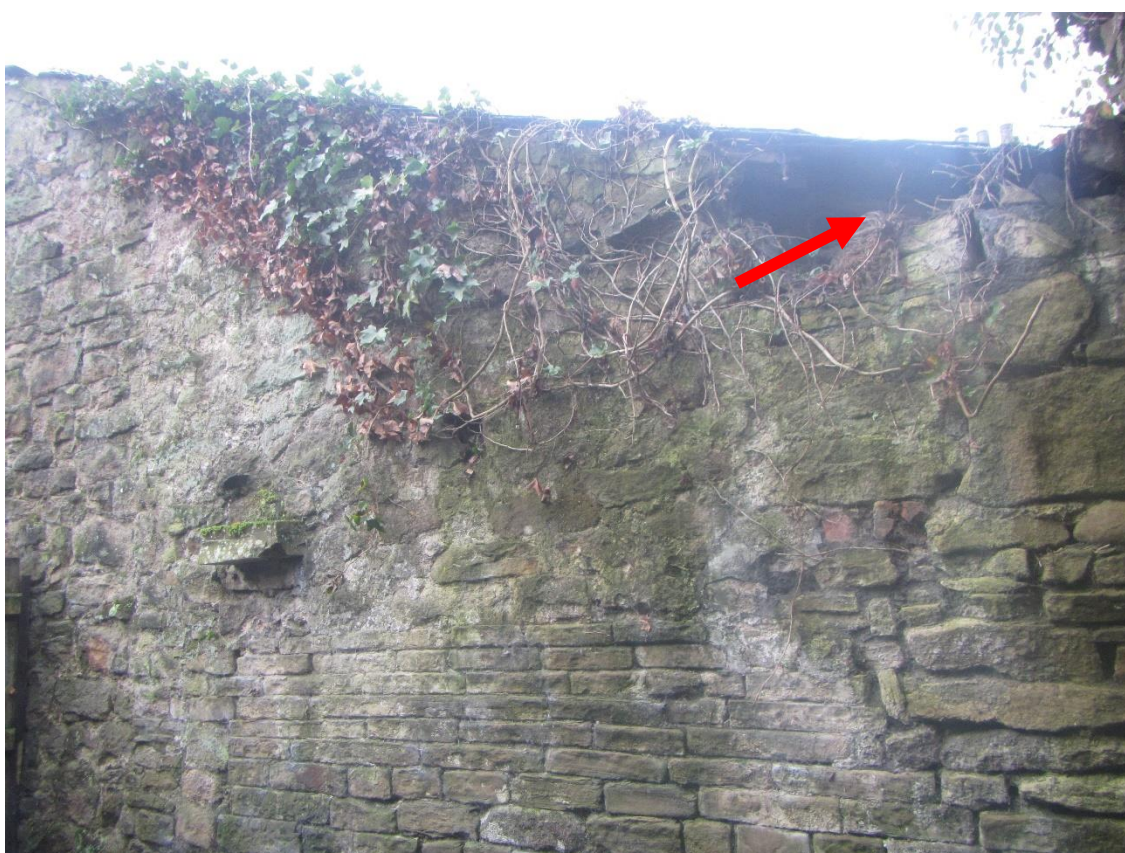
Photograph 8 – The northern aspect of Building 2, view of large gap below tiles where stonework is missing. Arrow pointing to location of a historic bird's nest.

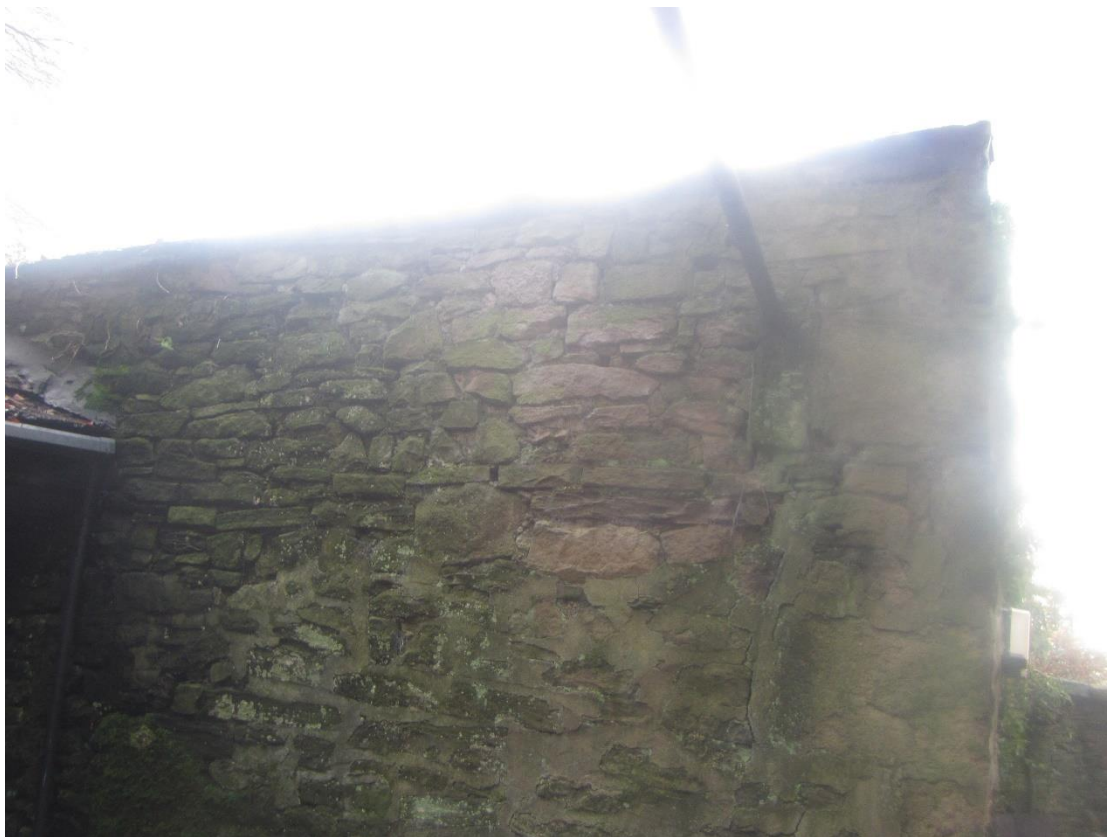
Photograph 9 – Western aspect of Building 2, with several superficial gaps in the stonework.

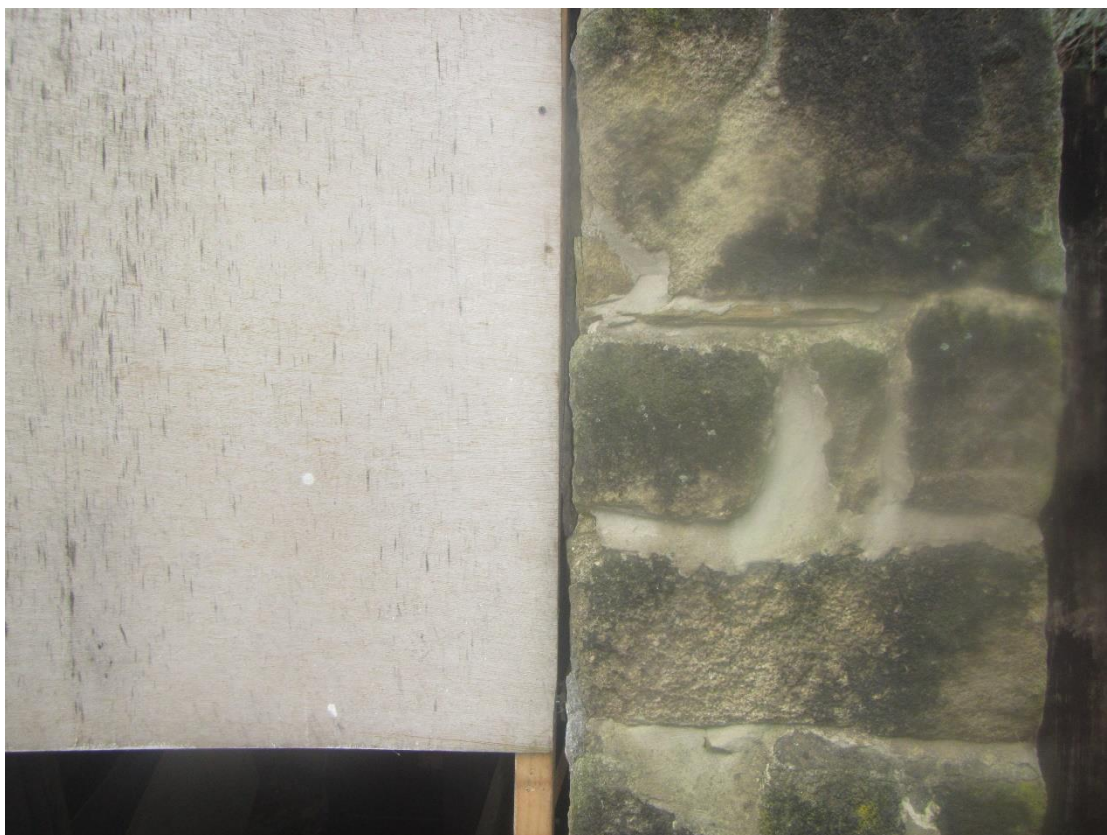
Photograph 10 – Gaps between the stone and MDF boarding on the eastern aspect of Building 2.

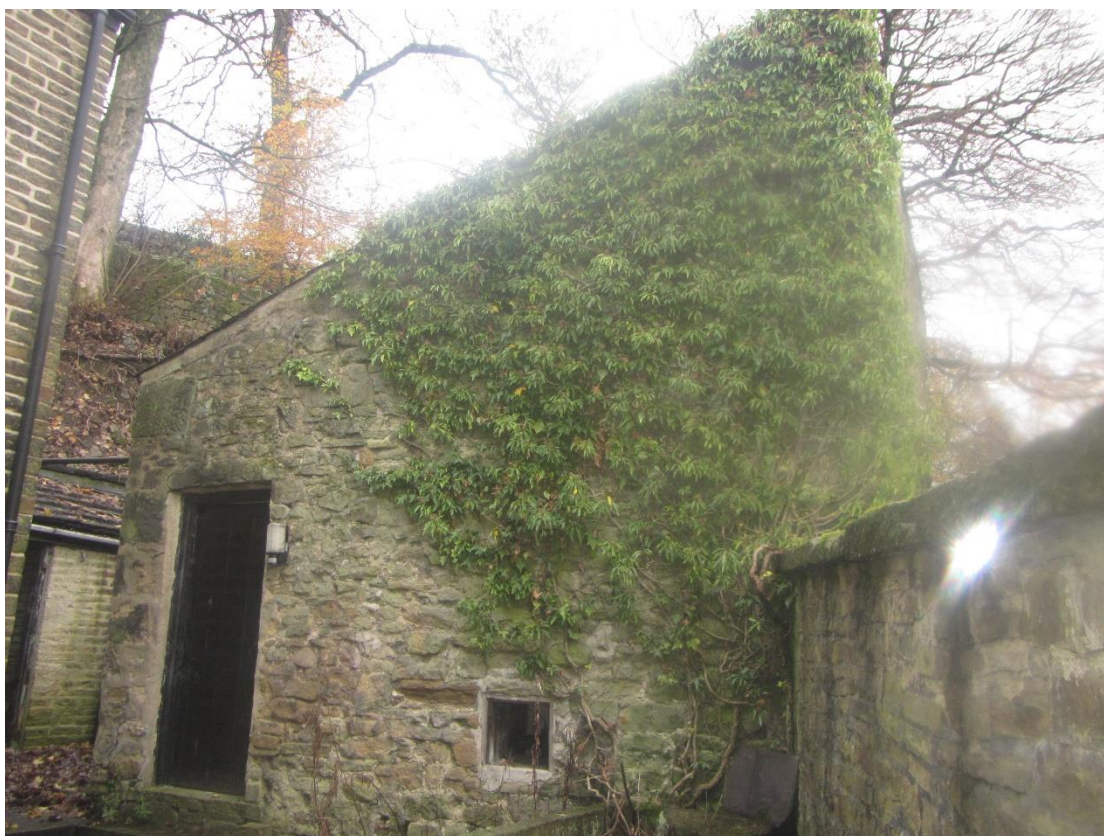
**Building 2** is located along the south-eastern site boundary. The building is constructed from stone and has a sloping mono-pitched roof, (Photographs 4 and 5). The roof is clad with slate roof tiles and there are slate ridge tiles present on the south-eastern aspect of the building (Photograph 4). There are multiple gaps present where the ridge tiles have lifted or are missing mortar, providing access to the wall plate, see Photographs 6 and 7. Visibility to the western aspect of the roof was limited due to the proximity of the surrounding buildings and the height of Building 2. However, a small number of lifted slate roof tiles were noted. The walls are generally in good condition, but there are a small number of gaps present, particularly on the northern and western aspects of the building. On the northern aspect, several stones are missing, creating a large gap and an old bird's nest was noted within the feature, see Photograph 8. On the western aspect of the building, there are several gaps in the stonework where mortar is missing, see Photograph 9. All features on the western aspect of the building were fully inspected with a high-powered torch and found to be superficial. Furthermore, there are several windows present on the south-eastern aspect of the building, which have stone or wooden lintels that are in excellent condition with no PRFs noted. Several of the windows and doorways on the south-eastern aspect have been boarded with MDF and there are numerous gaps around the MDF boarding providing bats potential access into the building (Photograph 10). Finally, there is also a doorway on the south-western aspect of the building, which is constructed from wood, but this is tightly sealed and in excellent condition, see Photograph 11.

Photograph 11 – South-western aspect of Building 2.

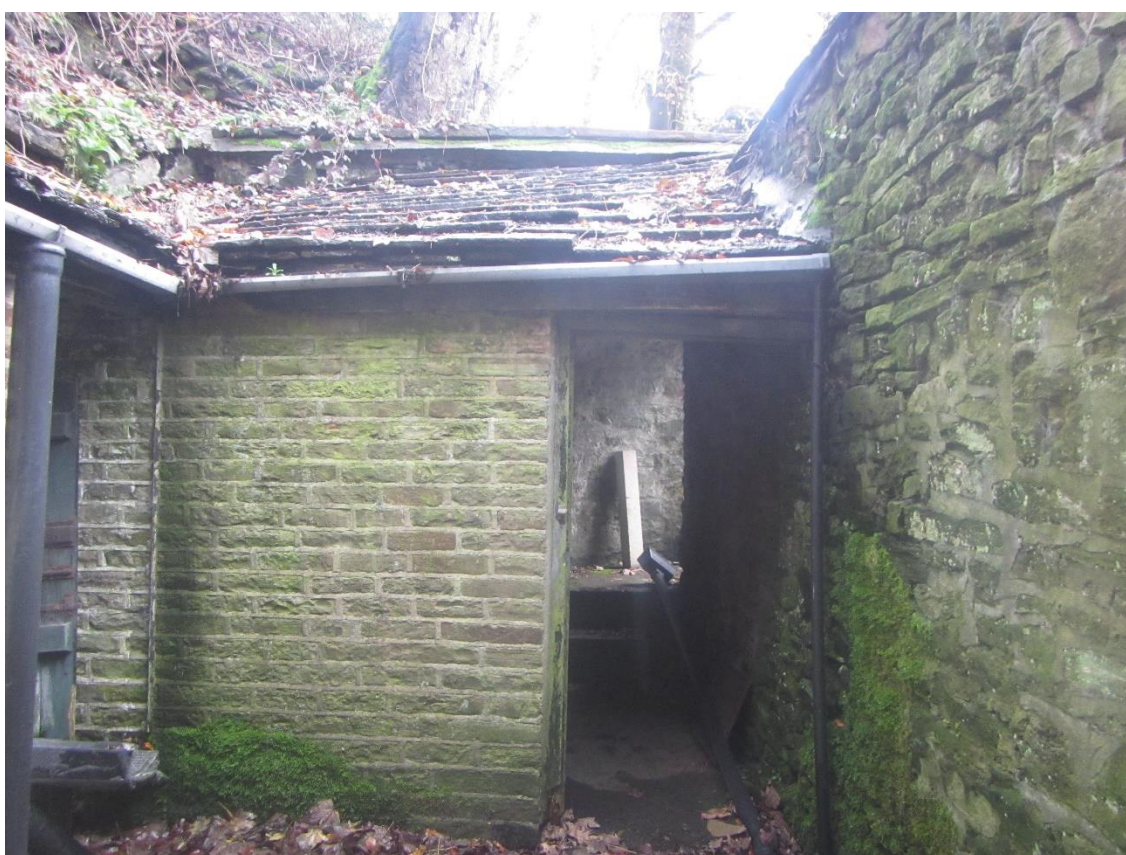
**Building 3** is a stone-built outbuilding which attached to the north-western aspect of Building 2. The building has a shallow mono-pitched roof which is clad with stone roof and ridge tiles (Photograph 12) and there are several gaps where mortar is missing from under the roof and ridge tiles. The stonework is generally in good condition, however there are several gaps near the apex of the wall on the eastern aspect of the building, see Photographs 13 and 14. However, the gaps are relatively large and as such are considered to be more suitable for nesting birds rather than roosting bats. The building also has two open doorways on the south-western and eastern aspects, allowing bats access into the building.

Photograph 12 – Southern aspect of Building 3.

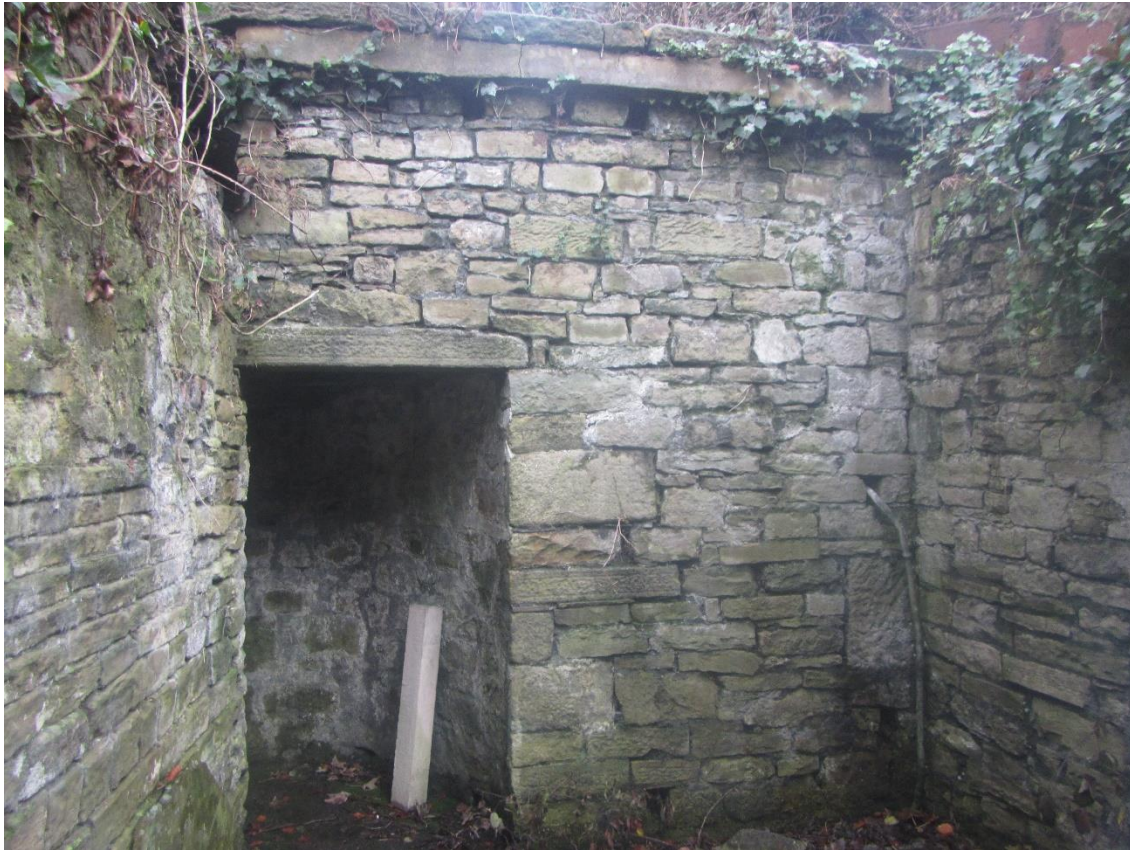
Photograph 13 – Eastern aspect of Building 3.

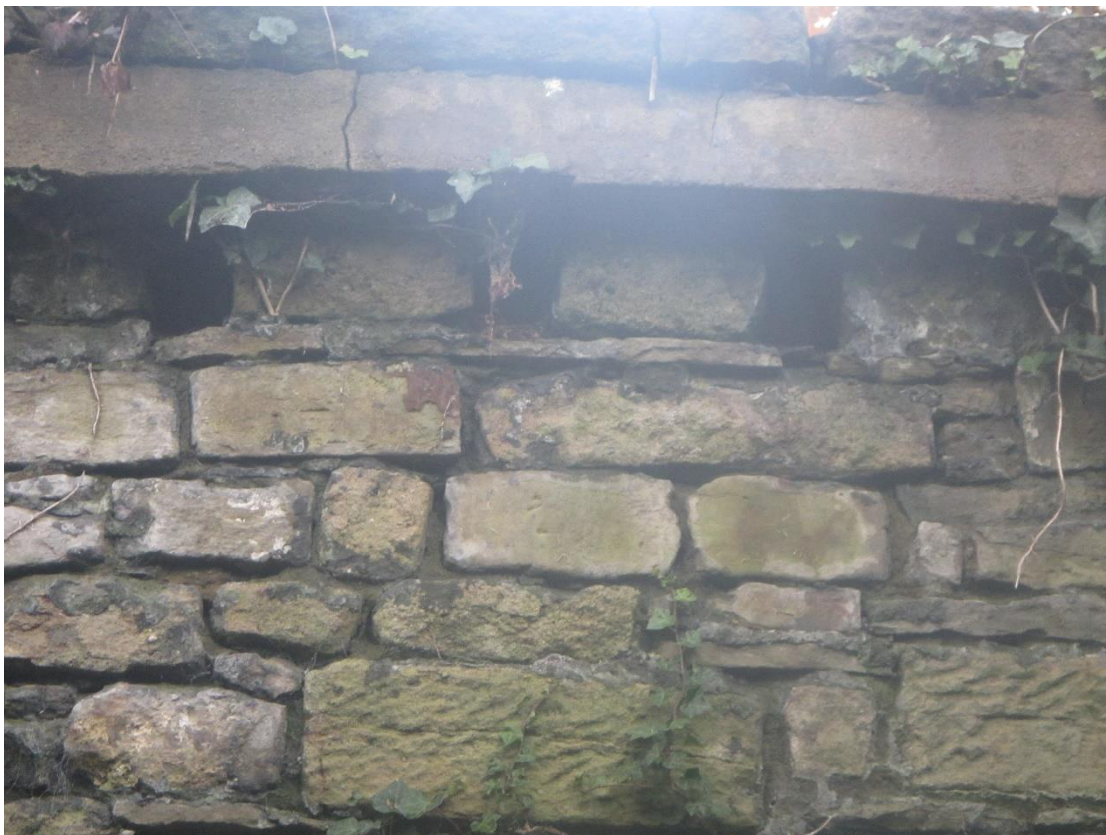
Photograph 14 – Close view of the large gaps at the apex of the wall on the eastern aspect of Building 3.

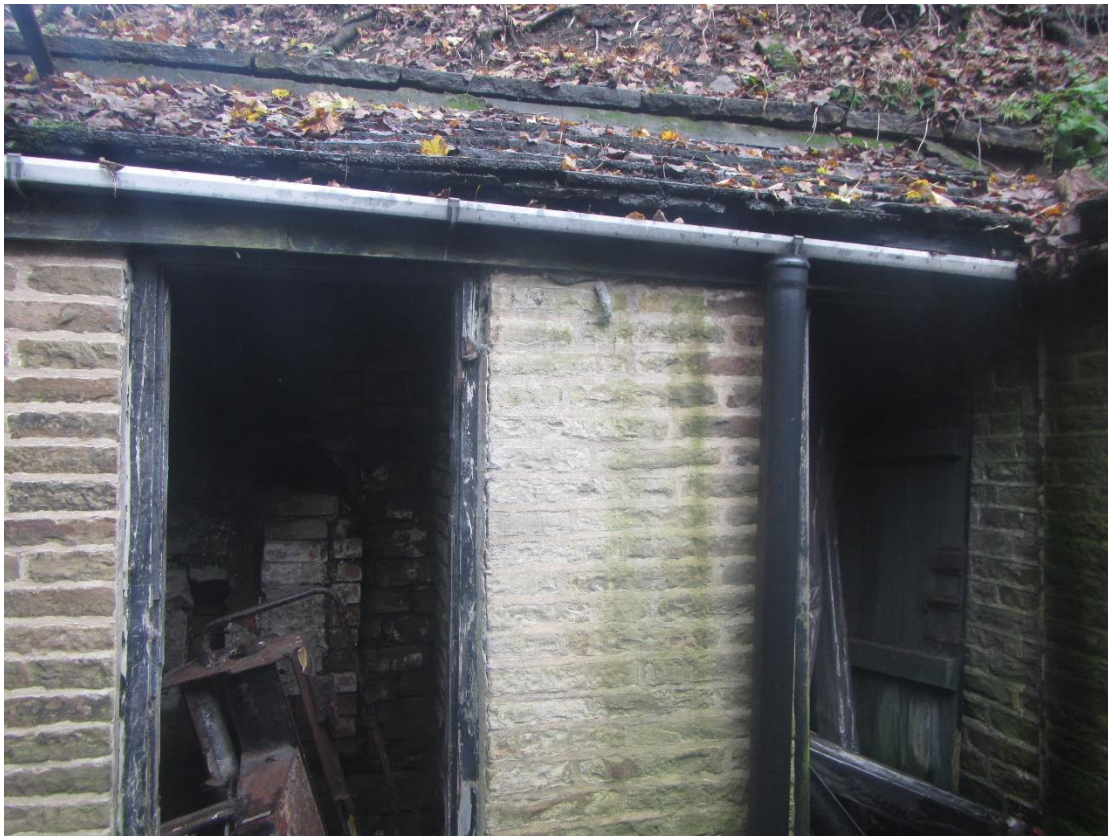
Photograph 15 – Eastern aspect of Building 4.

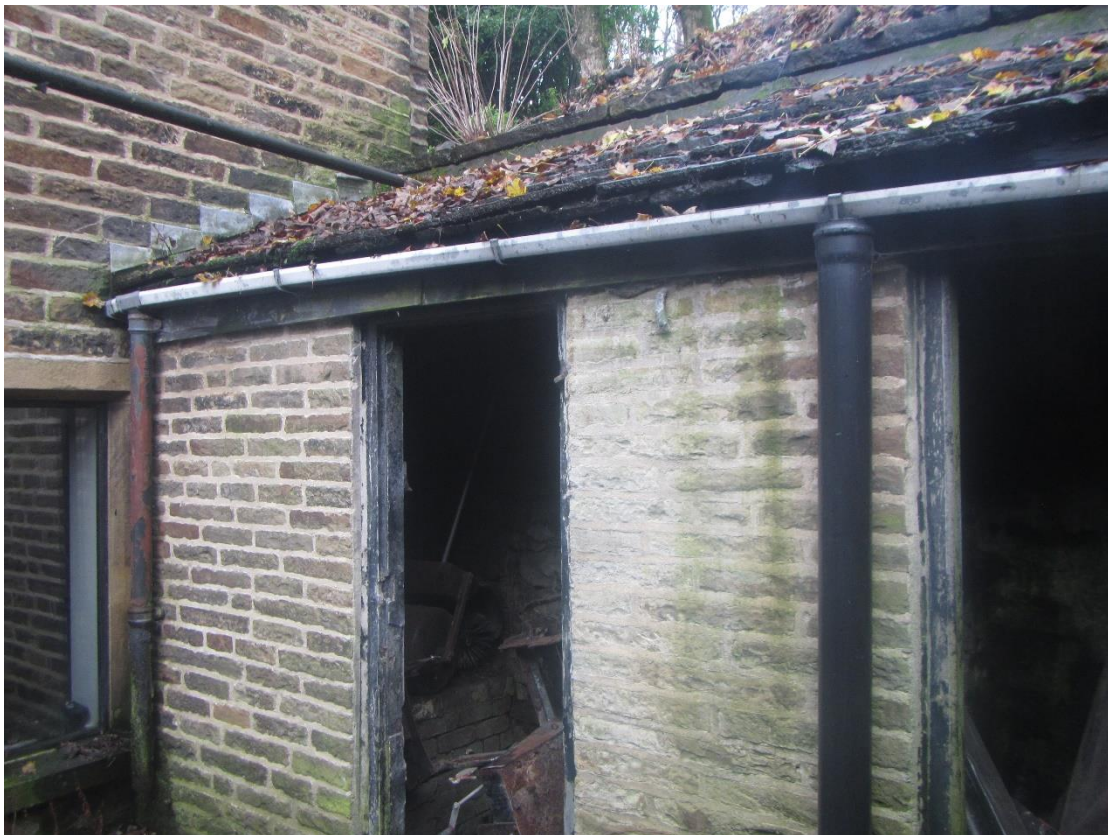
Photograph 16 – View of lead flashing on the eastern aspect of Building 4.

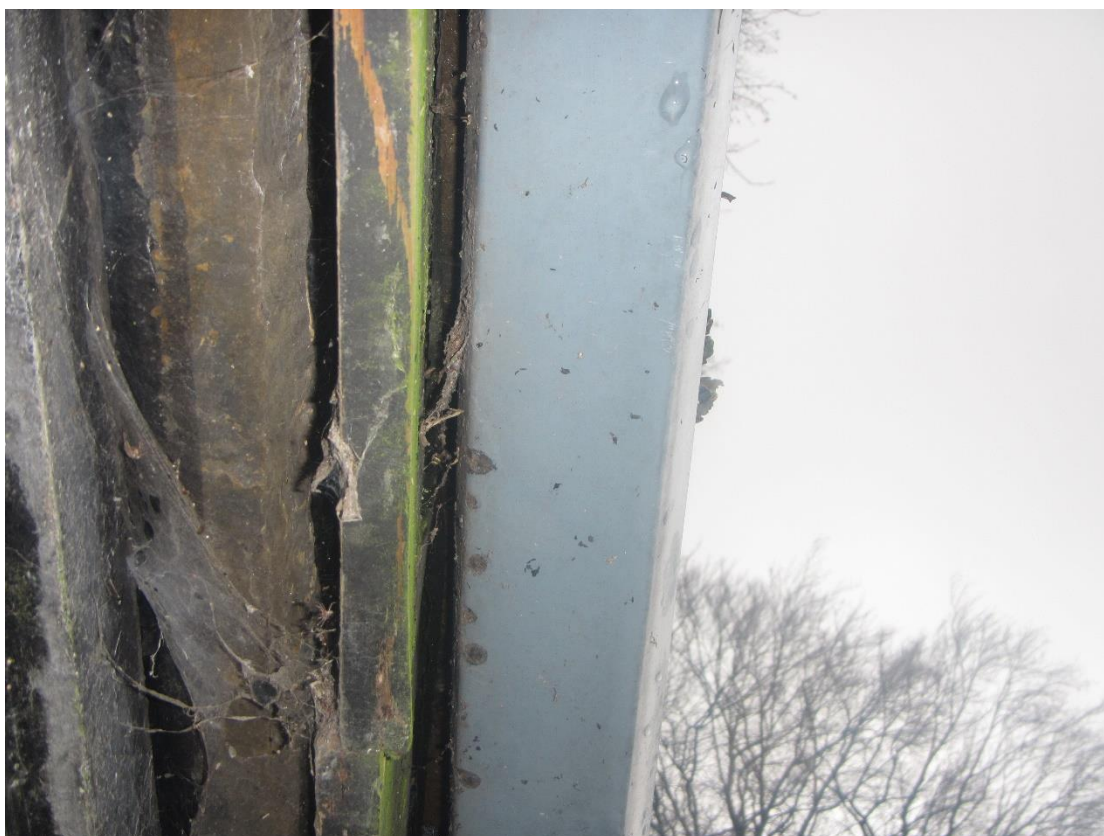
Photograph 17 – Gap between the wooden barge board and the wall on Building 4.

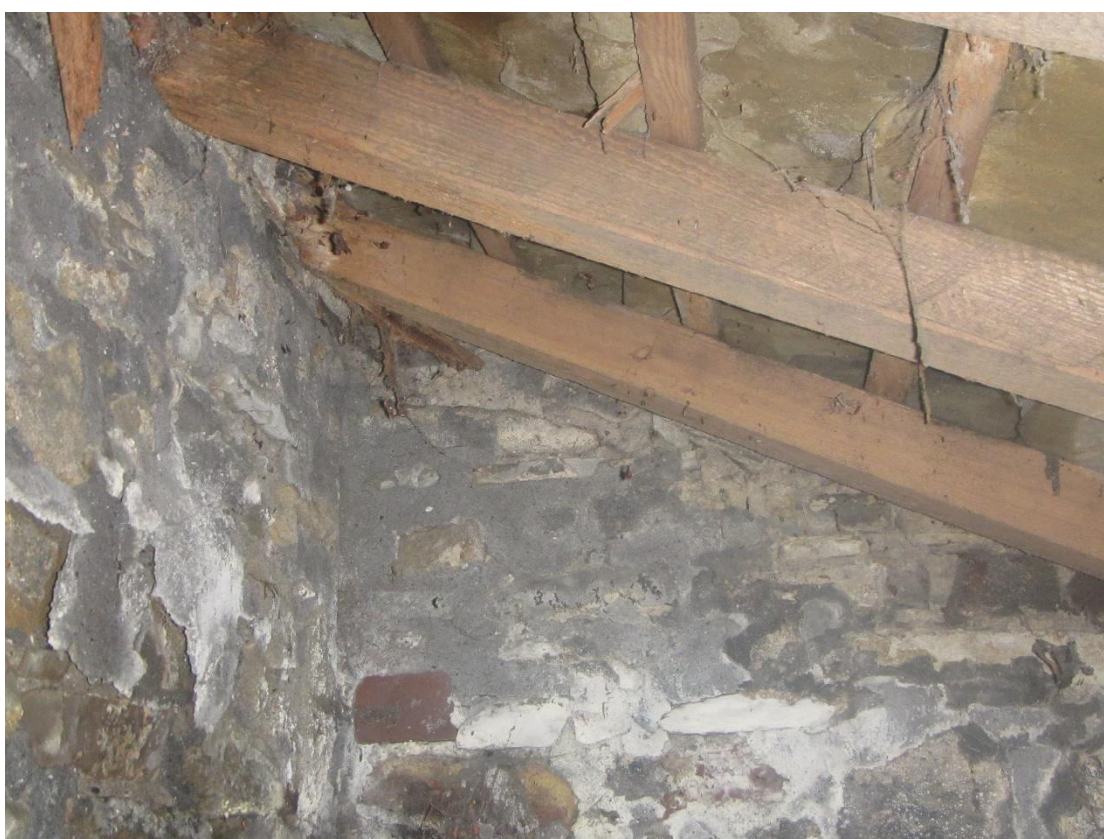
**Building 1** has no loft void. The roof is a traditional purlin rafter construction, constructed from wooden beams and is unlined (Photograph 18). The roof is in good condition, but there are several gaps between the roof tiles, but these were inspected with an endoscope and no

Photograph 18 – Internal view of Building 1.

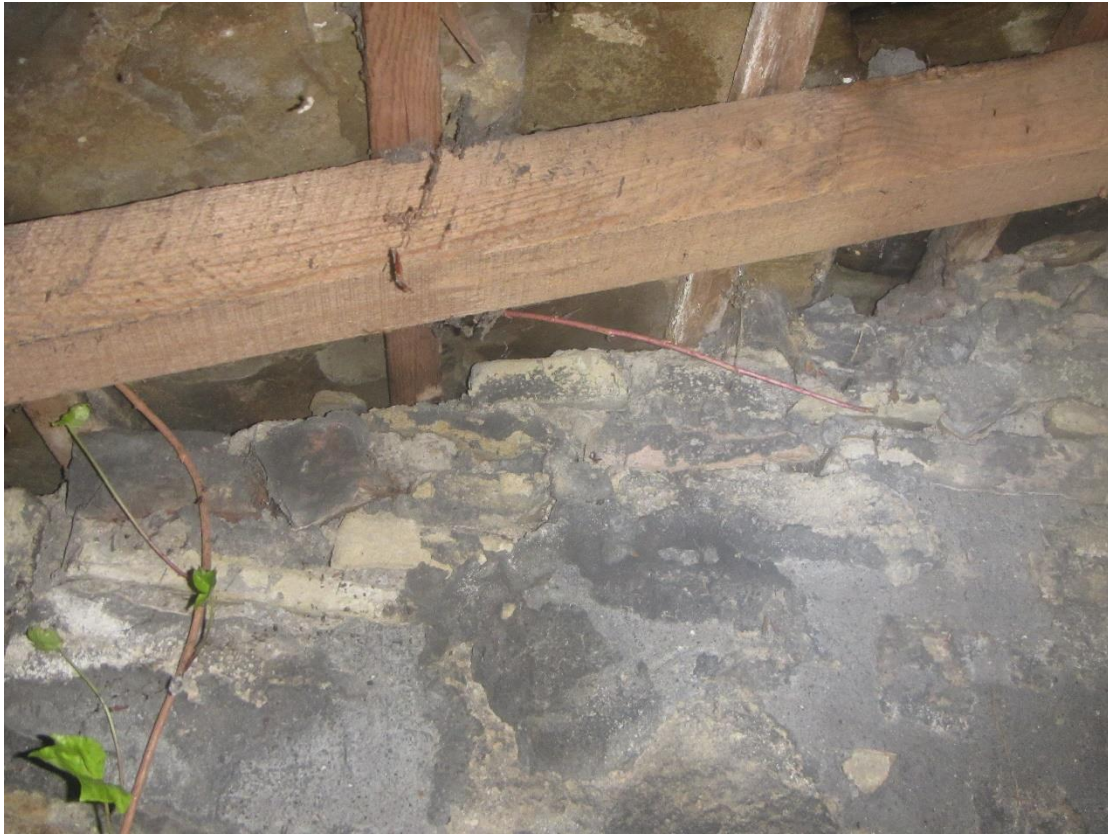
evidence of roosting bats was recorded. Furthermore, additional gaps are present above the wall plate, see Photograph 19, but these gaps were also inspected using an endoscope and no evidence of roosting bats was recorded, but many of the features could not be fully inspected. The stone walls within the building are in good condition with no PRFs recorded.

Photograph 19 – Example gaps above the wall plate within Building 1.

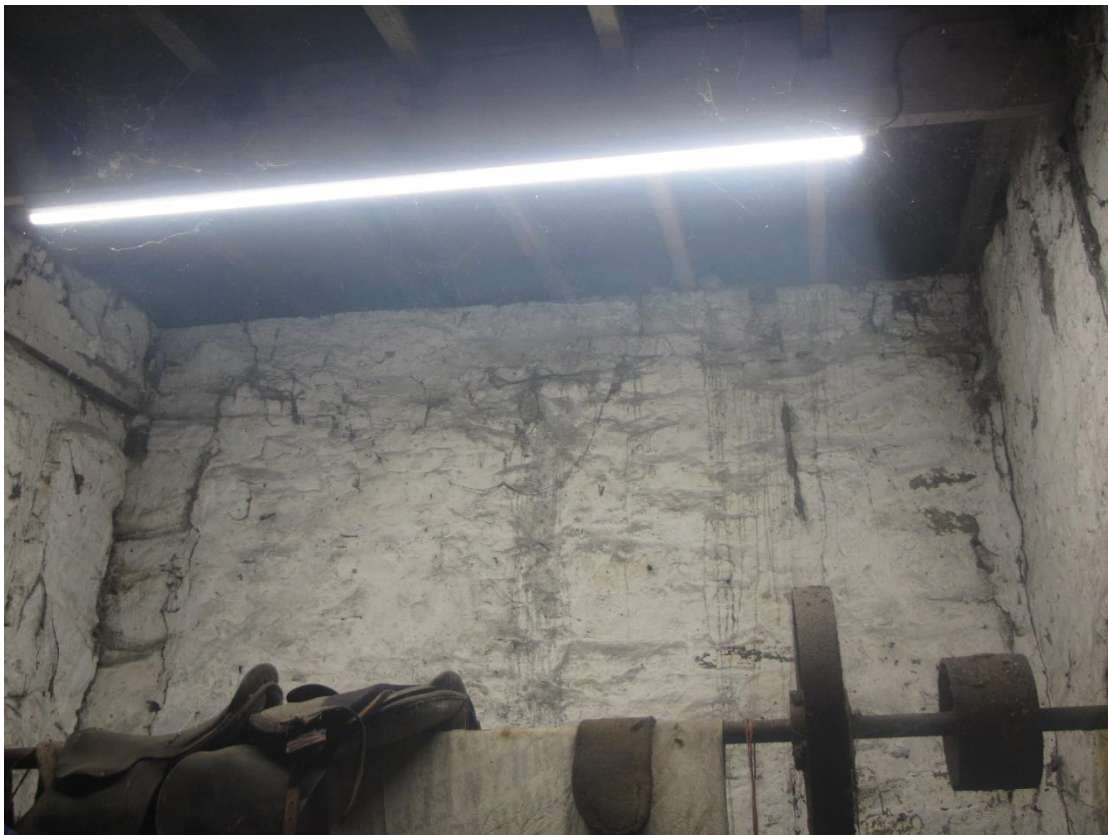
Section A has a typical wooden purlin rafter design, and the roof is lined with bitumen roofing felt creating additional PRFs between the roofing felt and roof tiles (Photograph 20). The walls within the building are generally in good condition, however there are several gaps present along the wall plate and there are gaps between the end rafter and stone wall (Photograph 21). Furthermore, there is one large crack in the stonework on the northern aspect of the building (Photograph 22). The crack was inspected and extended approximately 40cm into the wall, providing a suitable roosting feature for bats, although no evidence was recorded. Furthermore, one historic birds' nest was noted within the building (Photograph 23).

Photograph 20 – Internal view of Section A within Building 2.

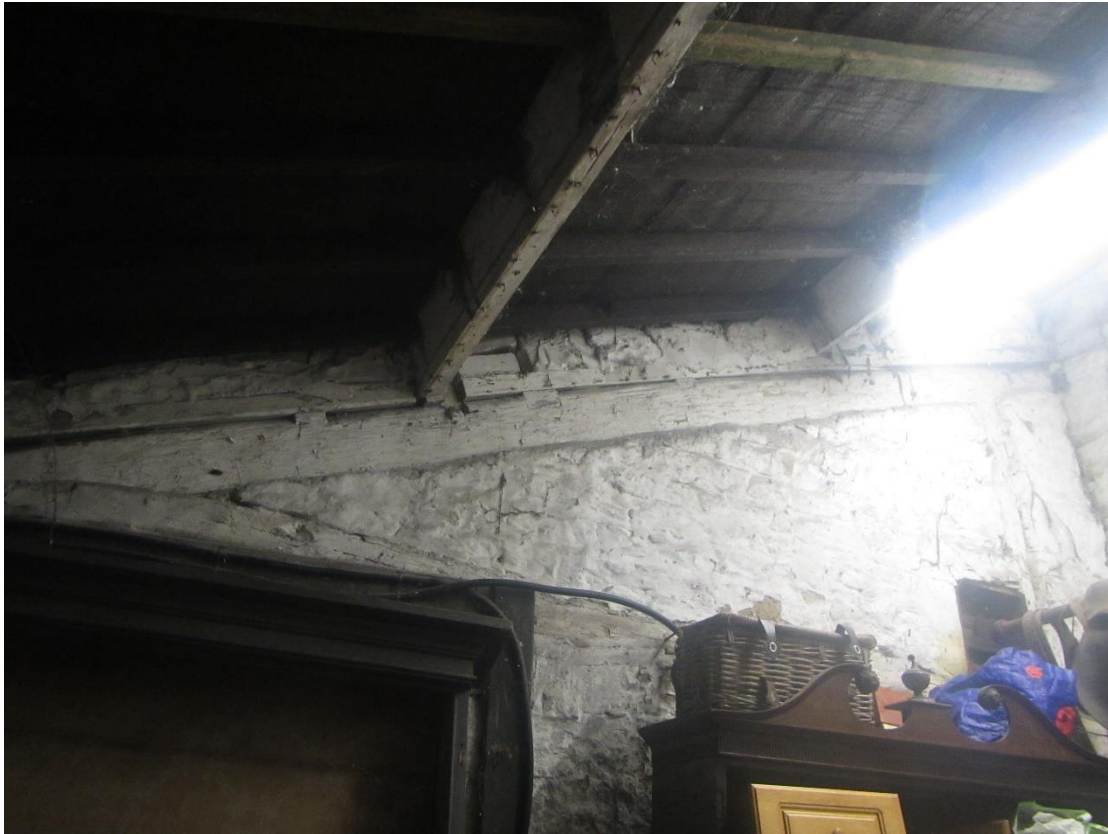
Photograph 21– Internal view of Section A within Building 2.

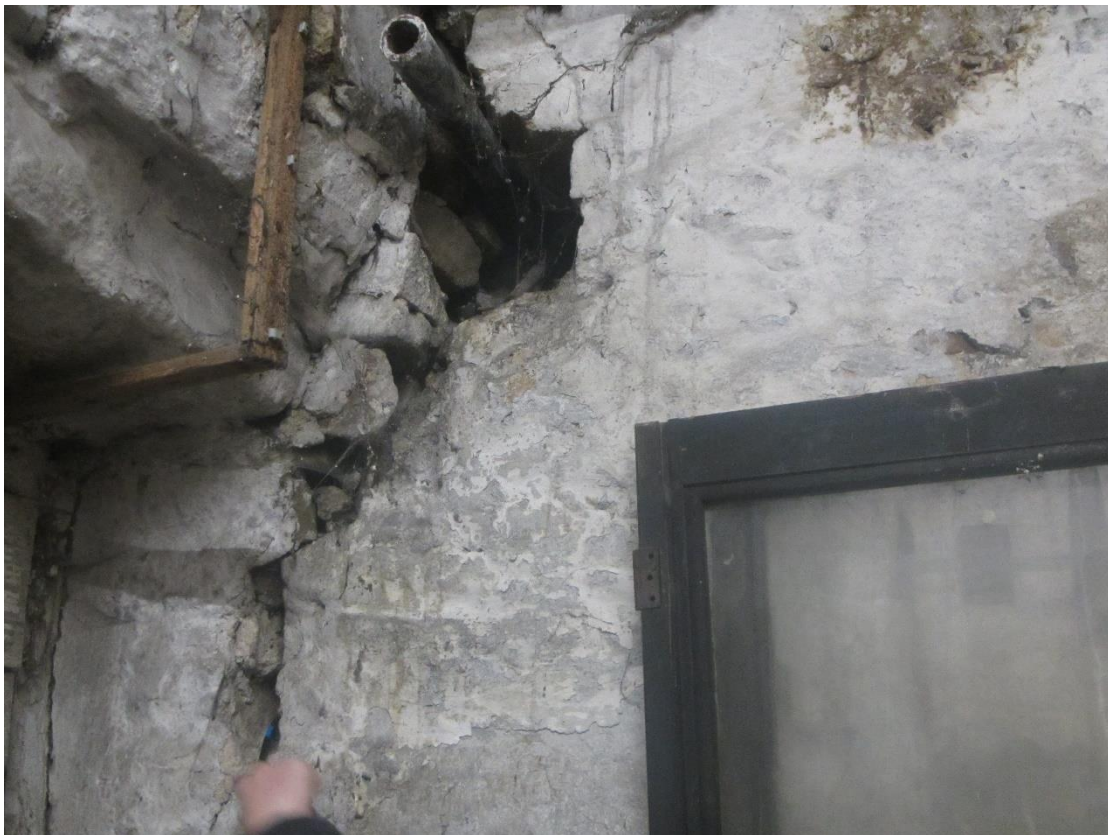
Photograph 22 – Large crack in the stonework identified during the internal inspection within Section A of Building 2.
