## **BAT PRESENCE / ABSENCE SURVEY**

**Higher House**

Moor Road  
Holcombe  
BL8 4NX

| UES reference: | UES03580/01 |

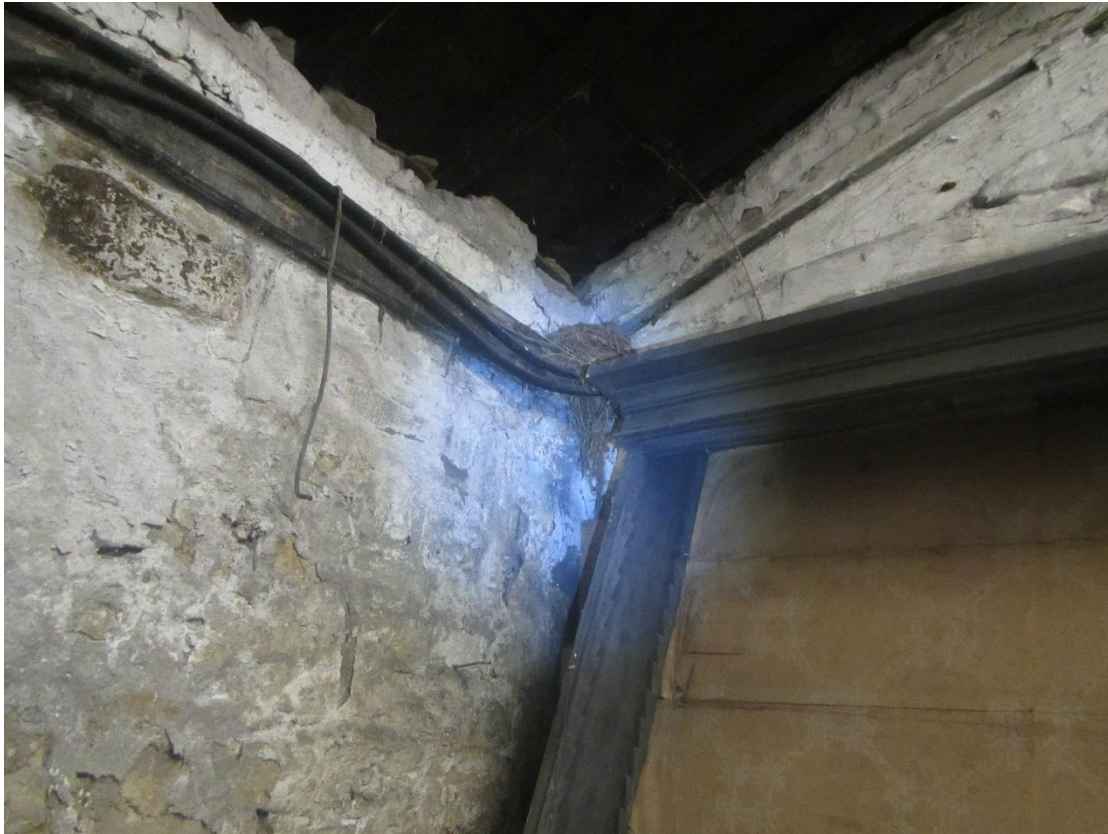
Photograph 23 – Birds nest located within Section A of Building 2.

Due to the potential presence of breeding birds in the buildings on site, it is recommended that the initial site clearance (including vegetation) and demolition works take place outside of the breeding bird season and should not be undertaken from March to August inclusive. If this is not possible, a breeding bird nest survey should be undertaken prior to the commencement of works by a suitably experienced ecologist and an ecological clerk of works appointed if considered necessary.

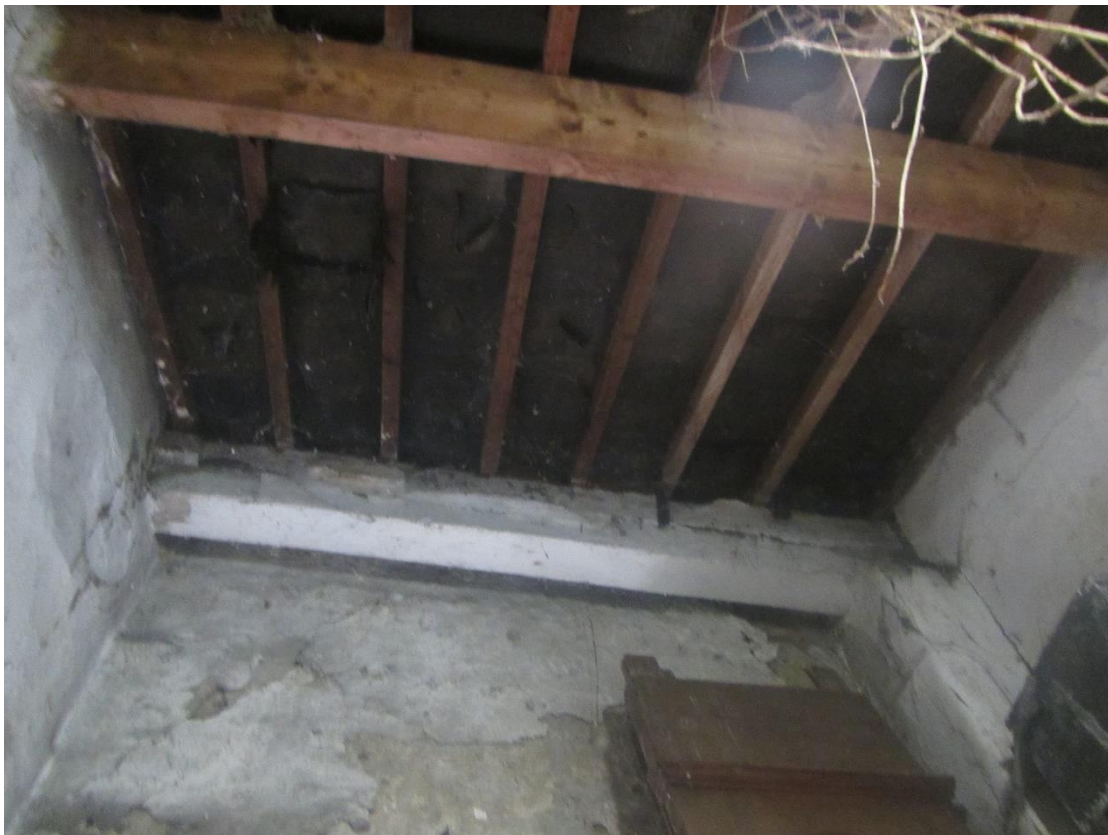
Section B is similar in design and construction, and the roof is also lined with bitumen roofing felt, see Photographs 24 and 25. Furthermore, there are additional access points into the building due to the gaps around the windows and doors. The walls within Section B have been rendered and are in excellent condition with no PRFs identified, although gaps are still present along the wall plate. Furthermore, one bird's nest was recorded within the building (Photograph 26).

Photograph 24 – Internal view of roof within Section B of Building 2.

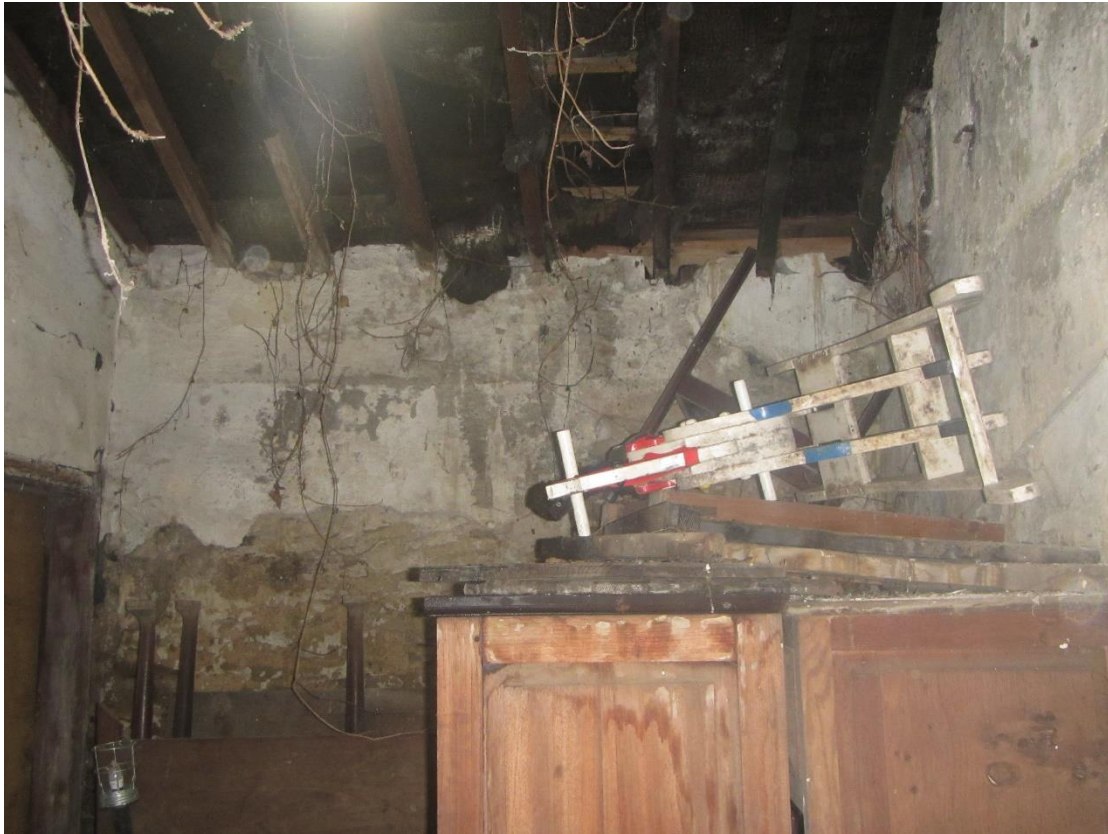
Photograph 25 – Internal view of Section B within Building 2.

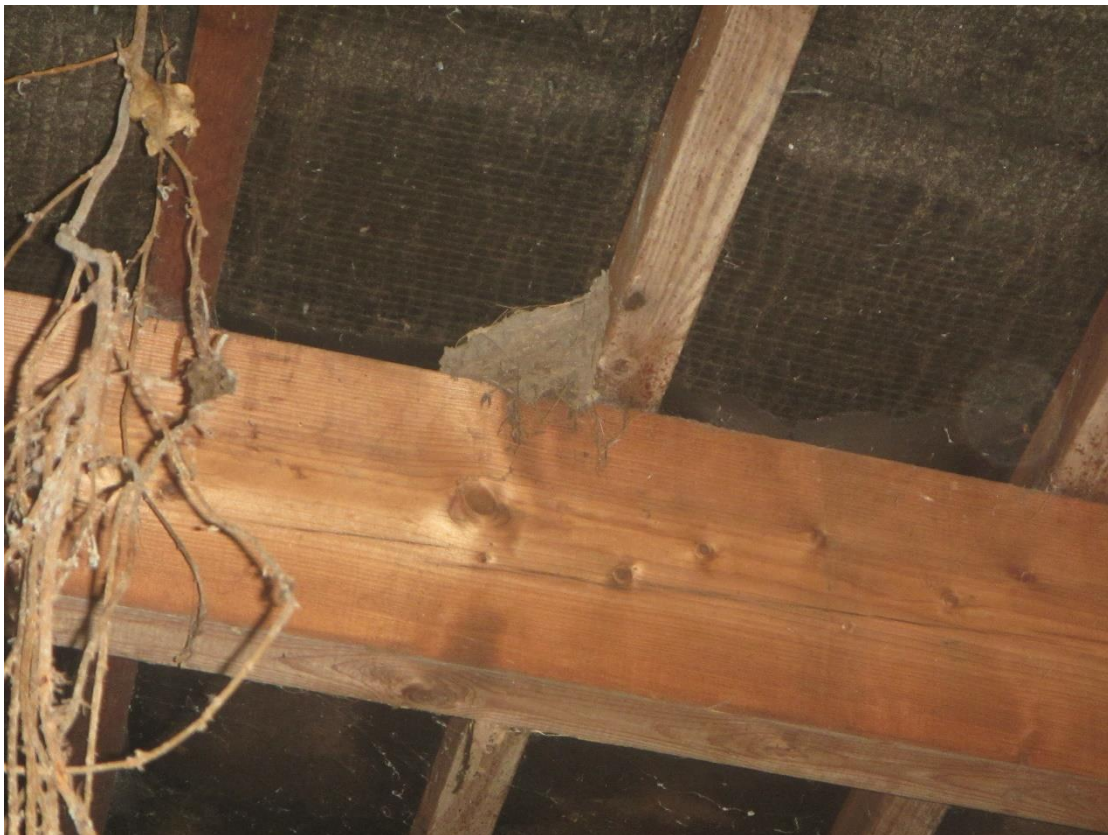
Photograph 26 – Birds nest within Section B of Building 2.

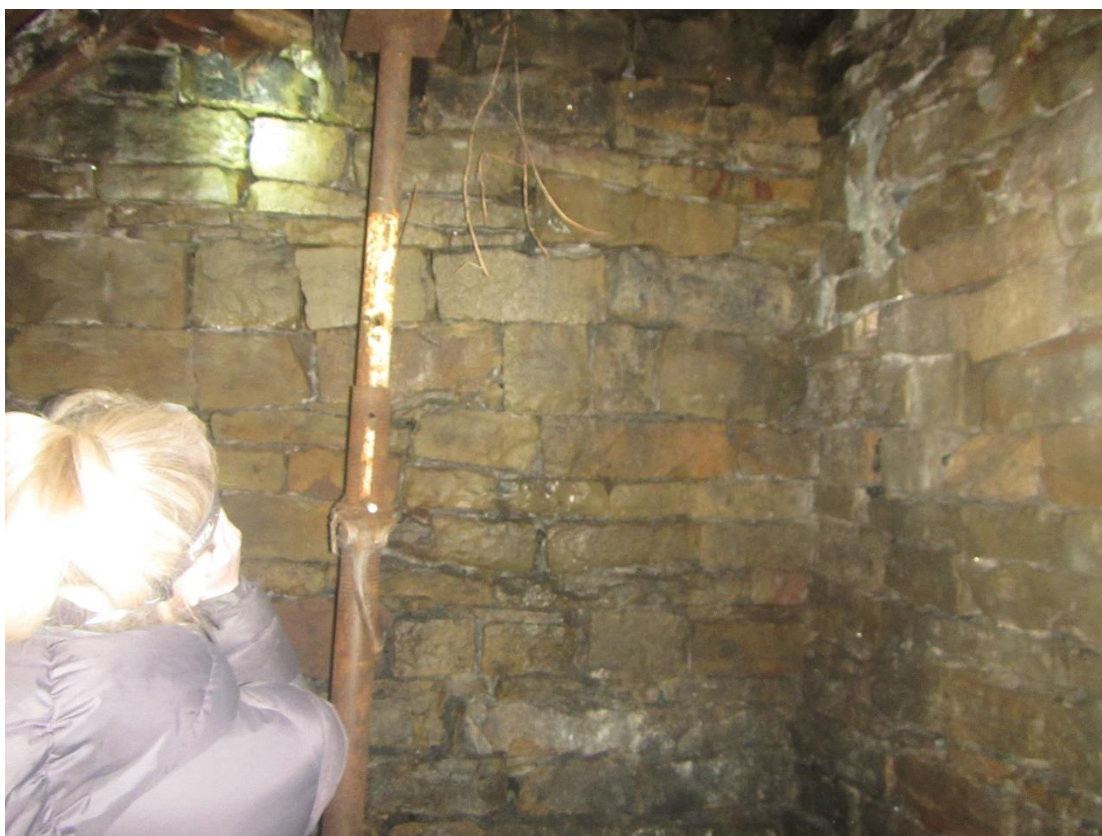
**Buildings 3** has no loft void and due to the absence of doors, the building is extremely draughty. The roof is a typical wooden purlin rafter design, but it is in poor condition and the roof has partially collapsed and is currently supported via steel supports (Photograph 27). However, the intact sections of the roof are partially lined with bitumen felt, which is in poor condition with numerous rips present (Photograph 28). Furthermore, there are several gaps in the brickwork, but these were inspected with a high-powered torch and the majority were found to be superficial (Photograph 29). Due to the partially collapsed roof, the building is extremely damp and there is significant water ingress, reducing the suitability of the building for roosting bats.

Photograph 27 – View of steel support within Building 3.

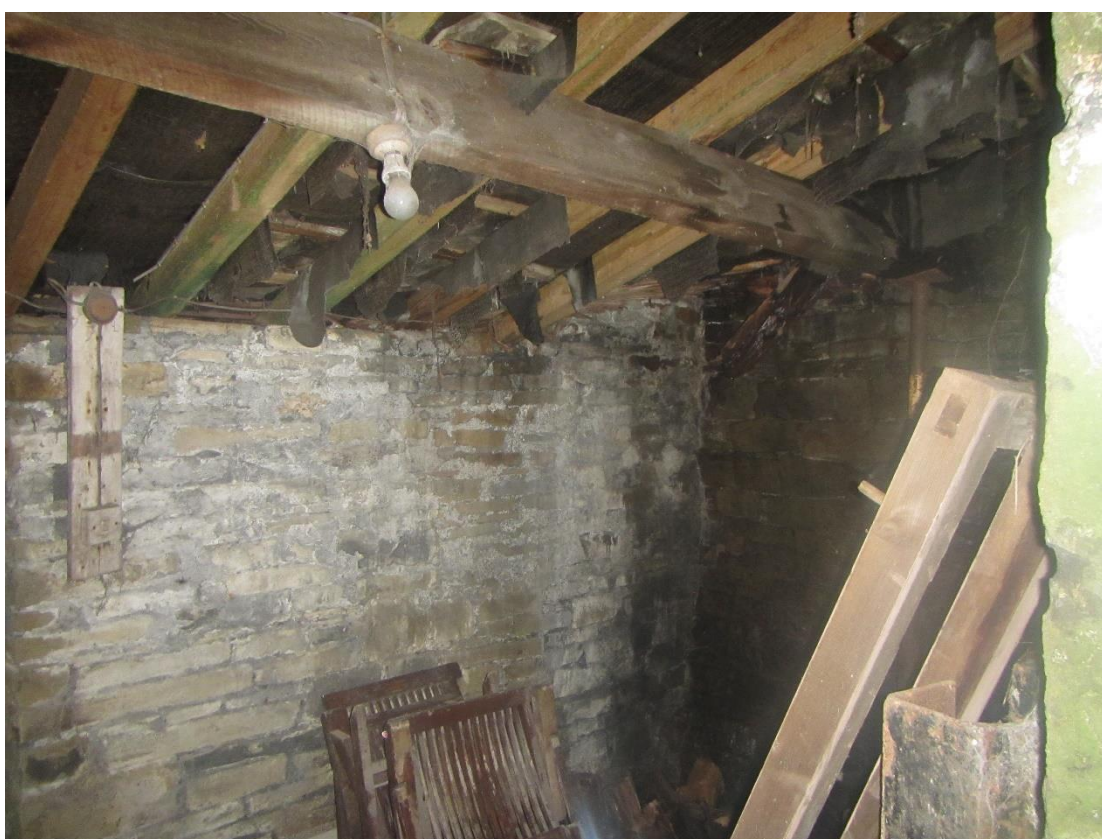
Photograph 28 – Internal view within Building 3.

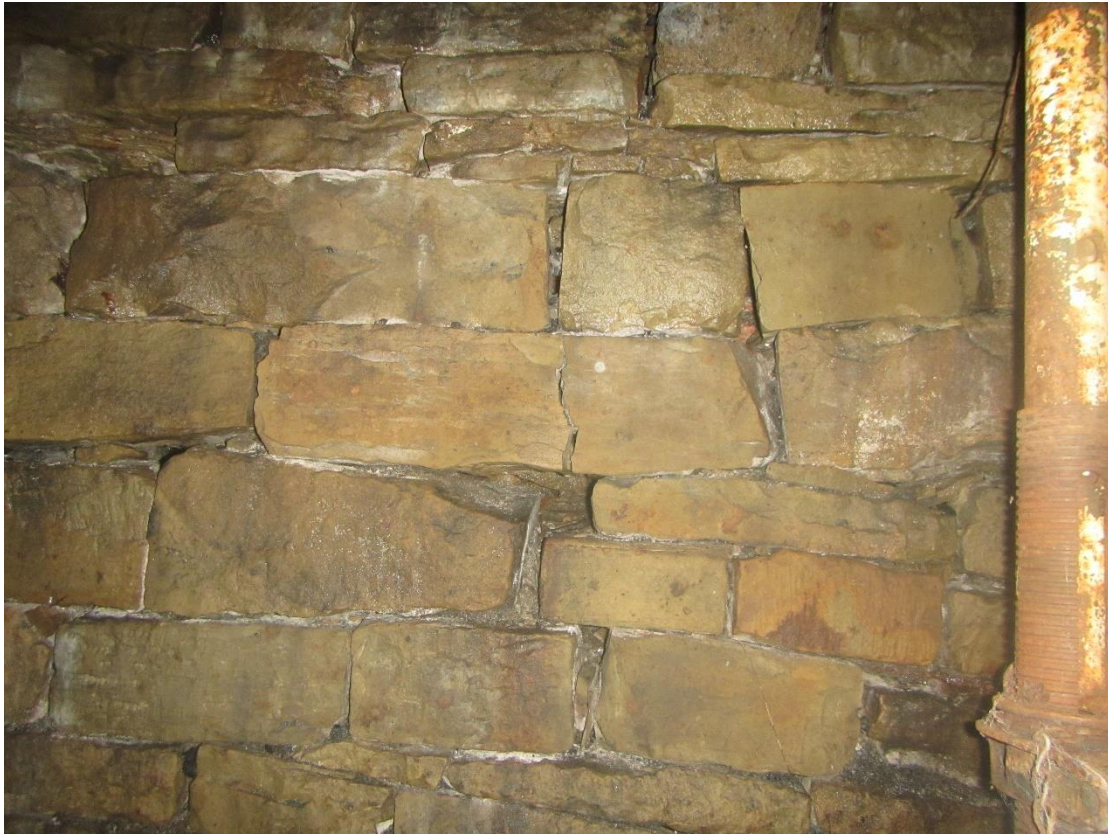
Photograph 29 – Gaps in the stonework within Building 3.

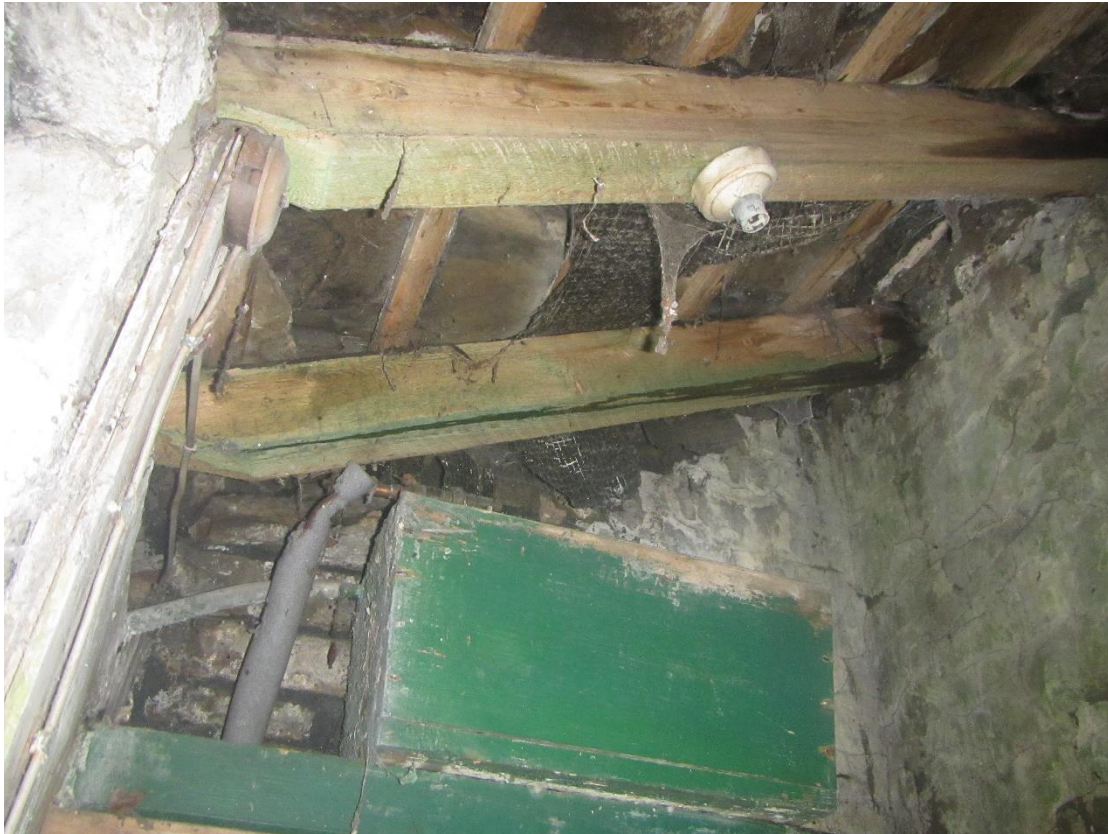
**Building 4** has no loft void and has been split into two small rooms. The roof within both rooms is a typical purlin rafter design and is lined with bitumen roofing felt (Photograph 30), creating PRFs between the roof tiles and roofing felt. Furthermore, gaps were noted along the wall plate and between the end rafter and stone wall. The stonework within the building is in good condition with no PRFs noted.

Photograph 30 – Internal view of Building 4.

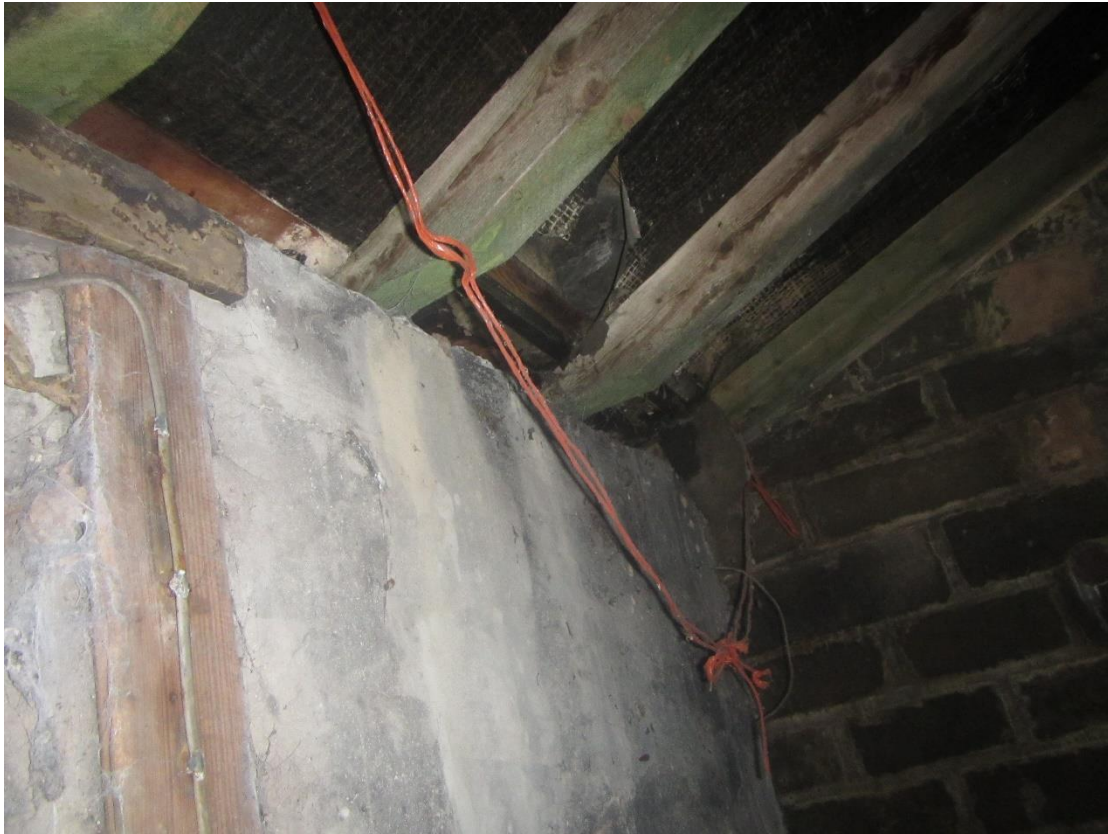
Photograph 31 – Internal view within Building 4, gaps above the wall plate.
