**CONSTRUCTION TRAFFIC  
MANAGEMENT PLAN (CTMP)  
IN RELATION TO CONDITION 31 OF  
PLANNING REF:71426/24**

**Land adjacent to Bealey Industrial Estate,  
Dumers Lane, Radcliffe**

**April 2026**

# **HIGHWAY DILAPIDATION SURVEY**

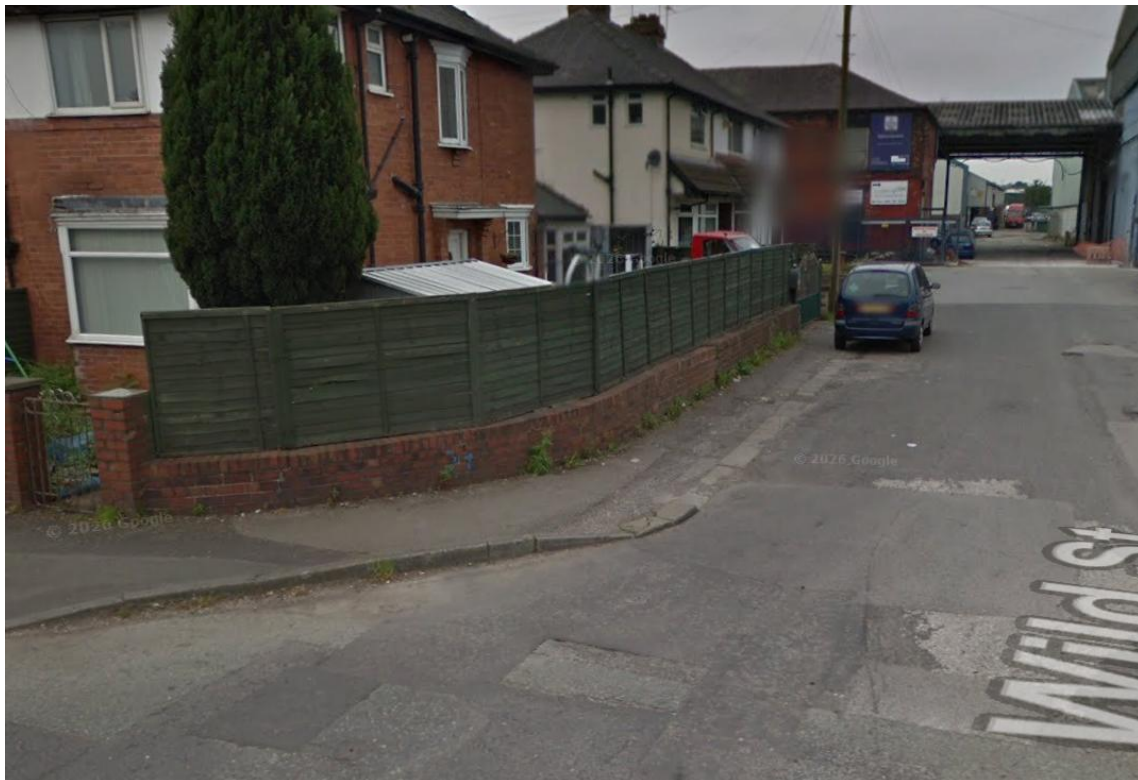
Fig 4: Southern edge of Wild Street with demarked pedestrian route but now kerb upstand to differentiate for vehicles

Temporary signage will be employed to encourage pedestrians to use this as a route. This will be monitored by the site management team and if an alternative pedestrian access on the northern edge of the Wild Street corridor, this will be provided with a suitably safe and level hard surface, with associated signage.

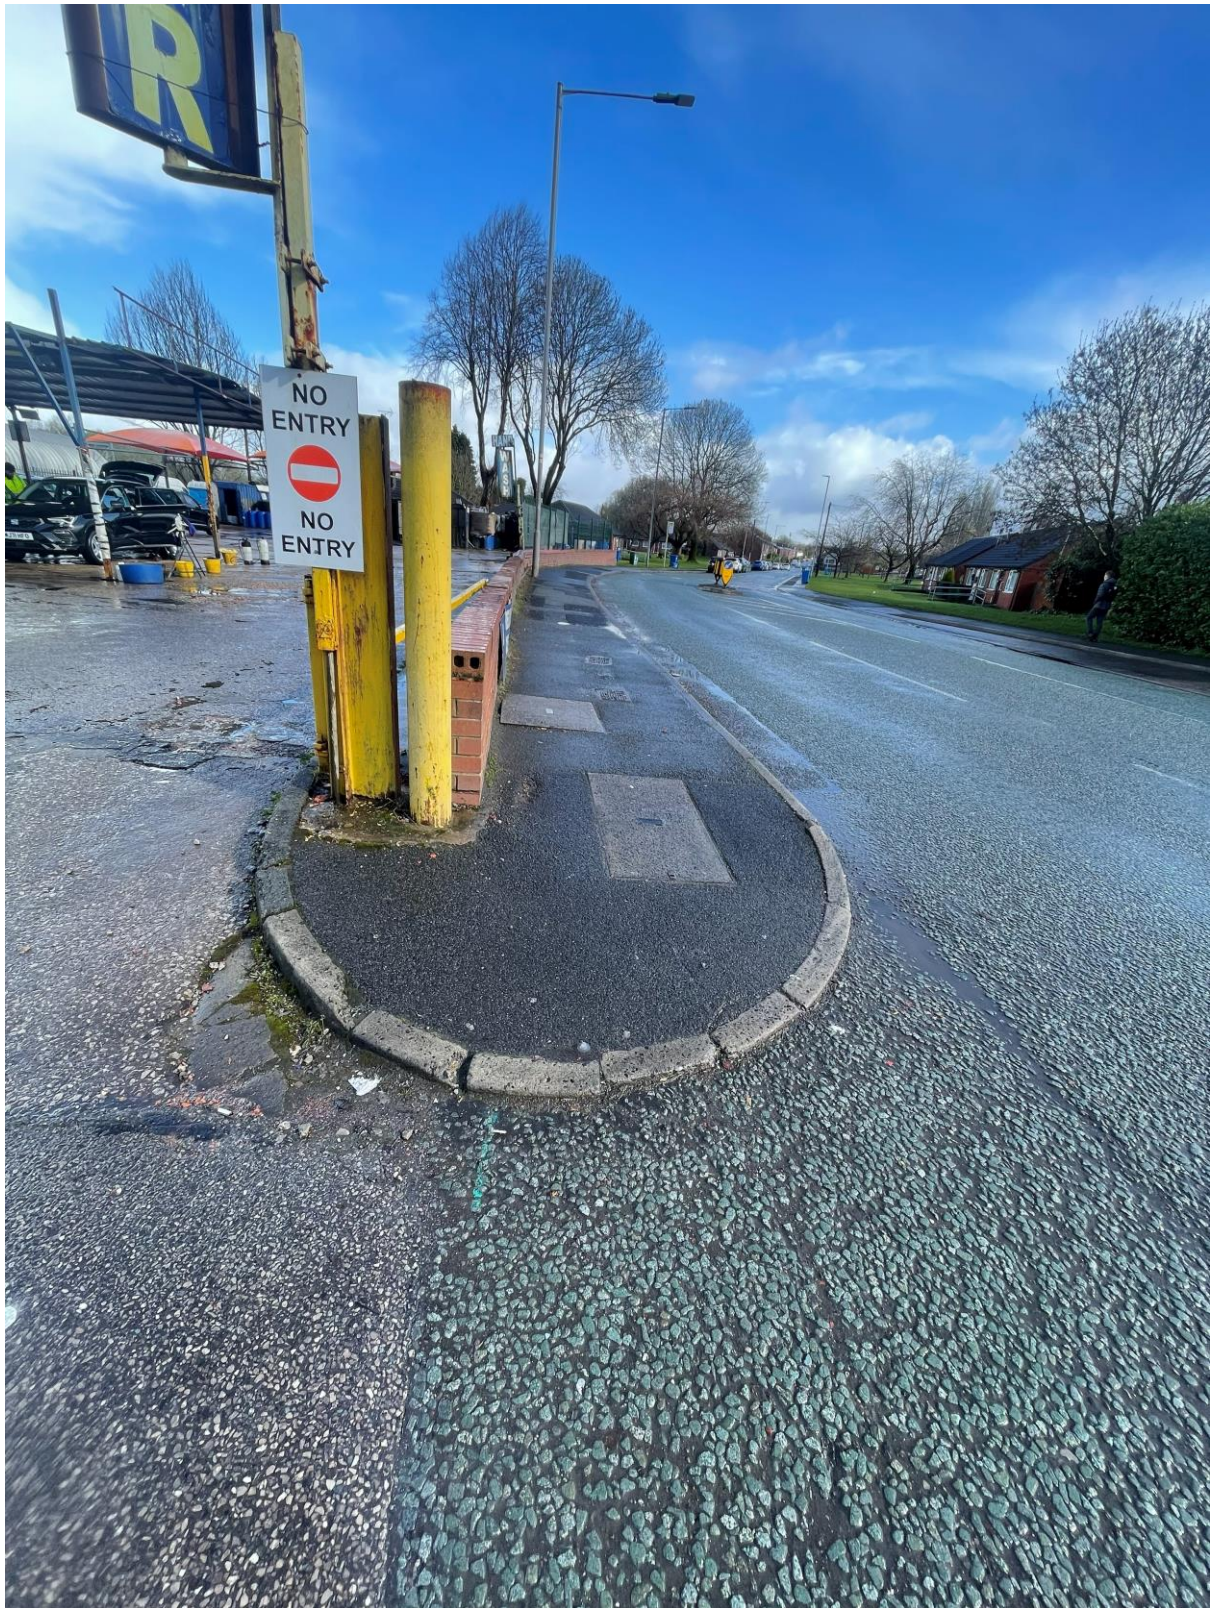
FRAME 1

| <b>FRAME</b> | <b>KERB<br/>CONDITION</b> | <b>FOOTPATH<br/>CONDITION</b> | <b>CARRIAGEWAY<br/>CONDITION</b> | <b>GENERAL<br/>CONDITION</b> |
|---|---|---|---|---|
| <b>1</b> | Radius kerbs damaged, poor condition and level inconsistent. | Medium condition tarmac footpath, well-worn with BT box positioned in footpath. | Evidence of holding water on channel line. | Signs of aging, wear and tear. |

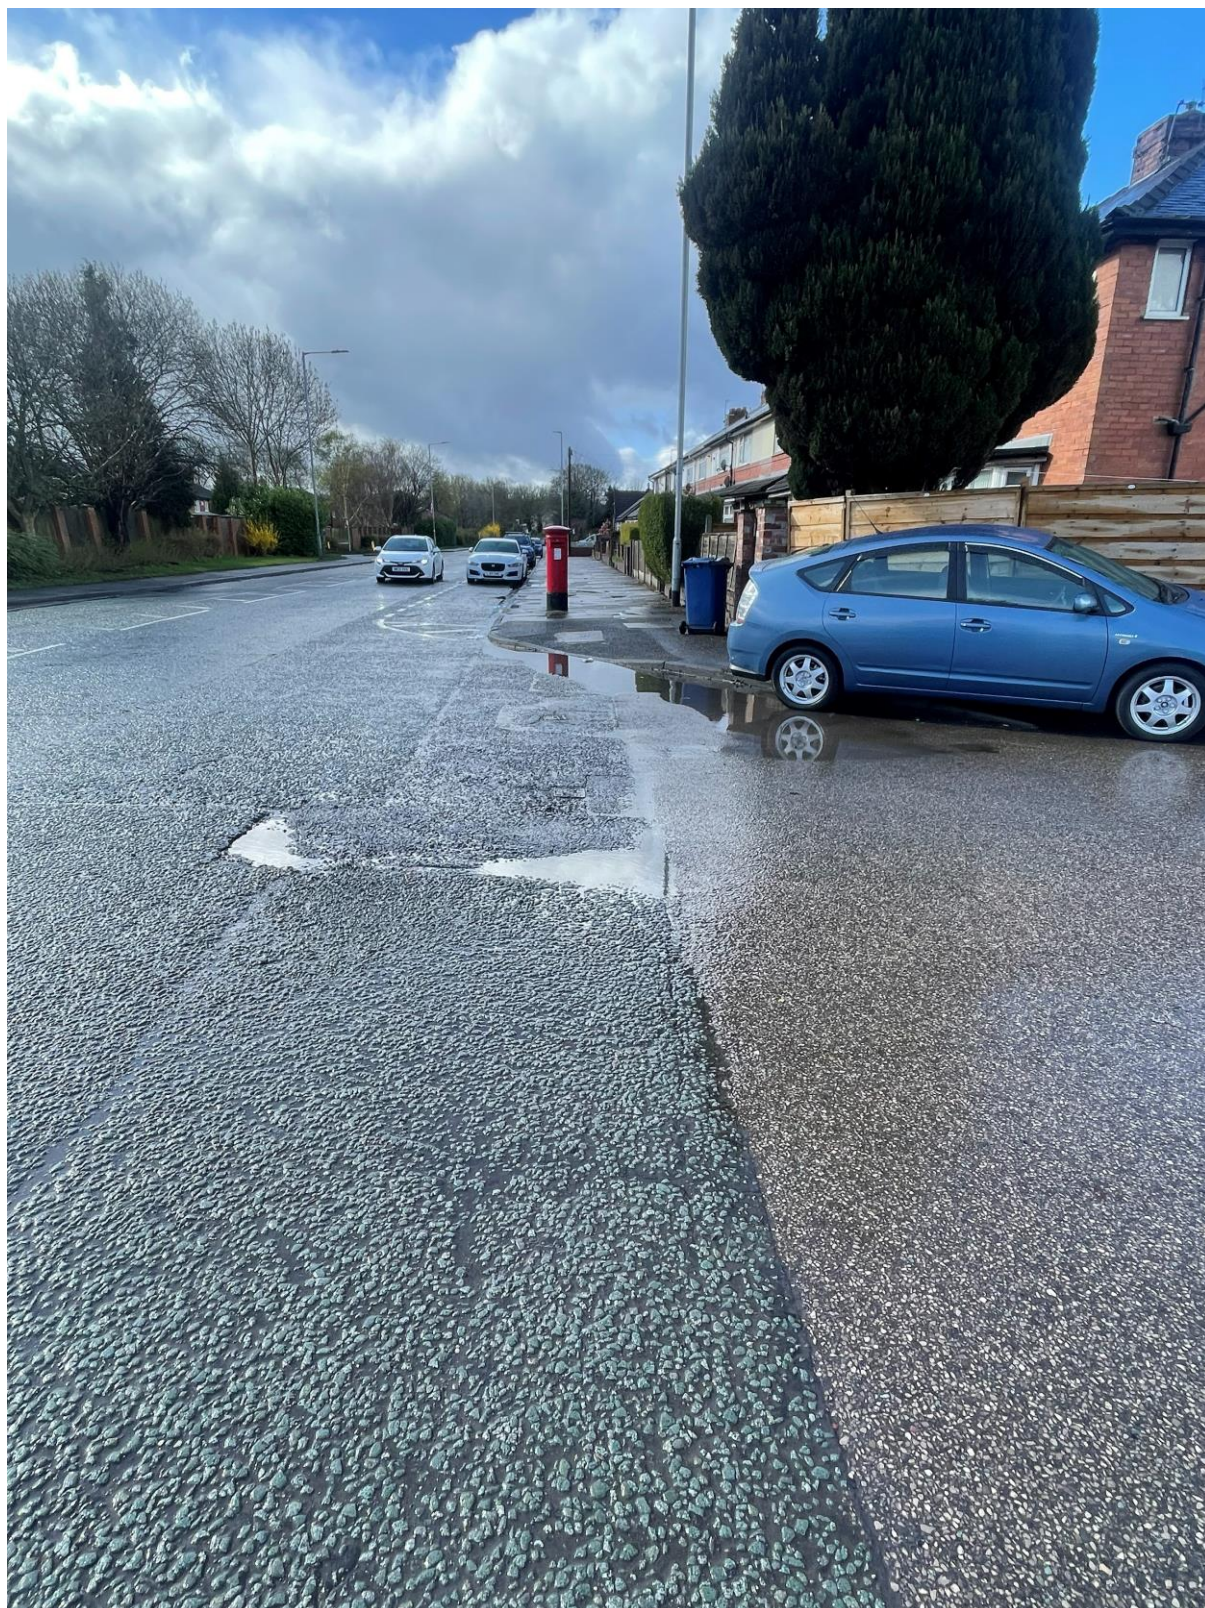
FRAME 2

| <b>FRAME</b> | <b>KERB<br/>CONDITION</b> | <b>FOOTPATH<br/>CONDITION</b> | <b>CARRIAGEWAY<br/>CONDITION</b> | <b>GENERAL<br/>CONDITION</b> |
|---|---|---|---|---|
| <b>2</b> | N/a | N/a | Surface in poor condition with potholes, patches, stress fractures with ponding in the middle of junction. | Carriageway showing signs of wear and deterioration. |

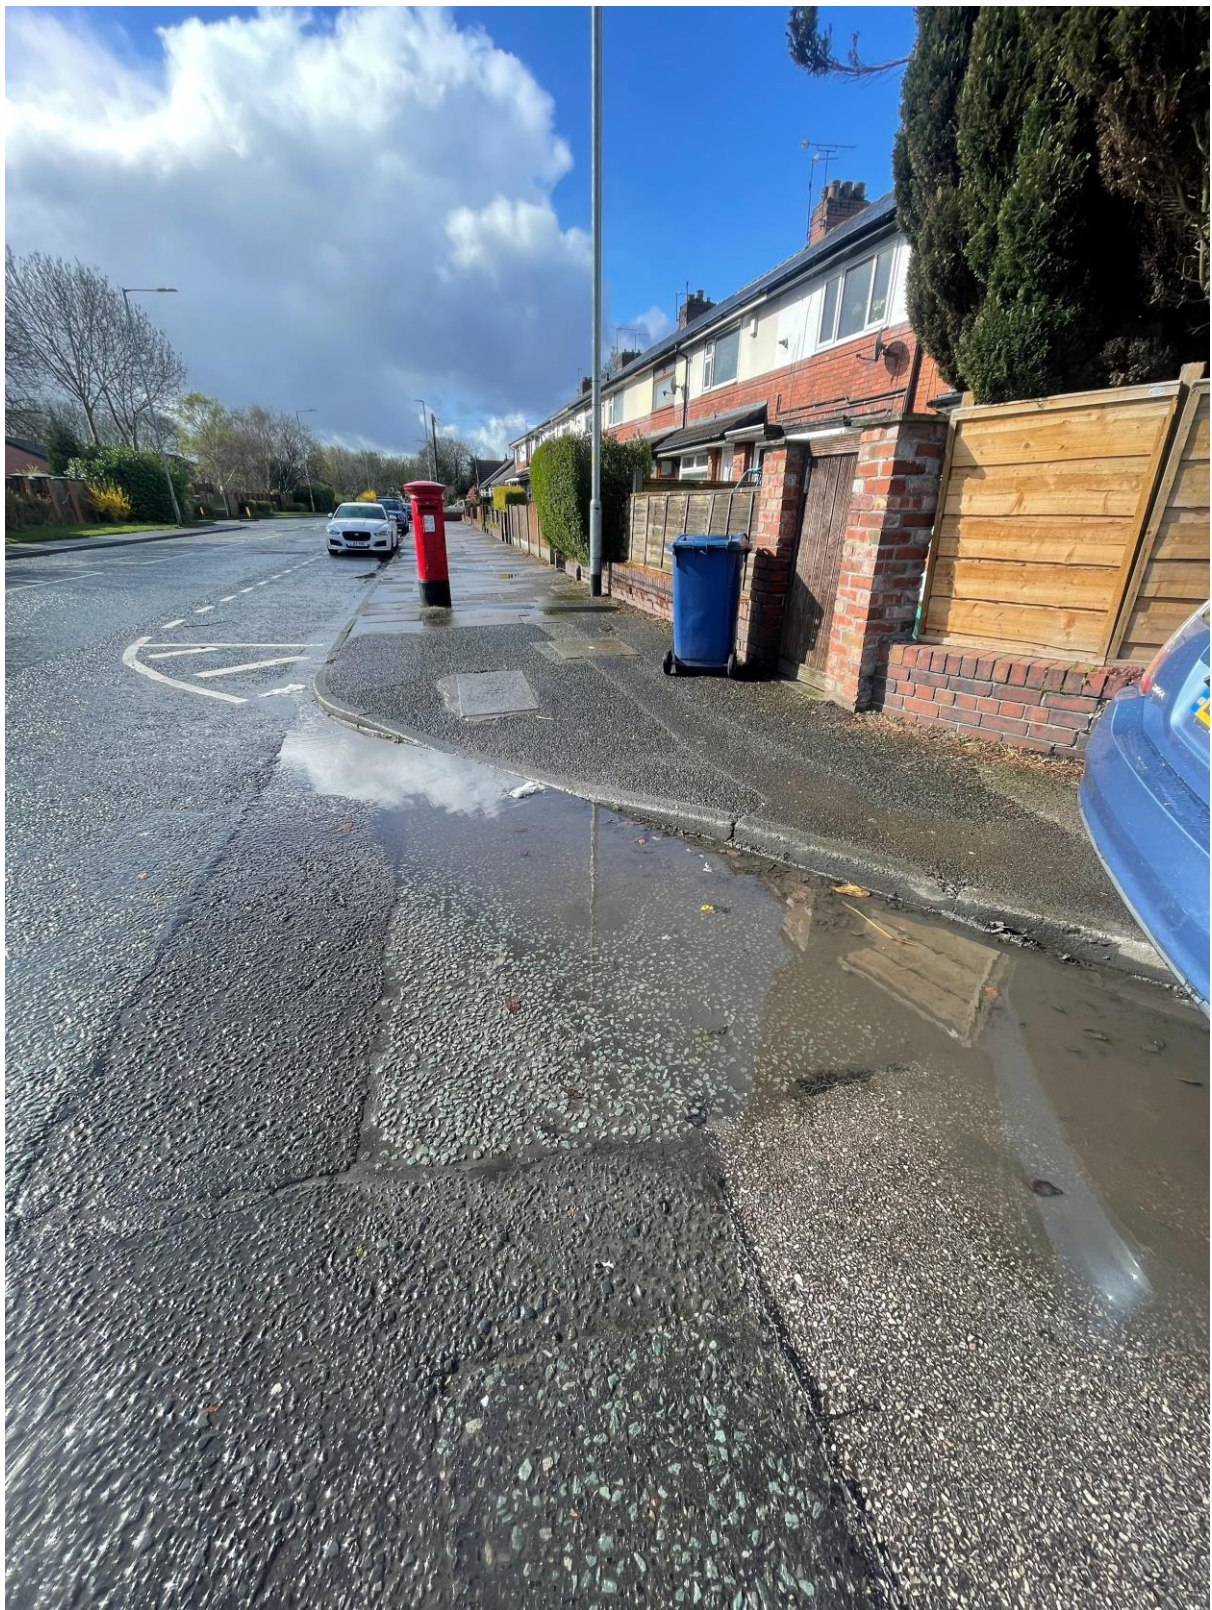
FRAME 3

| <b>FRAME</b> | <b>KERB<br/>CONDITION</b> | <b>FOOTPATH<br/>CONDITION</b> | <b>CARRIAGEWAY<br/>CONDITION</b> | <b>GENERAL<br/>CONDITION</b> |
|---|---|---|---|---|
| <b>3</b> | Kerbs damaged and poor condition. | Tarmac Poor condition. Various scars associated with patch utilities repairs. | Large amount of ponding on junction around kerbs and leading into site. | Footpath in poor condition. Carriageway showing signs of wear and deterioration. |

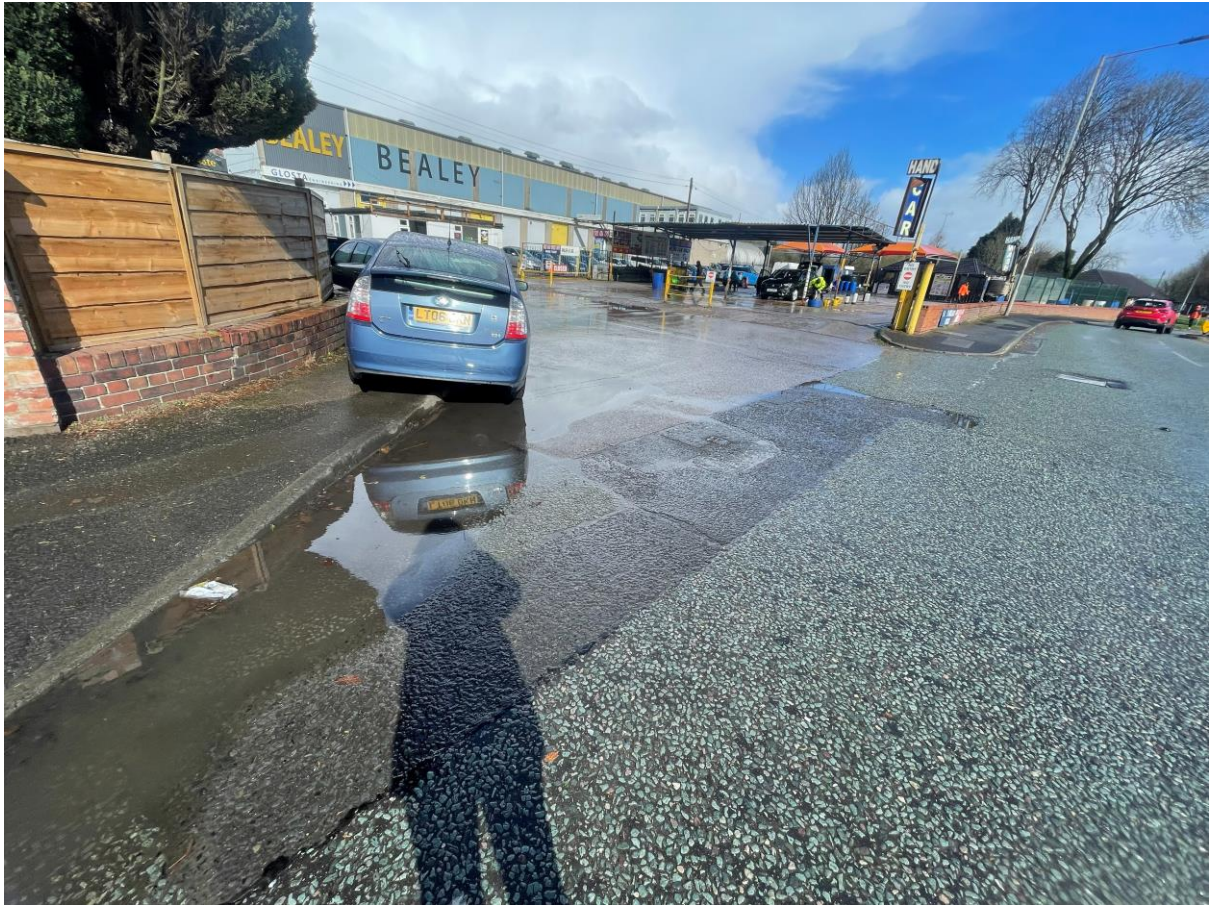
FRAME 4

| <b>FRAME</b> | <b>KERB<br/>CONDITION</b> | <b>FOOTPATH<br/>CONDITION</b> | <b>CARRIAGEWAY<br/>CONDITION</b> | <b>GENERAL<br/>CONDITION</b> |
|---|---|---|---|---|
| <b>4</b> | Kerbs damaged and poor condition. | Tarmac Poor condition. Various scars associated with patch utilities repairs. | Large amount of ponding on junction around kerbs and leading into site. | Footpath in poor condition. Carriageway showing signs of wear and deterioration. |

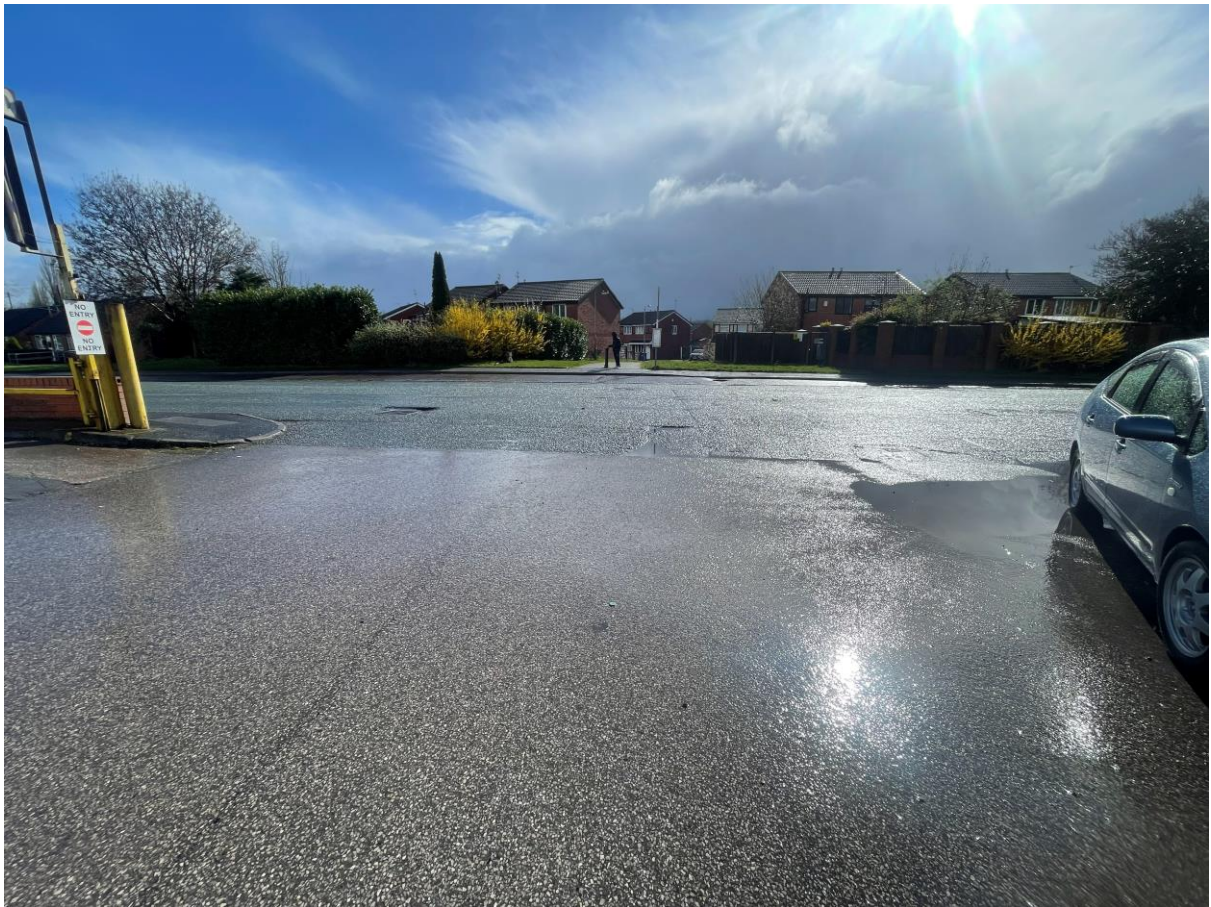
FRAME 5

| <b>FRAME</b> | <b>KERB<br/>CONDITION</b> | <b>FOOTPATH<br/>CONDITION</b> | <b>CARRIAGEWAY<br/>CONDITION</b> | <b>GENERAL<br/>CONDITION</b> |
|---|---|---|---|---|
| <b>5</b> | N/a | N/a | Section of carriageway surface in reasonable condition. | Reasonable condition. |

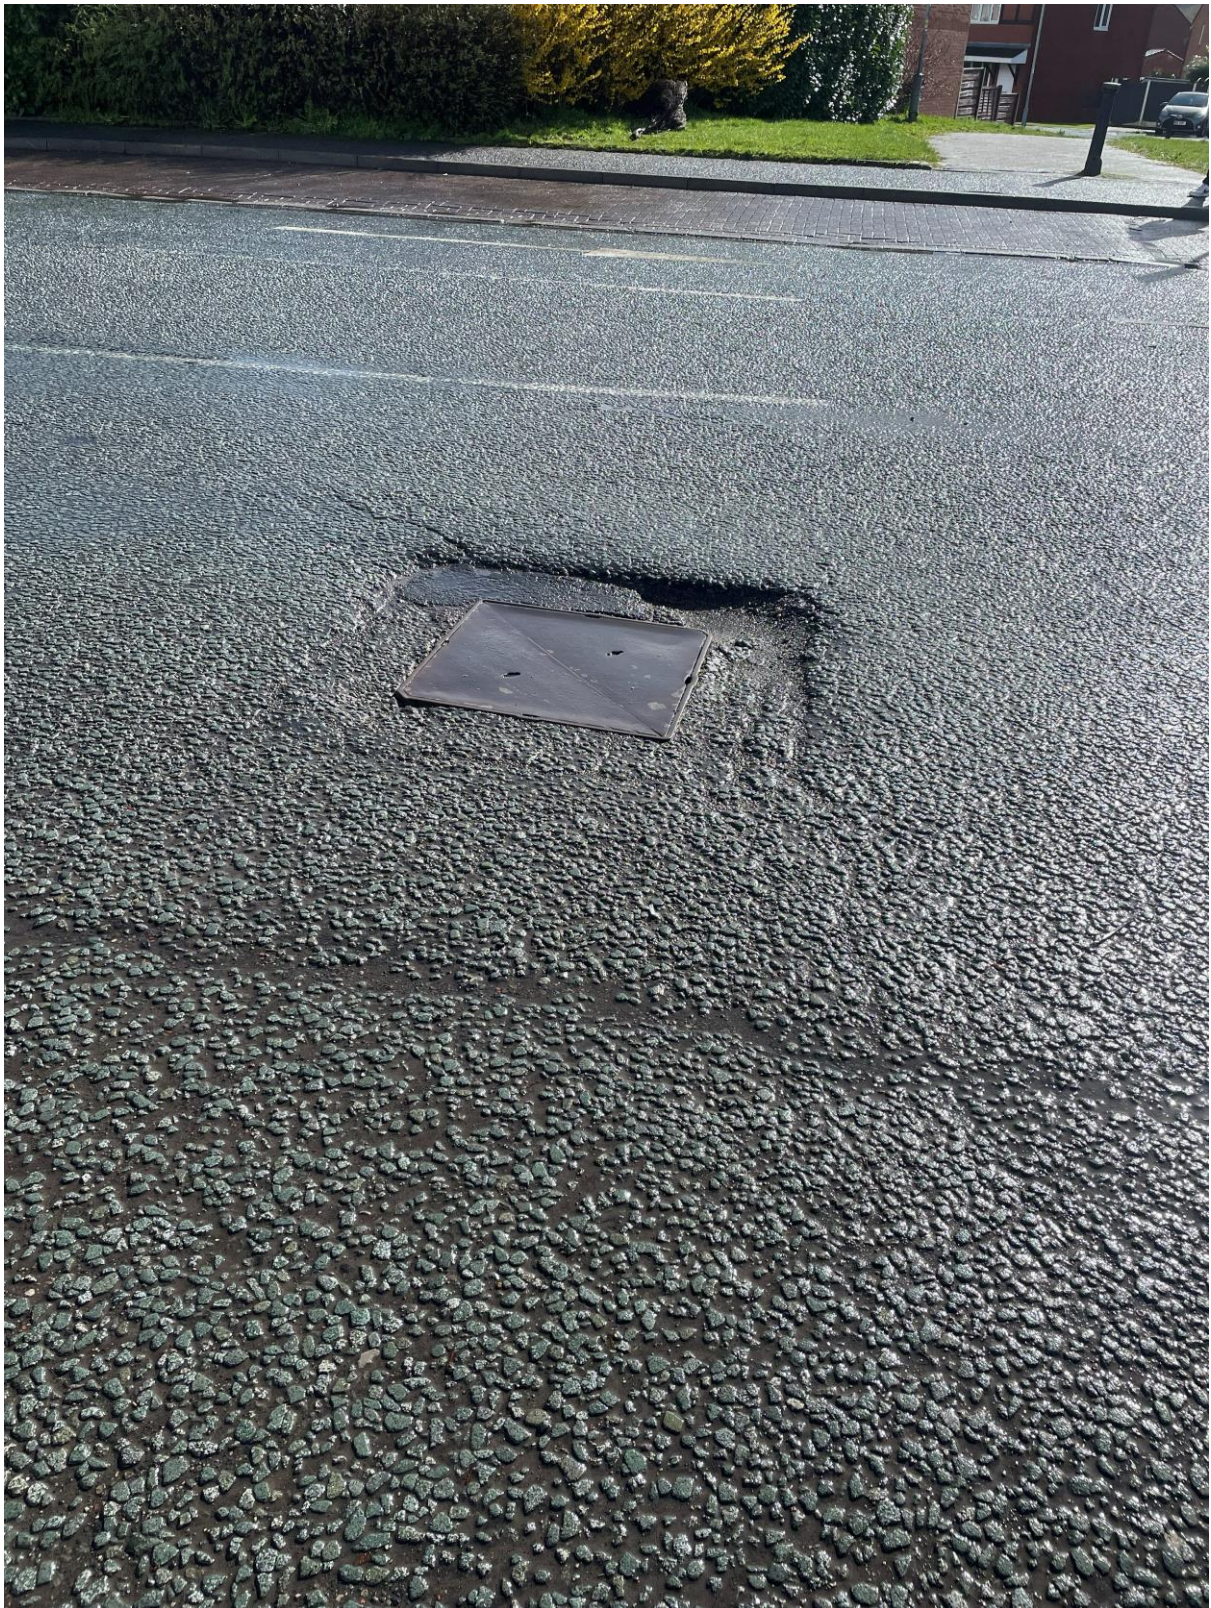
FRAME 6

| <b>FRAME</b> | <b>KERB<br/>CONDITION</b> | <b>FOOTPATH<br/>CONDITION</b> | <b>CARRIAGEWAY<br/>CONDITION</b> | <b>GENERAL<br/>CONDITION</b> |
|---|---|---|---|---|
| <b>6</b> | N/a | N/a | Manhole positioned on existing road (Dumers Lane) settled and tarmac deterioration | Poor condition. |

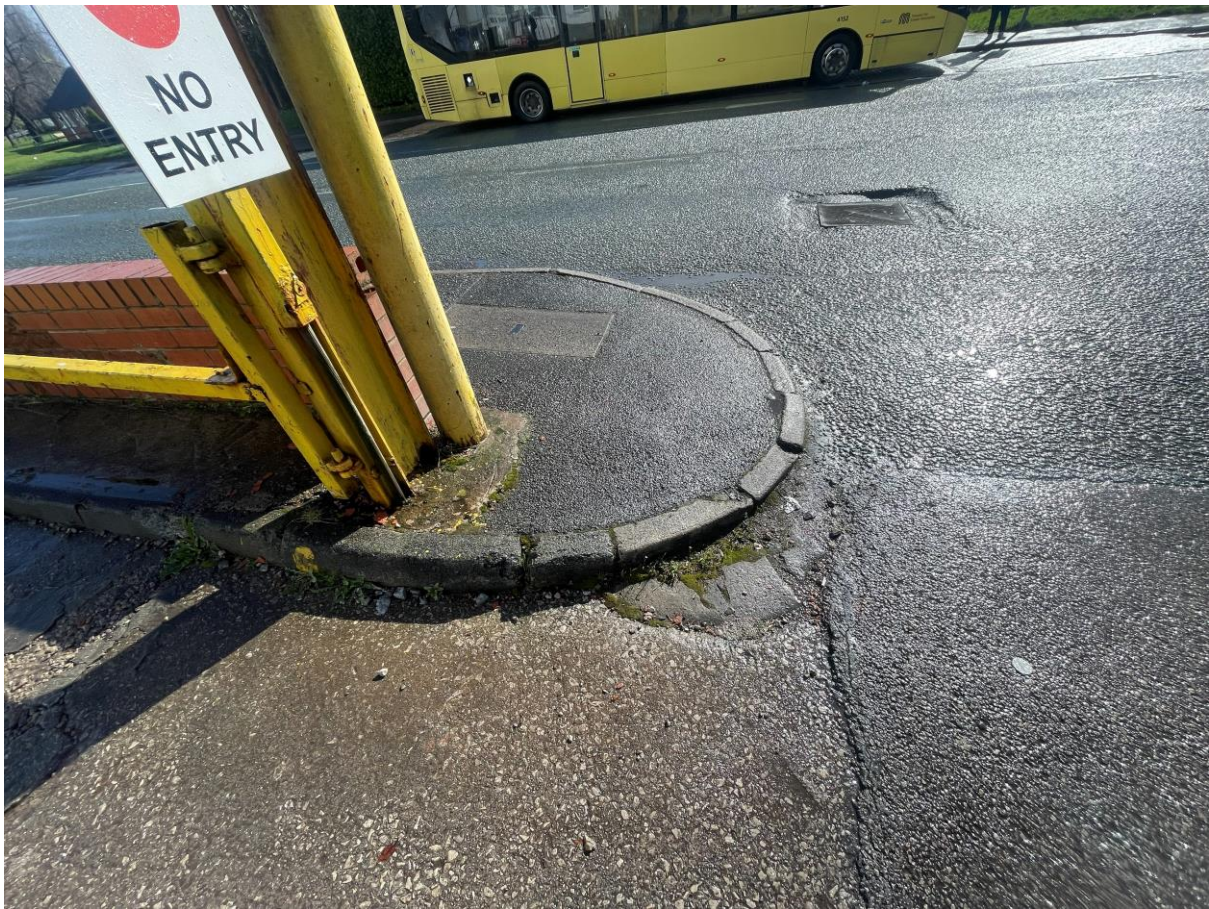
FRAME 7

| <b>FRAME</b> | <b>KERB<br/>CONDITION</b> | <b>FOOTPATH<br/>CONDITION</b> | <b>CARRIAGEWAY<br/>CONDITION</b> | <b>GENERAL<br/>CONDITION</b> |
|---|---|---|---|---|
| <b>7</b> | Radius kerbs damaged, poor condition and level inconsistent. | Medium condition tarmac footpath, well-worn with BT box positioned in footpath. | Weeds around kerb line. Change of surfacing, poor condition. | Carriageway entering car wash – poor condition. |

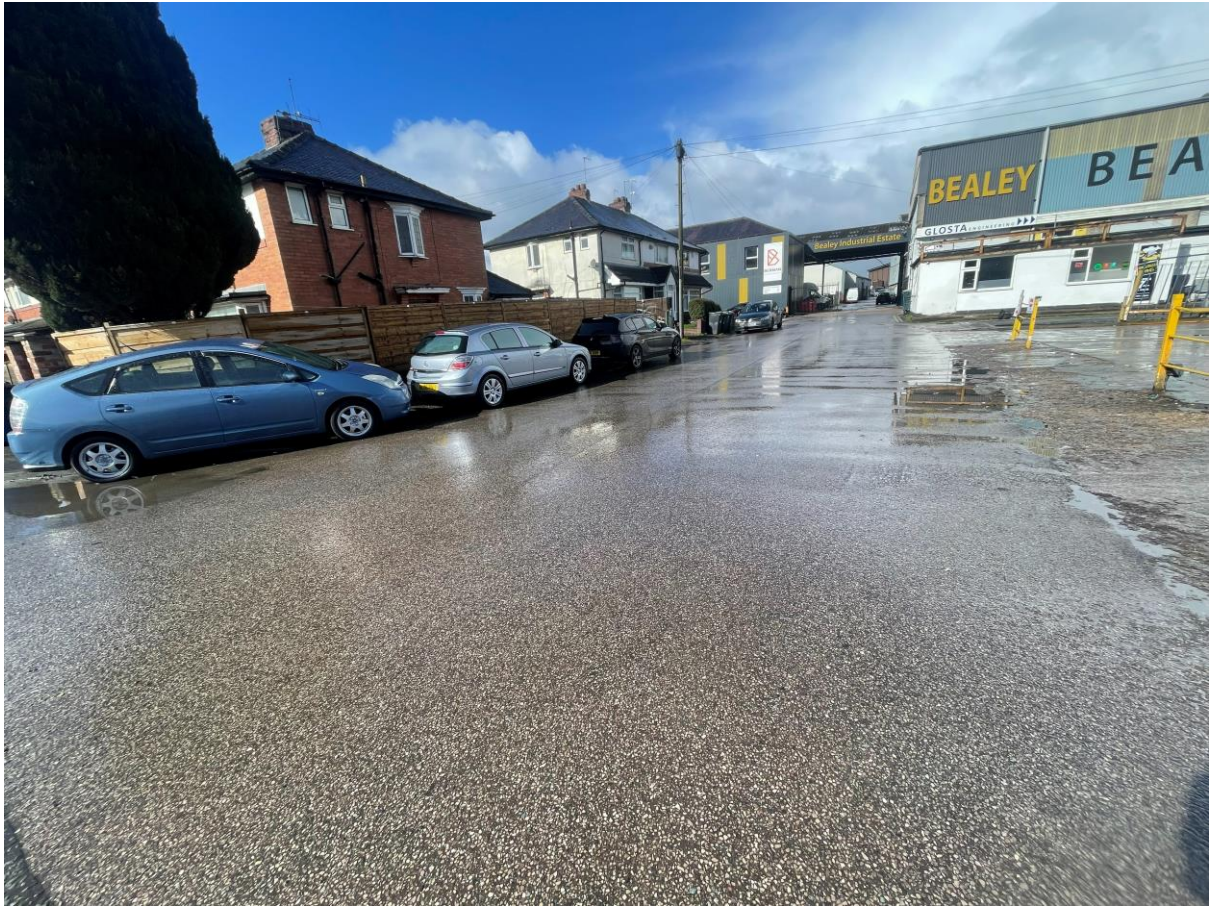
FRAME 8

| <b>FRAME</b> | <b>KERB<br/>CONDITION</b> | <b>FOOTPATH<br/>CONDITION</b> | <b>CARRIAGEWAY<br/>CONDITION</b> | <b>GENERAL<br/>CONDITION</b> |
|---|---|---|---|---|
| <b>8</b> | N/a | N/a | Section of carriageway surface in | Reasonable condition. |

| | | | reasonable condition. | |

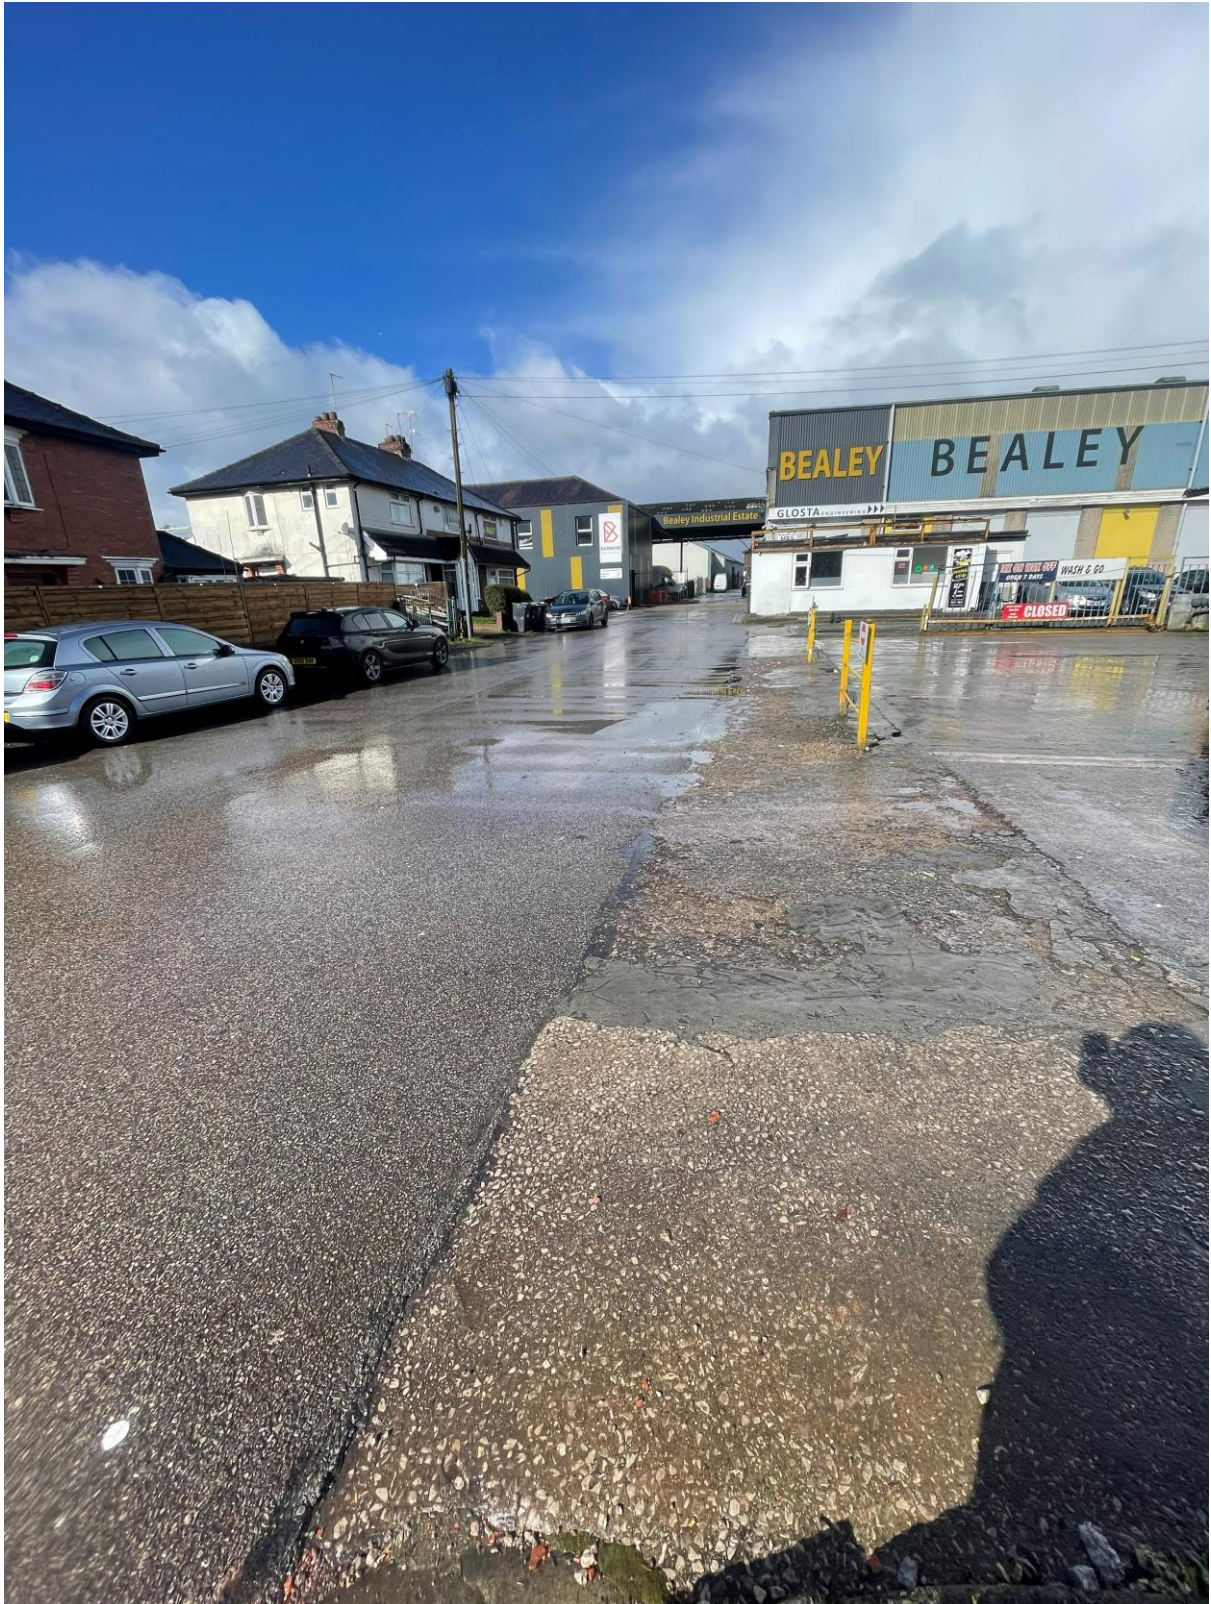
FRAME 9

| 9 | N/a | N/a | Entrance into carpark surfacing deteriorated, uneven surface. | Surfacing in poor condition. |

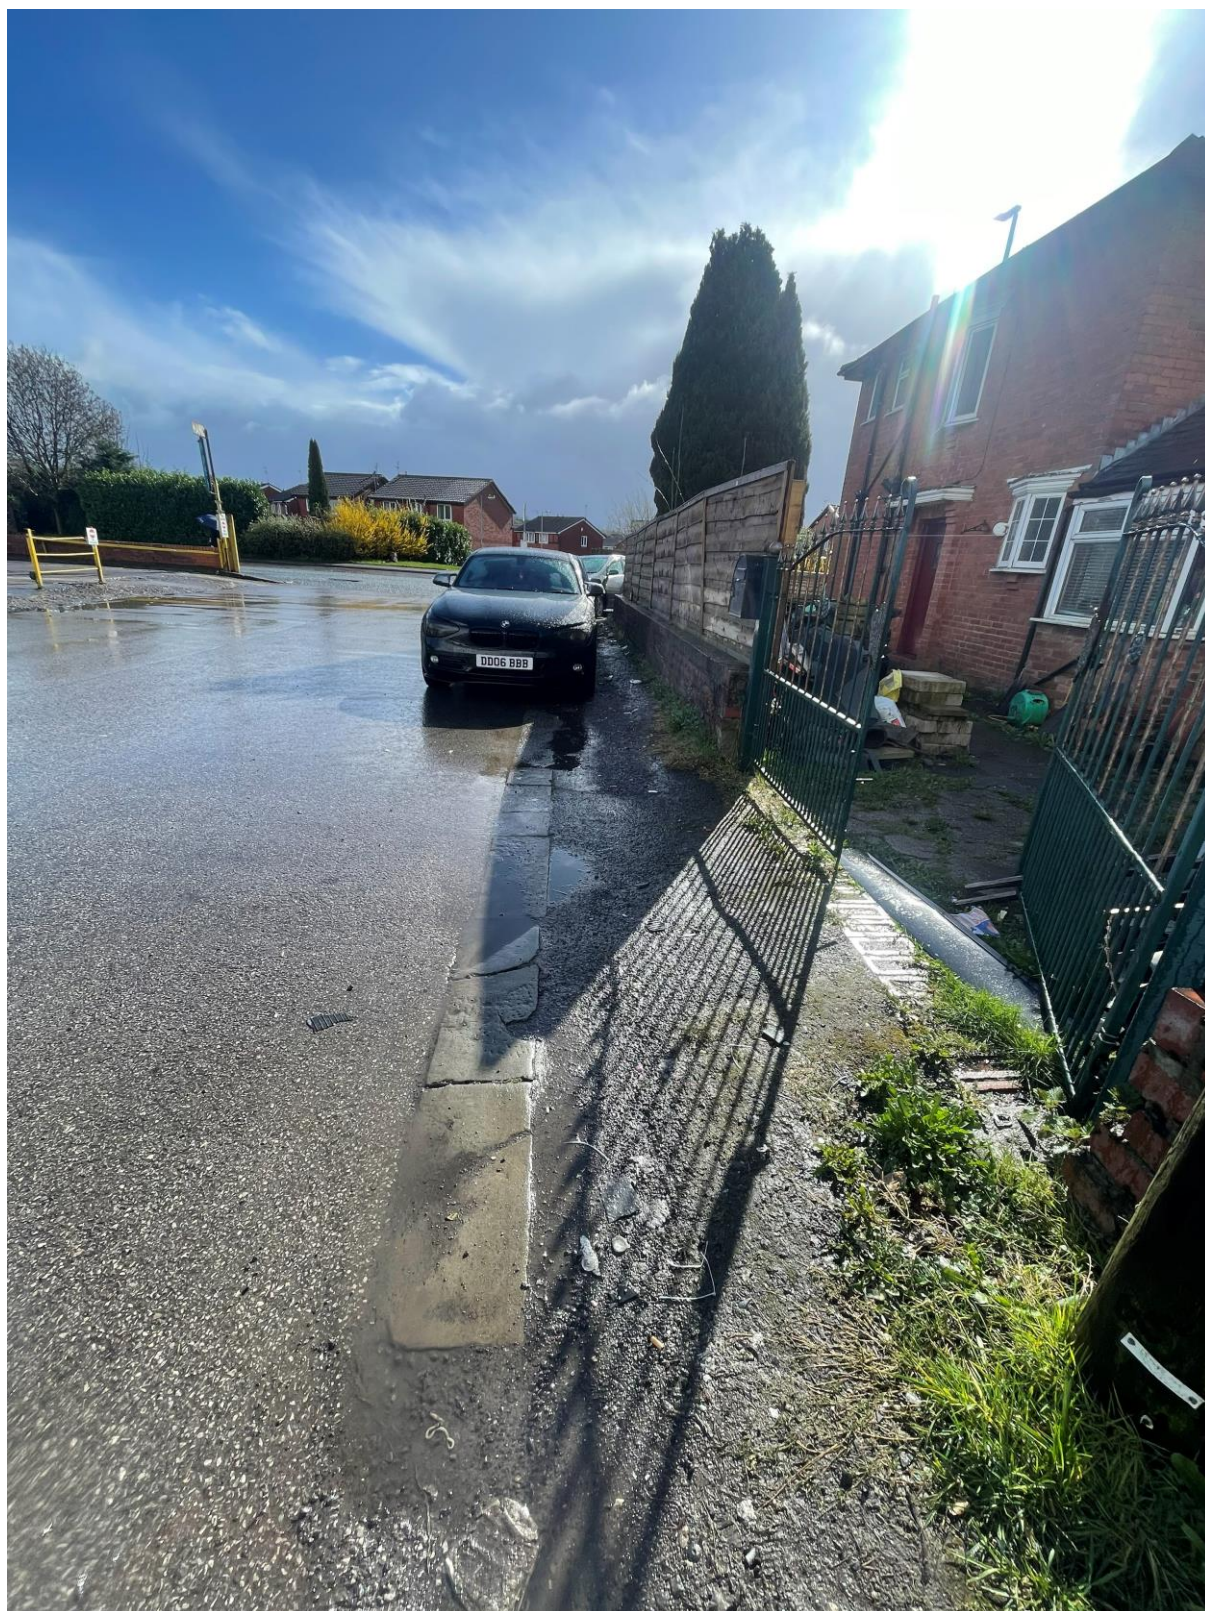
FRAME 10

| 10 | Parked vehicles restricting kerbs. Kerb line damaged and in poor condition. | Parked vehicles restricting footpath. Weeds located down the boundary line, poor conditioned uneven footpath with minor ponding. | Section of carriageway surface in reasonable condition. | Footpath & Kerbs In poor condition. |

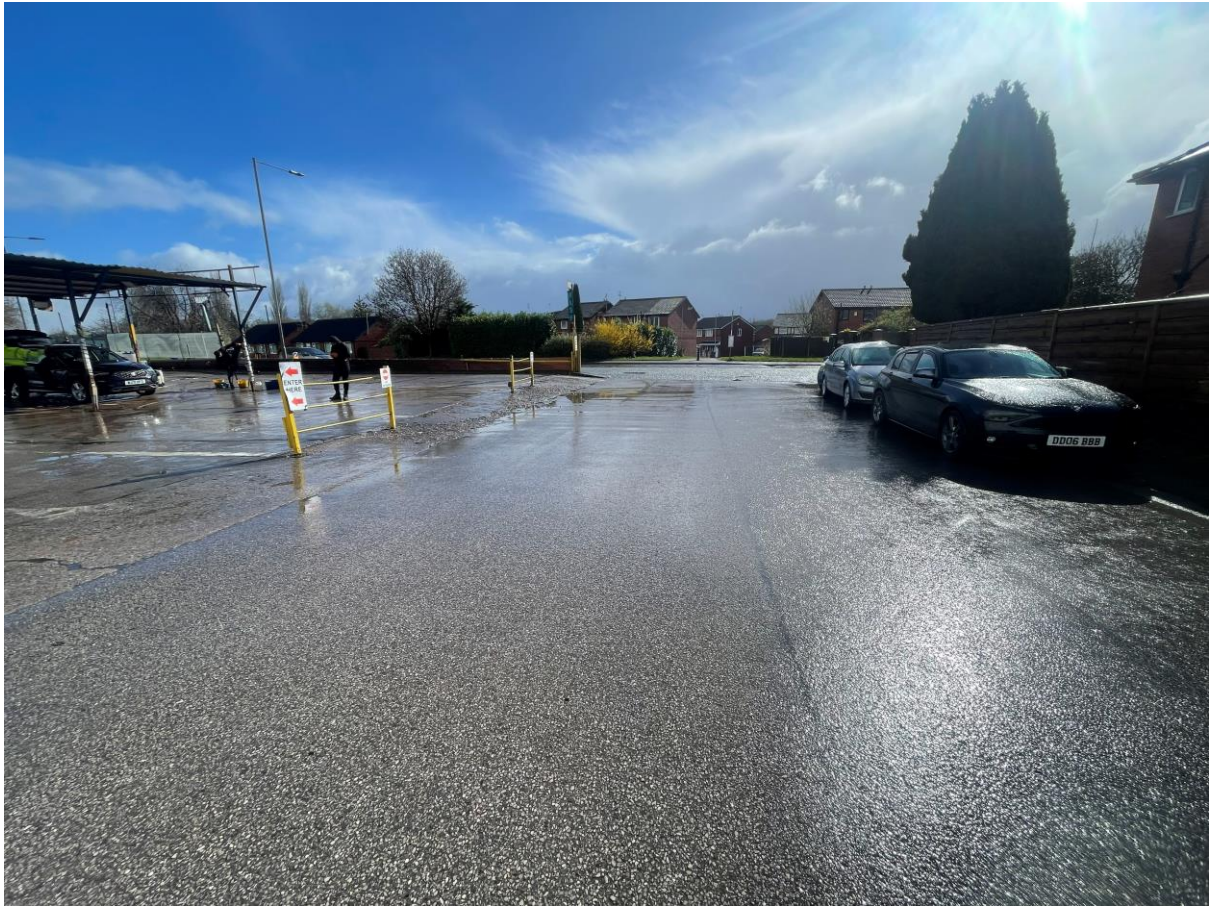
FRAME 11

| 11 | N/a | N/a | Section of carriageway surface in reasonable condition. | Reasonable condition. |

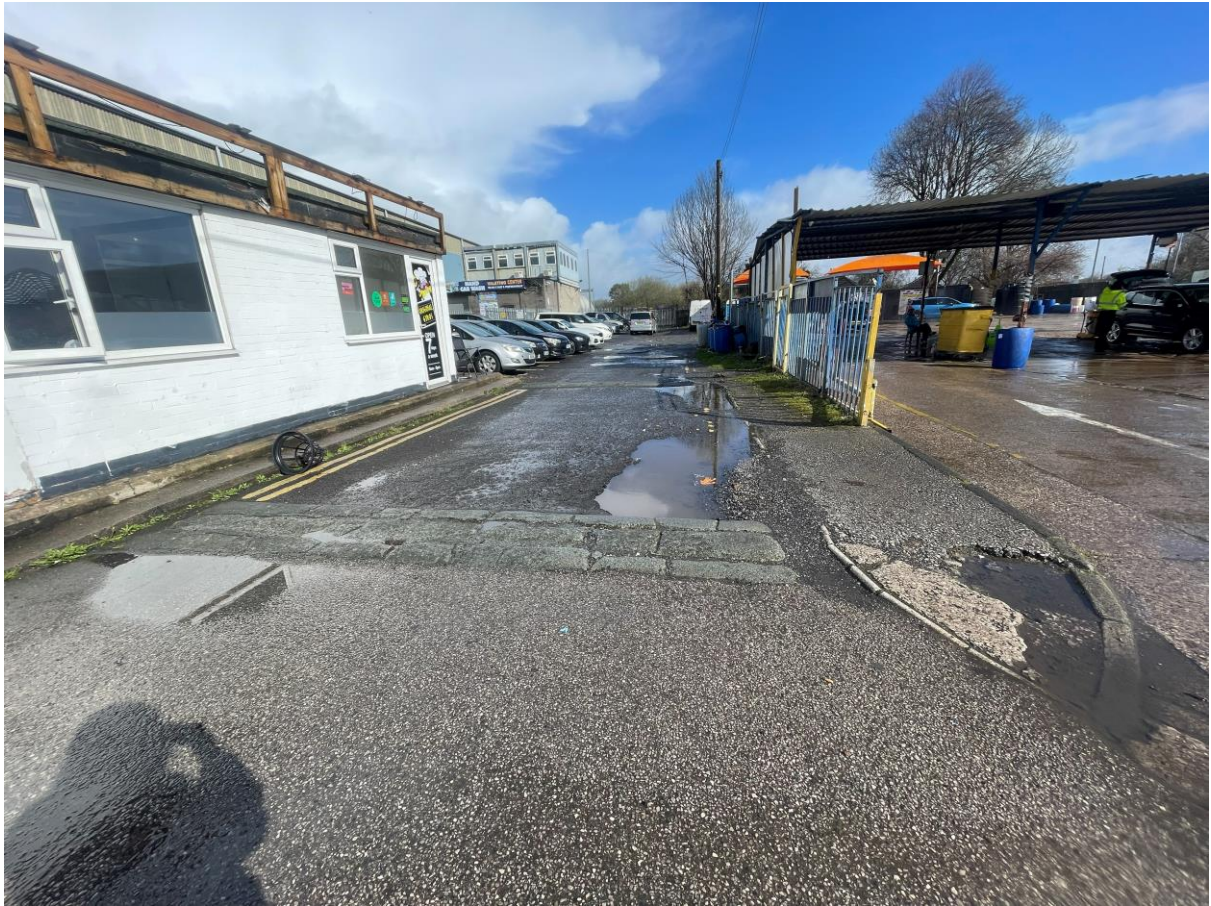
FRAME 12

| 12 | N/a | N/a | Site entrance poor condition, stoned ramp, ponding. | Poor condition |

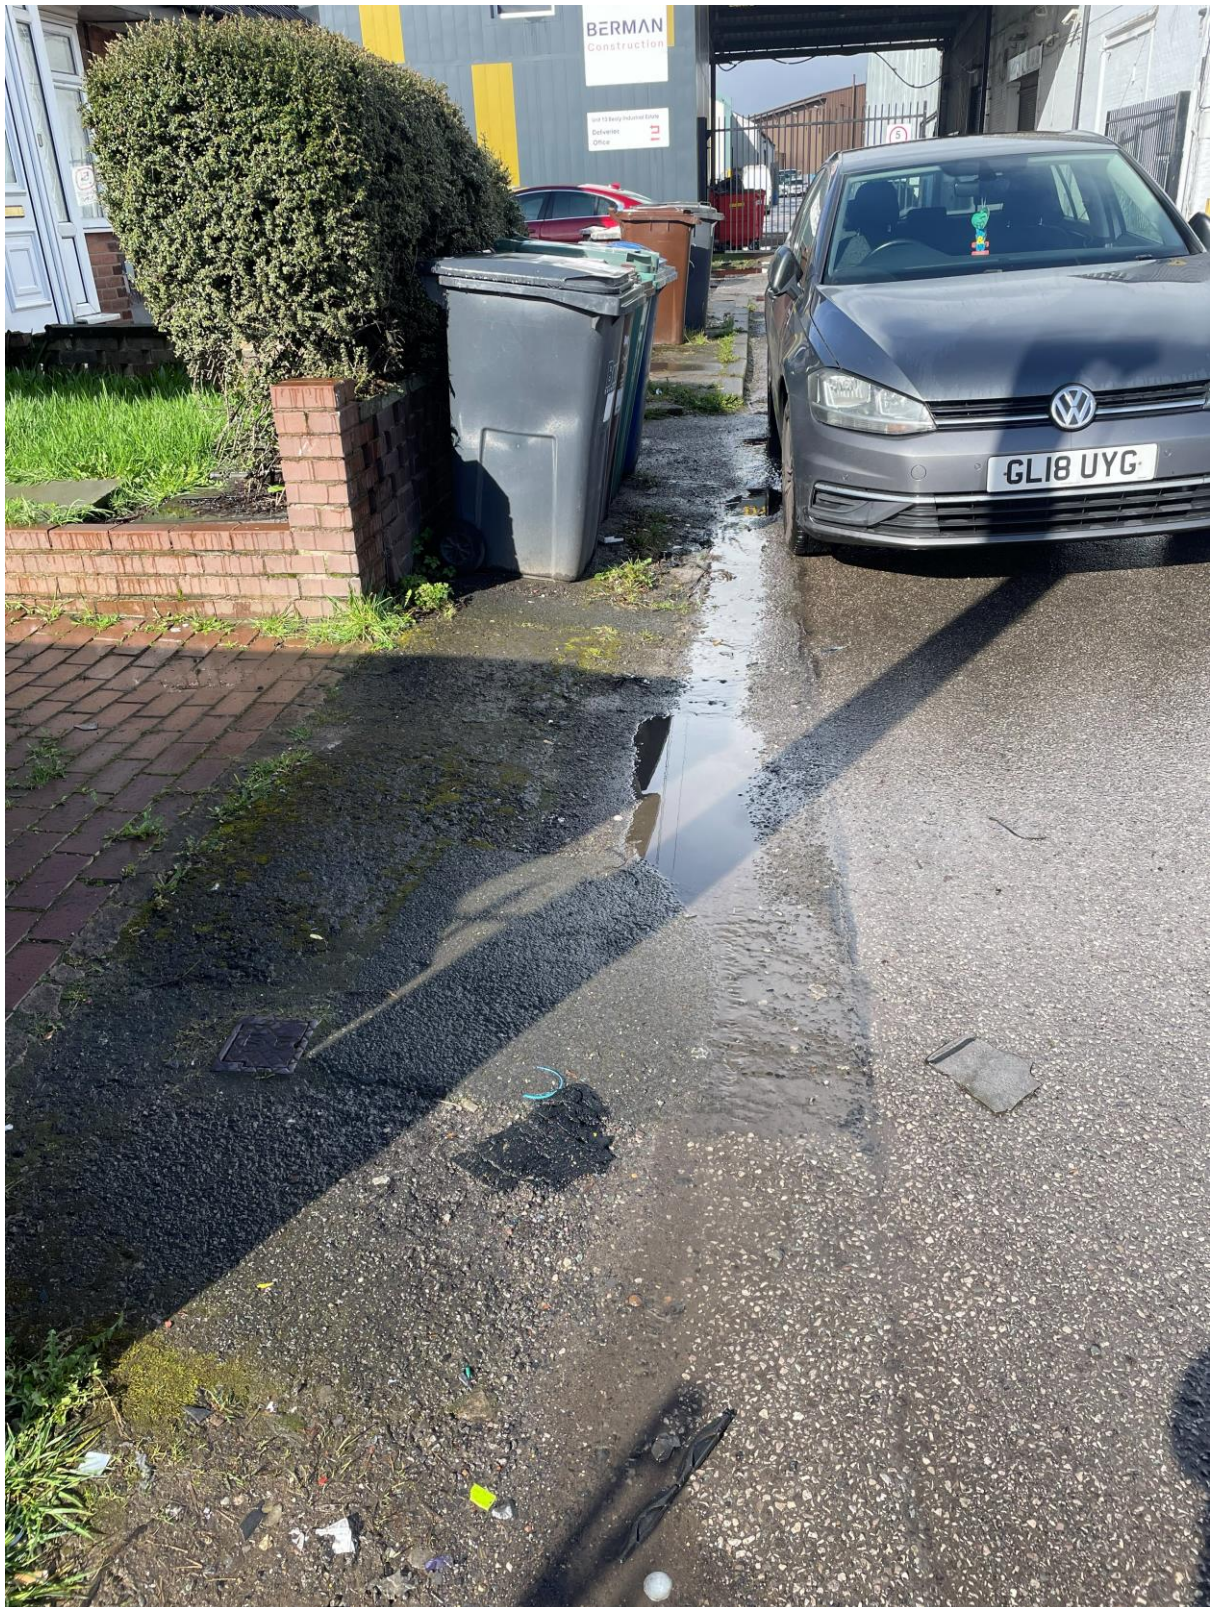
FRAME 13

| 13 | N/a | Weeds located down the boundary line, poor conditioned uneven footpath with minor ponding. | N/a | Poor condition |
