**CONSTRUCTION TRAFFIC  
MANAGEMENT PLAN (CTMP)  
IN RELATION TO CONDITION 31 OF  
PLANNING REF:71426/24**

**Land adjacent to Bealey Industrial Estate,  
Dumers Lane, Radcliffe**

**April 2026**

# **HIGHWAY DILAPIDATION SURVEY**

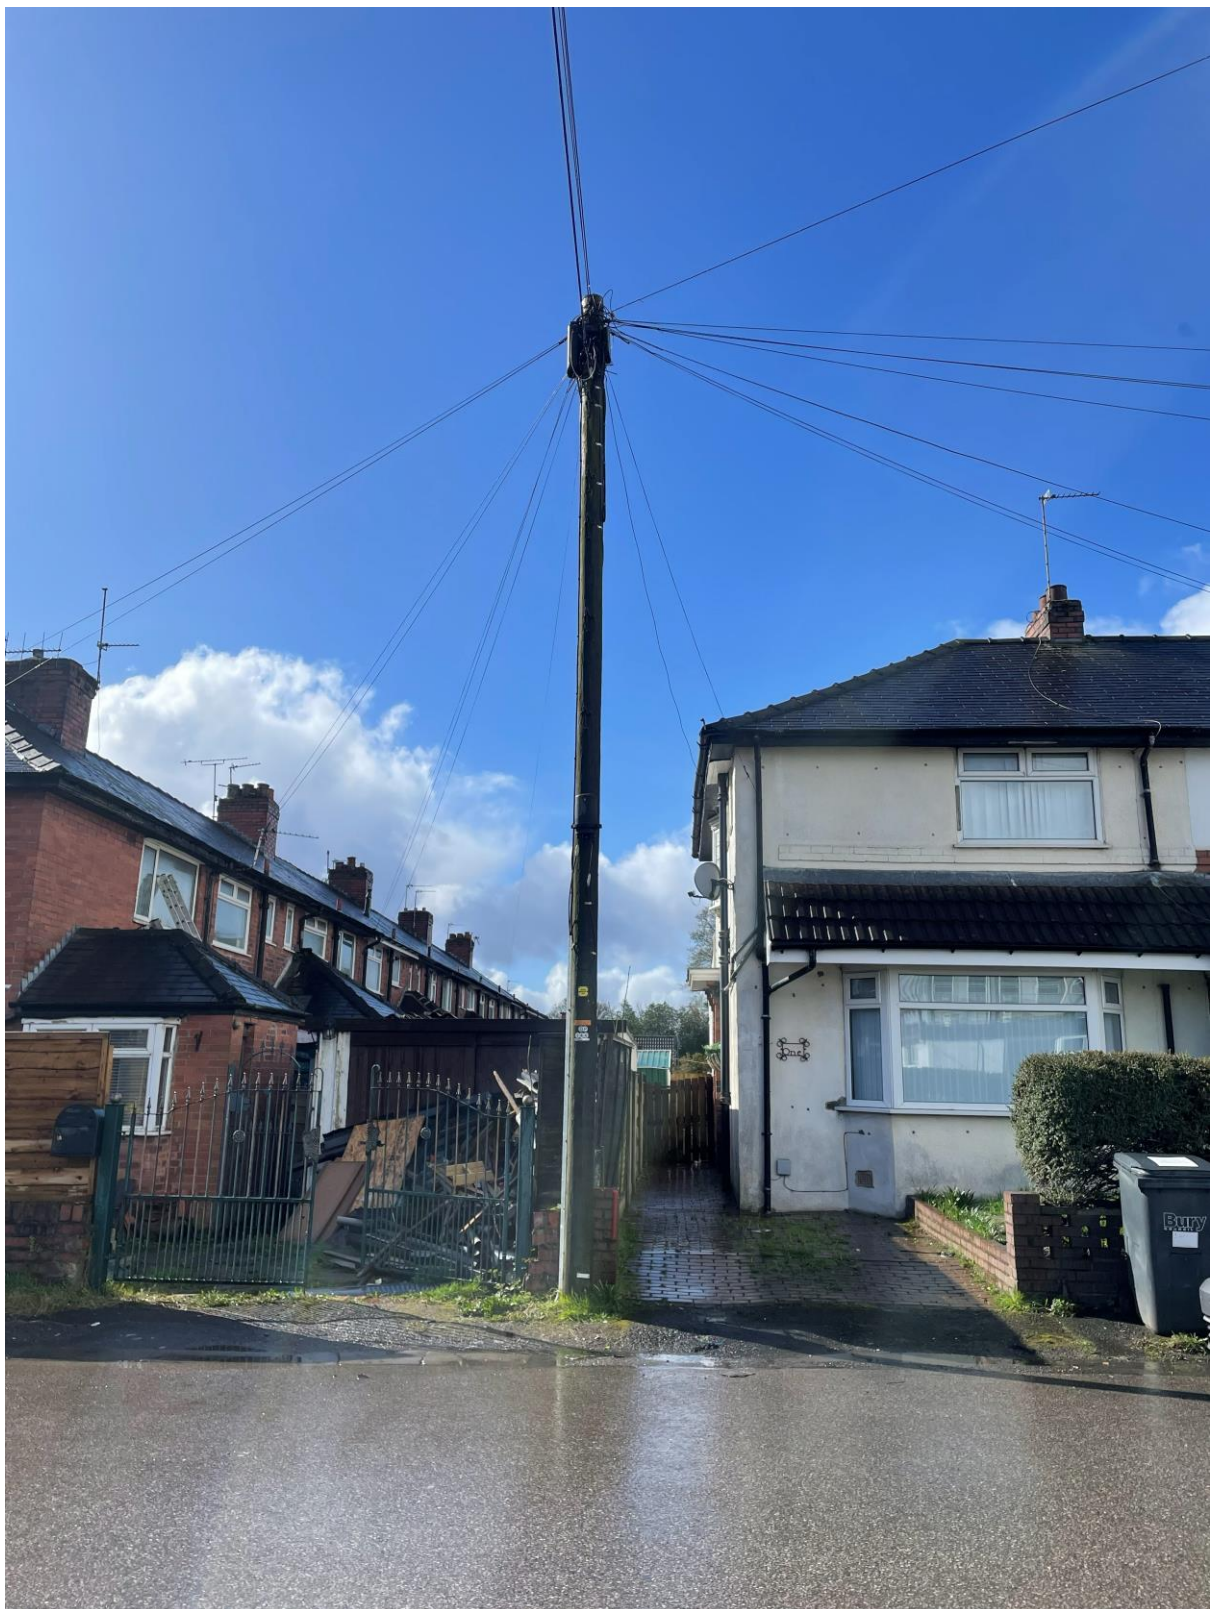
FRAME 14

| 14 | Kerbs damaged, poor condition and level inconsistent. | Overheads BT pole positioned in footpath. Weeds located down the boundary line, poor conditioned uneven footpath with minor ponding. | N/a | Poor condition |

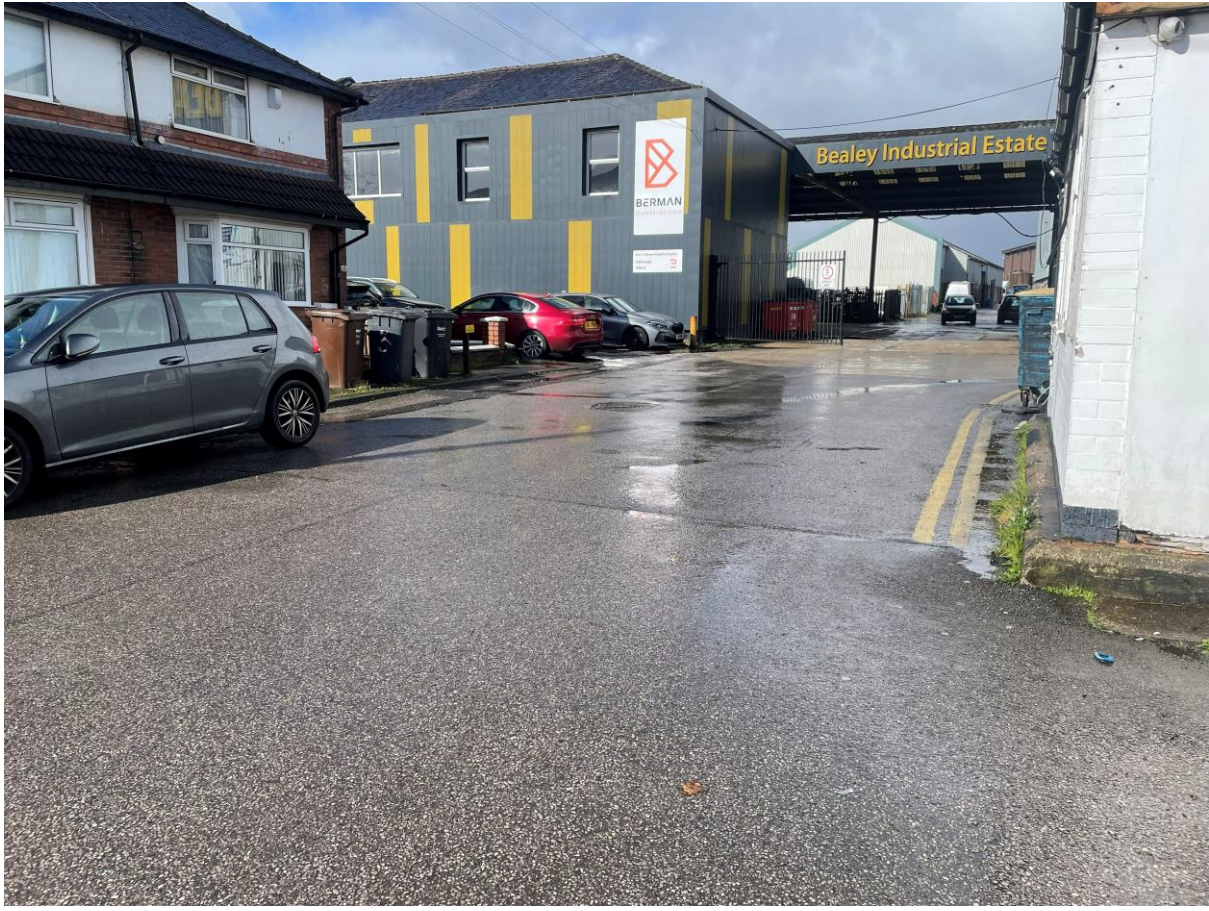
FRAME 15

| 15 | N/a | N/a | Section of carriageway in reasonable condition, worn yellow lining, weeds located down existing building. | Carriageway in reasonable condition. |

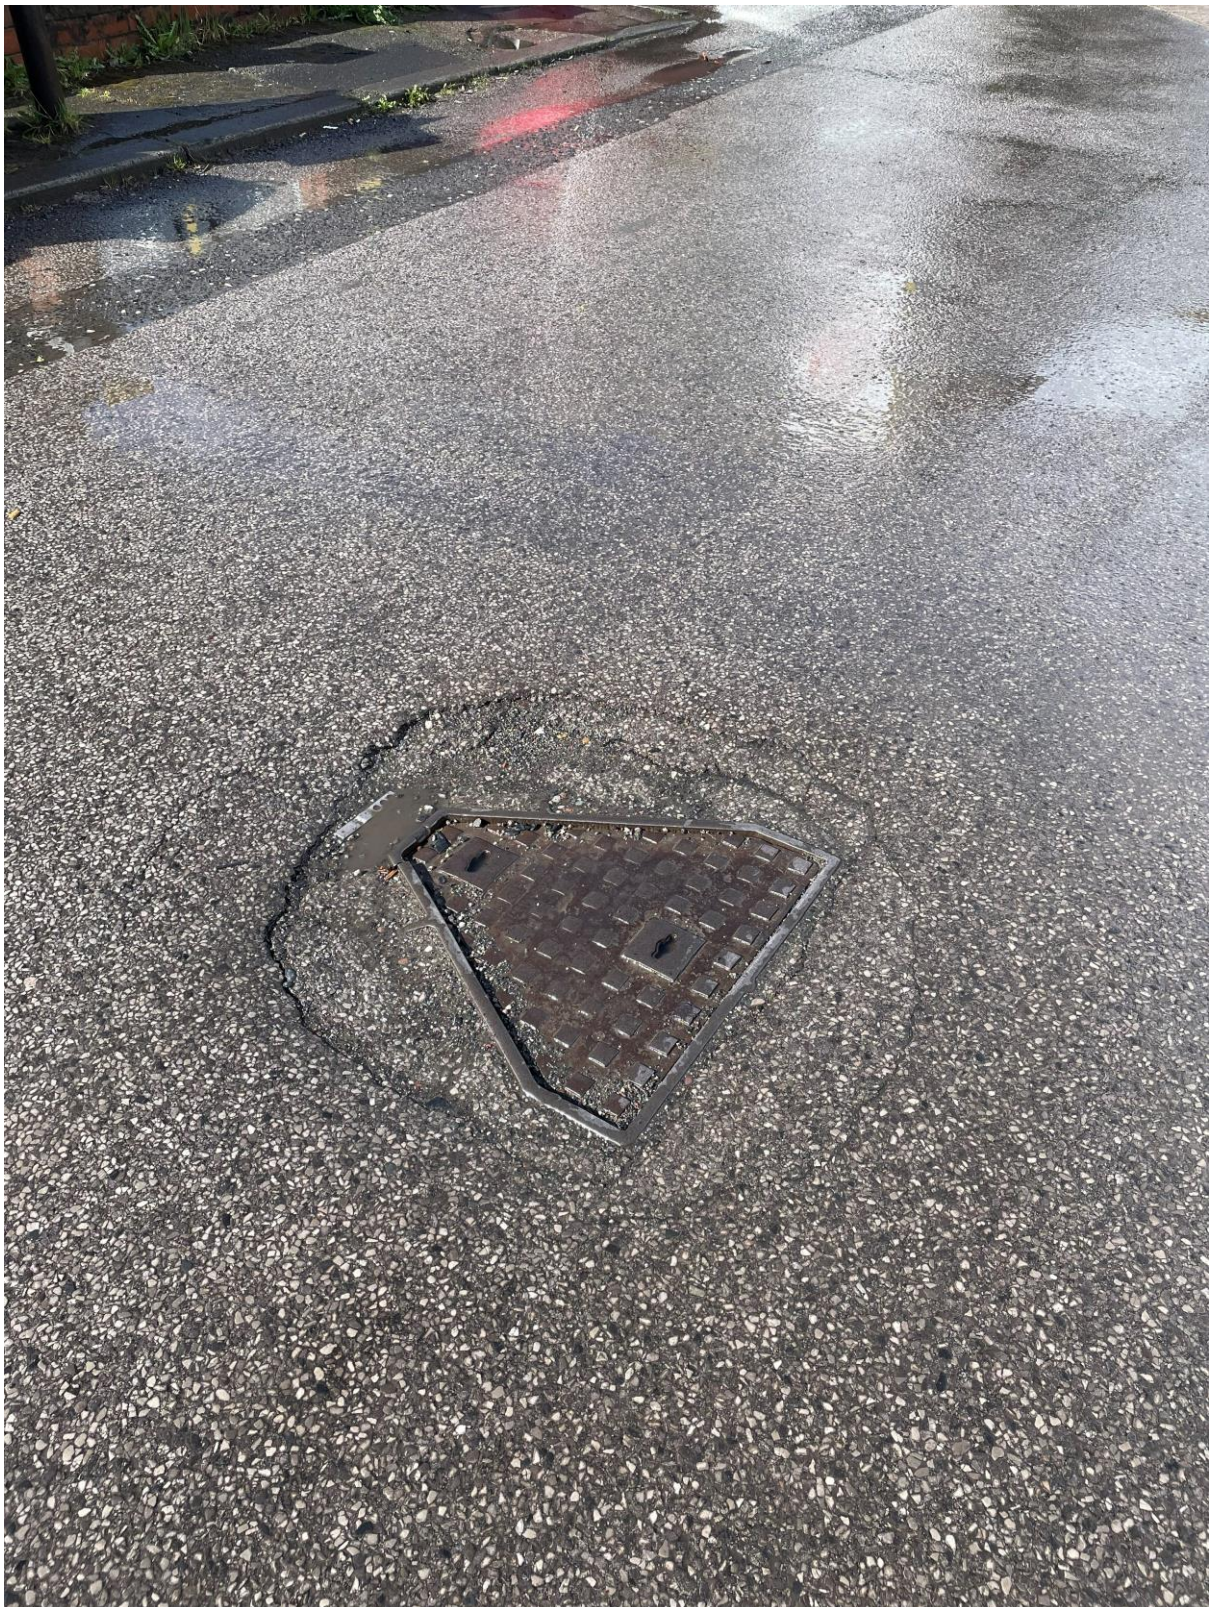
FRAME 16

| 16 | N/a | N/a | Carriageway settled around Manhole. | Manhole lid is reasonable condition. |

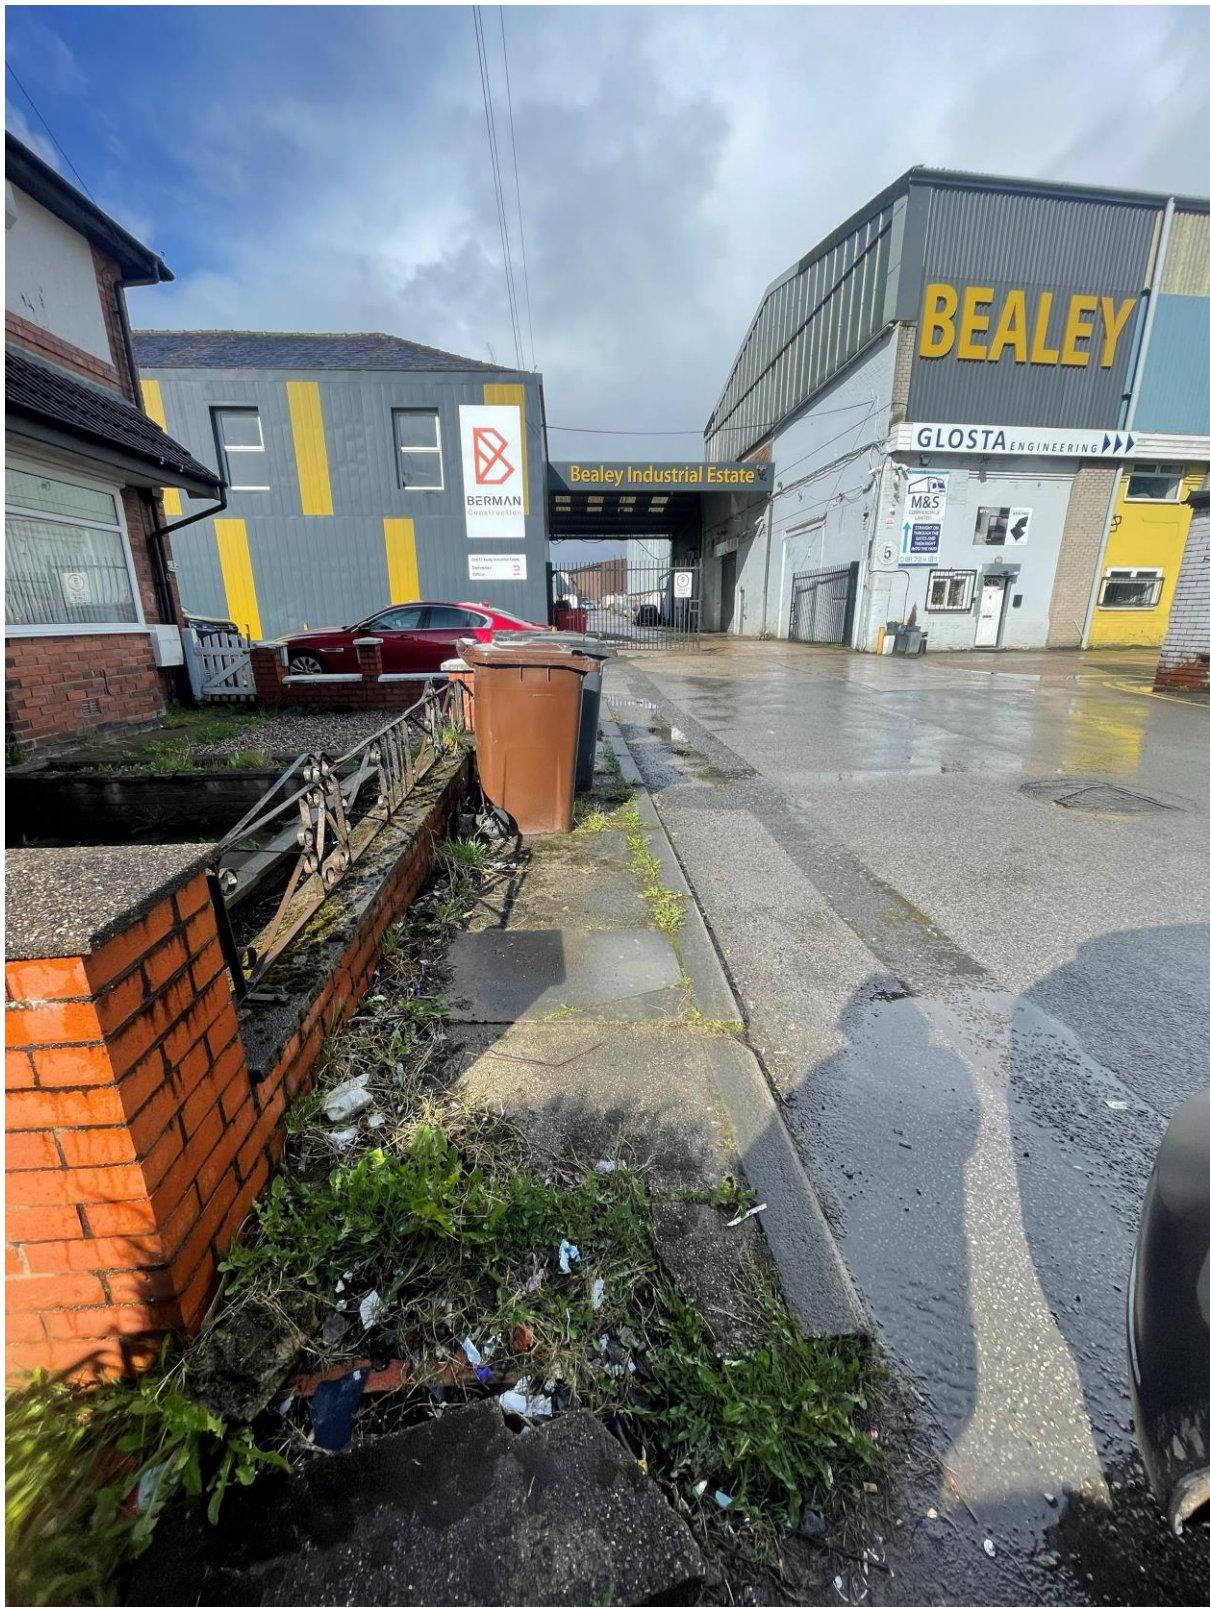
FRAME 17

| <b>17</b> | Kerb line consistent, kerbs well-worn and damaged. Weeds at the back of kerb line. | Footpath damaged, uneven with poor condition. Footpath covered in weeds and rubbish. | Utilities patch running though carriageway. | Carriageway in reasonable condition. Kerbs and footpaths poor. |

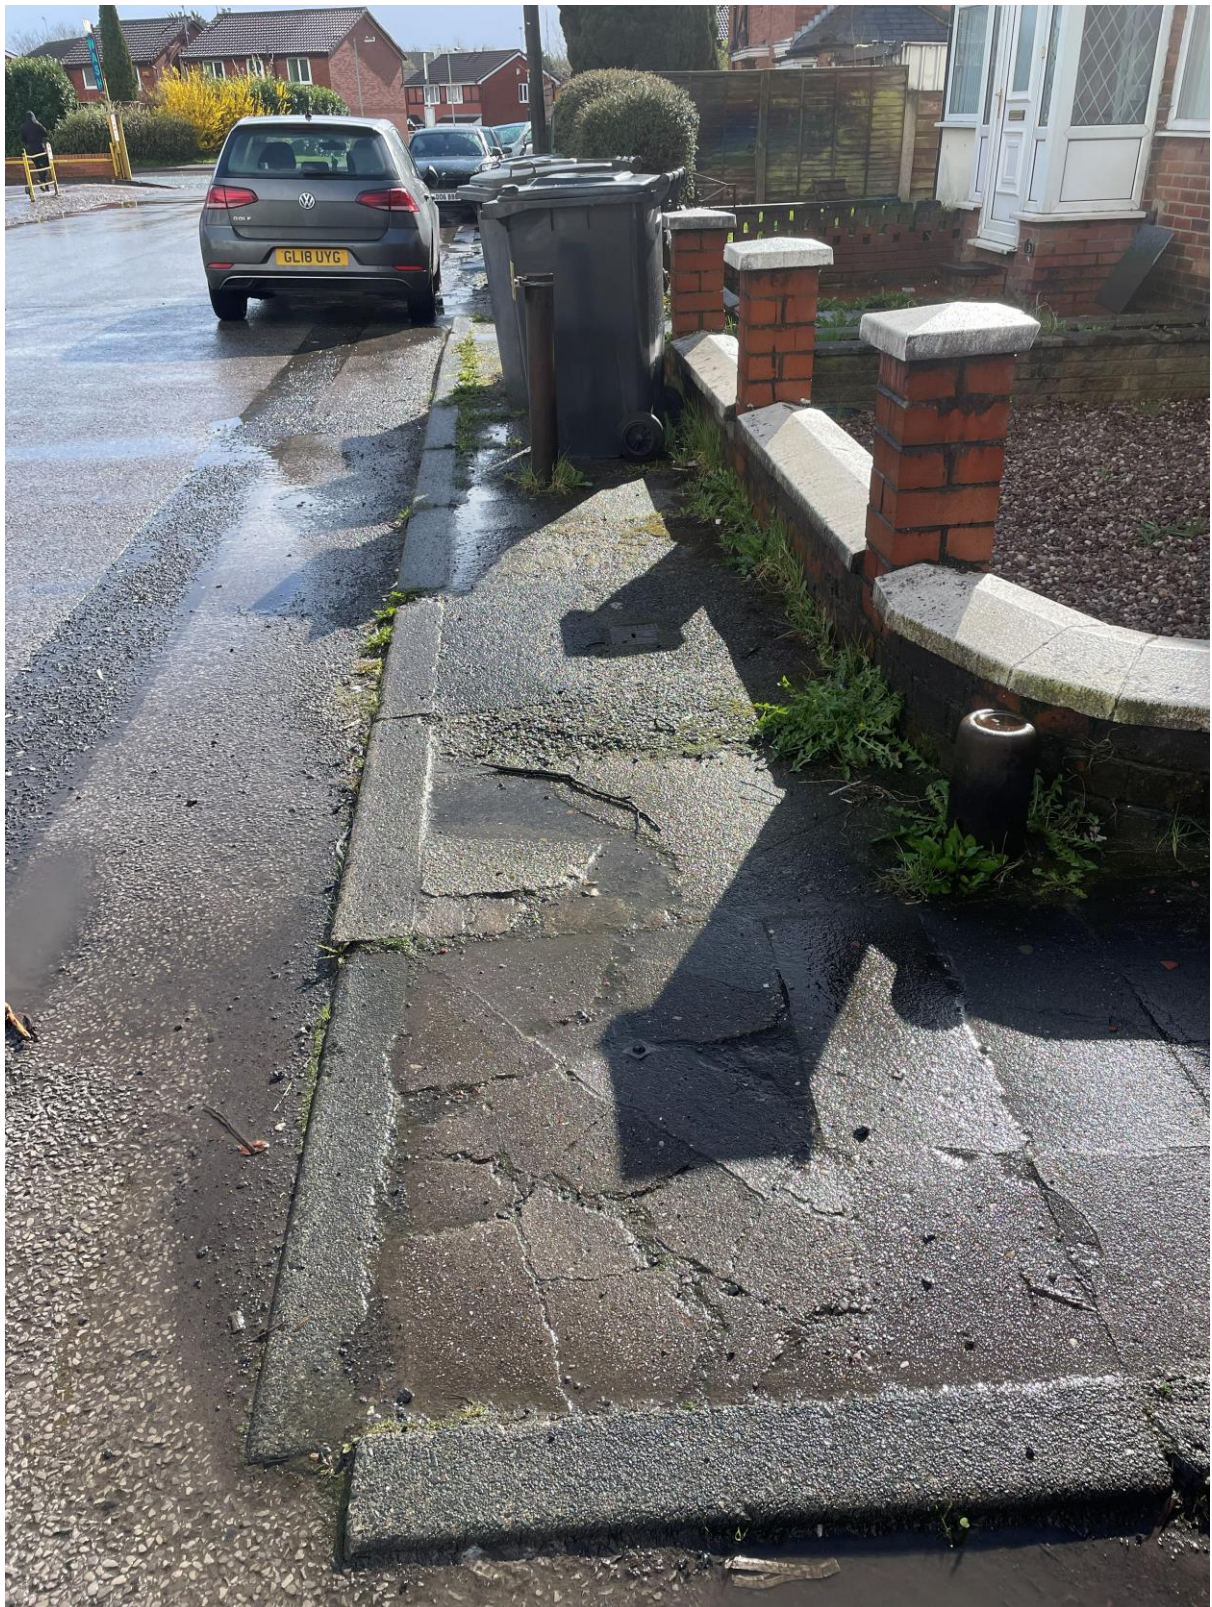
FRAME 18

| <b>18</b> | Kerbs well worn, running flush with carriageway. Weeds running along kerb line. | Footpath damaged with cracked flags, weeds running along back of footpath. | Reasonable condition. Utilities patch running though carriageway. | Reasonable Condition |

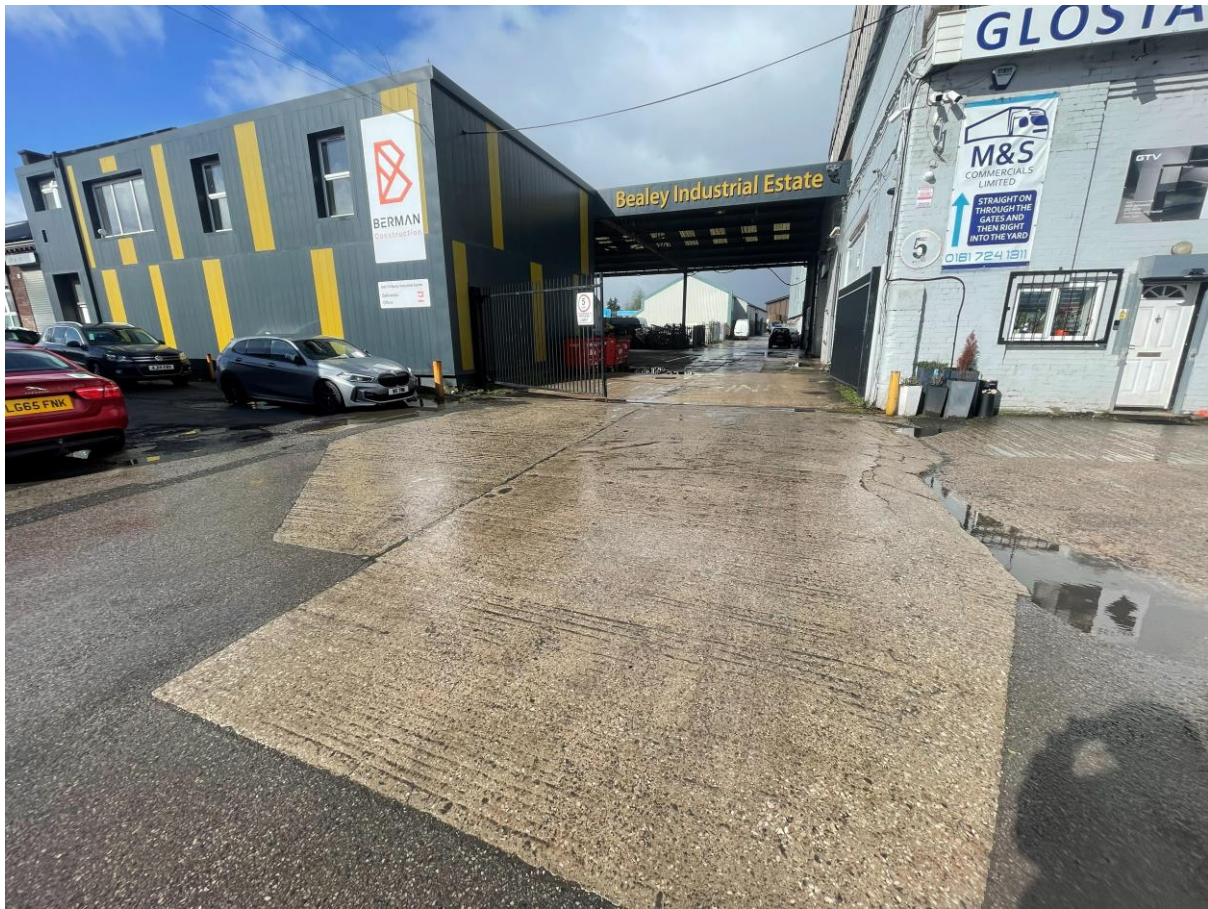
FRAME 19

| <b>19</b> | N/a | N/a | Carriageway surfacing material changed, cracking and ponding due to level change. | Poor condition |

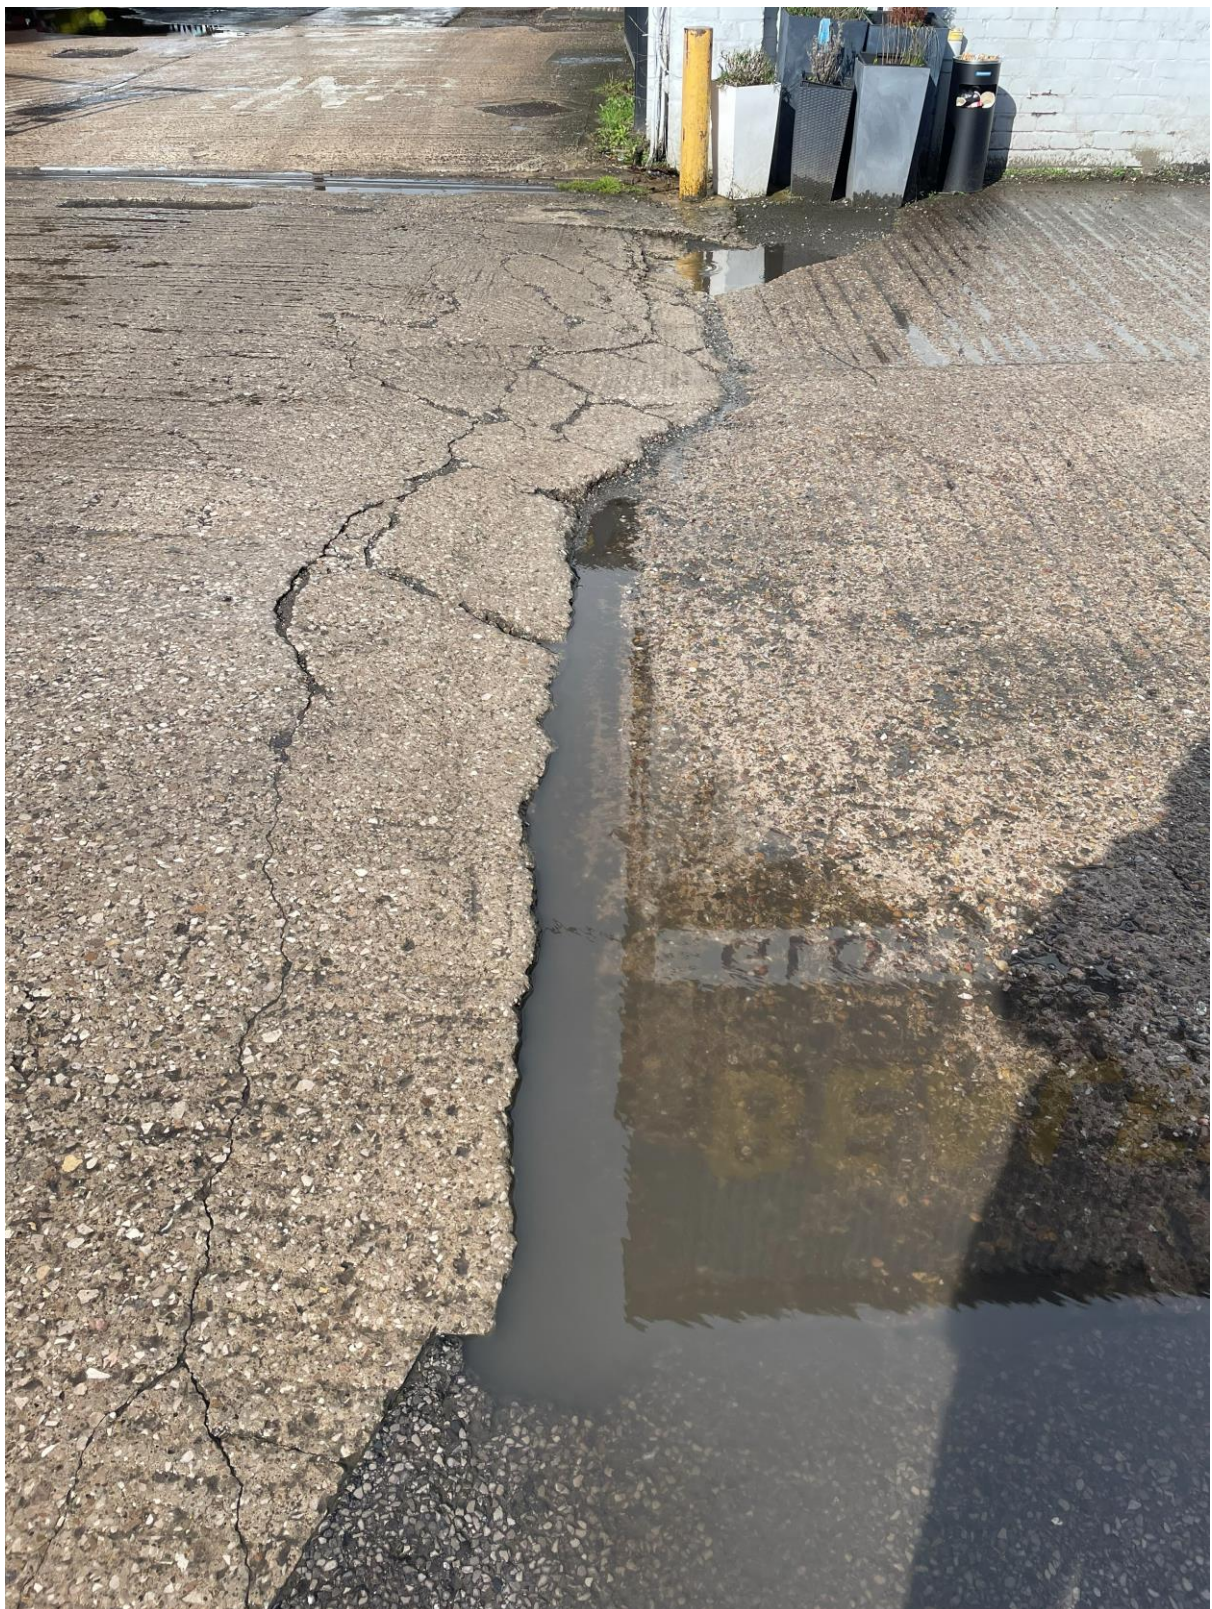
FRAME 20

| <b>20</b> | N/a | N/a | Carriageway surfacing material changed, cracking and ponding due to level change. | Poor condition |

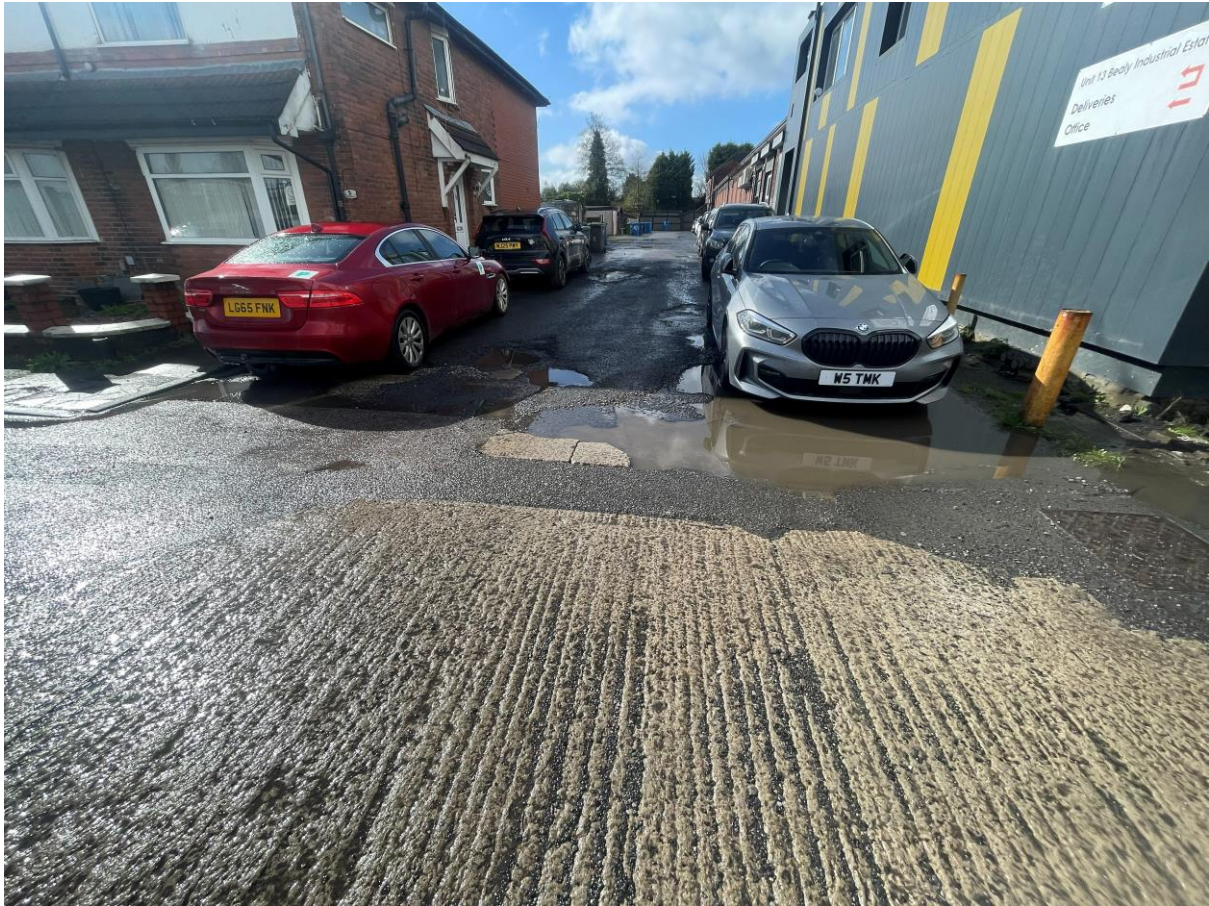
FRAME 21

| <b>21</b> | N/a | N/a | Carriageway surfacing material changed, cracking and ponding. Ironworks in reasonable condition. | Poor condition |

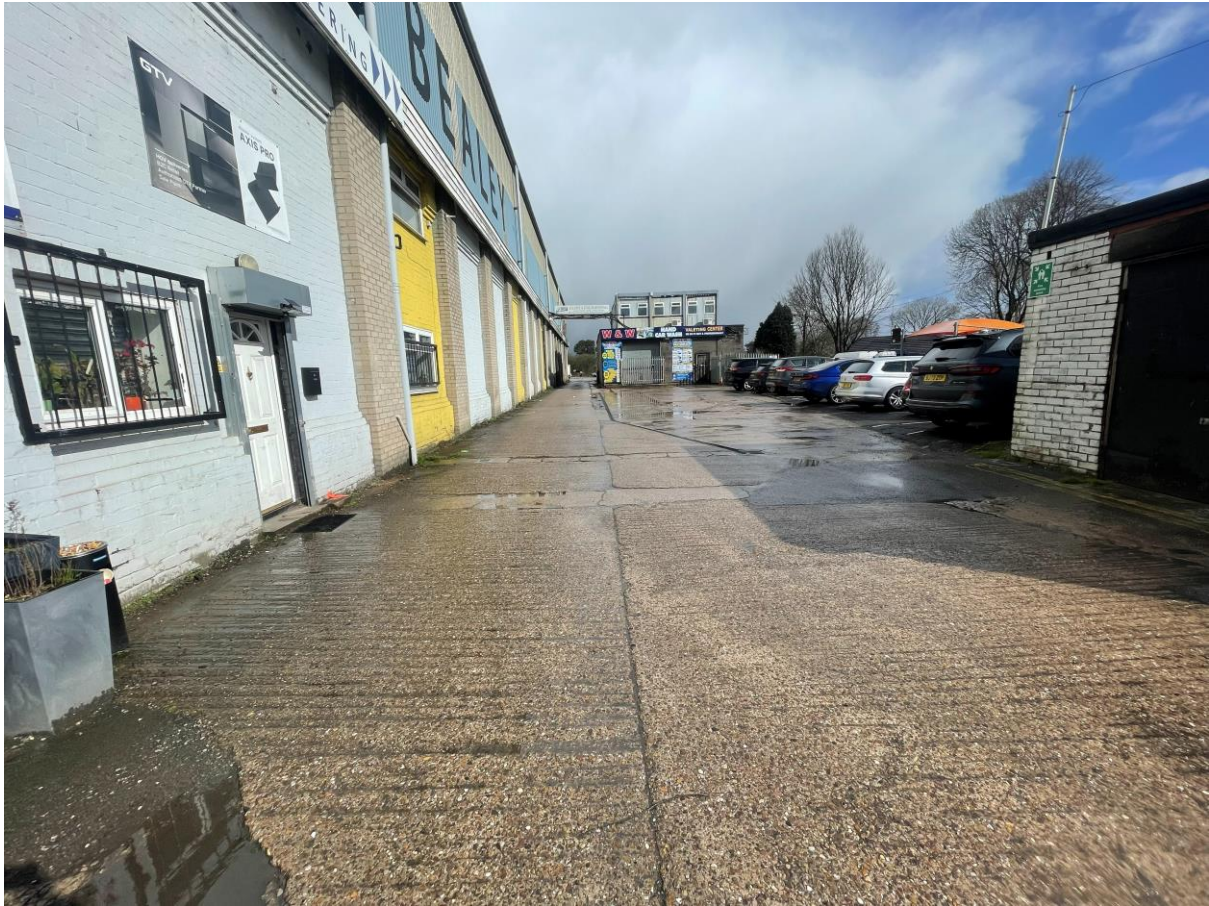
FRAME 22

| <b>22</b> | N/a | N/a | Surfacing in poor condition, uneven surfacing, cracking in material with utilities works patches. | Poor condition |

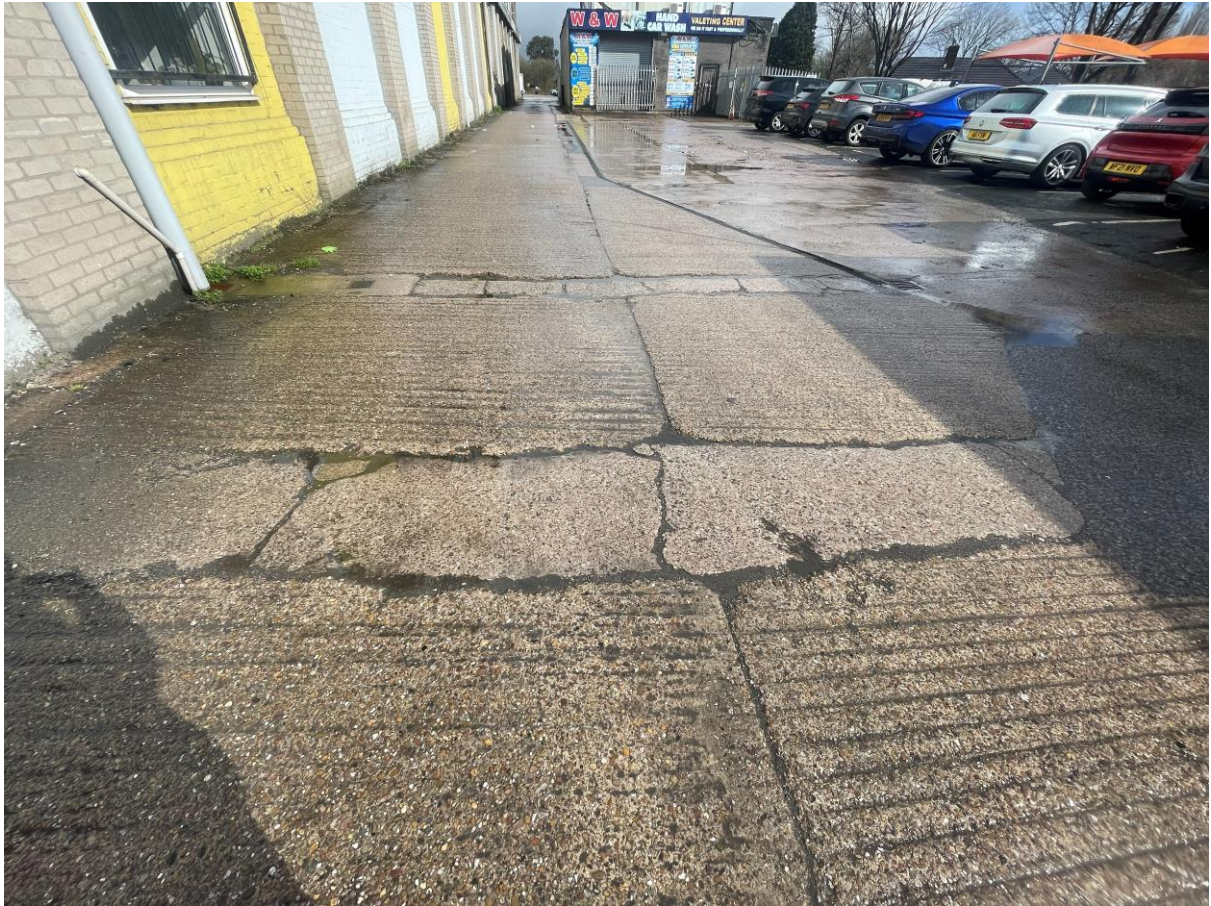
FRAME 23

| <b>23</b> | N/a | N/a | Surfacing in poor condition, uneven surfacing, cracking in material with utilities works patches. | Poor condition |

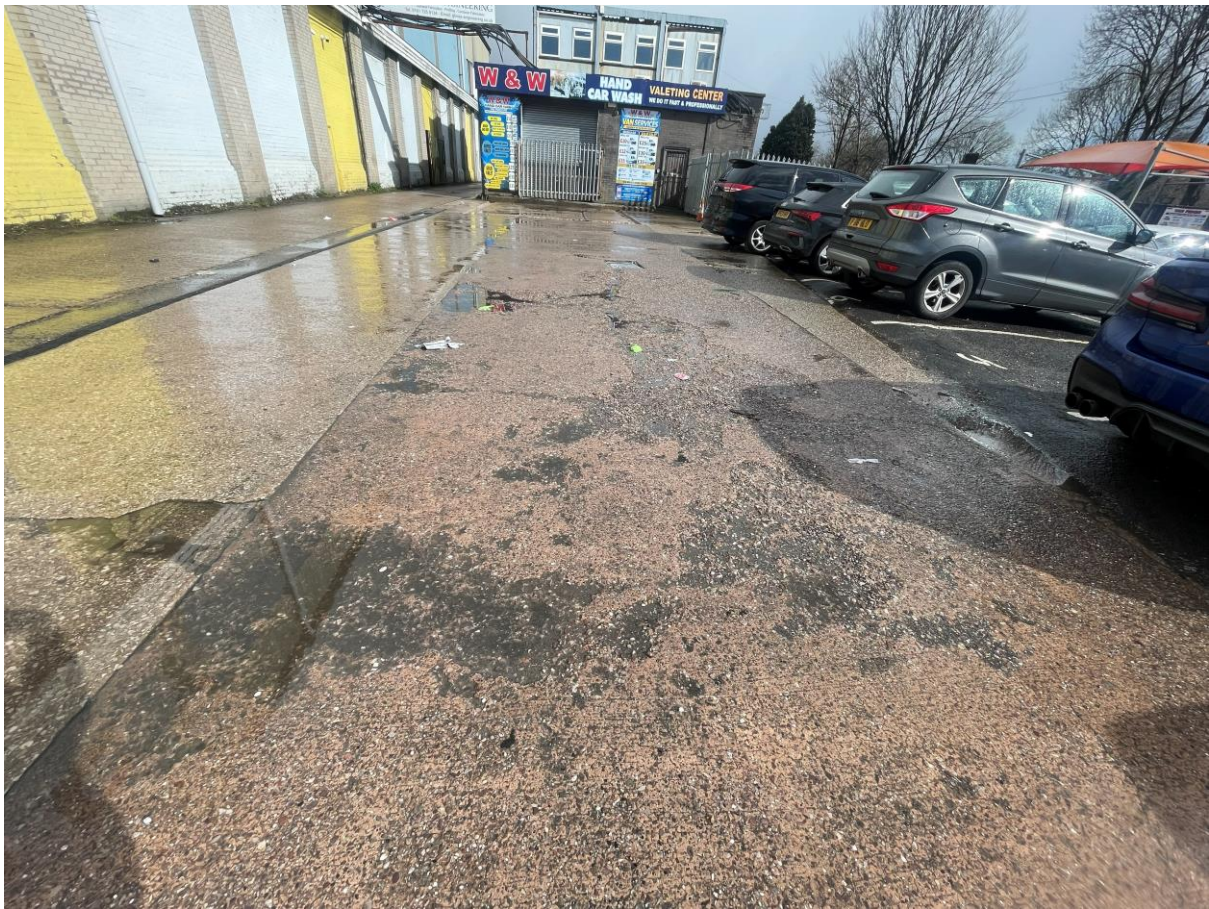
FRAME 24

| <b>24</b> | N/a | N/a | Tarmacked Car park to the right-hand side. Potholes and ponding with patched surfacing. | Poor condition |

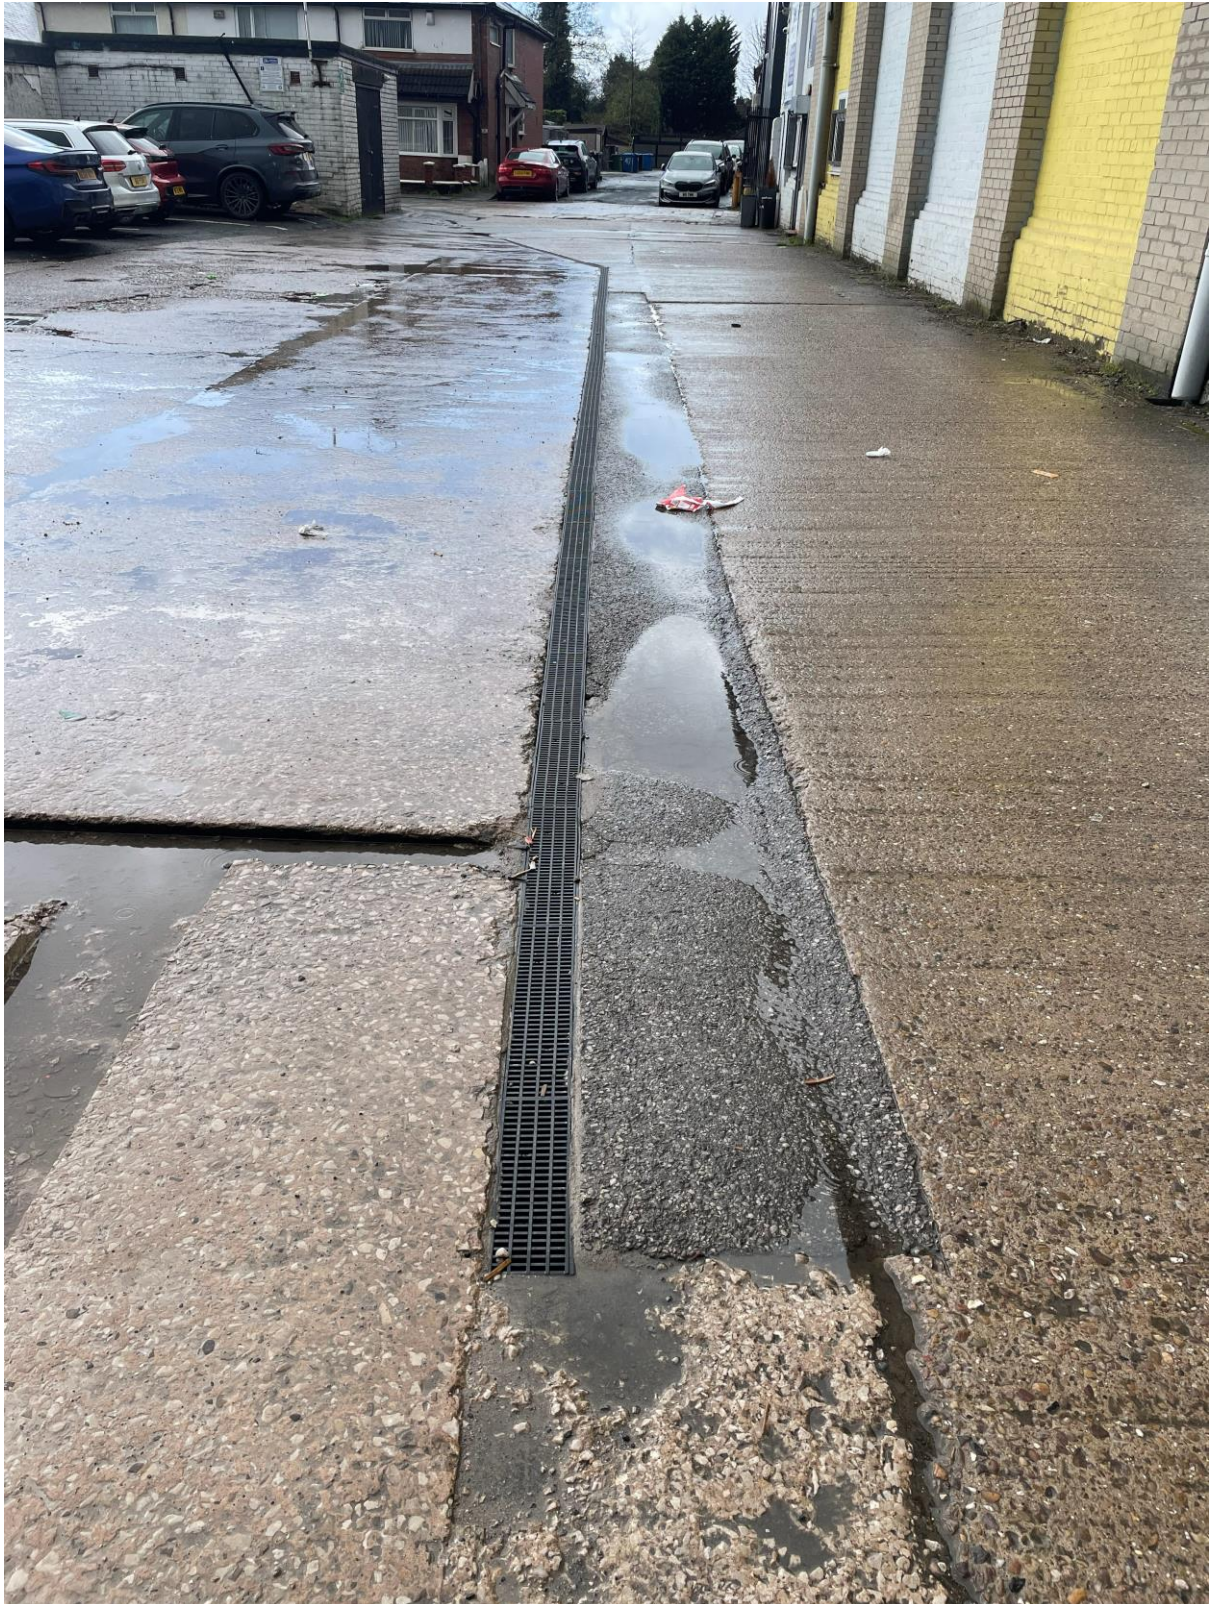
FRAME 25

| <b>25</b> | N/a | N/a | Utilities trench patches. | Poor condition |

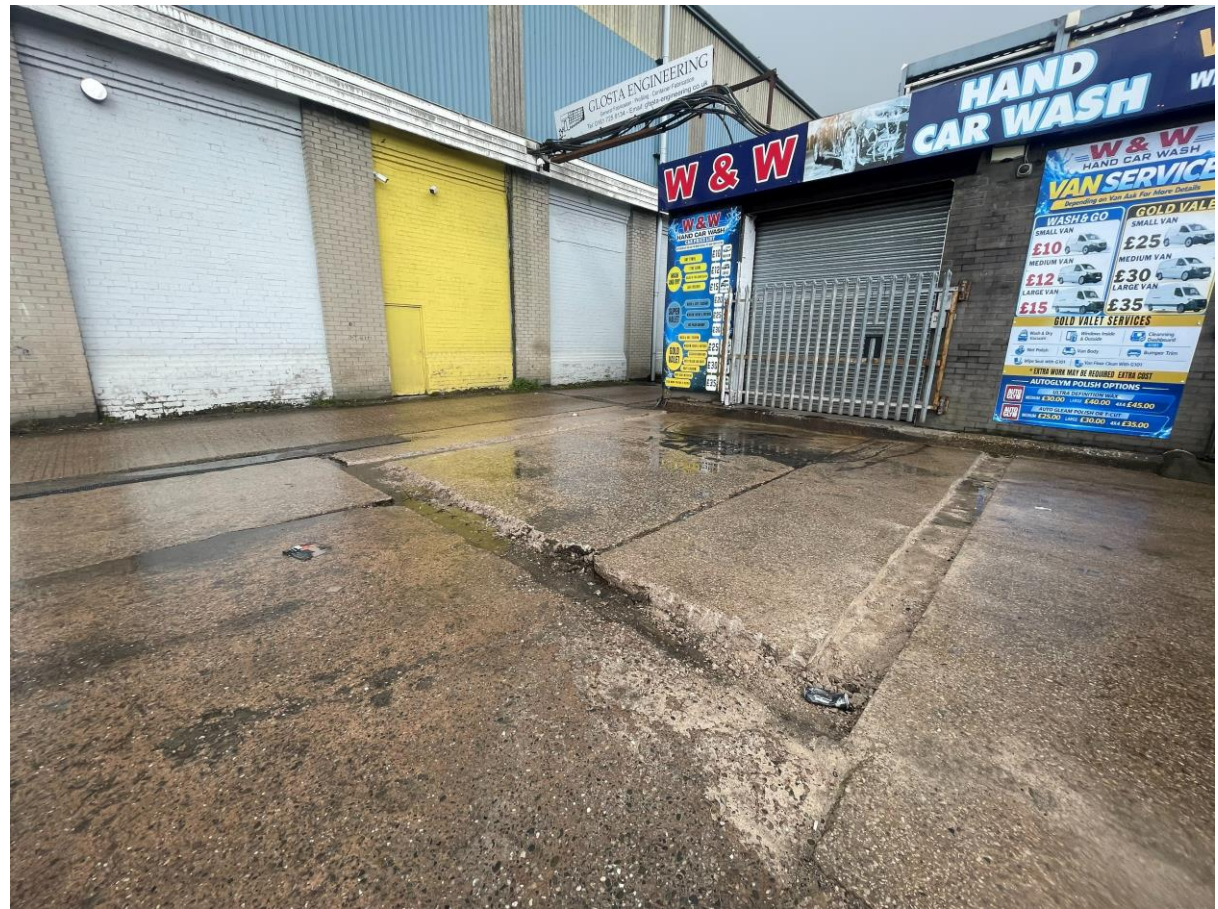
| <b>26</b> | N/a | N/a | Surfacing in poor condition, uneven surfacing, cracking in material with ponding. | Poor condition |

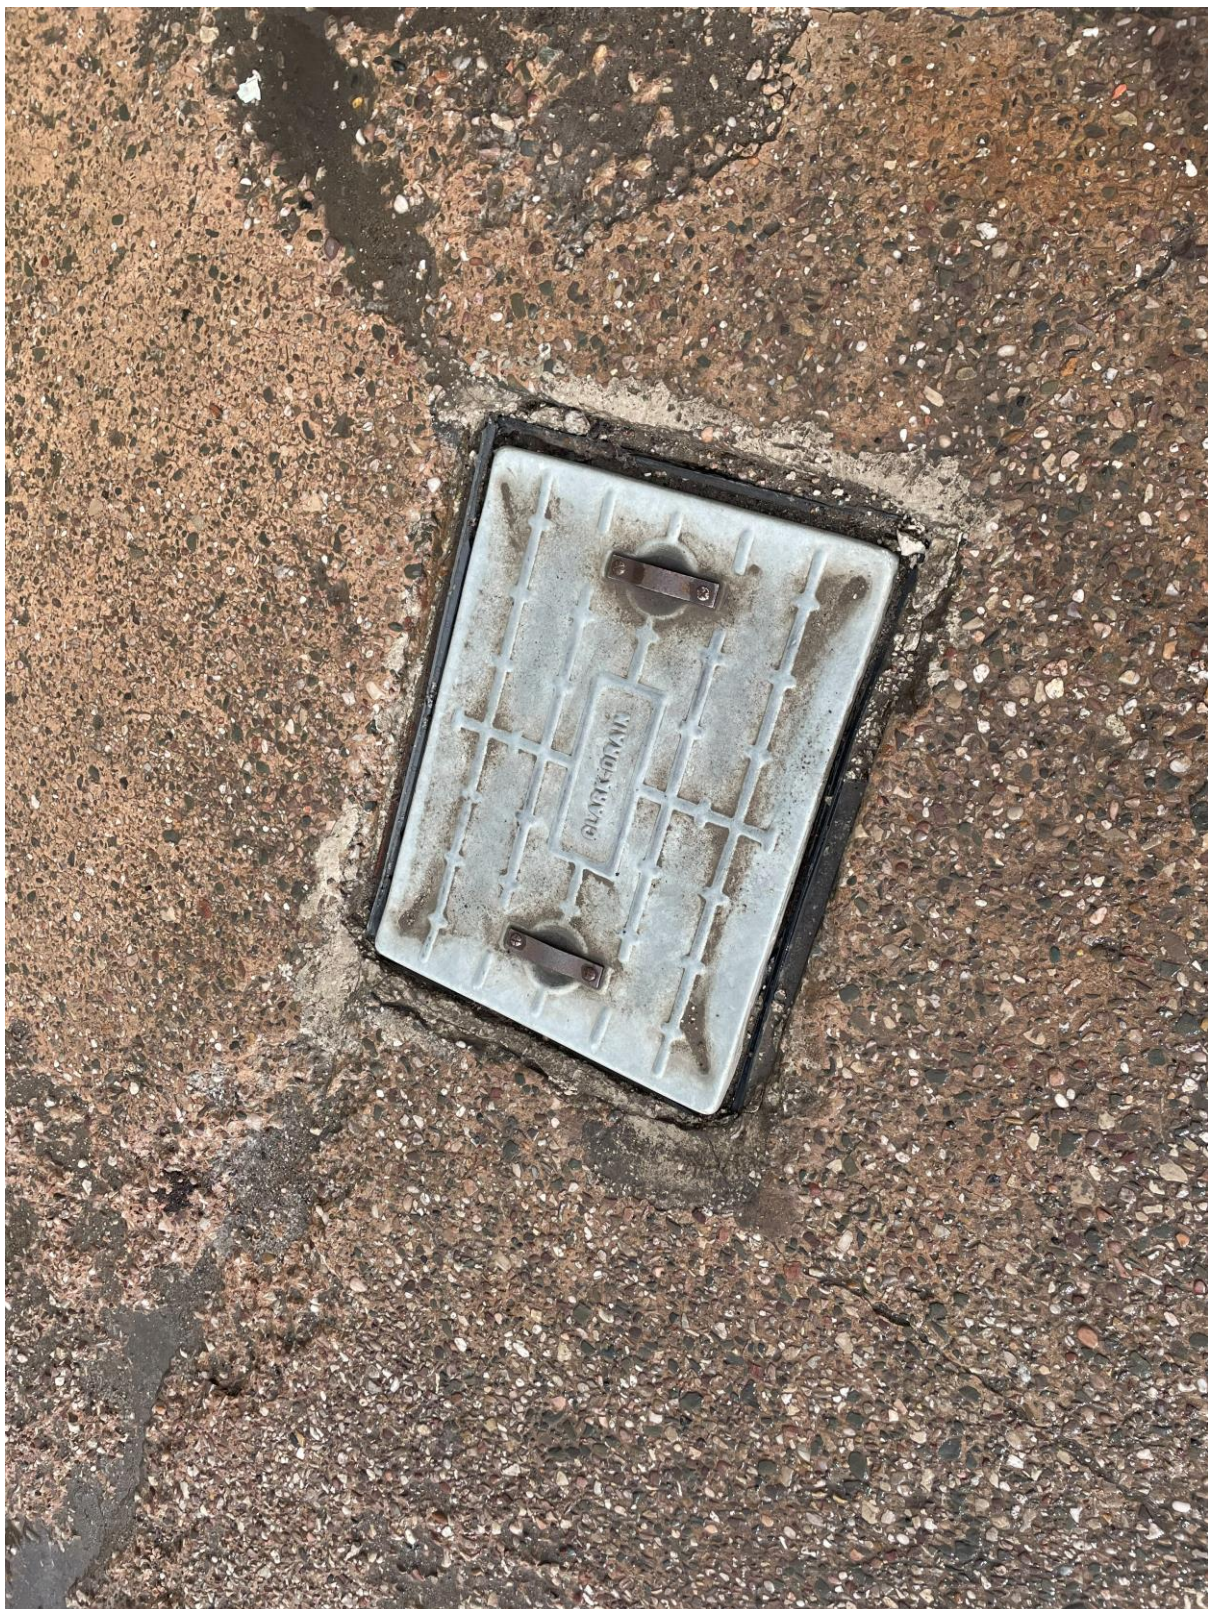
FRAME 27

| <b>27</b> | N/a | N/a | Clark drain positioned in carriageway, damaged worn-down lid. | Poor condition. |
