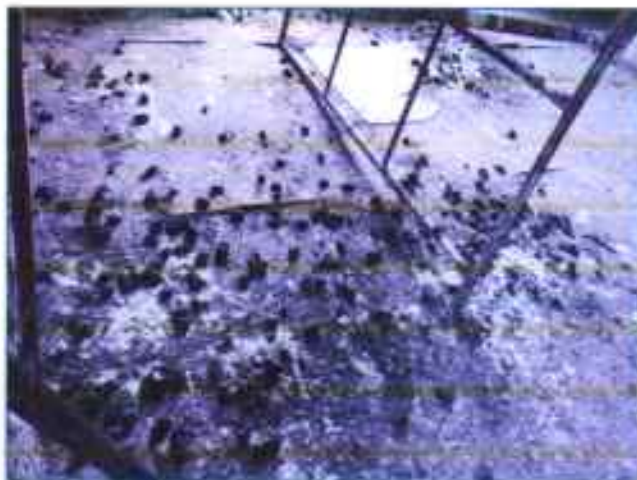
- 7.2.8 Upon inspection of the first floor void of the building it was evident that barn owl, a Schedule 1 species, have been roosting within first floor void, entering through the broken window. A small scaffold platform provides an ideal roosting space. Numerous pellets of a size and shape typical of barn owl were present, containing fur and bones of small mammals including field vole. Droppings were also evident.

*Barn owl pellets on the first floor*

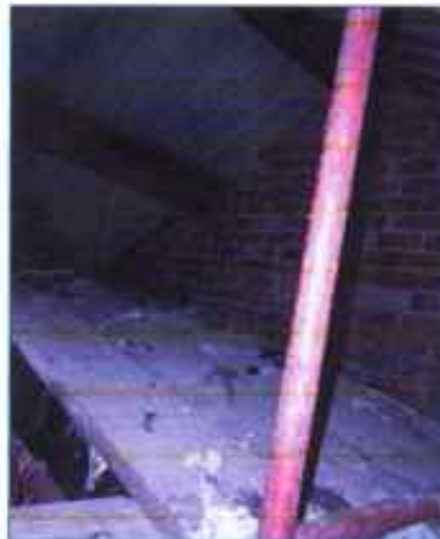
- 7.2.9 No evidence of nesting was observed when the platform present was inspected, for example, few feathers were present, no fragments of shell, unhatched eggs, or deep layers of pellets.
- 7.2.10 Compensation measures to replace the roost site will be required, along with appropriate avoidance mitigation to prevent harm and unnecessary disturbance to barn owl during any works on site.

*Barn owl pellets on the platform*
