# Preliminary Roost Assessment

The Garage at  
41 Bury Old Road  
Ainsworth  
BL2 5PF

# Gritstone Ecology

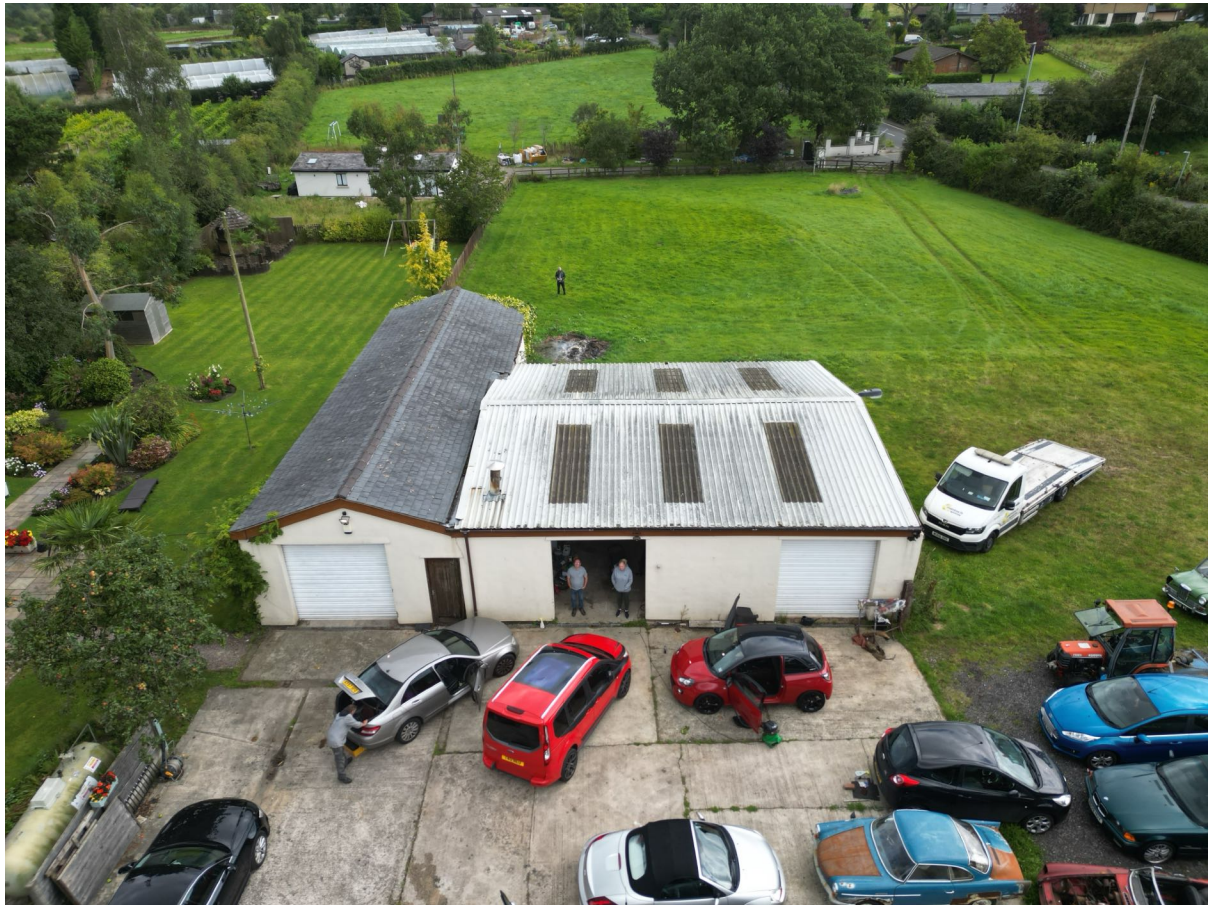
3.1a – The front of the garage.

The building is well maintained, and in good condition. Roof tiles are tightly fitted with no damaged, missing, or slipped tiles. Ridge tiles are tightly fitted, and fixed in place with cement. End tiles at the verges are sealed with cement. There are no gaps between roofing materials. UPVC fascia boards are fixed tightly against walls with no suitable gaps. Walls are in good condition with no gaps or cracks, and no missing mortar.

There are no features externally which are likely be used by roosting bats, and no indications of use by bats were present during the inspection.

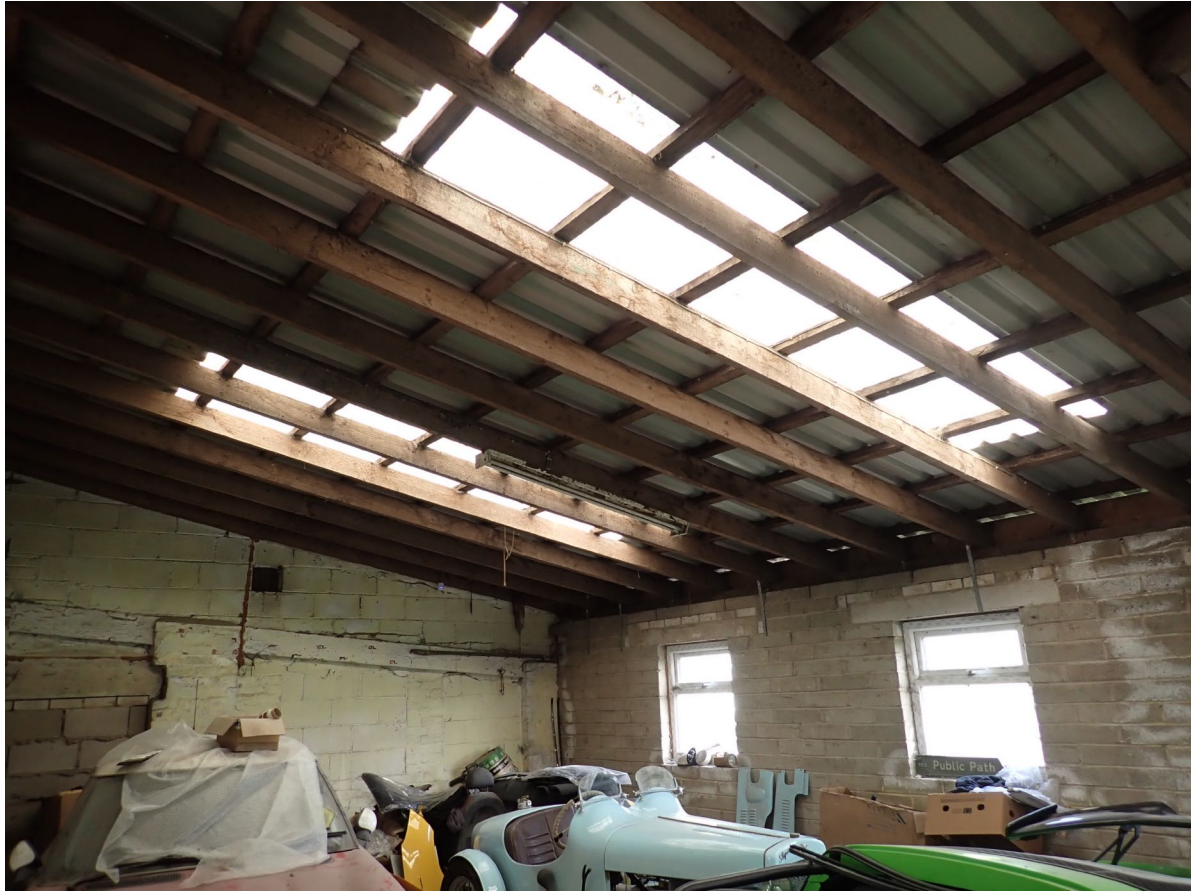
3.2a – Inside the garage.

Roof timbers are fixed tightly against the inside of the gable end walls with no suitable gaps, and fixed to the top of blockwork at the wall-plate. Timbers are dusty and cobwebbed. Roof lining in the western section is intact with no tears or gaps, and there are no holes or gaps in the roof which could give access to roosting bats. The building is well lit by natural light, and subject to daily disturbance.

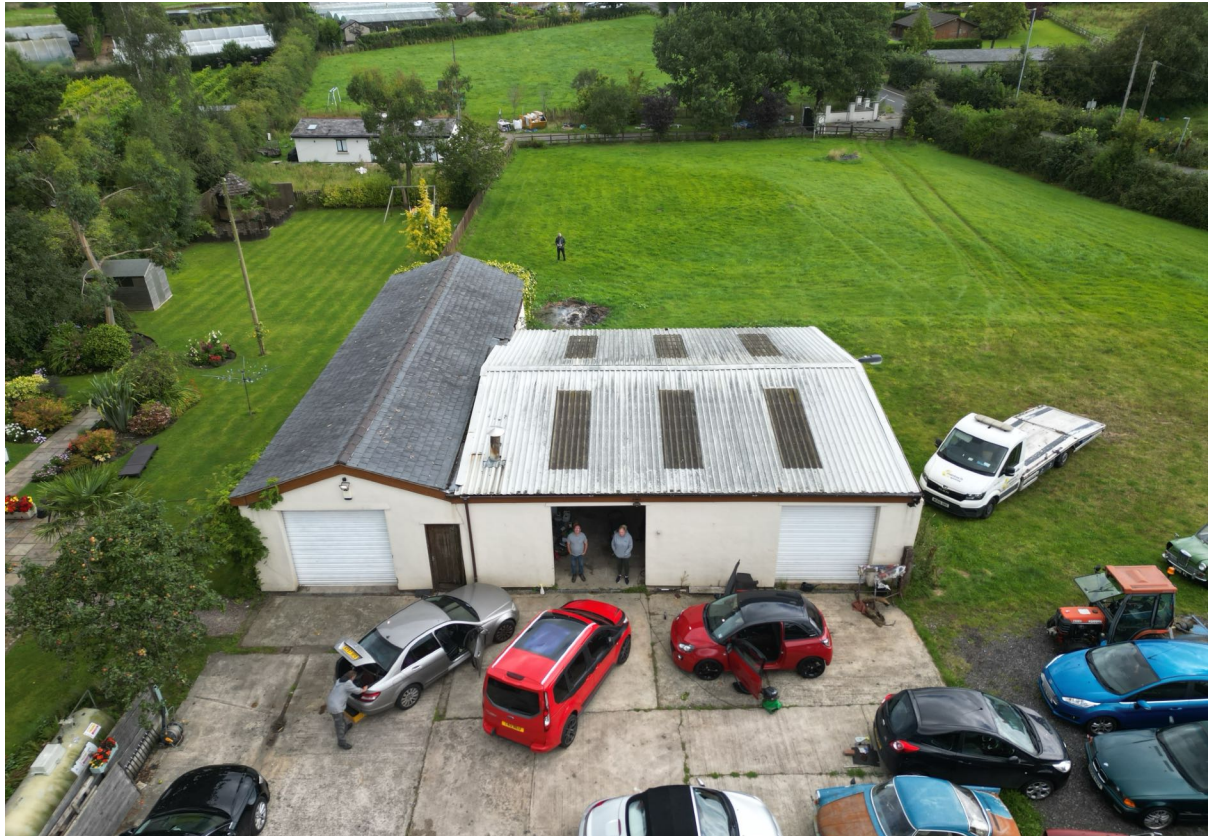
1 – The south side of the garage.

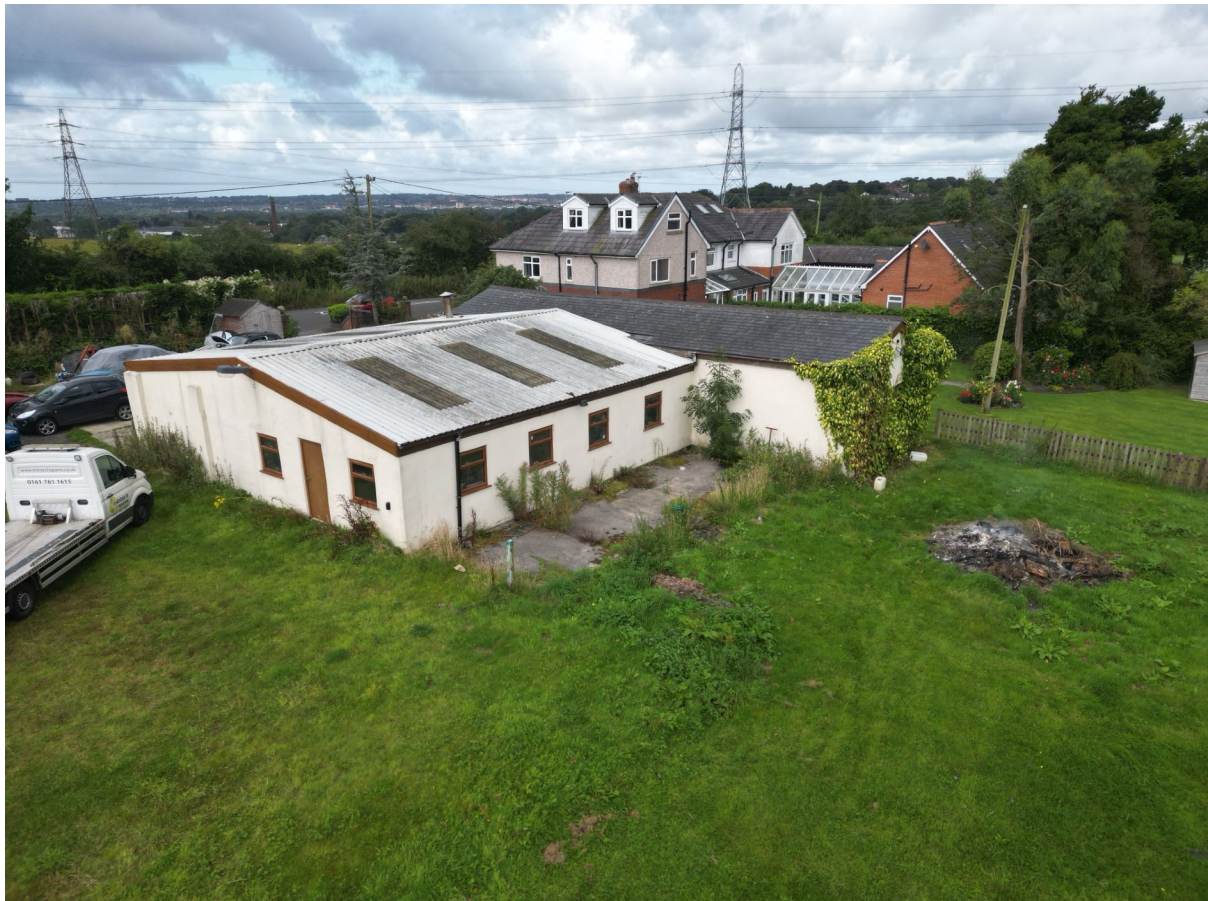
2 – The north and east sides of the garage.

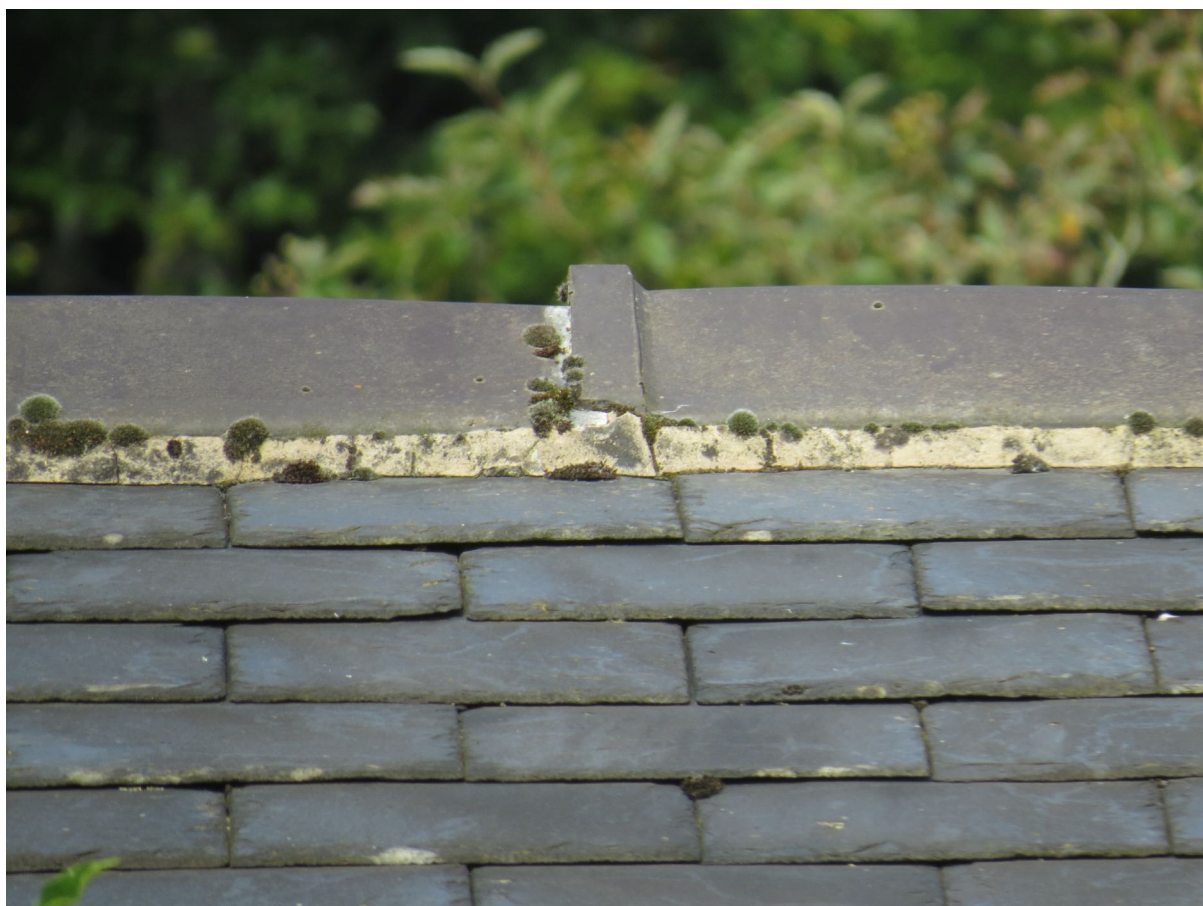
3 – Roof and ridge tiles are in good condition with no suitable gaps.

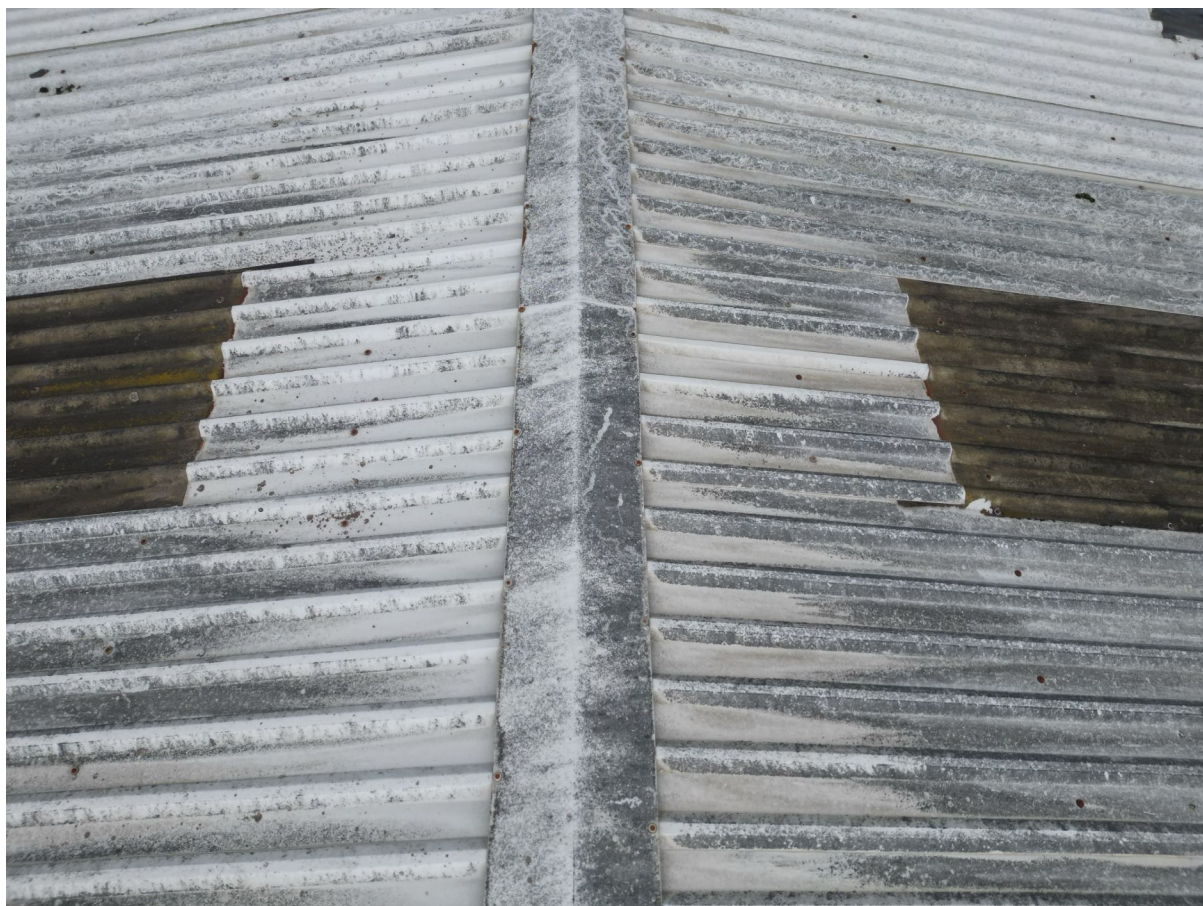
4 – Corrugated roof panels are fitted tightly with no gaps between panels.

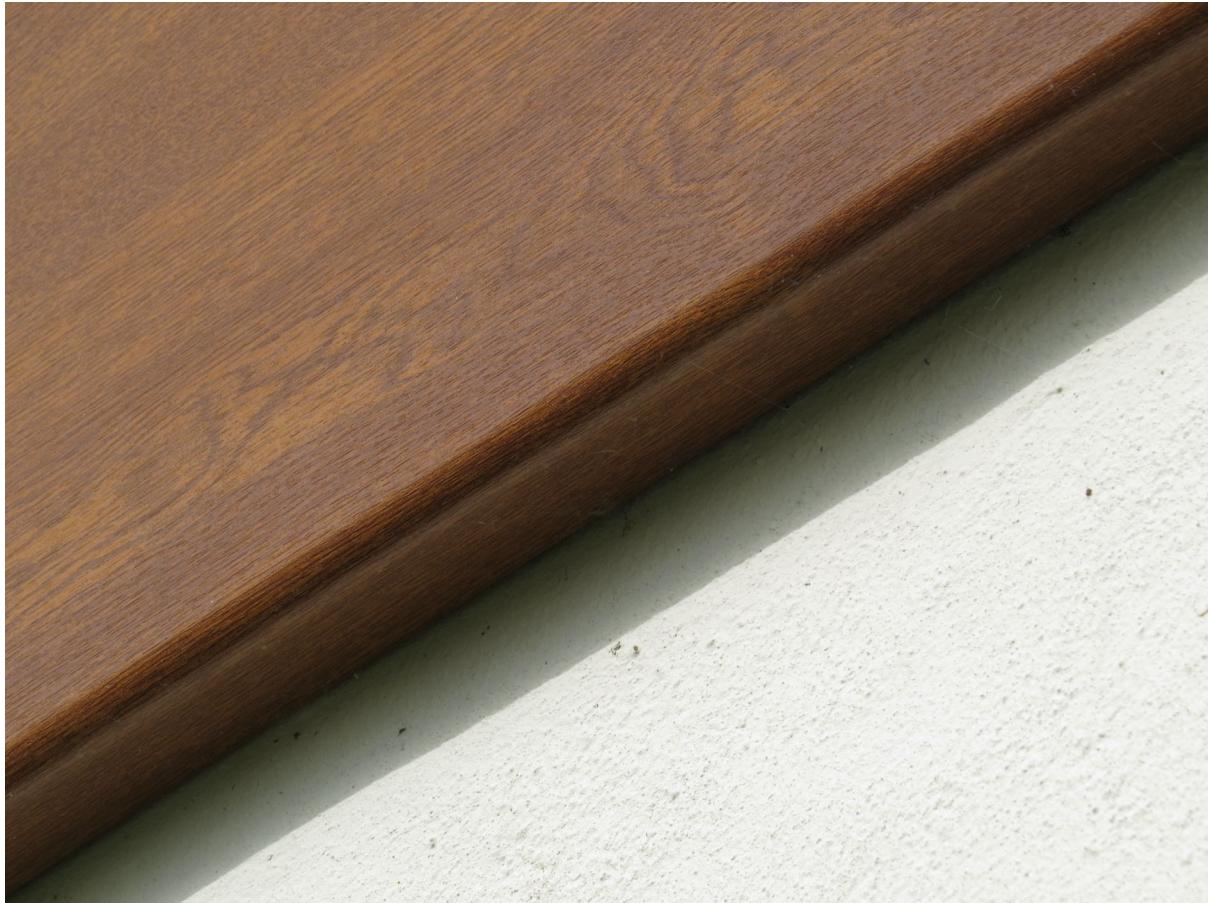
5 – UPVC fascia are tightly fitted with no suitable gaps.

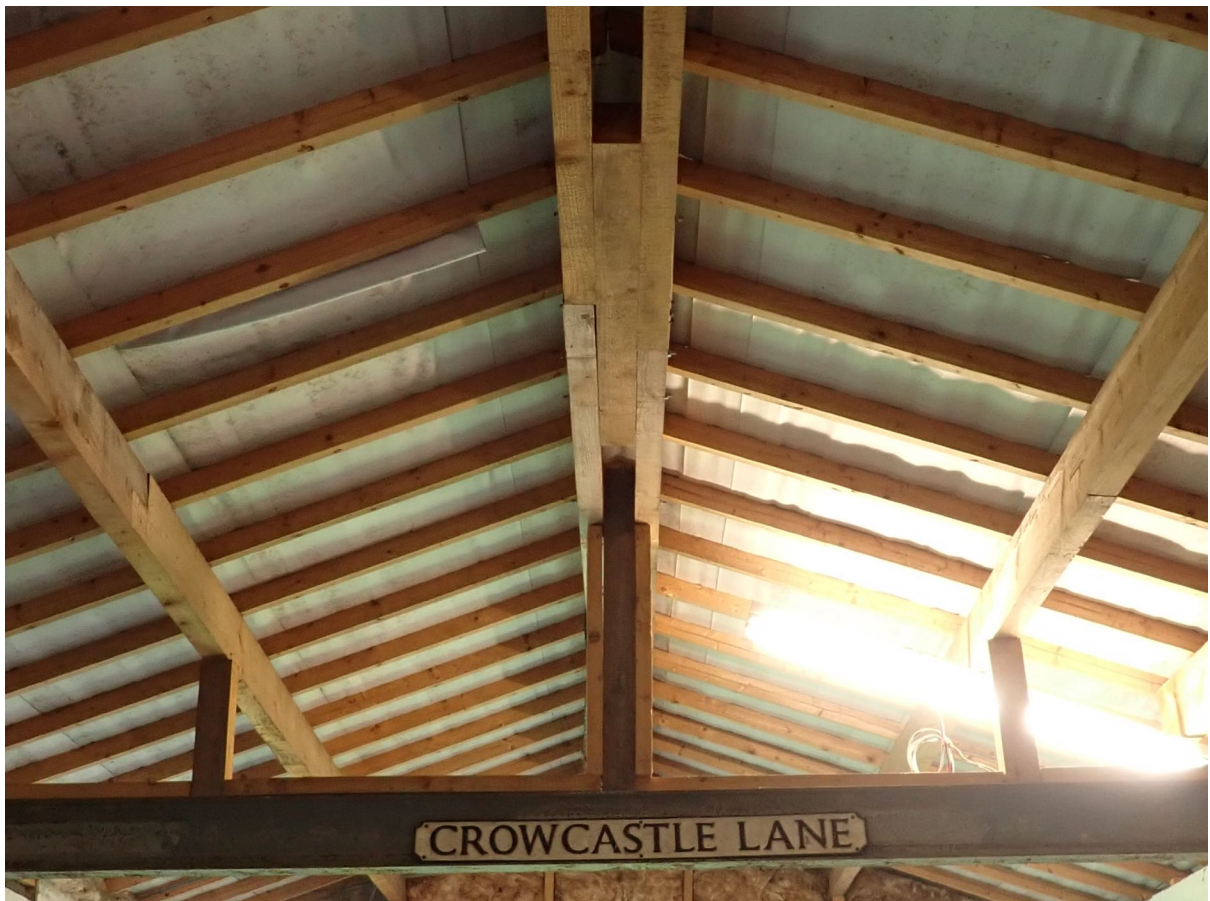
6 – The eastern section of the roof is lined with a modern breathable membrane.

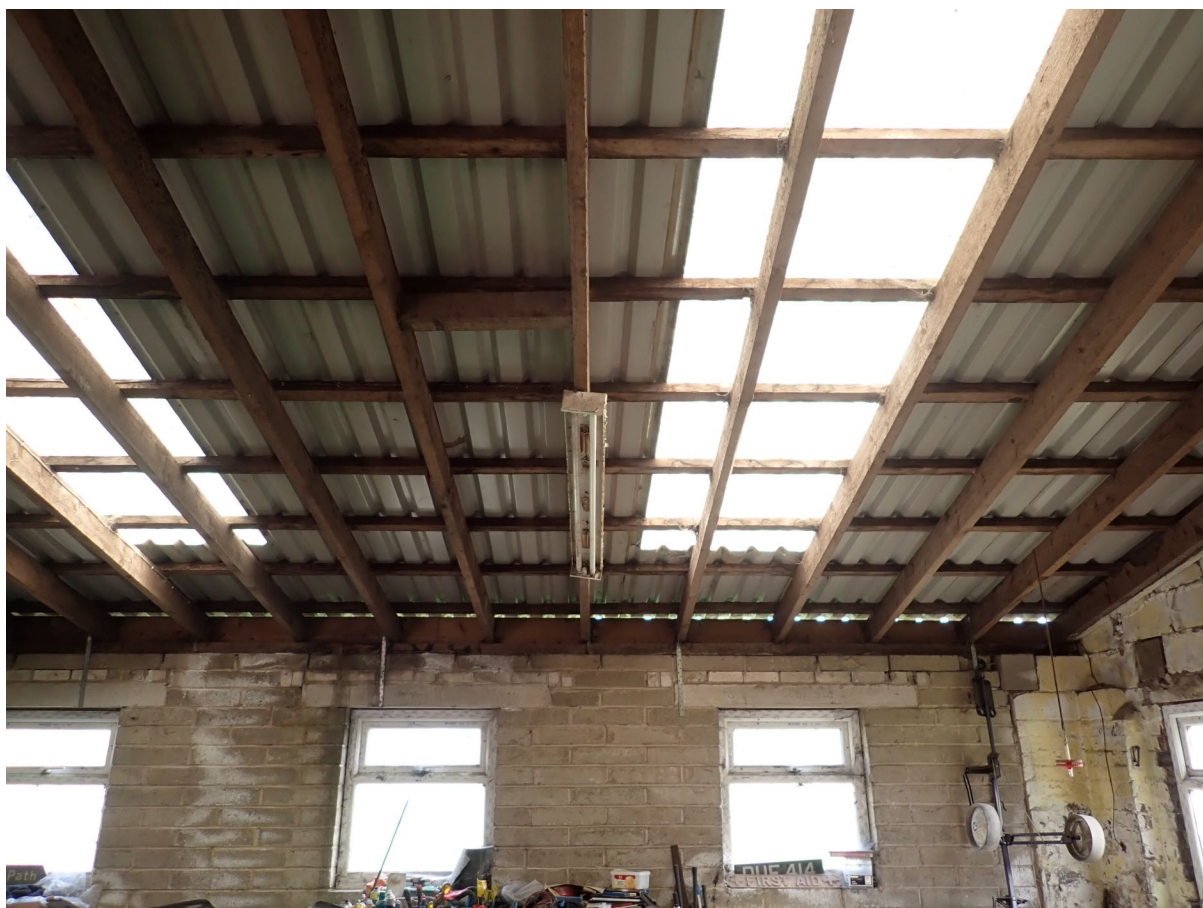
7 – The western section of the roof is not lined.

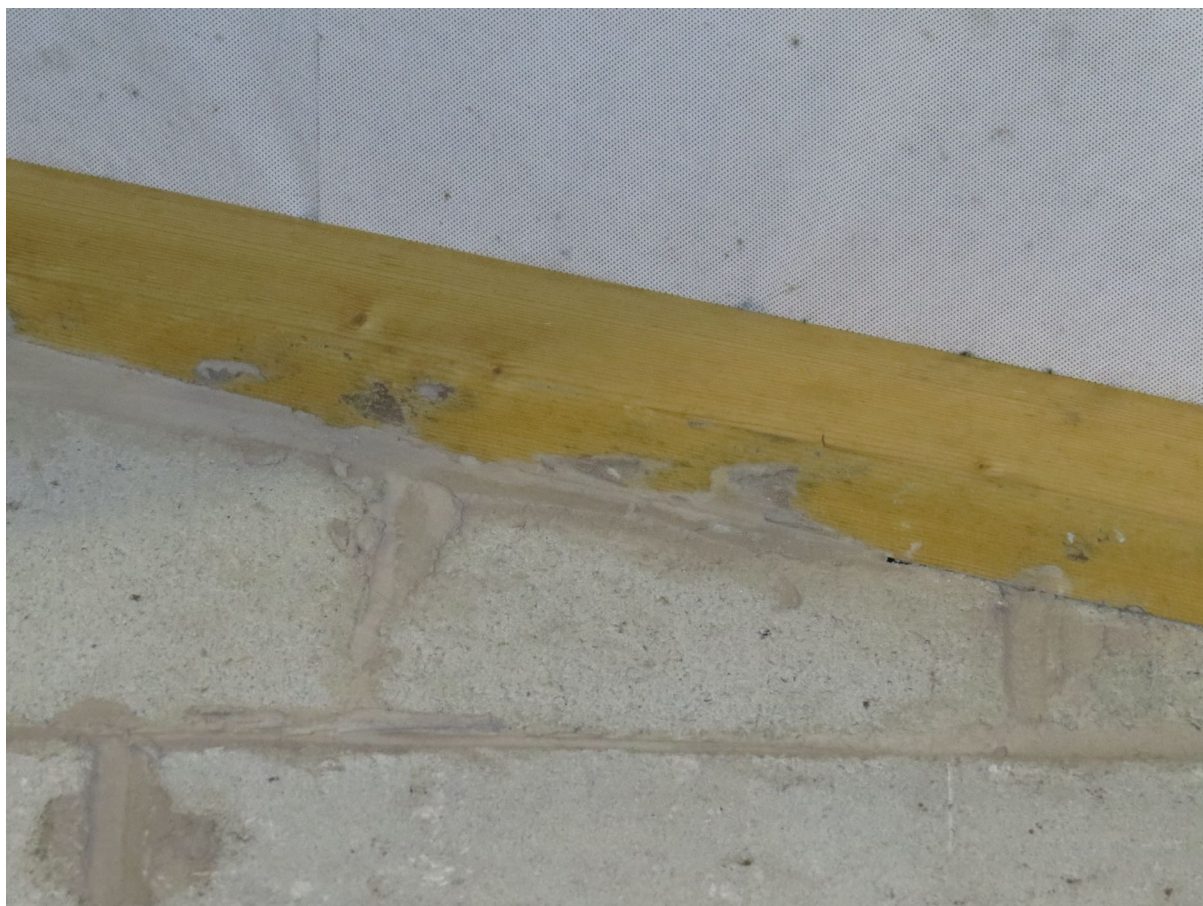
8 – Roof timbers are sealed against concrete block walls with no gaps.
