# *Martin Prescott Environmental Services*

## **Further Bat Survey of Industrial Buildings at Finishing Techniques, Holcombe Brook, Bury. 14.2.2012**

Surveyor- Martin Prescott, Lic. no. 2011/4572

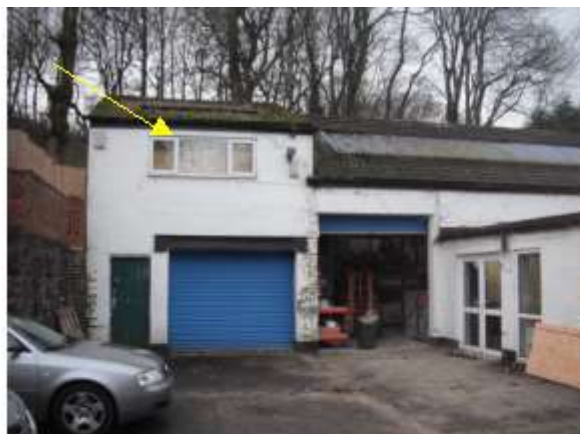
P1 SW aspect, occupied flat indicated

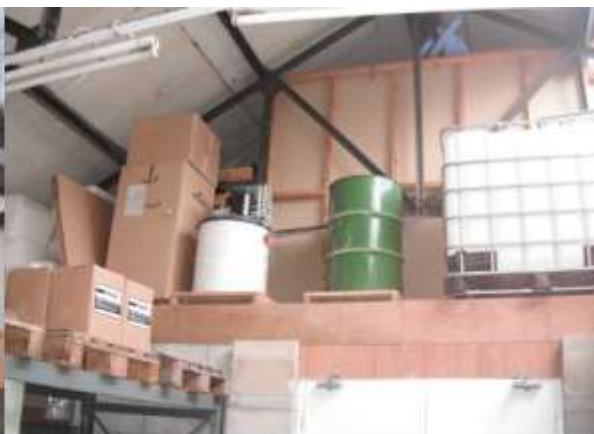
Storeroom, pitched tile roof with skylights, board-lined. Open void area, see photo.

No signs of bat occupation were found.

It was considered to have low bat roosting potential.

P2 Building 2, void beyond partition

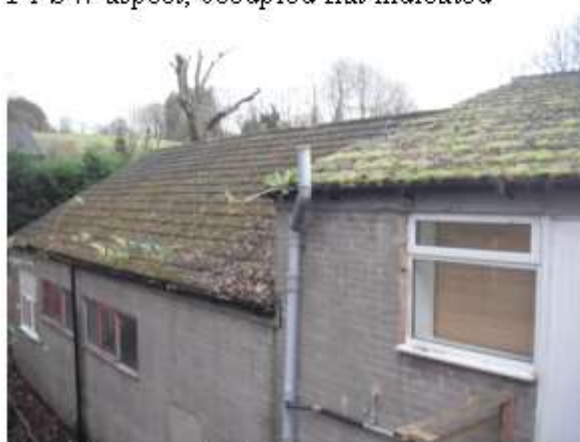
P3 NE aspect (rear)

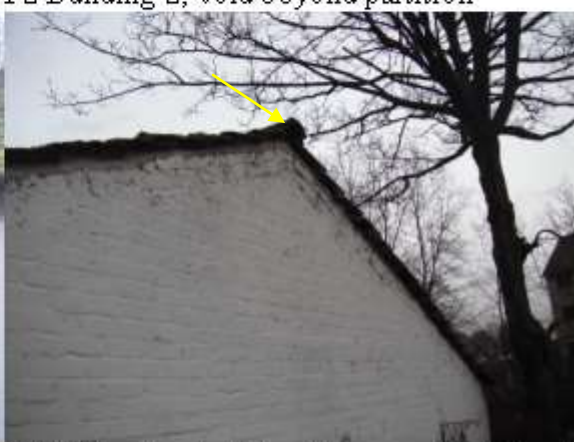
Gap under end ridge tile. This ridge tile was removed and the crevice underneath searched.

P4 NW gable (building 1) gap under ridge tile

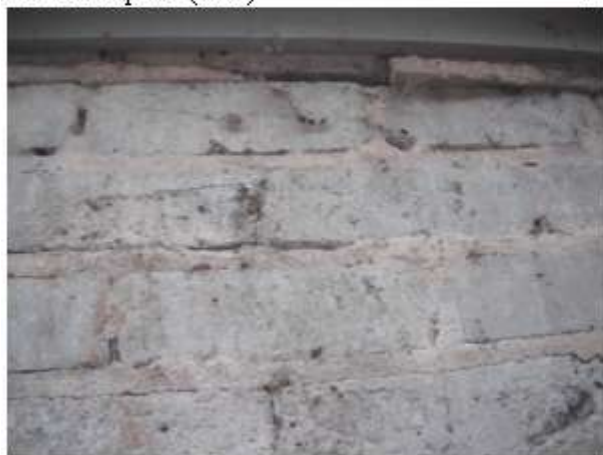
There were several gaps in masonry suitable for bat access

No droppings could be found on closer inspection

They were considered to have low bat roosting potential.

P5 Gap in masonry, building 6

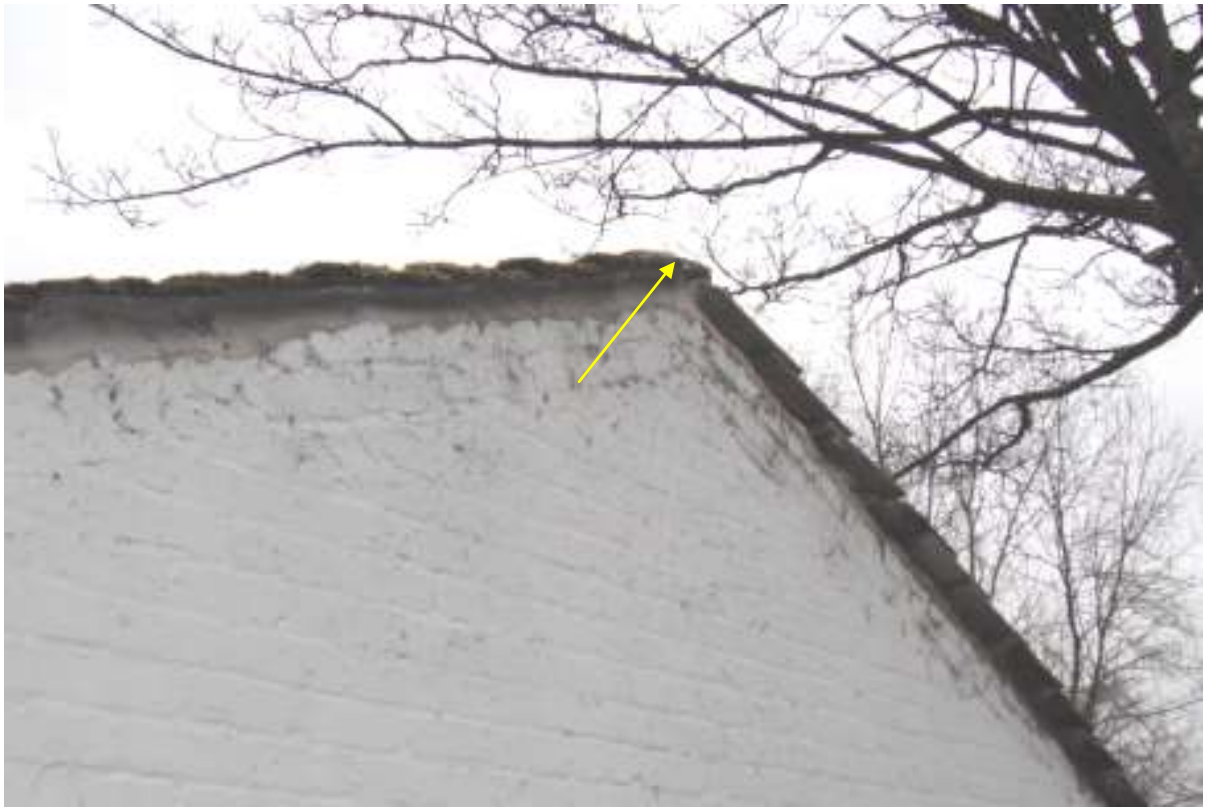
(P7) It was found to be a shallow crevice under the end tile only. No signs of bat occupation were found.

The chances of bat occupation were considered to be low.

P7, as P4 with ridge tile removed

The tile was replaced.
