# Whitehouse Farm Bat Assessment 2023

SEPTEMBER 12

Authored by: Daniel Lines

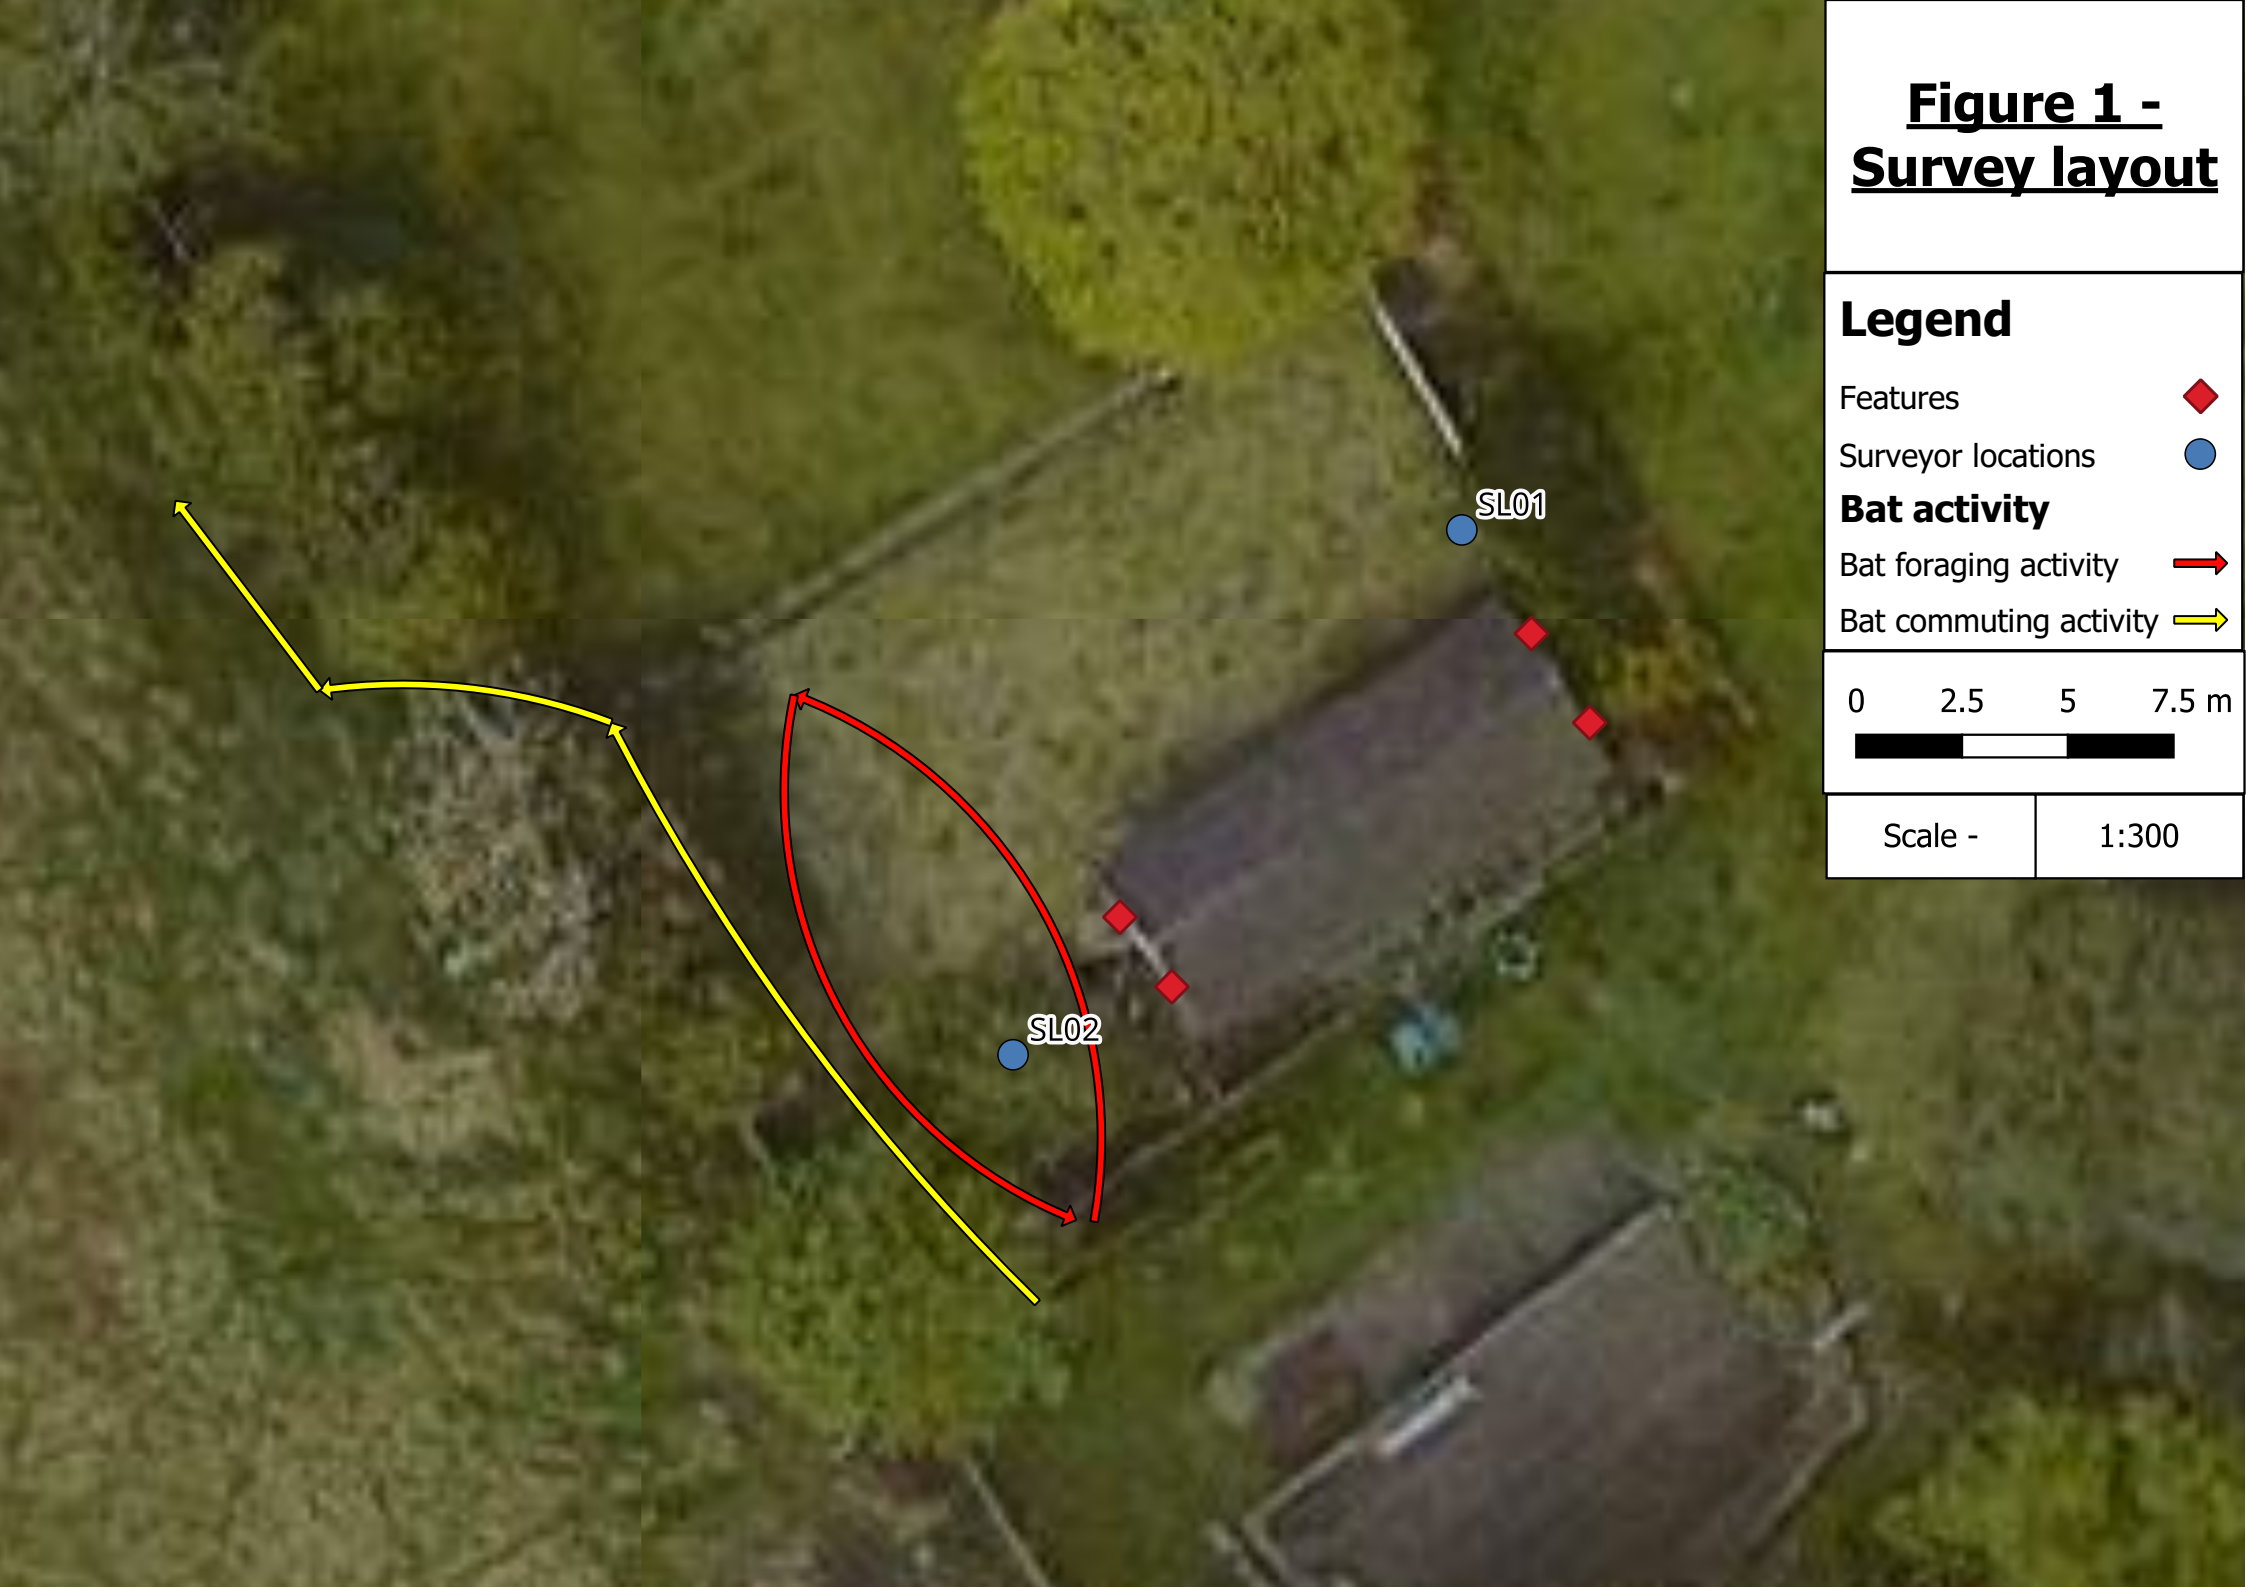
**Figure 1 -**  
**Survey layout**

- 3.3.2. Some foraging activity was observed to the north-west of the structure (Figure 1), however this was limited to one or two bats. At least three bats were also noted commuting along the hedgerow to the west of the property.

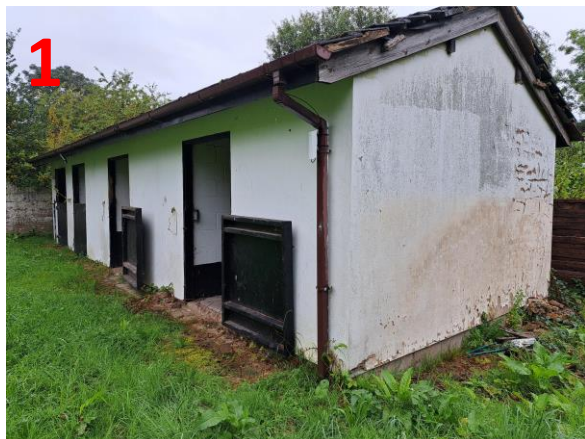
**Photo 1** – Outside of structure

- 2.3.5. The structure is in good condition with no cavities in the outer walls or facades (Appendix 1: Photo 1). At either end of the structure there are small gaps in the brickwork that lead into the interior of the structure (Appendix 1: Photo 2), the suitability of which is covered in section 3.3.7.

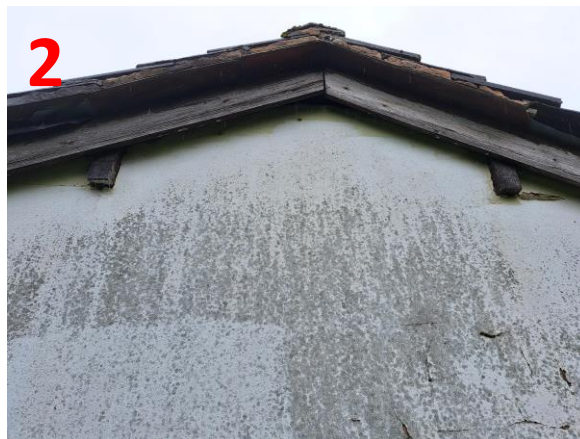
subject to regular disturbance from storage and maintenance. The interior walls and roof are in good condition with no cracks or crevices. As mentioned in section 3.3.5, there are small gaps in the brickwork at either end of the structure, but these lead directly outside with no sheltered space to support roosting bats. As such, all internal areas were assigned a negligible potential to support roosting bats.

**Photo 2** – Gaps between roof and brickwork

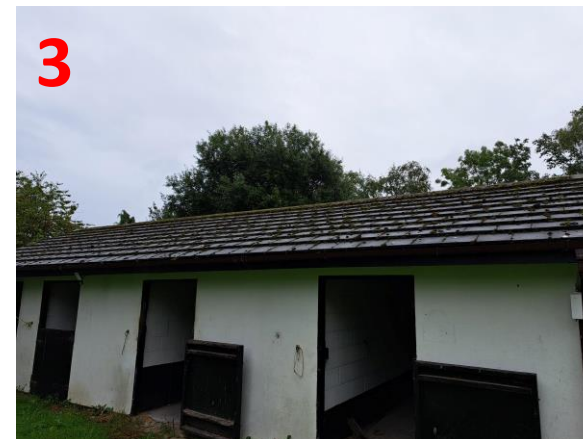
**Photo 3** – Structure roof

- 2.3.6. The roof of the structure is generally in good condition with no lifted tiles and good quality ridge flashing which has no crevices or openings (Appendix 1: Photo 3). At either end of the structure, there are small gaps between the roof lining and roof tiling where the mortar has crumbled, which leads to long, narrow cavities that span the length of the roof (Appendix 1: Photos 4-6). The east end has a relatively cluttered entry point, whilst the west end is clear and open. A small number of bats could use these spaces opportunistically, although it is unlikely to support a large number of bats or bats on a regular basis as there is little shelter from inclement weather provided and there would be large temperature fluctuations depending on conditions. As such, these features were assigned a **low suitability** to support roosting bats. It is not considered to have hibernation potential due to the poor levels of shelter and potentially large temperature fluctuations. There is no other flashing or features such as soffit boxes that may provide a sheltered space for roosting bats

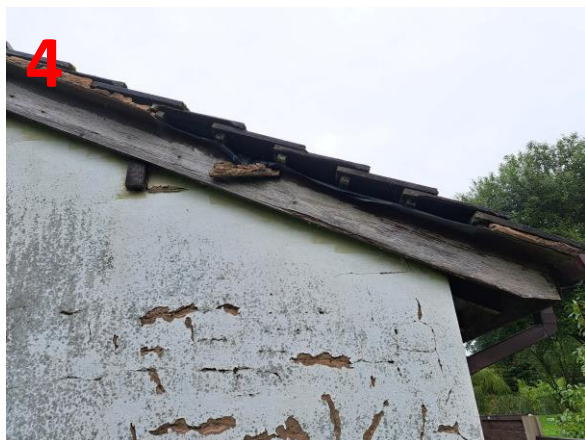
**Photo 4** – Gaps between roof and felting (south-west)

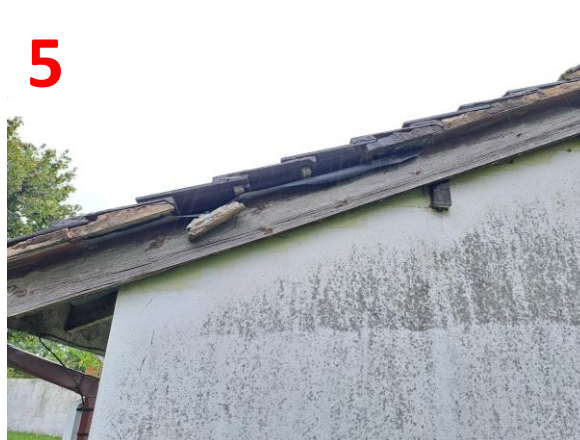
**Photo 5** – Gaps between roof and felting (north-west)

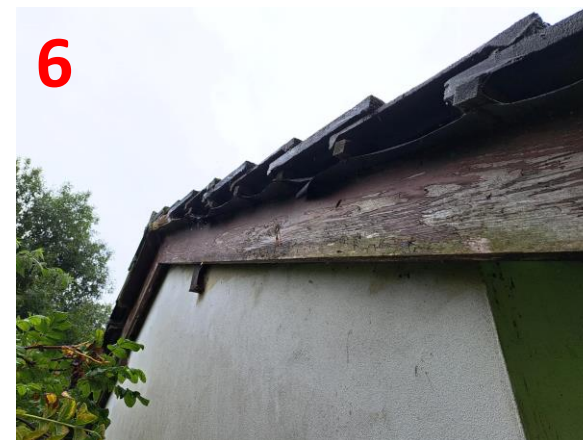
**Photo 6** – Gaps between roof and felting (north-east)

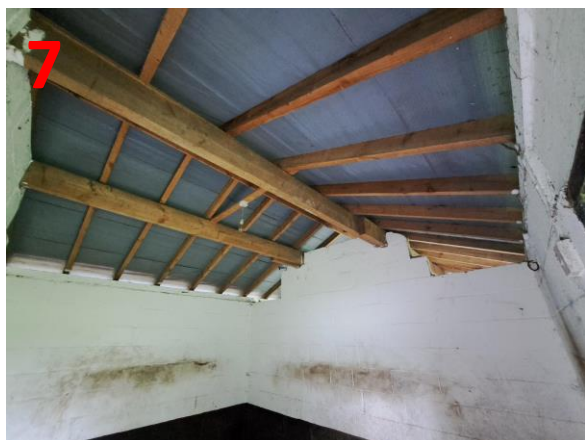
- 2.3.7. The interior of the structure consists of three open stables with no loft space that may provide a suitable sheltered space to support roosting bats (Appendix 1: Photo 7). Visual inspection and verbal confirmation with the owner confirmed that these stables are

**Photo 7** – Structure interior
